Report # MATC-MS&T: 196

Nondestructive Evaluation of Mechanically Stabilized Earth Walls with Frequency- Modulated Continuous Wave (FM-CW) Radar

June 2014

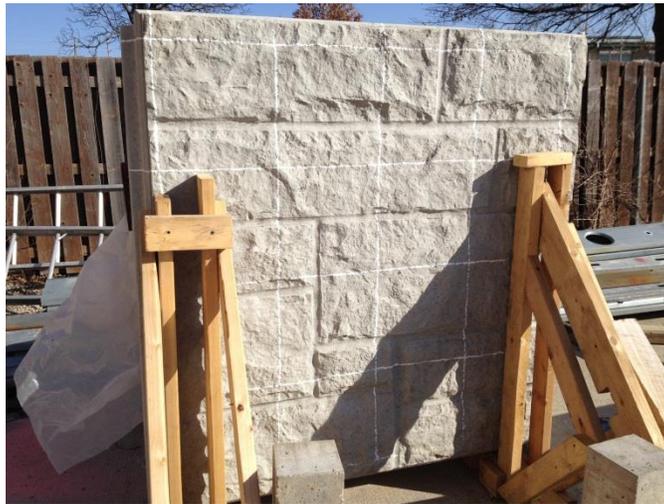
Figure 2.1 Erected MSE wall used in this investigation

As shown in figure 2.1, a 5ft × 5ft × 7in (full size) reinforced concrete MSE wall panel (TENSAR Int.) was used in this study. It was reinforced with #4 epoxy-coated steel bars that were 0.5 in. in minimum diameter and located approximately at its middle depth. The concrete used in the construction of panels was Class A-1, 4 ksi compressive strength, which contained both fine and coarse aggregates. The size of the coarse aggregates was up to 1 in. The wall panel had a 2 in. rugged decoration layer on the front side.

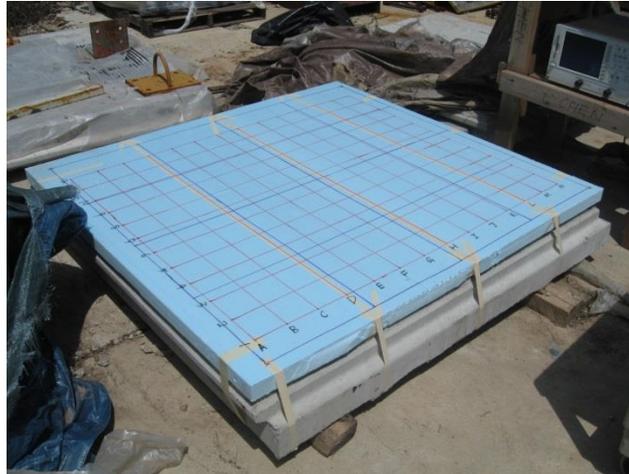
Figure 2.2 Construction foam (blue) on the decorative face of the wall to produce a uniform scanning/measurement distance

During testing, all MSE walls were supported on wood blocks to minimize electromagnetic interference (EMI). An erected panel in the application position is shown in figure 2.1, in which the orthogonal white lines represent the location of reinforcement bars embedded in the concrete. To provide a uniform scanning distance, a piece of foam (2 in. thick) was attached on the decorative face, as indicated in figure 2.2.

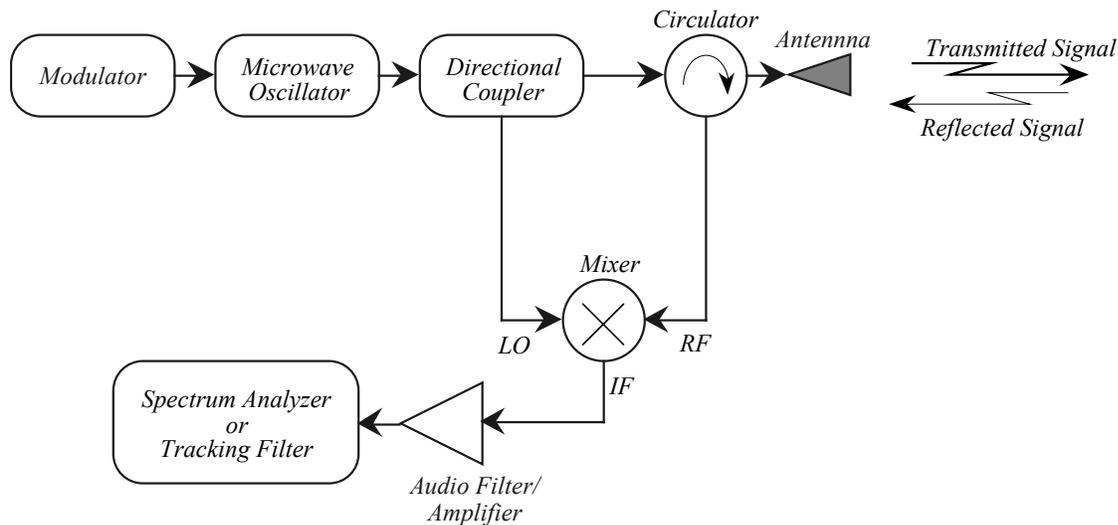
Figure 2.3 The general schematic of an FM-CW radar system

Figure 2.3 shows the general schematic of an FM-CW radar system. The modulator produces a triangular (or a linear ramp) waveform. A portion of the modulated signal is then sent to the local oscillator (LO) port of the mixer, using a directional coupler, while the remaining portion passes through a circulator and is then transmitted via the antenna. This signal travels through the wall and is partially reflected back from boundaries behind the wall, received by the antenna, sent through the circulator, and fed to the radio frequency (RF) port of the mixer. The reference signal at the LO port and this reflected signal at the RF port are then “mixed” to produce a low frequency signal at the intermediate frequency (IF) port of the mixer, which is proportional to the delay introduced in the reflected signal due to its two-way travel to the end of the wall and back (i.e., range or distance). Consequently, the frequency at which the signal appears at the IF port can be measured from a spectrum analyzer or a simple tracking filter and is *directly* related to the distance of the target.

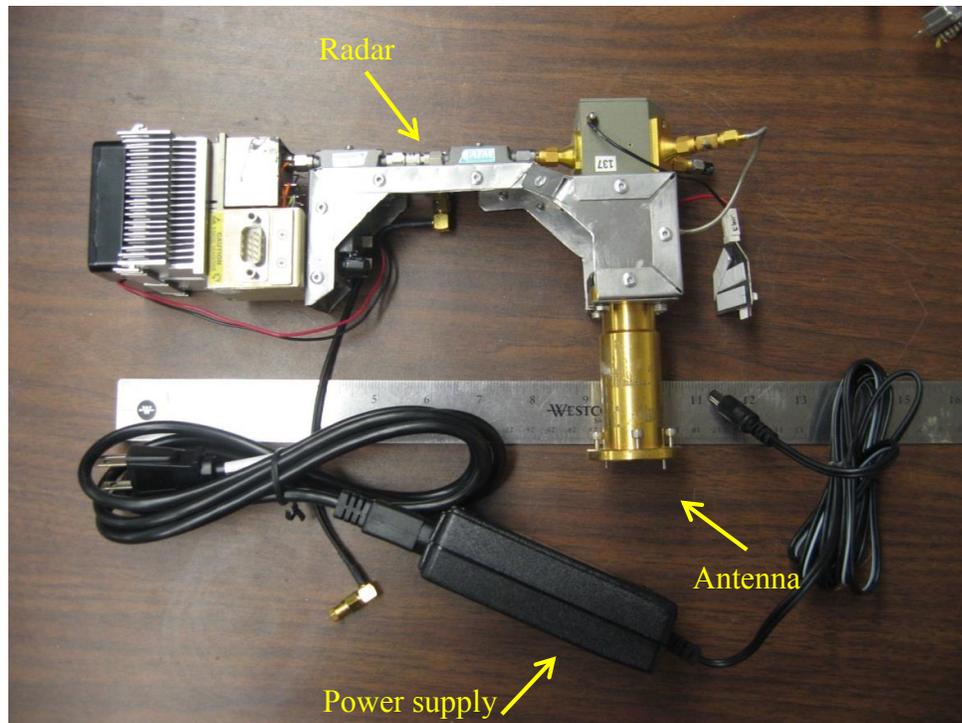
Figure 2.4 The modified FM-CW radar circuitry prior to packaging

Figure 2.4 shows the modified FM-CW radar circuitry before packaging. Figure 2.5 shows the ABS-packaged FM-CW radar with a high gain antenna attached. Figure 2.6 shows the

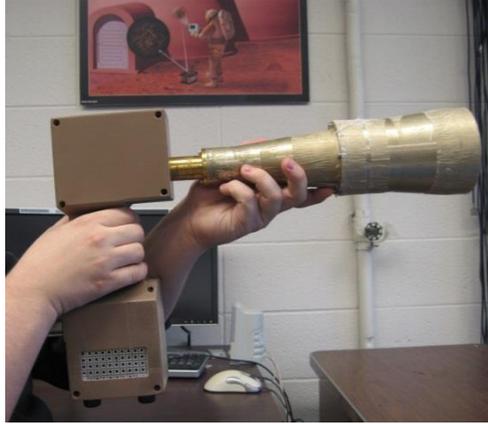
Figure 2.5 ABS-packaged FM-CW radar with a high-gain horn antenna

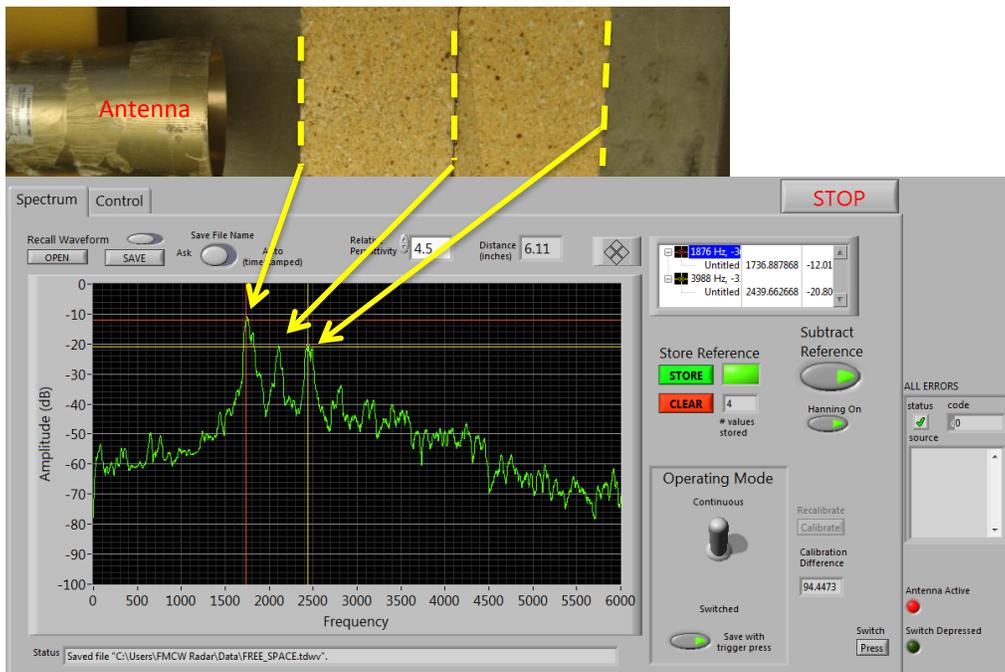
Figure 2.6 Using the FM-CW radar to find interfaces in-between refractory bricks; each peak represents a dielectric interface

application of the FM-CW radar for finding interfaces between refractory bricks. In the graph shown, each peak represents an interface. The reflection from the horn-air interface is removed by measuring this reflection when radiating into air and subsequently subtracting it from any consequent measurements.

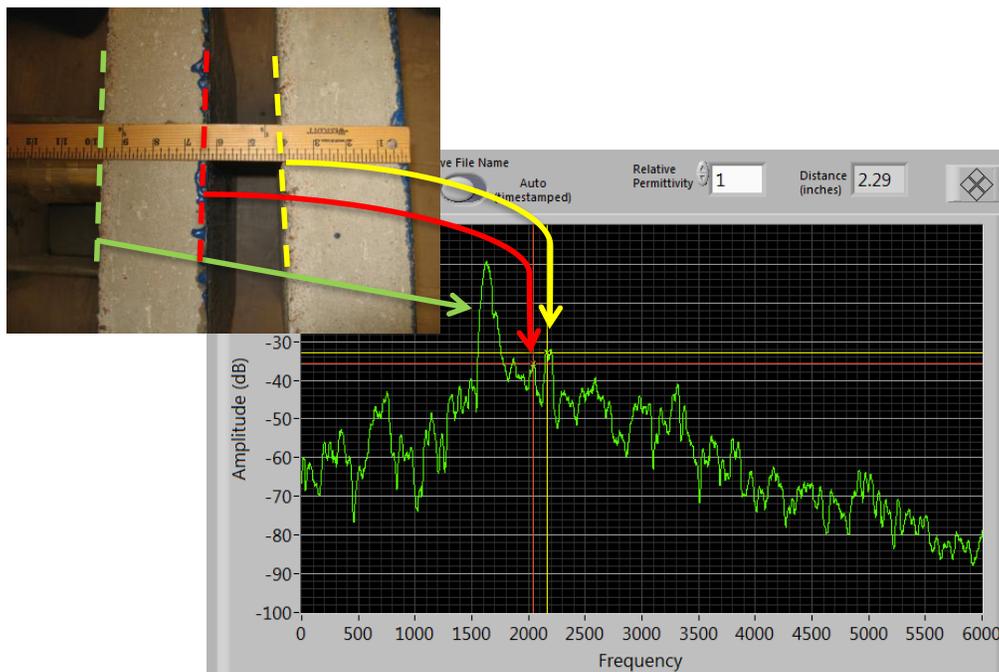
Figure 2.7 Testing the 8-18 GHz FM-CW radar on two concrete slabs in the laboratory

Figure 2.7 shows the results from a laboratory test performed using two 4”-thick concrete slabs with the FM-CW radar. In this test, the FM-CW radar shows the capability of detecting voids through a 4”-thick slab of concrete. However, the high signal loss associated with the concrete slab significantly attenuates the microwave signal to a great extent. Consequently, the

peaks representing the back wall and the far side of the void are quite faint when compared to the background clutter (other peaks). This experiment showed that because this particular FM-CW radar operates at relatively high frequencies (8-18 GHz), it may suffer from such signal attenuations when used on a thick MSE wall. To further assess the signal attenuation issue, a time-domain reflectometry experiment was performed using an Agilent 8753E vector network analyzer (VNA) and a wideband (1-4 GHz) horn antenna. This experiment is similar to the one using the FM-CW radar, however in this case, a lower frequency range was used. Signal attenuation through materials decreases as the operating frequency decreases. This setup was used to detect an air gap behind an 8"-thick concrete block, as shown in figure 2.8. As indicated by the various arrows pointing to the peaks in the graphs, this setup was capable of detecting a void behind the 8"-thick concrete block. Furthermore, due to the lower operating frequency range and the lower signal attenuation, the peaks resulting from the void are distinguishable from background clutter. The drawback of this setup is the smaller bandwidth of the system (3 GHz) that results in a lower than desirable range resolution. To obtain a higher range resolution, an antenna capable of operating in a wider frequency band may be used, such as a Vivaldi antenna. Figure 2.9 shows a 1-6 GHz Vivaldi antenna being used to detect a void behind a retaining wall section. The smaller concrete blocks behind the wall were used to create a 4"-thick gap. The test results are shown in figure 2.10. The Agilent 8753E VNA was also used to make these measurements. The results show that this system is capable of detecting the front and back interface of the wall. It is also capable of detecting a metallic plate (strong reflector) placed 4" behind the wall. However, when detecting the small concrete block from a 4" distance, the signal peak becomes weak and fades into the background clutter. It must be noted that this MSE wall section is an inhomogeneous medium with an uneven surface, a large aggregate, and a mesh

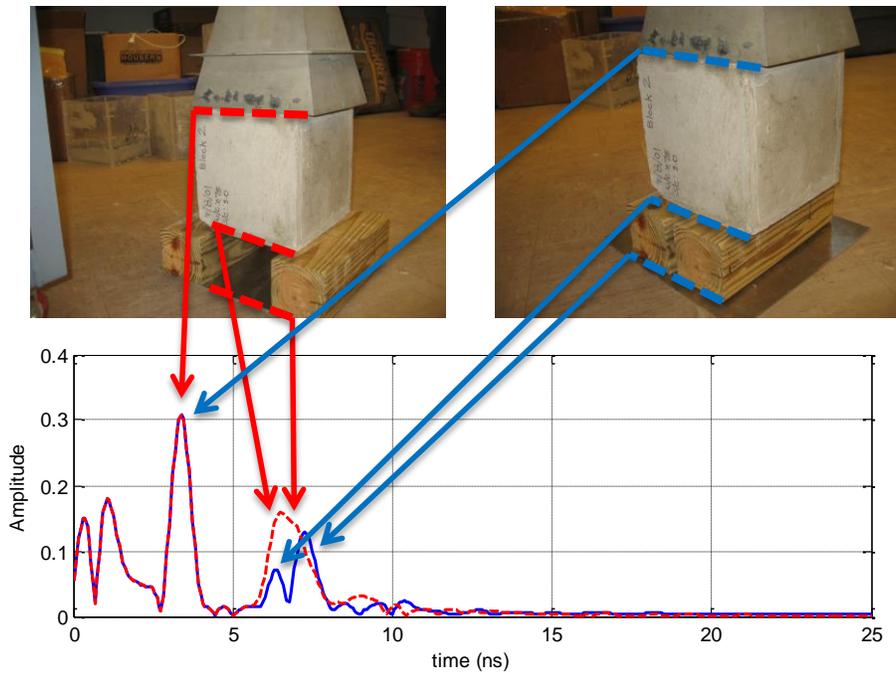
Figure 2.8 Time-domain reflectometry results from an 8"-thick concrete block using a VNA and a wideband (1-4 GHz) antenna

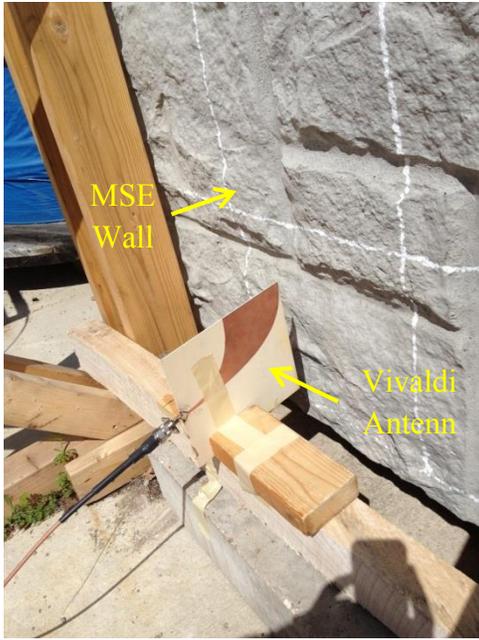
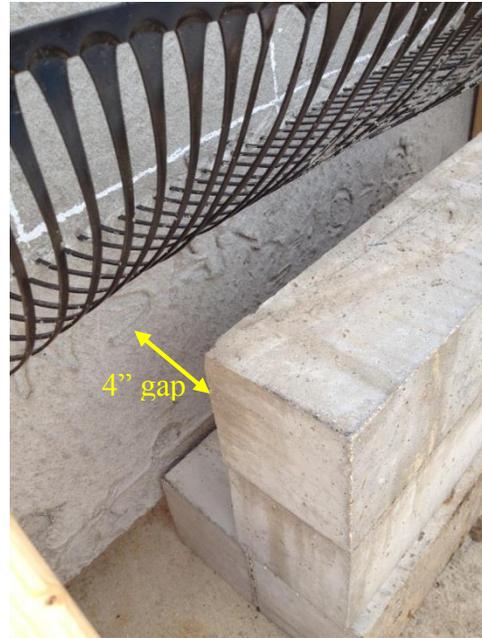
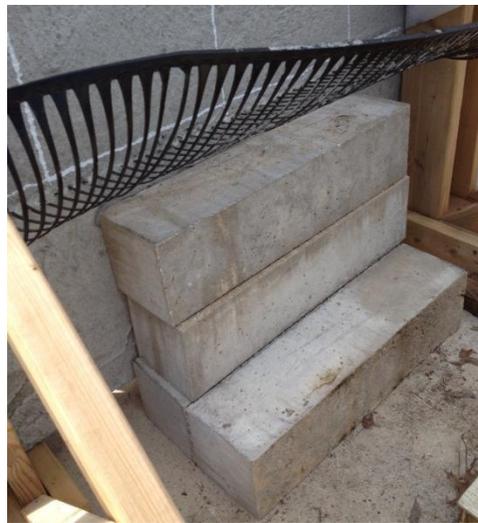
Figure 2.9 Using a wideband (1-6 GHz) Vivaldi antenna to perform time-domain reflectometry on an MSE wall section, which shows (a) the front of the wall with the Vivaldi antenna, (b) the back of the wall with concrete blocks creating a 4" gap, and (c) the back of the wall with concrete blocks firm against the wall (no gap)

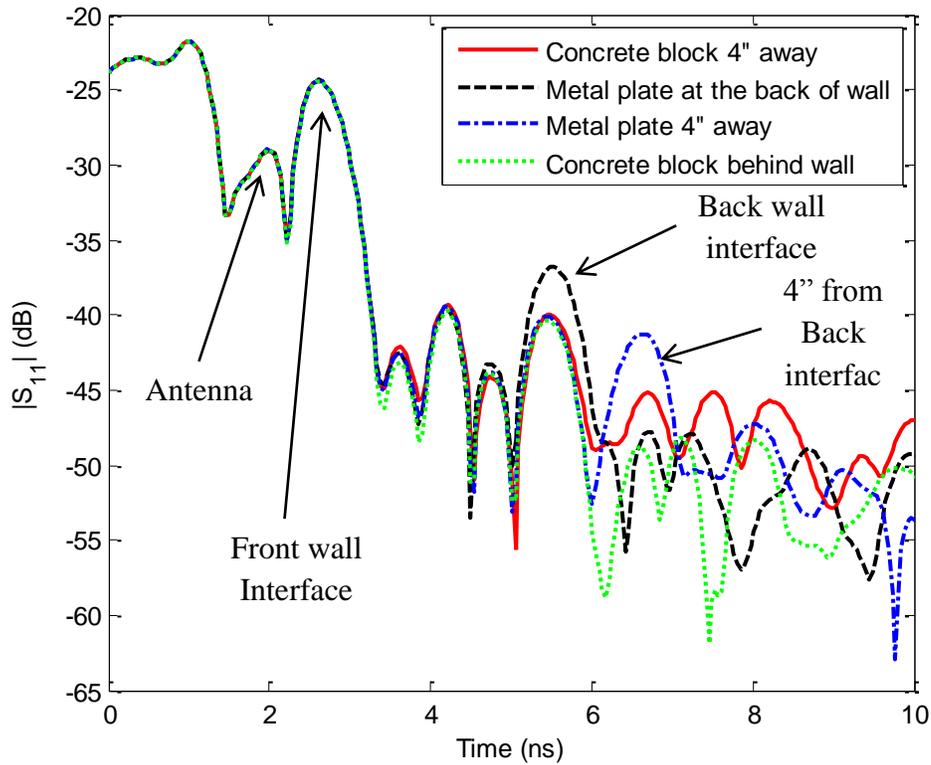
Figure 2.10 Time-domain reflectometry through the wall setup using the 1-6 GHz Vivaldi antenna

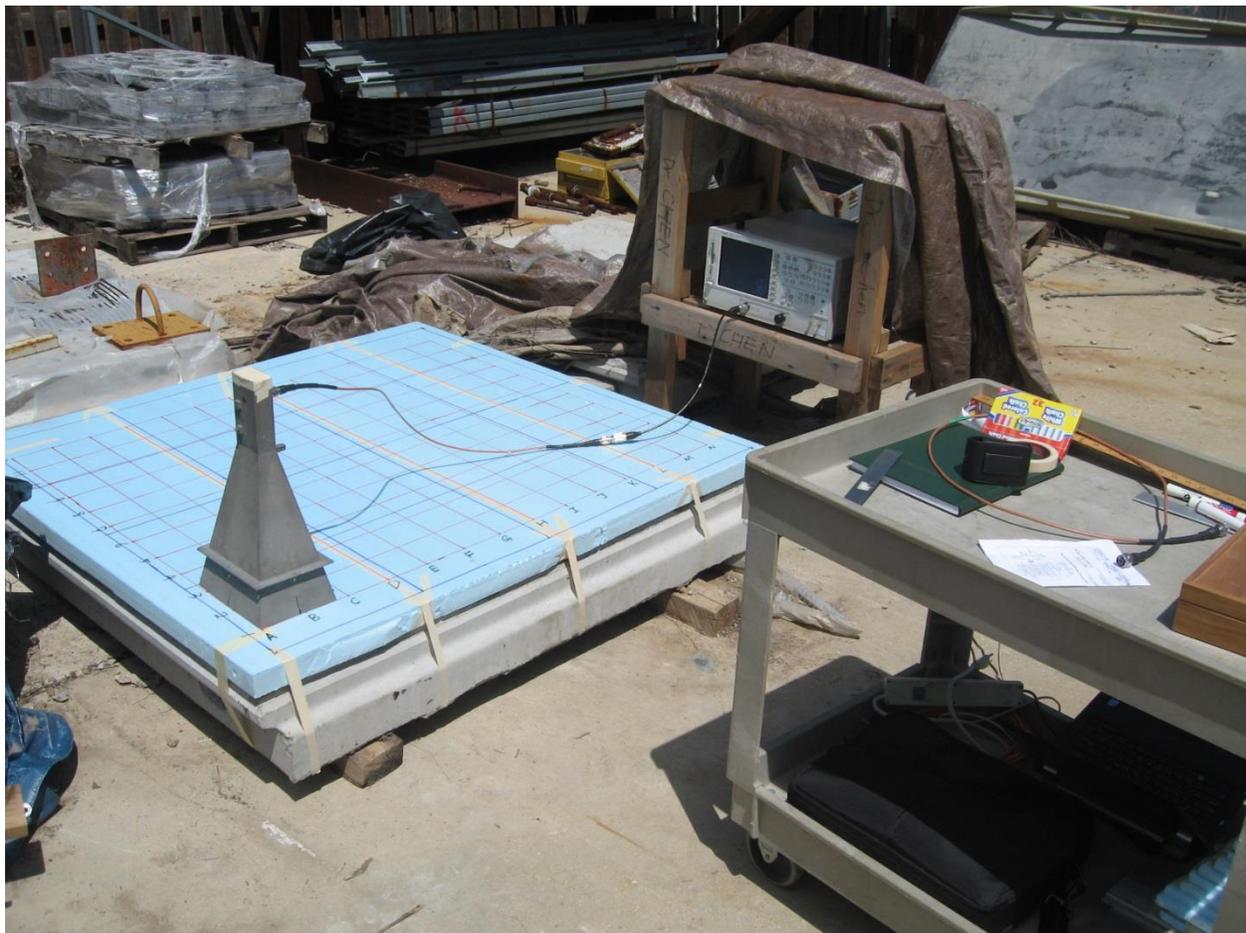
Figure 2.11 SAR imaging scan setup using a 50 mm-thick (2") construction foam placed on top of the MSE wall section to provide a flat surface for scanning

Three-dimensional (3D) SAR imaging involves performing wideband measurements on a two-dimensional (2D) plane parallel to the surface of the wall. This technology has become significantly more advanced during the past five years for the specific purpose of NDE imaging in both system hardware and imaging algorithm development aspects [4-7]. Figure 2.11 shows the measurement setup on a single MSE wall placed horizontally on the ground. For this purpose, an Agilent 8753E vector network analyzer (VNA) was used to make reflection measurements (S_{11}) using a wideband horn antenna. The horn antenna operated in the frequency range of 1 to 4 GHz. It was scanned on a 2D grid with a spacing of 10 cm on top of the

construction foam sheet. The sheet of foam provided a uniform and flat surface for manual scanning in the absence of an automated scanning platform. The sheet of foam was 50 mm thick, which made its dielectric properties similar to air at those frequencies. The S_{11} measurements were later phase-referenced to the aperture of the antenna by accounting for the measured characteristic of the antenna [4].

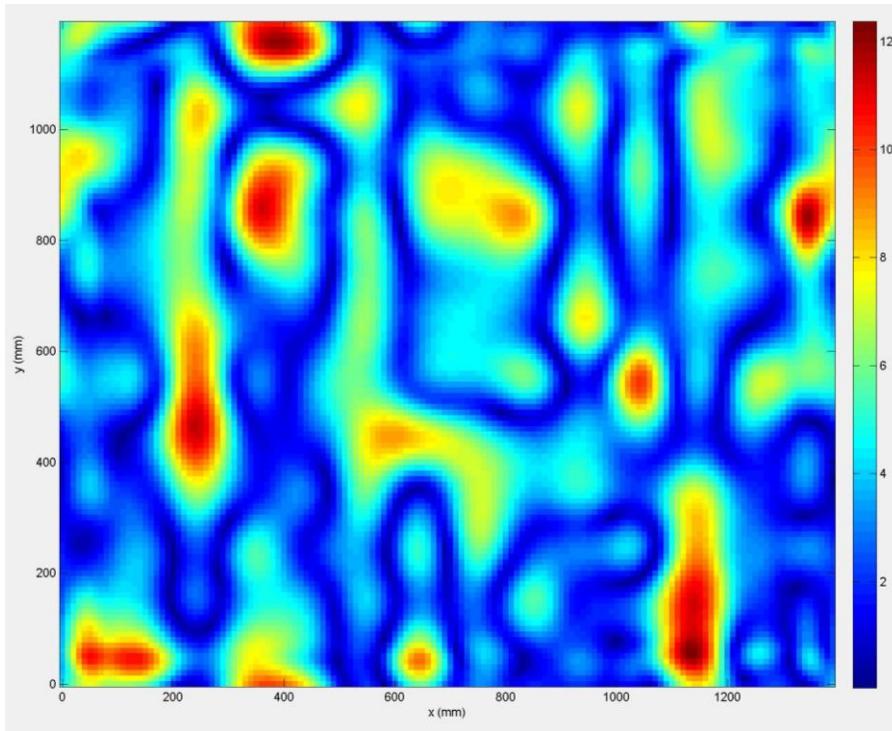
Figure 2.12 2D image slice corresponding to the surface of the MSW wall section

The wideband SAR imaging algorithms essentially provide a 3D image. Typically, 2D slices parallel to the scan plane (at a certain depth) can also be produced from the 3D image and displayed. Figure 2.12 shows a slice image corresponding to the surface of the sample. The non-flat surface of the sample (i.e., for decorative purposes) produces strong indications due to its significantly rough surface and relatively sharp edges. Thus, these indications are due to scattering from the grooves and peaks on the concrete surface. These grooves and peaks represented a surface roughness in the range of 20 mm to 50 mm. This level of surface roughness represents a substantial portion of the mid-band wavelength ($\lambda_o = 120$ mm) and is easily detected. Figure 2.13 shows a 2D image slice of the back surface of the MSE wall section that indicates a large metal plate with dimensions of 10" x 24", which was placed on the back surface to check whether or not the method would be able to detect it. The background of this image also shows false indications that are due to the same significantly rough surface that was mentioned above. These false indications are present in the back surface image due to the limited range resolution associated with the imaging system which is directly proportional to the limited bandwidth of the measurements. These false indications, which are relatively weak in this particular image slice, can mask indications of weak scatters such as voids that may be present behind an actual MSE wall. For example, figure 2.14 shows a 2D image slice of the same MSE wall section with a sand-filled bucket placed right at its back surface. Sand produces weaker reflections compared to

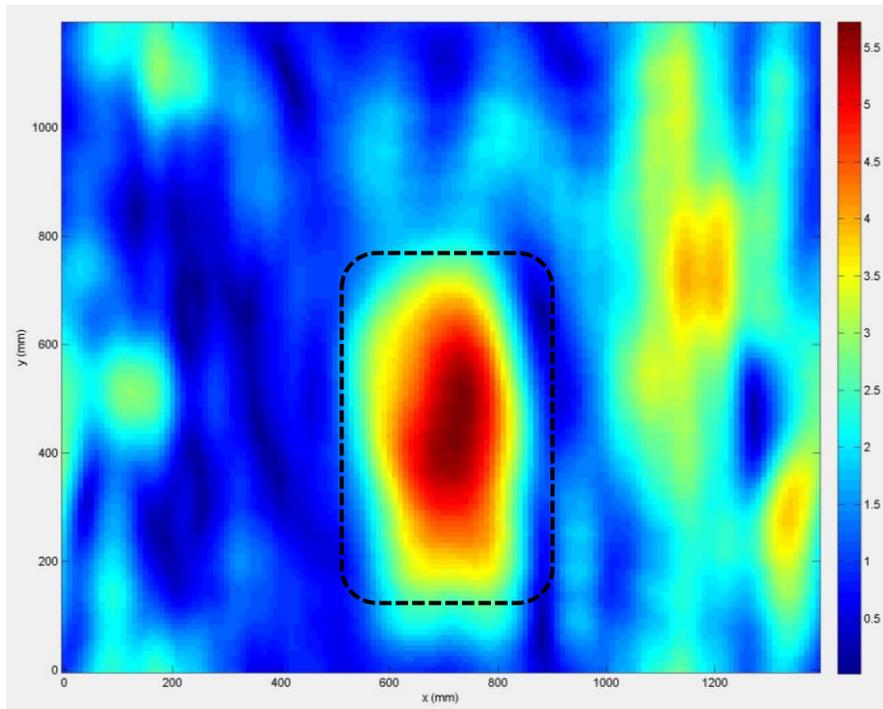
Figure 2.13 2D image slice corresponding to the back surface of the MSW wall section showing the indication of the metal plate

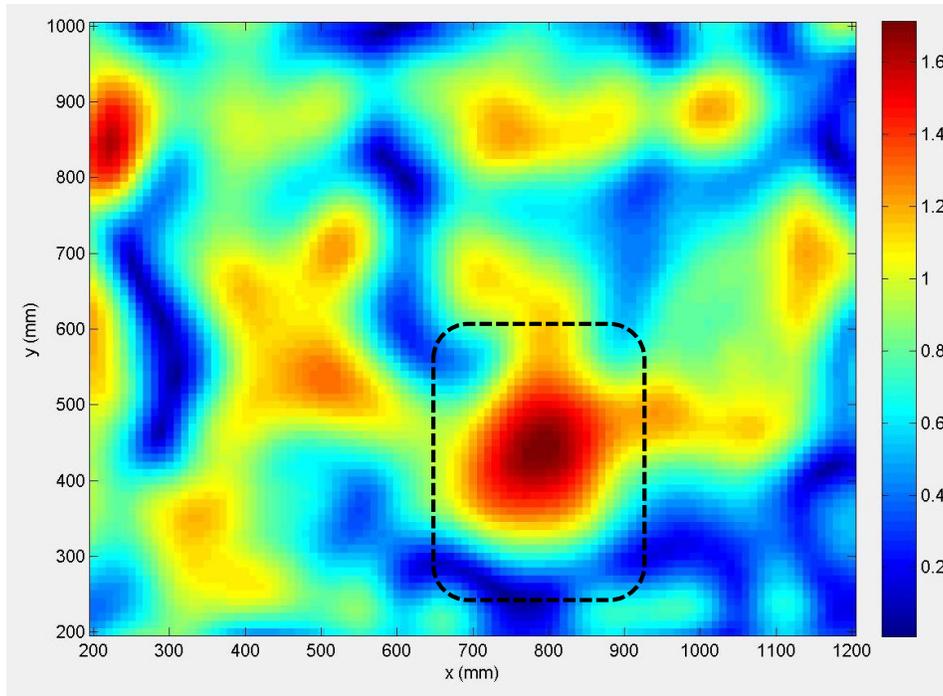
Figure 2.14 2D image slice of the back surface of the MSE wall section showing the indication of a sand-filled bucket right behind the wall section and at its back surface

the metallic plate, and as such, its indication in the image lower intensity. In this image, the false indications from the front surface are still present in the image slice of the back surface and are comparable to the indication from the sand. The sand was saturated with water, and the resulting image is shown in figure 2.15. Wet sand produces a much higher reflection compared to dry sand, as shown by the higher intensity on the indication in figure 2.15. These experiments presented a negative situation of sand in a background of air, as opposed to air voids in sand (or backfill soil). As it will be shown later, the opposite of voids in sand is similarly detected as well.

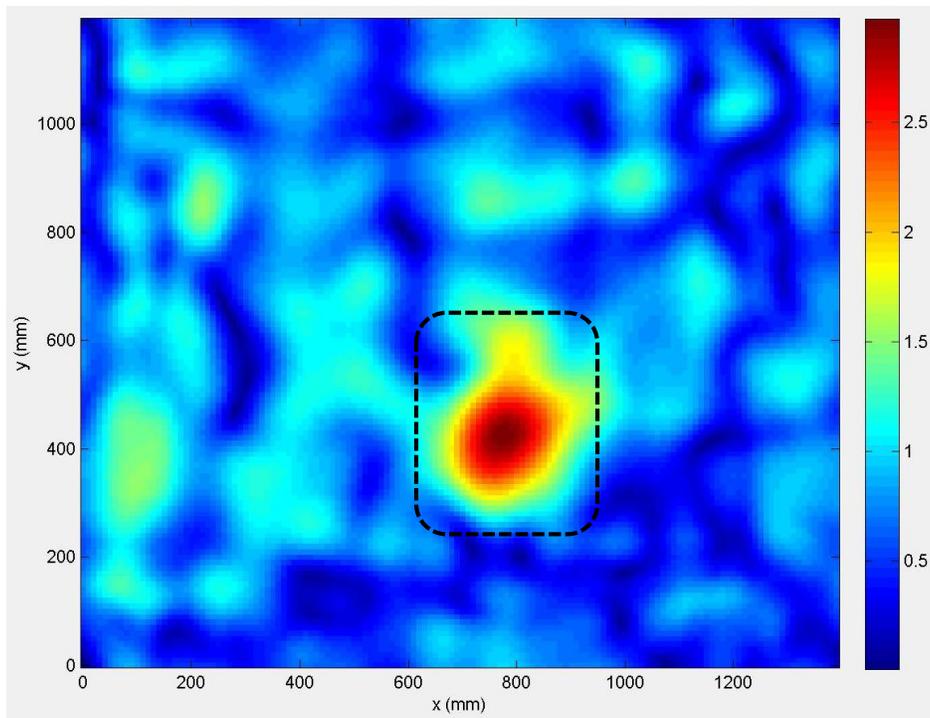
Figure 2.15 2D image slice of the back surface of the MSE wall section showing the indication of a wet sand-filled bucket

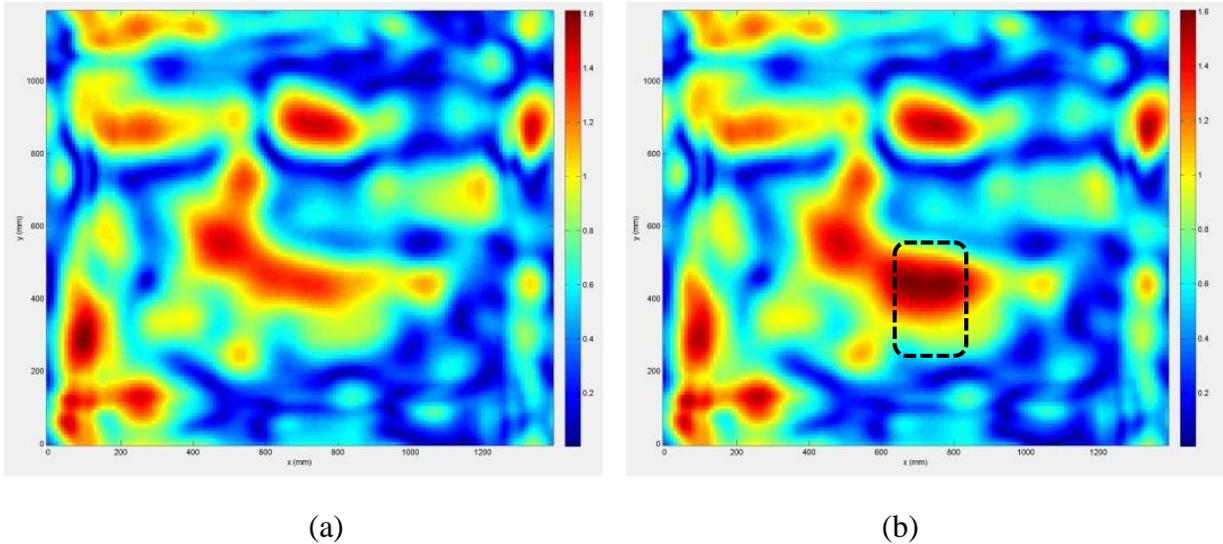
Figure 2.16 2D image slice of the back surface of the concrete MSE wall section (a) without and (b) with a sand box, indicated by the dashed rectangle

Figure 2.16 shows two image slices corresponding to the back surface of the concrete MSE wall section with and without a sand box placed behind it. This figure clearly shows the adverse effect of the surface features on detecting objects placed behind the wall since the indication of the sand box is not clearly distinguishable from the surrounding regions. Figure 2.17 shows obtained 2D slices corresponding to the front surface of the block. These images are essentially the same, signifying the repeatability of the imaging technique. When the raw measurement data of the block without the object (i.e., the sand box) is subtracted point-by-point from the raw measurement data of any subsequent scans, any fixed source of scattering, such as the surface profile and the embedded rebars, is removed. Figure 2.18 shows the image slice at the

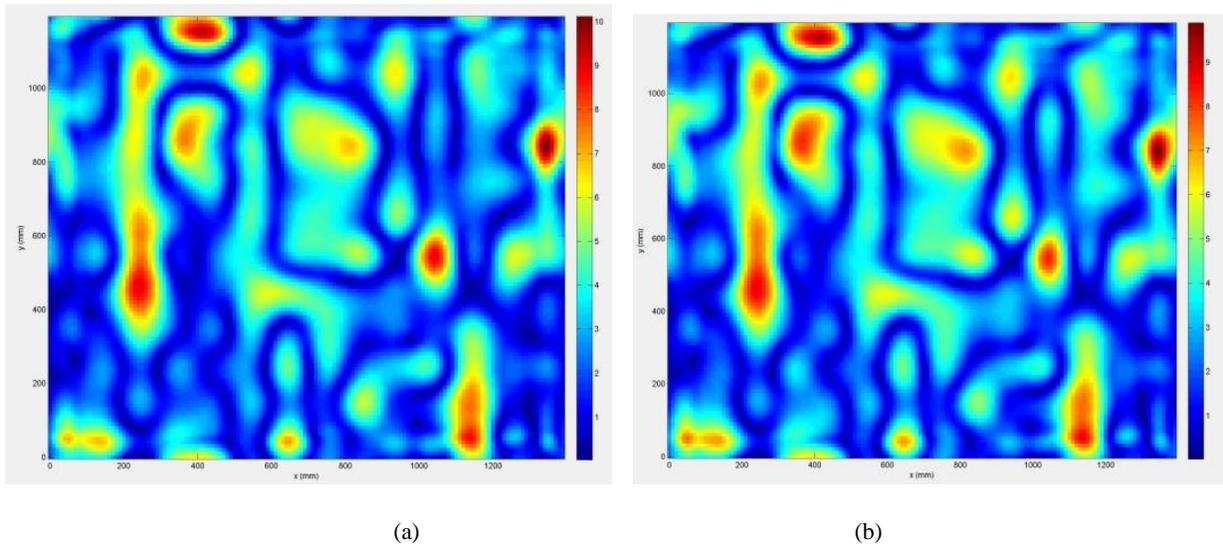
Figure 2.17 2D image slice of the front surface of the concrete MSE wall section (a) without and (b) with a sand box

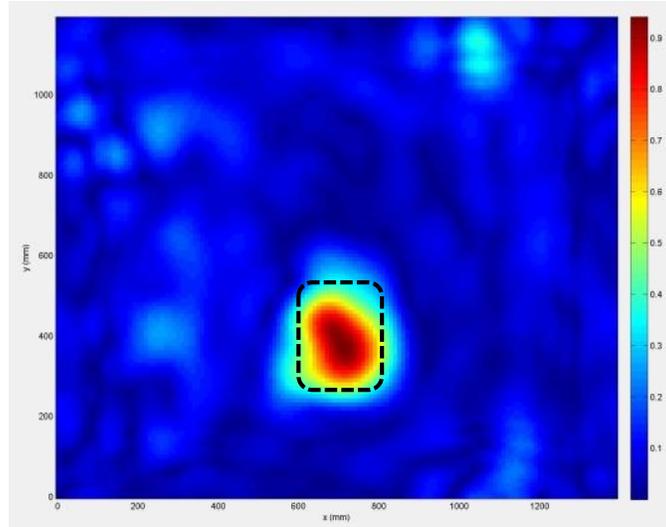
Figure 2.18 2D the back surface image slice of the concrete MSW wall section after subtraction

back wall from the wall indicating the presence of the sandbox, which was obtained by subtracting a reference measurement (without the presence of sandbox). This figure clearly shows the benefit of subtracting the exact reference measurement by removing the adverse clutter due to the non-uniformity of the surface top.

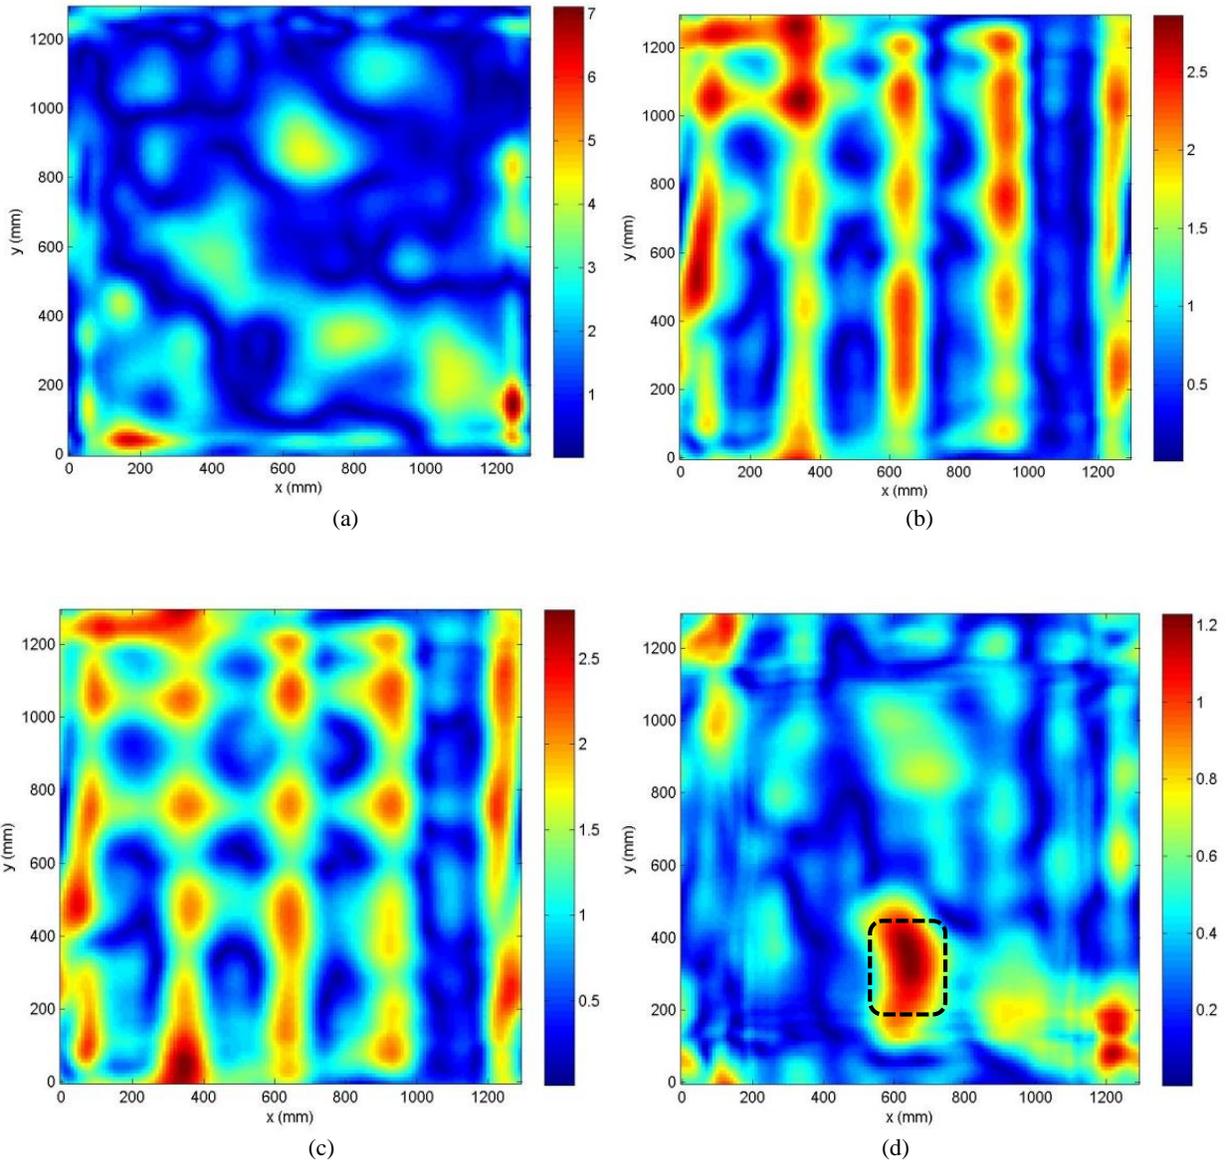
Figure 2.19 Image slices of the MSE wall section from the (a) surface of the wall, the (b) first row of rebars, the (c) second row of rebars, and the (d) surface of the back wall after filling the surface irregularities with concrete

To further illustrate the adverse effect of surface irregularities, the grooves in the surface of a second wall section was filled in with concrete to bring the surface irregularities from $\sim 2''$ to $\sim 0.25''$. Subsequently, this wall section was imaged as before. Figure 2.19 shows several 2D slices at various depths within the wall section. Figure 2.19 (a) corresponds to the image slice at the wall surface. Comparing this image to that of figure 2.17, the adverse effect of surface irregularities becomes apparent. Figures 2.19 (b-c) show the image slices at the depths of vertical and horizontal rebars (10 mm deep), respectively. Note that the vertical rebars are better indicated in these images due to the fact that the polarization of the electric field (linear polarization) matches the orientation of the vertical rebars. Previously, for concrete wall sections with a strong irregular surface, the rebars were masked by the strong influence of the surface and could not be imaged. Also, subtracting a reference measurement, as illustrated above, removes the rebar indications since they are common among the different samples of the same design and/or consequent measurements of the same sample. Finally, Figure 2.19 (d) shows an image slice corresponding to the back surface of the wall where a sandbox was located. The indication

of the sandbox is better distinguishable from the background clutter in this image compared to that of figure 2.16 (b). This experiment illustrates the adverse effect of the surface irregularities in cluttering the whole volumetric image, and subsequently the image slices at depths of interest, such as the back of the concrete wall where voids are expected to be present.

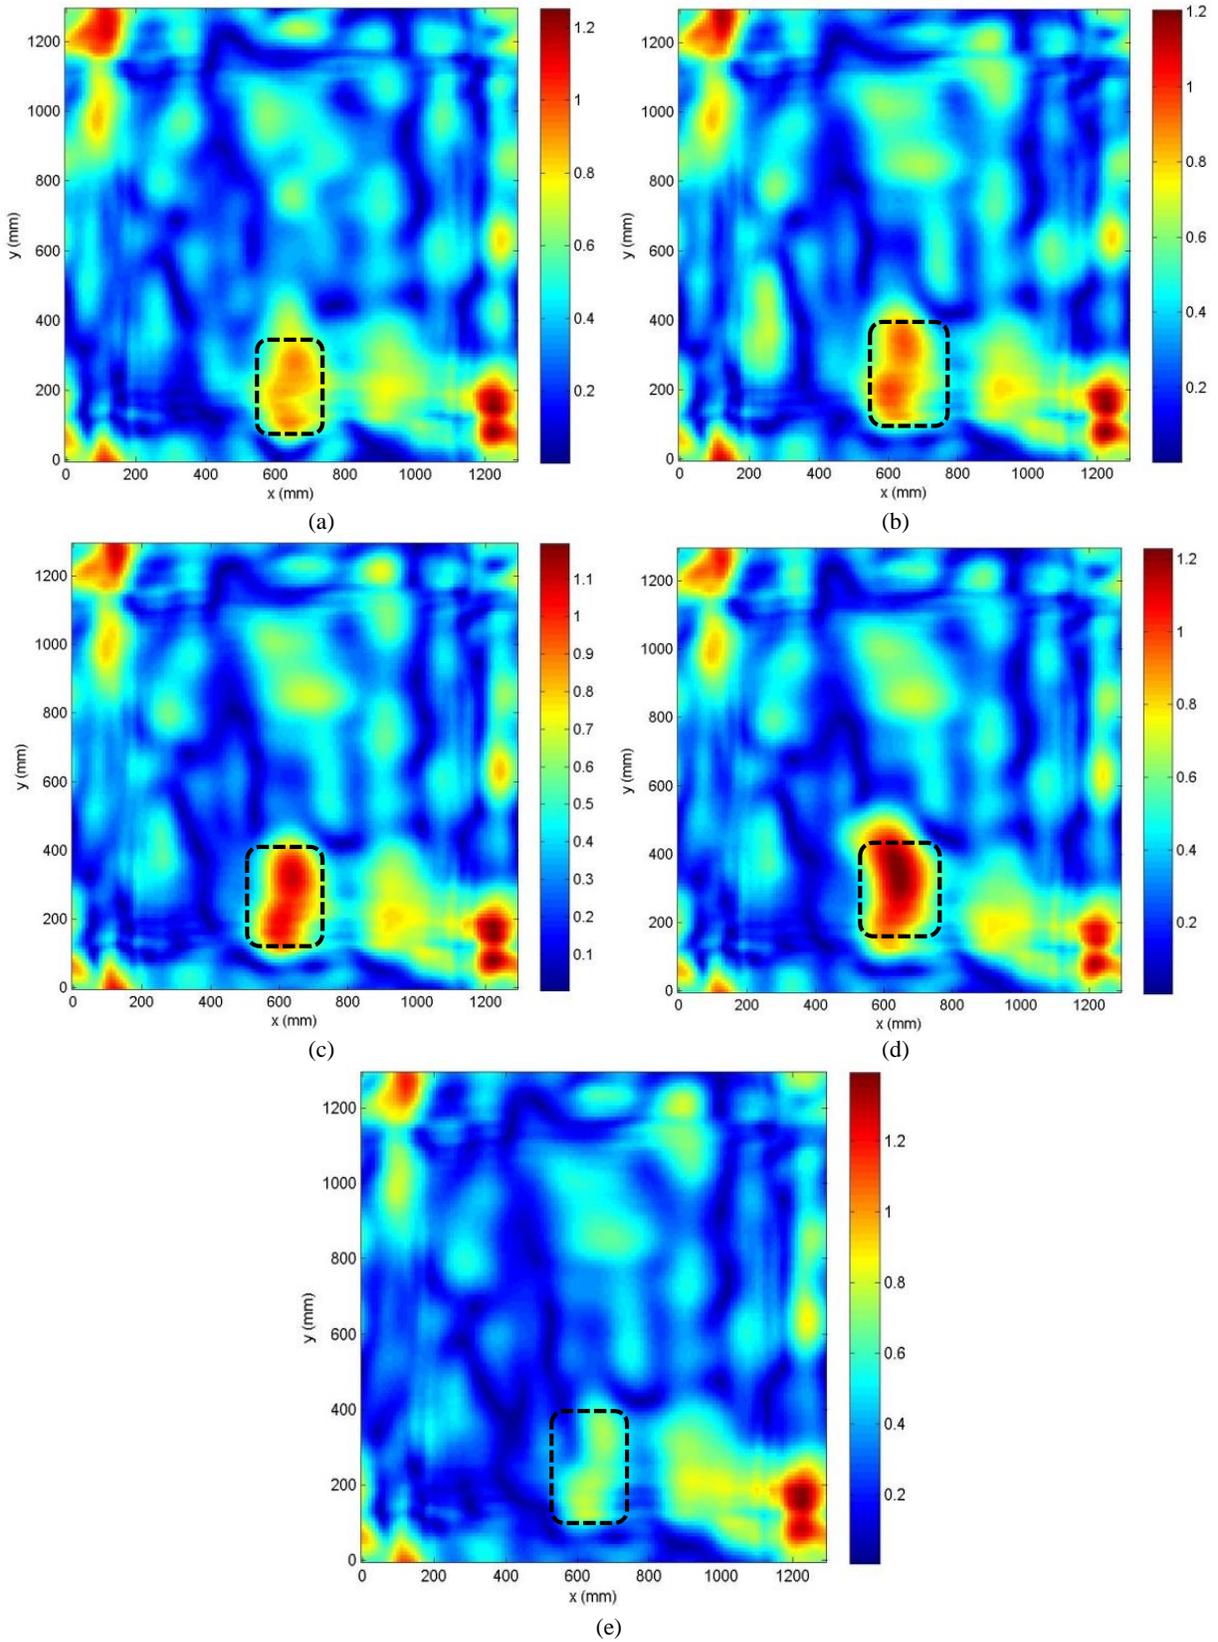
Figure 2.20 Images of the wall section after filling the surface irregularities with concrete: (a) dry sand, (b) wet sand 500 ml, (c) wet sand 1000 ml, (d) wet sand 1500 ml, and (e) water

The intensity of the void or sand indications is directly proportional to the dielectric property contrast among the wall, sand, and air. Concrete and sand have a close relative to air (vacuum) dielectric constant (real part of dielectric property) values, (~ 5 for concrete and ~ 3 for sand) and that makes detecting air-filled voids in sand possible. On the other hand, wet sand (due to presence of water) has a much larger dielectric constant in addition to a significant loss factor (imaginary part of dielectric property). A higher level of moisture in sand will further increase the contrast between air and sand resulting in a higher contrast in the image. Furthermore, the presence of moisture will also increase the contrast between wet sand and concrete, and that will result in larger reflections from the concrete sand boundary. Figure 2.20 shows images of a sandbox placed behind the MSE wall section with a smoothed surface (filled with concrete). The first image, figure 2.20 (a), is of dry sand. For the second image, figure 2.20 (b), the sand (≈ 7700 g) was mixed with 500 ml of water. For the next two images, figures 2.20 (c-d), the moisture level was increased by 500 ml increments, respectively. For the last image, figure 2.20 (e), the sand was replaced by water. As can be concluded from these images, the signal level in the sand indication is increasing proportionally with the moisture level. An exception is the water-only case, where the intensity of the indication decreased. We believe that for the latter case, a slight air gap existed between the back surface of the concrete wall section and the water container, along with the reduced the reflections from the water. Figure 2.21 shows a summary of these results where the target intensity is calculated and plotted along with the background intensity (clutter level). This figure shows that as the moisture level increases, the intensity of the target increases, while the clutter level in the background remains constant as expected. This experiment shows that the presence of moisture enhances void detectability. However, one can expect that non-uniform wetness and pockets of water behind the wall can lead to false

indications of voids. As will be shown later, voids produce a lower reflection compared to sand and water, and therefore voids will be represented as dark spots (blue) in the image compared to water which will be represented as bright (red) spots.

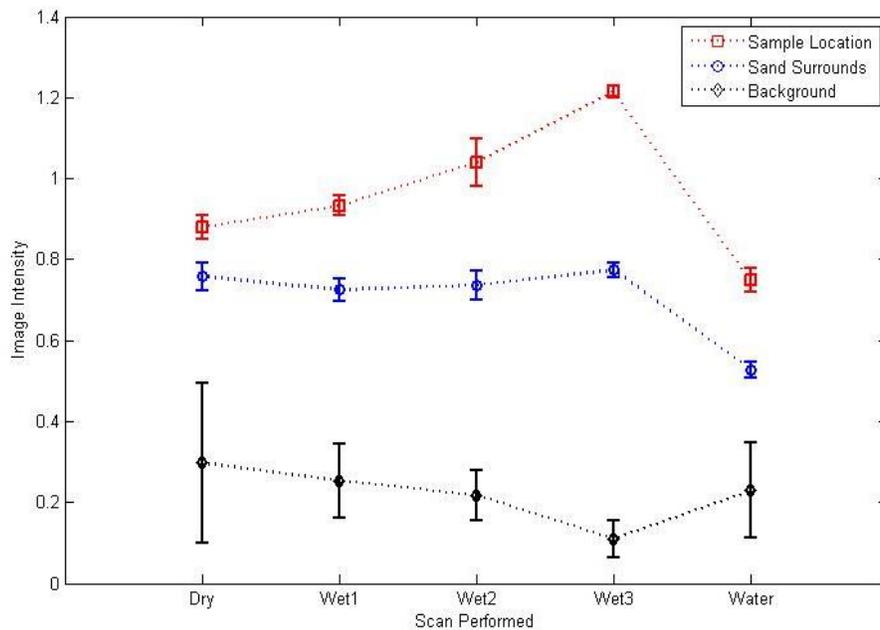
Figure 2.21 Target indication intensity compared to average background intensity

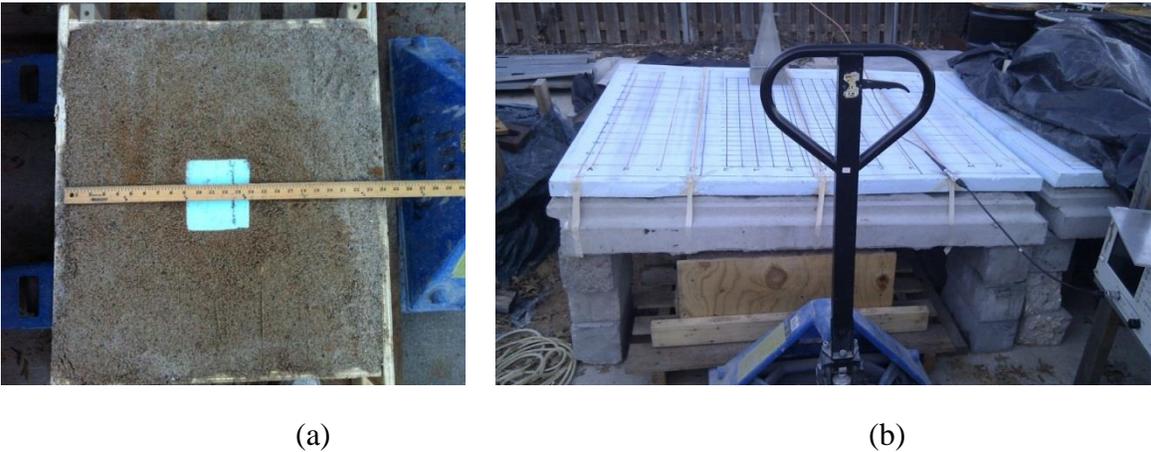
Figure 2.22 (a) Large sandbox and piece of construction foam to simulate void and (b) placed behind the MSE wall section using a palette jack

So far, the inverse of the void (i.e., sandbox surrounded by air) was scanned to practically show the feasibility of void detection behind a concrete wall. In this section, the results of imaging actual voids are demonstrated. A large 24”x24”x12” wooden box was constructed on top of a pallet. This large box was filled with sand, and pieces of construction foam were used to simulate voids. Foam is electromagnetically similar to air. Figure 2.22 (a) shows a 5”x5”x2” piece of foam placed inside the sand box to simulate a small void. Figure 2.22 (b) shows the sandbox placed behind a wall section using a pallet jack to move and press the sandbox to the back surface of the MSW wall section. This setup was scanned, and SAR image slices were produced as before. Figures 2.23 (a-b) shows SAR image slices at the location of the sandbox (the back surface of the wall) for a small (5”x5”x2”) and a large (10”x10”x2”) void, respectively. These images indicate the capability of SAR imaging for detecting voids in sand (or backfill soil)

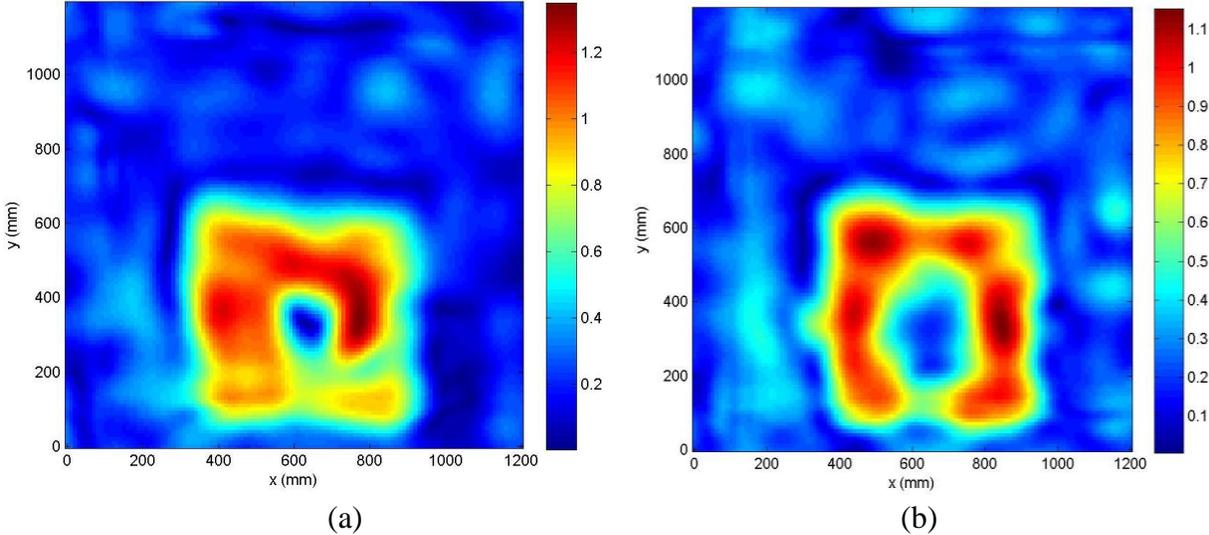
Figure 2.23 Image of (a) a 5''x5''x2'' void in the sandbox and (b) a 10''x10''x2'' void in the sandbox

behind the concrete wall. Furthermore, the size and extent of the voids are readily available in these images even through the 7”-thickness of lossy concrete. The depth of the void could not be detected due to the very limited range (depth) resolution. Nevertheless, these experiments illustrate the strength of SAR imaging in detection and the characterization of voids behind the concrete wall.
