Report # MATC-KU: 166

Final Report

Evaluation of Bonding Agent Application on Concrete Patch Performance

August 2014

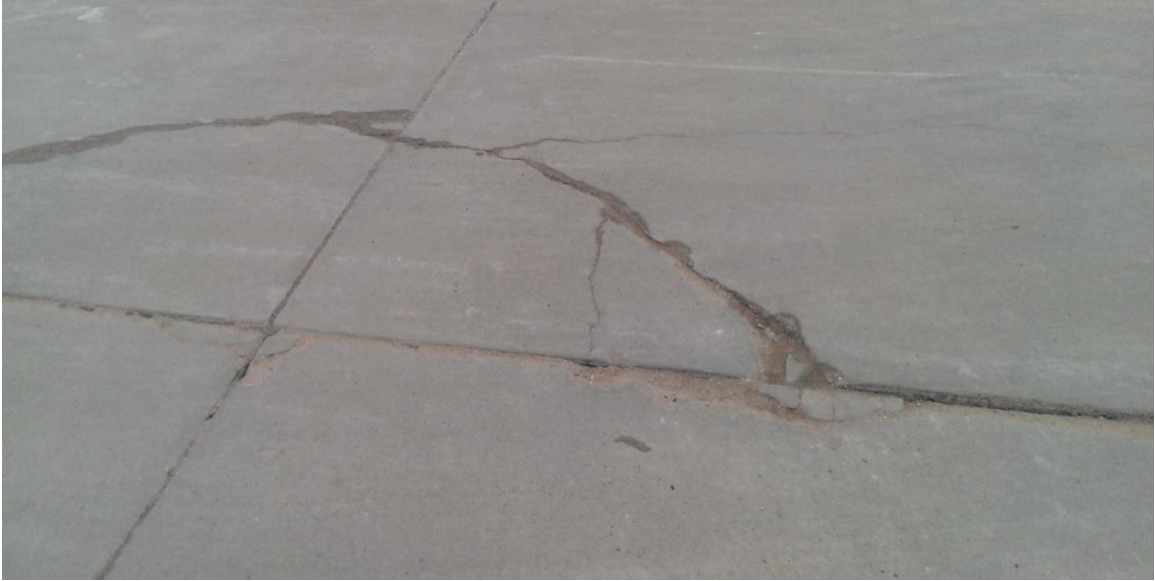
Figure 2.1 Pavement with surface cracks

Once cracking occurs, introduction of foreign containments into the pavement can accelerate the rate at which cracks propagate. Incompressibles become lodged in the cracks. When the pavement experiences expansion or contraction, the incompressibles cause stress in the pavement (T.P. Wilson 2000). Traffic loads can accelerate the rate of deterioration if cracks are present. When pavement deterioration is left unintended cracks are allowed to propagate and the condition of the concrete worsens. Figure 2.1 shows a pavement where the cracks have been allowed to propagate and the quality of the pavement has deteriorated. Figure 2.2 illustrates minor cracks that have started on the pavement.

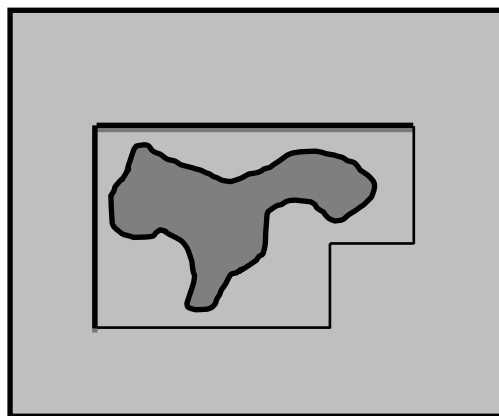
Figure 2.4 Example of simple boundary for pavement repair

When the damaged pavement is identified, all of the damaged areas need to be removed during a repair. This often involves removing concrete some distance beyond the identified damaged areas in order to ensure that damaged concrete that was not visible was not missed. Simple boundary conditions should be established for pavement repairs. Square or rectangular boundaries should be used, because uncommon irregular shapes will expose the repair material to edges that can produce stresses and can lead to premature material failure (T.P. Wilson 2000; Dar-Hao Chen 2011). The repair should be cut to provide the minimum perimeter. Minimizing

the perimeter can lower the overall repair cost, even if more repair material is needed because it lowers the amount of saw cutting required, and can help the bond last longer by reducing stress concentrations and cracking. Good performance on field patch repairs can be obtained, but only when all of the damage has been removed by removing slightly more concrete than is known to be damaged (Dar-Hao Chen 2011). This helps ensure that any difficult to detect micro-cracking at the edge of the damaged concrete is removed. The minimum depth of a partial depth patch should be more than two inches (KDOT 2007) in depth but no more than 1/3 slab thickness (T.P. Wilson 2000). This ensures that the patch is thick enough to have the strength to resist basic load induced cracks. If the patch is too thick, the old concrete may be damaged during removal or load transfer devices such as dowels may be damaged during removal. The outside boundaries should be a minimum of 2 inches from the spalled concrete and a maximum of 6 inches (T.P. Wilson 2000). An example boundary layout for a damaged area is illustrated in figure 2.4. Boundaries with four edges are ideal since boundaries with more edges will require additional cuts to be made (Emmons 1993; Dar-Hao Chen 2011; Fowler D 2008).

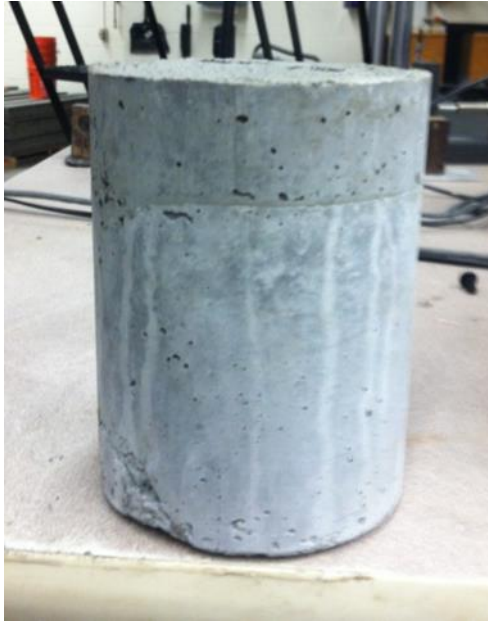
Figure 0.2 Composite concrete sample

The same mortar mix design was used for all of the bonding agent tests as well as the samples that did not have bonding agents, except for the rapid repair materials that were tested without bonding agents. The repair material was rodded 20 times with a 1/4 in steel tamping rod following the Illinois Standard Method of Test of Shear Strength of Bonded Polymer Concrete. After rodding, the samples were covered with plastic lids and stored in a 73°F 50% relative humidity room for a period of 24 hours. The samples were then de-molded and freeze-thaw cycles commenced. Figure 4.2 shows an example of the composite sample.

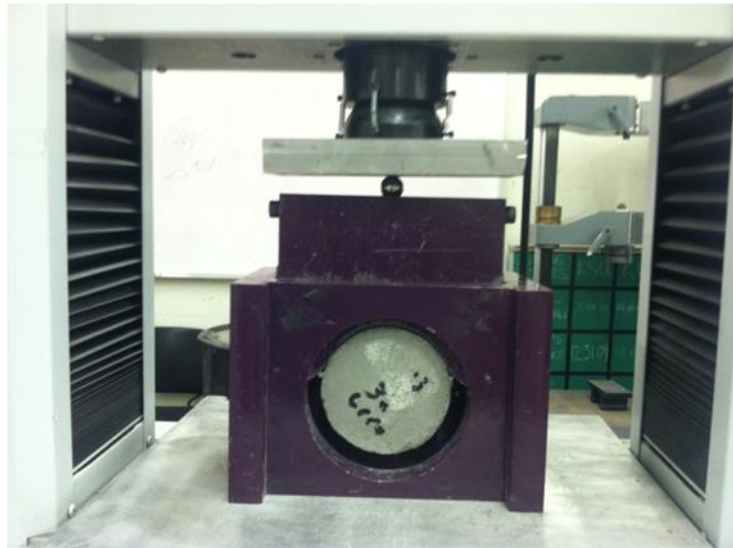
Figure 0.3 BNL guillotine

The Brookhaven National Laboratory (BNL) guillotine shear test apparatus was used to measure the concrete bond shear strength. When the freeze-thaw cycles were completed, both sample groups that were subject to thermal and non-thermal cycles were loaded until failure, as seen in figure 4.3, at a rate of .22 in. per minute with the BNL guillotine. The shear stress was calculated by dividing the maximum load recorded by the surface area of the cylindrical sample.

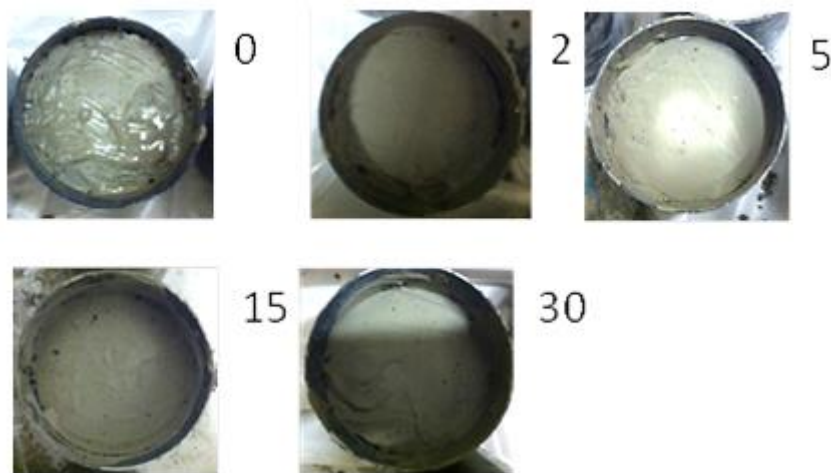
Figure 0.5 Waiting time effects for 0.5 W/C grout

The 0.5 bonding agent was much more viscous than the 3-1 grout used. Figure 4.5 illustrates how wait time affected the bonding agent. The 0.5 w/c grout lost its free water much sooner. After it dried, instead of becoming more of a paste-like consistency the 3-1 grout used, it started to resemble dried clay.

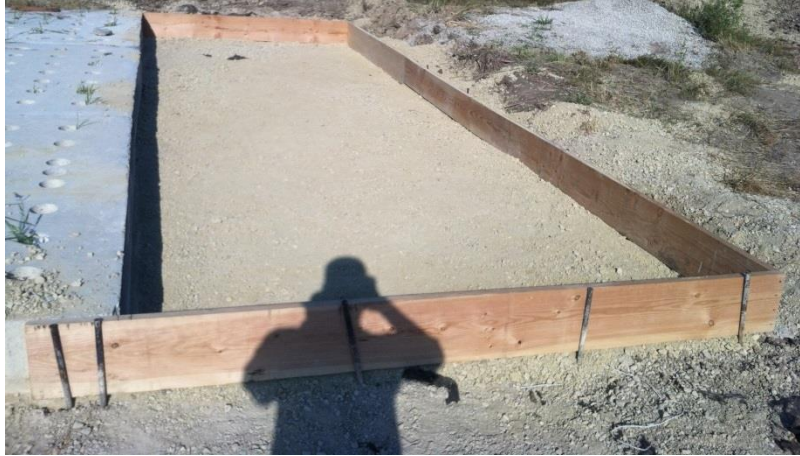
Figure 0.7 Site preparation

The field testing took place at the Civil Infrastructure Systems Laboratory at Kansas State University. Ten inch thick field slabs were constructed, one with dimensions of 8 x 24 ft. and the other 6 x 24 ft. The slabs were cast alongside already existing slabs. Ground leveling was completed using a skid-steer loader. Once the ground was level, wooden forms were set and stakes were placed so that the concrete forms would hold the pressure of the concrete during the placing process. The finished site before the first concrete slab was placed can be seen in figure 4.7.

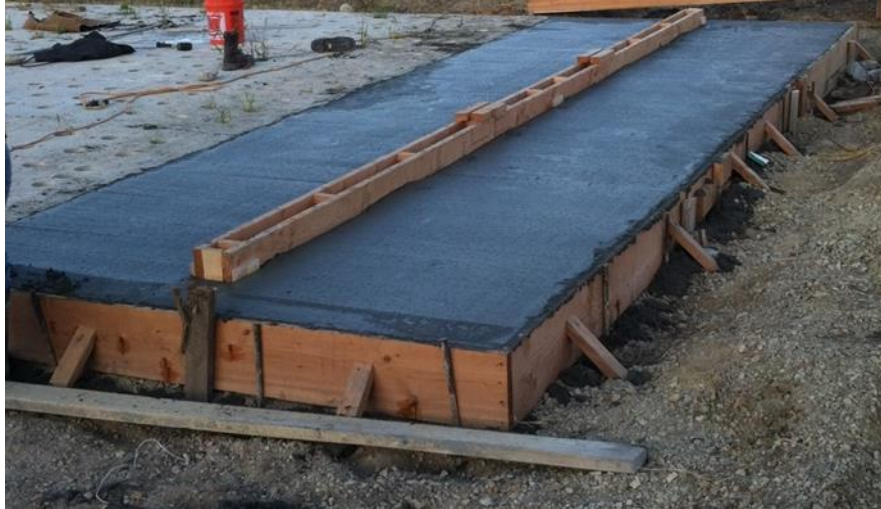
Figure 0.8 Field slab 1

The first slab was cast on September 24th, 2013. The concrete was supplied by a ready-mix concrete truck. Air-content and slump tests were performed immediately after arrival of the truck to make sure the concrete met required specifications. Compressive strength test cylinders were made to evaluate the compressive strength of the concrete used in the slabs. A concrete vibrator having a 1.5 in. diameter head was used to consolidate the concrete. The vibrating end was inserted and removed from the concrete in a vertical motion. The concrete slab was screeded with a wooden 2 x 6 in. beam that was ten feet in length. When the surface of the concrete slab was level, a 6 in. x 4 in. wooden box that spanned 22 ft. was placed in the center. The wooden box allowed a rectangular section in the middle of the slab to be open that was 6 in. wide and 2 in. deep. The cut out section was left in the concrete slab to make space for the repair and lessen the amount of concrete that would need chipped out later. Once the wooden frame was placed in the slab the surface was finished with a bull float. The finished field slab 1 is shown in figure 4.8. After one day of curing, the wooden box frame was removed from the slab.

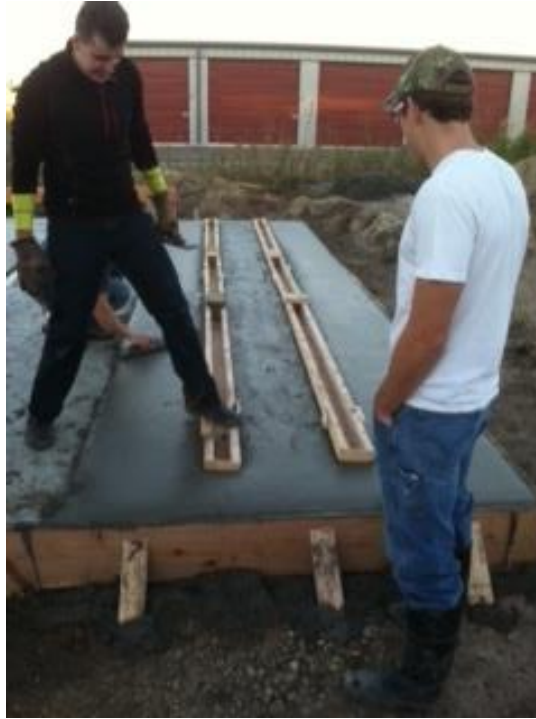
Figure 0.9 Field slab 2

Field slab two was constructed using the same process and mix design as the first slab and was placed on October 4th of 2013. The difference between slab 1 and 2 was that slab two had two box frames placed in the slab. Field slab 2 is shown in figure 4.9. After the two boxes were placed on the slab, weights were used to keep the boxes from being uplifted by the buoyant force.

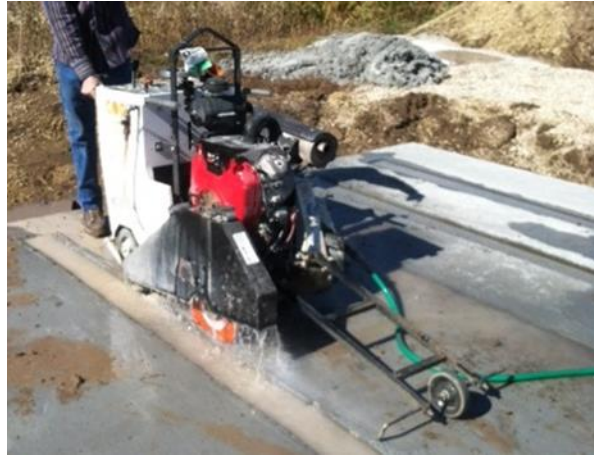
Figure 0.10 Saw cutting of edges

Before placing the bonding agents and repair materials on the repair sections of the field slabs, the surface interface had to be prepared to ensure bond strength development. A saw cut was made one inch from the edge of the formed void in the slab. The concrete between the saw cut and the formed edge was then removed. This left an eight inch wide void two inches deep.

Edge removal is shown in figure 4.10. After the edges of the repair section were cut, the surface of the repair area was roughened with the use of a needle scabber and is shown in figure 4.11.

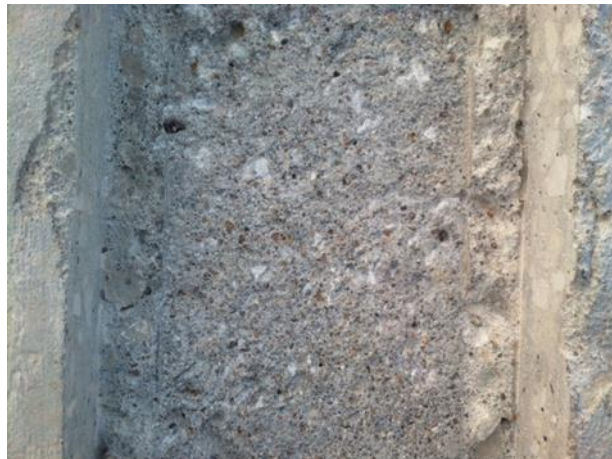
Figure 0.11 Prepared concrete surface

The top layer of the concrete surface was removed and aggregate was exposed. The surface had a roughness of 5 on the International Concrete Repair Institute surface roughness scale. The interface surface between the field slab and the repair material was kept clean and free of oil and

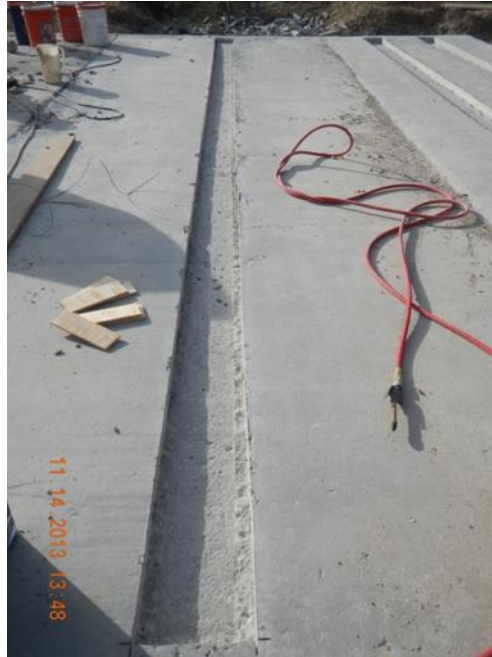
Figure 0.12 Concrete void strips before repair application

dust. Figure 4.12 shows the condition of the field slab before bonding agents and repair materials were placed.

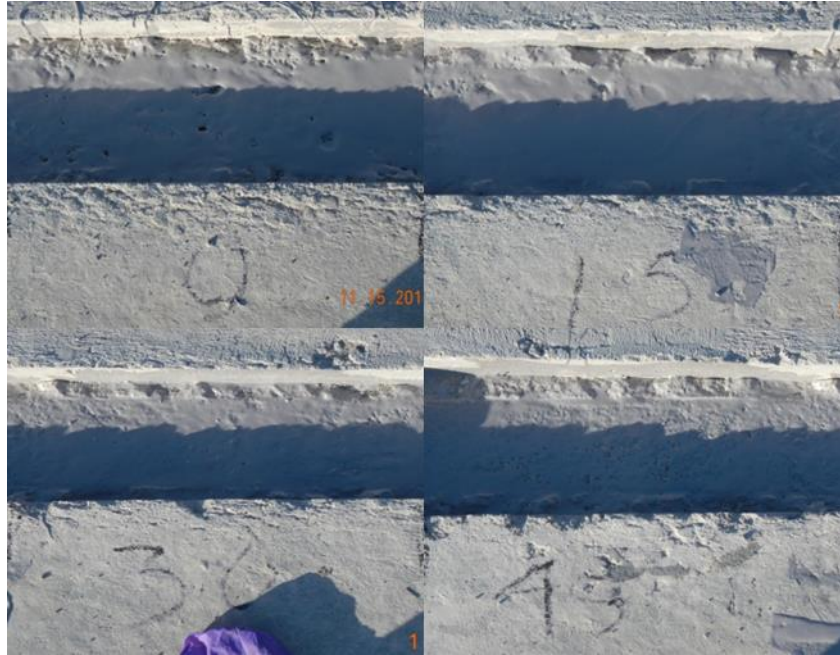
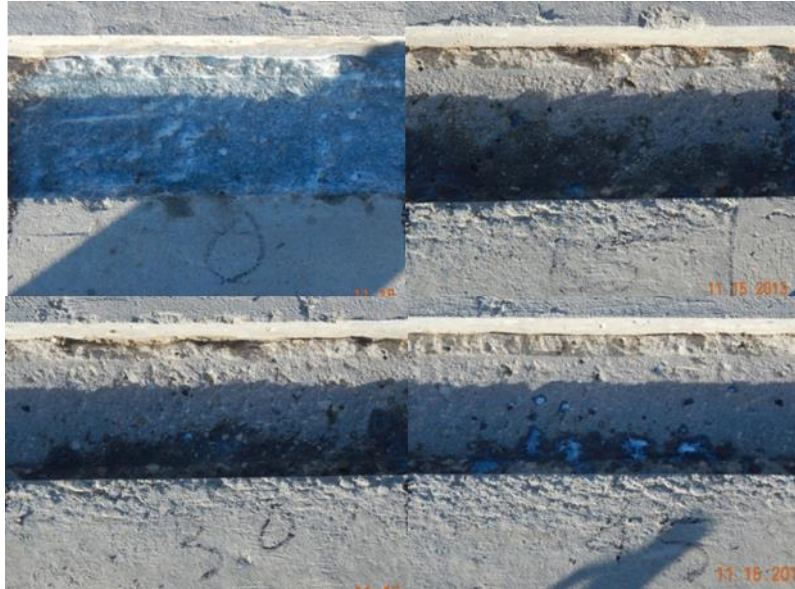
The surface of the repair slab sections were cleaned again before bonding agents and repair materials were placed. Because of the difficulty placing the 0.3 w/c grout in the laboratory tests, a grout with a w/c of 1 was used instead. The w/c for the portland cement grouts used were 3-1, 1-1 and 0.5. The bonding agent setting times before repair material placement were 0, 15, 30, and 45 minutes. The bonding agents were applied on the surface with a foam brush. Pictures were obtained of the setting time effects for the epoxy, PVA, and acrylic bonding agents, and are shown in figures 4.13 through 4.15.

Figure 0.13 0, 15, 30, and 45 minutes after epoxy bonding agent application

Figure 0.14 0, 15, 30, and 45 minutes after PVA bonding agent application

Figure 0.15 0, 15, 30, and 45 minutes after acrylic bonding agent application

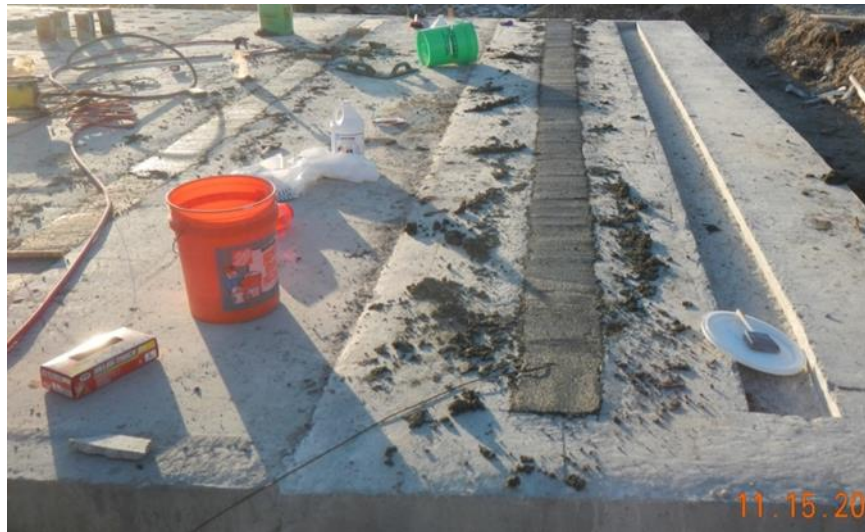
Figure 0.16 Repair material during placement

sheeting for 24 hours. Figure 4.16 shows the epoxy and latex bonding agent section with repair concrete 1 placed. Thermocouples were placed in the repair materials to measure the concrete temperature evolution.

The repair materials were cured after placement by covering the repair with plastic sheeting to reduce moisture loss due to evaporation. The repair materials were cured for a minimum of 24 hours.

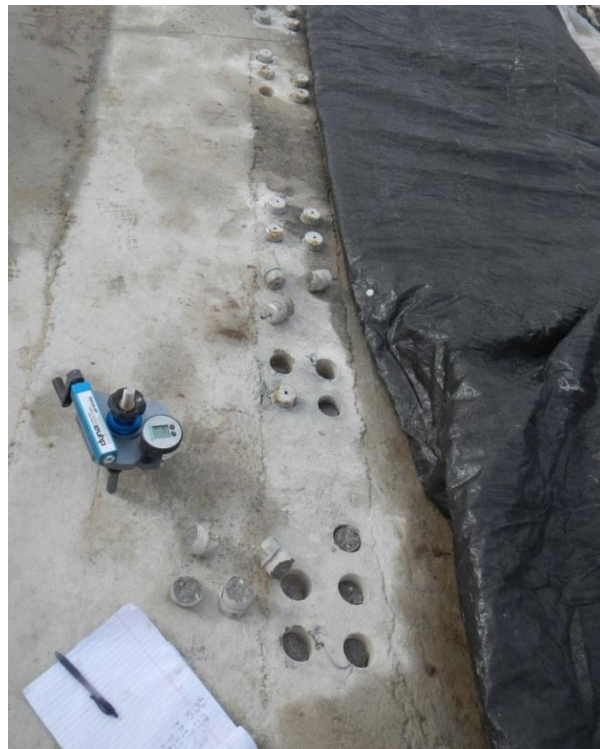
Figure 0.17 Pull-off tensile testing

Pull-off tensile tests were conducted 7 days and 5 months after repair material placement. ASTM C1583 was followed when using the pull off procedure. Two inch diameter cores were first drilled 2.5 inches deep. ASTM C1583 requires that the cores have a minimum depth of 0.5 inches into the substrate material past the bond interface surface. Four cores were drilled for each waiting time and bonding agent used. After coring, aluminum disks were epoxied onto the core top surface. The aluminum disks were sand blasted prior to being attached to the repair material

to guarantee that the disk was free of containments. The pull-off tensile loading was displacement controlled with a loading rate of 0.18 in./min. The concrete repair material after the pull-off tests can be seen in figure 4.17. The maximum tensile force during the pull-off test was recorded. If any failures occurred between the epoxy and the aluminum disk the test was considered invalid according to ASTM C1583. The type of failure that occurred during the pull-off test was recorded.

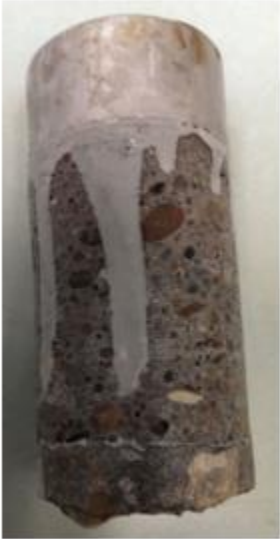
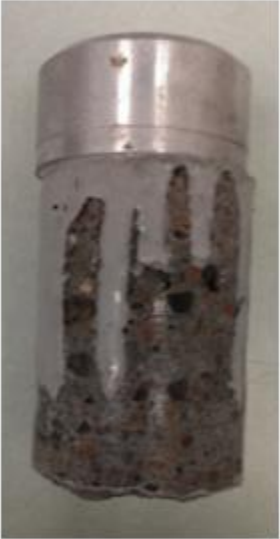
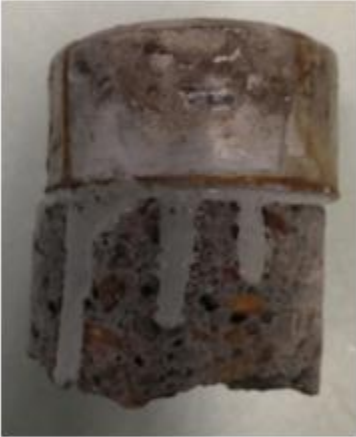
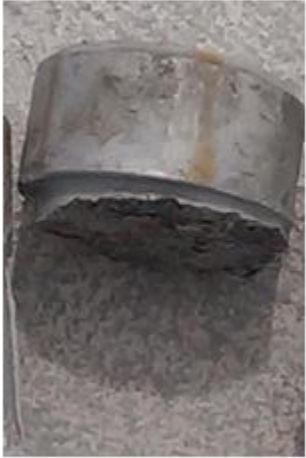
Figure 0.18 Types of pull-off test failures

The four types of failure are illustrated in figures 14-8 (a), (b), (c), and (d). For type 1 failure, the substrate concrete is still attached to the repair concrete by the bond interface layer. Type 2 breaks are located right at the bond interface. Type 3 failure is located in the repair

material, and type 4 failure is located at the epoxy interface between the aluminum disk and repair material.

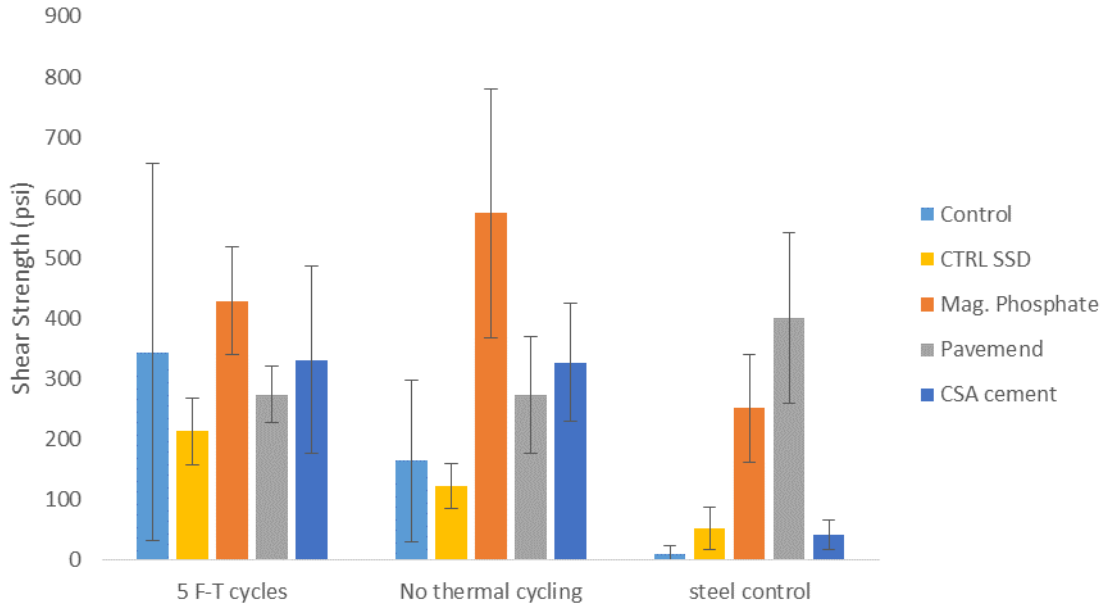
All bonding agents and repair materials except the MgP experienced failure at the bond interface. The direct shear test caused a clean break at the bond interface between the repair material and the substrate concrete. The MgP experienced failure in the repair material with parts of MgP still attached to the substrate concrete.
