**Materials & Research Section
Research Report**

**ALTERNATIVE PAVEMENT DESIGNS
RANDOLPH PARK AND RIDE**

Report 2013 – 04

Final Report

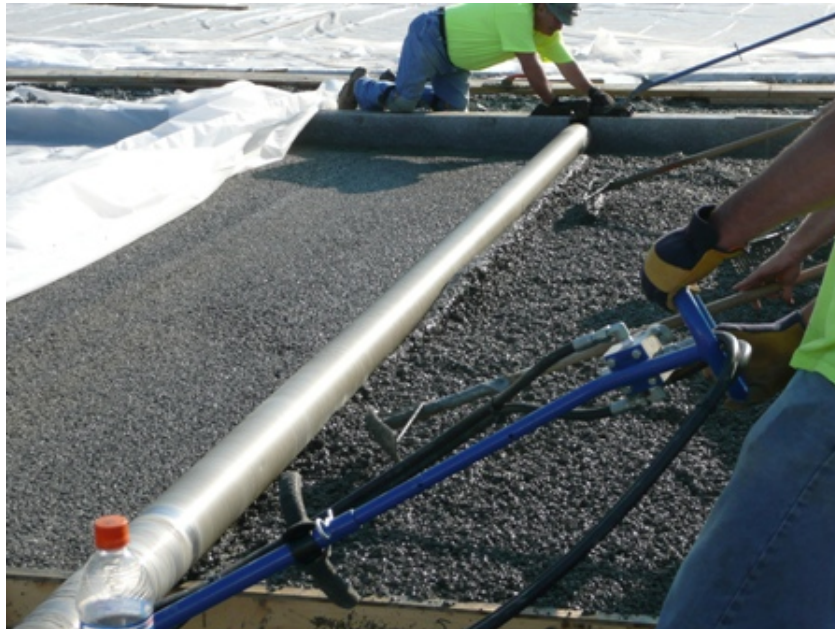
Prior to the end of placing the concrete, it was noted that an area in the northeast corner of the lot was showing signs of raveling. The raveled section was removed and placed once again on September 10. A typical installation at the park and ride is shown in Figure 3, with the

roller in the middle, the as-poured material on the right and the rolled material on the left. The plastic sheeting, used for curing, is also beginning to be placed over the slab on the far left.

Figure 3. Placement and rolling of porous concrete.

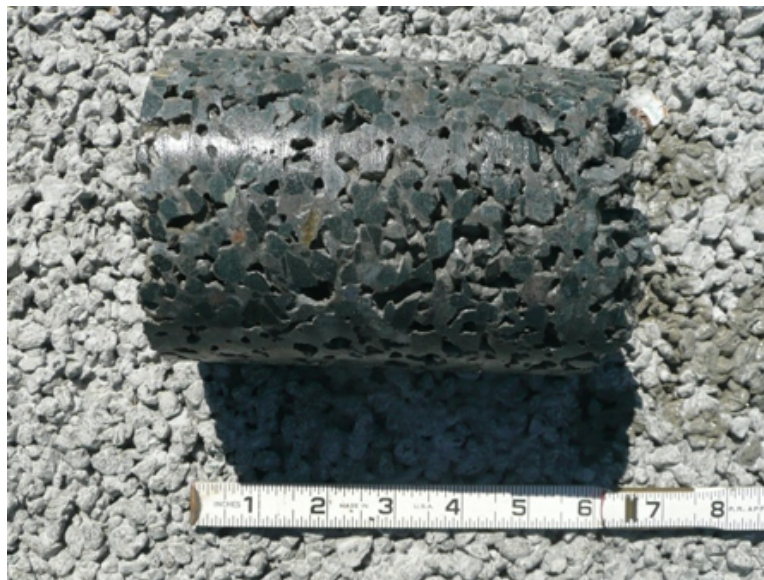
Core 1

Core 1, was taken from a location east of the median, where winter maintenance activities are not performed. The location was selected in the eleventh parking space from the southern edge of the last row of spaces because the visual and audibly testing suggested the area was sound. As seen in Figure 5, the 6 in. core was extracted fully intact and represented the specified design depth.

Figure 5. Core 1, taken from a visually and audibly sound portion of the lot.

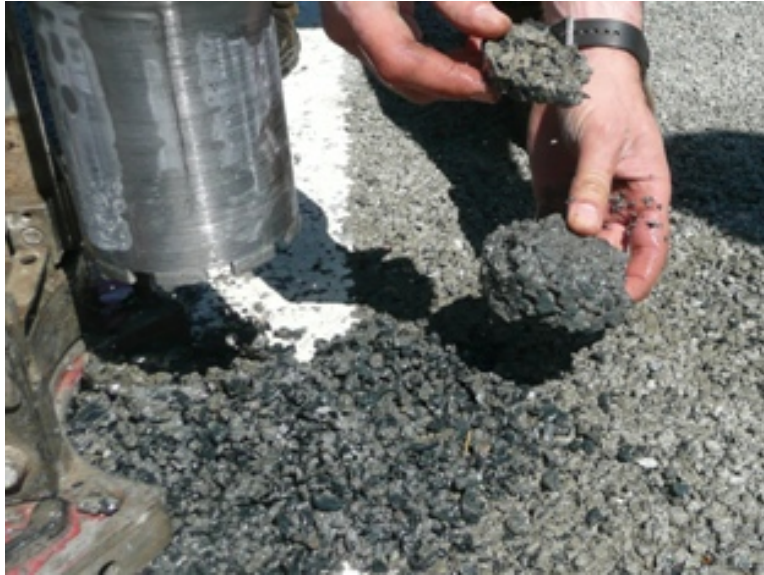
Core 2

Core 2, as seen in Figure 6, was taken from a location that visibly looked good (virtually no raveling) but sounded delaminated during sounding tests. It was taken from the pavement marking gore area located at the northern end of the parking lot encompassing parking rows two and three. The core was extracted in three material regimes. The top of the core was a few solid pieces of concrete roughly 0.75 in. thick (top of picture). The bottom of the core was one solid piece roughly 1.5 in. thick (middle of picture). The middle approximately 3.75 in. came out as un-adhered concrete, or rather, gravel (on the ground in the picture), with very little cement present on the aggregates.

Figure 6. Core 2, taken from a visually sound but audibly unsound location.

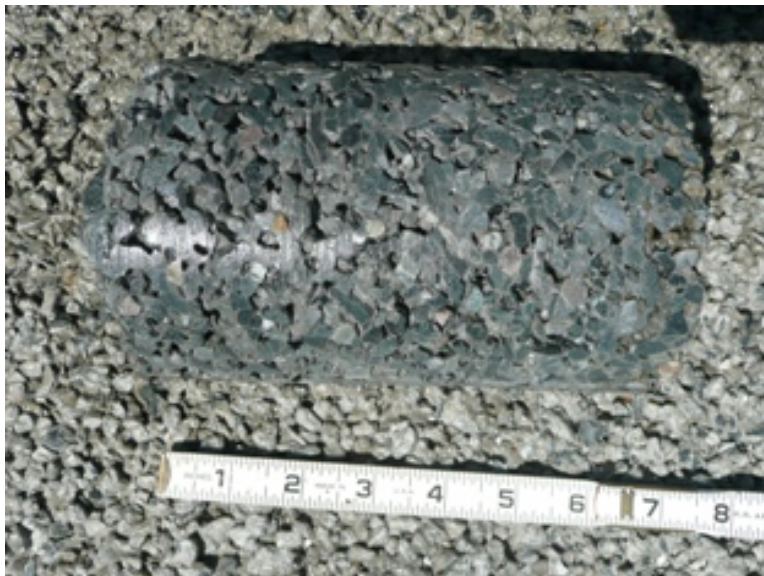
Core 3

Core 3, as seen in Figure 7, was taken from a location 2 ft. away from Core 2, where sounding tests indicated a spot of good concrete, in addition to a good visual spot. The core was

also located in the gore area. When extracted the core was indeed in sound condition as it came out as a complete 6 in. core.

Figure 7. Core 3, taken from a visually and audibly sound location, two feet from Core 2.

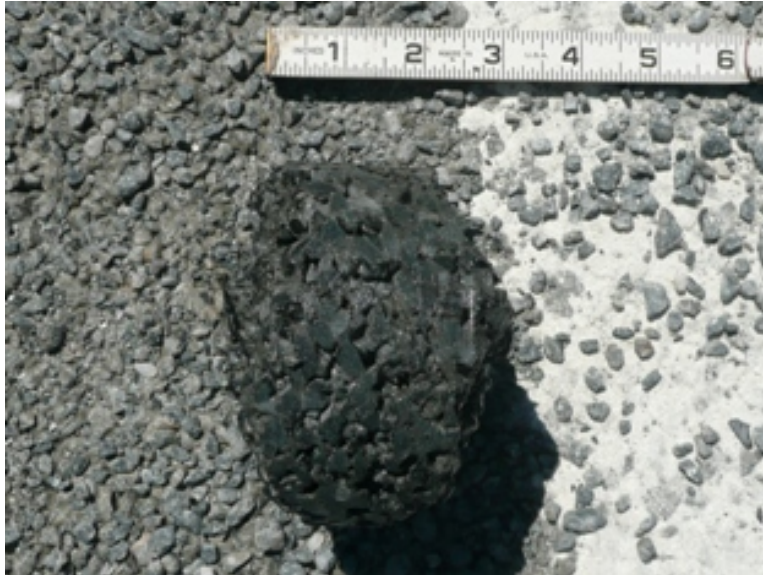
Core 4

Core 4, as seen in Figure 8, was extracted from one of the most severely raveled areas, also in the same gore area, in which an approximately 1 in. deep hole had already raveled away. When extracted, the bottom roughly 2.5 in. of the core were intact (shown in the picture) while all concrete above this was gravel-like with little cement visible.

Figure 8. Core 4, taken from a visually and audibly unsound location.

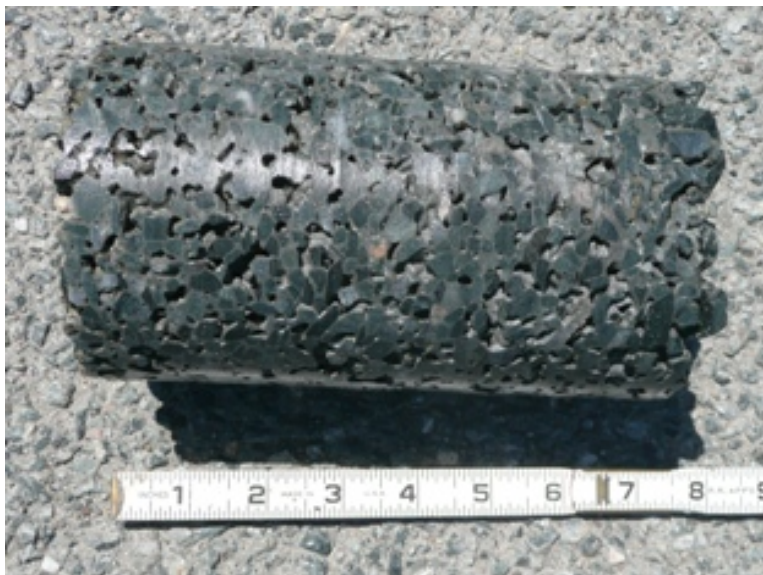
Core 5

Core 5, as seen in Figure 9, was taken from the entrance lane onto the porous concrete, in the southern most concrete slab. Sounding tests on this area indicated good concrete. When extracted the core came out whole and measured 7 in., one inch thicker than the specified 6 in. thickness.

Figure 9. Core 5, taken from a visually and audibly sound but clogged location at the entrance.

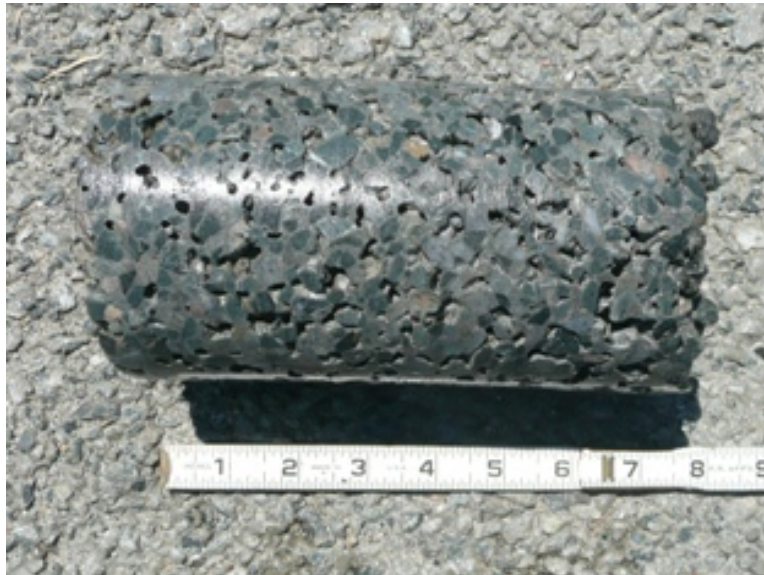
Core 6

Core 6, as seen in Figure 10, was taken from the exit lane from the porous concrete, in the second slab from the south. As with Core 5, sounding tests in this area indicated good concrete. When extracted the core came out whole and measured 7 in., one inch thicker than the specified 6 in. thickness.

Figure 10. Core 6, taken from a visually and audibly sound but clogged location at the exit.

After seeing the condition of these cores, it was evident that at least portions of the porous concrete slab were in danger of significant failures, which has continued to present itself over the course of the following two and a half years.

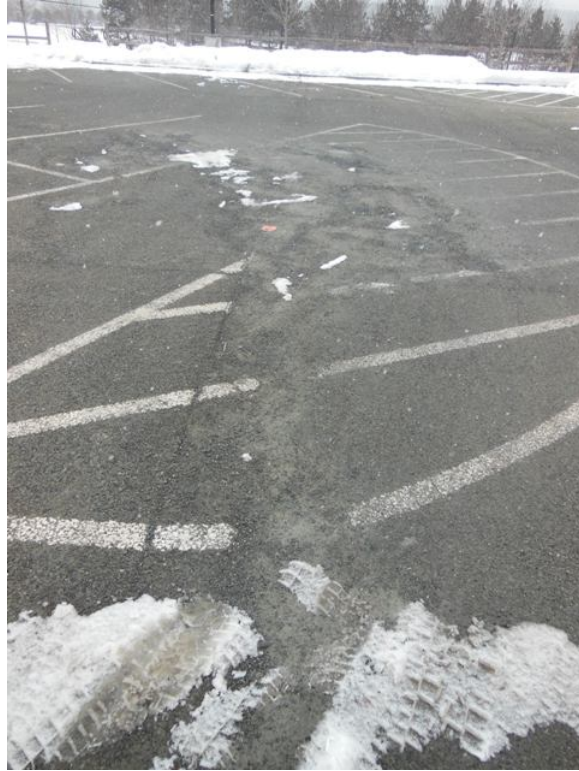
A site visit was conducted in March of 2013 to photograph the condition of the lot following the majority of its fifth winter season. The lot displayed readily noticeable deterioration since the previous fall. Two pictures of its state during this visit are shown in Figures 12 and 13.

Figure 12. Deterioration in the gore area of the front portion of the lot after five winter seasons.

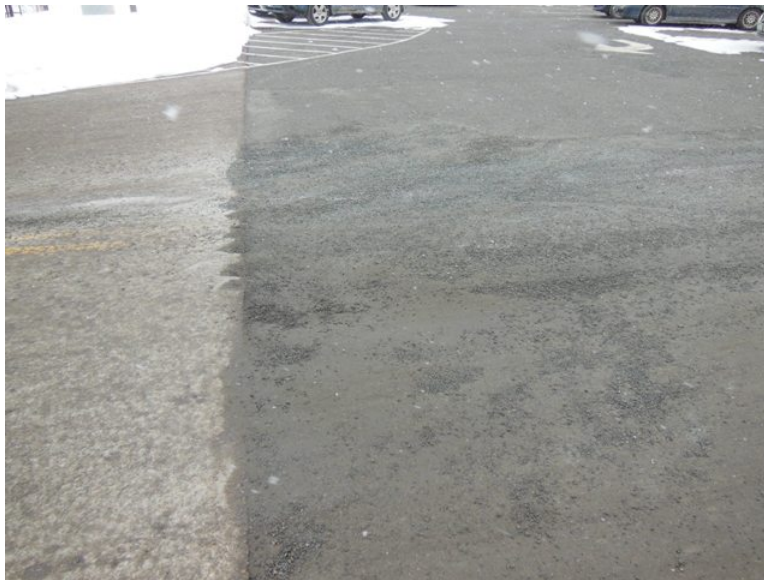
Figure 13. Deterioration at the transition between the bituminous drive (left) and porous concrete lot (right) after five winter seasons.
