**Experimental Investigation of the Effect of Surface Markings on the Mechanical Integrity of
Weathering Bridge Steels**

Final Report

FDOT Contract Number: BDV31-977-02

University of Florida

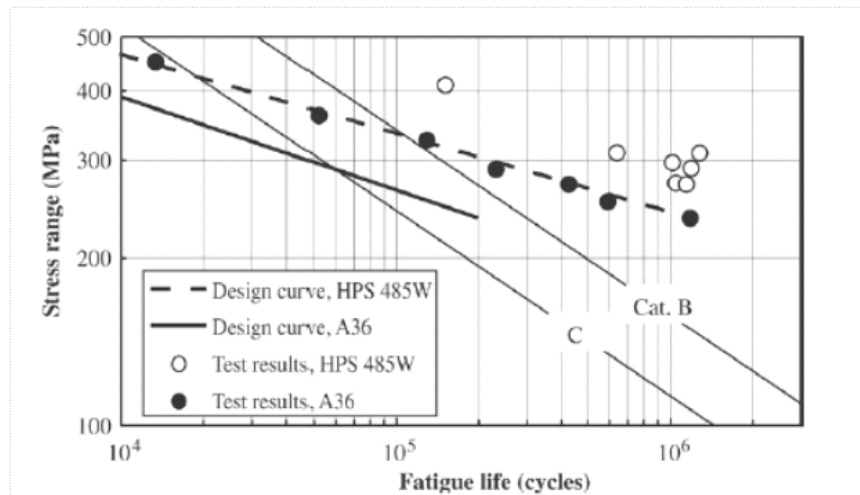
Figure 2-5. Fatigue life data from conventional (labeled A36) and HPS 70W (labeled HPS 485W) weathering steels with drilled holes represented as solid and open circles, respectively.[20]

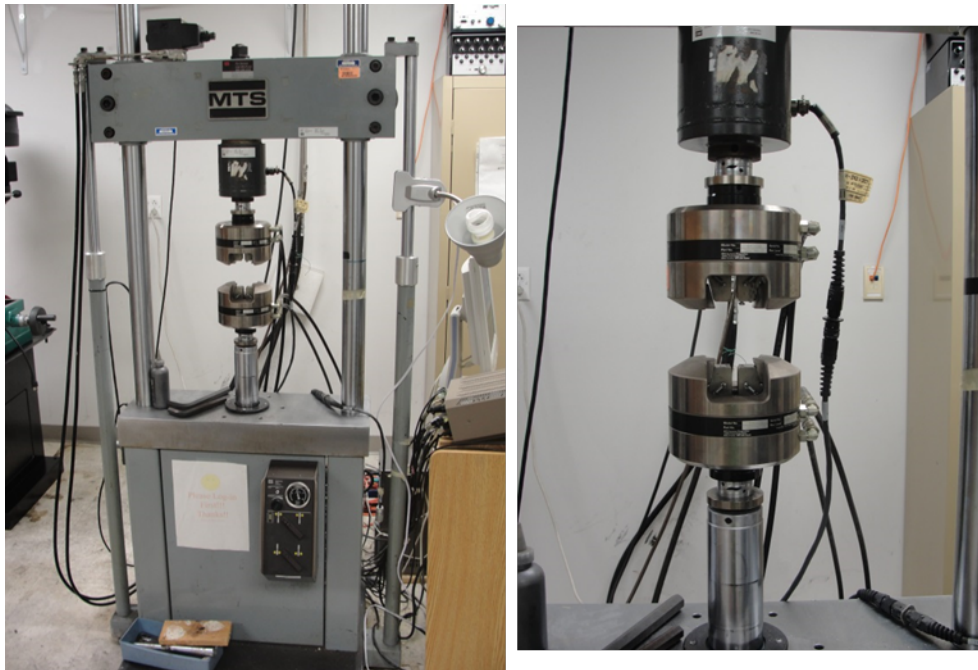
Figure 5-5. MTS 470 with hydraulic grips.

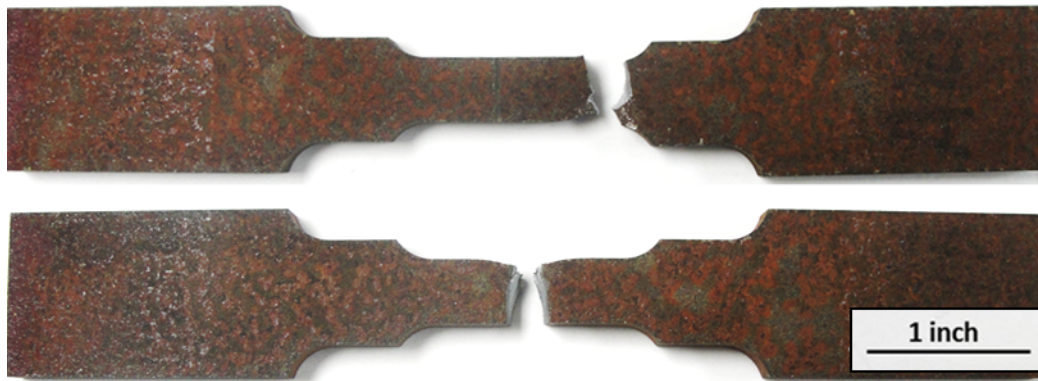
Figure 5-12. Fatigue specimen that fractured (top) near the shoulder and (bottom) at the plasma notch.

Despite the presence of plasma and laser scribed notches, fatigue cracks generally formed near the shoulder of the fatigue specimens (Figure 5-12 top). None of the laser scribed notches resulted in fracture initiation at the notch and only two, both tested at a stress range of 48.3 ksi, of the 16 tested plasma notched samples initiated at the notch (Figure 5-12 bottom). The samples shown in Figure 5-12 had fatigue lives of 5.31×10^5 cycles (top) and 5.64×10^5 cycles (bottom). Microscopic analysis conducted on

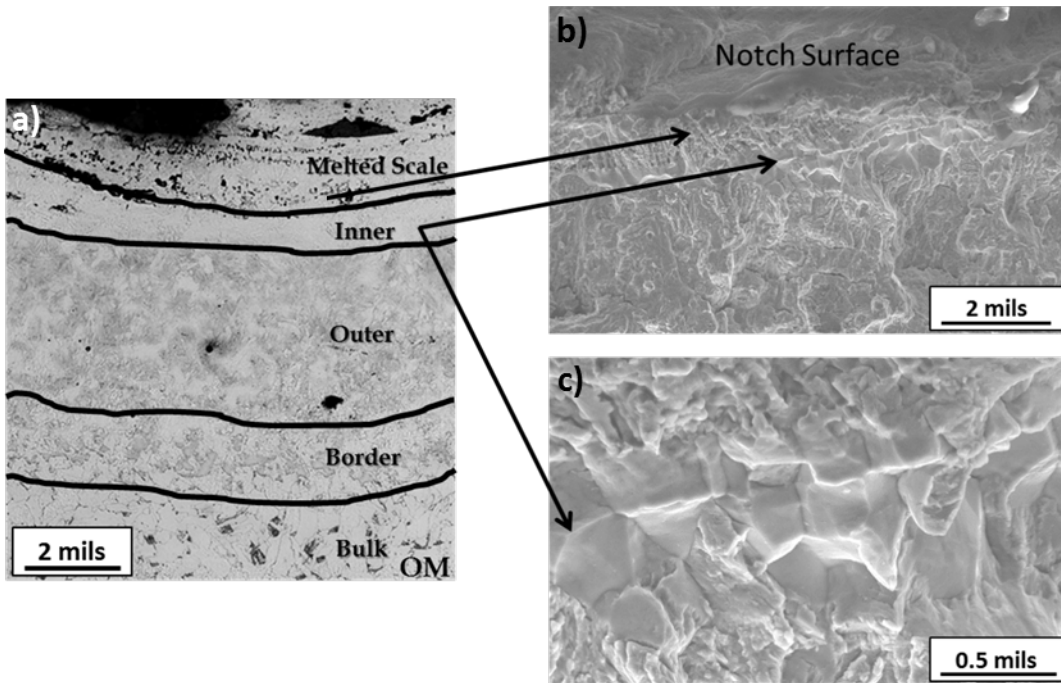
Figure 5-15. An optical micrograph of a) the profile of the HAZ caused by the plasma scribe and SEM micrographs of b) the fracture surface near the notch surface associated with the crack propagation showing c) intergranular fracture in the 'Inner' region.
