**UNDERSTANDING AND MITIGATING
EFFECTS OF CHLORIDE DEICER
EXPOSURE ON CONCRETE**

Final Report

SPR 742

Oregon Department of Transportation

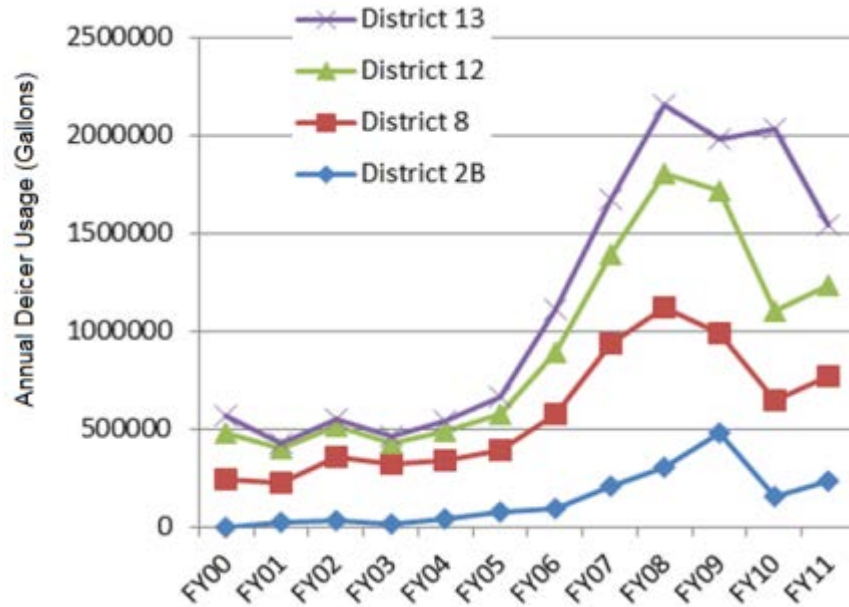
Figure 2.4: Annual Deicer Usage Data for the ODOT District 13, 12, 8 and 2B

Assumptions had to be made to address missing data for certain bridge decks: Figure 2.4 shows that the deicer usage in these four districts generally followed the same trend, with a gradual increase in the first six years (FY 2000 to FY 2005), followed by a sharp increase in the next four years (FY2006 to FY2009) and subsequent fluctuations in the recent years. Assuming that the temporal evolution of application rates on specific bridge decks followed the district-level trend, the deicer usage data for the missing years were infilled from the data from the existing years. Note that the chemical application rates are site-specific and depend on a variety of factors including type of deicer used, air and pavement temperatures, amount of snow on the ground, and steepness of the roadway (*Fischel 2001*). As such, the district deicer usage data should be considered as correlated information and not a statistical representation for the bridge site's actual deicer usage.

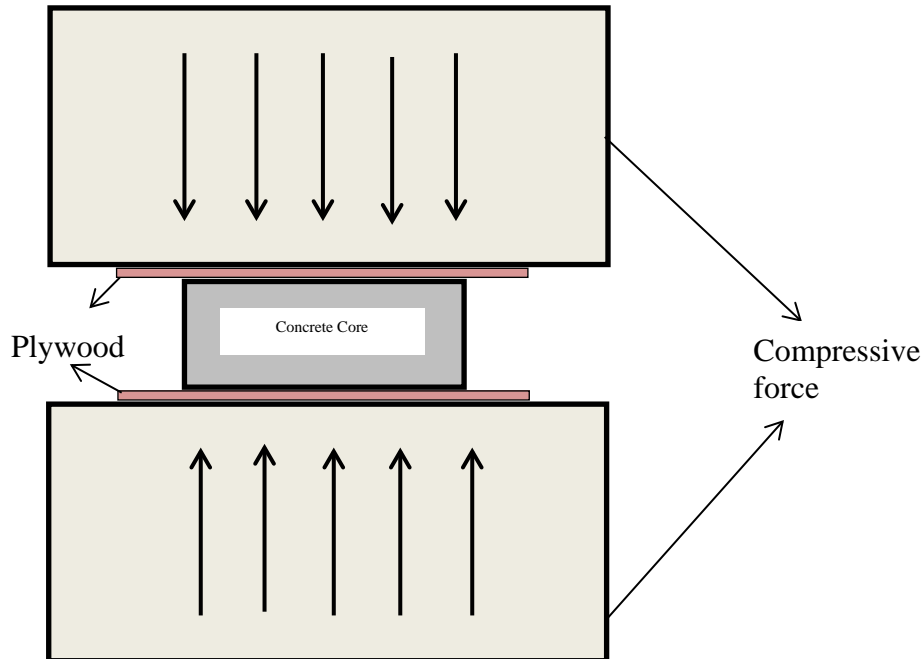
Figure 3.1: The setup of the splitting tensile strength test.

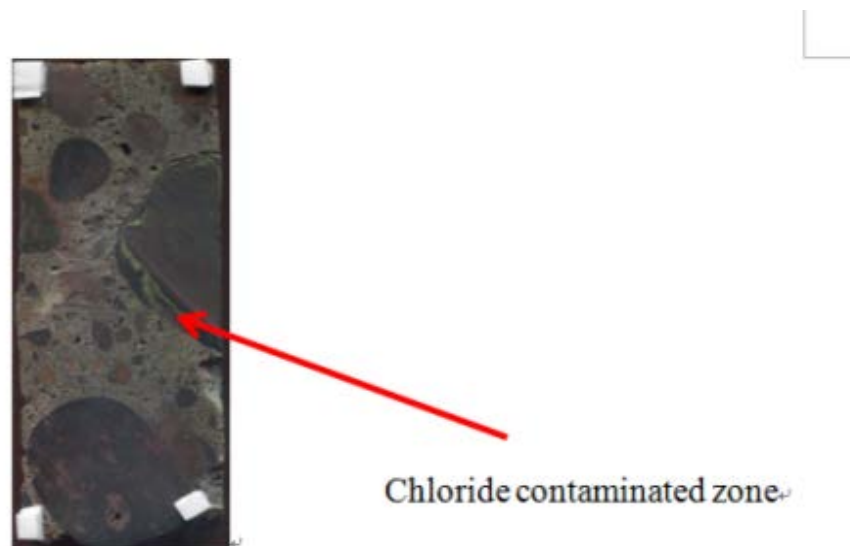
Figure 3.2: Example of chloride penetration in an ODOT concrete sample

To measure the depth of chloride penetration, the Mautzsch procedure (*Baroghel-Bouny 2007*) was utilized. To reveal the depth of chloride penetration, the concrete core sample was first stained with silver nitrate (0.1N AgNO₃) solution followed by potassium chromate. After staining, the relatively yellow areas indicate the presence of high chloride concentration (as shown in Figure 3.2), whereas the relatively red or brown areas indicate little chloride concentration. As such, this semi-quantitative method allows the measurement of the depth of chloride penetration.

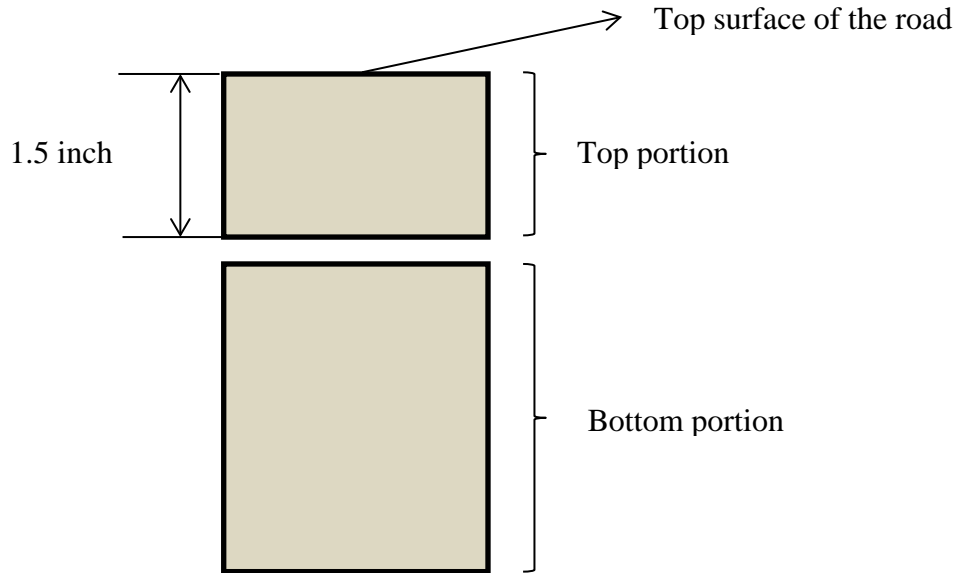
Figure 3.3: Cutting of Samples for Absorption Test.

water followed by immersion into boiling water and subsequently natural cooling. The immersed apparent mass was determined by weighing the concrete core sample immersed into the water by wire. These different mass data were used to calculate the water absorption of each tested concrete core sample.

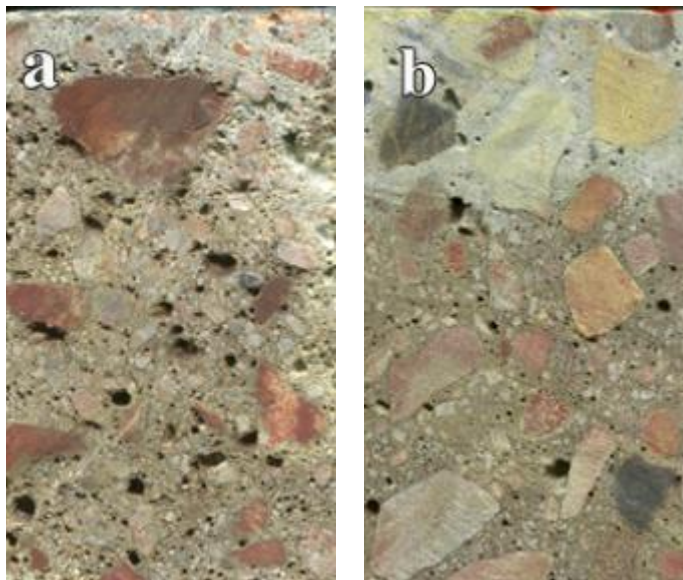
Figure 3.6: Cl⁻ penetration staining test results of cores from a) NE and b) UT

Figure 3.6 shows the image of the concrete samples that represents the extent of chloride penetration in the cores extracted from NE and UT, respectively. Table 3.3 further quantitatively lists the chloride penetration depth of the samples from the two states. As demonstrated in Figure 3.6, there is a clear difference between these two samples, and from the quantitative analysis, the chloride penetration depth is much higher in UT than in NE. The chloride penetration in the NE deck cores may be attributed to the chloride deicers applied on the roadways adjacent to the bridge deck and carried on to the deck by traffic.

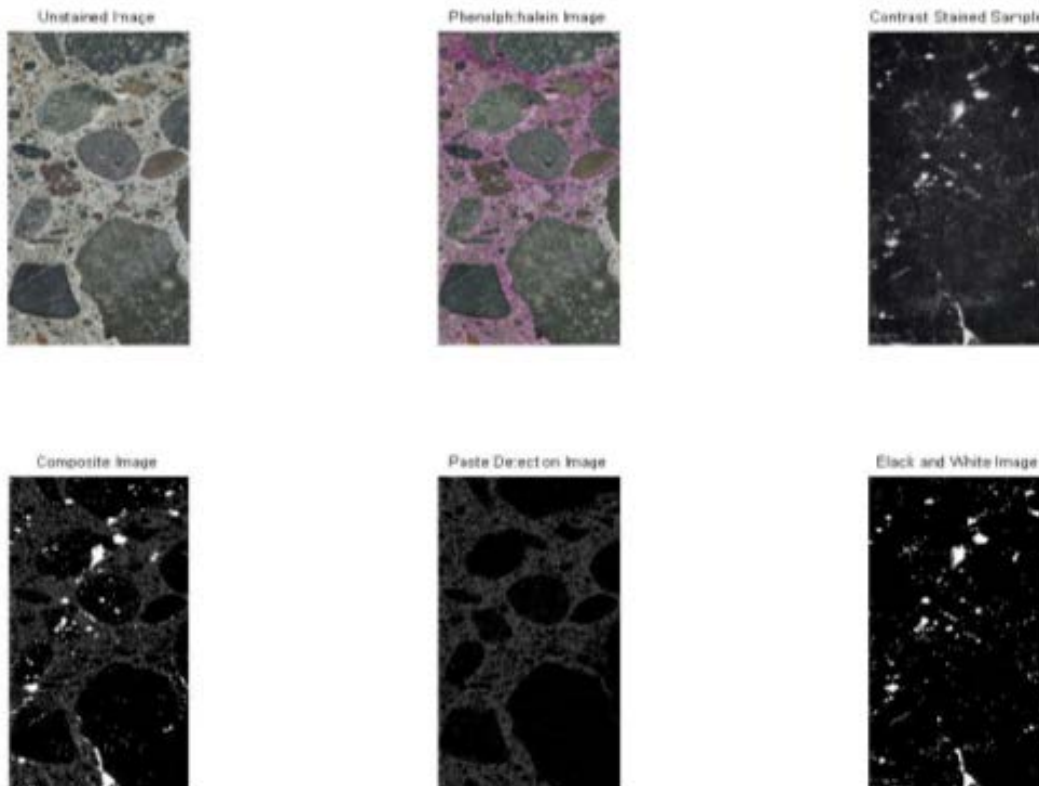
Figure 3.7: the image of a core sample processed for phenolphthalein and air-void tests

Table 3.4 provides the parameters calculated using the air-void test based on the images such as those shown in Figure 3.7. The quantitative analysis showed that the paste content was about 39% in UT and 63% in NE. The spacing factor was about 0.0020 ± 0.0001 inches (51 ± 3 microns) for all decks, implying similar resistance to F/T of their air void systems. All the cored decks exhibited a proper air-void system for freeze-thaw resistance as their spacing factor remained well below 200 microns per the ASTM C457 test method. The spacing is a simplified measure of the theoretical maximum distance from any point in the paste to the nearest void. The F/T resistance of a concrete sample is directly related to the amount of paste that is located in the beneficial zone of influence, the area near and around the air voids, of one or more air voids (*Hover 2006*).

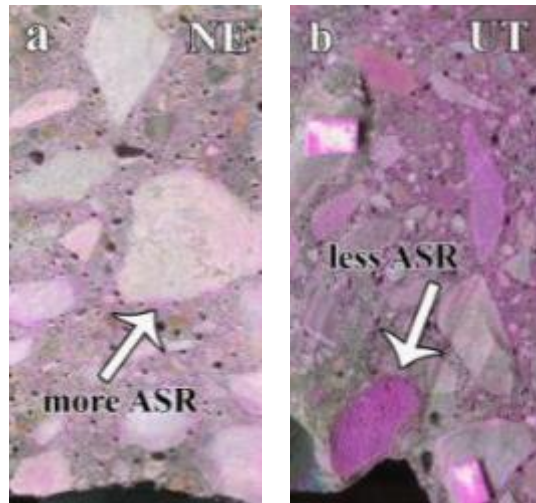
Figure 3.8: Staining image illustrating the presence of ASR in concrete samples from a) NE and b) UT

In the field, more ASR occurred in NE bridge decks. This is attributable to the use of 70% North Platte riversand and gravel aggregate (highly ASR reactive) in both NE decks. This is also consistent with the recent findings by Clemson University that the acetate-based deicers could induce increased levels of expansion in concrete with aggregates susceptible to ASR, and could trigger ASR in concrete that previously did not show susceptibility to ASR (*Rangaraju et al. 2005, 2006, Rangaraju and Desai 2006*). It was proposed that such deicers react with one of the major cement hydration products, Portlandite, which leads to higher pH of the concrete pore solution (*Rangaraju and Olek 2007*). Furthermore, the concrete specimens exposed to KAc deicer showed presence of certain secondary reaction products, the effect of which on the durability of concrete merits further investigation (*Rangaraju 2007*). Other factors that may have influenced the ASR occurrence include: the annual precipitation (as rain may mitigate deicer accumulation inside the concrete pavement) and the average temperature of the service environment (as higher temperature generally accelerates the chemical attack process).

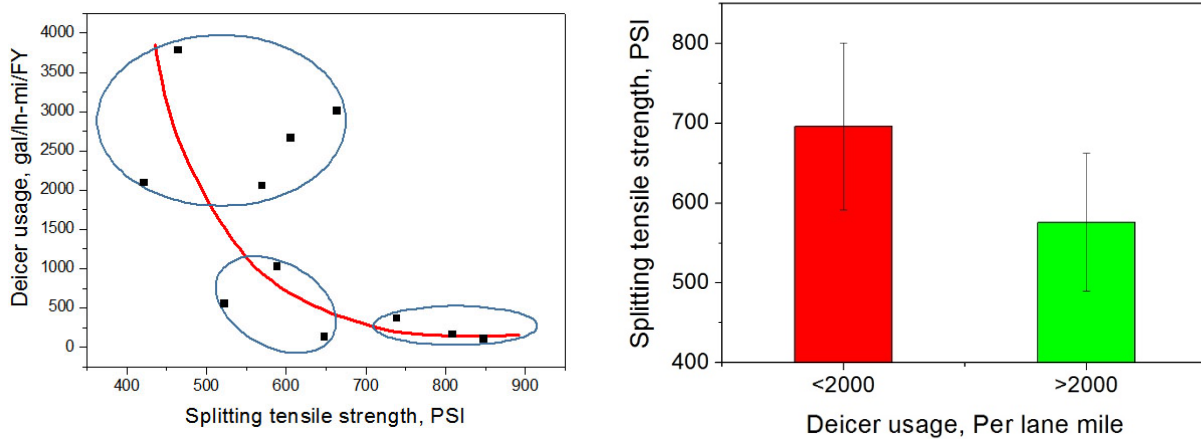
Figure 3.10: The splitting tensile strength as a function of annual deicer usage.

Figure 3.10 illustrates the splitting tensile strength for core samples from two different groups of bridge decks, with deicer usage higher or lower than 2000 gallons per lane mile (1286 mL/m²) per fiscal year (FY). The results reveal that the average splitting tensile strength of concrete decks with deicer usage over 2000 gal/in-mi/FY was lower than those with lower deicer usage. This implies the potentially deleterious role of MgCl₂ deicer in the splitting tensile strength of ODOT concrete decks.

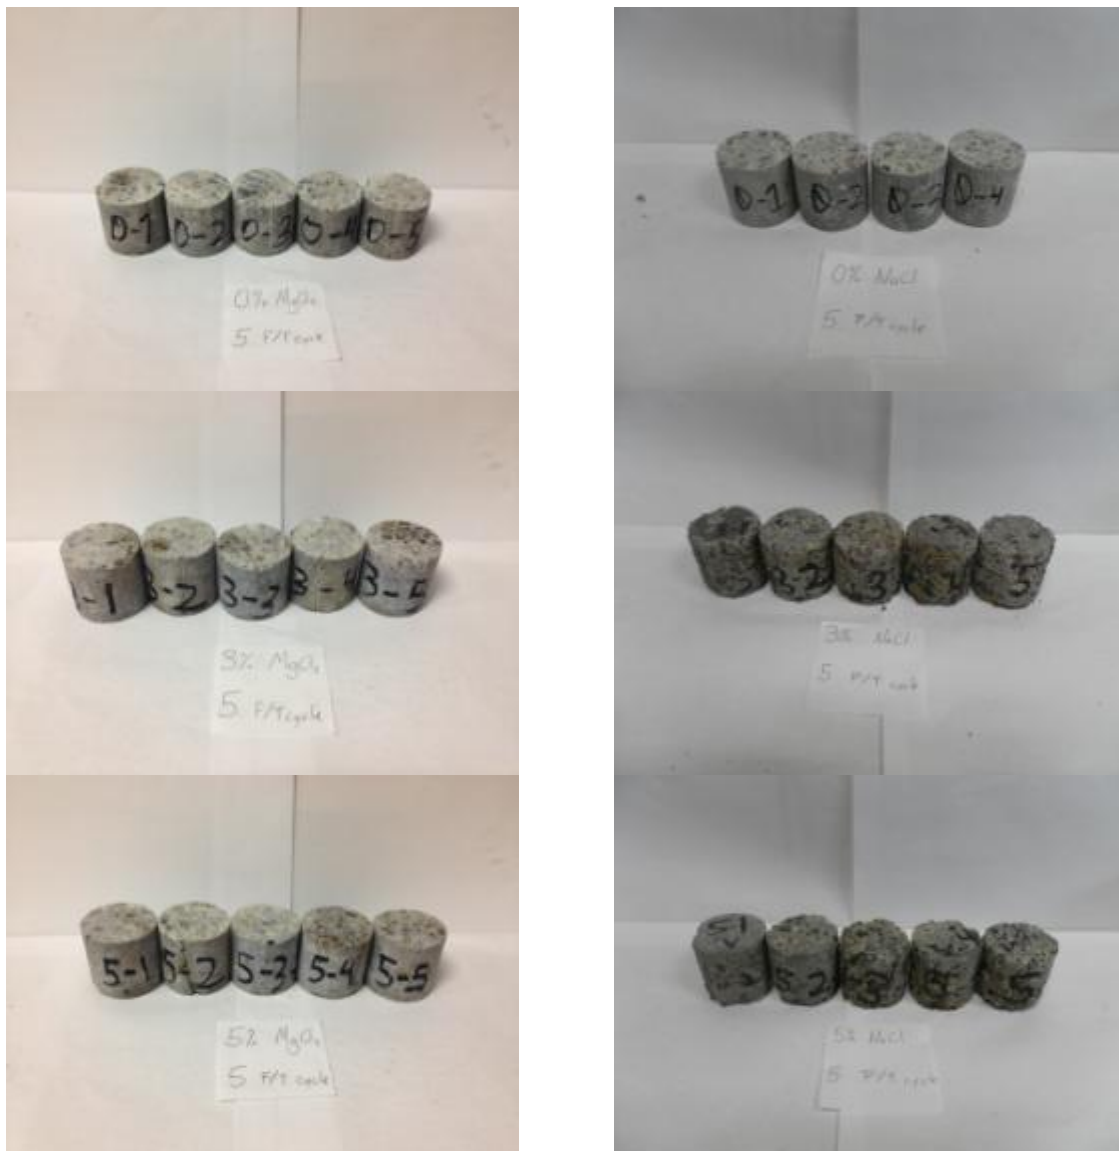
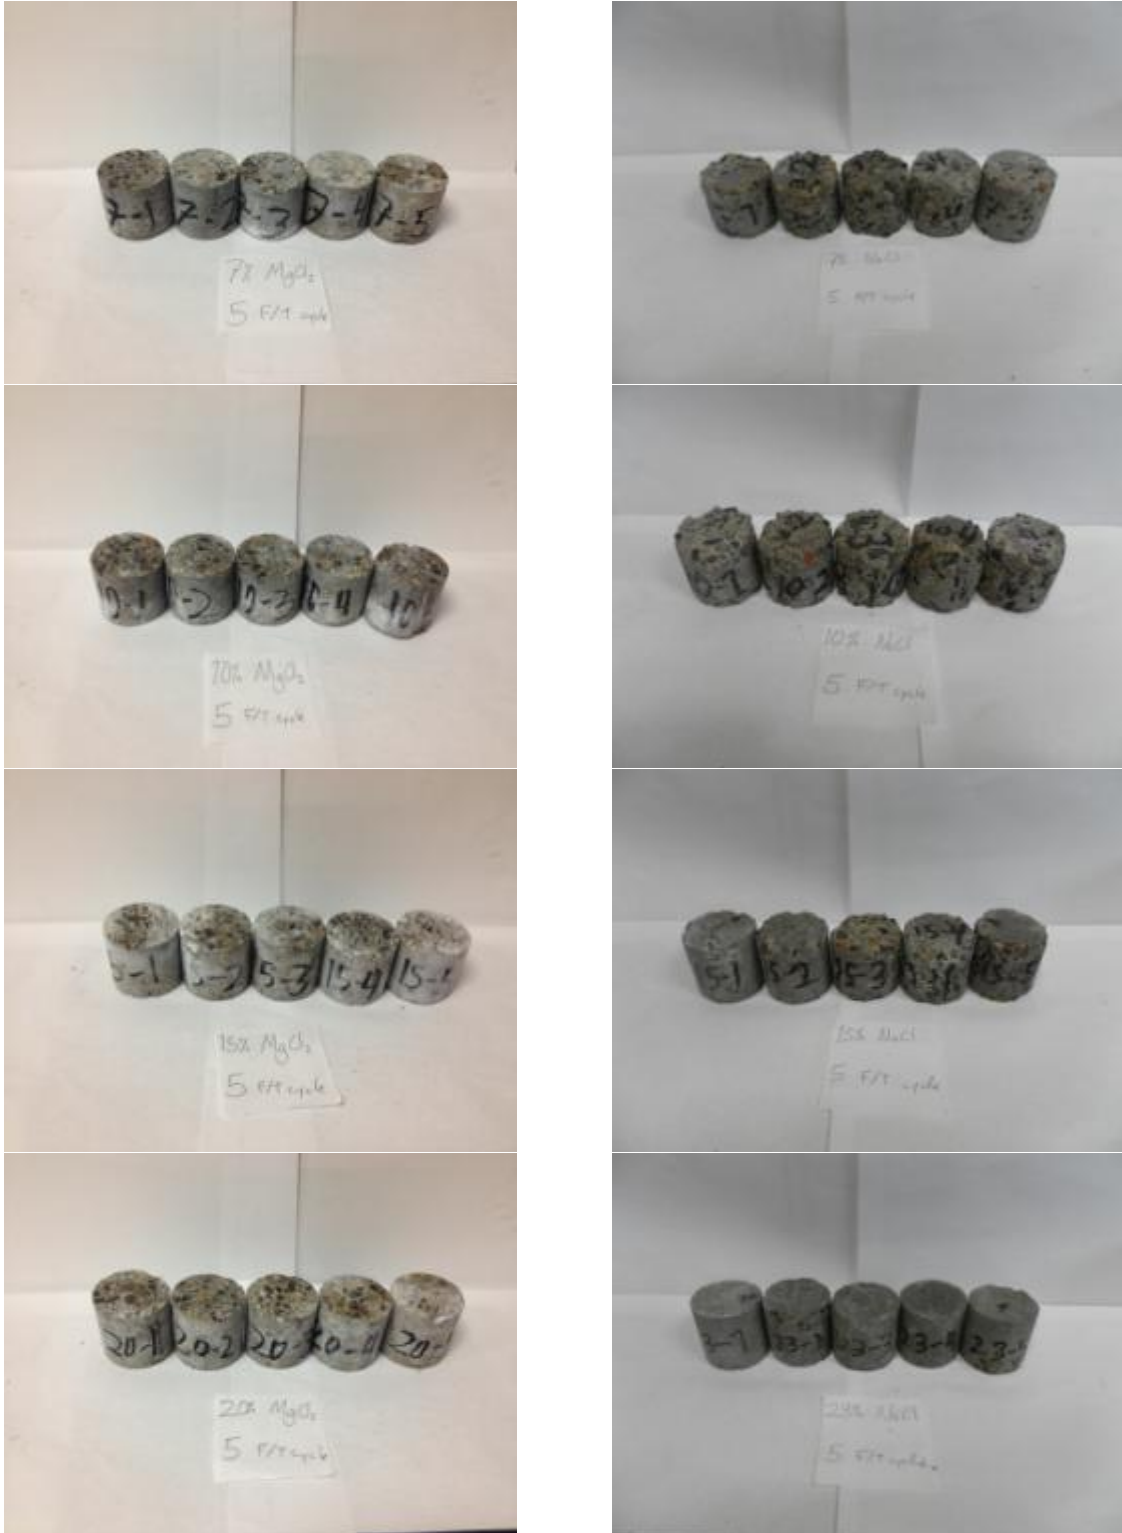
Figure 3.13: Lab concrete samples exposed to 5 F/T cycles in $MgCl_2$ and $NaCl$ solutions, respectively

To validate some of the observations in the field core samples, concrete samples of the same mix design were fabricated and exposed to the combined effect of F/T cycles and chloride deicers under well-controlled laboratory conditions. Figures 3.13 and 3.14 illustrate the external morphologies of laboratory-fabricated concrete cylinders exposed to MgCl₂ and NaCl solutions with various concentrations after 5 and 10 F/T cycles, respectively. The concrete samples exposed to NaCl exhibited significant surface scaling after 5 F/T cycles; however, all the concrete samples exposed to MgCl₂ solutions exhibited no surface distress even after 10 F/T cycles. As a result, to accelerate the salt scaling phenomenon of the concrete samples in MgCl₂ solution, the concentration of the solutions were fixed to 15% in both NaCl and MgCl₂ solutions from the 11th to 15th F/T cycles.

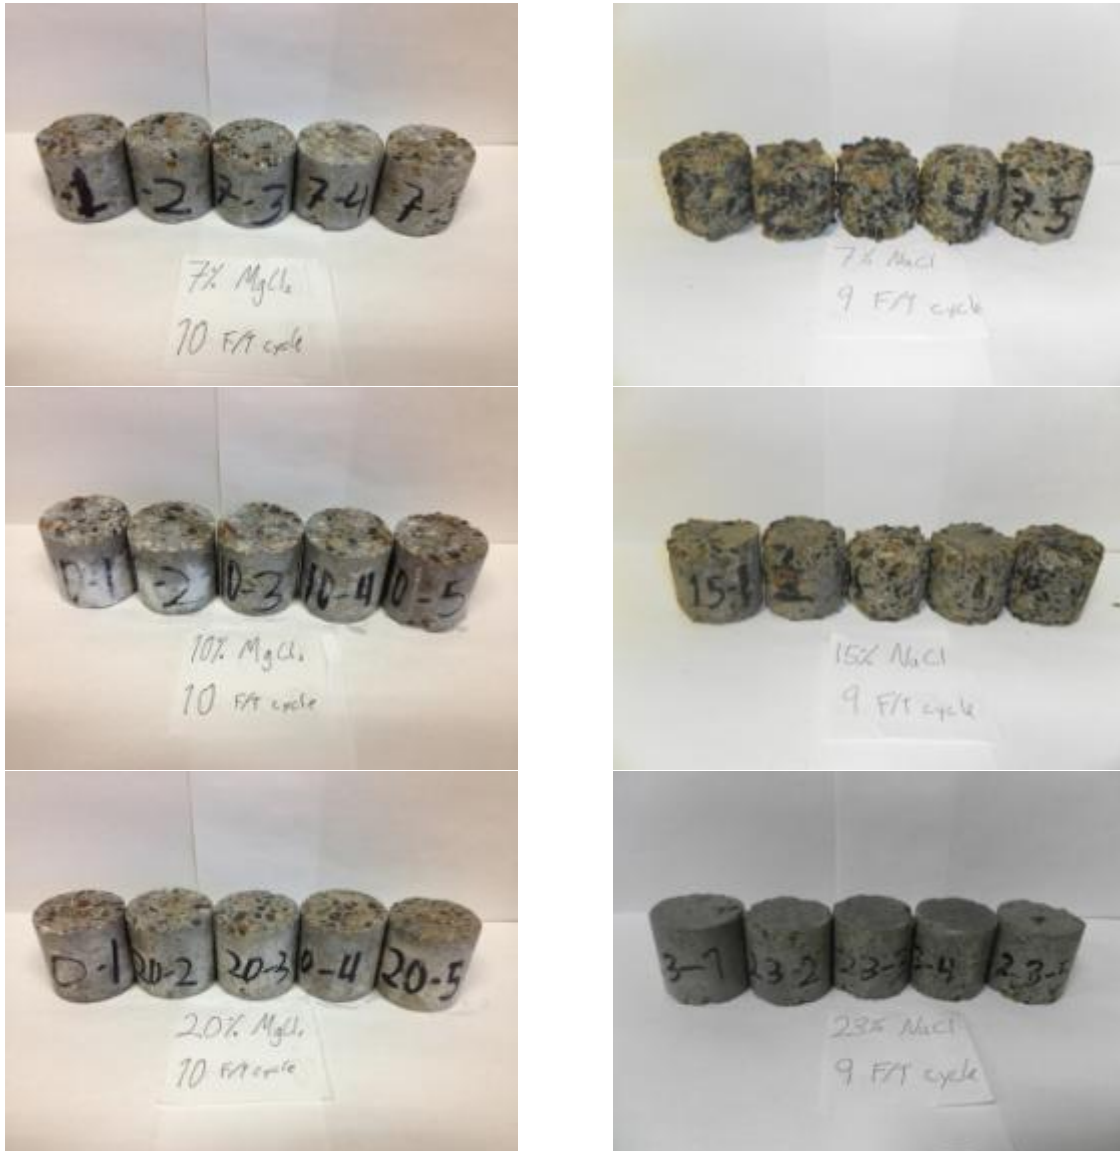
Figure 3.14: Lab concrete samples exposed to 10 F/T cycles in MgCl₂ and NaCl solutions, respectively

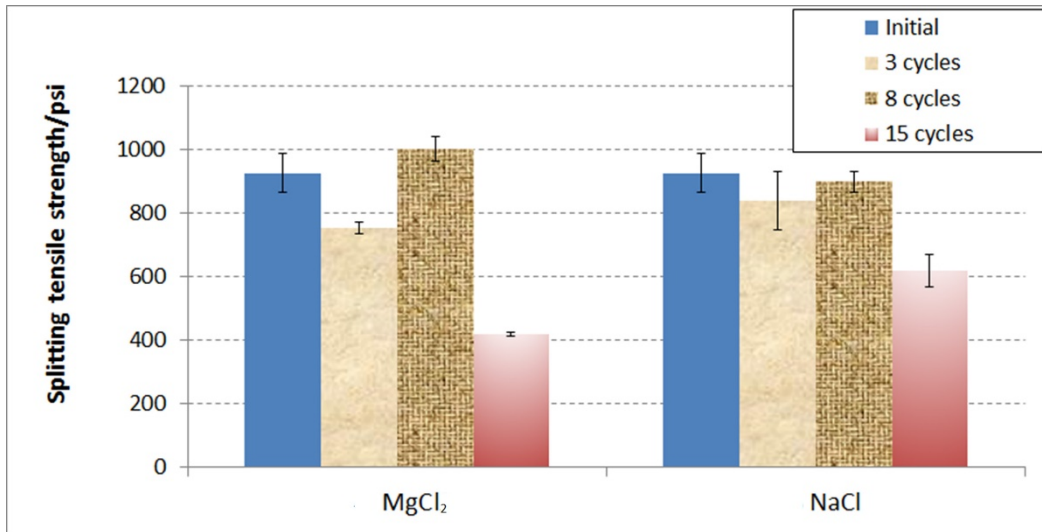
Figure 3.15: Splitting tensile strength of lab concrete samples exposed to F/T cycles in NaCl and MgCl₂ solution.

Figure 3.15 shows the splitting tensile strength results of a separate set of concrete specimens exposed to 15 F/T cycles in MgCl₂ and NaCl solutions. In this F/T cycling process, the MgCl₂ and NaCl concentrations were 2.54% and 3%, respectively, from the 1st to the 10th F/T cycles after which all the solution concentrations were changed to 15% for the following 5 F/T cycles. The 2.54% and 3% concentrations were used to achieve the same molar concentration of Cl⁻ ions. It can be seen in this figure that the splitting tensile strengths of the samples that experienced F/T in MgCl₂ solution showed lower values than those in NaCl solution after 15 F/T cycles. Again, in this case, the visual inspection would be misleading for assessing the condition of concrete bridge decks exposed to MgCl₂ deicer, as the chemical attack by MgCl₂ did not exhibit apparent signs of distress until severe disintegration of the concrete occurred.

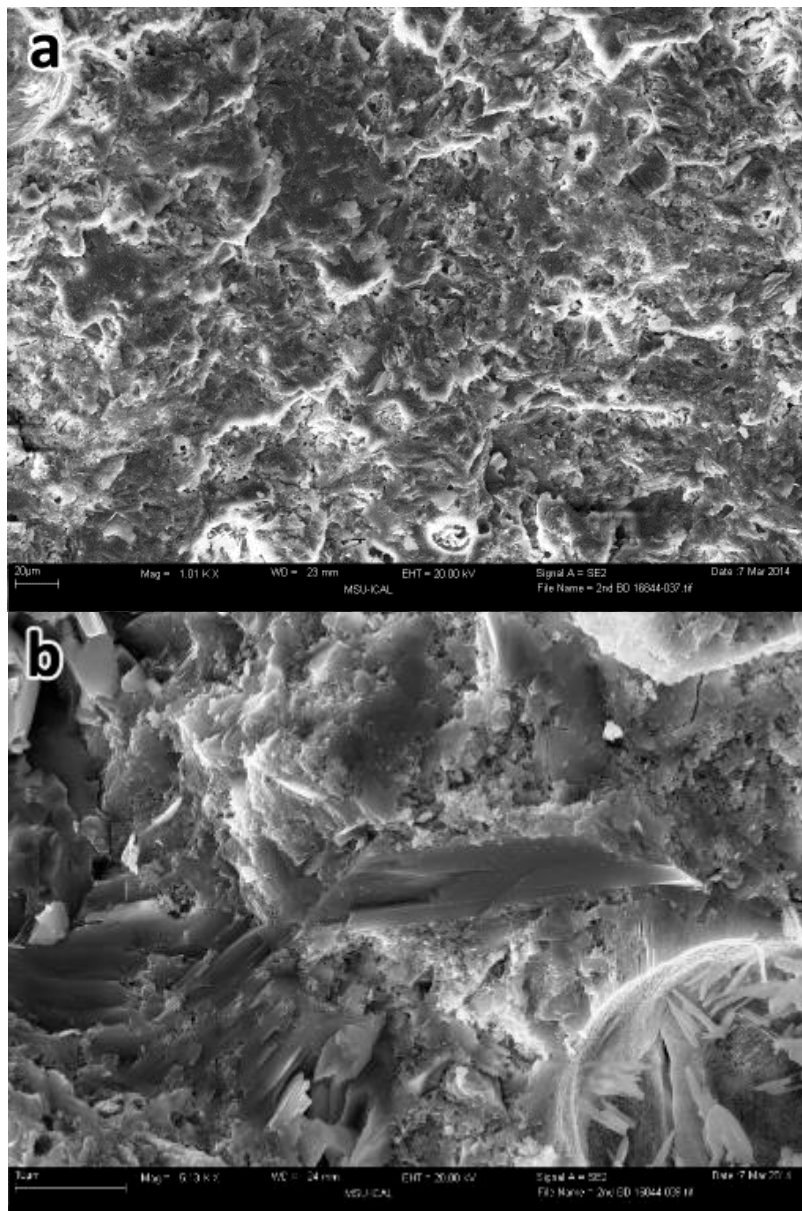
Figure 3.18: SEM micrographs of ODOT bridge deck 16844: a) low magnification and b) high magnification

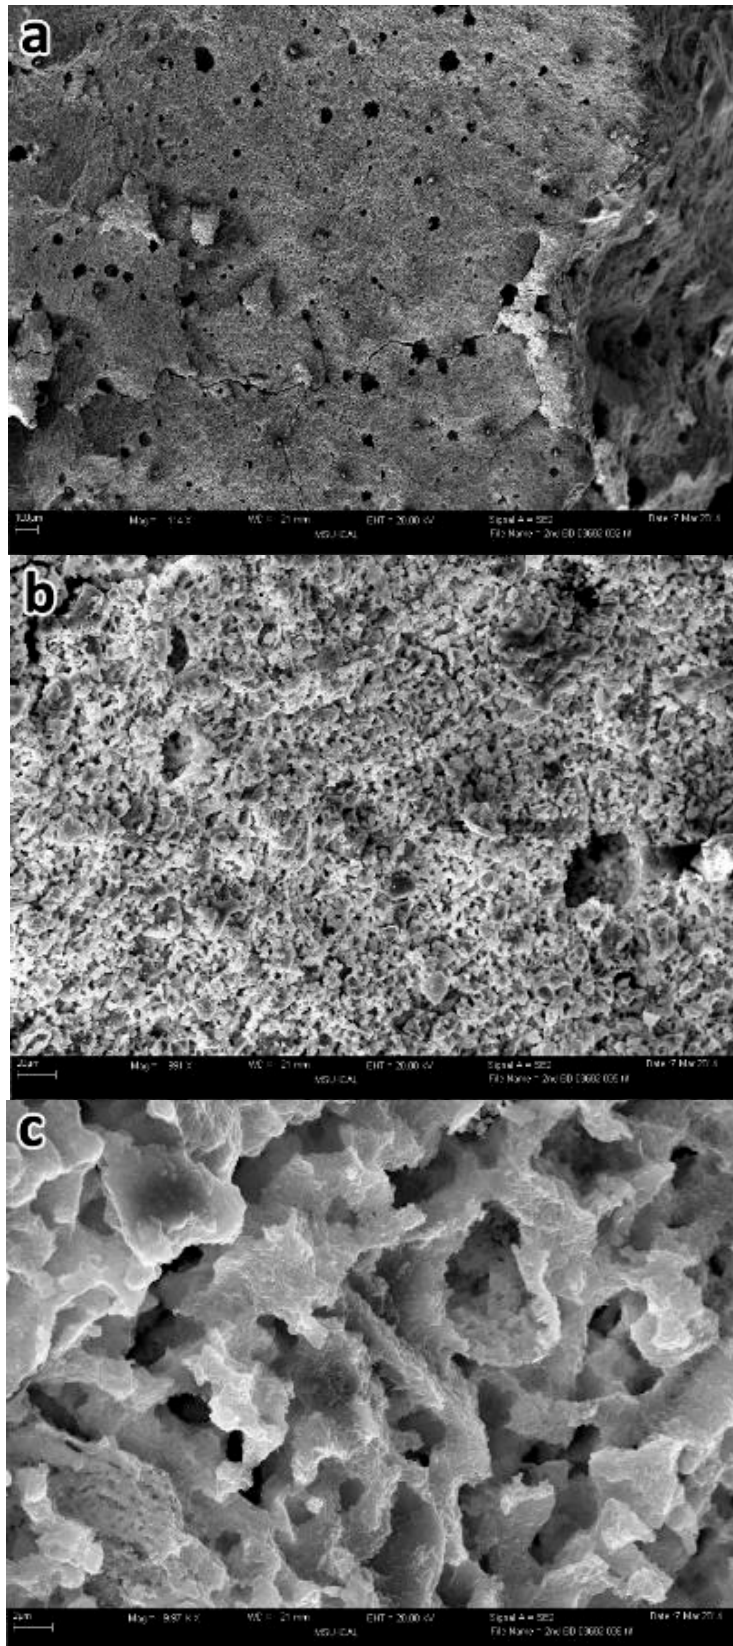
Figure 3.19: SEM micrograph of ODOT bridge deck 08682:
a) low magnification, b) high magnification, and c) ultrahigh magnification

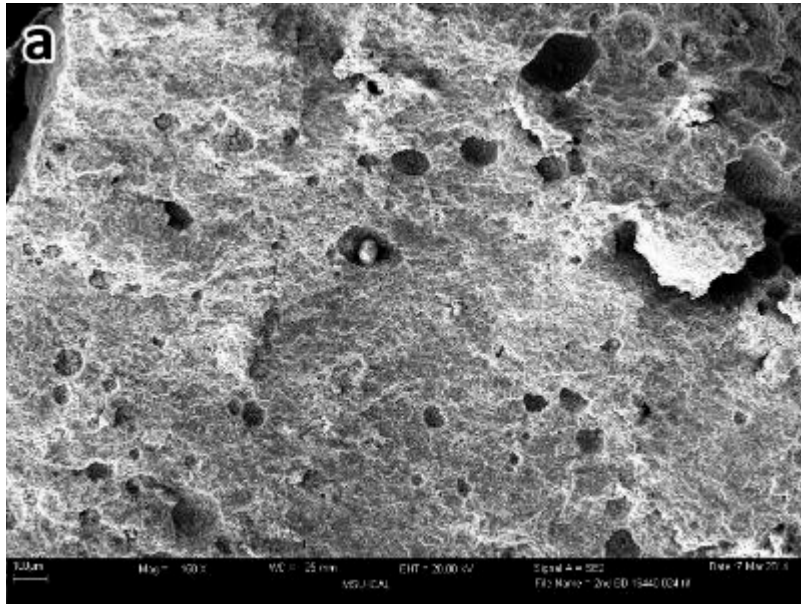
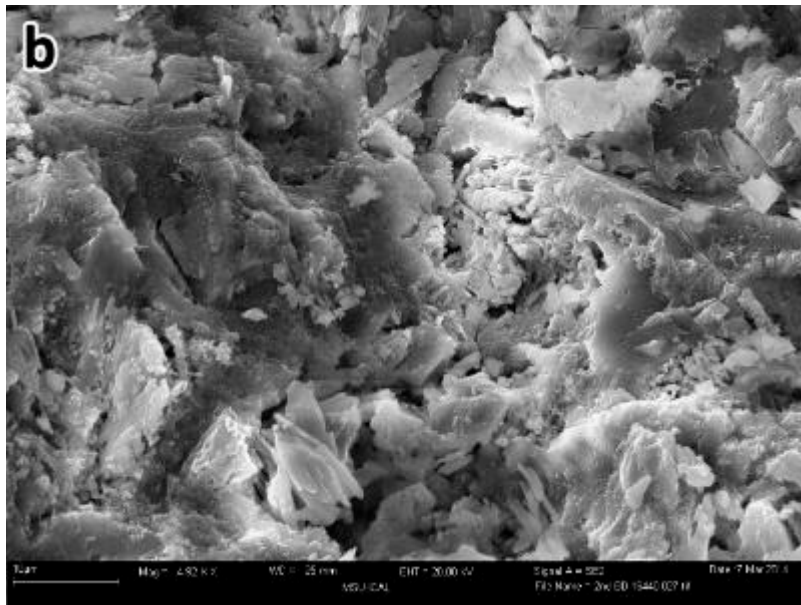
Figure 3.20: SEM micrographs of ODOT bridge deck 16440:
a) low magnification and b) high magnification

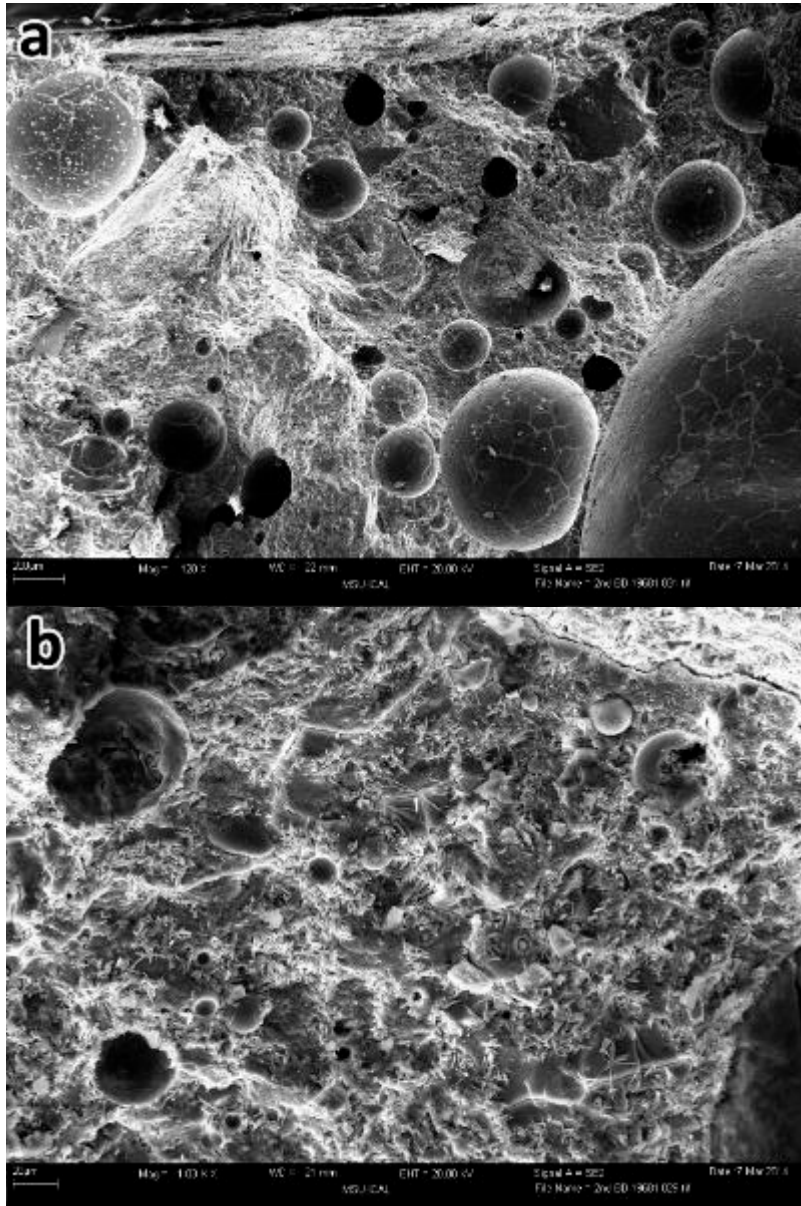
Figure 3.21: SEM micrographs of ODOT bridge deck 19681:
a) low magnification, b) high magnification

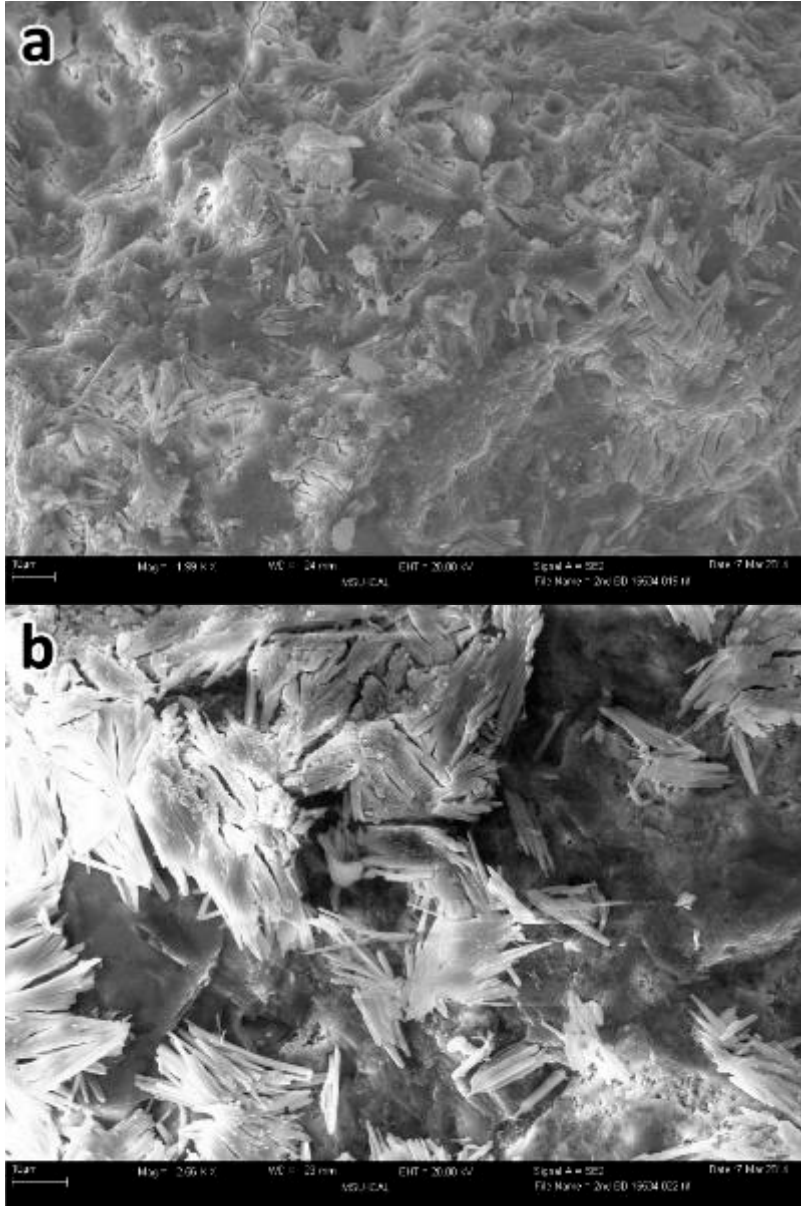
Figure 3.22: SEM micrographs of ODOT bridge deck 16534:
a) low magnification and b) high magnification

Figure 3.22 shows obvious crystalline precipitates in the core sample from the ODOT bridge 16534. Compared with the microstructure of 19681, there were more obvious crystalized phases that had precipitated (Figure 3.22a). From the high magnification observation shown in Figure 3.22b, the precipitate phases were needle-shape with diameter of about 1 μm and length of 10-20 μm . The precipitation process and the chemical analysis of these precipitates need to be further investigated in future studies.

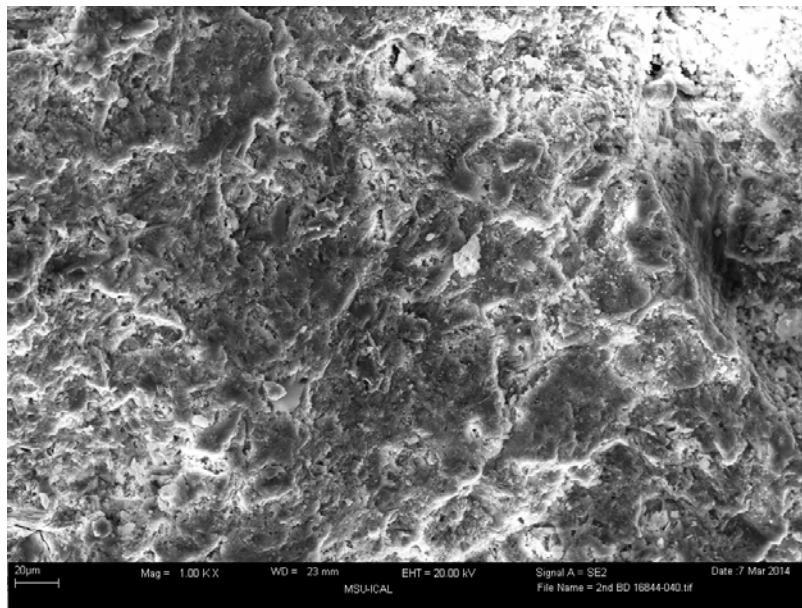
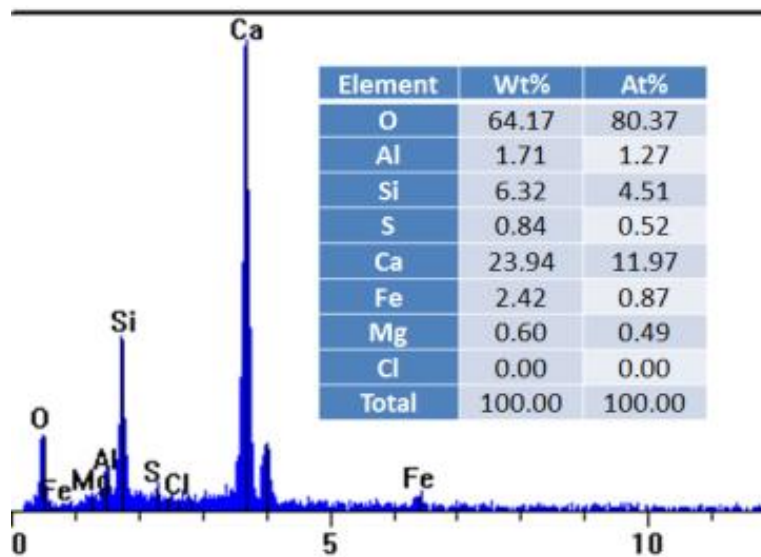
Figure 3.23: SEM/EDS analysis of 16844 bridge deck

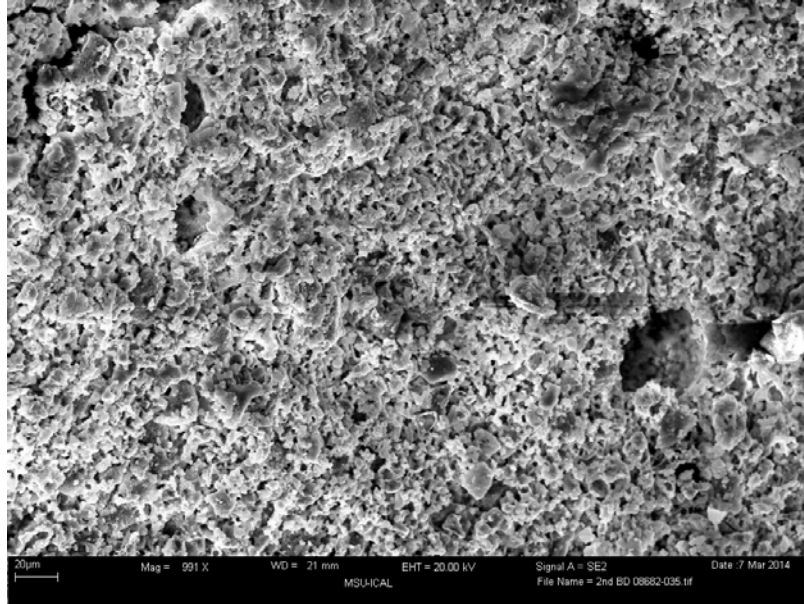
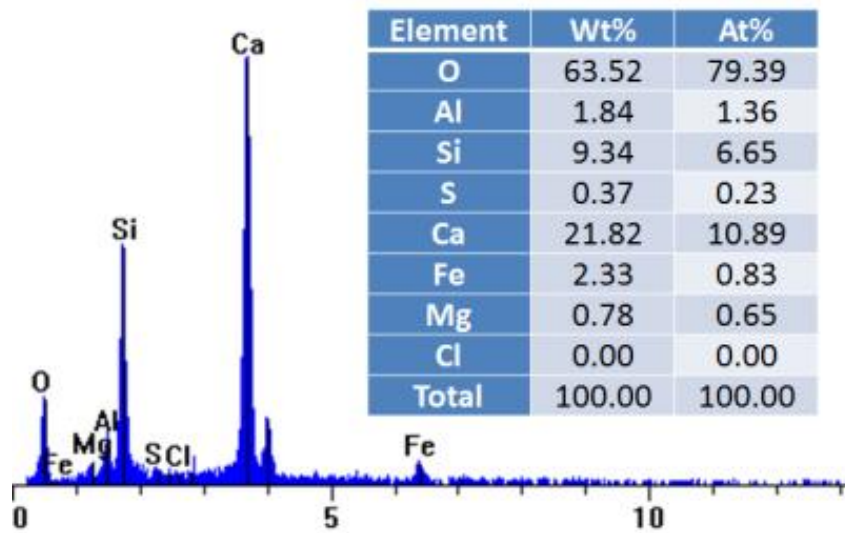
Figure 3.24: SEM/EDS analysis of 08682 bridge deck

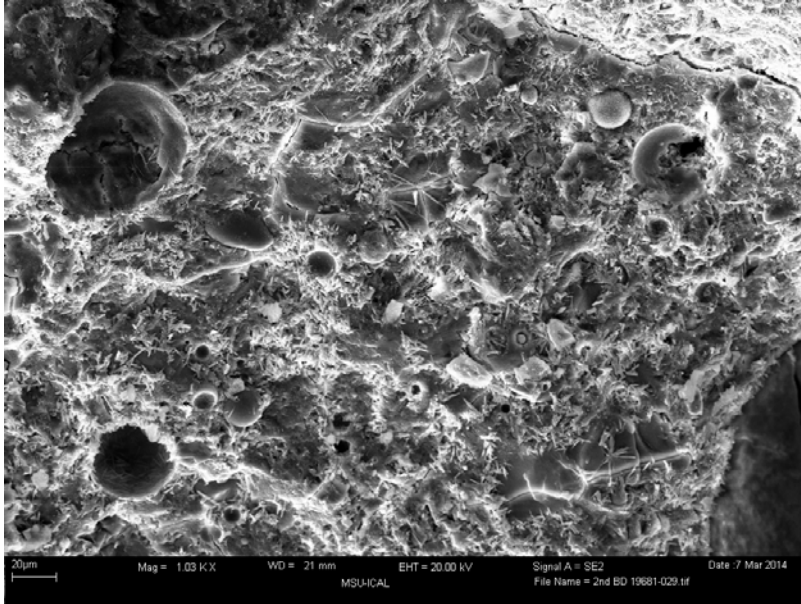
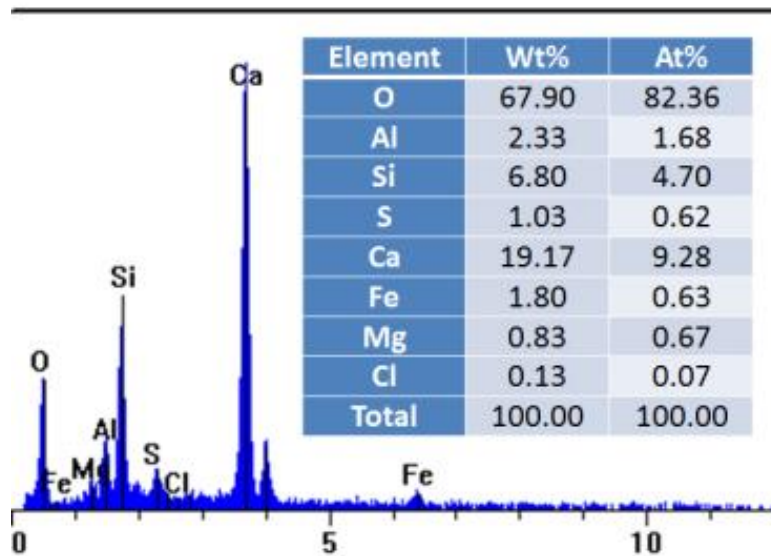
Figure 3.25: SEM/EDS analysis of 19681 bridge deck

Figure 3.25 gives the SEM/EDS analysis results of bridge deck 19681, which was ranked as GOOD by ODOT while 53-57% by CSIL. In this sample, the Mg content was as high as 0.83 wt.% and the Ca content was as low as 19.2 wt.%, which suggested more severe Ca^{2+} leaching than the bridge deck 08682.

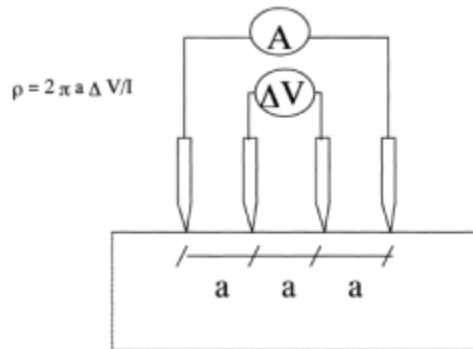
Figure 4.1: Setup of four electrode measurement of concrete resistivity

The surface resistivity of mortar specimens were periodically measured after the given number of freeze/thaw (F/T) and wet/dry (W/D) cycles. Such measurements were conducted during the dry stage after the mortar specimen had reached the room temperature. The resistivity was measured using a Resipod Resistivity Meter (Proceq USA, Inc., Aliquippa, PA) with four equally spaced point electrodes that are pressed onto the mortar surface (Wenner or 4-point method). The two outer electrodes induce an alternating current (AC) in the range of 50 to 1000 Hz and the two inner electrodes measure the potential drop, from which the surface resistivity can be calculated (Figure 4.1).

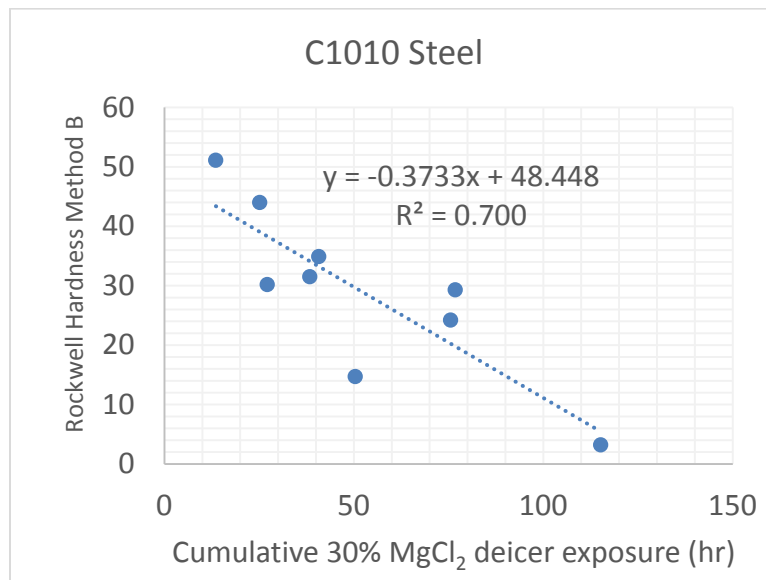
Figure 4.7: Rockwell hardness of carbon steel coupons as possible indicator of MgCl₂ deicer exposure

Figure 4.7 shows the Rockwell hardness of C1010 carbon steel coupons may serve as a possible indicator of cumulative MgCl₂ deicer exposure. There is a relatively good negative correlation between these two, with more deicer exposure leading to lower hardness values. However, the R-square is only 0.70, suggesting that this may not be as reliable as using mortar specimens and their engineering properties (discussed in Section 4.1).

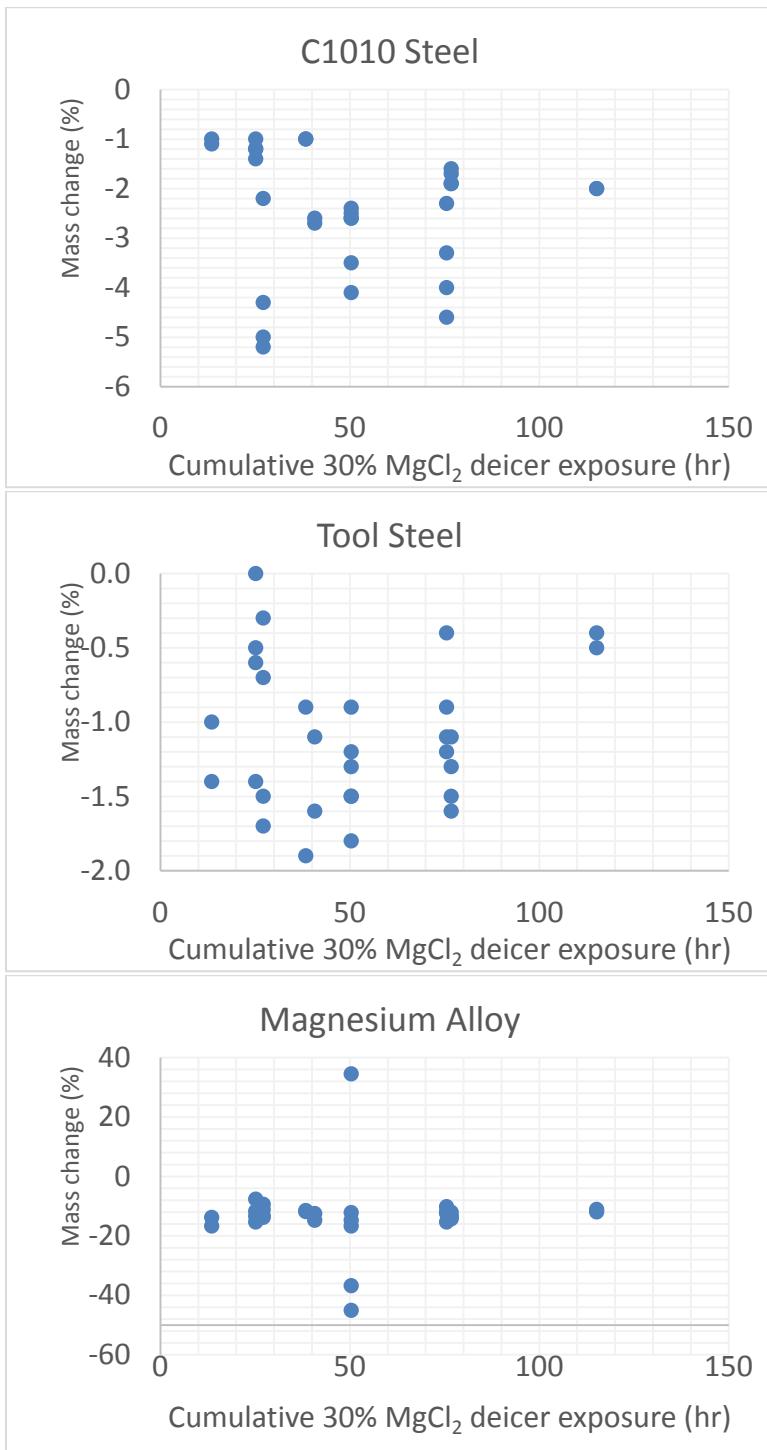
Figure 4.8: Mass loss of metallic coupons as a function of MgCl₂ deicer exposure

Figure 4.8 illustrates that the mass change of metallic coupons cannot serve as a reliable indicator of cumulative MgCl₂ deicer exposure. There was neither a clear trend nor a strong correlation between these two parameters. Note that under the investigated conditions, the mass change values for all the aluminum alloy specimens was 0%.

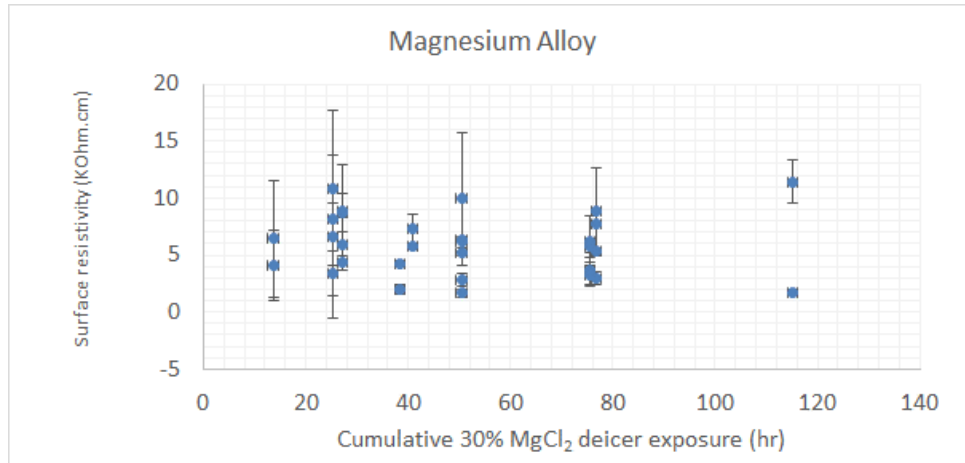
Figure 4.9: Surface resistivity of magnesium alloy coupons as a function of MgCl₂ deicer exposure
