**UNDERSTANDING AND MITIGATING
EFFECTS OF CHLORIDE DEICER
EXPOSURE ON CONCRETE**

Final Report

SPR 742

Oregon Department of Transportation

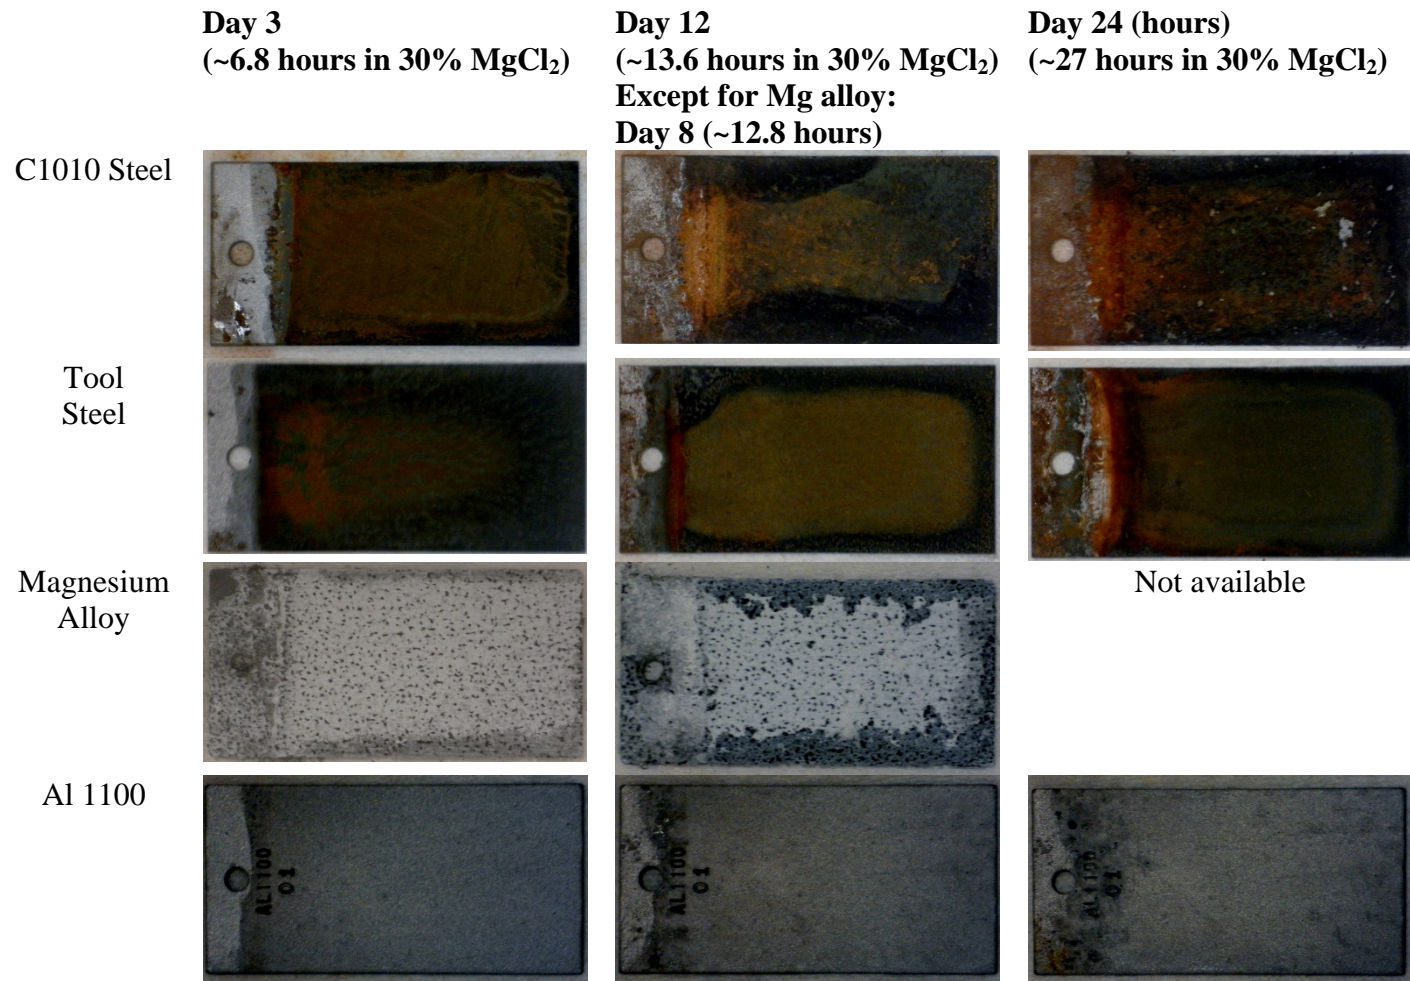
Figure 4.10: Representative digital photos of metallic coupons as a function of metal type and MgCl₂ deicer exposure

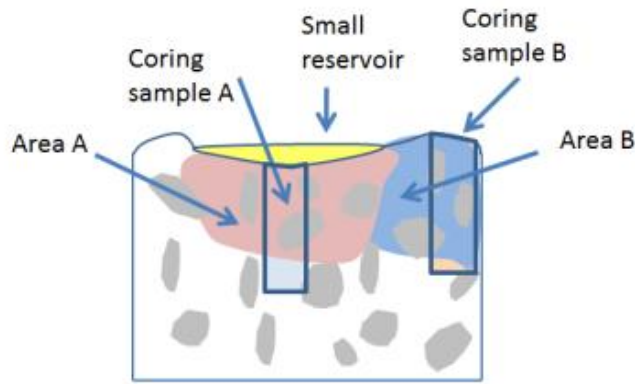
Figure 5.1: Schematic illustration of field concrete in a small area but with different external environmental conditions

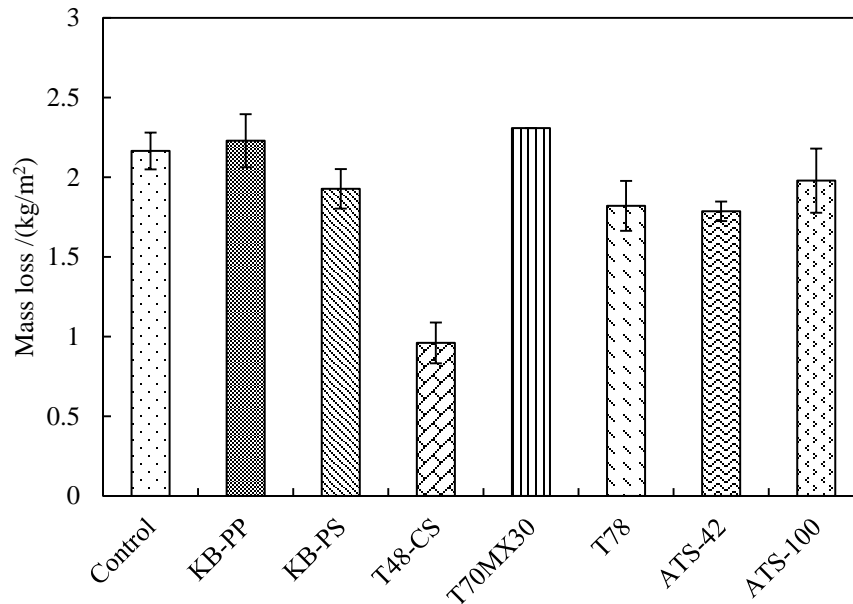
Figure 6.2: Abrasion mass loss of concrete samples with various surface treatments. The error bars show the standard deviations.

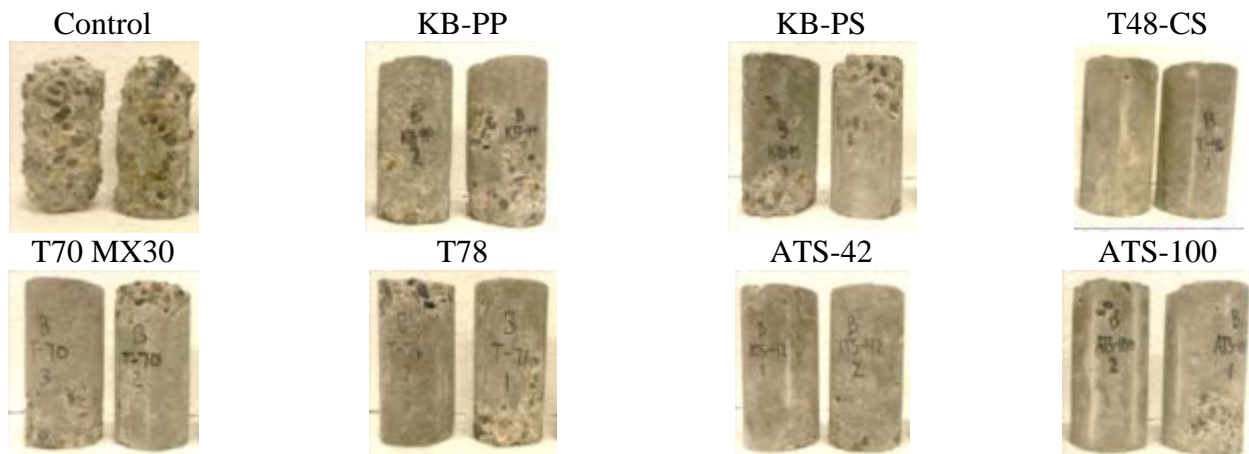
Figure 6.3: Exterior images of concrete cylinders after the deicer exposure and 15 F/T and W/D cycles

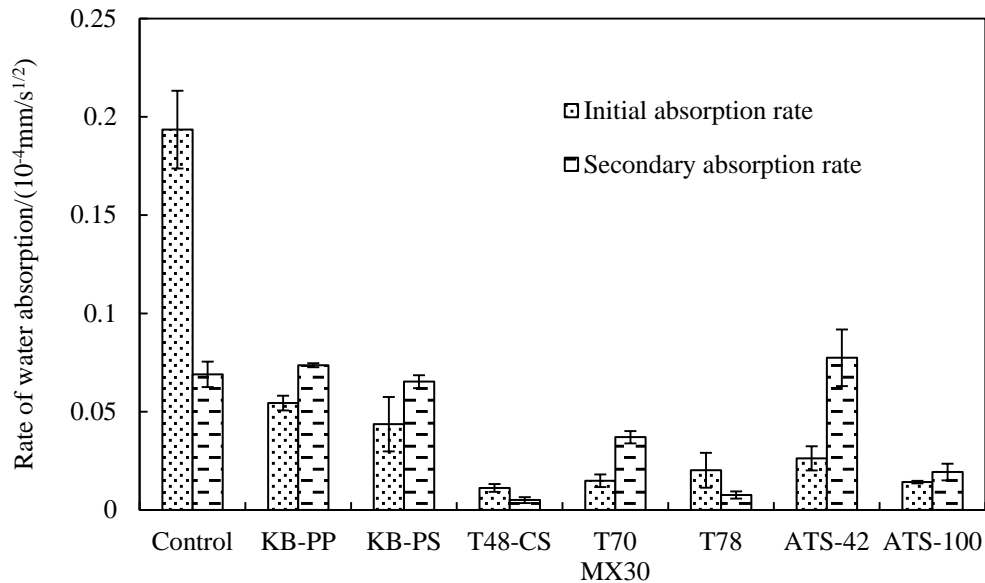
Figure 6.5: Rates of water absorption of concrete specimens with various surface treatments. The error bars show the standard deviations.

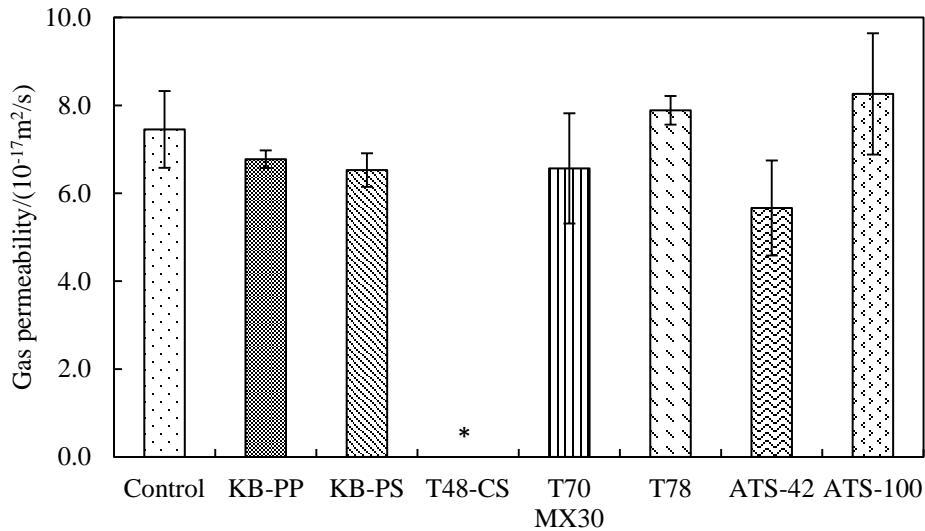
Figure 6.6: Gas permeability coefficient of samples with various surface treatments. Average value and standard deviation are shown.

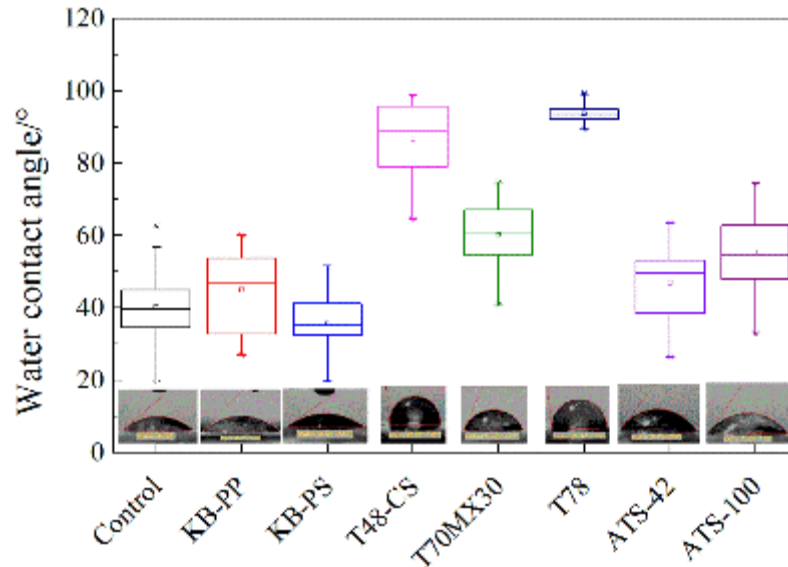
Figure 6.7: Water contact angle of samples with various surface treatments

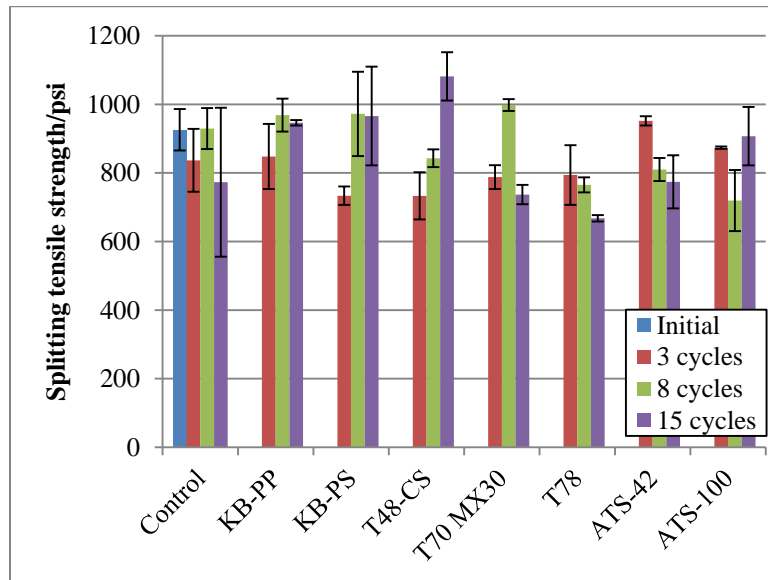
Figure 6.8: Splitting tensile strength of concrete samples surface treated with different sealers after F/T and W/D cycles in 3% NaCl solution

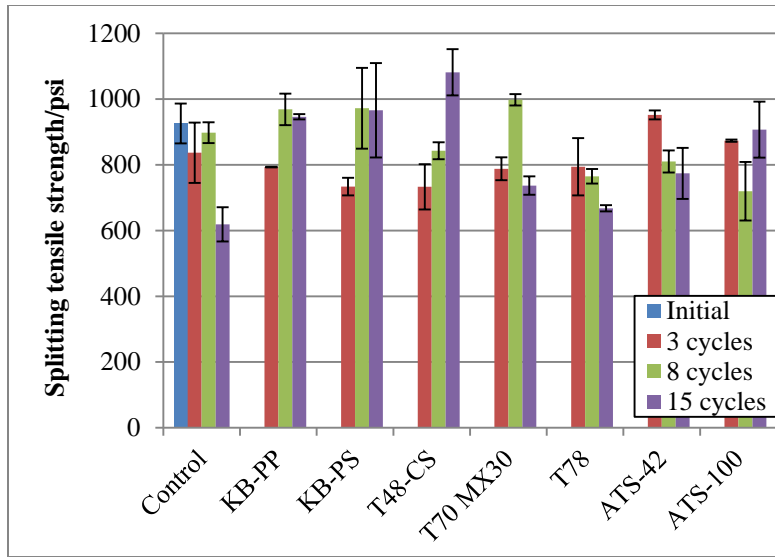
Figure 6.9: Splitting tensile strength of concrete samples surface treated with different sealers after F/T and W/D cycles in 3% MgCl₂ solution

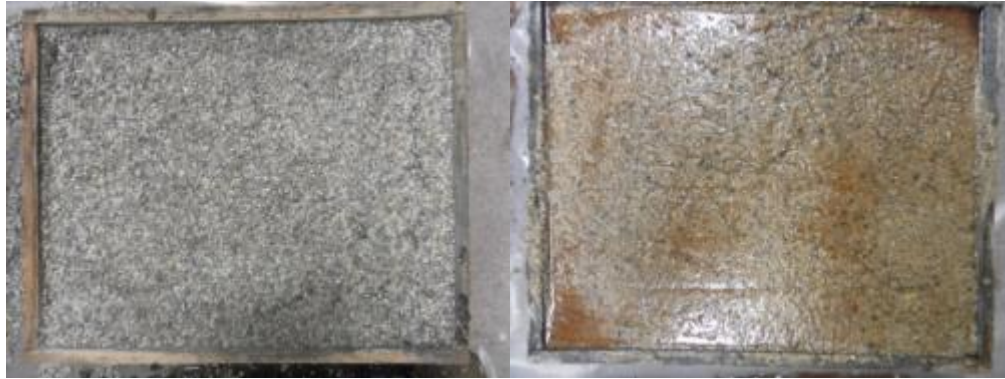
(a) Brushing the surface of concrete slab (b) Wetting and placing formwork
(c) Casting the cement based overlays (d) Covering for curing

Figure 7.1: Preparation of the cement based overlays

For cement based overlays, after moisture cured at $23 \pm 1^\circ\text{C}$ and RH 100% for 28 days, the concrete slabs were dried at $23 \pm 1^\circ\text{C}$ and RH 50% for 24 hours. A wire brush was used to polish the slabs until the paste on the surface of the slabs was removed (see Figure 7.1a). The slabs were wetted, and a wood mold with thickness of 1 inch was placed around the slabs (see Figure 7.1b). Then the overlay mixtures were cast into the form and sealed with a plastic sheet (see Figure 7.1c and Figure 7-.d). The slabs were transferred to a moisture room at $23 \pm 1^\circ\text{C}$ and RH 100% for another 28 days.

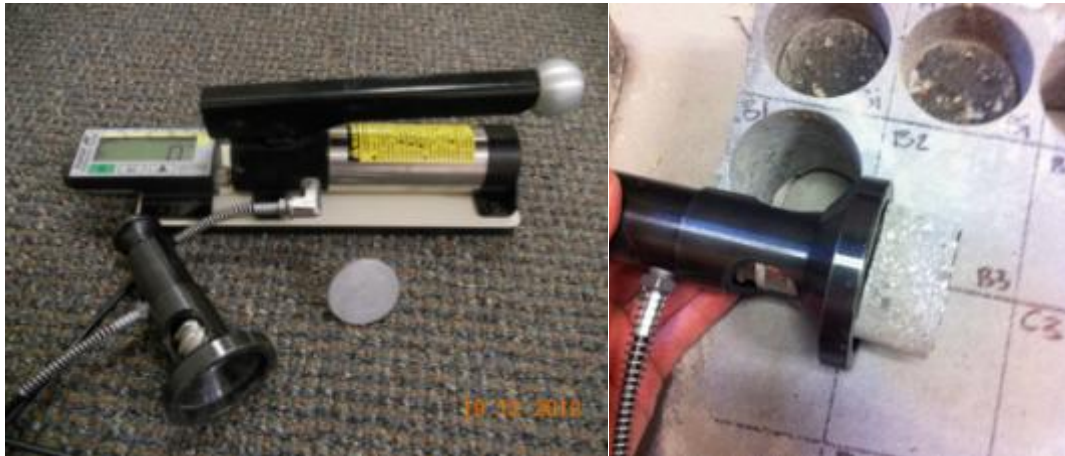
Figure 7.3: Bond strength tests

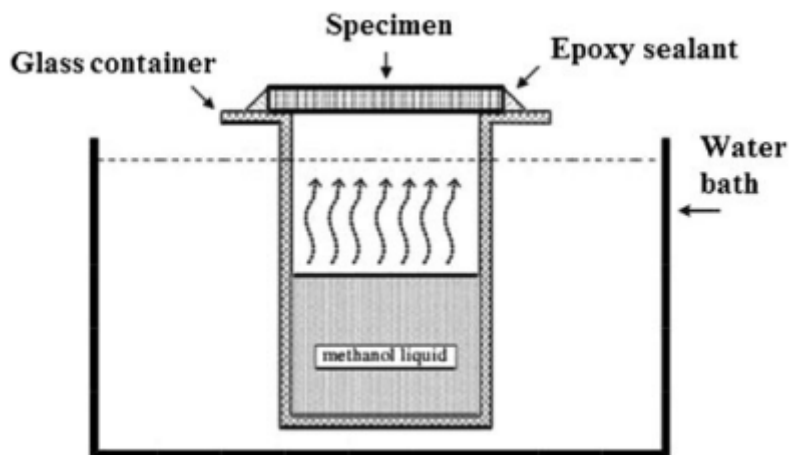
Figure 7.4: Schematic drawing for the gas permeability test setup

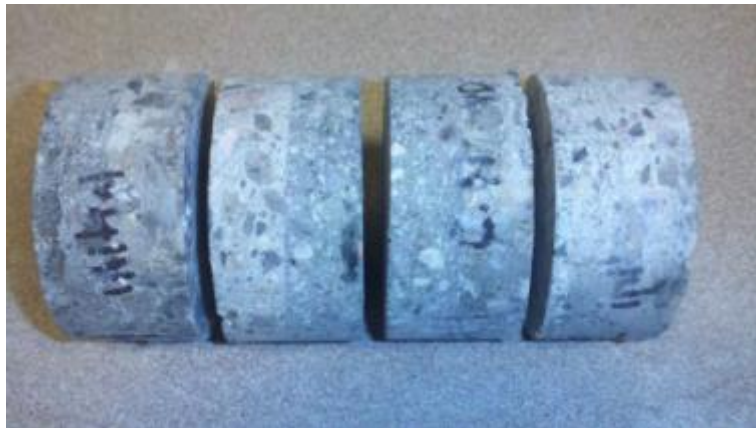
Figure 7.5: Samples of cement based overlays including overlay (0.5'') and concrete (0.5'') used for gas permeability test

For concrete slabs covered by cement-based overlays, a core with 2'' diameter was drilled from slabs, and the core was cut into three pieces that included only overlay (0.5''), overlay (0.5'') + concrete (0.5''), and only concrete (0.5''). For organic overlays, 2 pieces were cut from the drilled cores: overlay (1/3'') + concrete (2/3'') and only concrete (0.5''). Figures 7.5 and 7-6 show the sectioned samples.

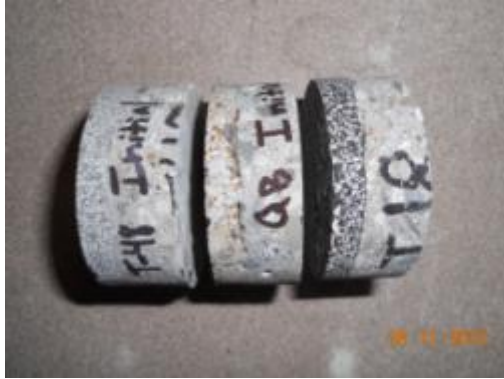
Figure 7.6: Samples of organic overlays including overlay (1/3") and concrete (2/3") used for gas permeability test

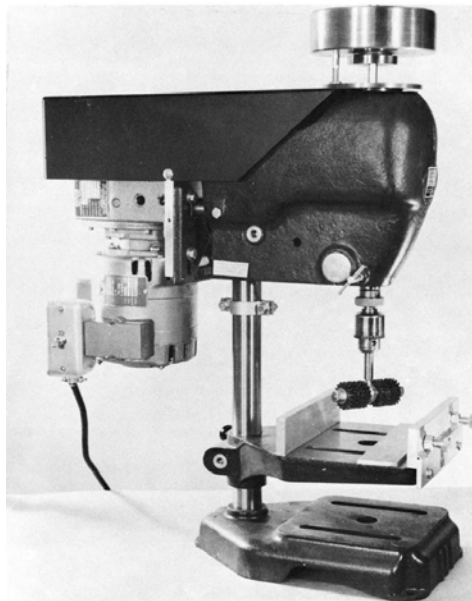
Figure 7.7: Rotating-Cutter Drill Press

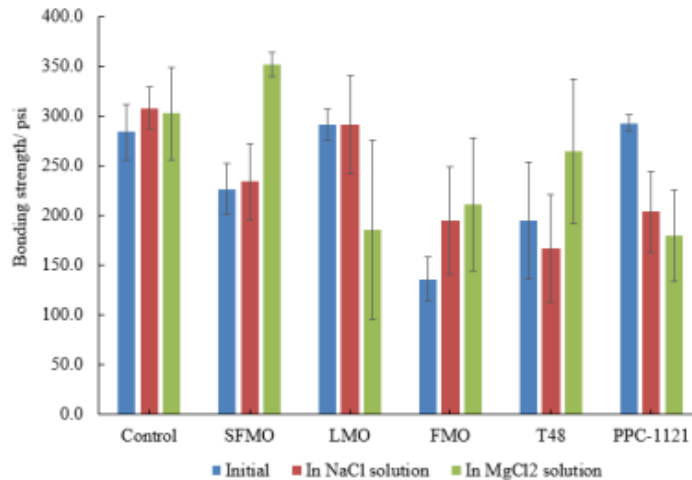
Figure 7.8: Bond strengths of various overlays

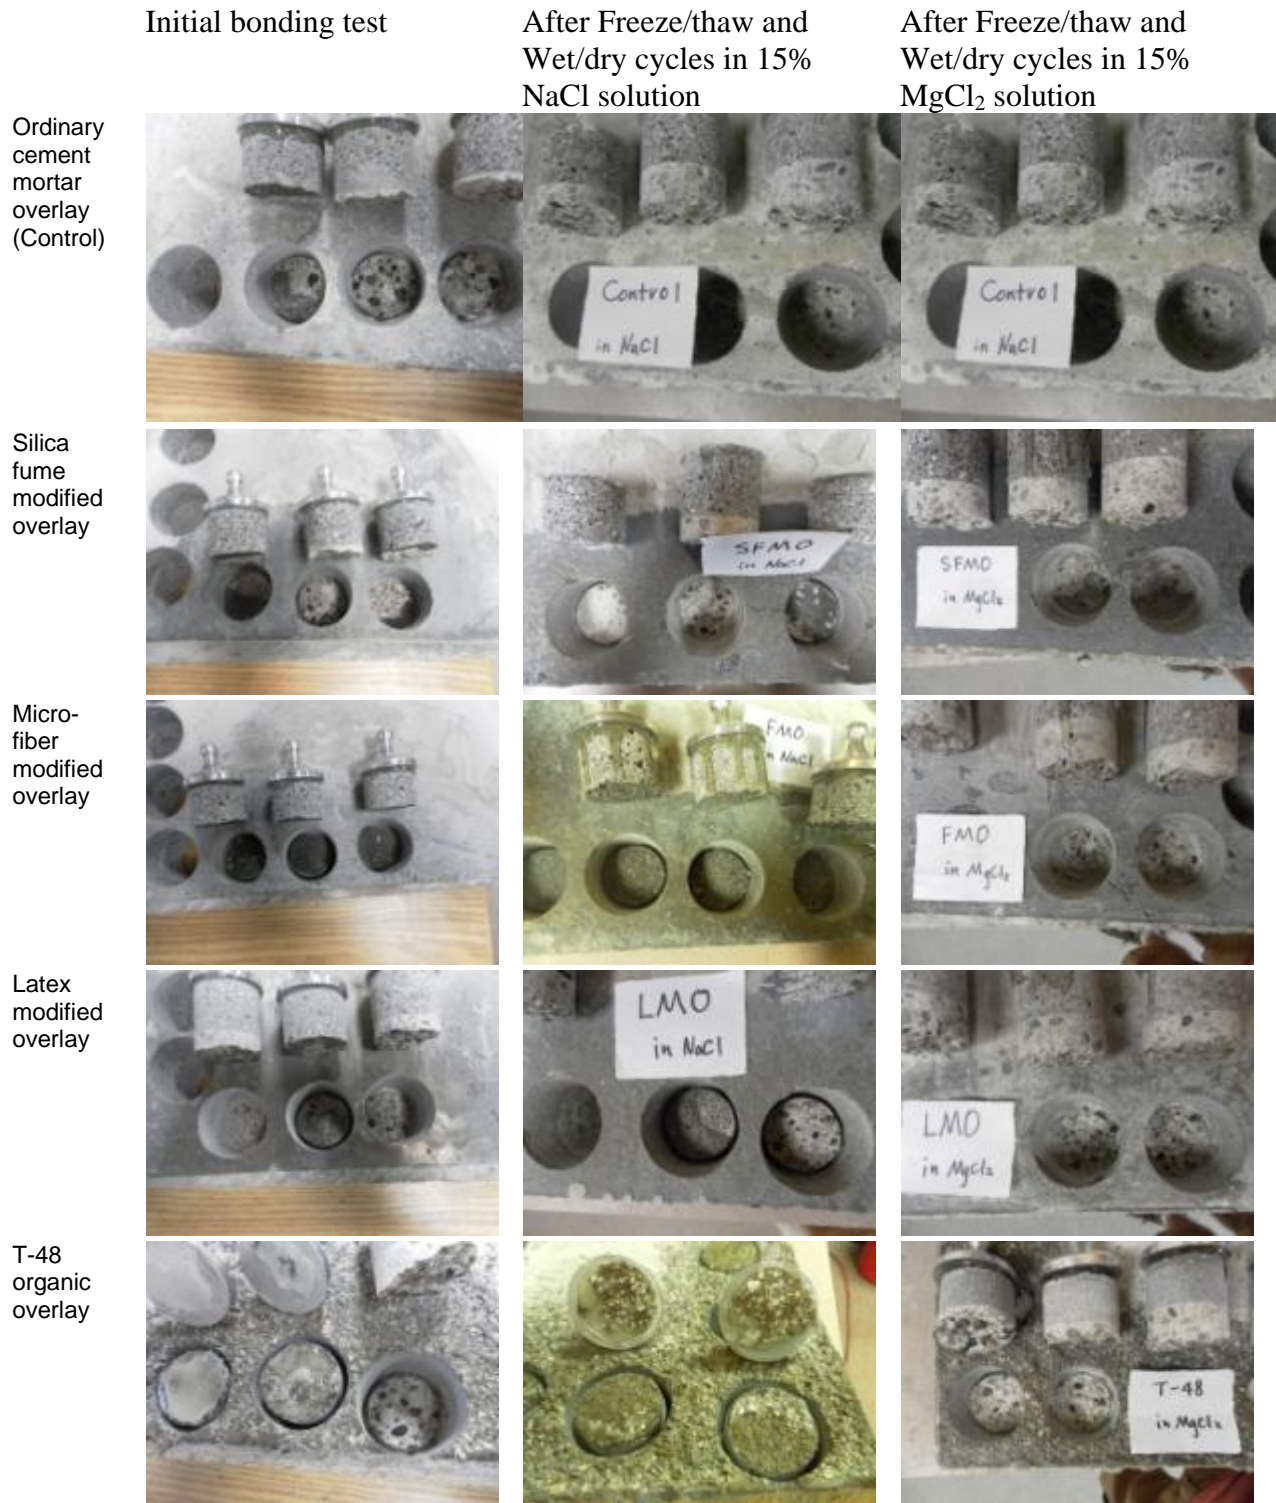
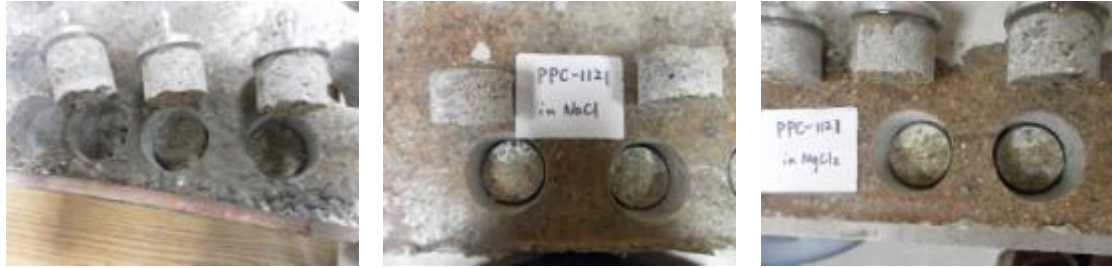
Figure 7.9: Digital photos of concrete samples after bond strength tests

Figure 7.9 gives the images of bond strength tests after F/T and W/D cycles in 15% NaCl and MgCl₂ solutions. The fracture of all cementitious overlays, including the control (without overlay), SFMO, and FMO, of the initial bonding tests occurred at the interfaces between the overlays and the substrates. However, after F/T and W/D cycles, most of the fractures occurred in the substrates rather than at the interfaces. This phenomenon proved the assumption that the bond strength of the interfaces between the cementitious overlay and the concrete substrates will be strengthened during the F/T and W/D cycles because of the further hydration process.

For the organic overlays (T48 and PPC-1121) and organic modified overlay (LMO), the fracture of the initial bonding tests occurred at the interfaces between the overlays and the substrates. After the F/T and

W/D cycles, the fracture still occurred at the interfaces between the overlays and the substrates, except the T48 in $MgCl_2$, which showed increased bond strength after the F/T and W/D cycles (Figure 7.8).

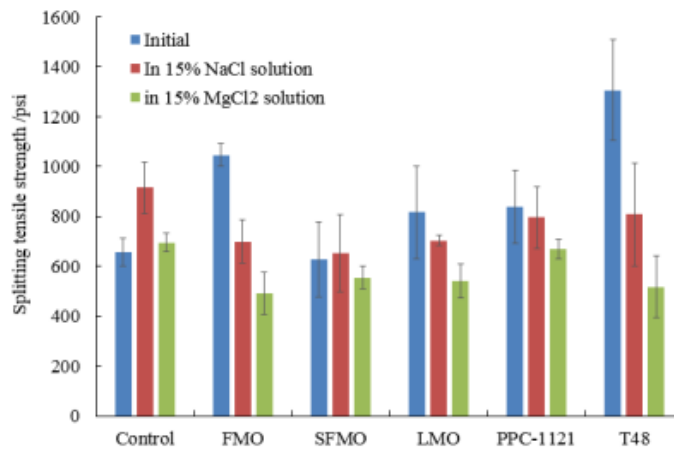
Figure 7.10: Splitting tensile strengths of various overlays

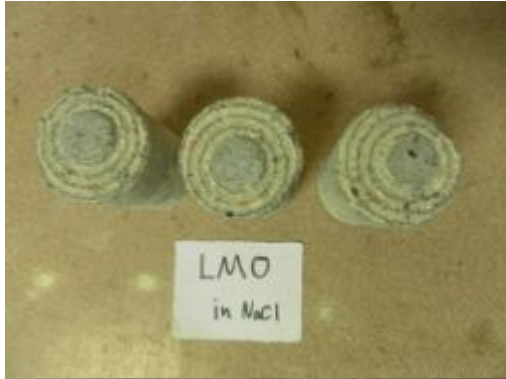
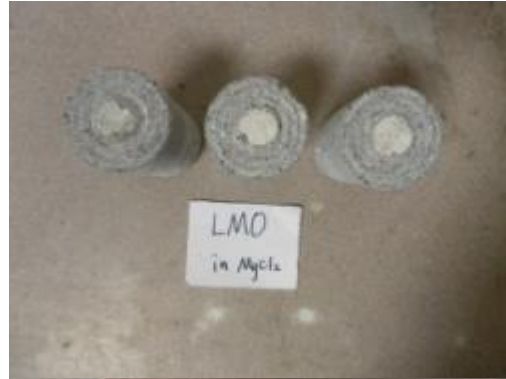
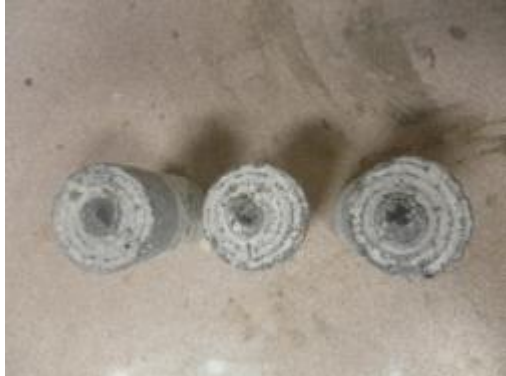
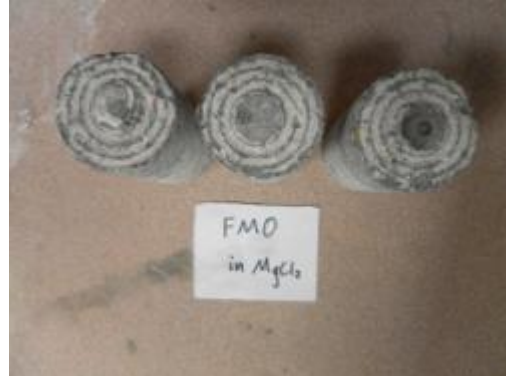
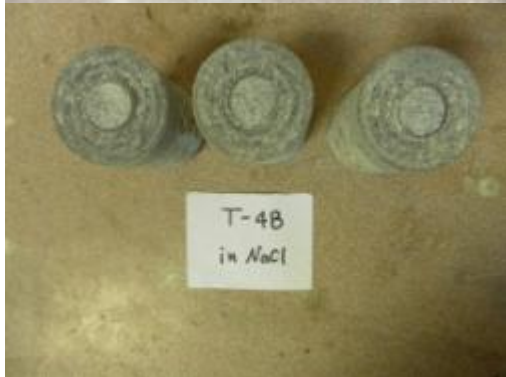
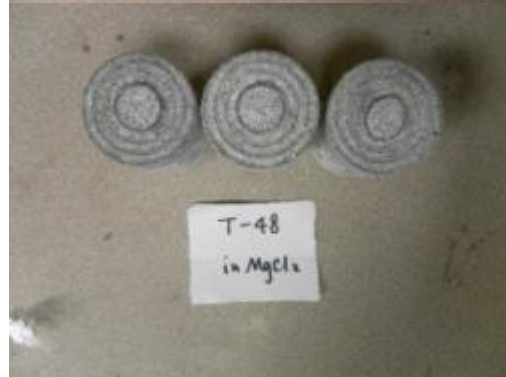
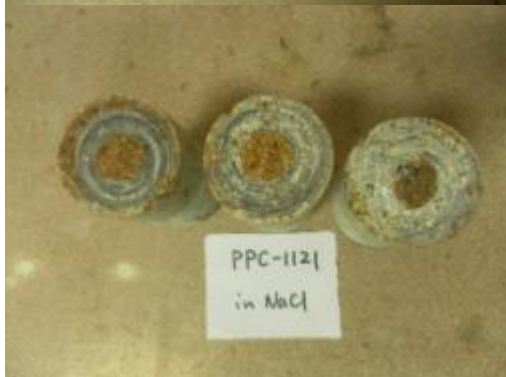
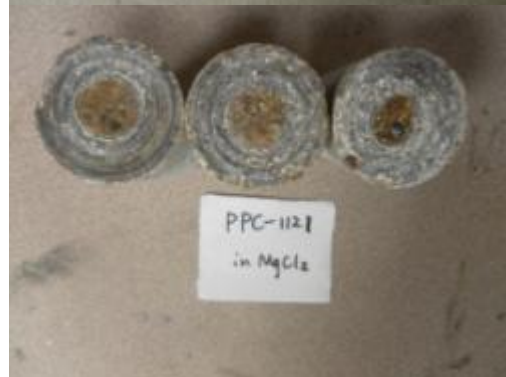
Figure 7.13: Abrasion test surfaces of cored overlay cylinders after freeze/thaw and wet/dry cycles in 15% NaCl solutions

Figure 7.13 gives the images of abrasion tests after F/T and W/D cycles in 15% NaCl and MgCl₂ solutions. The polymer overlays (T48 and PPC-1121) had intact edges after abrasion test, while the cementitious overlays showed scaling at the edges.

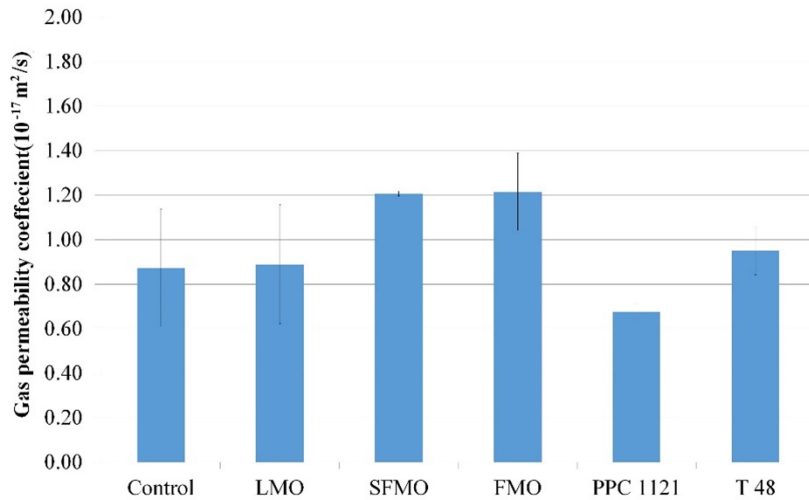
Figure 7.14: Gas permeability of various overlays after F/T and W/D cycles in 15% NaCl solutions

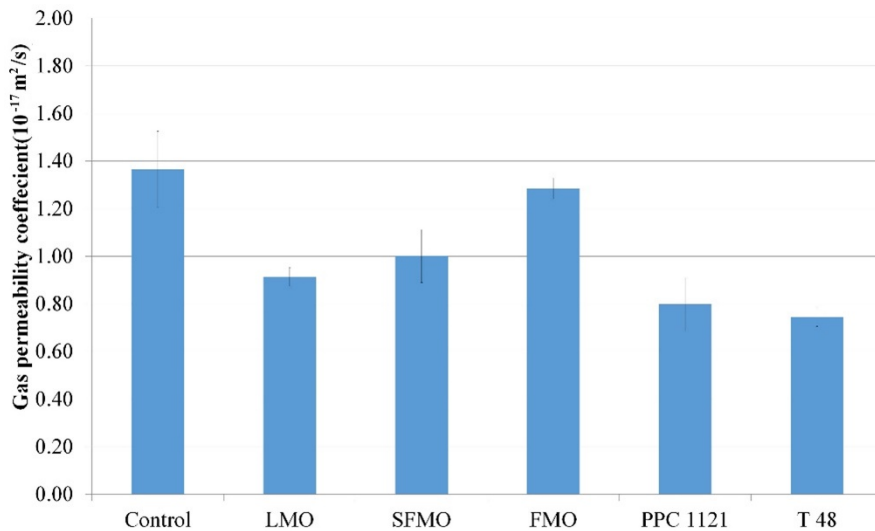
Figure 7.15: Gas permeability of various overlays after F/T and W/D cycles in 15% MgCl₂ solutions
