Enhancement of Welded Steel Bridge Girders Susceptible to Distortion-Induced Fatigue

A Transportation Pooled Fund Study - TPF-5(189)

1 Report No. FHWA-KS-14-03	2 Government Accession No.	3 Recipient Catalog No.	
4 Title and Subtitle Enhancement of Welded Steel Bridge Girders Susceptible to Distortion-Induced Fatigue		5 Report Date October 2014	
		6 Performing Organization Code TPF-5(189)	
7 Author(s) Caroline Bennett, Ph.D., P.E., Adolfo Matamoros, Ph.D., Ron Barrett-Gonzalez, Ph.D., and Stan Rolfe, Ph.D., P.E.		7 Performing Organization Report No. SM Report No. 106	
9 Performing Organization Name and Address The University of Kansas Center for Research, Inc. 2385 Irving Hill Road – Campus West Lawrence, Kansas 66045		10 Work Unit No. (TRAIS)	
		11 Contract or Grant No. C1795	
12 Sponsoring Agency Name and Address Kansas Department of Transportation Bureau of Research 2300 SW Van Buren Topeka, Kansas 66611-1195		13 Type of Report and Period Covered Final Report September 2008 – June 2014	
		14 Sponsoring Agency Code RE-0510-01 & TPF-5(189)

Final Report

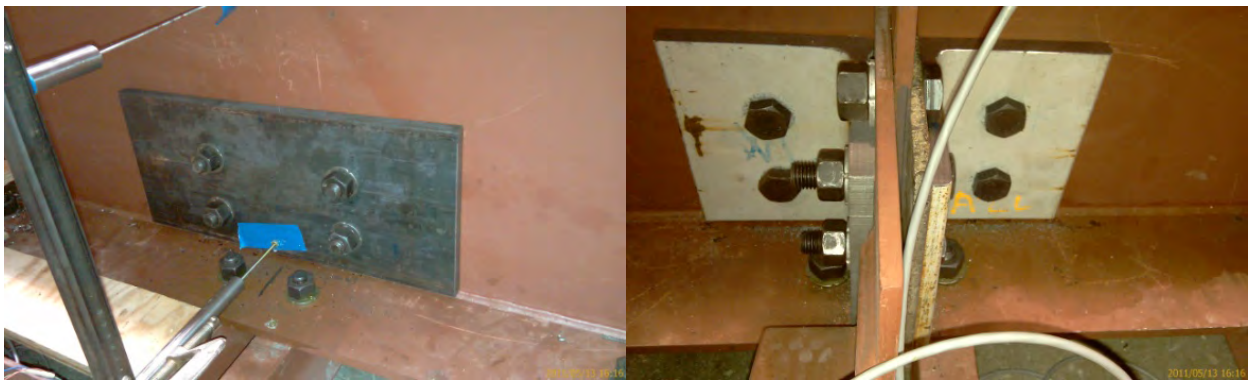
Figure 3.3: Angles-with-plate repair installed in the bottom web gap of the 2.8 m (9.3 ft) girder model

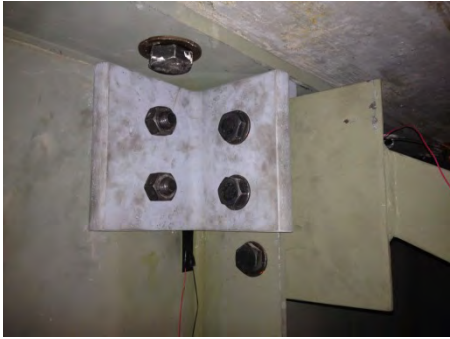
L152x152x19mm
[L6x6x3/4"]

L127x152x19mm
[L5x6x3/4"]

L457x203x19mm
[18x8x3/4"]

Figure 3.5: Angles-with-plate retrofit applied in Trials 2 to 6
(a) angles (b) back plate

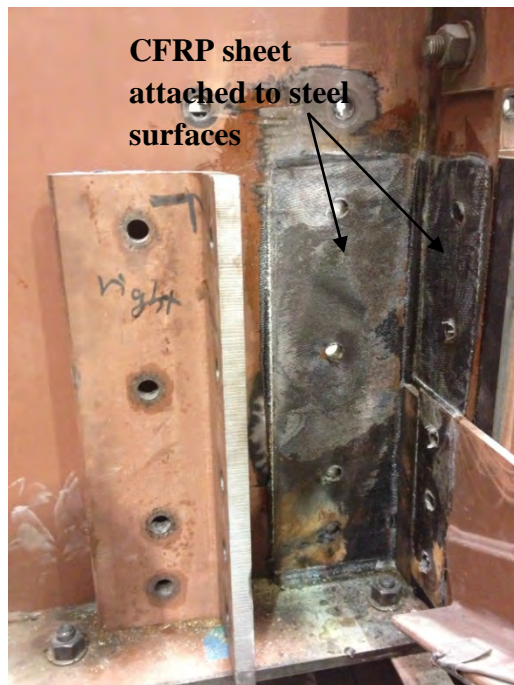
Figure 3.15: Trial 2: view of the interior face of the girder's web before application of the angles-with-plate-with-CFRP retrofit measure

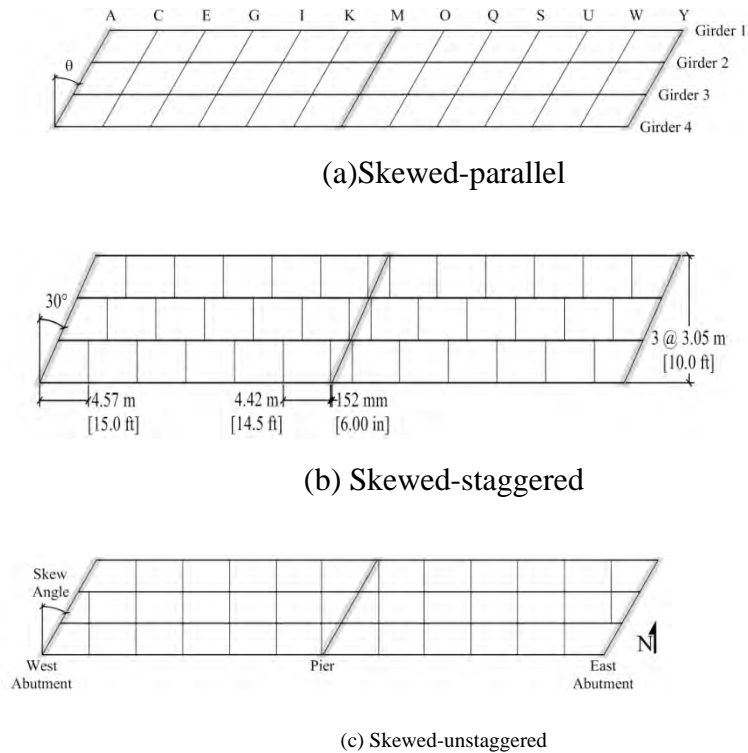
Figure 3.21: Bridge layouts (30° skew with 4.6 m (15 ft) cross-frame spacing shown)

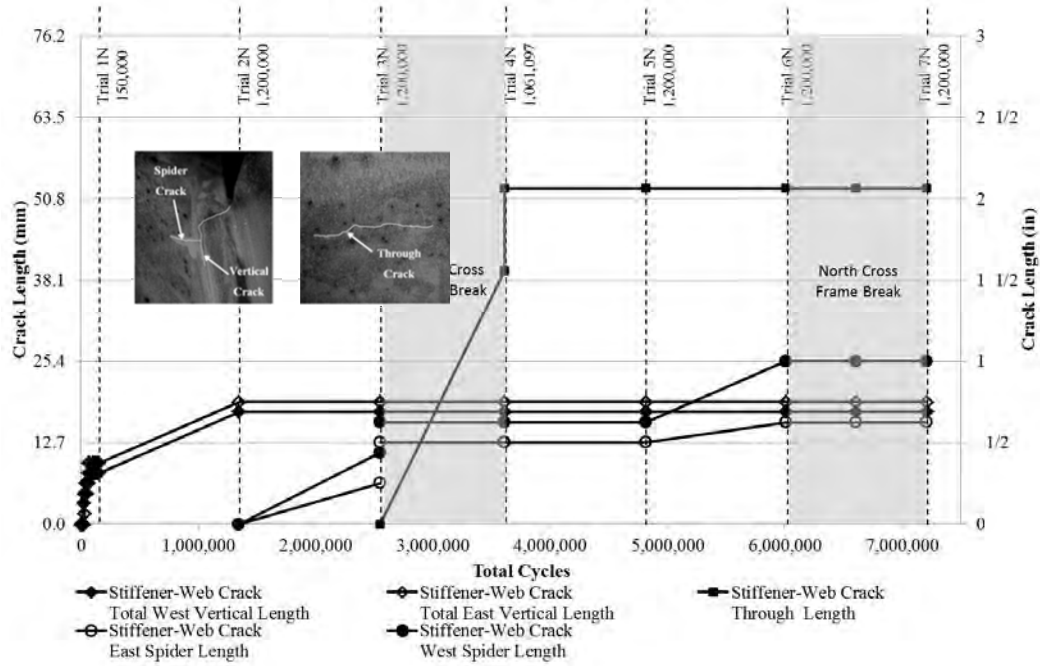
Figure 4.4: Crack growth – North girder

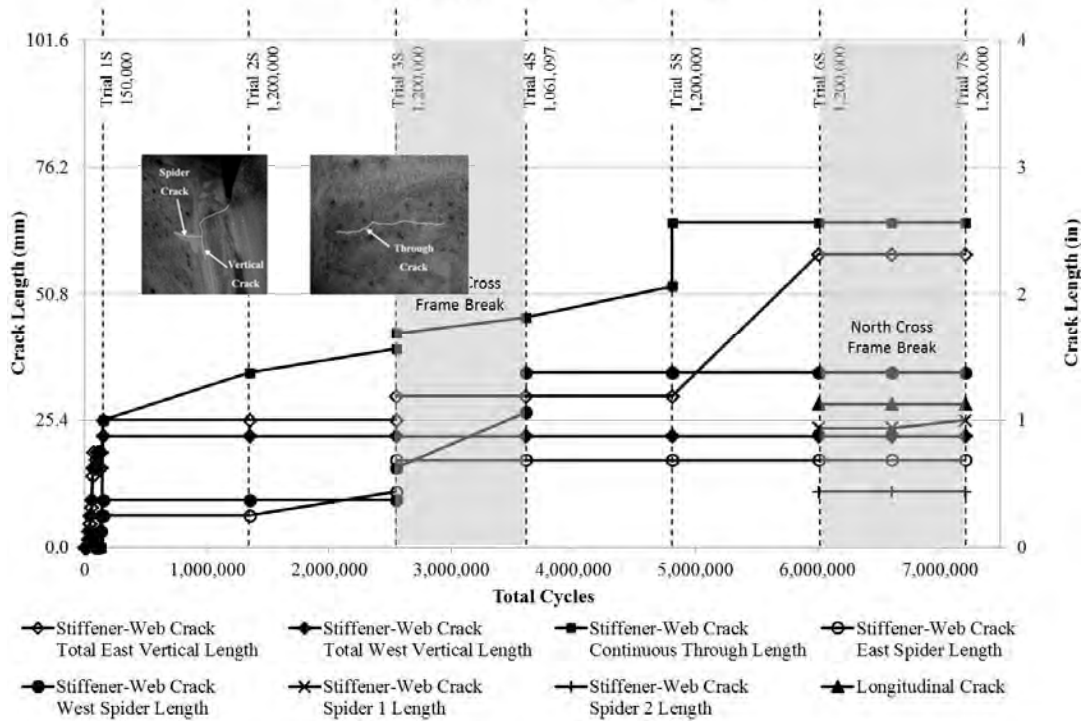
Figure 4.5: Crack growth – South girder

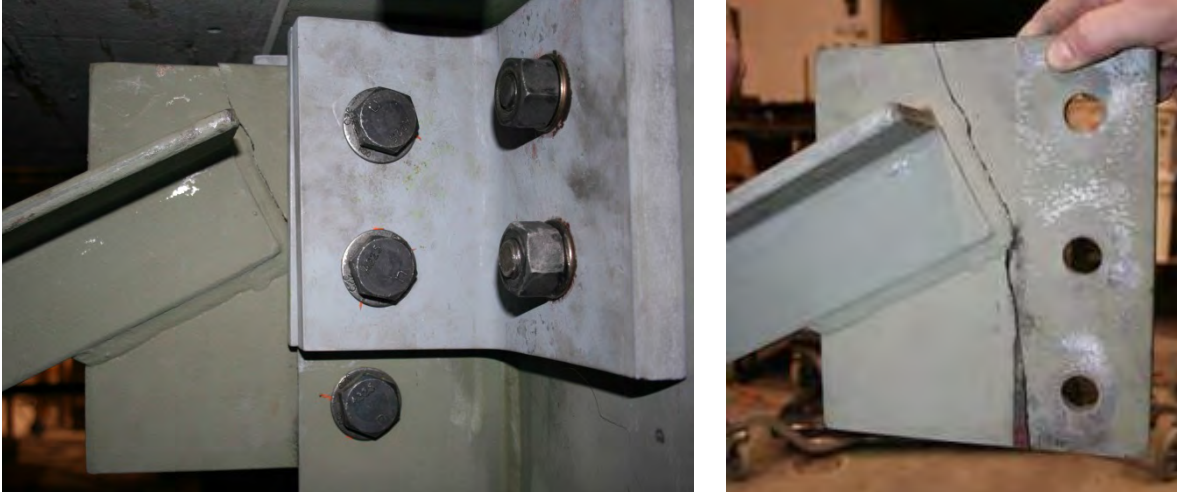
Figure 4.6: North cross frame failure during Trial 4N

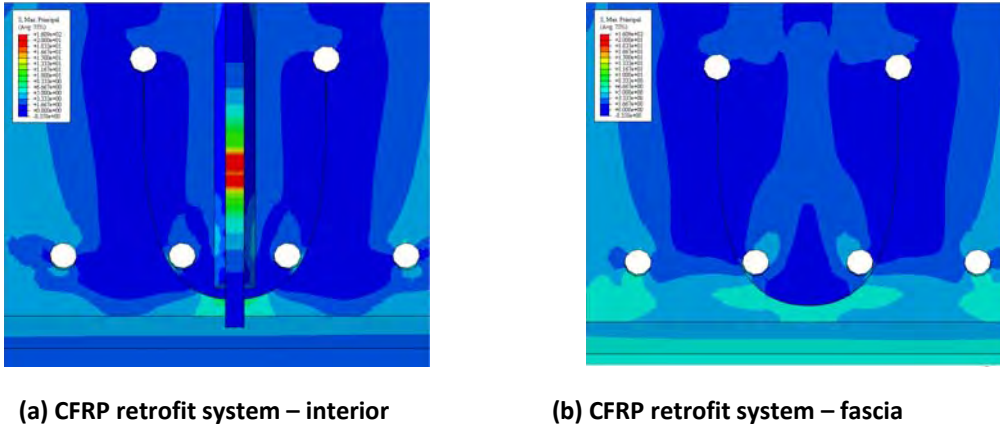
Figure 4.13: Maximum principal tension stresses in model repaired with CFRP
