# Investigation of Field Corrosion Performance and Bond/Development Length of Galvanized Reinforcing Steel

**Final Report  
December 2014**

**Sponsored by**  
Federal Highway Administration  
Iowa Highway Research Board  
(IHRB Project TR-666)  
Iowa Department of Transportation  
(InTrans Project 13-481)

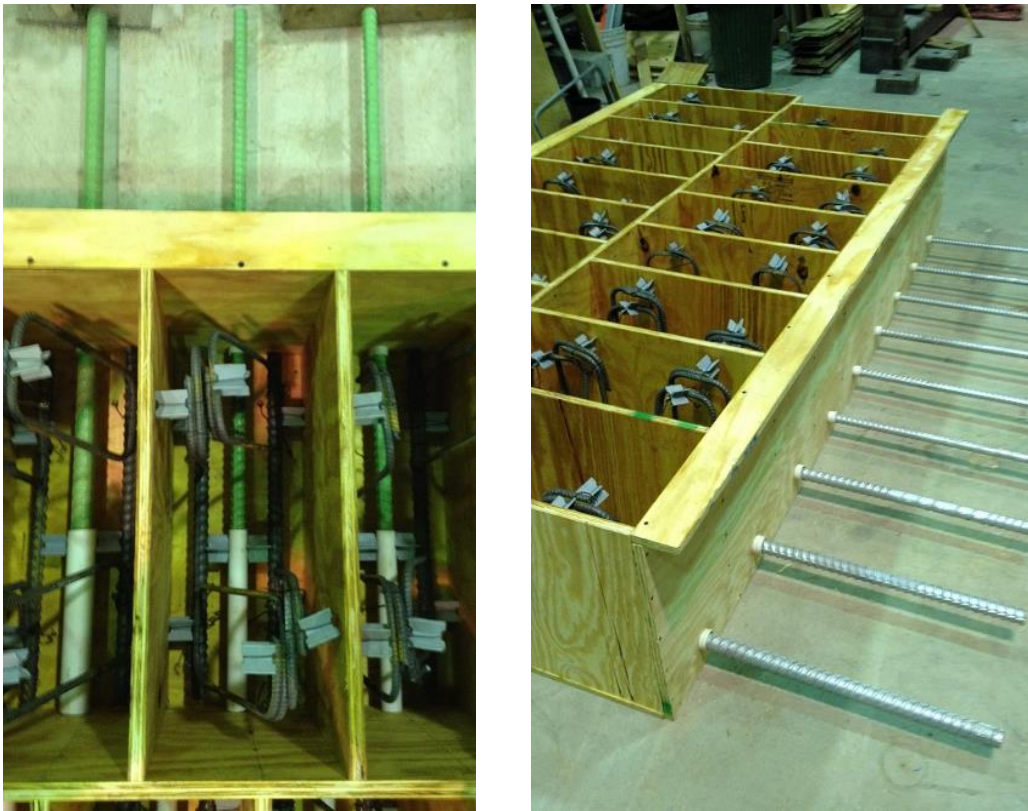
**Figure 3-2. Wooden forms with epoxy-coated (left) and galvanized (right) test bars**

in the specimens was between 6,500 psi and 7,000 psi with an average value of 6,827 psi. Photographs taken during the specimen fabrication process are shown in Figures 3-2 and 3-3.

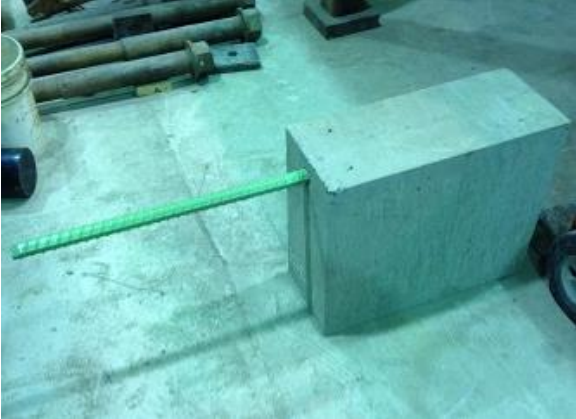
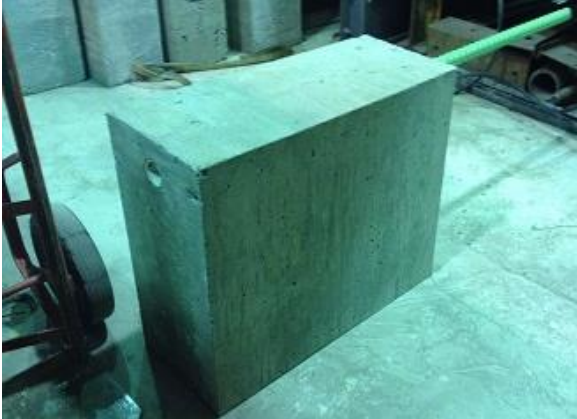
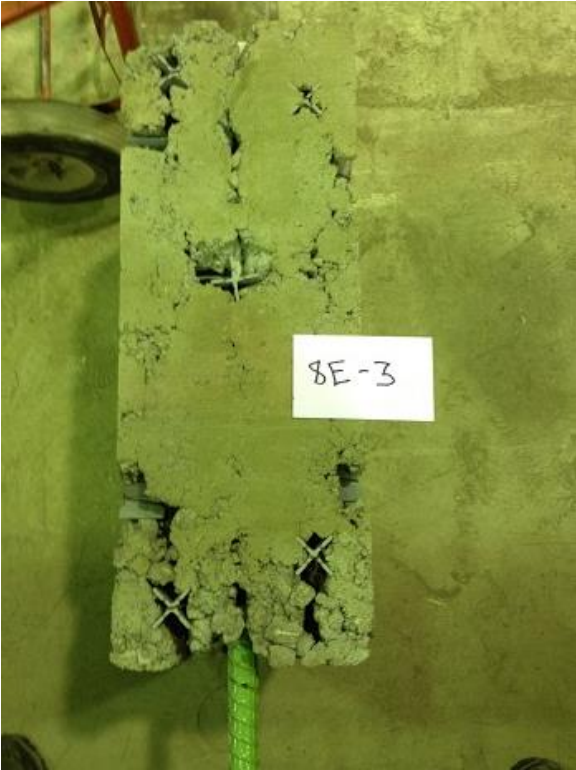
**Figure 3-4. Sample specimens**

Each specimen was labeled in the following format: size of longitudinal rebar, followed by a letter E for epoxy-coated or G for galvanized, followed by the specimen number. For example, 8G-2 corresponded to the second of the three test specimens containing a #8 galvanized test bar. Sample photographs of specimens used in the beam end test are presented in Figure 3-4.

(a) Isometric view showing the loaded end

(b) Isometric view showing the unloaded end

(c) Specimen with poor concrete consolidation

(d) Specimen with #8 galvanized test bar

As can be seen in Figures 3-6 through 3-11, the load-slip relation generally softens as the load reaches the maximum load, followed by reduction in tensile force associated with bond failure. Note that the force reductions of specimens 8E-3 and 10E-2 were more abrupt than those of others. It is speculated that this phenomenon was due to poor consolidation of the concrete along the top and front faces of these specimens (Figure 3-4c).

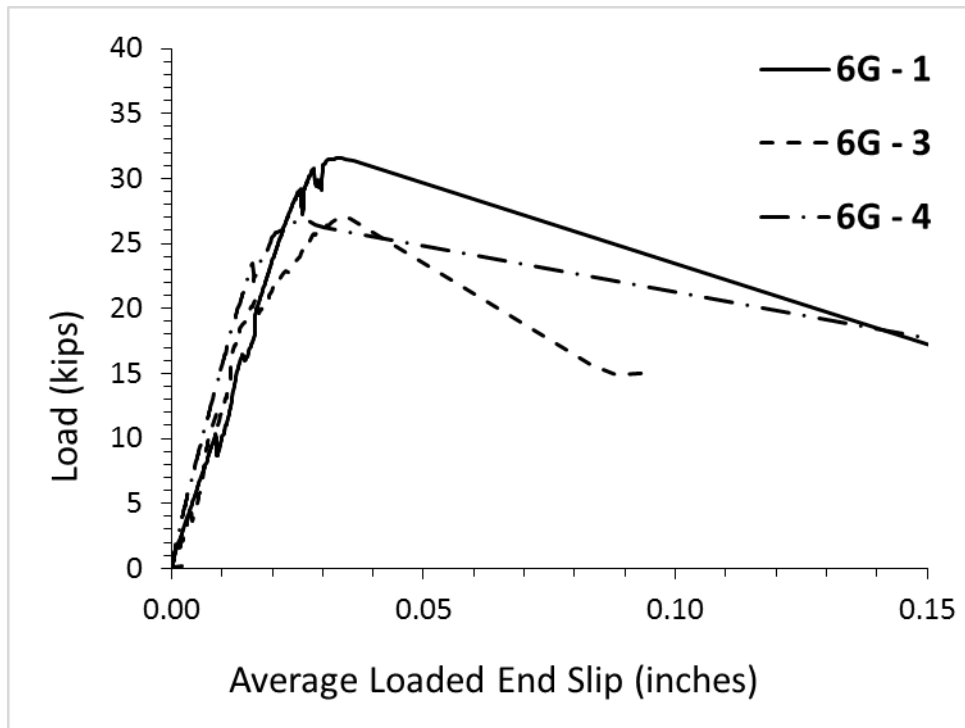
Figure 3-6. Load versus loaded end slip (#6 galvanized test bars)

The average bond strength of #6 epoxy-coated bar was 28.6 kips with an average slip at the loaded and unloaded ends of 0.037 inches and 0.004 inches, respectively. For the #6 galvanized bars, the average bond strength was 28.5 kips with an average slip at the loaded and unloaded ends of 0.031 inches and 0.004 inches, respectively. The relationship between the loads at failure

versus the average loaded end slip for the #6 galvanized bars and the #6 epoxy-coated bars are shown in Figures 3-6 and 3-7, respectively.

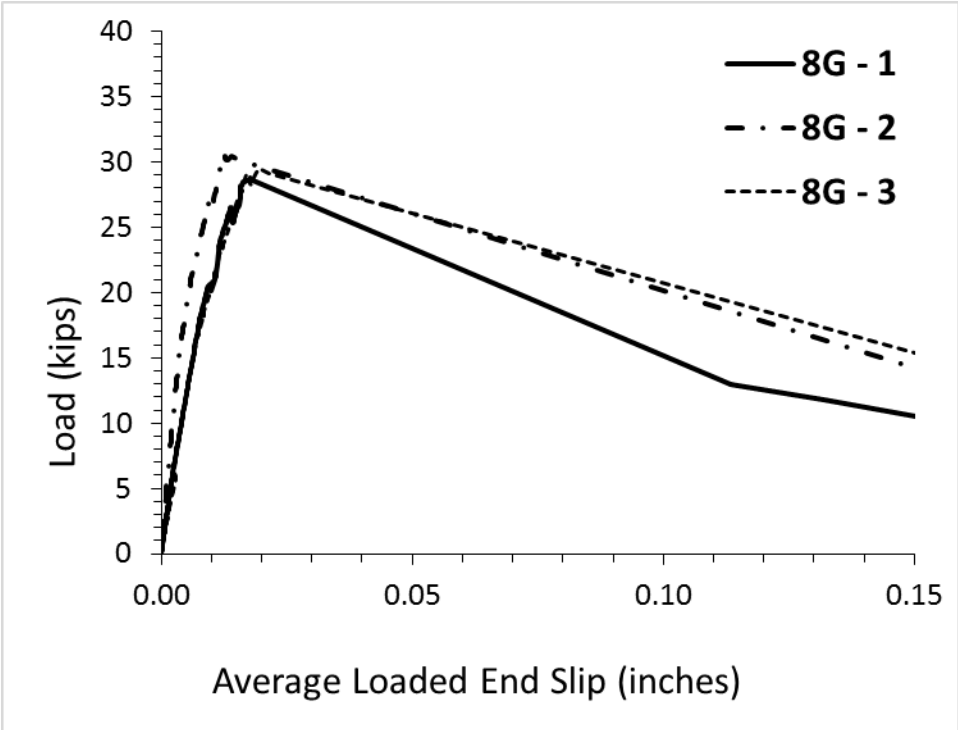
Figure 3-8. Load versus loaded end slip (#8 galvanized test bars)

The average bond strength for the #8 epoxy-coated rebar was 28.8 kips with an average slip at the loaded and unloaded ends of 0.019 inches and 0.004 inches, respectively. The average bond strength of the #8 galvanized rebar was 29.5 kips with an average slip at the loaded and unloaded ends of 0.016 inches and 0.002 inches, respectively. The relationship between the loads at failure versus the average loaded end slip for the #8 galvanized bars and the #8 epoxy-coated bars are shown in Figures 3-8 and 3-9, respectively.

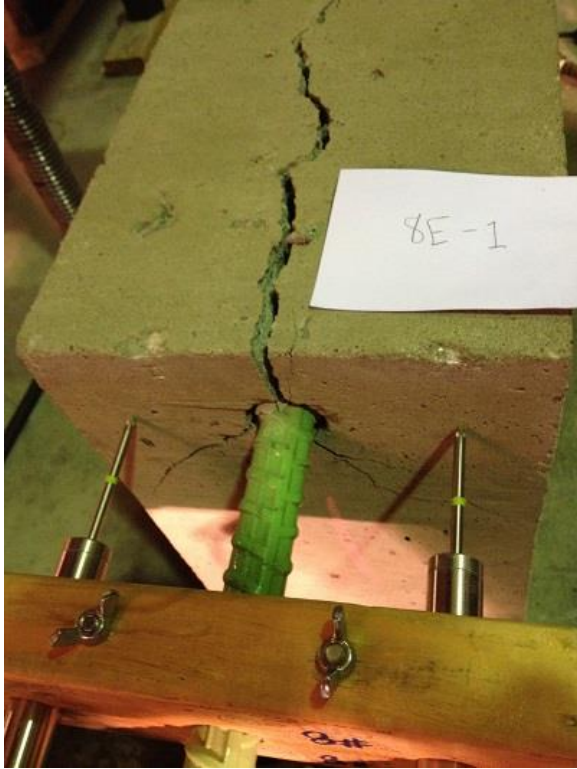
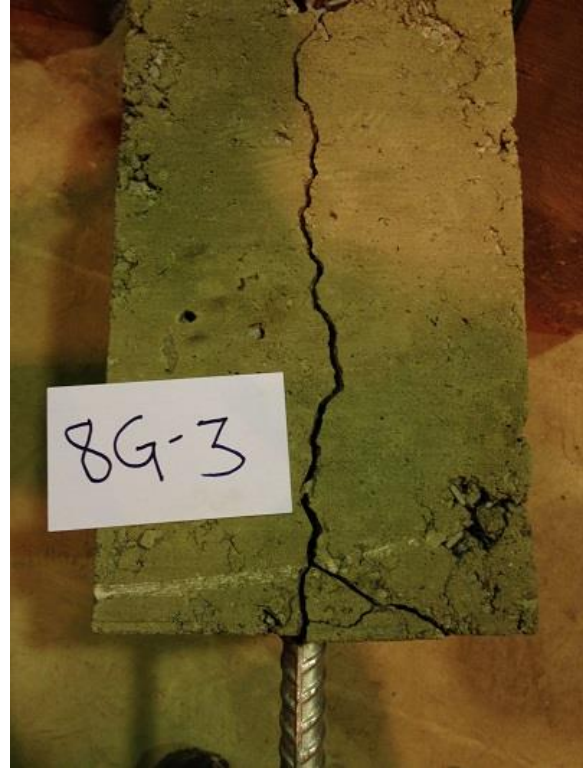
**Figure 3-12. Crack patterns of the specimens**

After testing was completed, the failed specimens were visually inspected. Figure 3-12 shows typical crack patterns of the specimens observed during the testing.

(a) Specimen with #8 epoxy-coated test bar

(b) Specimen with #8 galvanized test bar

In general, longitudinal cracks initiated around the loaded end and propagated to the top surface and then toward the unloaded end of the specimen along the test bar. This indicates a typical splitting mode of failure, which was observed, to various extents, in all specimens. In general, the width of the longitudinal crack increased as the applied load increased. In most cases, the failure was by pullout mode with relatively smaller radial cracks developing around the loaded end as the test bar was pulled from the specimen.
