Final Technical Report #01-2

*Evaluation of the Norridgewock Intersection
Collision Avoidance Warning System on Route 201A,
Norridgewock, Maine*

November 2006

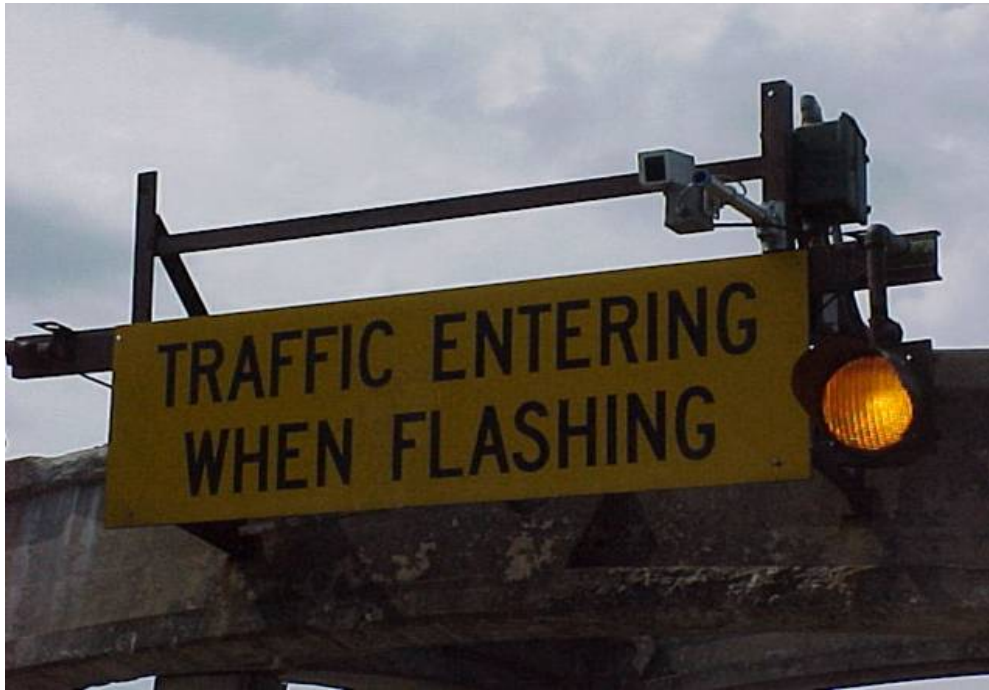
Figure 2. View of mainline warning sign.

The site is a rural intersection along Rt. 201A in Norridgewock, Maine. At that site, a multi-arch concrete bridge with large structural concrete columns and railings limited sight distances in one direction at a stop-controlled intersection. One complication at the chosen site is that a traffic-actuated warning sign had been in place for many years. The mainline warning sign is shown in Figure 2. In a typical installation a different sign design would be used on the mainline. However, it was felt that the existing sign could be used so that a study of the mainline warning message only could be conducted prior to installation of the new system. The existing sign was retained in the new system. The results of the two pre- and post-installation traffic conflict studies are discussed later in this report.

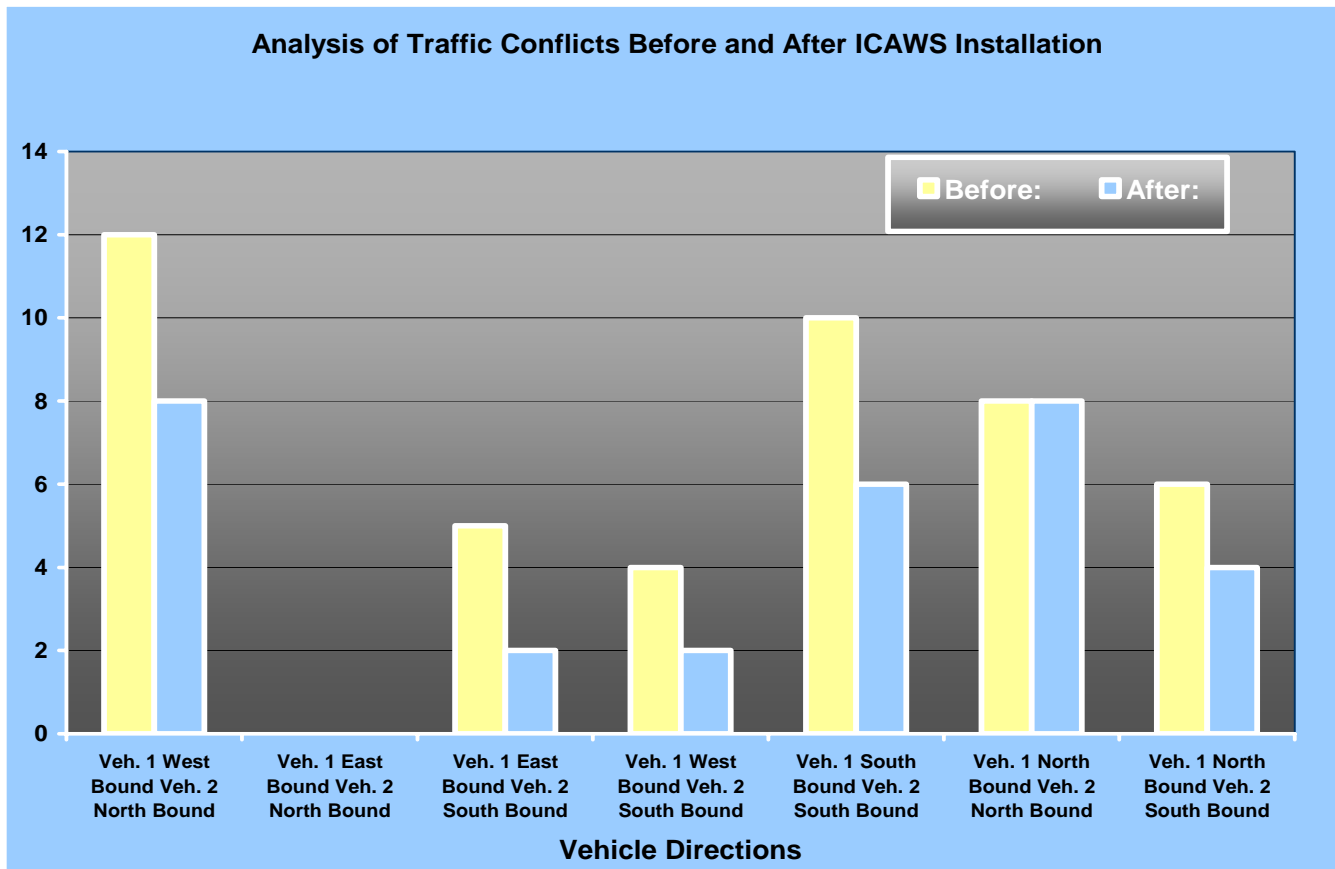
Figure 4. Comparison of Traffic Conflicts Before and After Installation

An assessment of the TCT data shows an improvement in potential collisions after installation of the ICAWS, demonstrated by a reduction in the conflict rate of 35%. Table 1 demonstrates a decline in traffic conflicts in all categories except for one. The number of traffic conflicts between two or more north-bound vehicles remains constant at eight incidents for both the before and after observation periods.

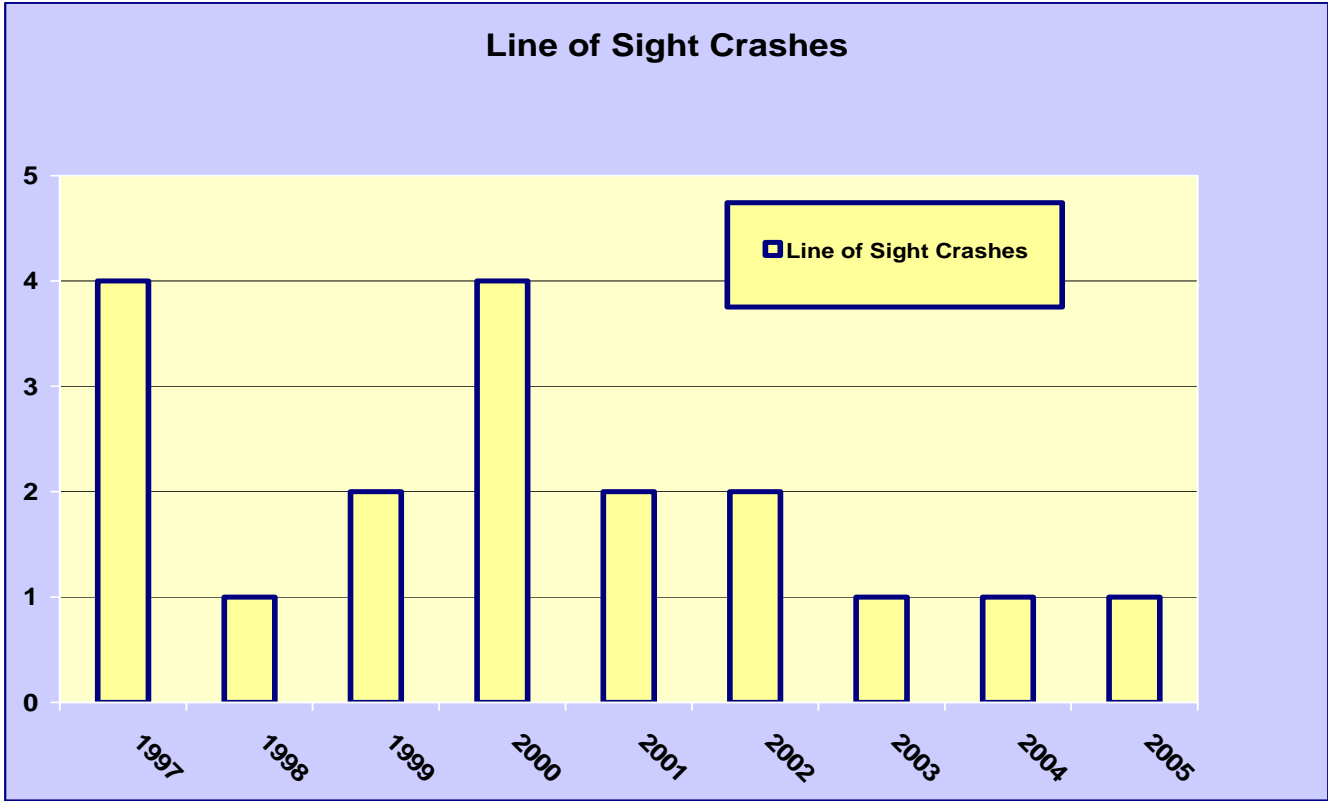
Figure 5. Crashes on or near Norridgewock Bridge Where Sight Distance Was an Issue

The Maine Department of Transportation has collected updated police crash data through the year 2005. Figure 7 shows only those crashes that are the result of limited sight line distance. The number of crashes fluctuates between 1 and 2 between the years 2001 – 2005 after the installation of the ICAWS. Updated TCT data is not available as TCT observation has not been conducted since the initial observation in 2001.

There is a noticeable decline in line of sight crashes between the years 2000 and 2001, from 4 crashes in 2000 to 2 crashes in 2001. The two limited line of sight crashes for 2001 occurred before the installation of the ICAWS. There was one crash due to line of sight issues in the years 2002 and 2003, one crash due to line of sight issues in 2004, and only one crash in 2005. Table 2 displays the limited sight distance crashes at the intersection from 2001 to 2005 and their associated economic impacts.

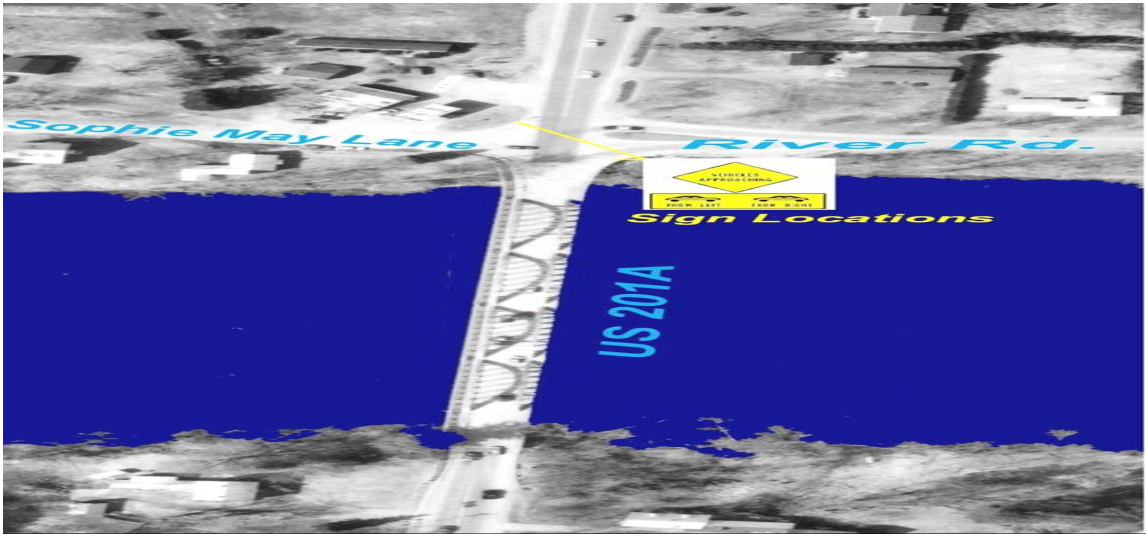
Figure 6. Aerial View of the Site

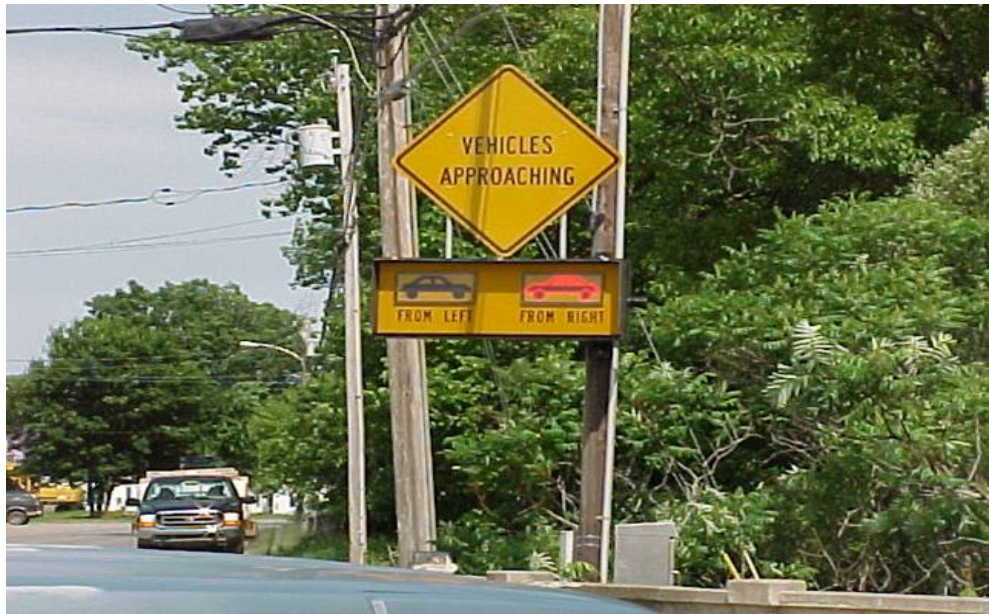
Figure 7. View of Sign Across from Sophie May Lane

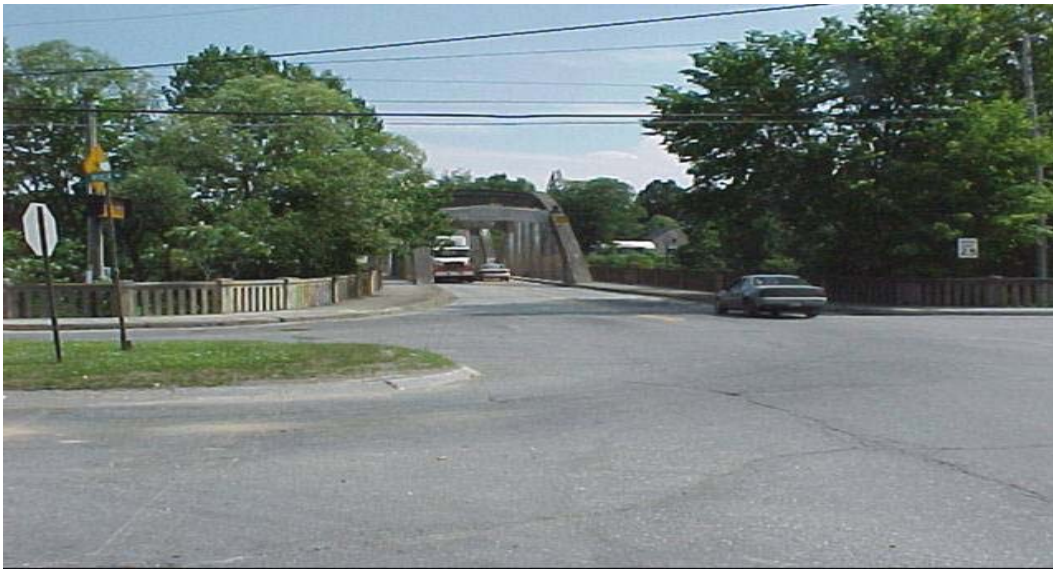
Figure 8. View of Site Conditions
