**Technical Report 03-1**  
*Bridge Deck Resurfacing using Rosphalt 50*

*Interim Report - First Year, December 2004*

## *Bridge Deck Resurfacing using Rosphalt 50*

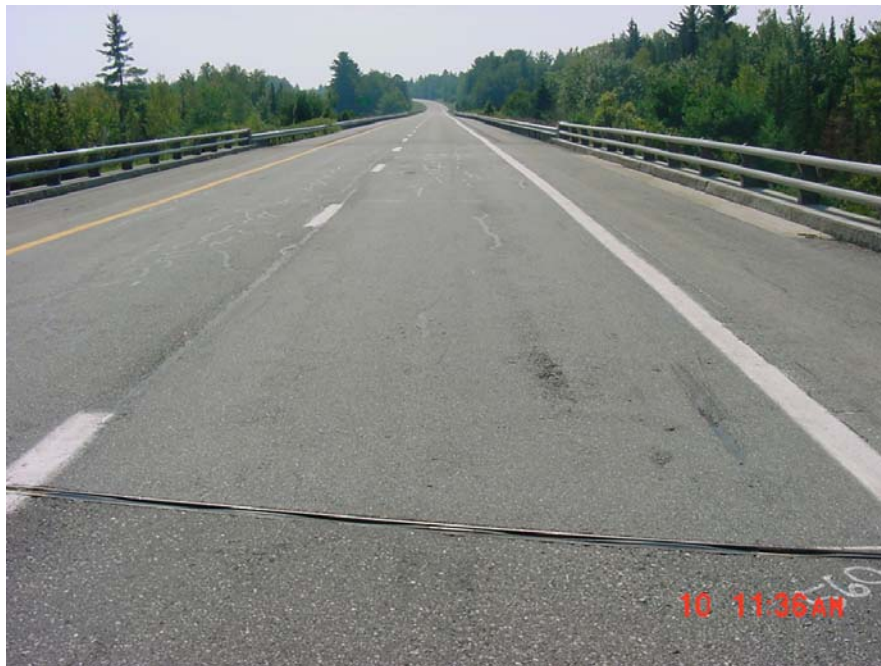
Photo 1. Bridge #6070 wearing surface

Two bridges are located in the town of Howland (Figure 1). Bridge number 6070 is on the southbound lane of Interstate 95 and crosses Seboeis Road. This bridge is 41 meters (136 ft) in length and 14 meters (47 ft) wide with a 2001 AADT of 3980. The wearing surface was in poor condition and needed replacement (Photo 1). Bridge number 6069 is also on the southbound lane of Interstate 95 and crosses the Piscataquis River. This bridge is 163 meters (536 ft) long, 11 meters (36 ft) wide with a 2001 AADT of 3980. The wearing surface on this bridge was also in poor condition (Photo 2).

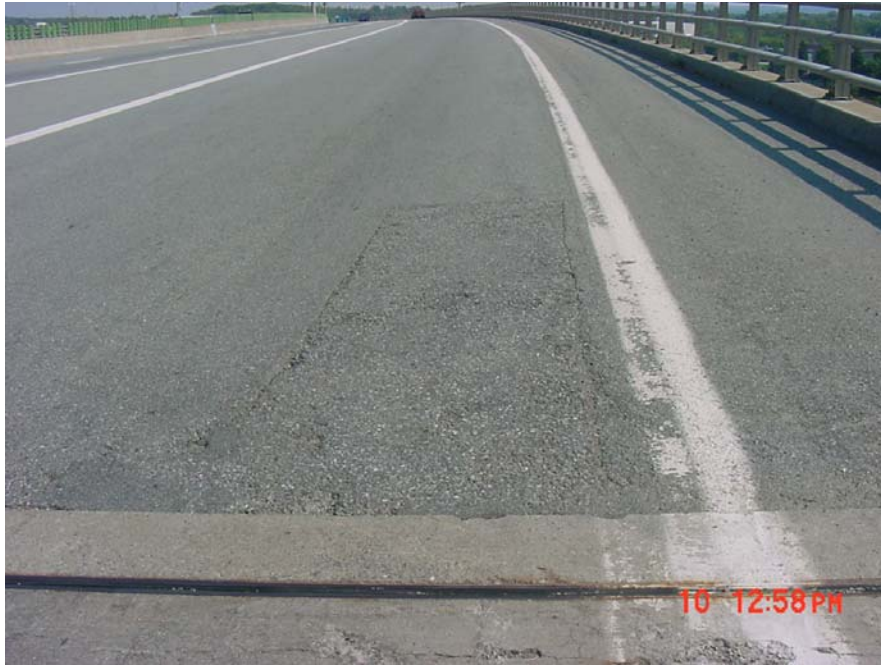
Photo 3. Bridge # 1558 patch area on entrance ramp

Although the wearing surface was in fair condition, there were areas of shoving that have been repaired over the past five years (Photos 3 & 4). The problem areas are located on the accelerating lane of each entrance ramp and decelerating lane of each exit ramp.

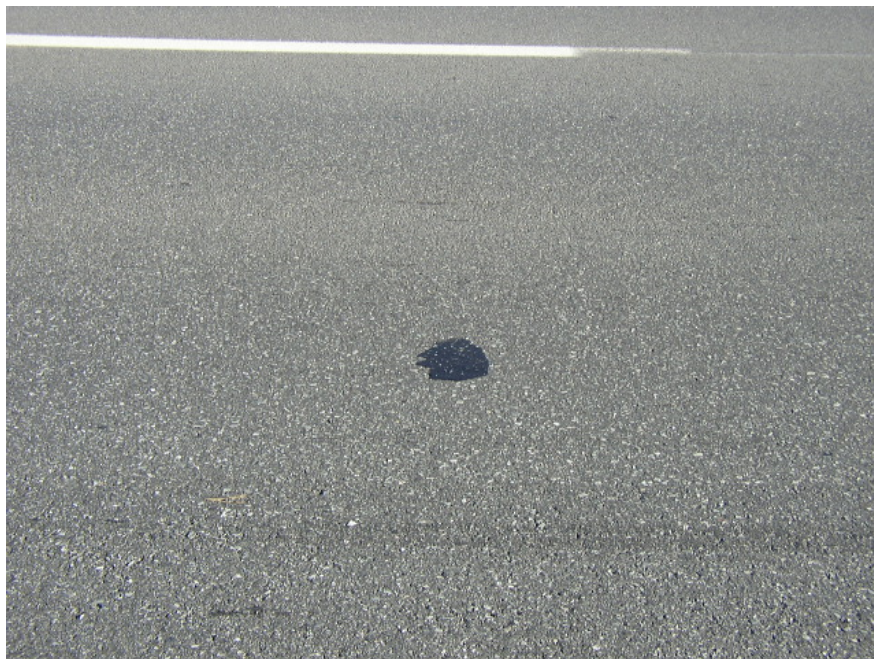
Photo 6. Surface defect on Bridge # 1558

Bridge No. 1558 over the Penobscot River in the city of Bangor was inspected on October 7, 2003. The wearing surface looks very good with minimal rutting, less than 12 mm (0.25 in) in depth. All joints are very tight and difficult to see in some areas. The 3 meter square (12 foot square) patch area in the west bound travel lane that was referenced in the construction report is in good condition and matched well with the surrounding mat. One of the reasons for utilizing Rosphalt 50 on this bridge was to reduce surface mix shoving at the exit ramps. After one year of traffic, Rosphalt 50 has effectively eliminated shoving in these areas. Mix around curbing and scuppers are well sealed but the mix around scuppers looks very coarse possibly due to less than adequate compaction effort in these areas during construction. Approximately two dozen defective areas were observed in both lanes of the bridge. These defects are concentrated orbs of Rosphalt 50 polymer that range in diameter from 50 to 200 mm (2 to 8 in). The defect in Photo 6 is 125 mm (6 in) in diameter. All defects inspected are intact and are not separating from the mat and don't appear to reduce the sealing capabilities of Rosphalt 50.

Rosphalt 50 has been performing as expected after one year of exposure to traffic and the environment. Frictional resistance has increased to within normal readings. Rutting is minimal and Rosphalt 50 has eliminated shoving at exit ramps on the Bangor I-395 Bridge. Defective areas (concentrated asphalt spots) on the I-395 Bridge are a concern and will be monitored closely for ravel or separation from the mat.
