STATE OF MAINE DEPARTMENT OF TRANSPORTATION

EXPERIMENTAL CONSTRUCTION 96-25 and 97-19

EXPERIMENTAL USE OF SAWED AND SEALED JOINTS TO MINIMIZE THERMAL CRACKING

Interim Report - Third Year

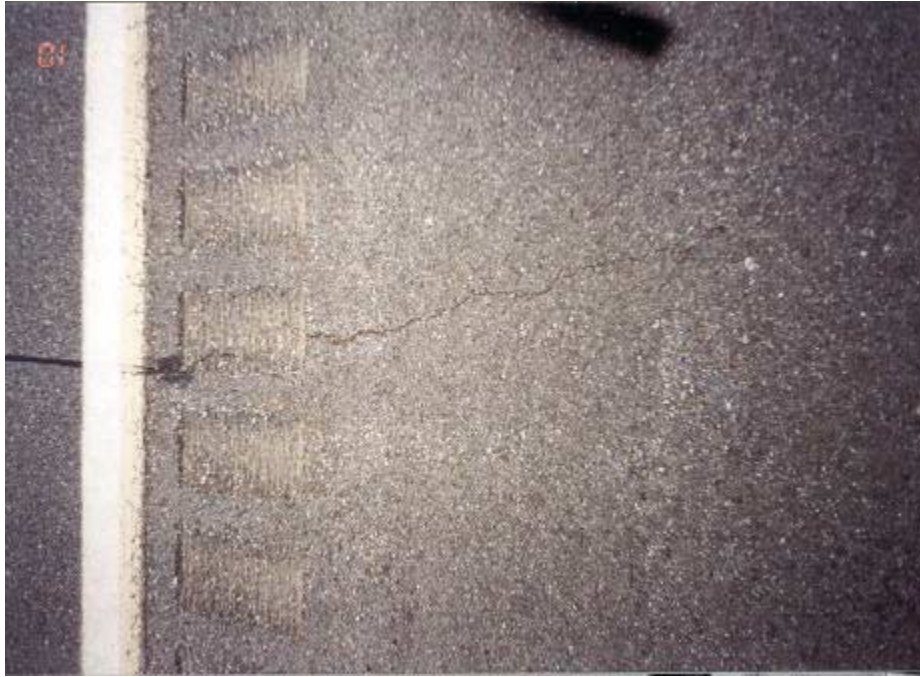
Edge of Travel Lane

One concern identified during these inspections were cracks extending from the end of the sawed joints into the paved shoulders. This was noticed in each project; however, the T1-R6 project has a much higher number of these cracks and their severity is also greater (see attached photos). Sawed joints were measured and found to be the recommended one-foot into the paved shoulder for the Beddington-Deveraux project. For the T1-R6 project, the sawed joint did not extend into the paved shoulder as recommended. This was probably due to the presence of a rumble strip at the edge of the travel and passing lanes, which limited the sawing process. It appears this may be the cause of the above-mentioned increase in number and severity of these cracks.

The next scheduled field inspections are for the fall of 2001. A more detailed evaluation of the crack extension at the end of sawed joints will be performed at that time. The result

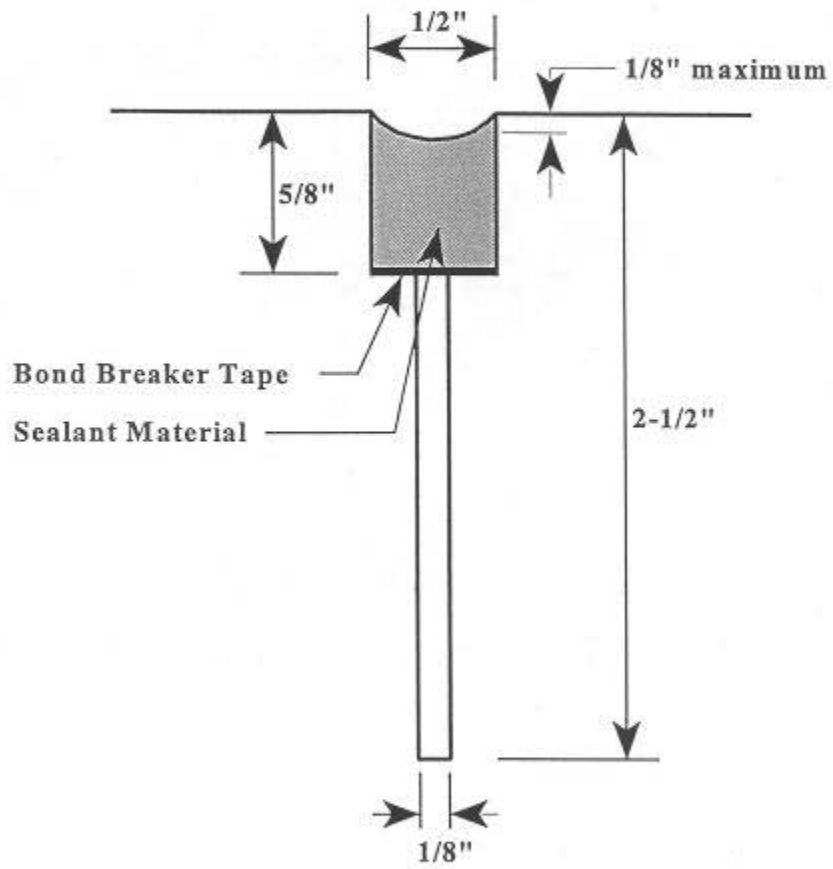
FIGURE I

The construction process, including the bituminous wearing surface was completed in the experimental area September 10, 1997. The Saw and Seal process began October 2, 1997 at station 70+00. Full width joints (including one foot into each paved shoulder) were sawed to a total depth of 2 ½ inches. A reservoir ½ inch wide by e inch deep was included to accommodate the sealant (see Figure I). This cutting was accomplished in a single pass using a “wet cut” pavement saw. After the correction of several problems associated with the Sawed and Sealed joints, this experimental feature was successfully completed October 23, 1998. Although air temperatures during this second phase of installation were below the 50-degree minimum, installation was allowed to continue. Bond breaker tape was used in each joint and in some instances a double layer was applied to assure the sealant remained in the reservoir.

Typical Joint Section
