DEPARTMENT OF TRANSPORTATION

INNOVATIVE SOLUTIONS to BURIED PORTLAND CEMENT CONCRETE ROADWAYS

FIRST INTERIM REPORT

Project No. STP-8651(00)X on Route 100 between the towns of Benton and Palmyra is 30.6 kilometers (19 miles) long and scheduled for an overlay of maintenance mix. This is a 7.3 meter (24 foot) bituminous roadway over 6.2 meters (20 feet) of PCC. The 0.6 meter (2 foot) edge of pavement on both sides has deteriorated, creating a traffic hazard and maintenance problem for years. Condition of the drainage ditch is poor along the entire project and there is very little underdrain. A section of this project beginning 4.5 kilometers (2.8 miles) north of the junction of Route 100A in Benton and extending north 2.5 kilometers (1.6 miles) to the town of Clinton was selected to construct four experimental shoulder rehabilitation sections. This project was activated in August with a deadline of October 30, 1998, so time and available money to develop experimental sections was limited. An E-mail request, phone interviews, and literature search of AASHTO members were conducted to gather information on techniques used to correct composite roadway shoulder problems. A panel with pe

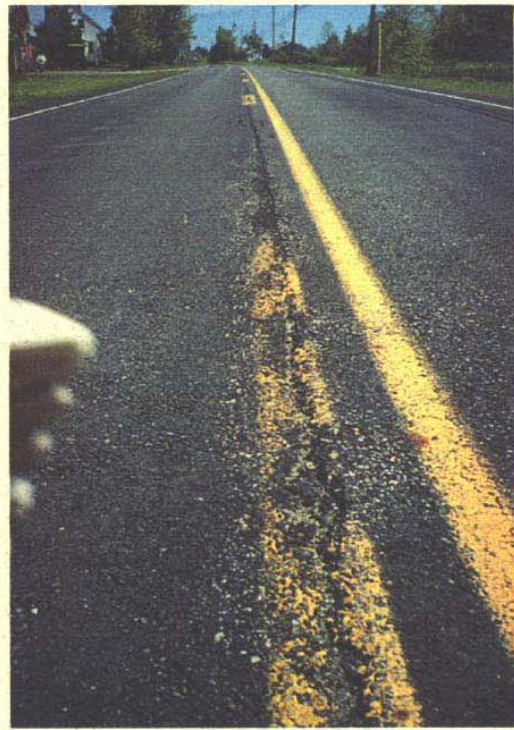
Ninety percent of the centerline joint has raveled largely due to winter plowing (photo 2).

Section 1 Centerline Joint

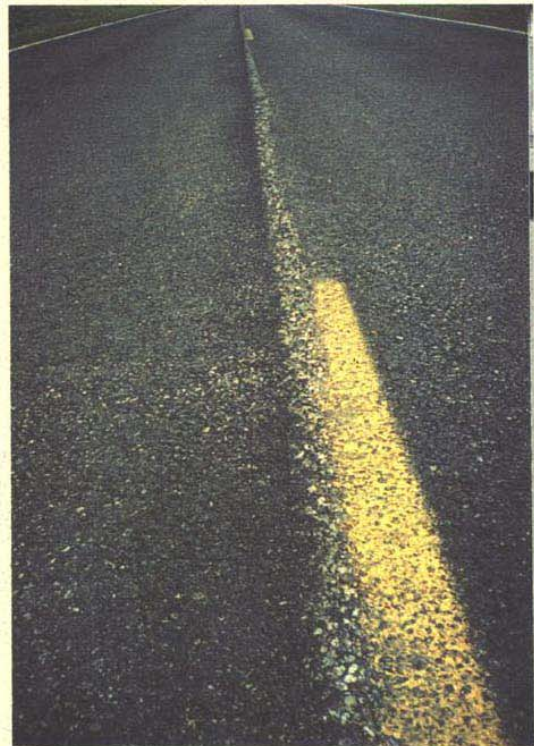
This section has no transverse cracks, slight rutting and 30% of the centerline joint is raveling (photo 4).

Section 3 Centerline Joint

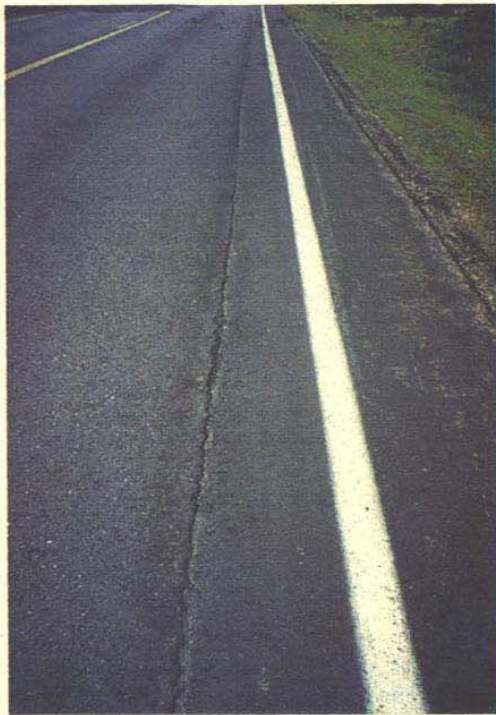
This section was constructed differently than the other sections due to seasonal restrictions when placing surface mix. MDOT specifies that traveled way surface mix can be placed between the dates of April 15th and the Saturday following October 15th. The surface paving deadline was nearing when section 3 shoulder construction began. To avoid the deadline the binder and surface was placed on the roadway to an offset of 3 m (10 ft) left and right of centerline. Reconstruction of the shoulder began after the roadway was paved. Binder and surface mix was placed after the shoulder reconstruction was completed. This left a longitudinal joint along the entire length of this section making it difficult to evaluate. The shoulder construction longitudinal joint has separated from the roadway throughout 93.2% of this section (photo 5). A longitudinal crack caused by the PCC pavement edge is located 3.1 - 3.2 m (10.25 to 10.5 ft) right and left of centerline along 12.7% of the section (photo 6). Twenty meters of this PCC related crack in the NBL is 13 mm (0.5 in) wide and has an elevation change of 6 mm (0.25 in) as shown in photo 7.

Section 3 Typical Shoulder Joint

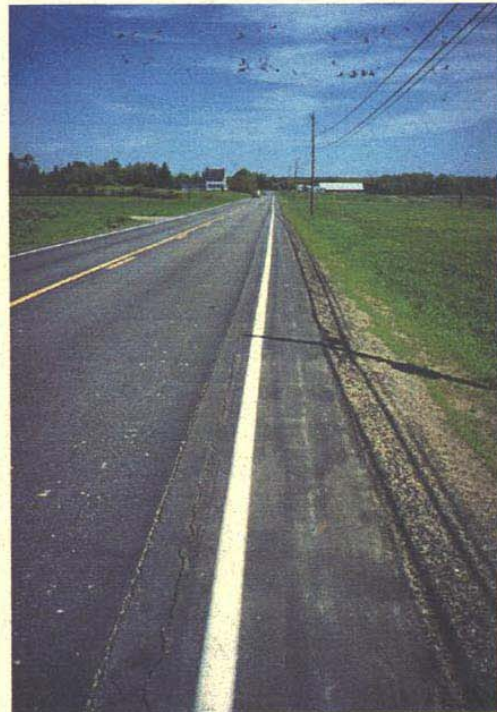
Section 3 Longitudinal PCC Edge Related Cracking

Section 3 using Superpave mix has the second lowest deflections but has the highest amount of PCC related longitudinal cracking of all sections. The unusual construction procedure for this section may be contributing to the PCC reflected cracking. Perhaps core samples will determine whether the PCC edge or the shoulder pavement joint is causing this additional longitudinal cracking.

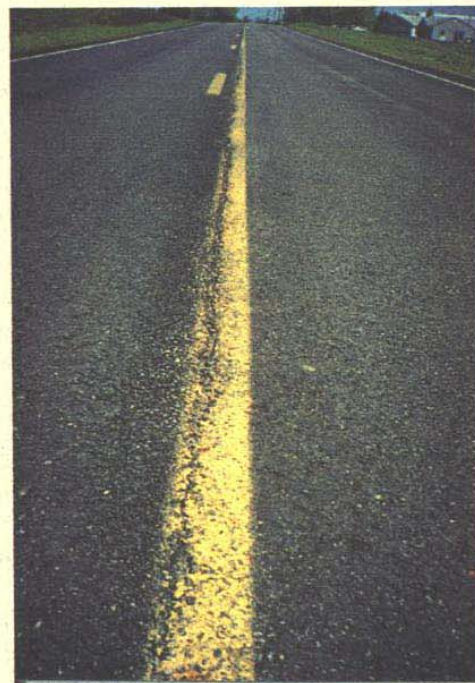
Section 4 has less than one quarter the transverse cracks than section 0 with slight rutting and 85% of centerline joint ravel (photo 8).

Section 4 Centerline Joint
