Role of Sulfates on Highway Heave in Lake County, Ohio

Prepared for:
The Ohio Department of Transportation,
Office of Statewide Planning & Research

January 2014

Final Report

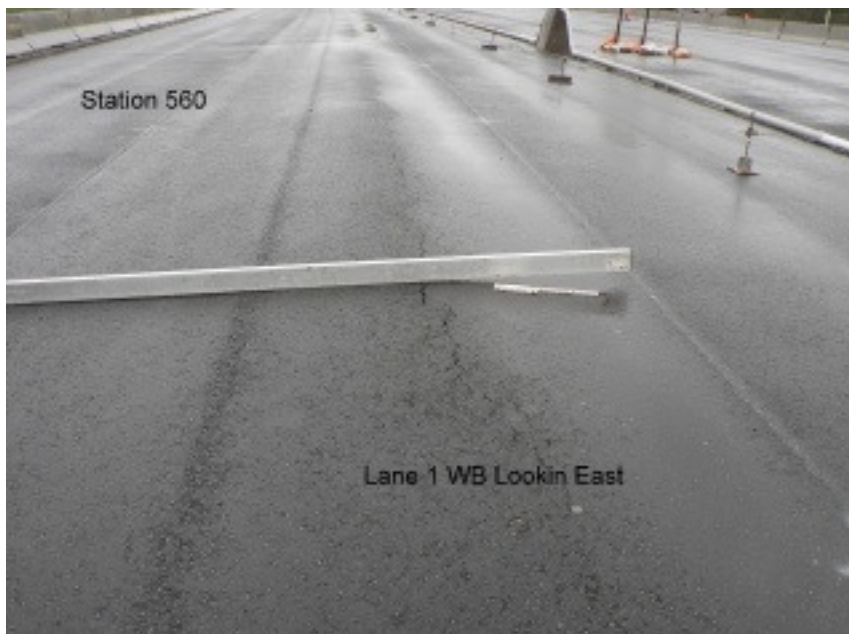
In late winter 2010, longitudinal cracking of the concrete was discovered and documented. In the spring of 2011, evidence of pavement heave of ½ to > 4 inches was observed at the longitudinal joint between the center median barrier wall and shoulder pavement in numerous locations throughout the entire stretch of pavement (Fig. 1). Repetitive cracking in the center median barrier wall was also observed.

Figure 1. Picture showing heave present in the west bound lane of Route 2 at station 560.

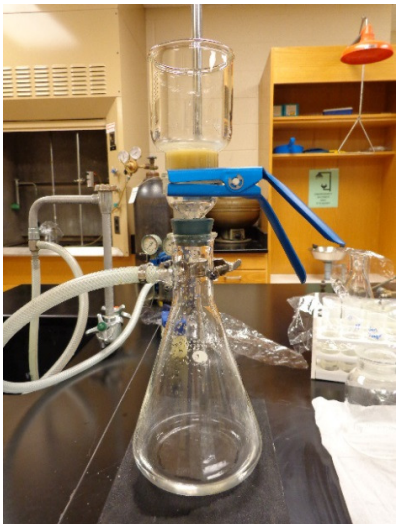
Briefly, 20 grams of each of the soil samples provided by ODOT were first passed through a No. 40 sieve (425 μm). Ten grams of each sample were weighed out and placed into HDPE bottles to which 200 ml of deionized water was added, each sample was then shaken vigorously for one minute. The samples were then allowed to sit undisturbed for a minimum of 24 hours. After the 24-hour period, each sample was shaken gently for one minute and then filtered with 0.45 μm filter paper (Fig. 2). Two drops of concentrated HCl was added to the filtrate followed by a barium chloride packet. Sulfate testing was performed using a Thermo Scientific Orion AQUAfast AQ 3700 Colorimetry Meter following the manufacturer's operating instructions. Three readings were taken and averaged. The first reading was taken immediately upon sample preparation, followed by the second and third readings.

Figure 2. Filtration setup for soil sulfate analysis.

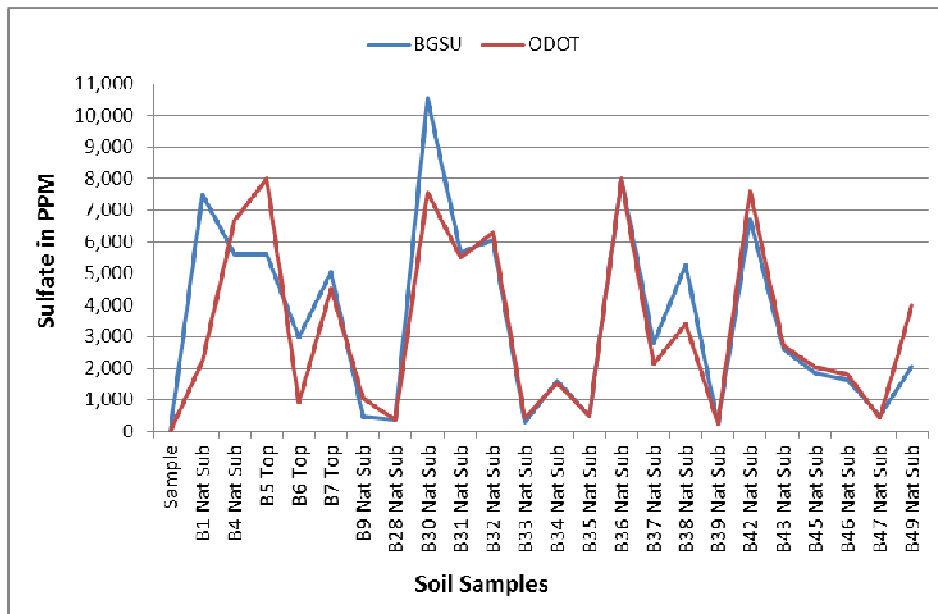
Results of the sulfate analysis of the borings samples are presented in Table 1. The sulfate values in the natural subgrade soils samples range from low risk (<3000 ppm) to unacceptable risk (>10,000 ppm) for heaving of lime/cement stabilized clayey soil based on the TxDOT guidelines (Table 2), and 36% of the natural subgrade samples tested above the moderate risk level (>5000 ppm). The sulfate values measured at BGSU compare well to the values provided by ODOT after the samples were run at BGSU (Fig. 3), the variability observed being due to the heterogeneous distribution of gypsum in the samples and the difficulty of obtaining a truly representative 10 gram aliquot for testing. The samples from bore B5 show a modest increase in sulfate content with depth, but samples from B6 show the opposite trend and the variability may simply reflect the inconsistency in gypsum distribution in the 10 gram sub-samples used for the analysis.

Figure 3. Comparison of sulfate testing results for BGSU and ODOT. Samples run from west to east spatially.

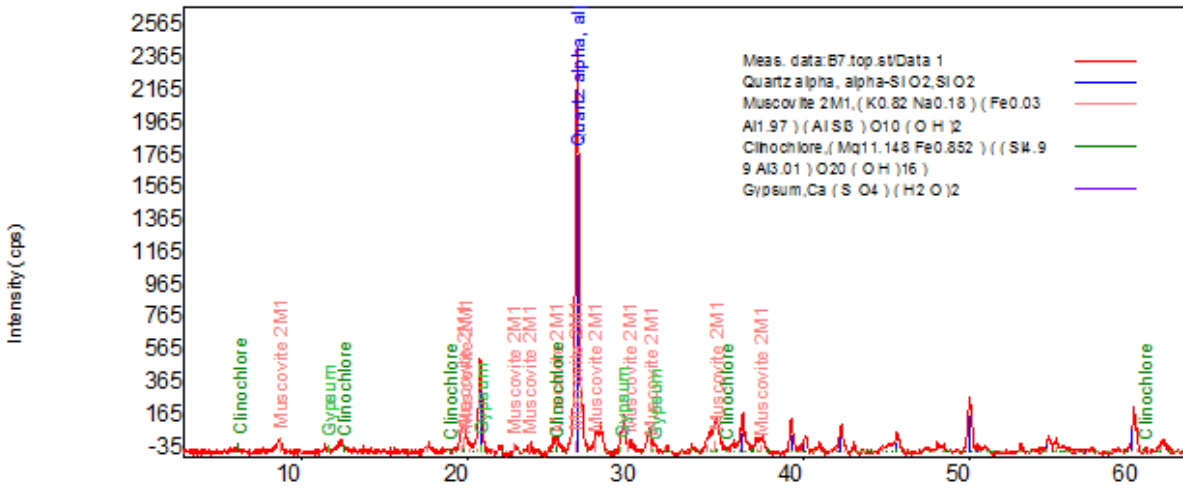
A representative XRD pattern of a borings sample (B7) is presented in Fig. 4. The XRD analysis of the borings samples show the major mineral components are quartz, muscovite/sericite mica, clays (clinochlore, kaolinite, and illite), and hematite (Supplemental data can be obtained from ODOT). Also, the common sulfate minerals gypsum and/or anhydrite were detected in 64% of the natural subgrade samples; all of the samples that had >1000 ppm sulfate. Hence, the primary source of sulfate in these soils is gypsum/anhydrite.

Figure 4. Representative XRD pattern for bore sample (B7).

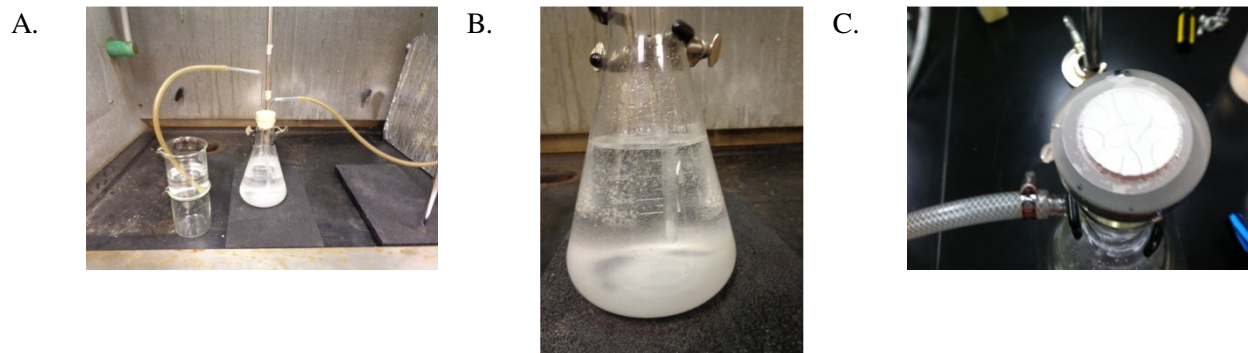
The method was adopted from Cody et al. (2004). All solutions were made using deionized water and were filtered through Whatman 0.45 micron filter paper before use. A saturated calcium hydroxide solution was produced by adding 2.57 g of CaO to 1 L of deionized water and stirring with a magnetic stir bar for 2 hours. An aluminum sulfate solution was produced by adding 2.61 g of AlSO_4 to 1 L of distilled water. Then, 178 ml of the CaOH solution was placed in an Erlenmeyer flask and dry N_2 gas was bubbled through the solution overnight in order to purge the solution of dissolved CO_2 that could react with the CaOH forming calcite instead of ettringite (Fig. 5A). After bubbling dry N_2 gas through the CaOH solution overnight, 222 ml of the AlSO_4 solution was added to the CaOH solution and again bubbled overnight with dry N_2 gas. A fuzzy, white precipitate formed within an hour of adding the AlSO_4 solution (Fig. 5B). The precipitate was scraped off the sides of the flask, and the solution was filtered through 0.45 micron filter paper (Fig. 5C). The white precipitate was left on the filter paper in a desiccator to air-dry overnight (see Appendix II for details). Note, it is important to NOT dry the ettringite in an oven because at very low humidity it can begin to thermally decompose at $<80^\circ\text{C}$ (Purchez et al., 2006).

Figure 5. (A) Nitrogen gas bubbler setup. (B) Fuzzy, white precipitate that forms after the addition of the AlSO_4 solution. (C) White precipitate on filter paper after filtration.

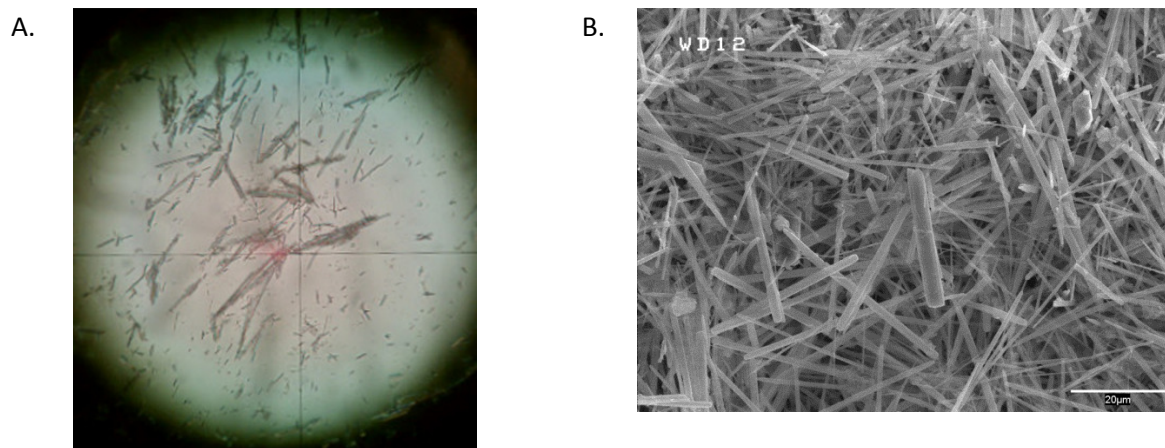
Under the petrographic microscope, the precipitate crystals appear as long, thin, solitary needles or clusters of needles (Fig. 6A). In the SEM, the crystals also appear elongate and needle-like, and some orientations show the characteristic hexagonal prismatic needle-like morphology (Fig. 6B).

Figure 6. Examples of needle-like morphology of synthetic ettringite crystals. (A) Petrographic microscope (field of view ~1 mm). (B) SEM: 20 kV, Working Distance 12 mm, scale bar = 20 μm.

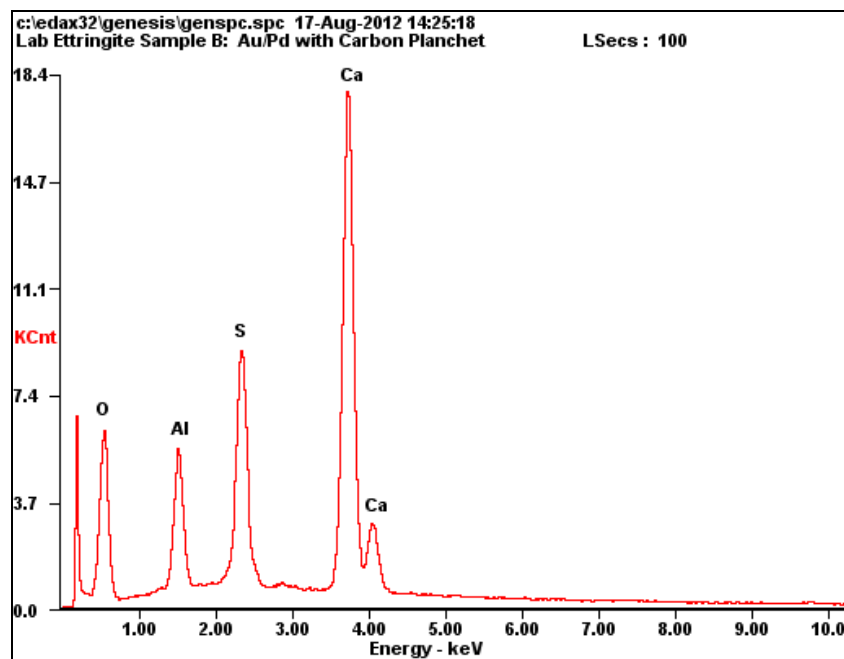
The EDAX analysis yielded a bulk chemical composition of 46.09 wt% O, 34.61 wt% Ca, 11.91 wt% S, and 7.39 wt% Al, respectively (Fig. 7), and the XRD analysis showed well defined peaks at 9.14 and 15.86° 2θ, characteristic of ettringite (Fig. 8).

Figure 7. EDAX spectrum of synthetic ettringite.

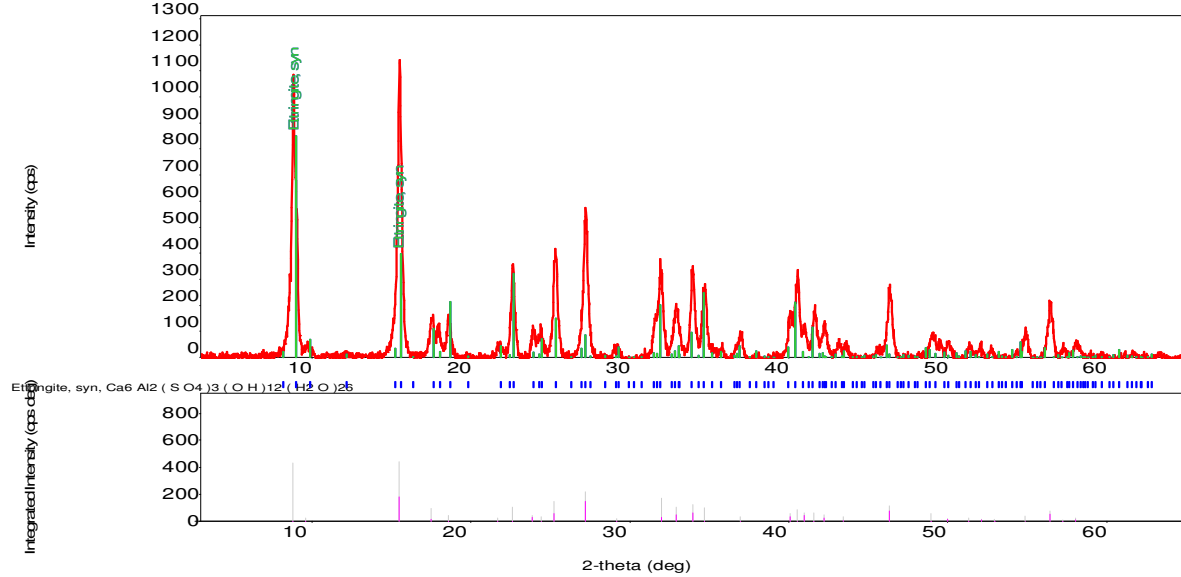
Figure 8. XRD scan of synthetic ettringite.

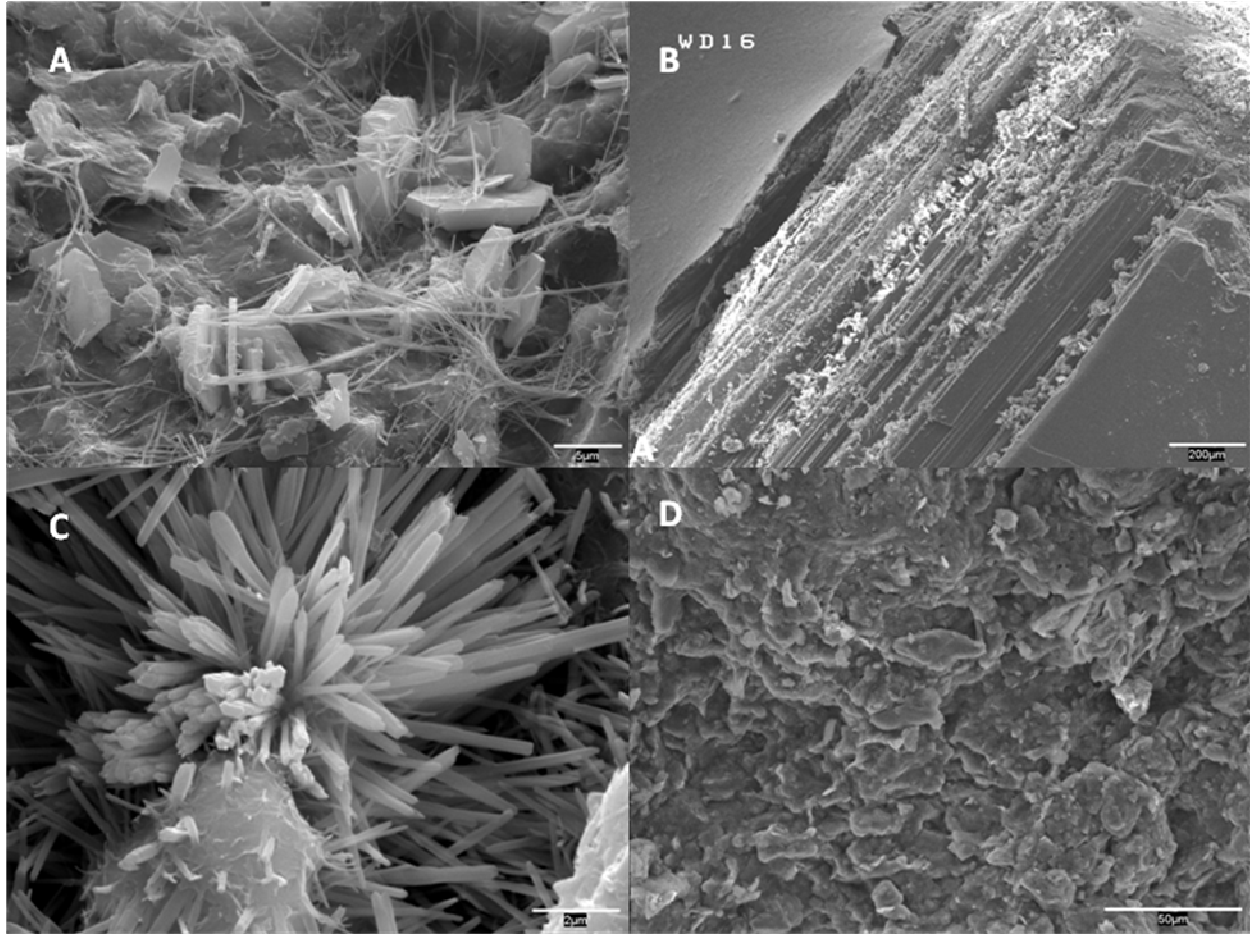
Both non-stabilized and cement-stabilized soil samples from stations 729+00, 730+00, and 730+80 were also analyzed using a scanning electron microscope (SEM) and energy dispersive X-ray spectroscopy (EDAX) to determine the texture/crystal morphologies and chemistry of the soils/mineral grains. The texture/crystal morphologies of some minerals commonly found in the clayey soils are shown in Fig. 9. Clay minerals have characteristic thin pseudo-hexagonal plate morphology (Fig. 9A); gypsum grains are tabular with prominent basal cleavage (Fig. 9B); ettringite are elongated hexagonal needle-like grains (Fig. 9C); and typical soils have platy and rounded to subrounded grains (Fig. 9D).

Figure 9. SEM images of common minerals in clayey soils. (A) clays, scale bar = 5 μm . (B) gypsum, scale bar = 200 μm . (C) ettringite, scale bar = 2 μm . (D) typical soil, scale bar = 50 μm .

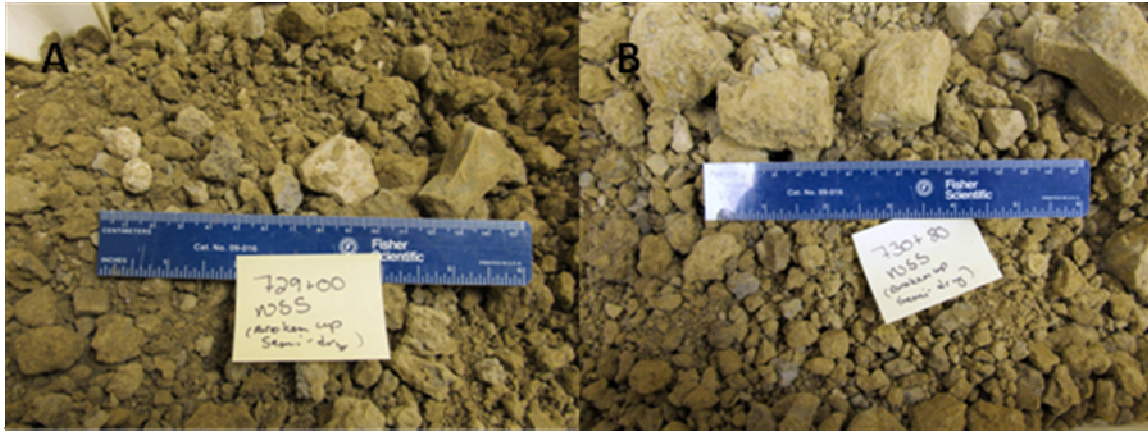
Visual inspection showed, in general, the soils are brown/gray sandy silts (Soil type A-4a). The non-stabilized samples have abundant clay minerals, and there were gypsum crystals ranging up to 2 cm in diameter as well as clasts 2-3 cm in diameter of the underlying Ohio Shale bedrock. In addition, there was abundant Fe-staining and iron oxides were disseminated throughout the samples (Figs. 10 and 11). The cement-stabilized samples were similar to the NSS samples but also contained several areas covered with a white precipitate (Fig. 12).

Figure 10. Representative samples of NSS soils. (A) NSS 729+00. (B) NSS 730+80.

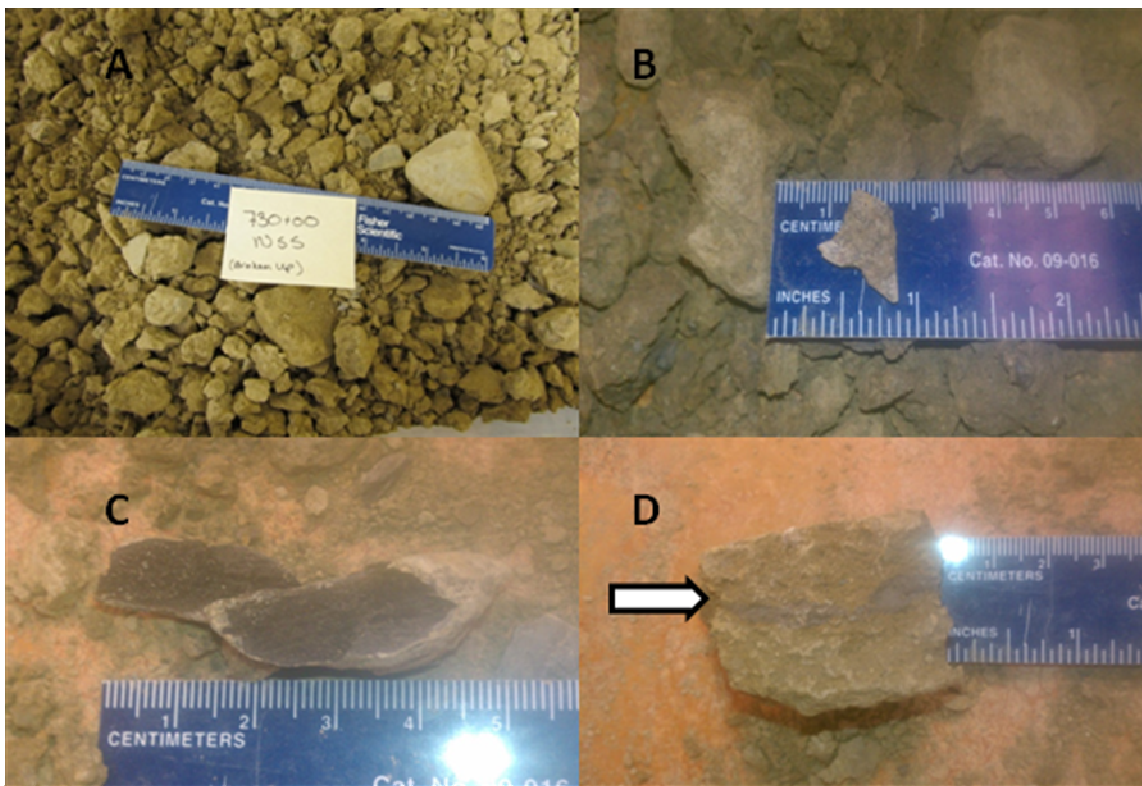
Figure 11. NSS 730+00. (A) Representative soil sample. (B) Large gypsum crystal. (C) Clasts of shale bedrock. (D) Arrow points to clay seam, hematite and iron oxide staining on surface and in the background.

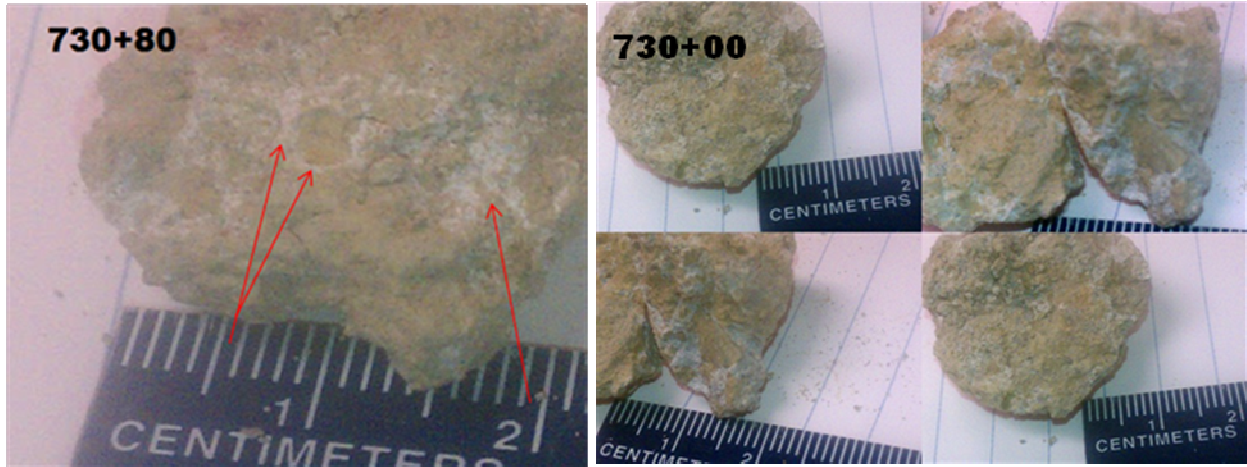
Figure 12. Samples of CSS 730+80 and 730+00 soils. Note the white precipitate.

Initially, sample material for SEM/EDAX and XRD analysis was preferentially gathered from the white precipitate areas found on the surface and along fracture fillings. However, the XRD analysis of the white precipitate showed it to be mostly calcite (Fig. 21B), similar to the white precipitate found in the cement-stabilized soils (Figs. 12, 15).

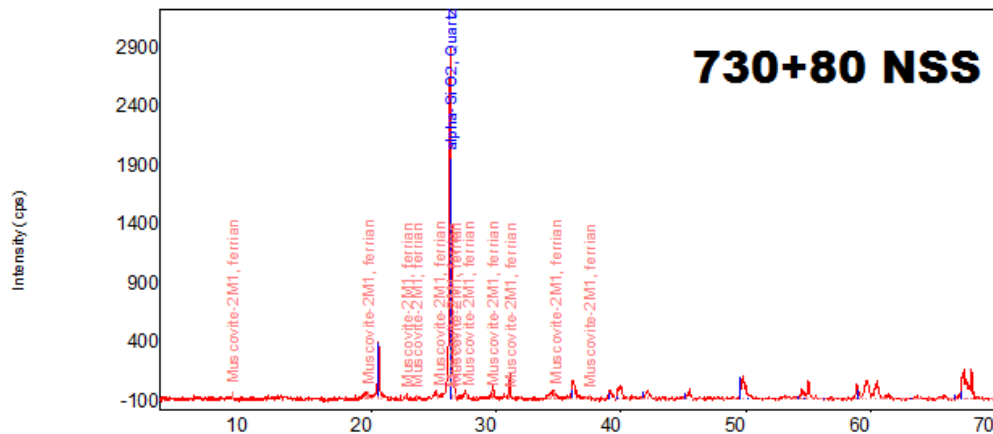
The XRD analysis confirmed the major mineral components of the NSS and CSS samples are quartz, muscovite/sericite mica, clays (kaolinite, illite, clinochlore), and hematite (Figs. 13 and 14). In addition, gypsum was identified in variable amounts in both the NSS and CSS samples.

Figure 13. XRD scan of representative sample of NSS 730+80 soil.

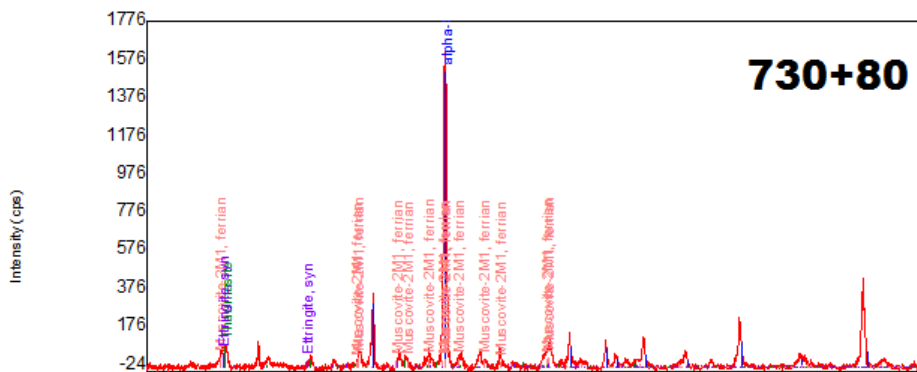
Figure 14. XRD scan of representative sample of CSS 730+80 soil.

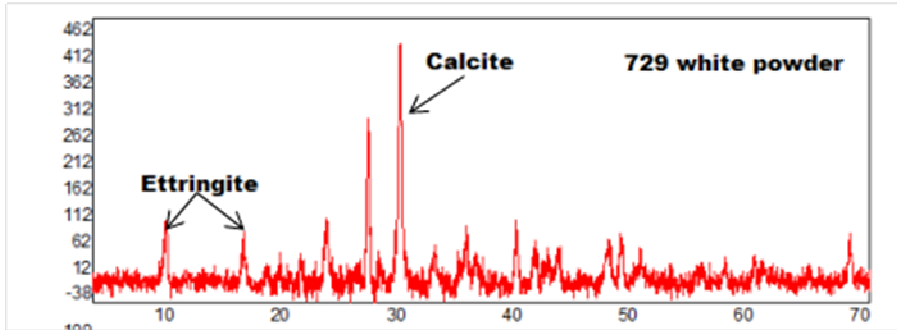
The XRD analysis showed that the white precipitate in the CSS samples was largely calcite (Fig. 15) but with measurable amounts of ettringite in some cases (Supplemental data can be obtained from ODOT).

Figure 15. XRD scan of white precipitate from CSS 729+00 soil.

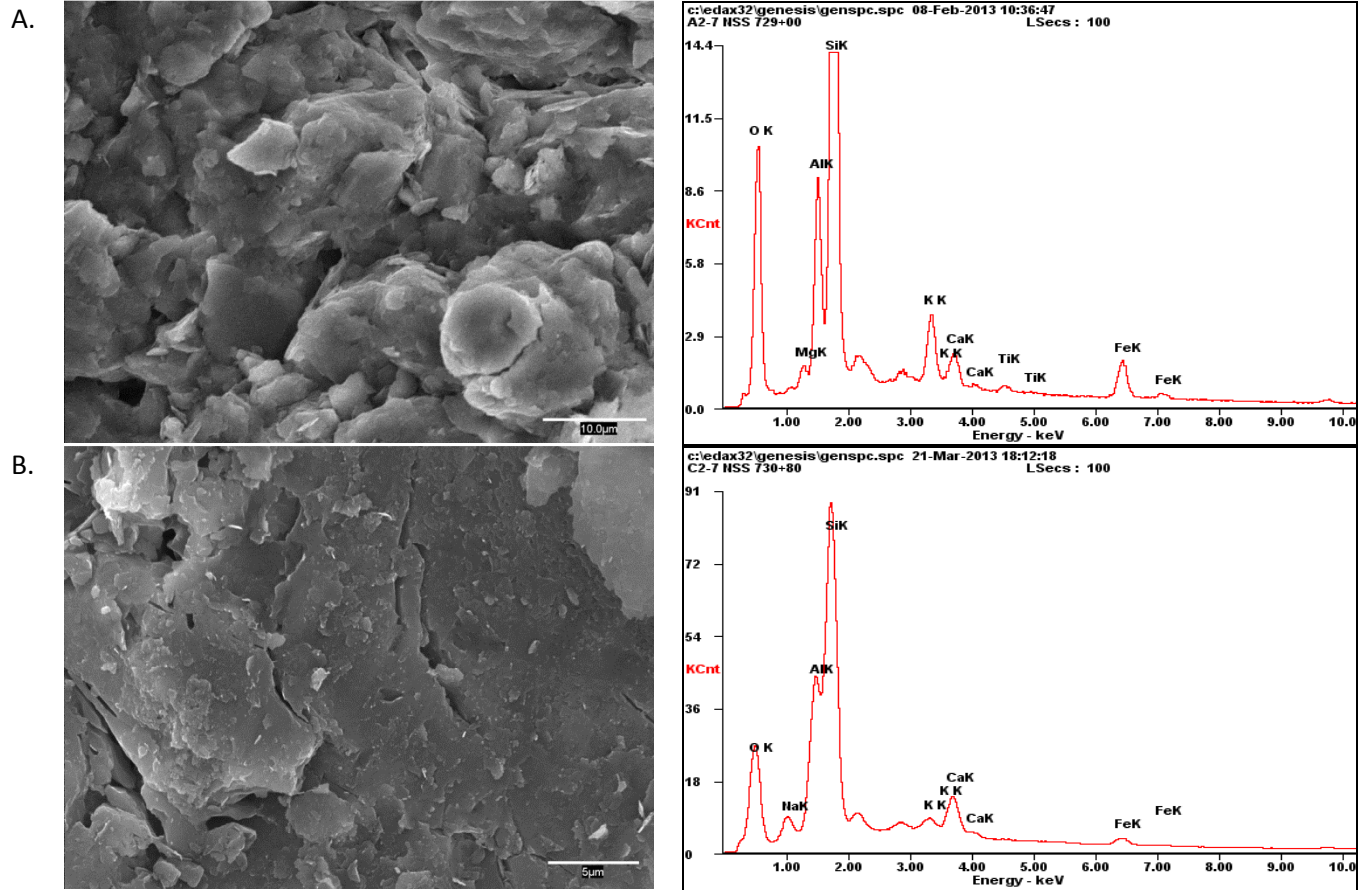
The SEM observations of non-stabilized soil from stations 729+00, 730+00, and 730+80 indicate the substrate has a platy morphology (Fig. 16). The EDAX results show major elemental average abundances in non-stabilized soils were O 39.15 wt%, Si 28.67 wt%, Ca 11.37 wt%, Fe 9.56%, Al 9.54 wt%, K 4.30 wt%, Mg 0.97 wt%, and Ti 0.79 wt%. Minor elements including sulfur, manganese, and sodium were present in the following average weight percent abundances: S 11.53%, Mn 0.58%, and Na 0.53%. Sulfur was classified as a minor element because it was found in only two of the samples.

Figure 16. Typical SEM/EDAX results for NSS samples. (A) Sample A2-7 729+00 NSS. Scale bar is 10.0 μm . O 39.86 wt%, Si 35.17 wt%, Al 9.79 wt%, Fe 6.47 wt%, K 4.93 wt%, Ca 2.21 wt%, Mg 1.03, and Ti 0.54 wt%. (B) Sample C2-7 730+80 NSS. Scale bar is 5.0 μm . O 37.15 wt%, Si 34.27 wt%, Al 16.41 wt%, Ca 5.72 wt%, Fe 2.23 wt%, Na 2.23 wt%, and K 2.00 wt%.

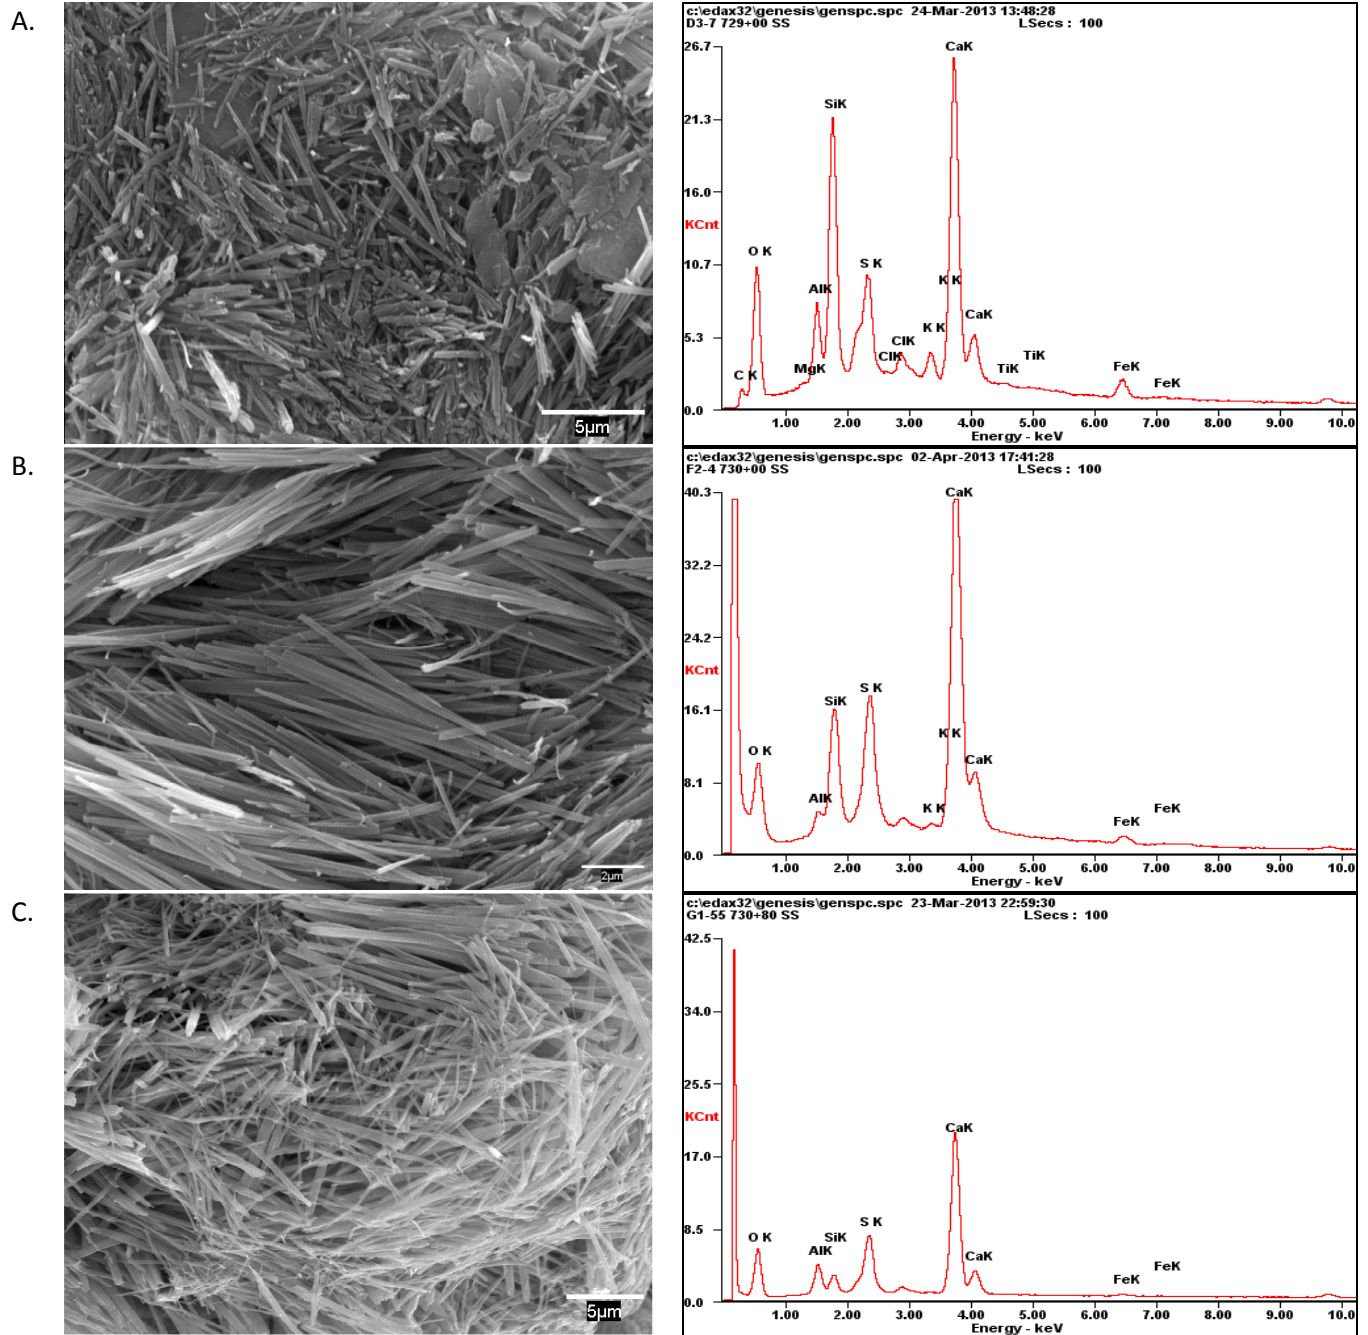
The SEM observations for the cement-stabilized soils from stations 729+00, 730+00, and 730+80 indicate a platy substrate morphology as well as numerous areas where the platy soil was covered in long, thin needles (Fig. 17). The EDAX analysis yielded the major elemental average abundances of cement-stabilized soils were O 37.42 wt%, Ca 23.68%, Si 16.01%, S 8.79%, Al 5.13%, Fe 4.77 %, K 2.25%, Mg 0.69%, Ti 0.65%, Na 0.11%, and Cl 0.11%.

Figure 17. SEM images of regions in CSS samples containing ettringite crystals. (A) Sample D3-7 729+00 CSS. Scale bar is 5 μm . O 37.83 wt%, Ca 24.52 wt%, Si 14.13 wt%, c 7.21 wt%, S 6.03 wt%, Al 4.24 wt%, Fe 3.53 wt%, K 1.80 wt%, Ti 0.42 wt%, Mg 0.17%, and Cl 0.11%. (B) Sample F2-4 730+00 CSS. Scale bar is 2 μm . Ca 39.95 wt%, O 33.66 wt%, S 11.94 wt%, Si 10.22 wt%, Al 2.06 wt%, Fe 1.98 wt%, and K 0.19%. (C) Sample G1-55 730+80 CSS. Scale bar is 5 μm . O 44.82 wt%, Ca 35.71 wt%, S 9.71 wt%, Al 5.34 wt%, Si 3.36 wt%, and Fe 1.05 wt%.

Published SEM images of ettringite show similar needle-like morphologies and similar chemical composition based on EDAX analysis (e.g., Blanco-Varela et al., 2006; Tosun et al., 2009; Tosun-Felekoglu, 2012). All cement-stabilized soil samples tested had ettringite needles present; however, it was noticed that the needles in the 729+00 samples were not as well developed and/or were in much less abundance than in samples from 730+00 and 730+80 soils, indicating a possible limiting factor for ettringite growth in the 729+00 soils. The majority of non-stabilized soil samples had platy substrate morphologies and did not have needles, indicating that ettringite did not form in the non-stabilized soils.

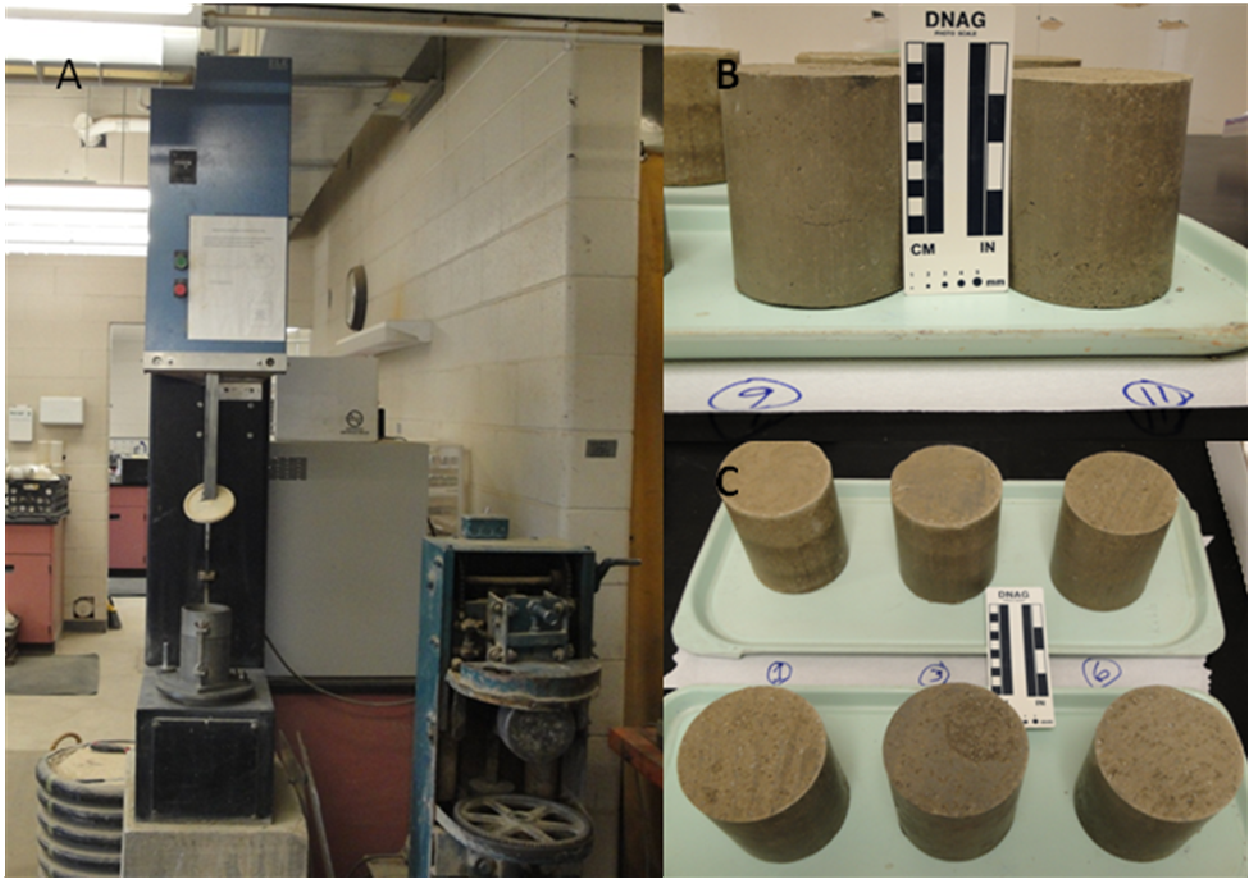
Four swell test samples per station (729+00, 730+00, and 730+80) were made at the ODOT testing facilities for a total of twelve swell test samples. Samples of the 729+00 and 730+00 non-stabilized soils were sieved with a #5 (4 mm) sieve and the 730+80 sample was sieved with a #40 (425 μm) sieve. The samples were compacted using a standard Proctor machine with a 2.5 kg (5.5 lb) rammer and a 305 mm (12 in) drop (Fig. 18). The samples were compacted in a 4 inch diameter by 4.5 inch height mold in three layers which received 25 drops per layer (AASHTO T99 method). All but one of the samples had 1850.0 g of soil, 111.0 g or 6% of cement, and 280.0-400.0 g or 15-22% of distilled water (Appendix III). The type of cement (St Mary's T1) and the amount of cement and water match what was used for the Lake County Route 2 highway, and represents the optimum cement content (6%) and slightly over the optimum moisture content (16%) determined for this soil type (Type A-4a).

Figure 18. (A) Proctor machine used to produce swell test samples and (B and C) images of resulting swell test sample cylinders.

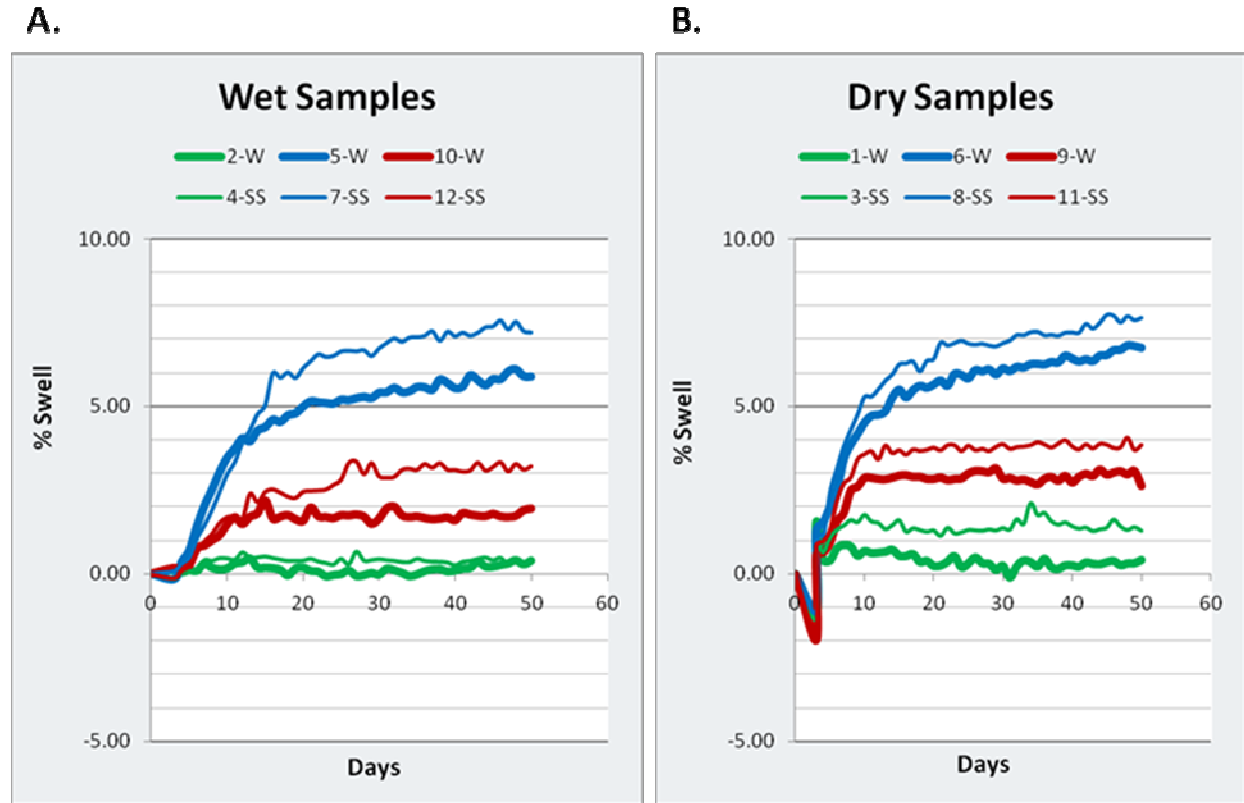
The results of the 56 day swelling test for each sample are plotted in Figure 20. Graph A shows the “wet” samples that were kept in plastic bags for three days before being placed in either deionized water (thick lines) or 7000 ppm sodium sulfate solution (thin lines). Graph B shows the “dry” samples that were air-dried for three days to cause shrinkage before being placed in either deionized water (thick lines) or 7000 ppm sodium sulfate solution (thin lines). Table 4 ranks the samples by highest to lowest amount of swelling.

Figure 20. Swelling of test samples over 56 days. (A) Wet swell samples in water (thick lines) or 7000 ppm sodium sulfate solution (thin lines). (B) Dry swell samples in water (thick lines) or 7000 ppm sodium sulfate solution (thin lines).

In contrast, the amount of swelling was substantially different between the three different soil samples/stations (Fig. 20). One possible explanation is that the different soils had different initial sulfate contents (Table 3), but the cylinders made using the 730+80 soil which had the highest initial sulfate level yielded the least amount of swelling (Fig. 20). The lack of a correlation between sulfate content and swelling has been noted by others (e.g., Little and Nair, 2009 and references therein). Interestingly, ettringite crystals were found throughout the samples of the 730+80 soils which showed little (<1.5%) swelling, although it has also been reported that in some systems ettringite formation is not associated with expansion (e.g., Hime and Mather, 1999; Odler and Colan-Subauste, 1999).

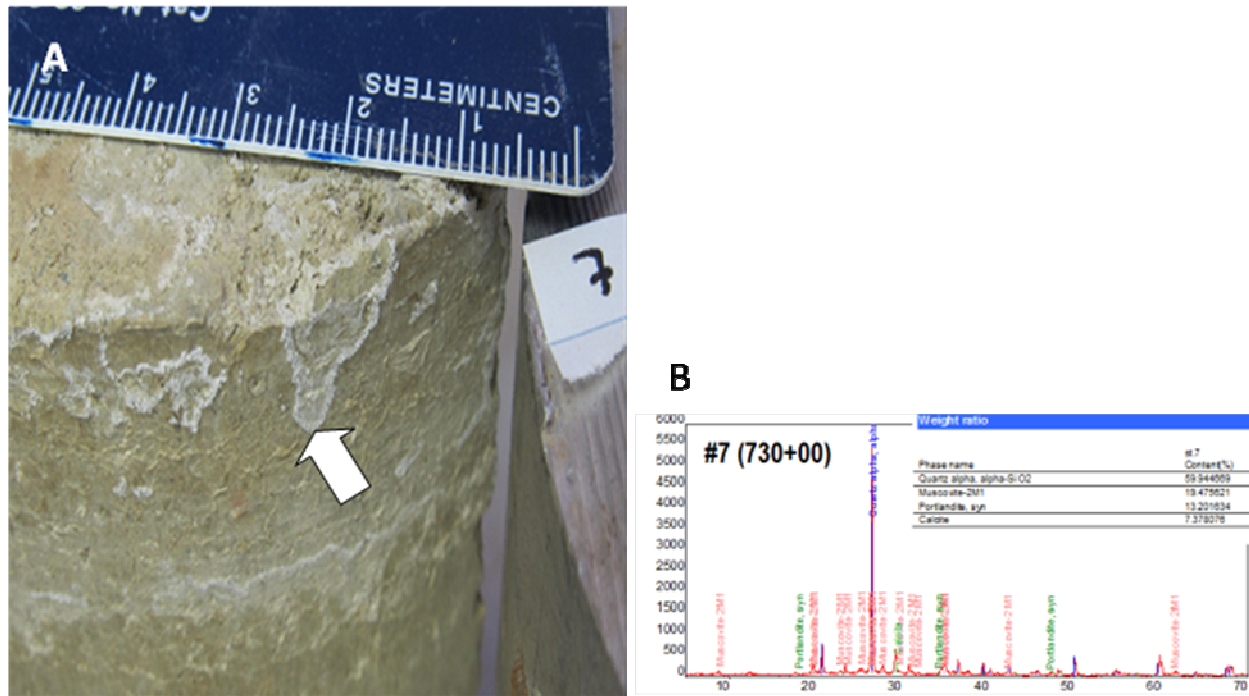
Visual inspection of the cylinders after the swell test experiment showed many had fractures that were filled with a white precipitate. In addition, a white precipitate was often found on edges and the top and bottoms of the cylinders (Fig. 21A).

Figure 21. (A) Swell test sample #7 (730+00, SS, Wet) showing white precipitate on surface, and (B) corresponding XRD pattern indicating the white precipitate is mostly calcite (CaCO_3) and portlandite ($\text{Ca}(\text{OH})_2$).

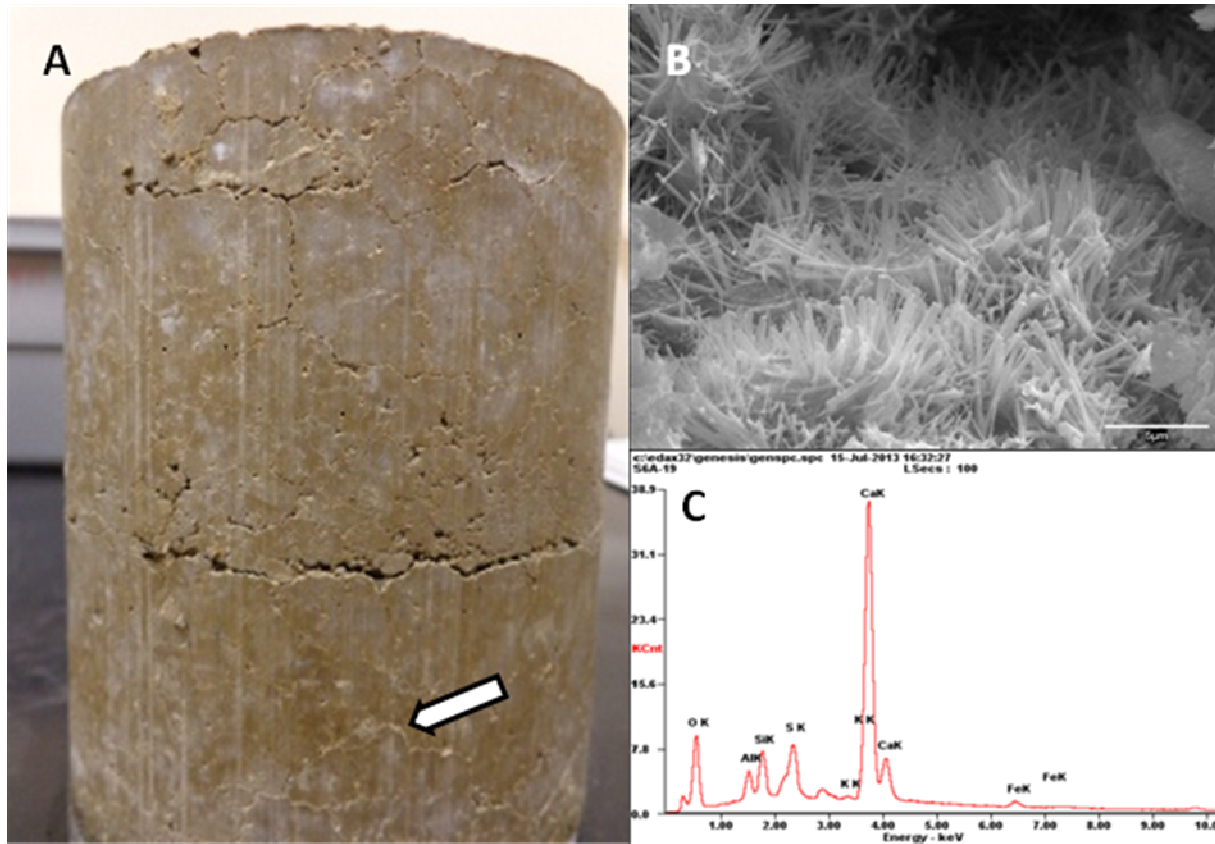
Sampling was then focused on the interior of the split cylinders especially around what appeared to be small vugs or fractures as well as “normal” looking areas. The SEM analysis of these samples showed regions with abundant needle-like bundles of crystals that were confirmed by EDAX analysis and by XRD analysis to be ettringite (Figs. 22, 23).

Figure 22. (A) Swell test sample #6 (730+00, DW, Dry) arrow showing location sampled. (B) SEM image of sample material, scale bar = 5 μm. (C) EDAX spectrum for area shown in B indicating the presence of ettringite.

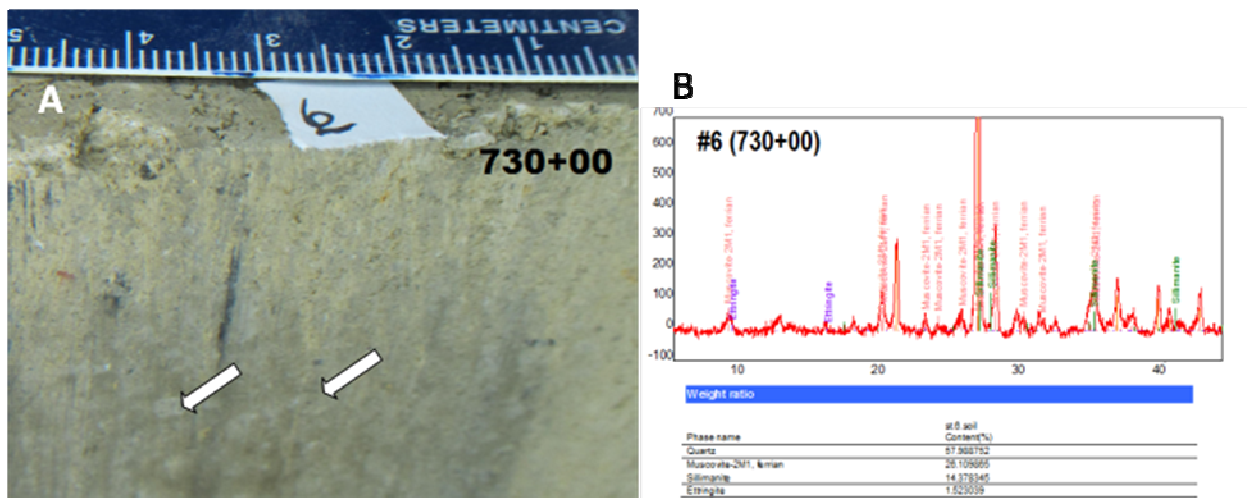
Figure 23. (A) Swell test sample #6 (730+00, DW, Dry) sawn interior surface near top, arrows show locations sampled. (B) XRD pattern of sample confirming the presence of ettringite.

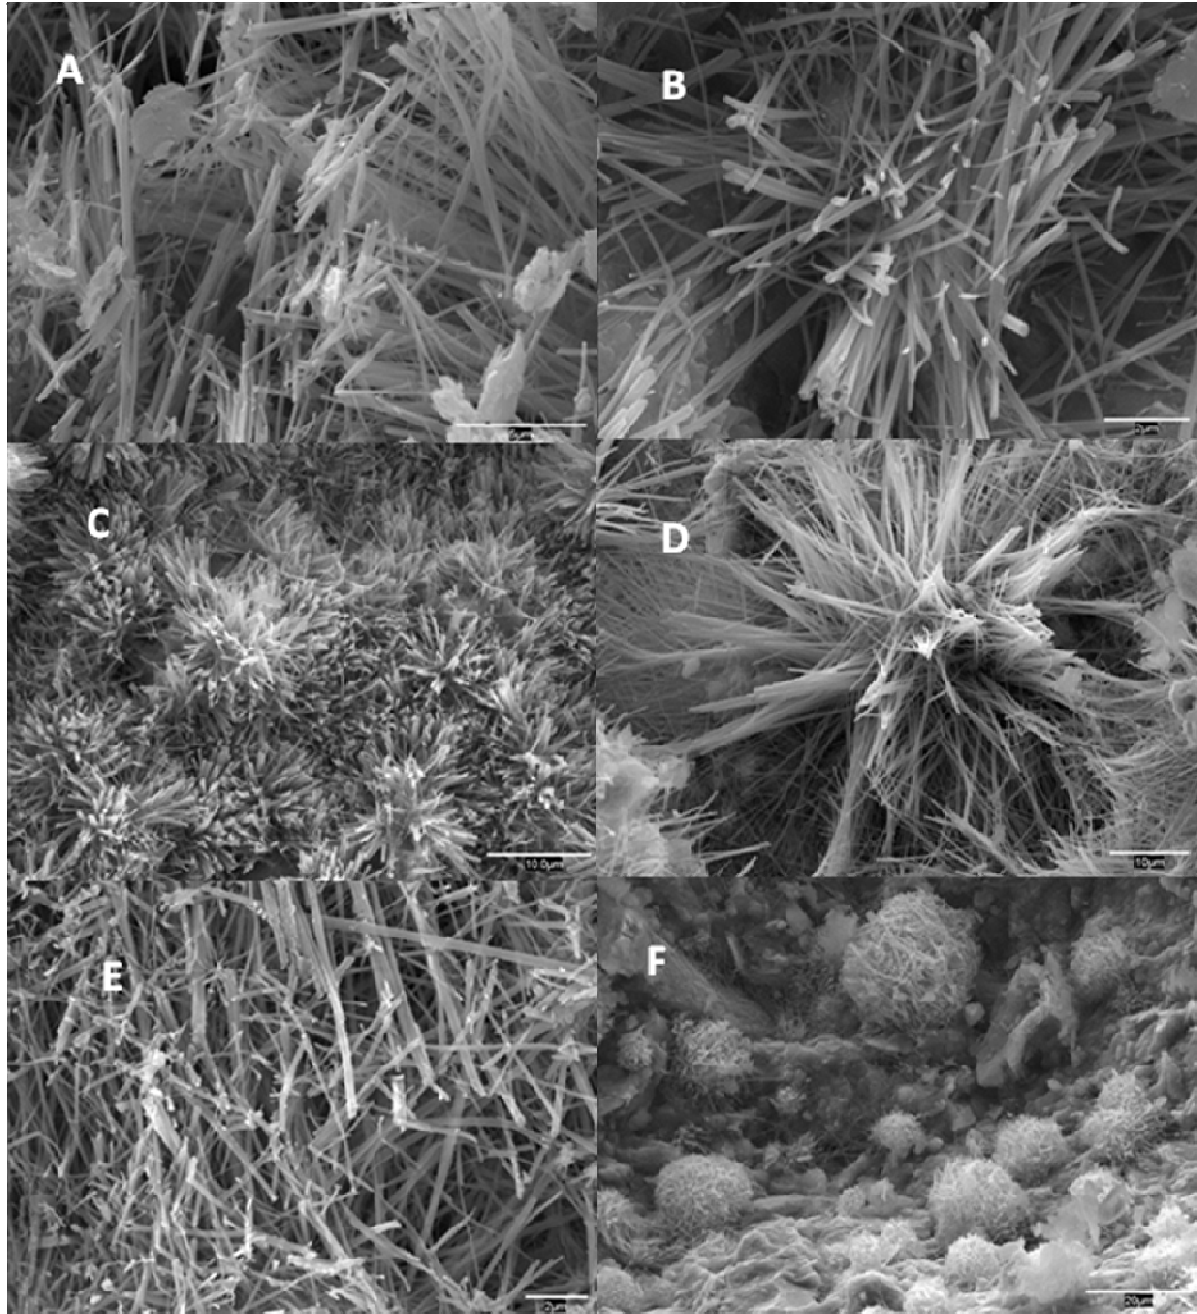
Upon further inspection, ettringite crystals were found throughout all of the test specimens (Fig. 24). Given the heterogeneous nature of its distribution in the swell test samples, it is not possible to quantify the amount of ettringite in each sample, but qualitatively it was more prevalent in the 730+80 samples than in the 729+00 and 730+00 samples even though the 730+80 samples showed the least amount of swelling (Fig. 20, Table 4).

Figure 24. SEM images of ettringite crystals observed in different swell test specimens (A) Sample #1, 730+80, DW, Dry, scale bar = 6 μm . (B) Sample #2, 730+80, DW, Wet, scale bar = 2 μm . (C) Sample #7, 730+00, DW, Dry, scale bar = 10 μm . (D) Sample #9, 729+00, DW, Dry, scale bar = 10 μm . (E) Sample #10, 729+00, DW, Wet, scale bar = 2 μm . (F) Sample #12, 729+00, SS, Wet, scale bar = 20 μm .
