Role of Sulfates on Highway Heave in Lake County, Ohio

Prepared for:
The Ohio Department of Transportation,
Office of Statewide Planning & Research

January 2014

Final Report

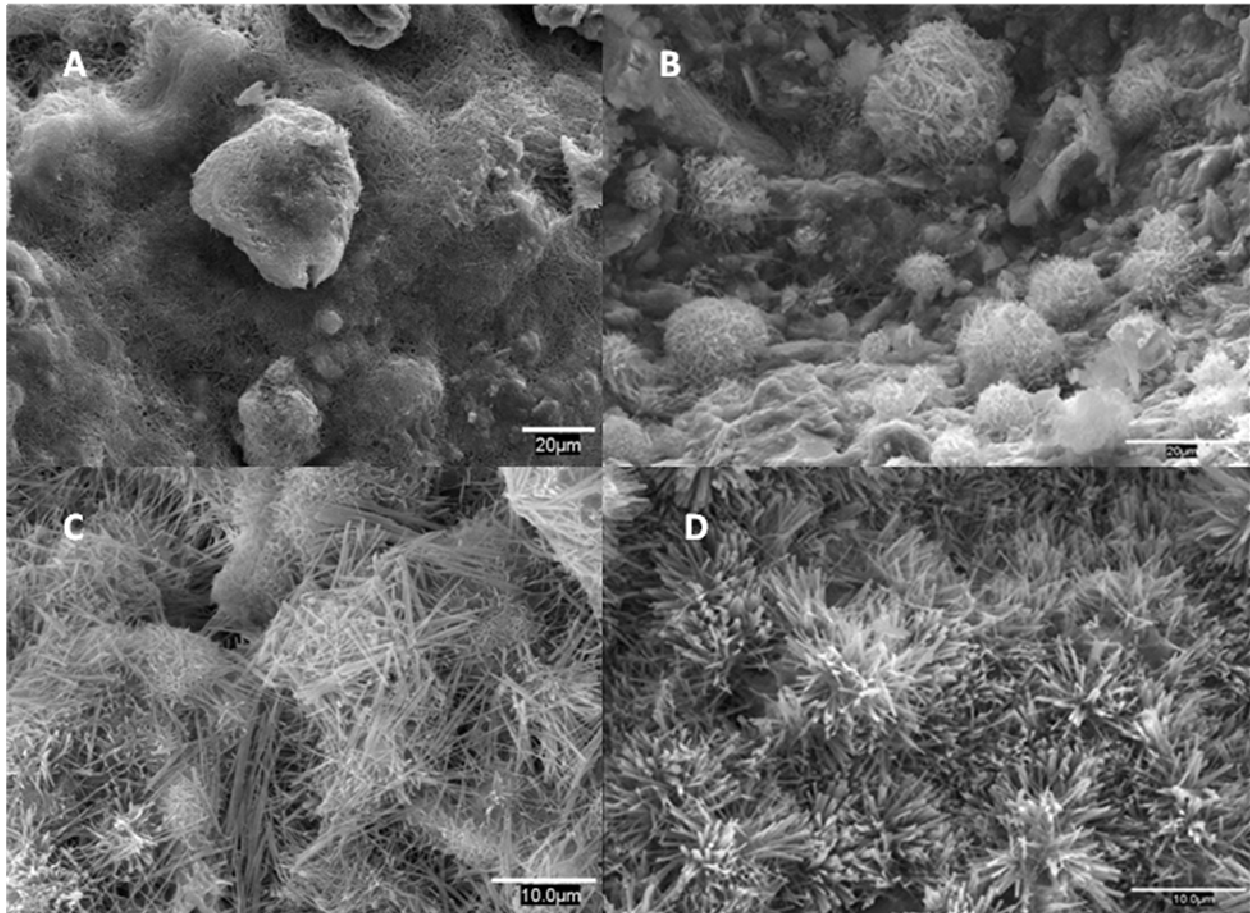
The SEM analysis of the cement stabilized soils and our swell test samples showed that sometimes the ettringite crystals were flat and more of a coating on the soil particles (Fig. 25 A, B) while at other times the ettringite appears as long needles in loose bundles with radiating flower-like structures (Fig. 25 C, D). The flat crystals coating the soil particles are likely primary ettringite whereas the radiating bundles are secondary. A time-series swell test wherein some samples are mixed but left to cure uncompactd for a day or two, and wherein some swell tests are stopped after a few days rather than running the entire 56 days of this study, then analyzed for the presence and the texture/morphology of the ettringite could refine the role of primary versus secondary ettringite formation and swelling.

Figure 25. SEM images of ettringite crystals observed in different specimens. (A) 730+80 CSS, primary, scale bar = 20 μm . (B) 730+00, swell, SS, Wet, primary going into secondary, scale bar = 20 μm . (C) 730+80, CSS, secondary, scale bar = 10 μm . (D) Sample #9, 729+00, swell, SS, Wet, secondary, scale bar = 10 μm .
