Methods for Preventing ASR in New Construction

Results of Field Exposure Sites

December 2013

1. Report No. FHWA-HIF-14-004		2. Government Accession No.		3. Recipient's Catalog No.	
4. Title and Subtitle Methods for Preventing ASR in New Construction: Results of Field Exposure Sites				5. Report Date December 2013

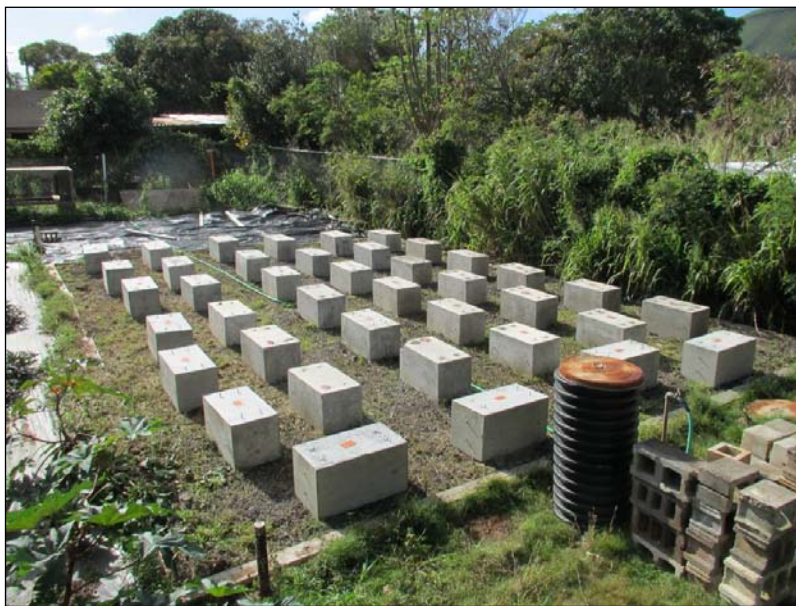
Figure 1. Completed Exposure Site at the University of Hawaii at Manoa, Hawaii (January 2013)

The exposure site in Hawaii was constructed in June 2011 and is situated at the Magoon Research and Instruction Facilities, which is part of the College of Tropical Agricultural and Human Resources at the University of Hawaii at Manoa (see Figure 1). A total of 40 concrete mixtures were produced (30 in 2011 and an additional 10 mixes in January 2013), and blocks (0.38 x 0.38 x 0.71 m, 15 x 15 x 28 in.) from these mixtures were placed on the exposure site. A number of local aggregates (coarse and fine) from various quarries on the islands and an imported sand from British Columbia, that is used by some Hawaiian concrete producers, were used together with cements of varying alkali, fly ash, and a lithium-nitrate admixture. Known

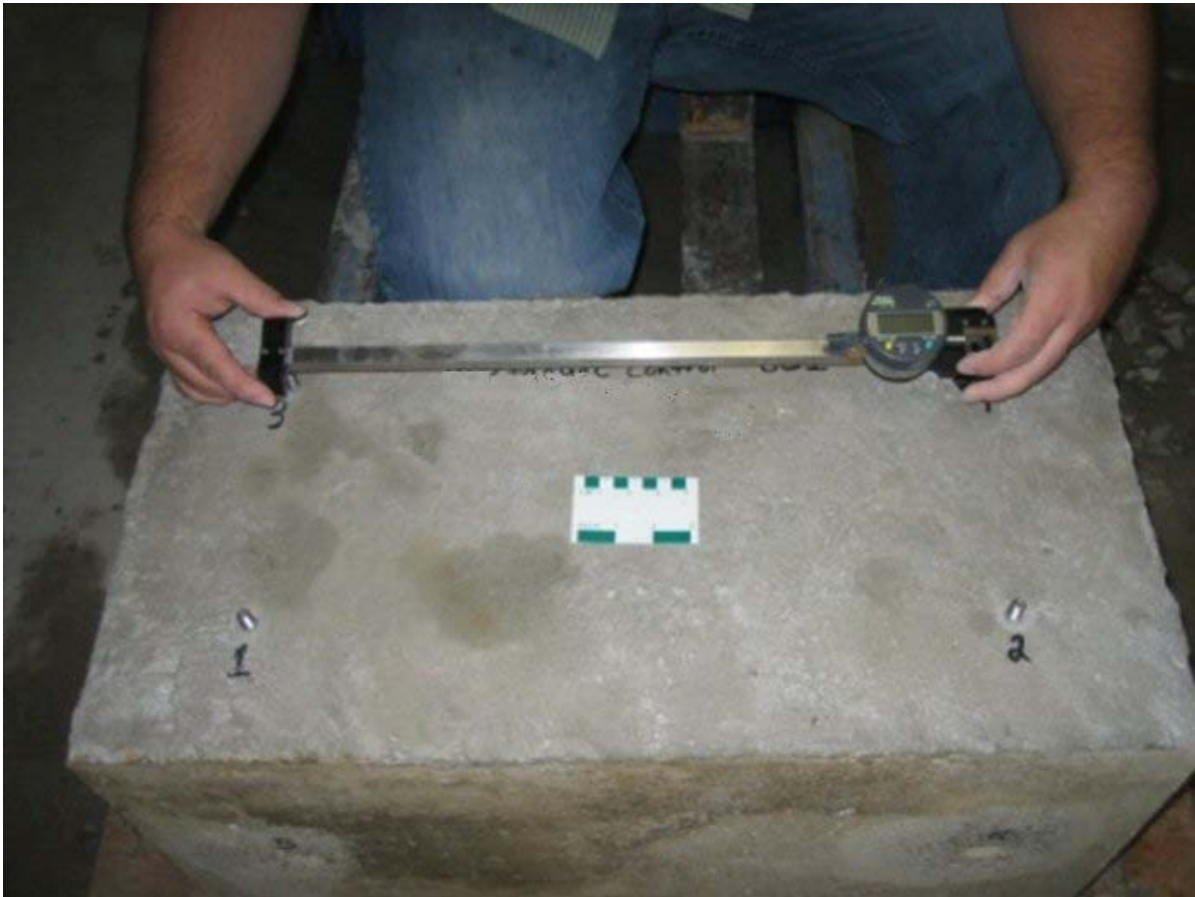
Figure 2. Length-Change Measurements Using a Demec-Type Gauge

Concrete for 27 of the first 30 mixtures was batched, mixed, and cast at Hawaiian Cement's Halawa Plant in June 2011. For each mixture 0.14 m³ (5 ft³) of concrete was mixed in a drum mixer, placed into the forms for the concrete blocks, and consolidated in two layers using an immersion vibrator. Stainless steel pins were cast into the blocks to permit measurements of length change to be made using a Demec-type strain gauge (see Figure 2). The blocks were cured under wet burlap and plastic for one day before the forms were stripped. The blocks were then moist-cured for a further (approximately) six days under wet burlap before being transported approximately 16 km (10 mi) to the Magoon Research Facilities in Manoa where they were placed on a layer of granular fill and exposed to the elements (see Figure 1), at which time the "zero-day" reference length-change measurement was carried out.

Length-change measurements of these 30 blocks were conducted again at 109, 265, 571, and 805 days. At 805 days (August 2013) representatives of the University of Hawaii (UH) Department of Civil Engineering also made length-change measurements using different Demec gauges. All future measurements will be performed by UH.

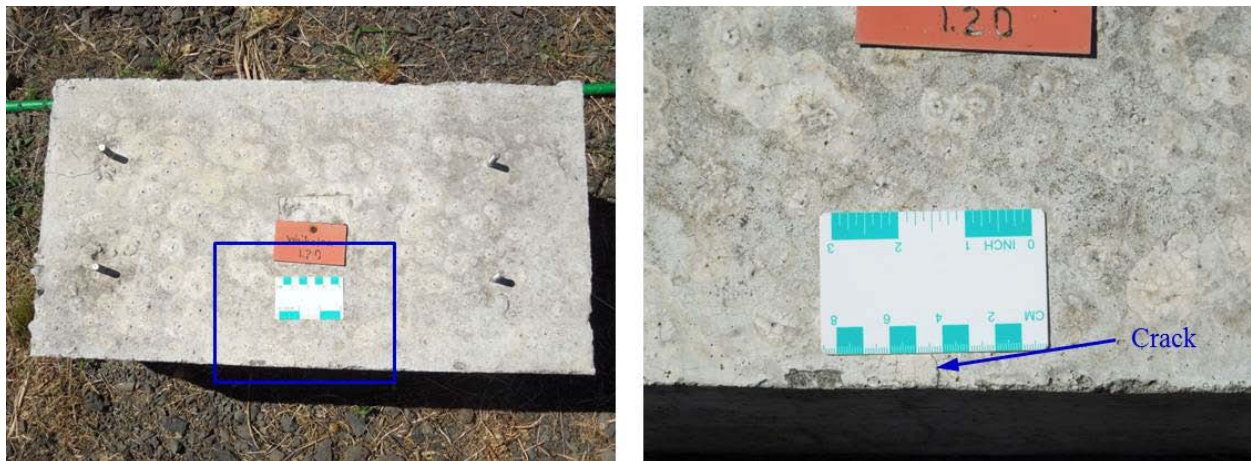
**Figure 4. Photograph of Block 4 at 805 days (August 2013)
(Photo on right is an enlargement of area in blue box on left)**

None of the blocks containing the local Hawaiian (basaltic) aggregates have shown deleterious expansion to date. Only one block, Mix 28 with Waikoloa aggregate, exhibited cracking at 805 days (see Figure 4) but this is not thought to be a result of ASR as the expansion is still less than 0.020% at this age. Consideration will be given to sampling the block at a later age and conducting a petrographic evaluation to determine whether there is any evidence of ASR.

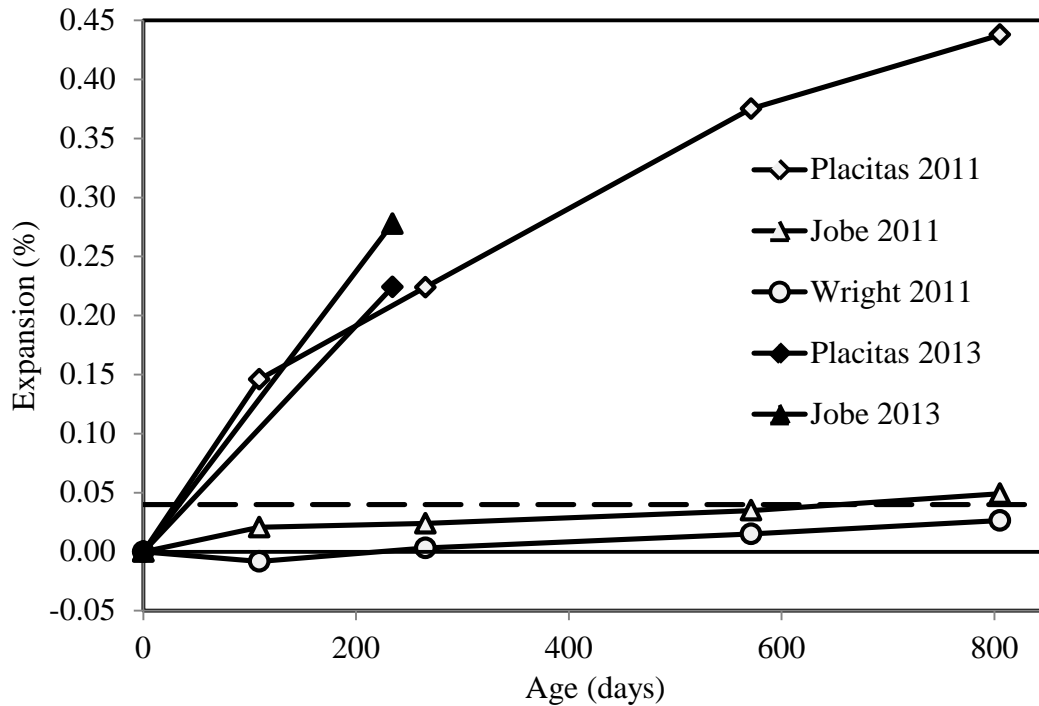
Figure 5. Expansion of Blocks with Imported Known Reactive Aggregates

Figure 5 shows the expansion of blocks containing the “imported” known reactive aggregates from Texas (Jobe and Wright) and New Mexico (Placitas). Of the blocks manufactured in 2011 only the block with Placitas (Mix 4) showed rapid expansion and cracking, and this is consistent with behavior observed for this aggregate on other exposure sites. The block containing Wright sand has not yet expanded, and this is not unexpected as this sand is more slowly reactive than the Jobe and Placitas. The behavior of the block with Jobe is surprising as this sand has produced very rapid expansion when combined with high-alkali cement in blocks on other exposure sites. To further investigate this apparent anomaly additional blocks were cast with Jobe and Placitas in January 2013. The data in Figure 5 show both blocks to expand rapidly this time, and the magnitude and rate of expansion of the 2013 Placitas block is very similar to the 2011 Placitas block. A corner of 2011 Jobe block was removed using a concrete saw and examined in the

laboratory; this confirmed that the sand was indeed Jobe. It is suspected that an error occurred during the batching of the 2011 Jobe block and that low-alkali cement was inadvertently used instead of high-alkali cement. If this is indeed the case the block is expected to start expanding at some point in the future and, at that time, consideration will be given to removal of another small sample from this block for the purpose of determining the alkali content of the concrete.

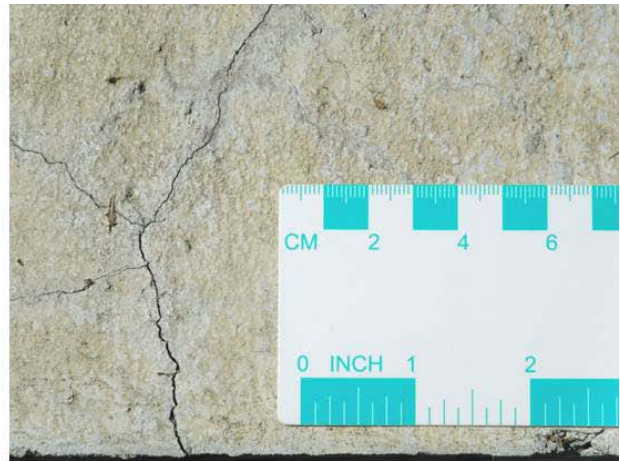
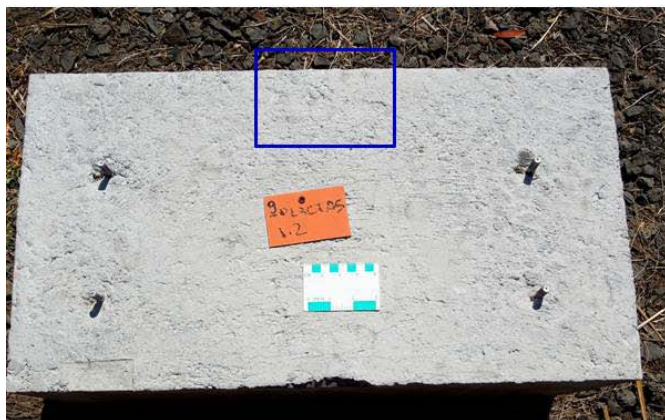
Figure 6. Photographs of Cracked Blocks with Placitas Aggregate Cast in 2011 (top) and 2013 (middle) and Jobe Sand Cast in 2013 (bottom) (Photos on right are enlargements of areas in blue box on left)

Figure 6 shows the condition of some of the blocks with known reactive aggregates. The photographs were taken in August 2013 when the 2011 blocks were at an age of 805 days and the 2013 blocks were just 234 days old. The cracking exhibited in the blocks constructed with Placitas (2011 and 2013) and Jobe (2013) is symptomatic of ASR.

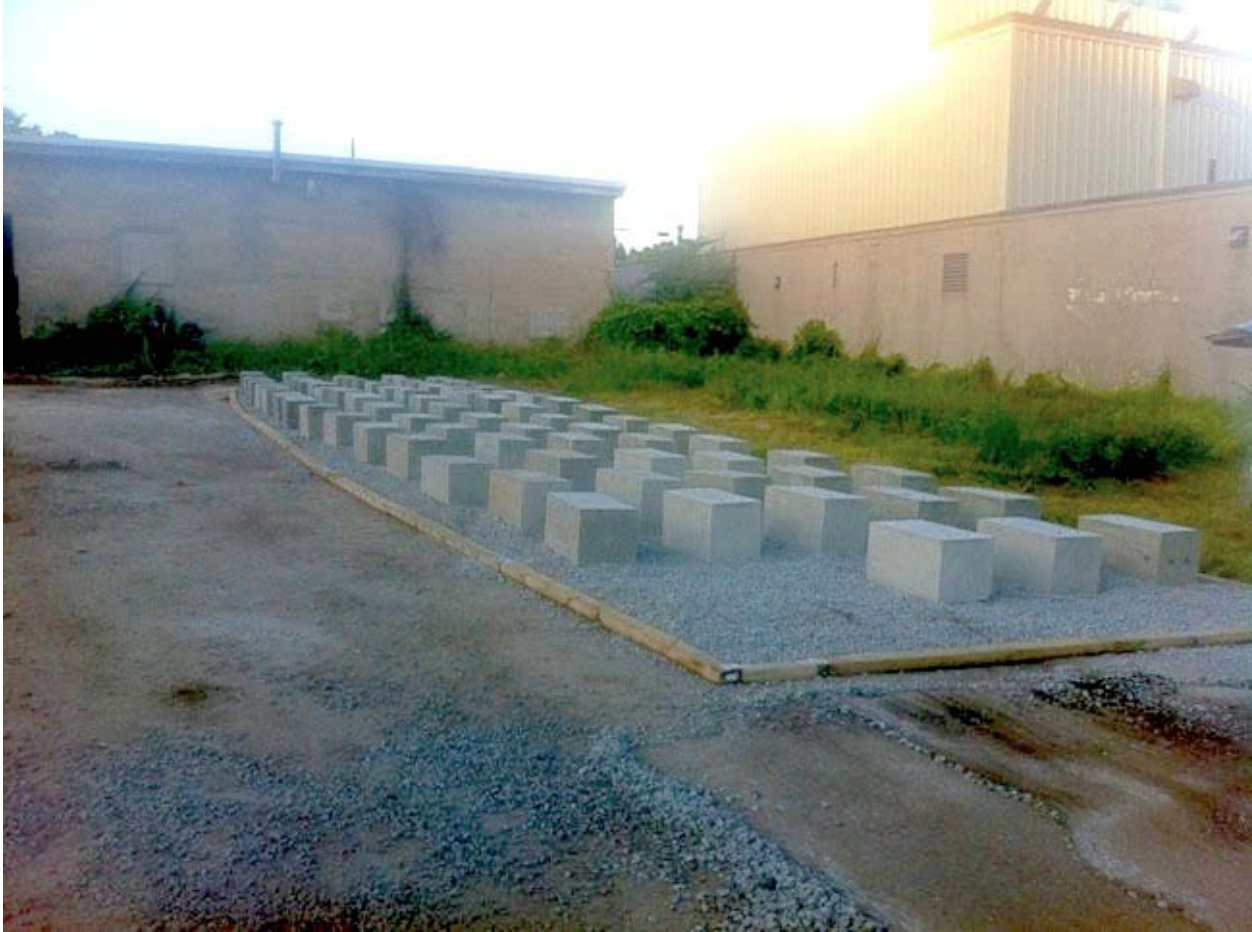
Figure 7. Completed Exposure Site in Lawrence, Massachusetts (June 2012)

The Lawrence exposure site was constructed in June 2012 at a Massachusetts Department of Transportation (MassDOT) storage facility in Lawrence, Massachusetts (see Figure 7). A total of 73 concrete mixtures were produced, and blocks (0.38 x 0.38 x 0.71 m, 15 x 15 x 28 in.) from these mixtures were placed behind the storage building. Eleven local aggregates (coarse and fine) were used together with cements of varying alkali, supplementary cementing materials (SCM), and a lithium-nitrate admixture. Known reactive aggregates from three different sources were also used. These aggregates have been used to produce blocks on other exposure sites including the site in Hawaii that was constructed under this program and other sites in Texas, Ontario, and New Brunswick. Having the same-size blocks with nominally identical composition on different sites will allow the effect of environmental exposure to be assessed. These blocks will be monitored periodically to determine the onset of cracking (by visual inspection) and length change. Laboratory tests are being conducted on similar mixtures, and the outcome of the tests will be compared when long-term test data (≥ 10 years) from the exposure site become available. At the time of writing, only one-year data are available from the exposure site. Continued monitoring of the blocks (beyond one year) will be performed by MassDOT.

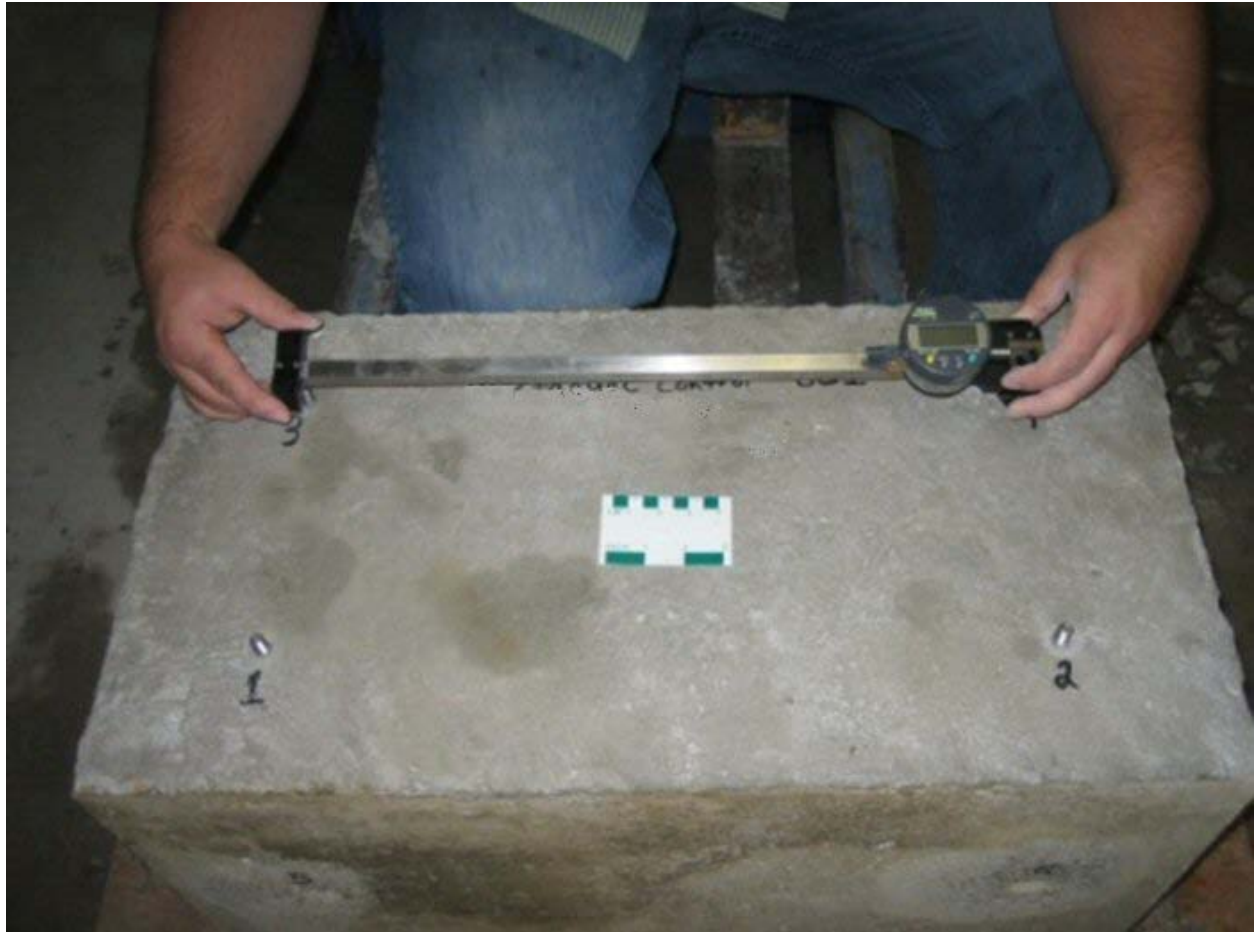
Figure 8. Length-Change Measurements Using a Demec-Type Gauge

Concrete was batched, mixed, and cast on the exposure site. For each mixture 0.14 m³ (5 ft³) of concrete was mixed in a drum mixer, placed into the forms for the concrete blocks, and consolidated in two layers using an immersion vibrator. Stainless steel pins were cast into the blocks to permit measurements of length change to be made using a Demec-type strain gauge (see Figure 8). The blocks were cured under wet burlap and plastic for one day before the forms were stripped. The blocks were then moist-cured for a further (approximately) six days under wet burlap before being placed on a layer of granular fill and exposed to the elements (see Figure 7) at which time the “zero-day” reference length-change measurement was carried out.

Length-change measurements were conducted again at 91 and 371 days. At 371 days representatives of MassDOT also made length-change measurements using different Demec gauges. All future measurements will be performed by MassDOT.

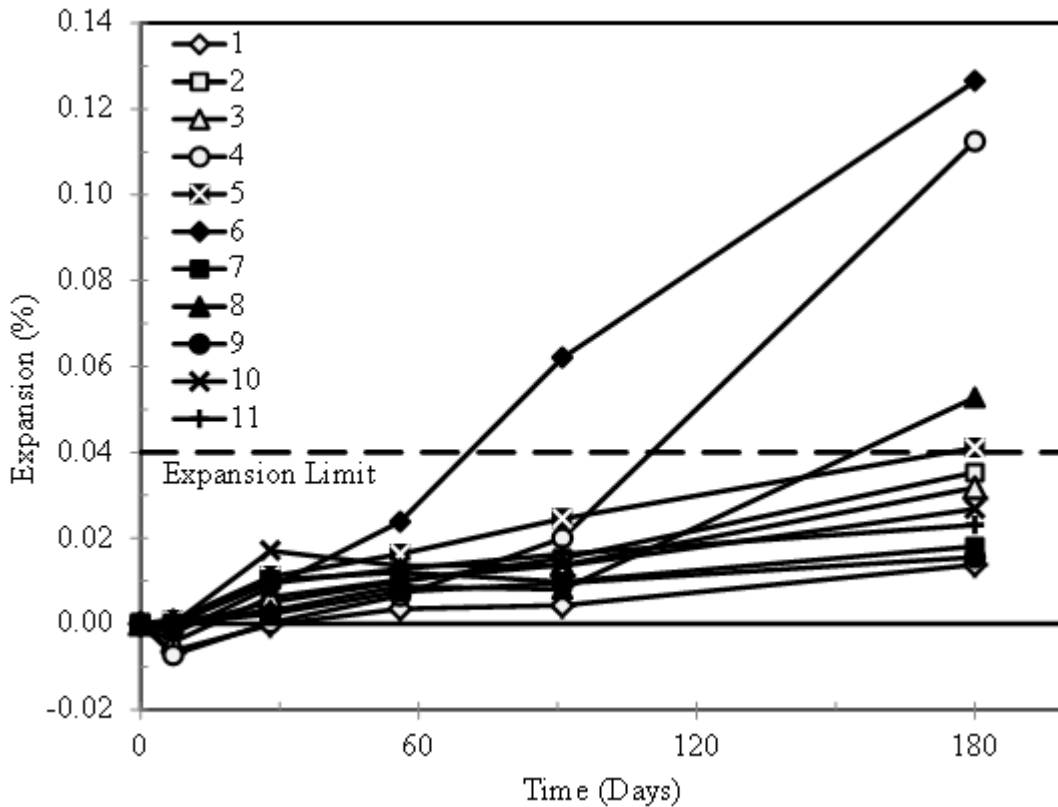
Figure 9. Expansion of Local Aggregates Tested in Concrete Prism Test (ASTM C 1293) – Data to 180 days only (Note: specified test duration is 1 year)

The relationship between expansion and time for the 11 aggregates tested in the CPT are presented in Figure 9. Although the tests are not sufficiently advanced for definitive statements to be made regarding the reactivity of the aggregates, the spread of data do confirm that the 11 aggregate samples selected represent a wide range in terms of alkali-silica reactivity (as intended).

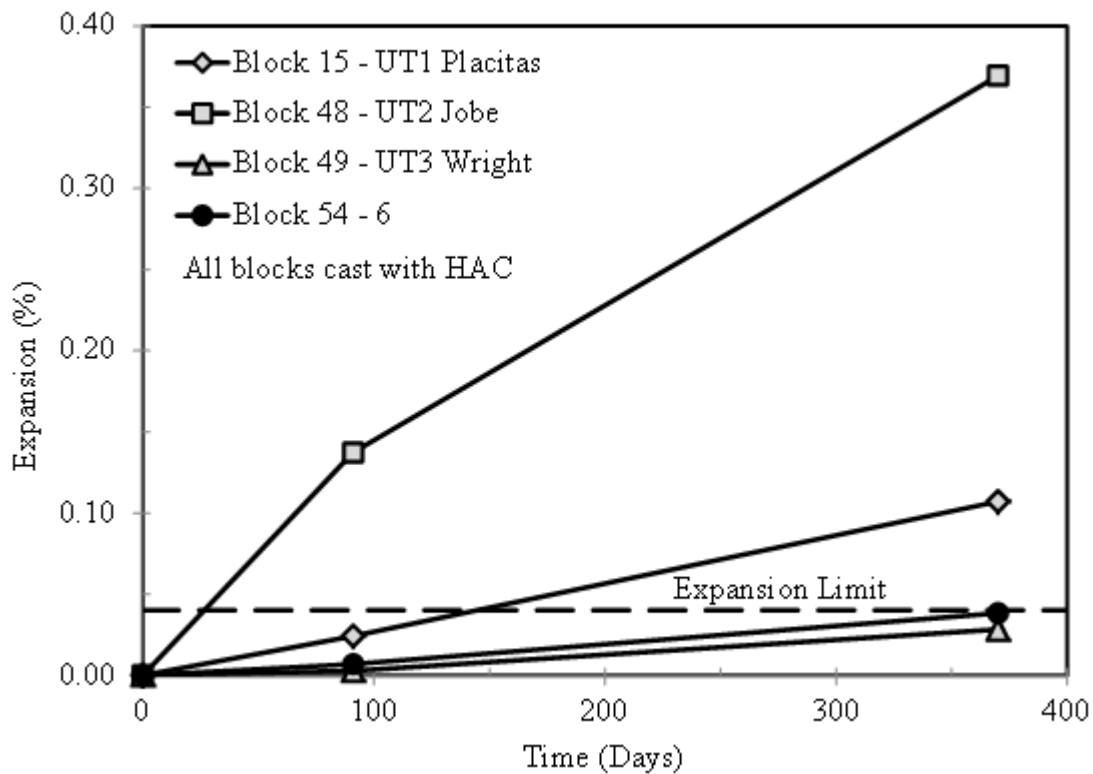
Figure 10. Expansion of Blocks on Exposure Site in Lawrence, Massachusetts

The expansion values for the concrete blocks after three months and one year on the exposure site are presented in Table 8. Figure 10 shows the expansion versus age for the three known reactive aggregates together with aggregate 6. Aggregate 6 was selected because it shows the highest expansion among the 11 local aggregates and has been implicated as a contributor to ASR in a number of structures in New England. The Jobe aggregate, which is considered to be one of the most, if not the most, reactive aggregates in North America, produces expansion in excess of 0.040% after just 91 days on the exposure site. After 1 year, the Placitas aggregate has also produced expansion in excess of 0.040%, but none of the other blocks have reached this level of expansion at this age. However, the block with aggregate 6 and high-alkali cement has expanded by 0.038% at 1 year. Significant expansion of the blocks produced with local aggregates is not expected after one year. Damaging expansion and cracking due to ASR often takes 5 to 10 years, and sometimes even longer, to occur under field conditions. Indeed in many cases the blocks exhibit shrinkage (negative values in Table 8) during the first year, and this is expected behavior.
