DEVELOPMENT OF DELINEATOR TESTING STANDARD

Test Report No. 0-6772-1

**TEXAS A&M TRANSPORTATION INSTITUTE
COLLEGE STATION, TEXAS**

TEXAS DEPARTMENT OF TRANSPORTATION

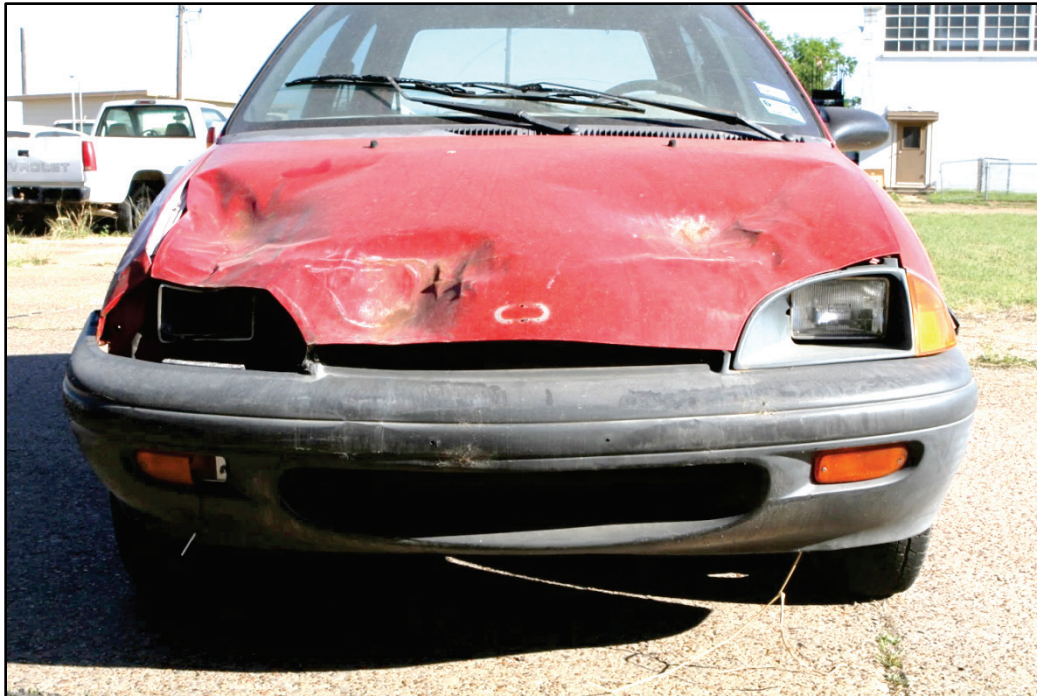
Figure 1.2. Geo Metro (*NCHRP Report 350* Test Vehicle) after Approximately 50 Impacts.

Over the years, TTI researchers have learned how the vehicle becomes damaged and have been able to compensate to an extent. As an example, Figures 1.2 and 1.3 show the resulting damage to two different test vehicles after being impacted 50+ times. The vehicle in Figure 1.2 was from one of the first attempts at running the Florida high durability testing standard. That vehicle was damaged beyond repair and would not have been able to finish the testing; however, it did outlast the product being tested. The test vehicle shown in Figure 1.3 was from the latest set of tests, where the vehicle impacted a set of delineators 100 times.

Notice the significant difference in the damage between Figure 1.2 and Figure 1.3. Some of the reduced damage is due to a difference in delineator design, some is due to a difference in the vehicle design, and finally some is due to the proposed modifications to the testing procedure. This vehicle could be used in future testing with some minor modifications; however, there is some damage to the vehicle that changed the profile of the vehicle and therefore the impact characteristics of the vehicle. TTI researchers believe that the use of technology used in the racing industry, such

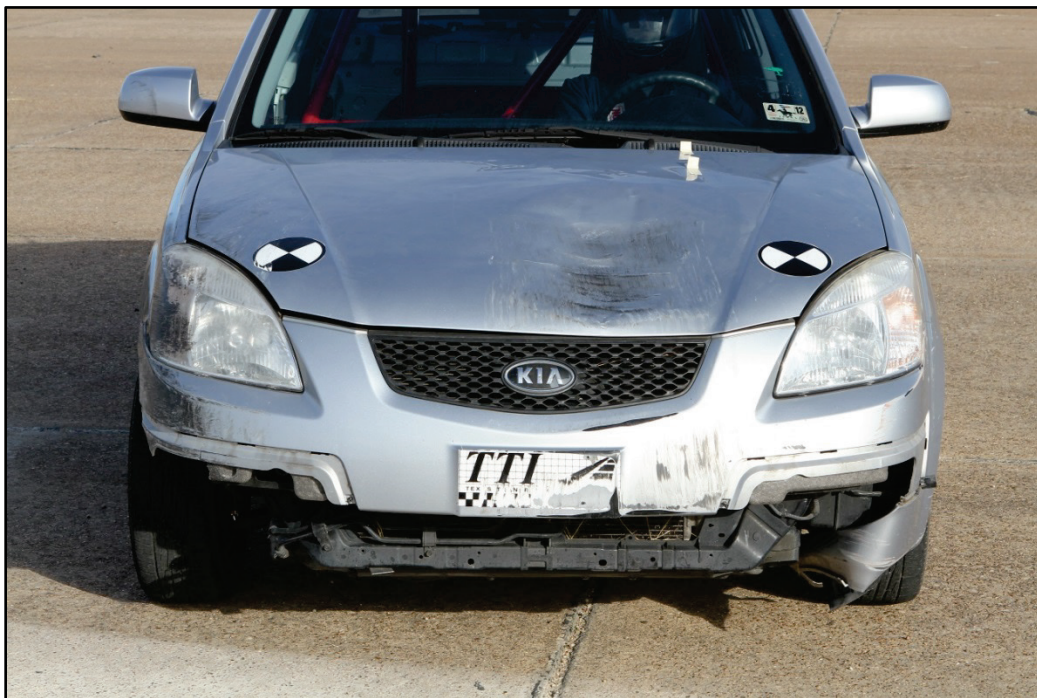
Figure 1.3. Kia Rio (*MASH* Test Vehicle) after 100 Impacts.

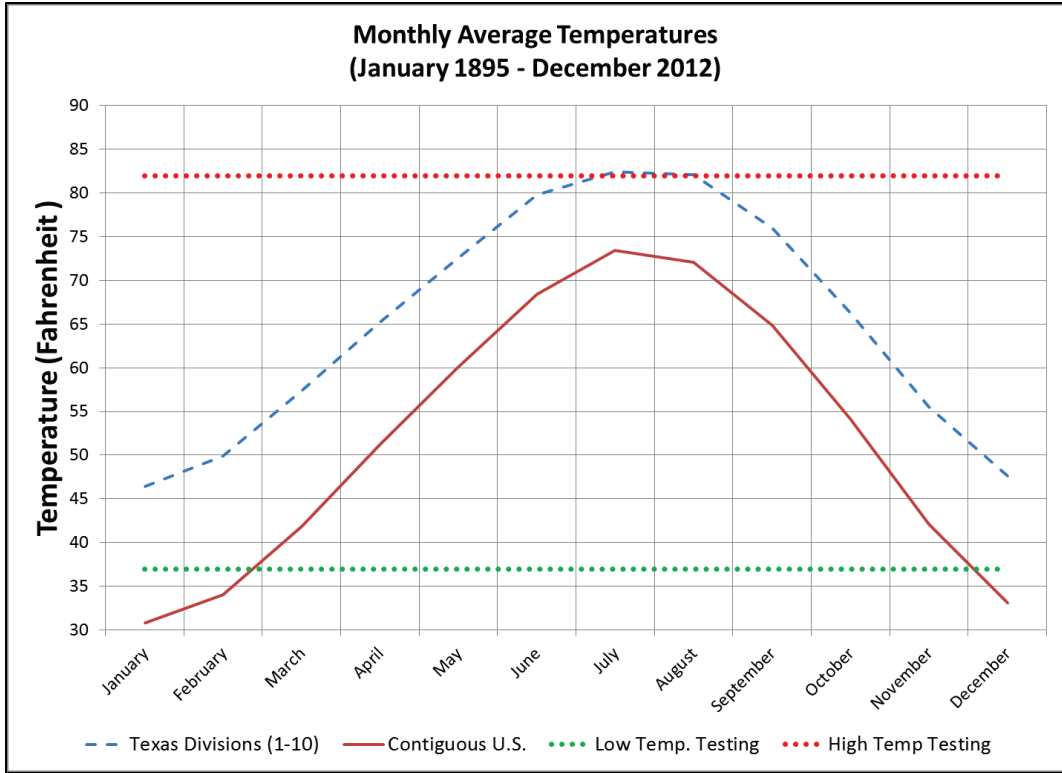
Figure 3.1. Average Temperature Comparison.

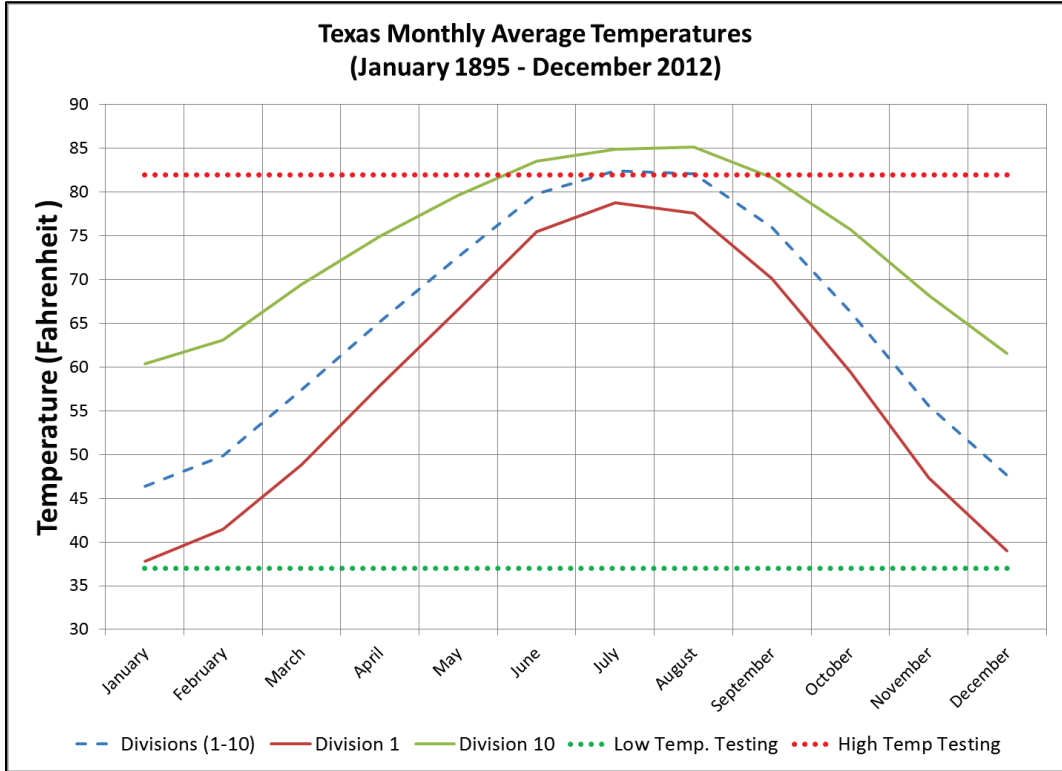
Figure 3.2. Texas Average Temperature Comparison.

Since Texas is such a large state, it contains many different sub-climates. For this reason, Figure 3.2 was generated to see the effect portions of Texas have on the temperature data. Two Texas divisions were chosen to bound the extremes of the temperature effects. The first division chosen was Division 1. Figure 3.4 shows that Division 1 has the highest latitude leading to the coldest expected temperatures. This division includes Amarillo, along with other smaller communities in the panhandle of Texas. The second division selected was Division 10, which is the most southern division in the state. It is expected that this division should represent one of the warmer portions of Texas. When plotted on the same axis, it shows that there are portions of Texas that regularly fall both above and below the recommended NTPEP testing temperatures. For this reason, the researchers determined that temperature effects cannot be simply ignored. The researchers recommend that testing be performed to determine if these temperature variations provide a significant difference in performance. If no substantial difference is noticed, then TTI researchers suggest following the example of Florida. If a substantial difference is noticed, then TTI researchers suggest that Texas follow the example set by NTPEP.

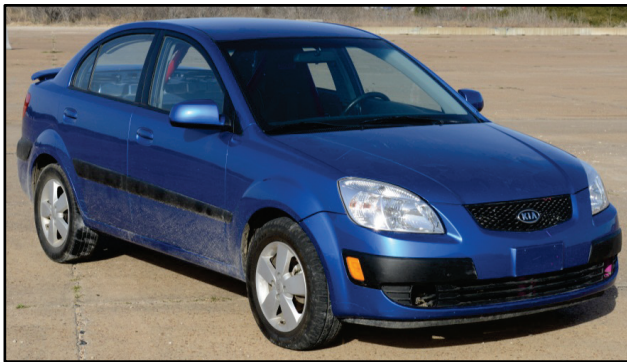
Figure 4.1. Modified 1100C.

Figure 4.1 shows the 2009 Kia Rio that was selected for modification and testing. This vehicle meets all of the AASHTO *MASH* 1100C standard vehicle requirements and is the primary vehicle used in current accredited *MASH* testing facilities. This vehicle model has been used at the TTI Proving Ground for testing delineators under contracts for private manufacturers. Figure 4.2 shows damage to the vehicle due to repeated impacts and also shows how the damage significantly altered the profile of the impacting vehicle's bumper. This damage significantly changes the way the delineators react when the vehicle impacted them. This shows that modifications to the vehicle bumper structure are required to support the bumper shell to prevent damage and to prevent alteration of the bumper profile during testing due to damage.

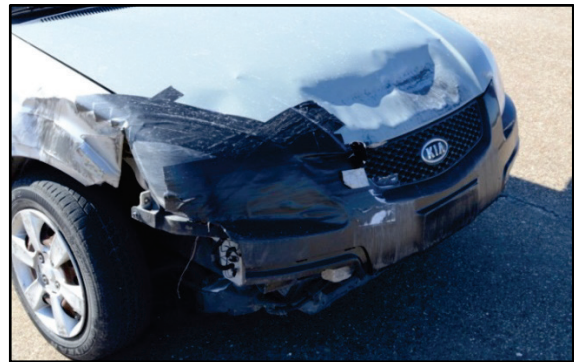
Figure 4.2. Damage to Previous Test Vehicle.

After evaluating the damage patterns shown in Figure 4.2, the researchers recommended that the primary focus of the modifications should be on supporting the bumper shell of the vehicle. Previous testing show that the bumper shell of the impacting vehicle becomes severely damaged after only a few impacts. This behavior should be prevented through modifications to the vehicle. These modifications should be designed to minimize the variance in impact behavior between a modified and unmodified vehicle.

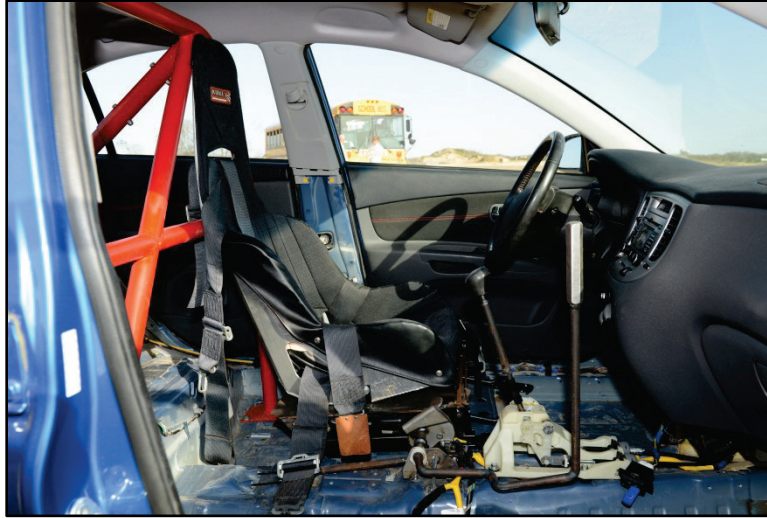
Figure 4.3. Modified 1100C.

Modifications to the 1100C vehicle were not limited to impact performance. Many of the modifications were performed to increase safety for the test vehicle operator. First, the entire interior of the vehicle (including seats, carpet, molding, and storage compartments) were removed to decrease the weight of the vehicle and to make room for safety equipment to be installed. Second, a roll cage meeting racing standards was installed near the “B” pillar of the vehicle (8). This roll cage minimizes occupant compartment deformation in the event of a rollover. Next, a racing seat with 5-point racing harness was installed to safely and securely restrain the vehicle operator in the event of a rollover or unplanned impact during testing. Finally, the vehicle controls were modified to allow for easier access for the operator while properly restrained by the racing seat and harness. Figure 4.3 shows the modifications made to the interior of the 1100C vehicle.

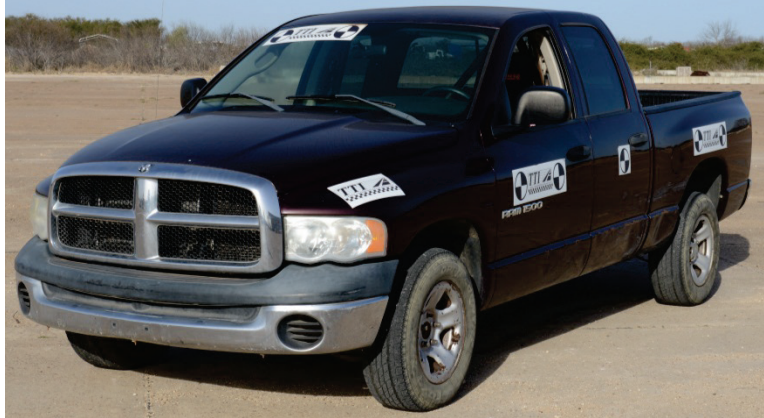
Figure 4.5. Modified 2270P.

A 2003 Dodge Quad Cab, shown in Figure 4.5, was selected to represent the *MASH* 2270P impact vehicle. This vehicle had been used previously in *MASH* compliance testing of a curb mounted delineator system. The truck was selected to reduce the cost of the project while still meeting the requirements of *MASH* 2270P specifications. Notice that only cosmetic damage was induced during testing. This minimizes the list of modifications required to perform the proposed low-speed impact tests. However, similar to the modified 1100C impact vehicle, the interior of the pickup truck was removed and safety equipment was installed to protect the operator of the test vehicle. Figure 4.6 shows the interior of the modified vehicle.

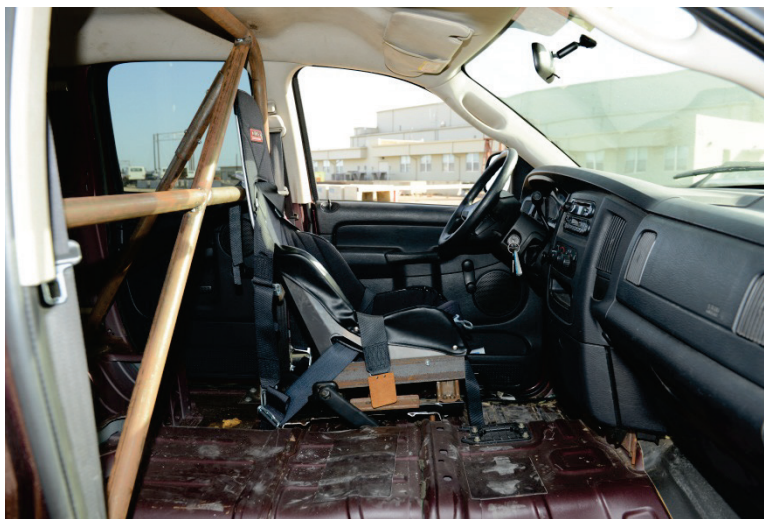
Figure 4.6. 2270P Vehicle Modifications.

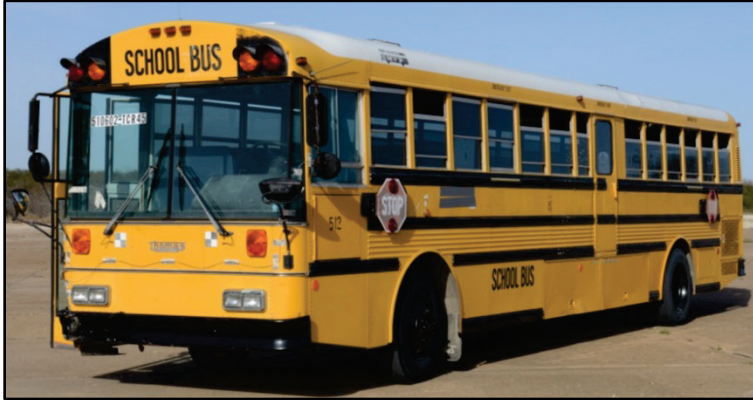
Figure 4.7. Heavy Transit Vehicle.

To replicate a transit class vehicle, a 1996 Thomas School Bus, shown in Figure 4.7, was selected. This vehicle was selected for its rear axle capacity and its low ground clearance (~14 inches). This low ground clearance and high axle weight produces a severe impact condition for delineators. To increase the rear axle weight to 20,000 lb (axle capacity) certain modifications were made to the impacting vehicle. First, all of the seats were removed from the interior of the passenger area of the bus (see Figure 4.8). This made it easier for our mechanic technicians to ballast the impacting vehicle. Another reason this vehicle was selected was due to the rigidity and safety requirements this class of vehicle must meet to transport passengers. Due to these added safety requirements and the low-impact speed, further safety equipment was not deemed necessary to protect the operator of the vehicle. Finally, to bring the rear axle weight up to 20,000 lb, eight barrels (shown in Figure 4.9) were installed in the bus near the rear axle. Each barrel was loaded with sand and weighted approximately 650 lb. The eight barrels were fastened together using two ratchet straps to prevent the ballast from shifting during testing. The final rear axle weight was measured to be 20,050 lb.

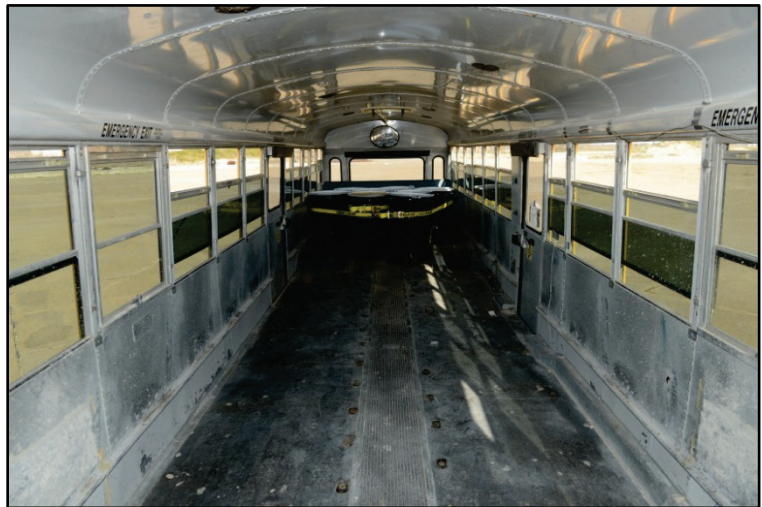
Figure 4.8. Heavy Transit Vehicle Modifications.

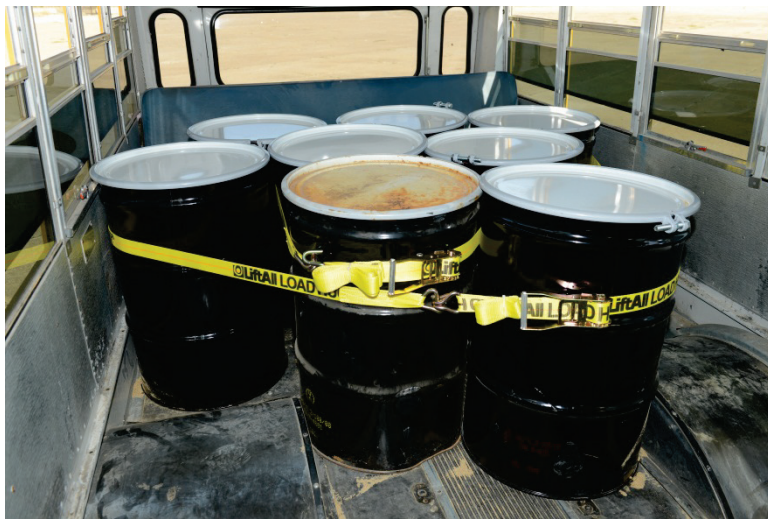
Figure 4.9. Vehicle Ballast.

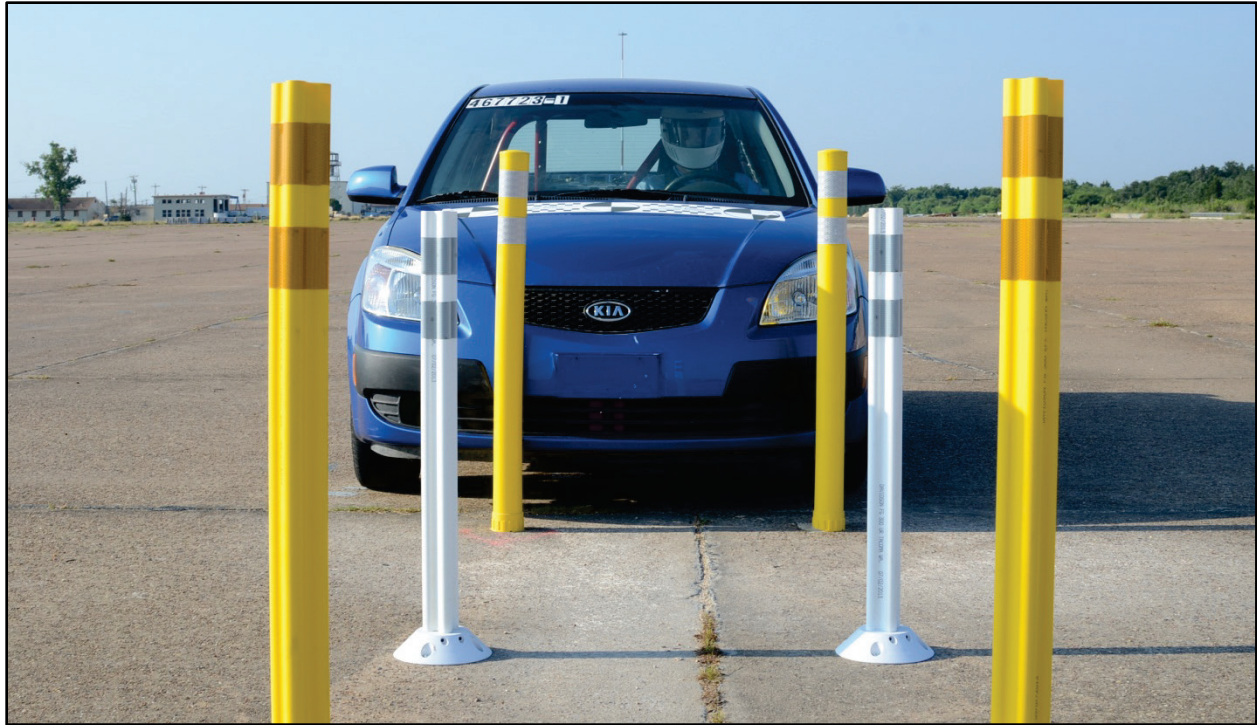
Figure 5.1. 1100C Impact Position before Testing.

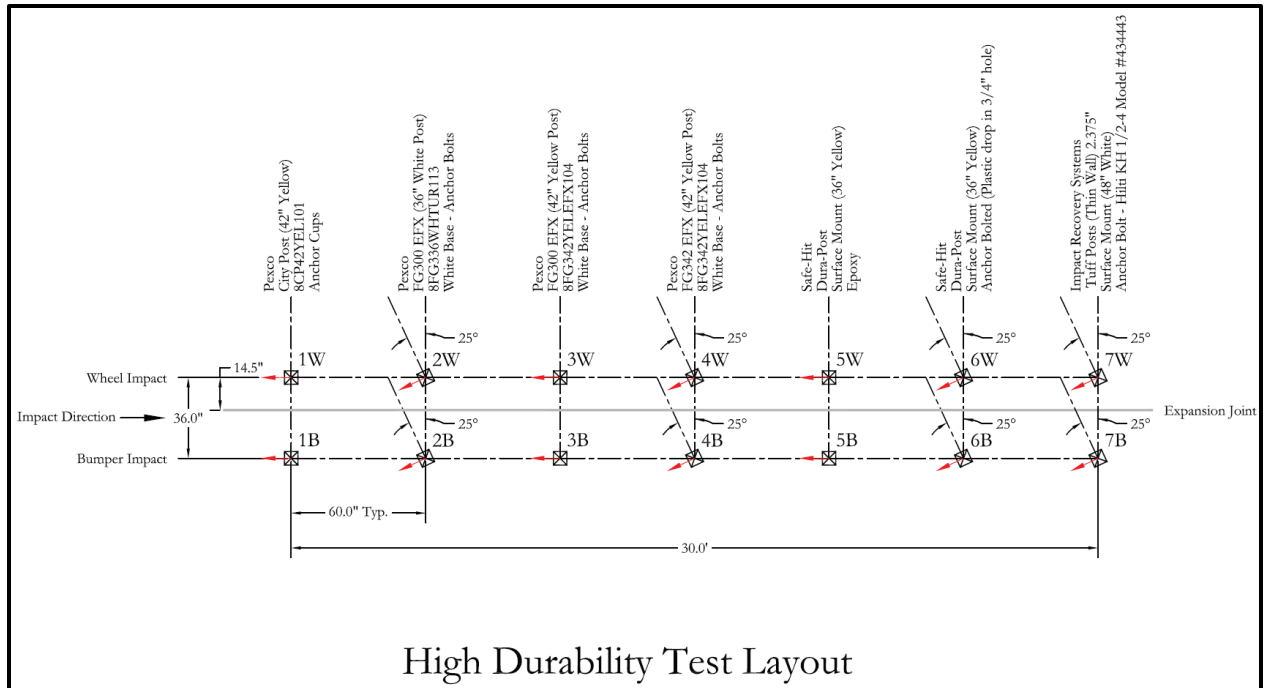
Figure 5.2. High Durability Test Sample Layout.

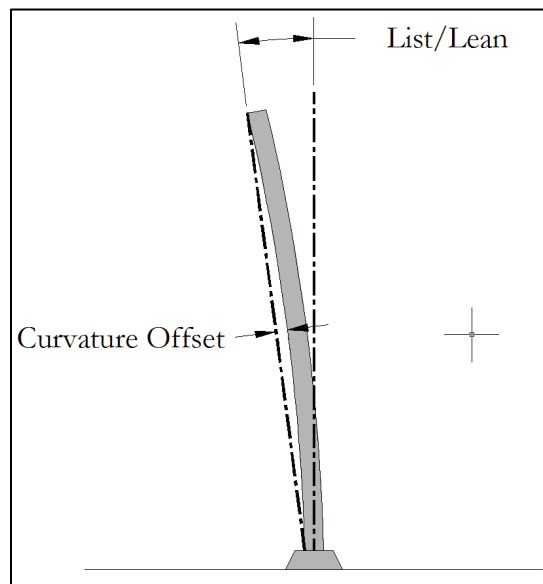
Figure 5.3. Diagram of Measurement Methods.

For this reason, the researchers developed a standard method for measuring list/lean and curvature offset shown in Figure 5.3. The list and lean are measured from the base of the delineator to the top edge of the delineator using a digital level that reads degrees. The curvature offset is measured at the maximum offset from the level in inches. These measurements were taken after the following impact numbers:

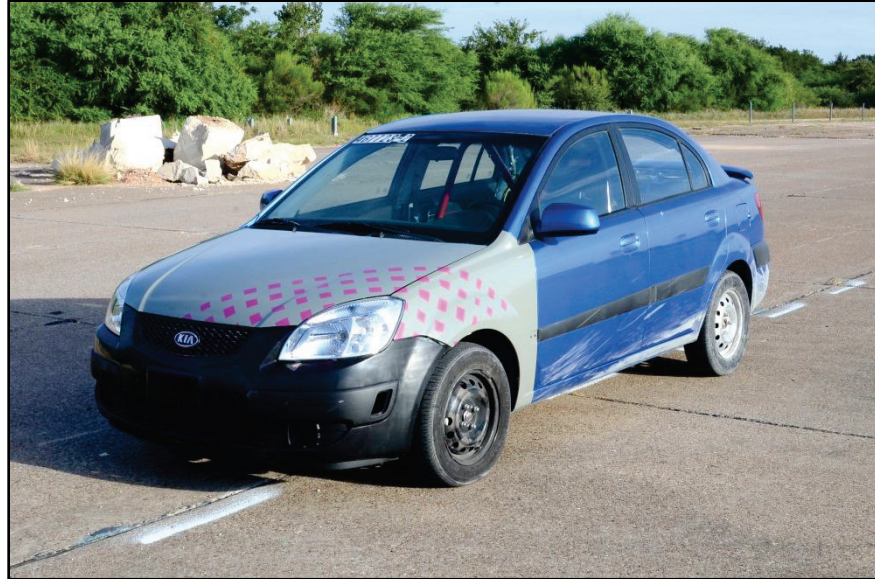
Figure 5.4. 1100C after Being Repaired and before Low Durability Testing.

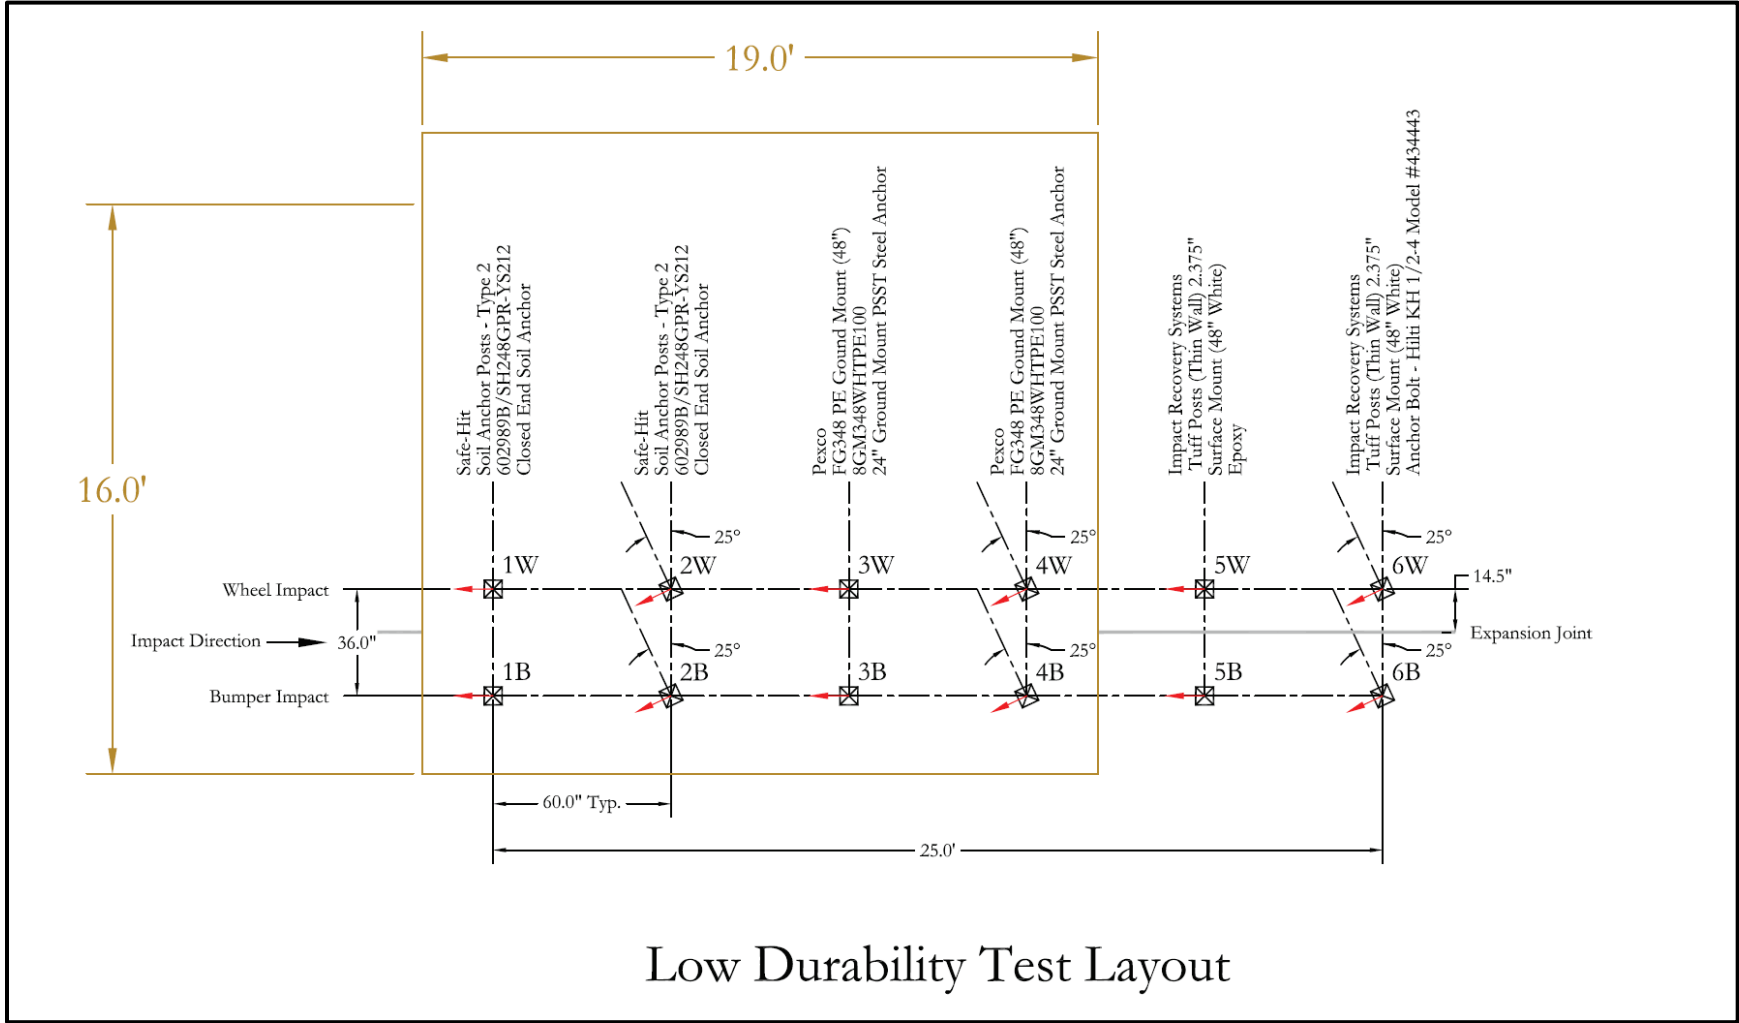
Figure 5.5. Low Durability Test Sample Layout.

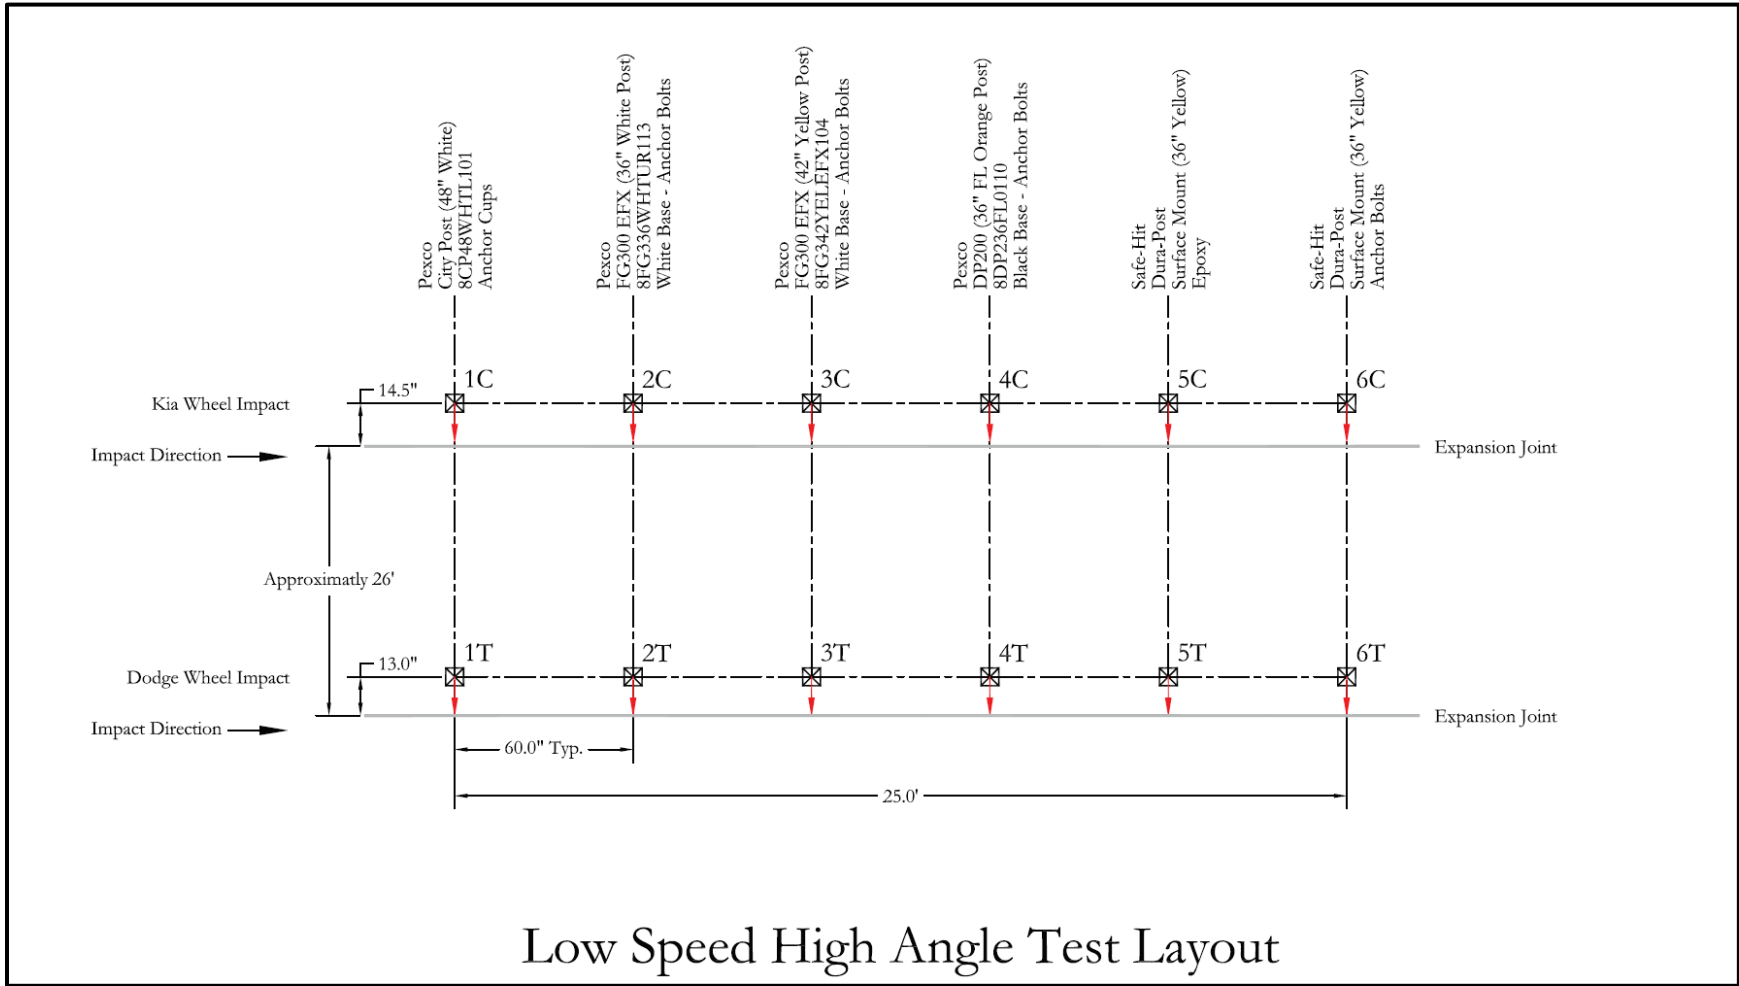
Figure 5.6. Low Speed High Angle Test Sample Layout.

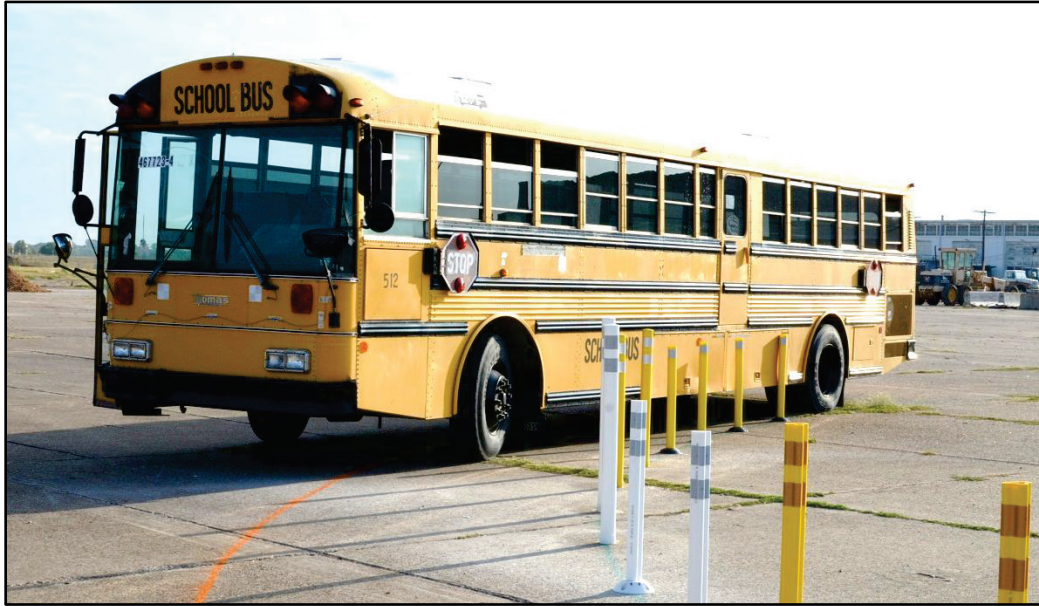
Figure 5.7. Modified Transit Vehicle prior to Impact.

Figure 5.7 shows the modified transit vehicle selected for testing. This vehicle was previously used in a crash test on an unrelated project. None of the vehicle's structural, powertrain, or body components were damaged during the previous testing. The vehicle was aligned such that the driver's side rear tandem tires impacted one row of delineators installed on a 125-foot diameter arc. The test procedure required the delineators be impacted up to 200 times at a speed between 10 mph and 20 mph. Figure 5.8 is a diagram of the test layout. A total of 14 samples were installed in single row. All samples were rotated to align the delineators with the tangent of the circle.

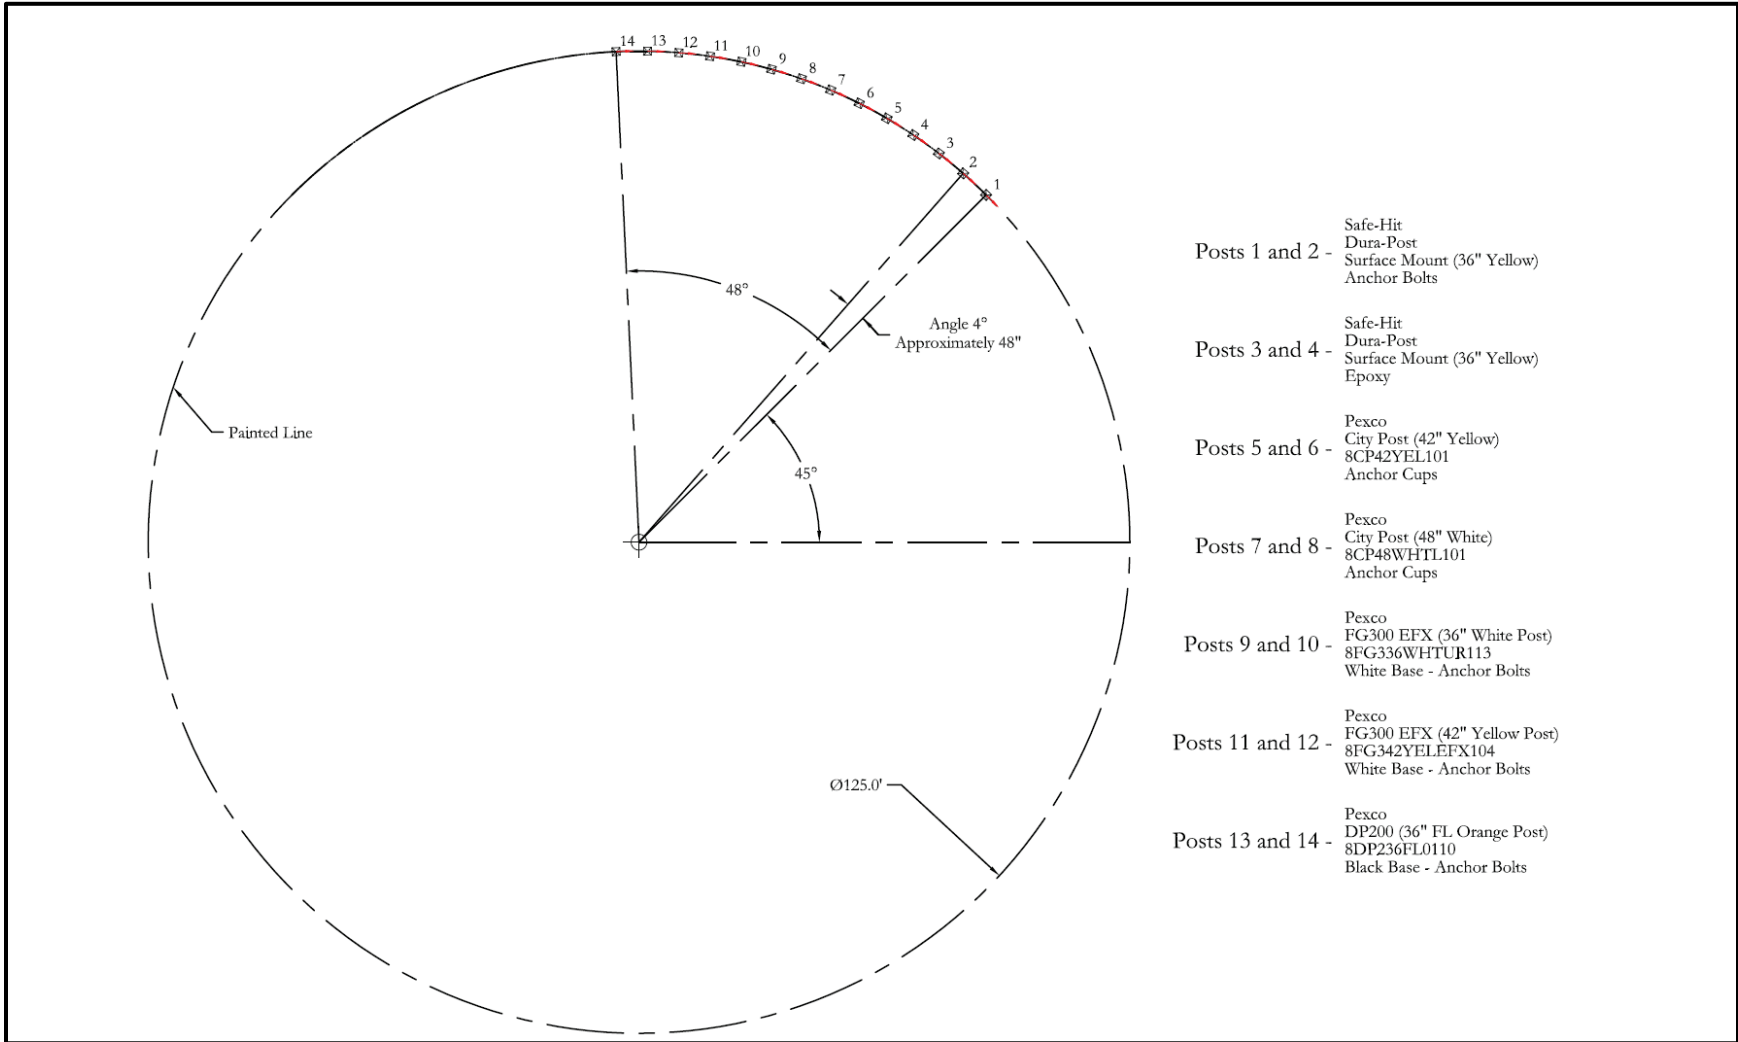
Figure 5.8. Heavy Vehicle Traversal Test Sample Layout.

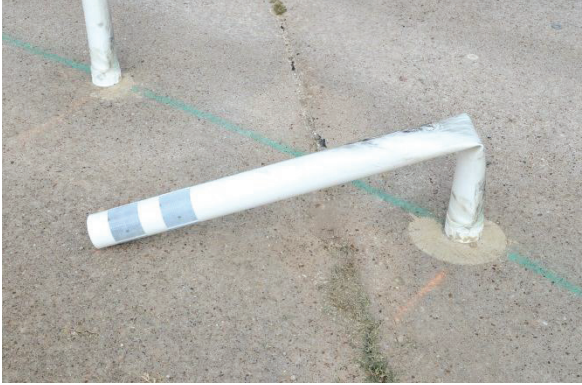
<p>A: Failure to Restore to Upright Position</p>

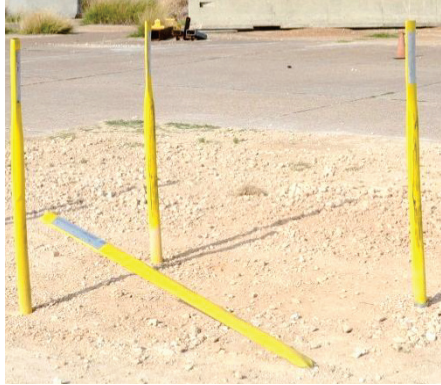
<p>B: Failure to Restore to Upright Position</p>

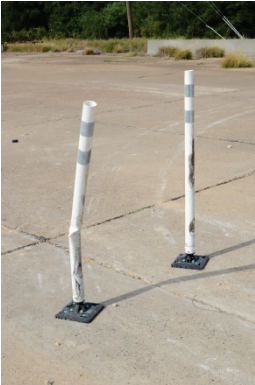
<p>C: Excessive List/Lean/Curvature</p>

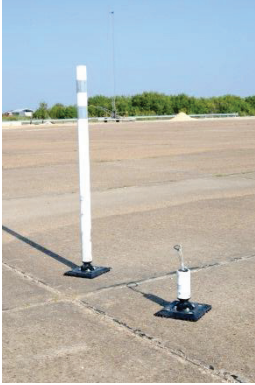
<p>E: Post Rupture</p>

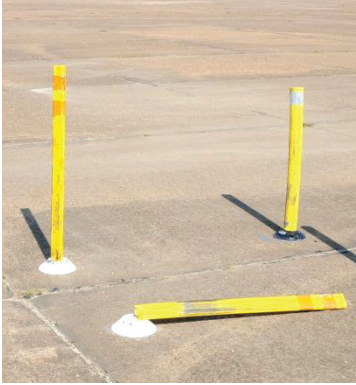
<p>F: Post Rupture (at base)</p>

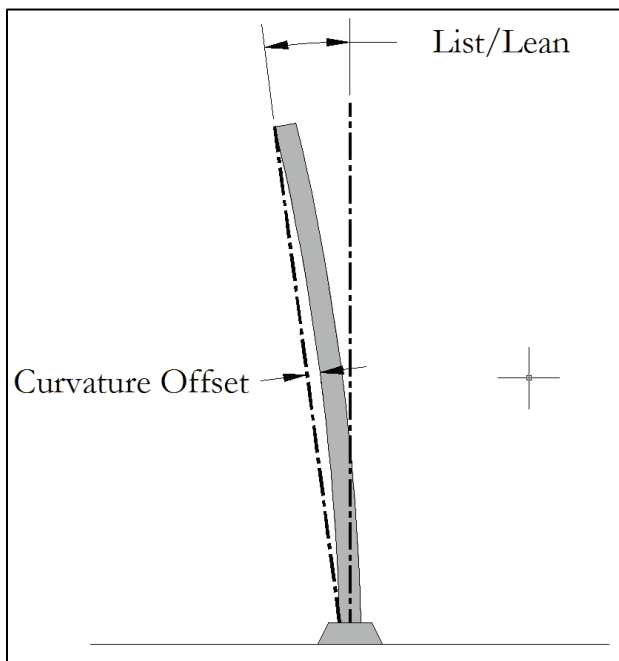
Figure 6.1. Diagram of Measurement Methods.

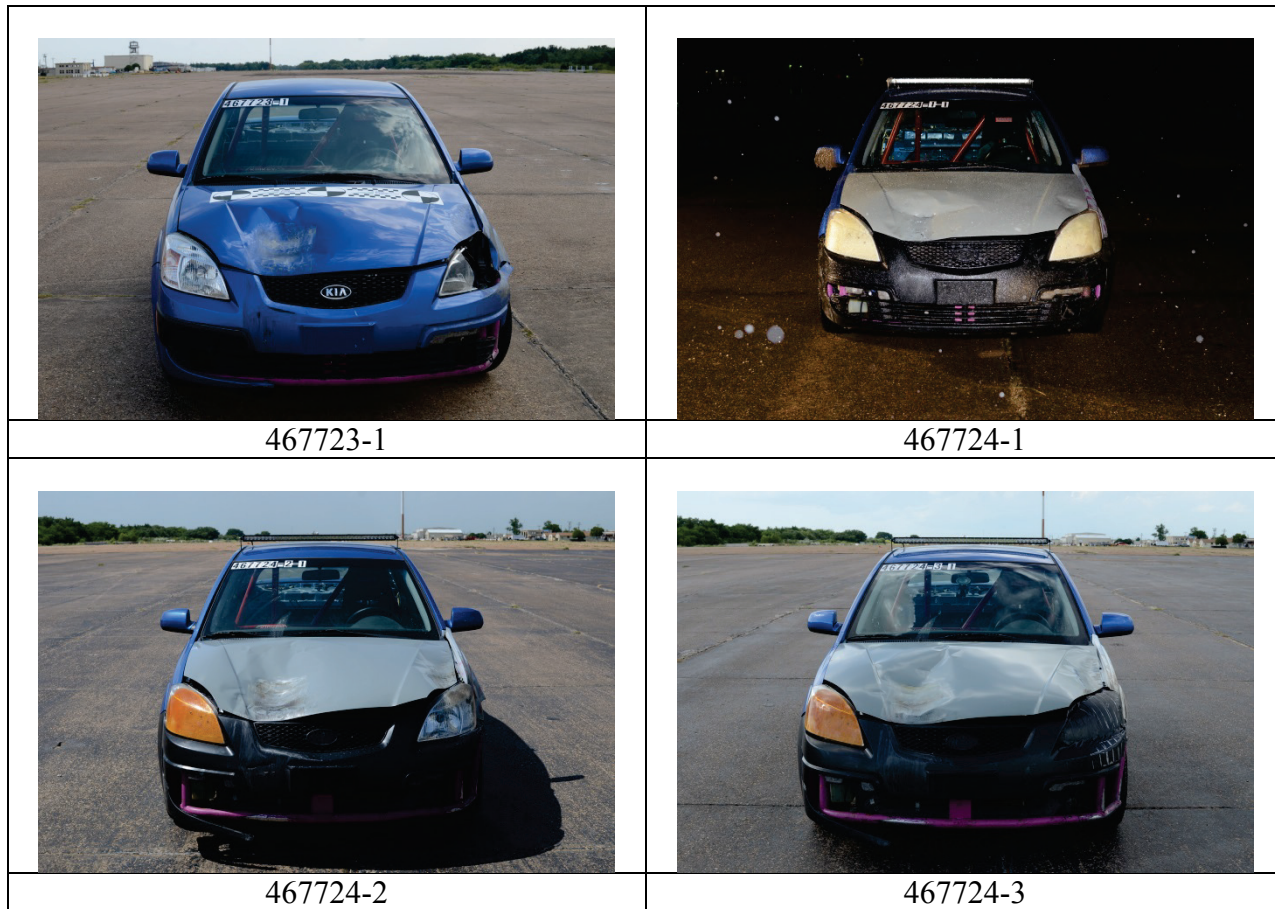
Figure 7.1. Bumper Shell Damage Comparison.

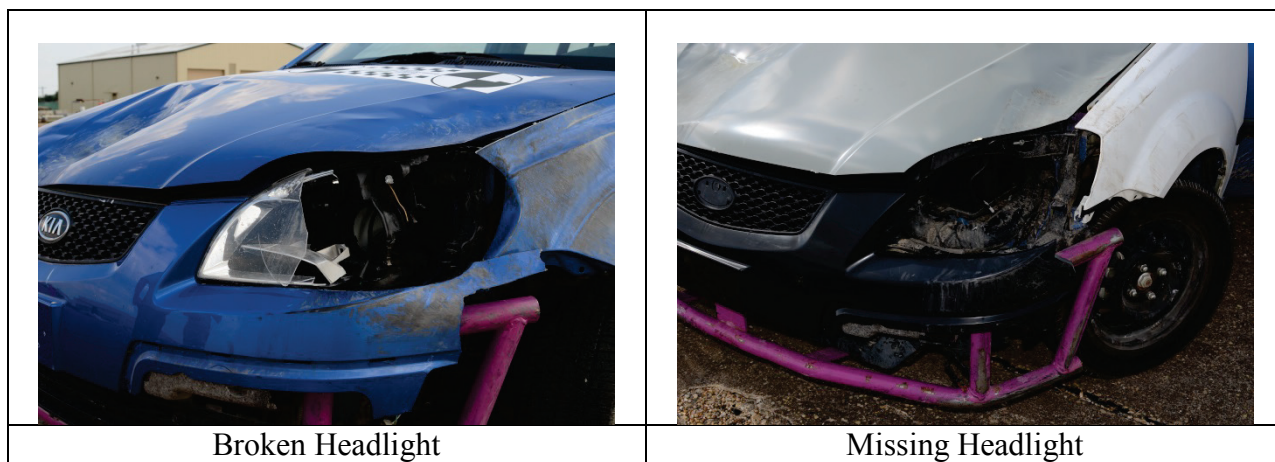
Figure 7.2. Headlamp Damage.

Two different failure modes of the headlamp were witnessed during the impact testing of delineators. The first was the failure of the lens itself due to repeated delineator impacts. The second was the failure of the mounting points for the headlamp. In this case, the intact headlamp was ripped from the vehicle by the repeated delineator impacts. Images of both failure modes can be found in Figure 7.2. The researchers felt this was a significant change in the geometry of the impacting vehicle and felt that this problem needed to be addressed to prevent it from occurring in future testing.

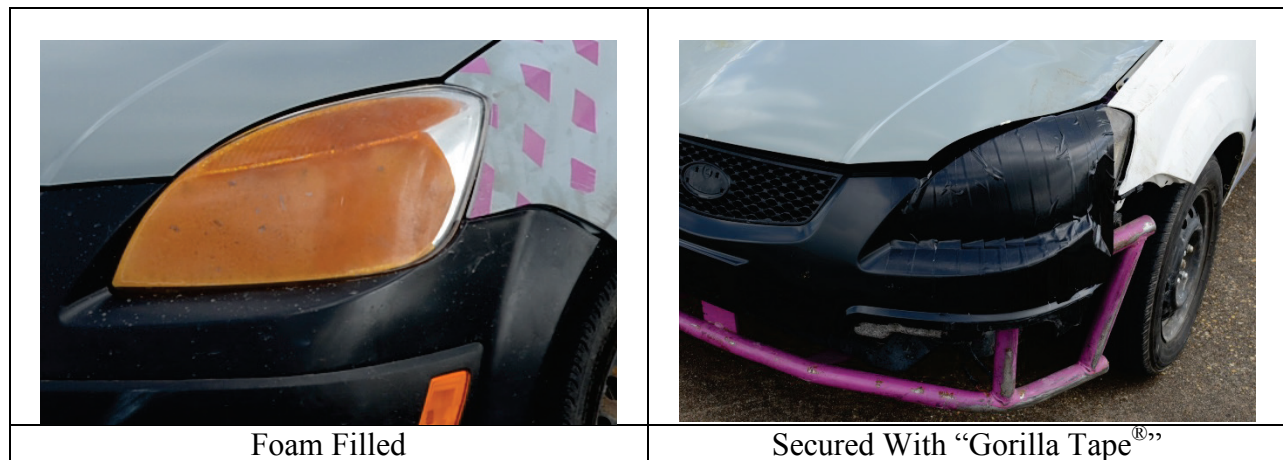
Figure 7.3. Headlamp Modifications.

lens from fracturing. This solved the fracture problem; however, in later testing the intact headlamp was knocked free of its supports by the impacting delineator. The headlamp was first replaced using its original mounting screws, but the failure mode repeated itself. To address this issue, the headlamp was secured to the body and bumper shell using a layer of black “Gorilla Tape[®].” An image of the modification can be found in Figure 7.3. The use of the layer of “Gorilla Tape” did not seem to affect the performance of the delineator impacted by the tire. It is the recommendation that these two methods of modifications be utilized in all future testing to provide a consistent and repeatable impact test.

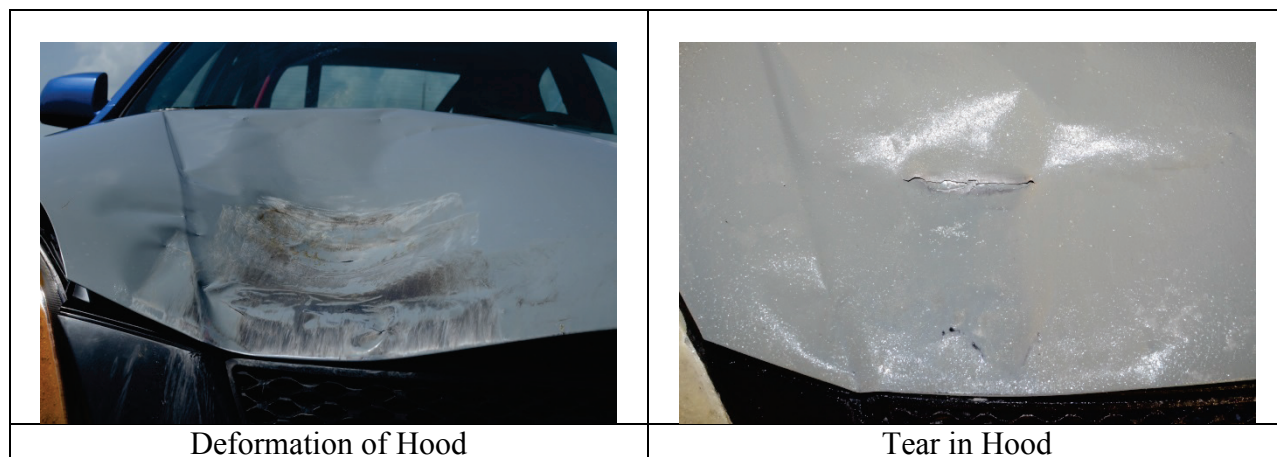
Figure 7.4. Hood Damage.

While the damage to the hood was significant, it did not seem to change the performance of the delineator. The researchers did investigate possible methods of strengthening the hood. The researchers took the strict stance that they did not want to change the surface of the hood or change its deflection characteristics significantly. The researchers did not want to stiffen the hood too much for fear of making the simulated impact too severe when compared to a “real world” impact. Upon investigation, the researchers found that most of the supporting structure under the hood in the front of the vehicle was made from plastic. This, coupled with the tight spaces under the hood, makes creating a support structure (similar to the bumper modification) very problematic. One idea that was tested includes filling voids within the hood with expanding foam (fire resistant), as shown in Figure 7.5. While this did seem to help the performance of the hood, the researchers are not sure the minor added capacity is worth the cost of using the foam.

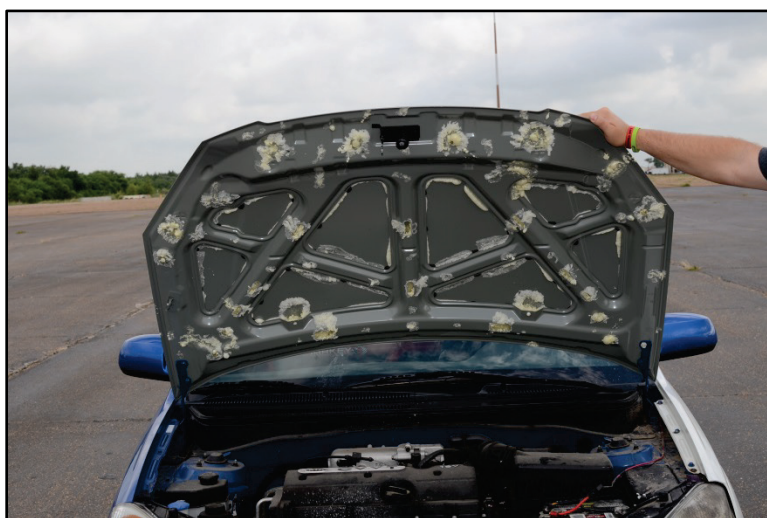
Figure 7.5. Hood Modification.

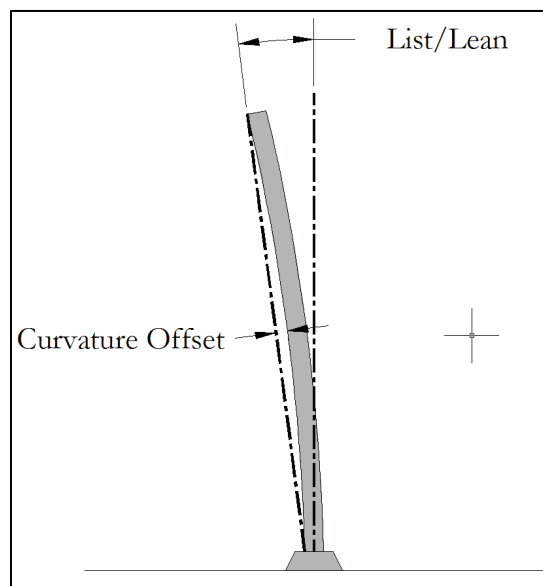
Figure 8.1. Diagram of Measurement Methods.

Testing and evaluation under this project showed that list and lean generally remained unchanged throughout testing until just before failure. The researchers noted that a delineator would fail soon after reaching a list or lean greater than 15° . For this reason, the researchers recommend a maximum angle (in any direction) of 15° .
