DEVELOPMENT OF DELINEATOR TESTING STANDARD

Test Report No. 0-6772-1

**TEXAS A&M TRANSPORTATION INSTITUTE
COLLEGE STATION, TEXAS**

TEXAS DEPARTMENT OF TRANSPORTATION

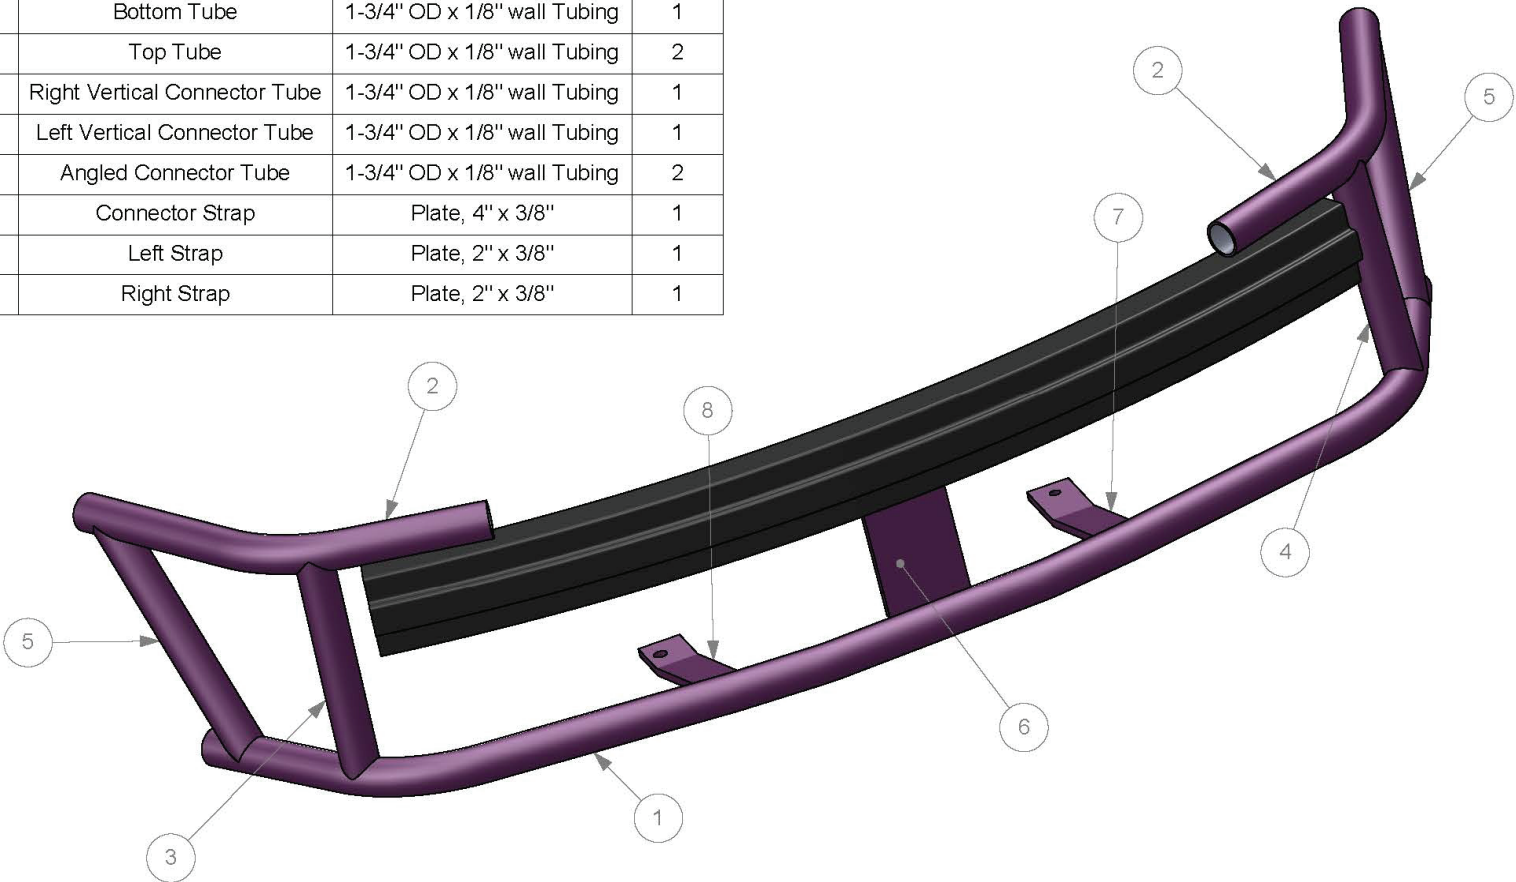
Project 467723	Kia for Delineator Tests	2013-02-20
Drawn By GES	Scale 1:7	Sheet 1 of 4 Iso View

GRILL GUARD PARTS			
#	NAME	TYPE	QTY.
1	Bottom Tube	1-3/4" OD x 1/8" wall Tubing	1
2	Top Tube	1-3/4" OD x 1/8" wall Tubing	2
3	Right Vertical Connector Tube	1-3/4" OD x 1/8" wall Tubing	1
4	Left Vertical Connector Tube	1-3/4" OD x 1/8" wall Tubing	1
5	Angled Connector Tube	1-3/4" OD x 1/8" wall Tubing	2
6	Connector Strap	Plate, 4" x 3/8"	1
7	Left Strap	Plate, 2" x 3/8"	1
8	Right Strap	Plate, 2" x 3/8"	1
