**VERMONT AGENCY OF TRANSPORTATION**

**EVALUATION OF THE EFFECTIVENESS OF CENTERLINE  
RUMBLE STRIPES ON RURAL ROADS**

**Report 2015 – 07**

Reporting on RAC SPR-714

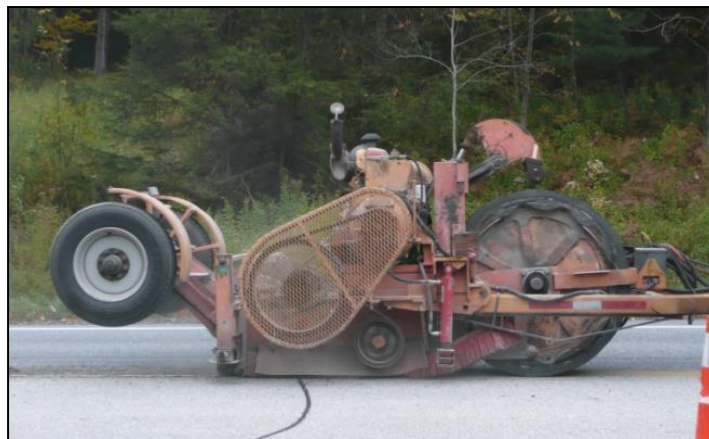
**Figure 5: Milling machine.**

The entire length of the rumble stripes was completed by Thomas Grinding on Friday, October 9th, 2009, with the milling machine shown in Figure 5 and Figure 6. Weather conditions were overcast and the air temperature was 50°F. After the milling machine ground the stripes, the stripes were swept by BD Sweeping. All sweeping operations were conducted directly after milling, shown in Figure 7. Figure 8 shows the rumble stripes after milling and sweeping processes finished.

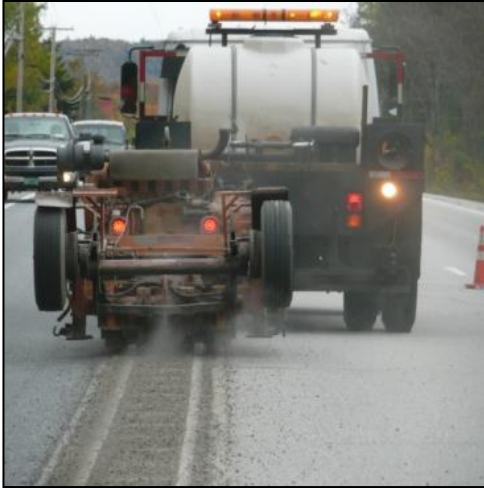
**Figure 6: Milling machine**

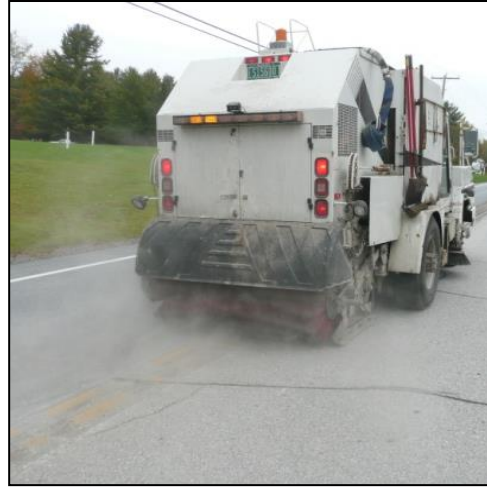
**Figure 7: Street sweeper**

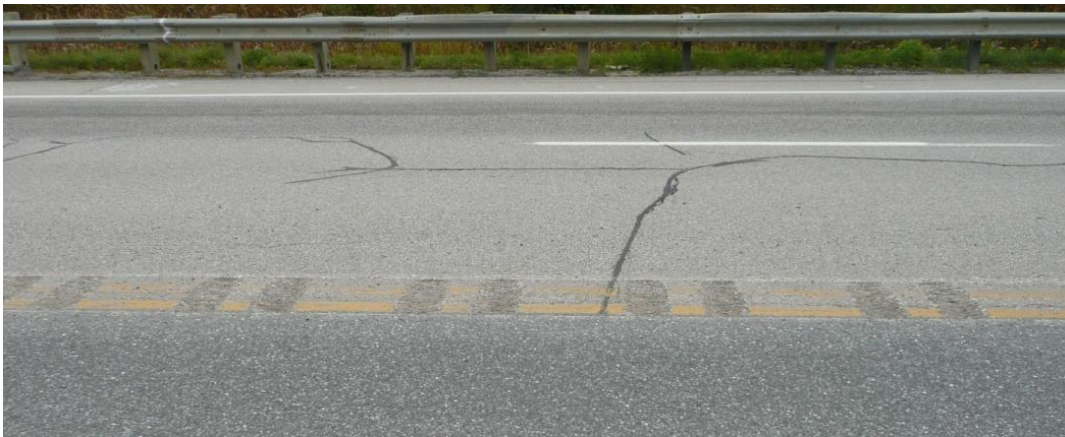
**Figure 8: Rumble stripes after milling and sweeping.**

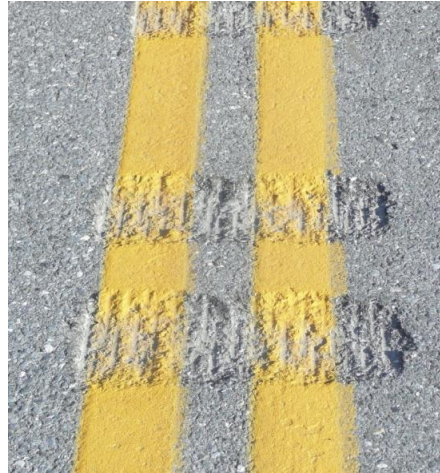
**Figure 9: Centerline rumble stripes approximately one month after installation in Mendon, VT.**

L&D Safety Markings Corporation completed all pavement marking striping operations on Monday, October 12. According to [www.wunderground.com](http://www.wunderground.com), weather conditions were recorded as clear with a mean temperature of 38°F; the temperature was approximately 45°F at noon (11). Research personnel were unable to be onsite for striping operations therefore no photographs were taken, however photos were taken at the first site visit following installation (See Figure 9).

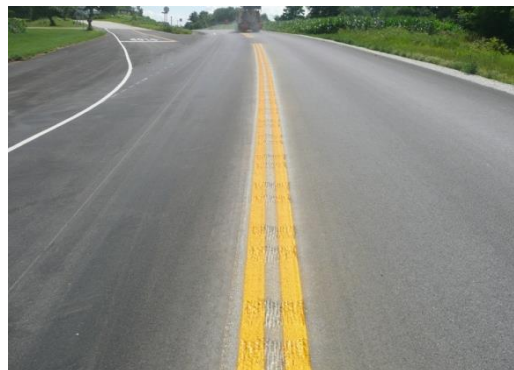
**Figure 10: Centerline rumble stripes immediately after painting in Sheldon, VT.**

In an attempt to extend the duration for retroreflectivity of the polyurea durable pavement markings, L&D Safety Markings Corporation recessed along the centerline for the pavement markings on Monday, July 12, 2010 and Tuesday, July 13, 2010. The subcontractor then milled the rumbles on Monday, July 19, 2010 from MM 5.200 to 11.015. The rumble stripes were then swept and the subcontractor applied polyurea along the centerline on Wednesday, July 21, 2010. According to [www.wunderground.com](http://www.wunderground.com), weather conditions were recorded as clear with a mean temperature of 70°F; the temperature was approximately 81°F at noon (11). The centerline rumble stripes are shown in Figure 10.
