Rapid Replacement of Bridge Deck Expansion Joints Study – Phase I

**Interim Report
December 2014**

Sponsored by
Iowa Department of Transportation
Federal Highway Administration
(InTrans Project 13-451)

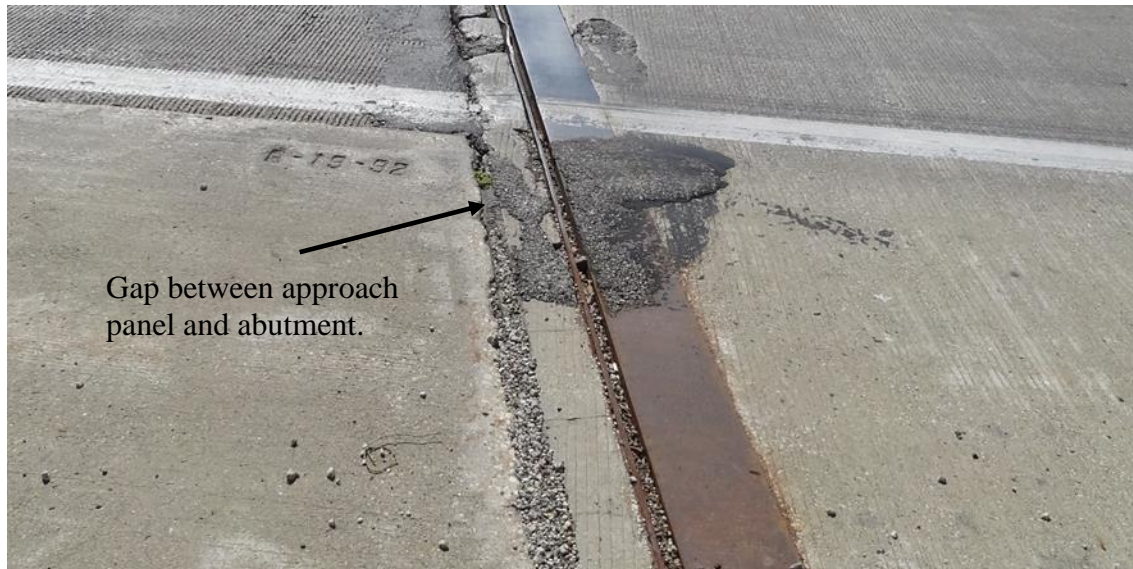
Figure 2.2. Gap forming between top of abutment and approach panel on the I-80 over I-35 west abutment

There are a few signs of an immobile joint that is pulling free from the abutment. The first sign is a gap gradually forming between the top of the abutment and the approach slab as shown in Figure 2.2.

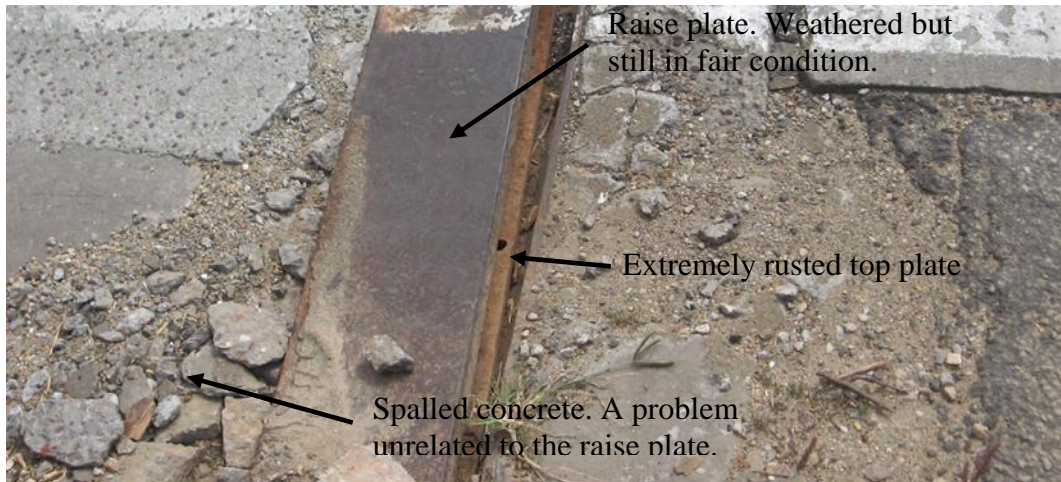
Figure 2.3. Rusty top plate beneath a raise plate showing relatively good condition on westbound US 20 over Catfish Creek in Cedar Rapids, Iowa

Years later, the original top plates are now beginning to fatigue, but the damage is hidden under a raise plate that usually appears to be in relatively good condition. This can be seen in Figure 2.3 (before replacement), where a badly rusted top plate can be viewed beneath a top plate showing relatively good conditions.

The portion shown is along the shoulder section of the highway. The top plate had come loose previously and been removed across the entire two lanes of traffic of the joint.

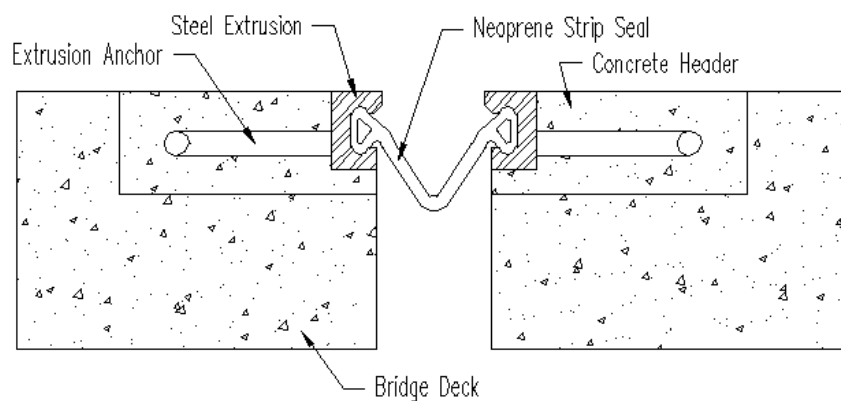
Figure 2.5. Strip seal joint

Strip seal and compression seal expansion joints are separate styles of joints that utilize a gland to prevent the passage of water through the expansion joint. In particular, a strip seal joint includes a gland, generally neoprene, that is mechanically locked in place through the use of steel extrusions embedded in the concrete header on either side of the expansion joint. An example of a strip seal joint is shown in Figure 2.5.

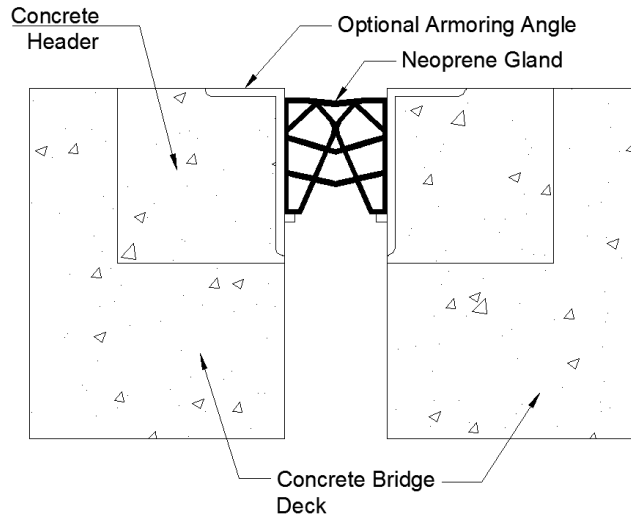
Figure 2.6. Compression seal joint

A compression seal is forced into place and uses the compressive force from the bridge deck to remain in place as seen in Figure 2.6.

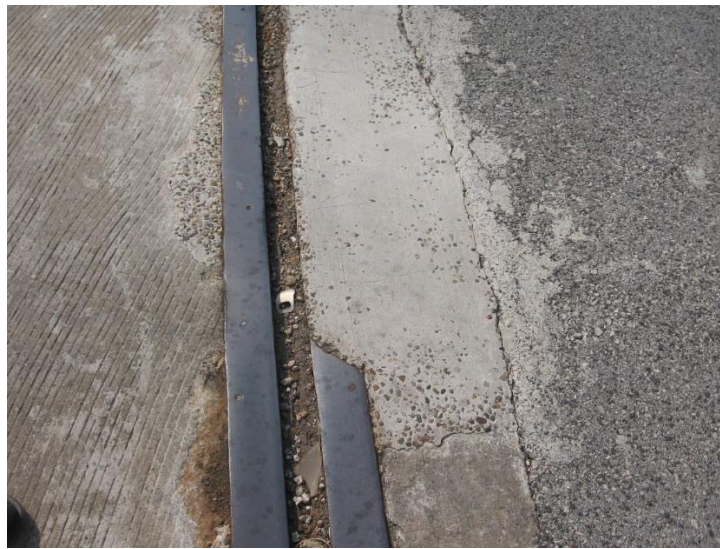
Figure 2.9. Compression seal joint with failed section of armoring

Broken sections of compression seal armoring are fixed much in the same way that sliding plate joints are fixed, by replacing the broken armoring, and any loose concrete, with new concrete to provide a flat, smooth riding surface. In this situation, compression seals have the advantage of still maintaining a well-functioning seal provided the concrete header is still largely in good condition and there is no damage to the neoprene gland. The steel armoring is merely present to protect the concrete edge and increase the durability of the joint. The armoring does not actually contribute to the ability of a joint to be watertight or accommodate expansion and contraction. This type of repair is shown in Figure 2.9

These repairs tend to be completed in several hours as there is no major removal of concrete involved. The longest schedule element is the required cure time for the new concrete.

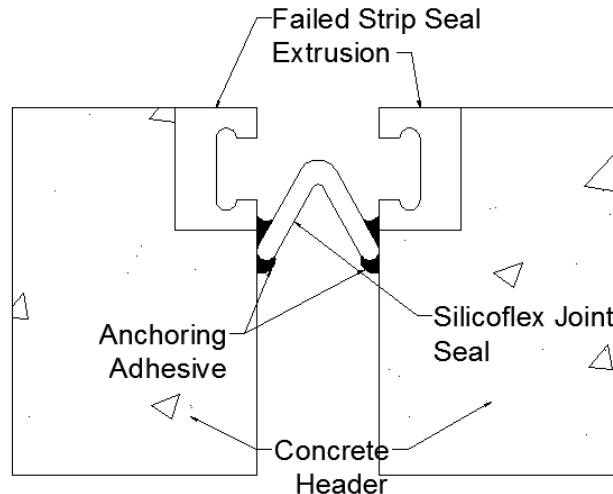
Figure 2.10. Silicoflex expansion joint example

Recently, the Iowa DOT has been experimenting with the use of a Silicoflex joint sealing system from R.J. Watson, Inc. as a repair measure for damaged expansion joints. A Silicoflex seal is essentially an inverted strip seal held in place by an adhesive instead of an extrusion. The use of an adhesive makes Silicoflex ideal for joint repairs involving damaged strip seal extrusion sections. An example of a repair done with a Silicoflex Joint is shown in Figure 2.10.

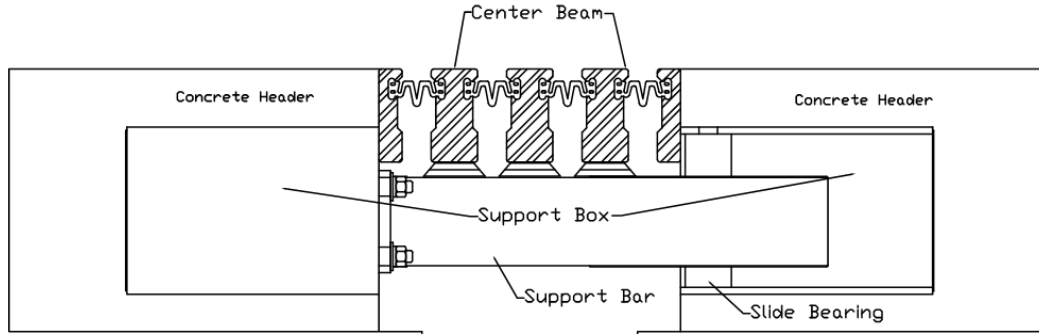
Figure 2.11. Modular expansion joint

Finger joints and modular expansion joints are styles used by the Iowa DOT for large expansion distances, typically greater than 5 inches. Finger joints, as the name suggests, are designed as a series of interlocking steel fingers used to transfer traffic across the joint. Modular expansion joints are essentially a series of strip seal joints supported by steel support bars placed parallel to traffic as shown in Figure 2.11.

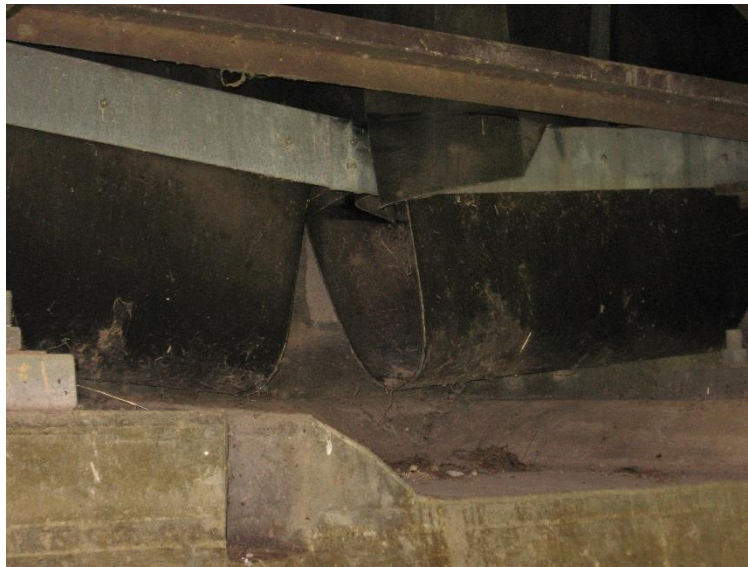
Figure 2.12. Neoprene trough below finger expansion joint

The one major disadvantage of finger joints is that they are not watertight and, thus, typically require that neoprene troughs be installed below the joint to catch the water and debris that flow through the joint and divert them from the structural members. Problems with finger joints can usually stem from this neoprene trough. The first problem with these troughs is associated with the neoprene tearing near the trough anchors to the bridge deck, which allows the trough to fall loose. This was said to be particularly prevalent near the end of the winter months due to ice building up in the troughs. Snow and ice on top of the roadway melts during the day and then freezes again at night. However, in the shaded parts beneath the bridge deck, the ice doesn't melt, forming heavier and heavier loads that can eventually tear the trough loose.

Another problem relating to these troughs is the flow of water. Where strip seal, compression seal, and modular joints prevent water from passing through the joint entirely, finger joints merely divert the water after it flows through the joint. Some troughs divert water away from the center of the abutment, while a neoprene trough below a finger expansion joint, as shown in Figure 2.12, diverts water to a catch basin at the center of the footing.

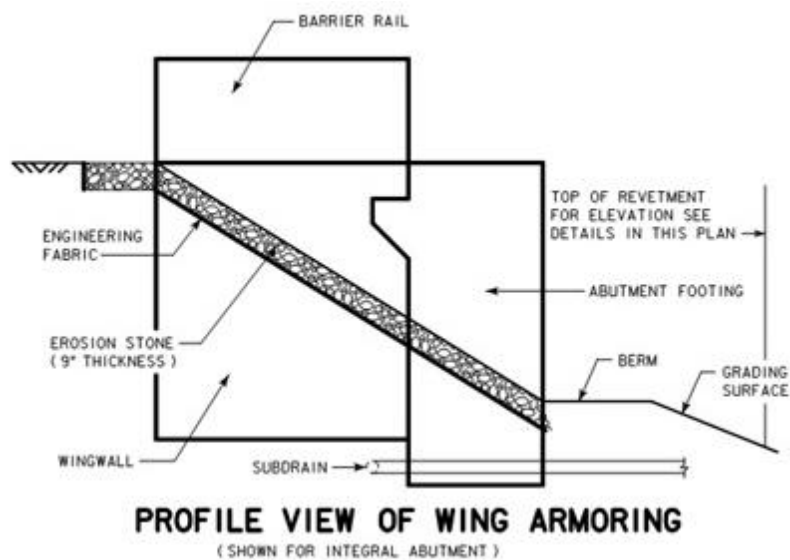
Figure 2.15. New Iowa DOT standard detail for wing wall armoring

This erosion problem is known to Iowa DOT staff who are currently working on implementing a new detail for wing armoring on bridges. The detail for new bridges includes a bed of erosion stone atop a layer of engineering fabric atop the compacted subgrade and following the slope of the subgrade. This layer of stone should act as a drain allowing the runoff to quickly flow around the abutment and footing without eroding the supporting soils. A profile view of this new detail is shown in Figure 2.15. Erosion is repaired in the same fashion as it is for finger joints. Eroded soil is replaced, compacted, and monitored for any future problems.

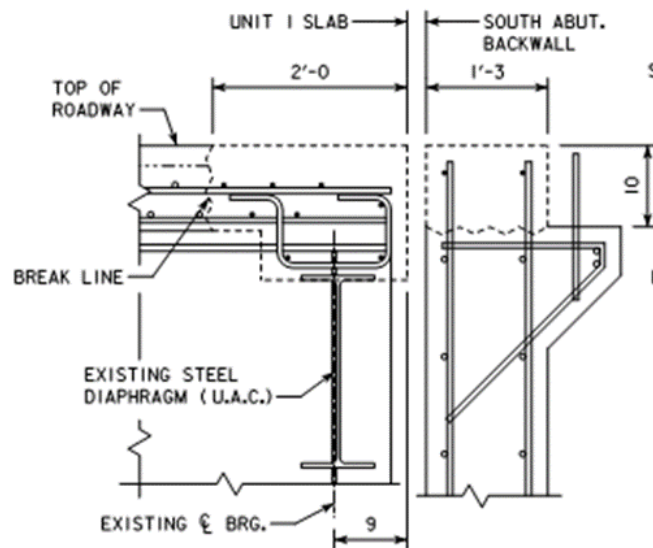
Figure 3.3 Typical I-380 concrete removal cross section

The old sliding plate joint was to be replaced with a new strip seal expansion joint. Concrete removal would consist of the top of the backwall from the existing riding surface to the top of the paving notch and the end two feet of roadway concrete (see Figure 3.3).

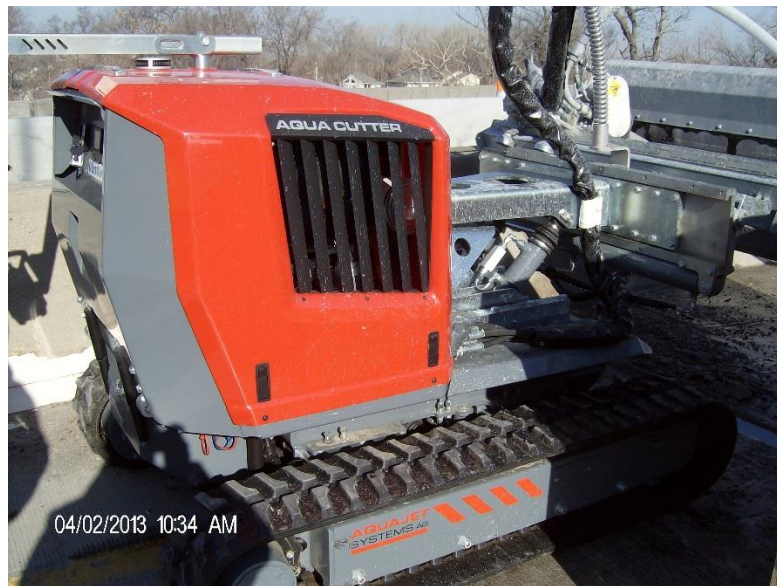
Figure 3.4 Aqua Cutter hydrodemolition machine

Equipment mobilization began shortly after traffic was completely rerouted, which was about an hour into the project. This job was unique in that the contractor utilized hydrodemolition for the majority of the concrete removal on Joint A. The contractor utilized an Aqua Cutter from Aquajet Systems AB, similar to the one shown in Figure 3.4.

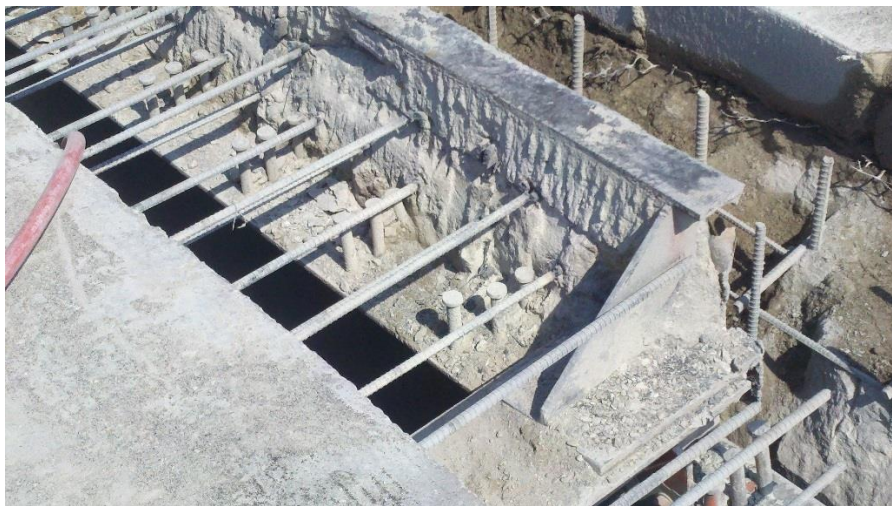
Figure 3.5. Joint A after hydrodemolition

The aqua cutter had a demolition width of about 5 ft. After completing the removal between the required limits, the machine was moved to the side, realigned with the previous sections of demolition, and restarted. Hydrodemolition of Joint A took place for about 14 hours (see Figure 3.5).

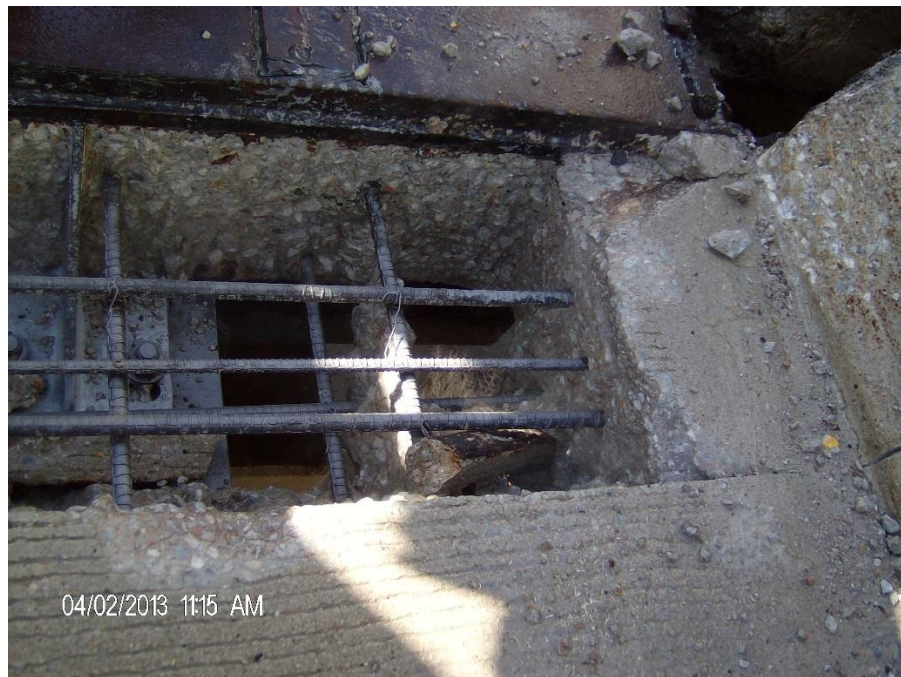
Figure 3.6 Concrete remaining after hydrodemolition

The aqua cutter was capable of removing most, but not all, of the concrete necessary to replace the joint. In particular, the aqua cutter could not remove the concrete within about 8 in. of the curb, as well as the curb itself. While not of concern to this project, this area near the curb may

be larger if the joint is at a skew to the curb. There was also a small section of concrete beneath the existing joint that could not be removed with the aqua cutter (see Figure 3.6).

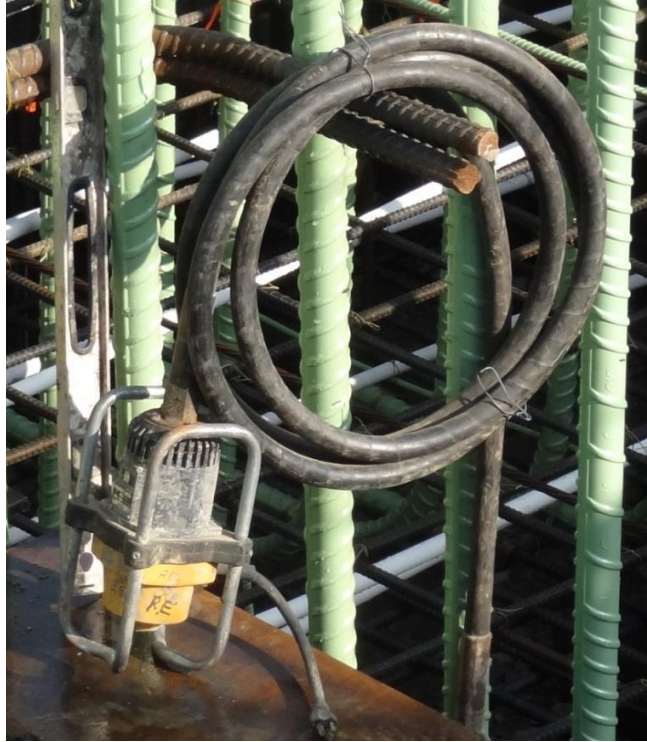
Figure 3.7. Flexible shaft vibratory compactor

The concrete pour was much more organized than the rest of the project and the construction laborers appeared to be very experienced with concrete pours. Immediately before concrete was placed, a thin layer of grout was placed by hand on all existing concrete faces that would adjoin the new concrete. Concrete was then placed directly from the truck into the formwork and vibrated with a flexible shaft vibratory compactor as shown in Figure 3.7.

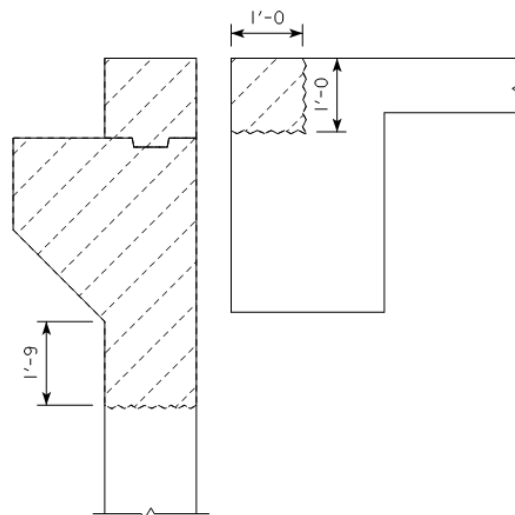
Figure 3.9. Typical US 18 removal cross section

Concrete removal was to consist of a 1-ft by 1-ft square section of concrete on the deck side of the joint along with the removal of the backwall to 1 ft 9in. below the bottom of the existing paving notch (see Figure 3.9).

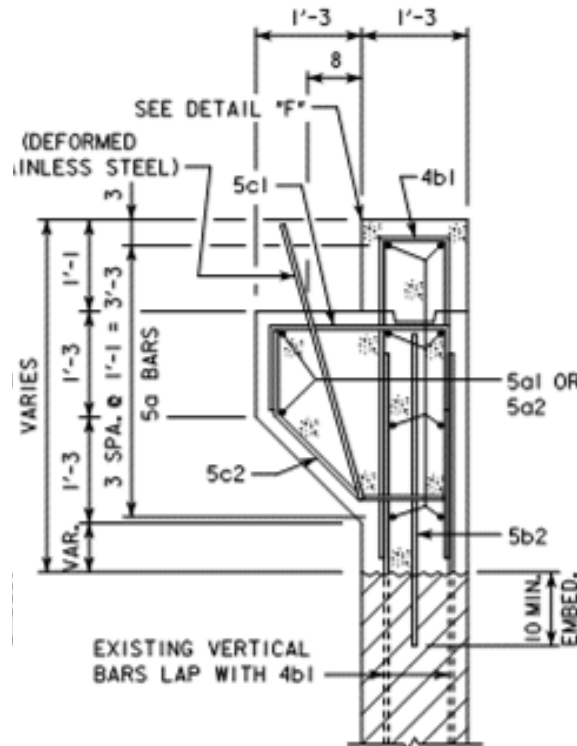
Figure 3.10. Replacement paving notch plan

On the deck side, any embedded longitudinal rebar was to be left in place for lap splices. On the abutment side, any embedded vertical bars were to remain. There was also an additional row of rebar doweled and epoxied into the remaining abutment to provide extra support (see Figure 3.10).

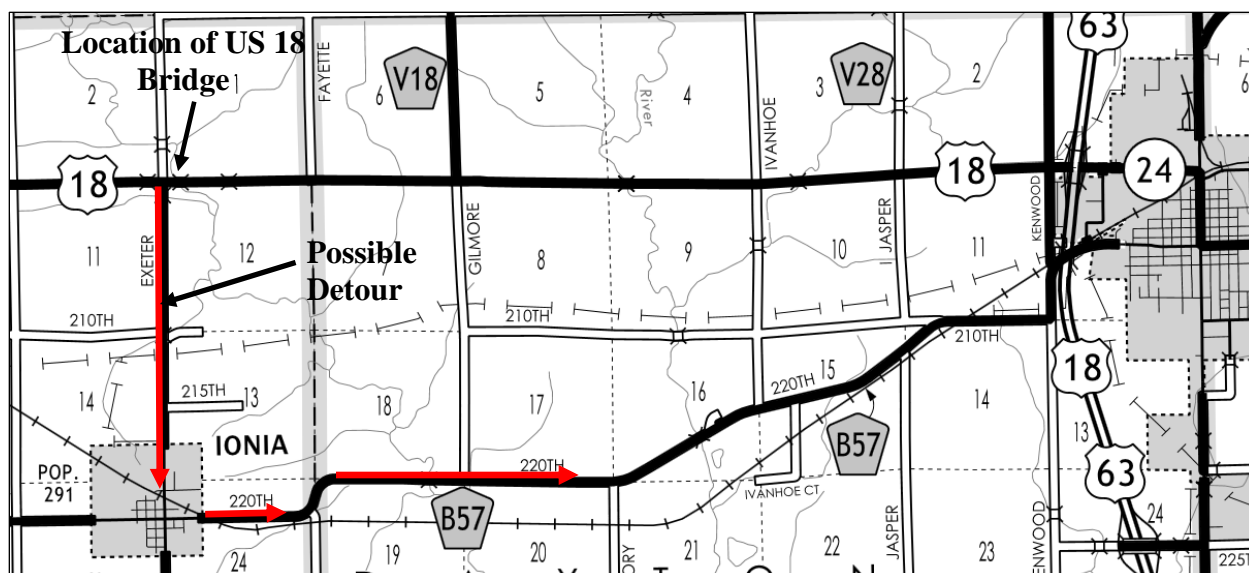
Figure 3.11. US 18 possible detour route

One observation that the research team found key was the use of a staged project instead of a detour to complete the US 18 job. As seen in Figure 3.11, the bridge of interest was only a few hundred feet beyond the intersection of US 18 and Iowa State Route V14 (Exeter Ave). This would be about a 2.5 mile detour to Iowa County Highway B57 that would meet US 18 in New Hampton, Iowa.
