Assessment of Asphalt Interlayer Designed on Jointed Concrete

Final Report
November 2014

IOWA STATE UNIVERSITY
Institute for Transportation

Sponsored by
Iowa Department of Transportation
(InTrans Project 13-475)
Federal Highway Administration

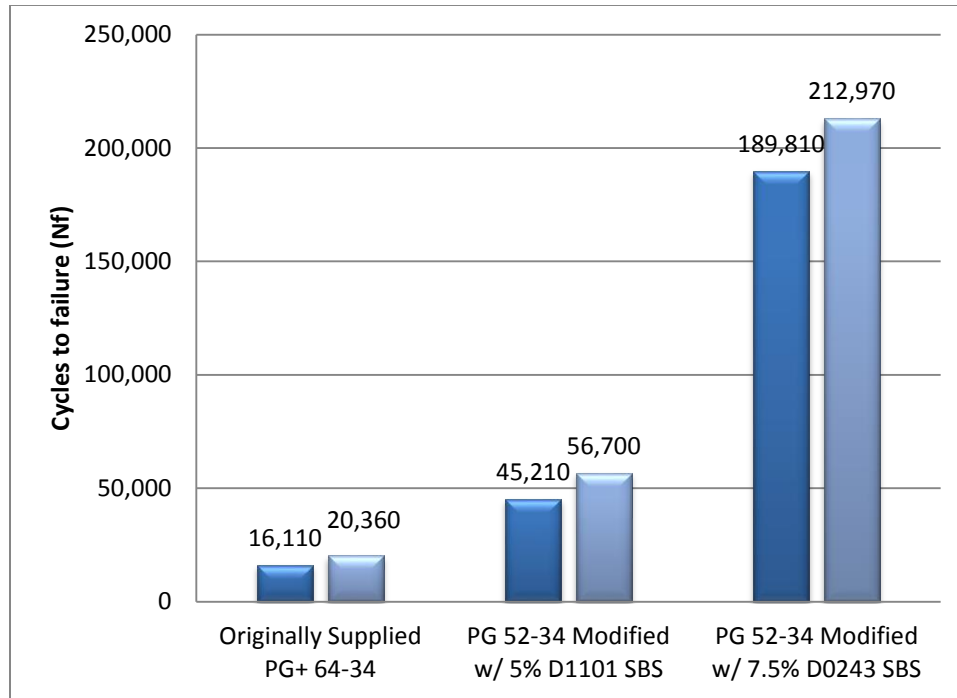
The initial binder supplied during the mix design phase, supplied by Bituminous Materials in Tama, Iowa, contained two percent poly(styrene-butadiene-styrene), or SBS polymer. Initial performance testing of the mix design at Iowa State (discussed in the next section) indicated the mix did not meet the four-point bending beam testing requirements of passing 100,000 load cycles (Figure 2).

Figure 2. Four-point bending beam results on different interlayer mixes

The asphalt mix design using the high-polymer modified binder passed the 100,000 load cycle requirement in the four-point bending beam (Figure 2). A regression analysis of the flexural stiffness data was performed in accordance with AASHTO T-321 on each of the two beams that were tested (Figures 3 and 4).

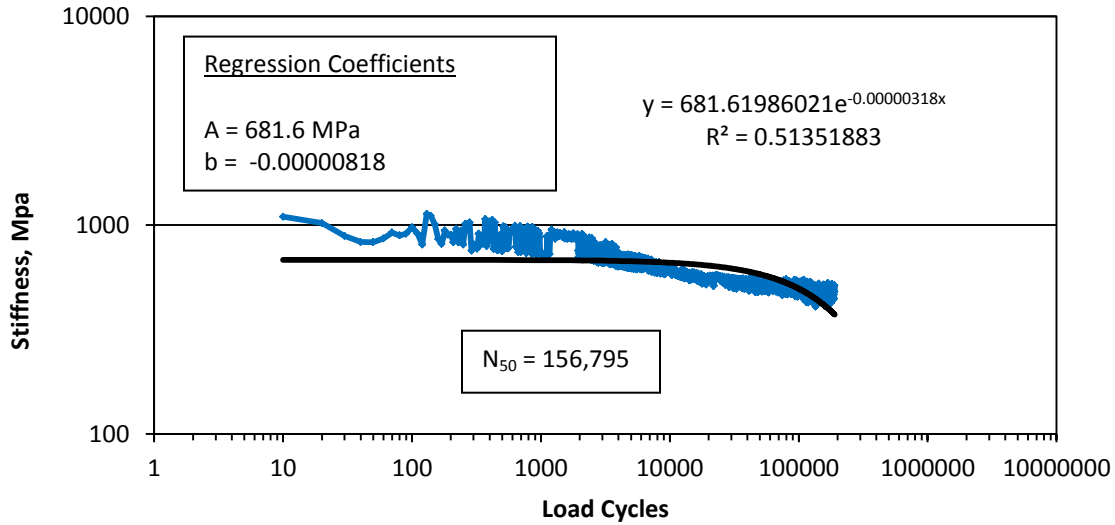
Figure 3. Stiffness versus load cycles (repetitions), beam-1

For the two beam samples tested, both the number of load cycles and the regressed failure number of load cycles exceeded the minimum fatigue life of 100,000 load cycles. The average regressed failure load cycles for the two beams was 244,623. Once the mix design with the 7.5 percent polymer modified binder passed the four-point bending beam results, the interlayer was approved by the Iowa DOT for paving.

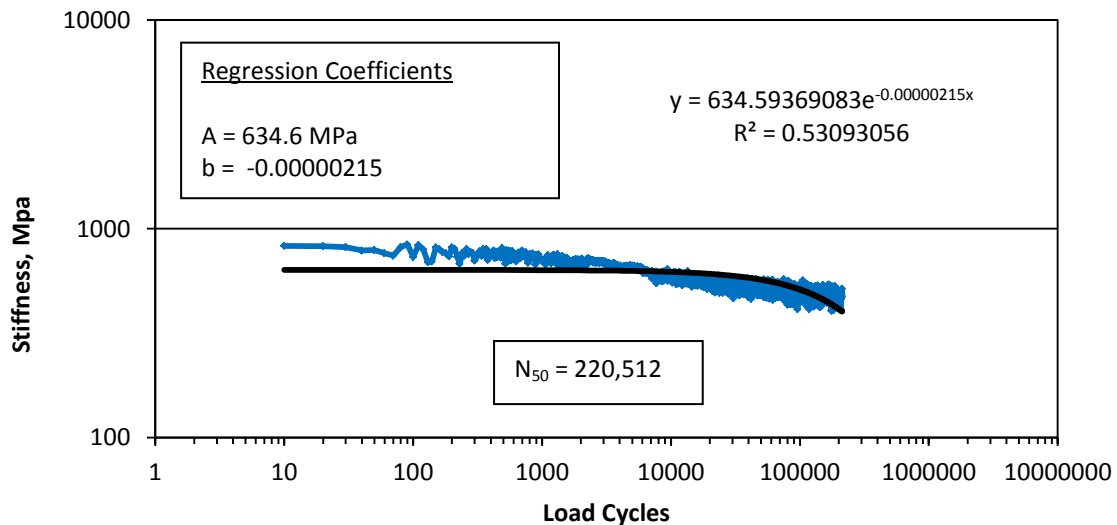
Figure 4. Stiffness versus load cycles (repetitions), beam-2

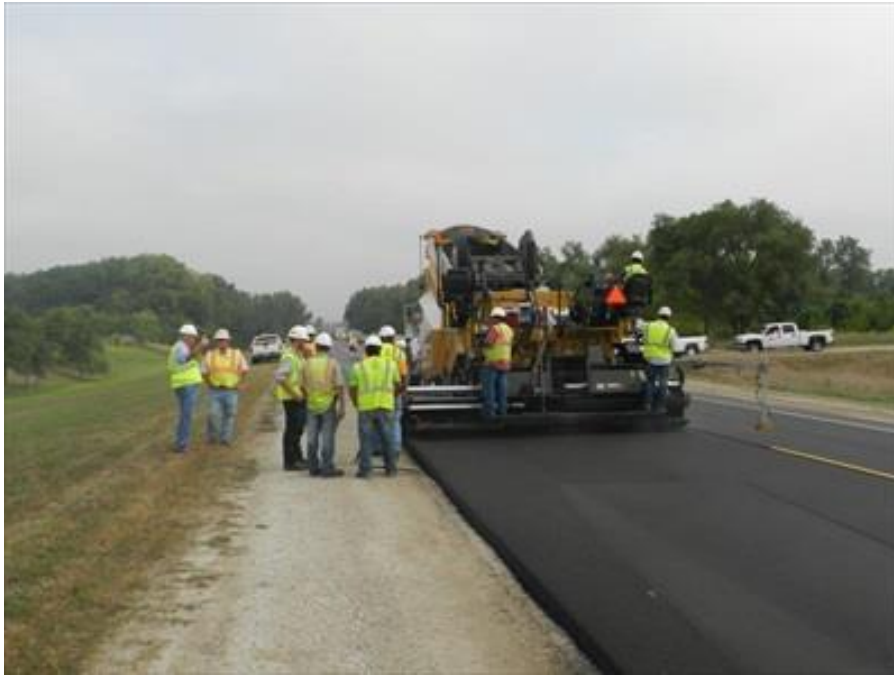
Construction of the interlayer was completed by Des Moines Asphalt and Paving on August 23, 2013 (Figure 5).

Figure 5. Interlayer paving on US 169

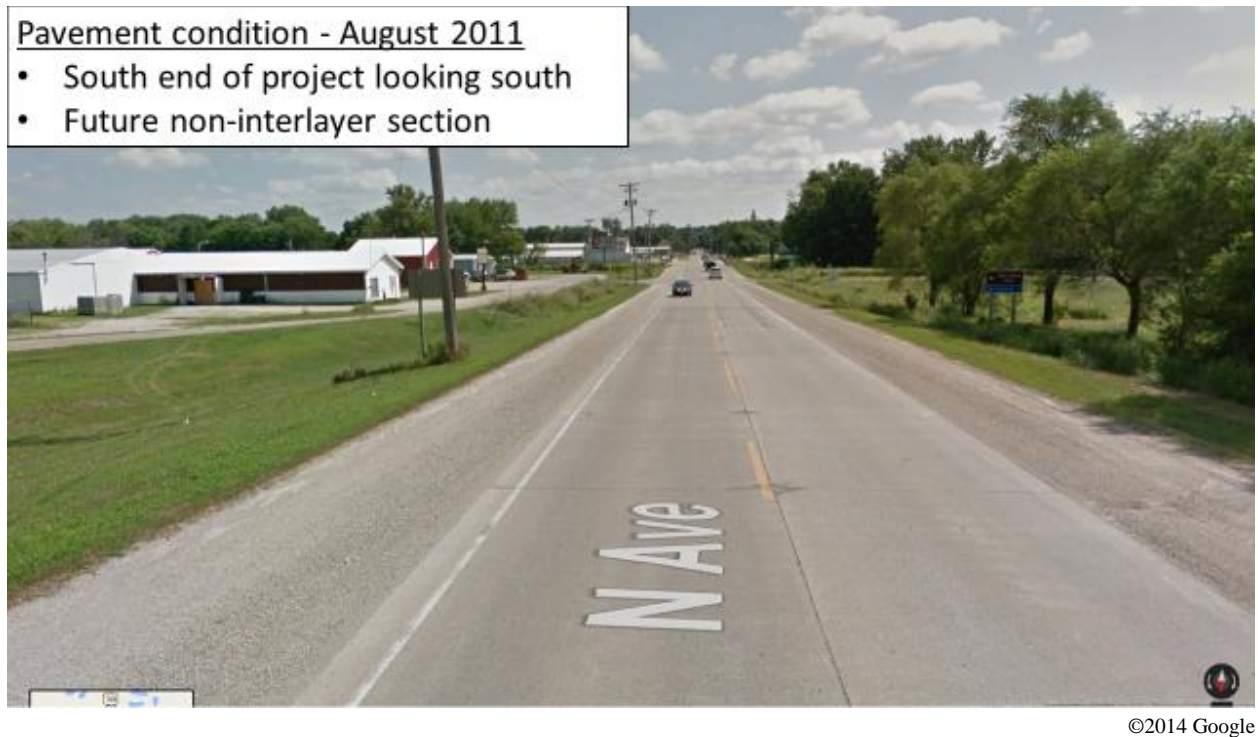
Figure 8. Pre-construction view of non-interlayer section on US 169

Transverse and longitudinal joint deterioration can be seen in the screen capture. Joint deterioration of this magnitude is the primary cause of reflective cracking in HMA overlays, thereby, making this overlay project a perfect candidate to evaluate the effectiveness of a crack-relief interlayer.

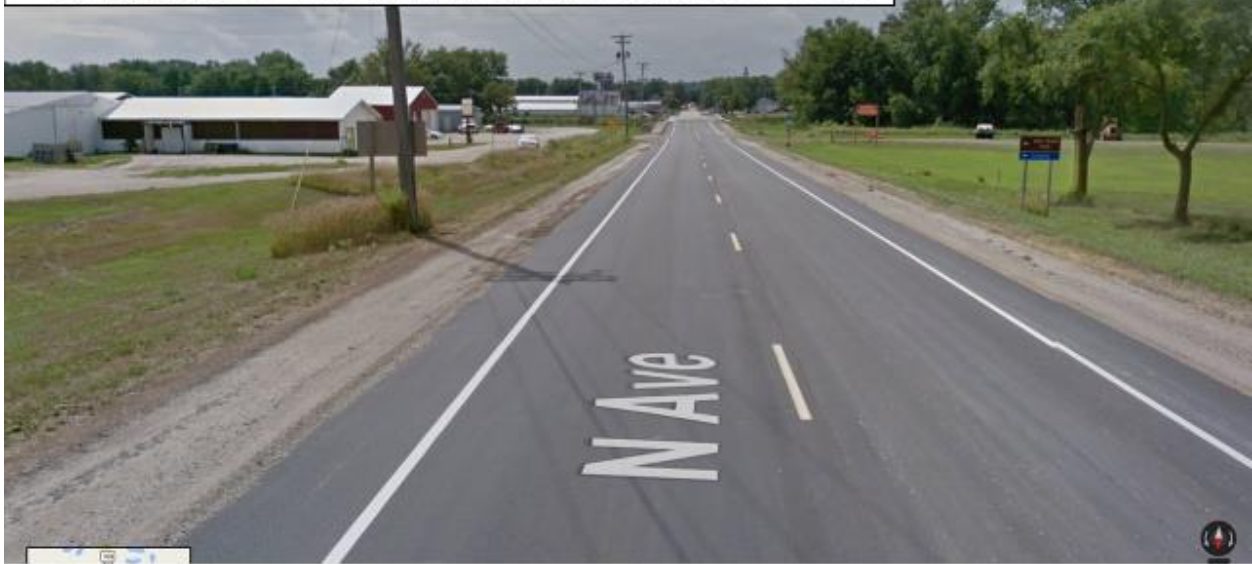
Figure 9. Post-construction view of intermediate course in non-interlayer section on US 169

In the non-interlayer pavement section, the intermediate course overlay is two inches thick. The screen capture shows the intermediate HMA course to be in good condition.

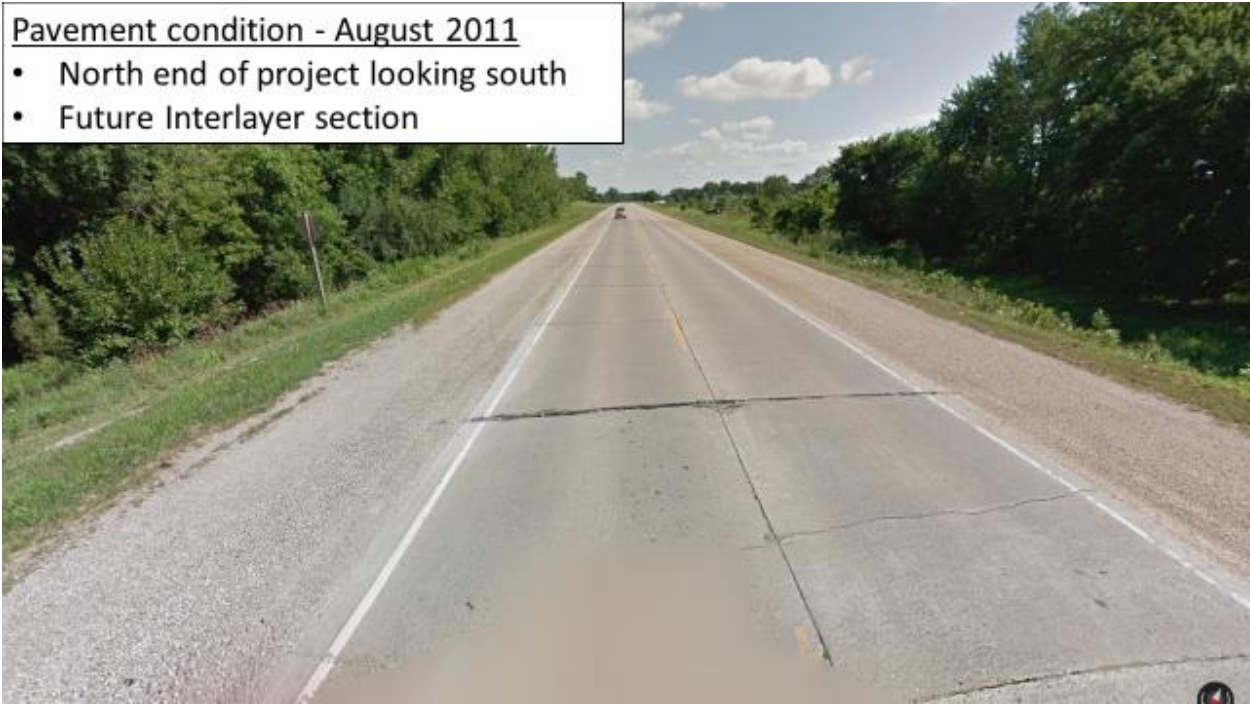
Figure 10. Pre-construction view of interlayer overlay section on US 169

In Figure 10, a high level of joint deterioration can be seen in the future interlayer section. And unlike the non-interlayer section, the intermediate course is already cracking in the same construction season (Figure 11). The difference between the two different overlay sections is the thickness of the intermediate course. The intermediate course in the interlayer section was only one inch thick, not two inches thick, to provide room for the interlayer. This demonstrates just how quickly reflective cracks form in thin overlays (one inches) and is precisely the reason why overlays for distressed PCC pavements are designed to have a certain minimum thickness. In the case of this project, the overlay thickness design was four inches. However, by waiting several weeks between construction of the intermediate course and the surface course, the one-inch course was thin enough to crack prior to paving the second lift.

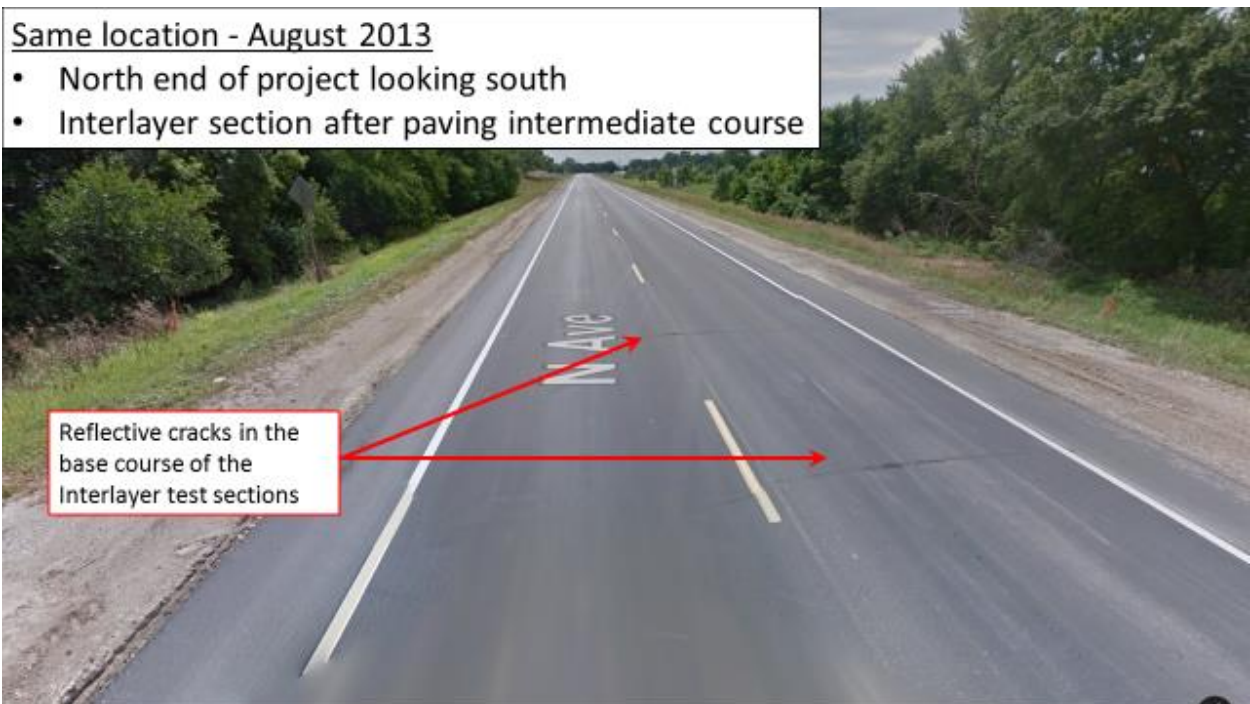
Figure 11. Post-construction view of intermediate course in interlayer section on US 169

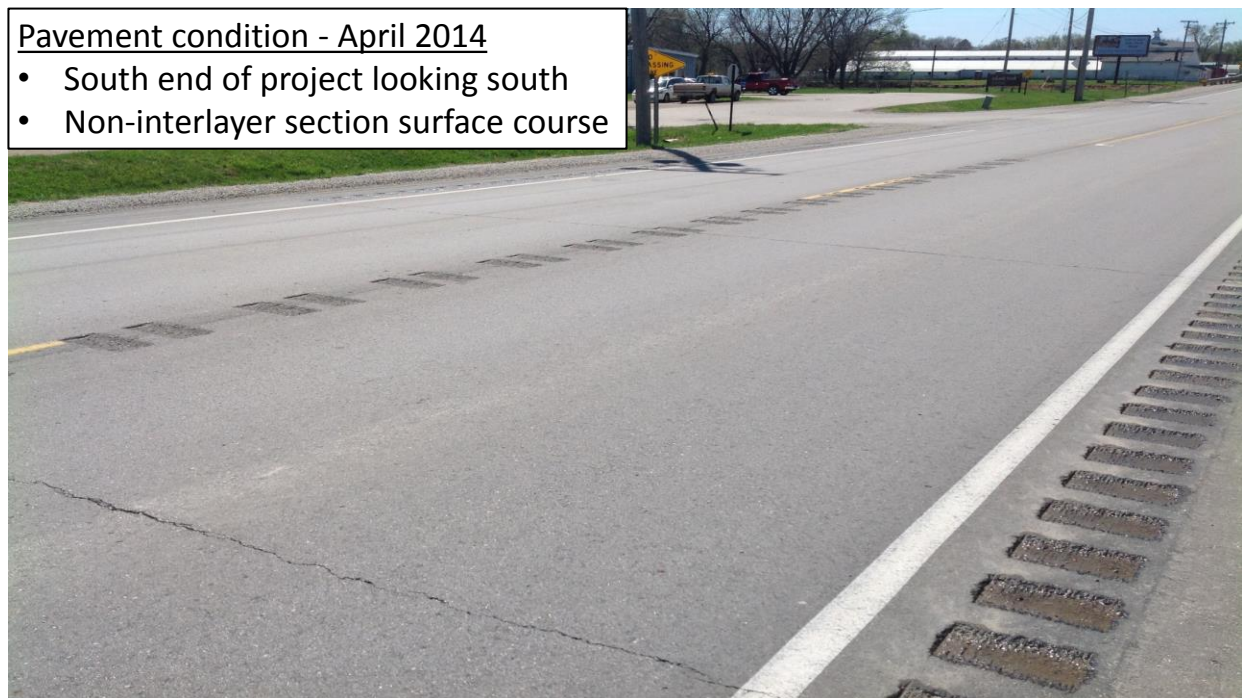
A pavement condition survey was conducted in April 2014, one winter season after the overlay project was completed, to assess the amount of cracking in the interlayer and non-interlayer overlays. Transverse cracking distresses are evident in the pavement as shown Figure 12.

Figure 12. Reflective cracks in non-interlayer overlay on US 169 in April 2014

The cracks are mostly like reflective cracks since the distance (20 feet) between the cracks exactly matches the joint spacing of the underlying PCC pavement.

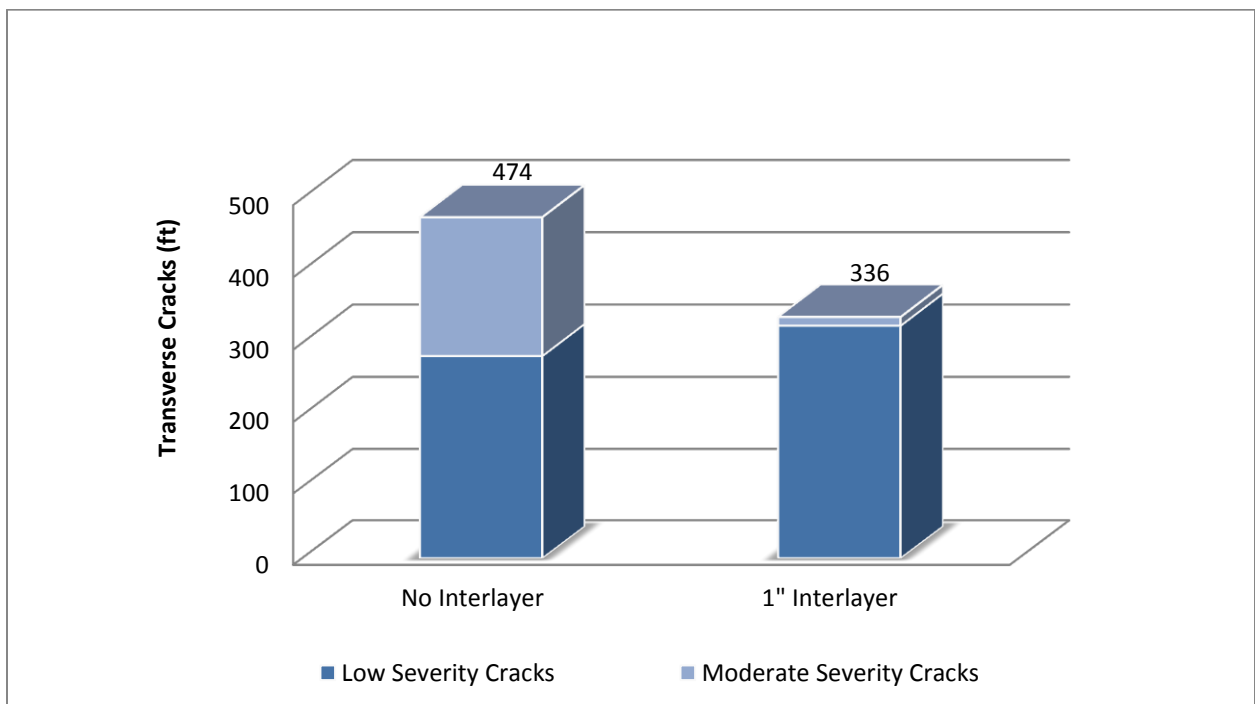
Results of the survey are summarized in Figures 13 and 14.

Figure 14. Total transverse cracking in traffic lanes

the severity of the cracking distresses between the end of construction in August 2013 and the pavement survey in April 2014. After one winter season, more cracking occurred in the pavement with the traditional overlay than in the pavement with the crack-relief interlayer. 474 linear feet of transverse cracking was measured in the traffic lanes of the interlayer section compared to 336 transverse cracking in the non-interlayer test section. These results are particularly positive for the interlayer test section since the quality assurance and performance testing results of the field produced mix (Table 5 above) revealed the interlayer was low on asphalt content and high on air voids with an air void level similar to a traditional HMA mix design. The four-point bending beam tests also revealed the interlayer did not meet the performance testing requirement. Nevertheless, the interlayer test section still contained 29 percent less reflective cracking than the non-interlayer test section. Even less cracking would exist in the interlayer overlay had the volumetrics of the interlayer been closer to the intended mix design targets.

Not only do the results of the survey demonstrate that more cracking occur in the non-interlayer section, but also the severity level of the cracking was greater in the non-interlayer section. In the non-interlayer section, 41 percent of the total transverse crack lengths measured contained moderate severity cracks. In the interlayer section, 4 percent of the total crack lengths measured contained moderate severity cracks. Moderate severity cracks have a width between 0.25 and 0.75 inches while low severity cracks have a width less than 0.25 inches.
