Integrating Intersection Traffic Signal Data into a Traffic Monitoring Program

Final Report

GDOT Research Project TO 02-128; RSCH PROJ 13-10 Georgia Tech Project No. 2006U45

October, 2014

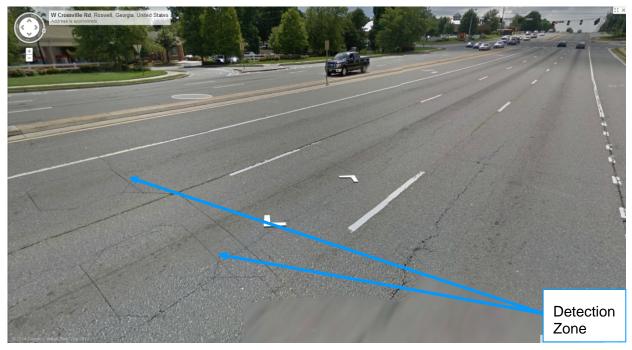
Figure 1: Typical Placement of Offset Loops (Induction Loop Detectors) on Pavement (SR 92 @ Woodstock Road). *Image Courtesy: Google Street View*

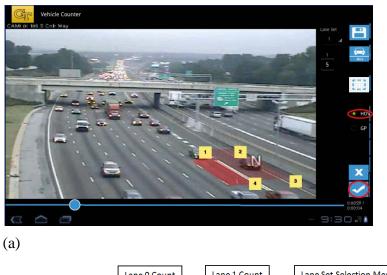
Figure 3: Traffic counting application screen shots: (a) lane setup, (b) buttons with the current count numbers showing. (c) Data collector collecting vehicle count data using application

For validating the pneumatic tube counts, manual vehicle count data was collected. To ensure repeatability and high quality of the data, counts were performed using pre-recorded video at the count locations. The video was processed by data collectors using a tablet application that was developed at Georgia Tech (as part of TO 02-69; RSCH PROJ 10-03). Screenshots of the application interface can be seen in Figure 3. The data was obtained at a per-vehicle record level and was aggregated up to 15 minute bins to match the data from the pneumatic tubes. The video data was also used for validation of the data at intersections that used Video Detection Systems for counts, because the extremely high volume of traffic at these sites and the lack of anchor points made it impossible to collect data using pneumatic tube counters.

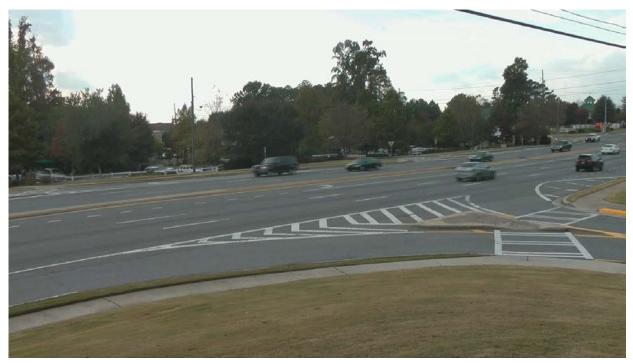
Figure 4: Recorded View of Traffic on SR 92 and Woodstock Road from Video that was Post Processed using the Tablet Application

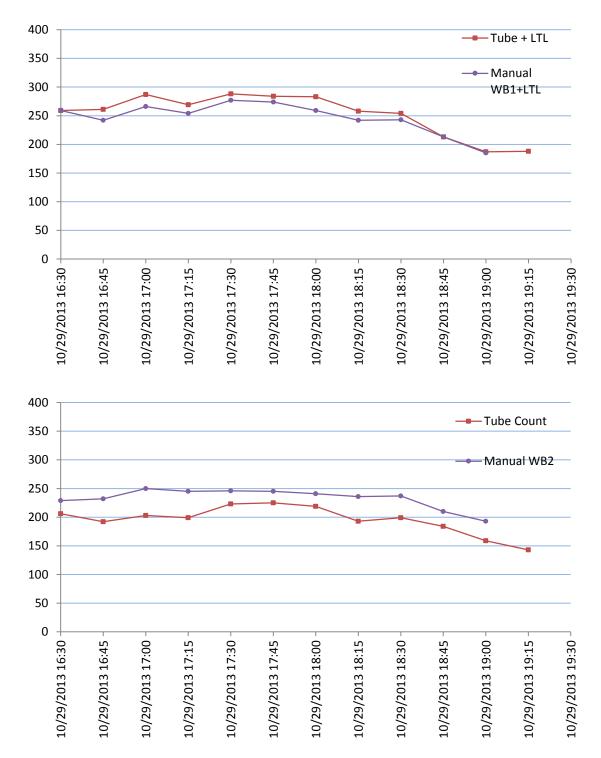
Figure 5: Time Series Plots for Manual Counts and Pneumatic Tube Counts at Intersection of SR 92 WB and King Road for Lane 1 (Top) and Lane 2 (Bottom)

A part of these errors can be explained away by the possibility of lane changes between the location of the tube count and the location of the screen-line for the manual count. However, the magnitude of the errors is too high to attribute completely to lane changes and differences in the arrival times at the two detection points. Due to the high degree of confidence in the manual data, it can be concluded that there is a certain amount of error in the pneumatic tube counts. While the error in the aggregates across lanes is 3%, the errors in counts in the individual lanes is likely to be higher (slightly less than the -6% to 8.7% range, if lane changing is taken into account).

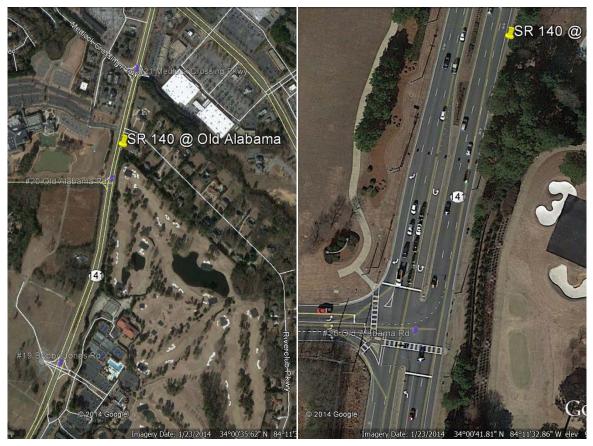
Figure 10: Layout of Test Site Location at Intersection of SR 141 and Old Alabama Road. Left: Site Overview; Right: Detailed View of Turn Lanes (*Image Courtesy: Google Maps*)

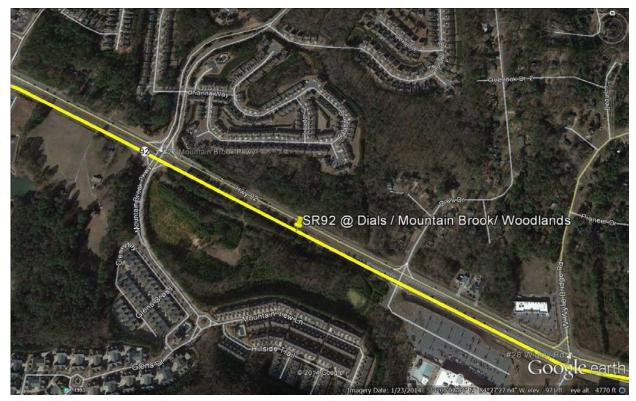
Figure 13: Layout of Test Site Location at Intersection of SR 92 and Dials Drive (Image Courtesy: Google Maps)

While no adverse effect of lane changing was observed at the Old Alabama Road site, some amount of lane changing was observed between the Pneumatic Tube data collection site and the intersection signal detector's detection zone for the study site on SR 92 between Woodlands Parkway and Dials Drive (Figure 13). There is a slight positive bias observed in the Lane 1 counts (Figure 14) while there is a slight negative bias observed in the Lane 2 counts (Figure 15). However, the total counts match quite well (Figure 16). The overall impact of lane changes at this site, where there are no other ingress or egress points between the detection zones is, as expected, minimal.

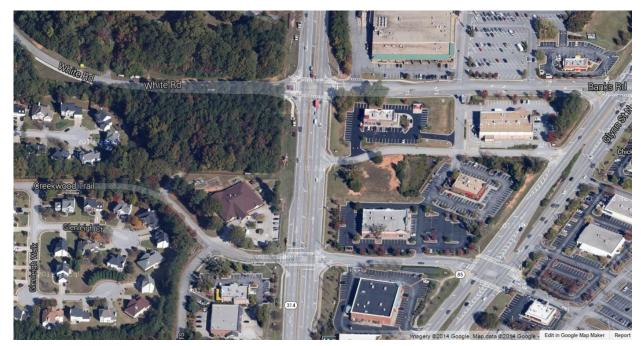
Figure 30: Layout of Test Site Location at Intersection of SR 314 and Banks Road (Image Courtesy: Google Maps)

SR 314 near Banks Road and Creek Wood Trail was a low volume road study site (Figure 30). This site experienced some connectivity issues leading to data losses in the intersection signal data stream. The available data, matched very well with the pneumatic tube counts. The pneumatic tube counts were matched with the upsteam signal counts as well to investigate if, under these low volume conditions, detection from a single intersection can be used instead of requiring a pair of intersections with available data. While Lane 1 upstream data matched very well (Figure 31), the Lane 2 upstream data match was not good (Figure 32), possibly due to differences caused by turning vehicles at the intersection.

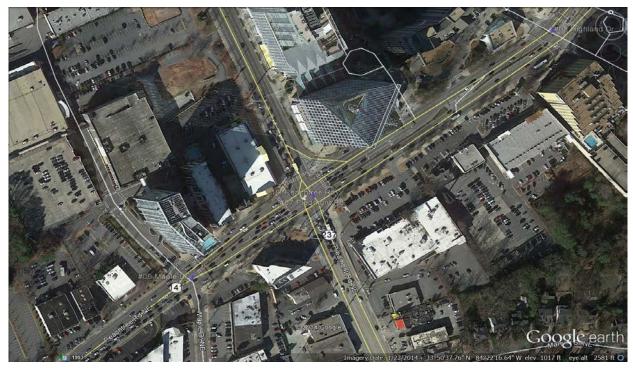
Figure 33: Layout of Test Site Location at Intersection of SR 237 and SR 141 (Image Courtesy: Google Maps)

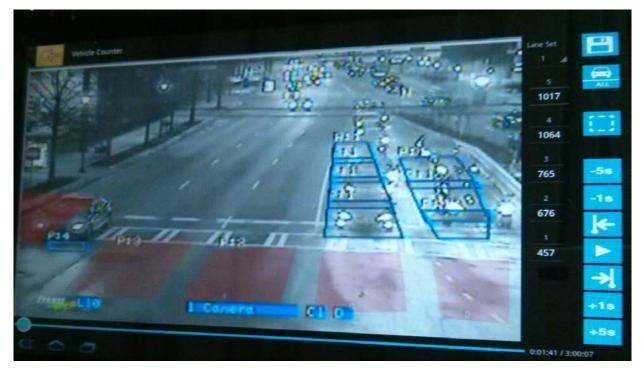
Figure 34: Layout of Detection Zones for Tablet based Manual Counts on video at Intersection of SR 237 and SR 141 (*Image Courtesy: Google Maps*)

- Given the resource intensive nature of the manual data reduction of the videos that were of low quality (Figure 34), the test was limited to a single approach (SR 141 EB) and a single morning peak period.
- The only adverse condition that was tested was the transition in lighting conditions (dawn). The other condition that might have been tested is camera vibration due to heavy vehicle traffic, but any movement of the camera was not noticeable in the observed video. Effects of precipitation, high wind, shadows etc. were not tested in this study.

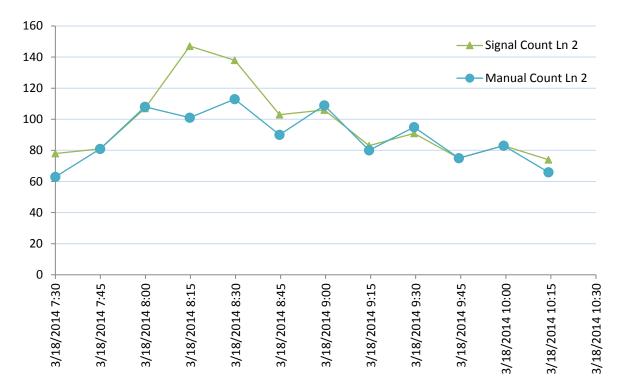
Figure 36: Time Series Plot for Manual Counts and Signal Detector Counts at Intersection of SR 237 and SR 141for Lane 2

As seen in Figure 35, Figure 36, and Figure 37 the errors were low except in two time periods on the middle lane. The video detection system was configured to detect vehicle counts on only three of the lanes. The left turning vehicles were not counted and are therefore unaccounted for (Figure 37). Discounting the left turn lanes, the mean percentage errors on the other three lanes were in the range of 2.6 to 11.8%.

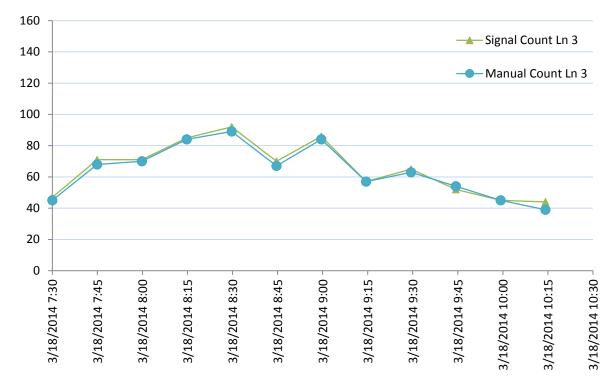
Figure 37: Time Series Plot for Manual Counts and Signal Detector Counts at Intersection of SR 237 and SR 141 for Lane 3

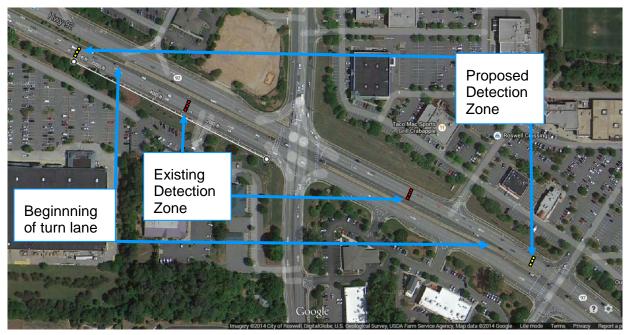
Figure 42: Proposed Detection Zone Placement Upstream of Beginning of Turn Lanes (Image Courtesy: Google Maps)

To improve the usability of intersection signal detector data for traffic monitoring it is recommended that for future installations and maintenance on existing detectors, detection zones are moved further upstream beyond the maximum queue length of a typical peak hour queue and beyond the beginning of the turn lanes. If it is not possible to move detections zones upstream of turn lanes, detectors should be installed on turn lanes as well.

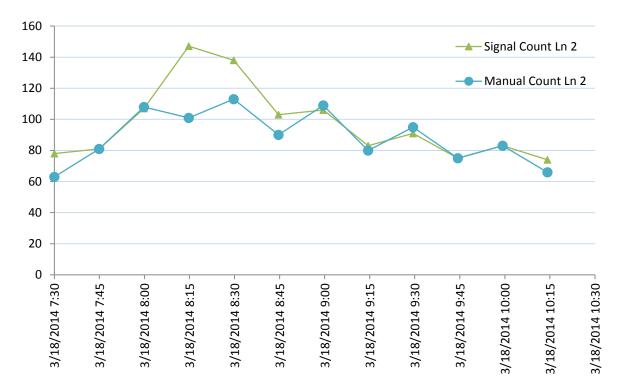
Figure A-47: Time Series Plot for Pneumatic Tube Counts and Signal Detector Counts at Intersection of SR 141 EB and SR 237 for Lane 2
