**BRIDGE CONDITION ASSESSMENT  
USING REMOTE SENSORS**

United States Department of Transportation  
Research and Innovative Technology  
Administration

Michigan Technological University

**Volume I of II – Main Body**

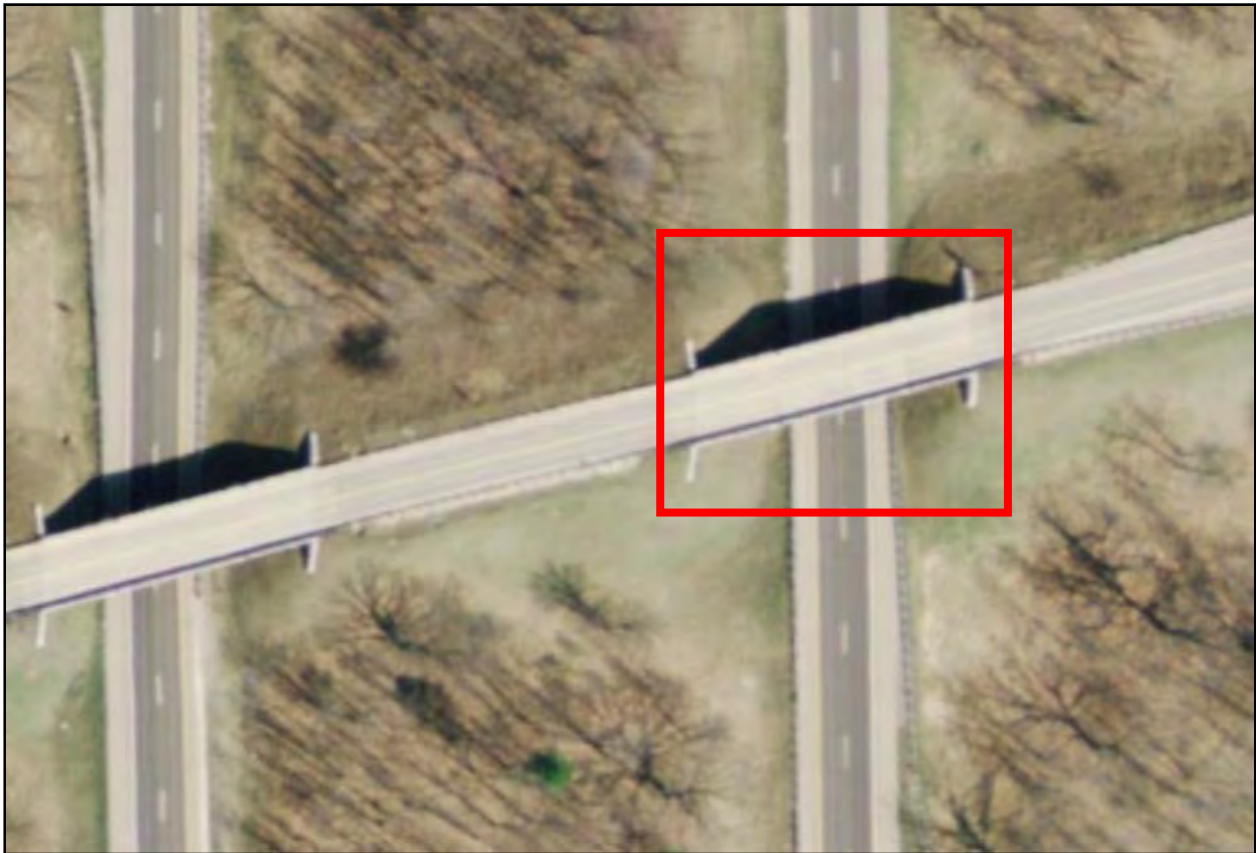
Figure 3-2: "Poor" bridge selection – Mannsiding Road NB.

The selected “Poor” condition bridge, MDOT structure n<sup>o</sup> 1713 – Mannsiding Road over US-127 north bound, is located in Clare County approximately 10 mi north of Clare, Michigan (Figure 3-2) and was determined to be the best candidate for field demonstration purposes.

The field demonstration candidate structure serves Mannsiding Road; a “Major Collector” road. The bridge was constructed in 1966 and is a 3-span prestressed concrete multiple I-beam composite structure. The structure is 130.92 ft in length and 31.17 ft in width, which translates into 26 ft of riding surface. During 1996, the average daily traffic (ADT) over the structure was found to be 1,000 with 3% being commercial (MDOT 2011).

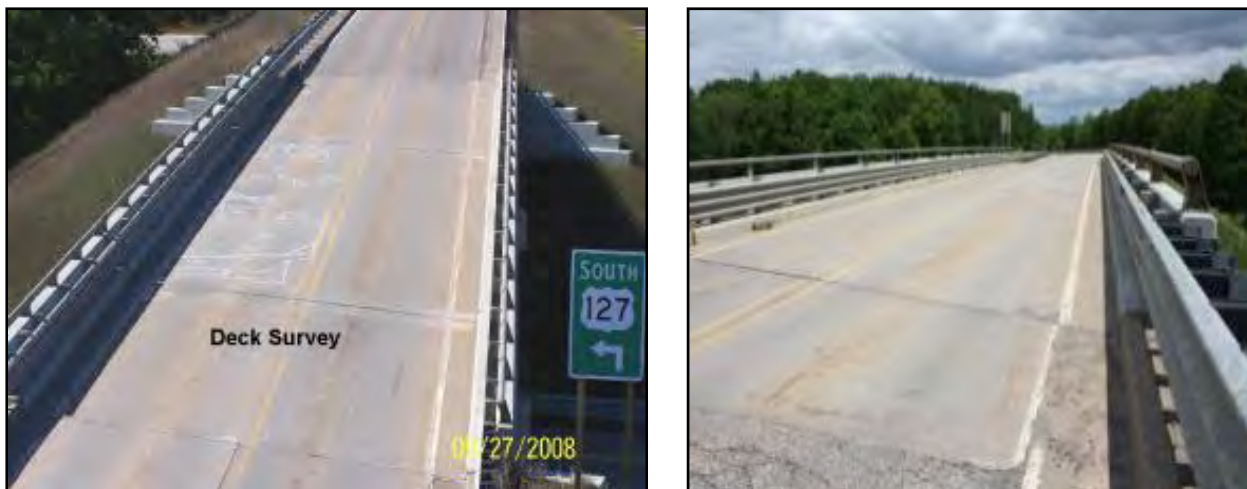
The condition of the concrete deck surfaces, both top and bottom, were an area of major concern. A 2008 MDOT scoping inspection classified the deck with a NBI rating of “4”. The scoping revealed that on the top surface of the concrete deck 176 ft<sup>2</sup> or 4.4% of the deck was delaminated. Additional testing on the bottom surface revealed that 623 ft<sup>2</sup> or 15% of the deck was in distress (MDOT 2011). The deck also possessed light scaling throughout and numerous transverse, longitudinal and diagonal cracks were present. Additionally, several high-load hits have resulted in scrapes and spalls of the superstructure underside, but currently there is no sign of exposed reinforcing steel or pre-stressing strands. The bridge is scheduled for complete replacement in 2012/13. Additionally, during the on-site inspection of the selected “Poor” bridge, it was found to have a complementing twin bridge, Mannsiding Road south bound overpass. The Mannsiding Road south bound overpass bridge is described in further detail in the “Supplemental” bridge selection section.

Figure 3-3: Mannsiding Road bridge NB deck condition in 2008 (a) and Mannsiding Road bridge NB deck condition in 2011 (b).

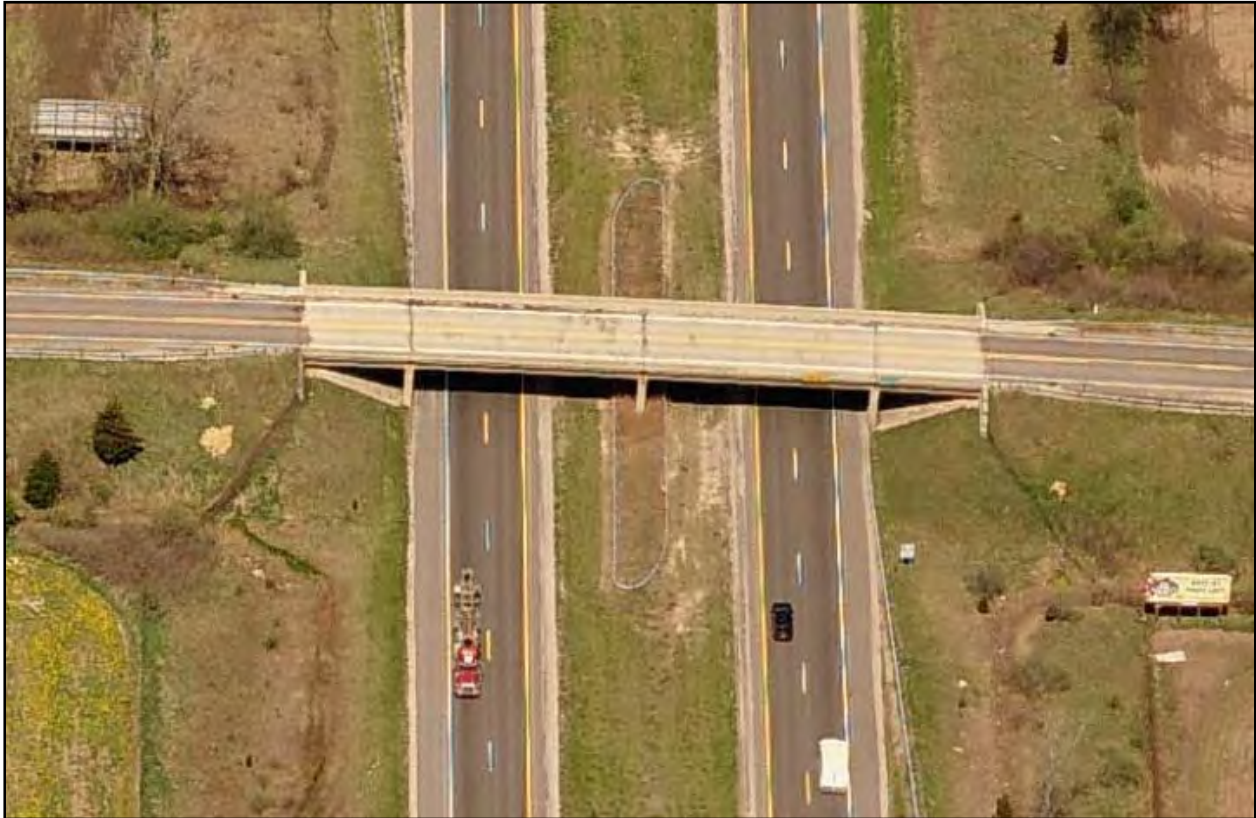
**Figure 3-4: "Fair" bridge selection – Willow Road.**

MDOT structure n<sup>o</sup> 10892 – Willow Road over US-23 was selected for the “Fair” condition field demonstration bridge. The bridge is located in Washtenaw County approximately 3 mi north of Milan, Michigan. An aerial photograph of the selected site is shown in Figure 3-4.

The “Fair” field demonstration structure serves Willow Road; a “Major Collector” road. The bridge was constructed in 1962 and is a 4-span prestressed concrete multiple I-beam composite structure. The structure is 209 ft in length and 30.83 ft in width, which translates into 26 ft of

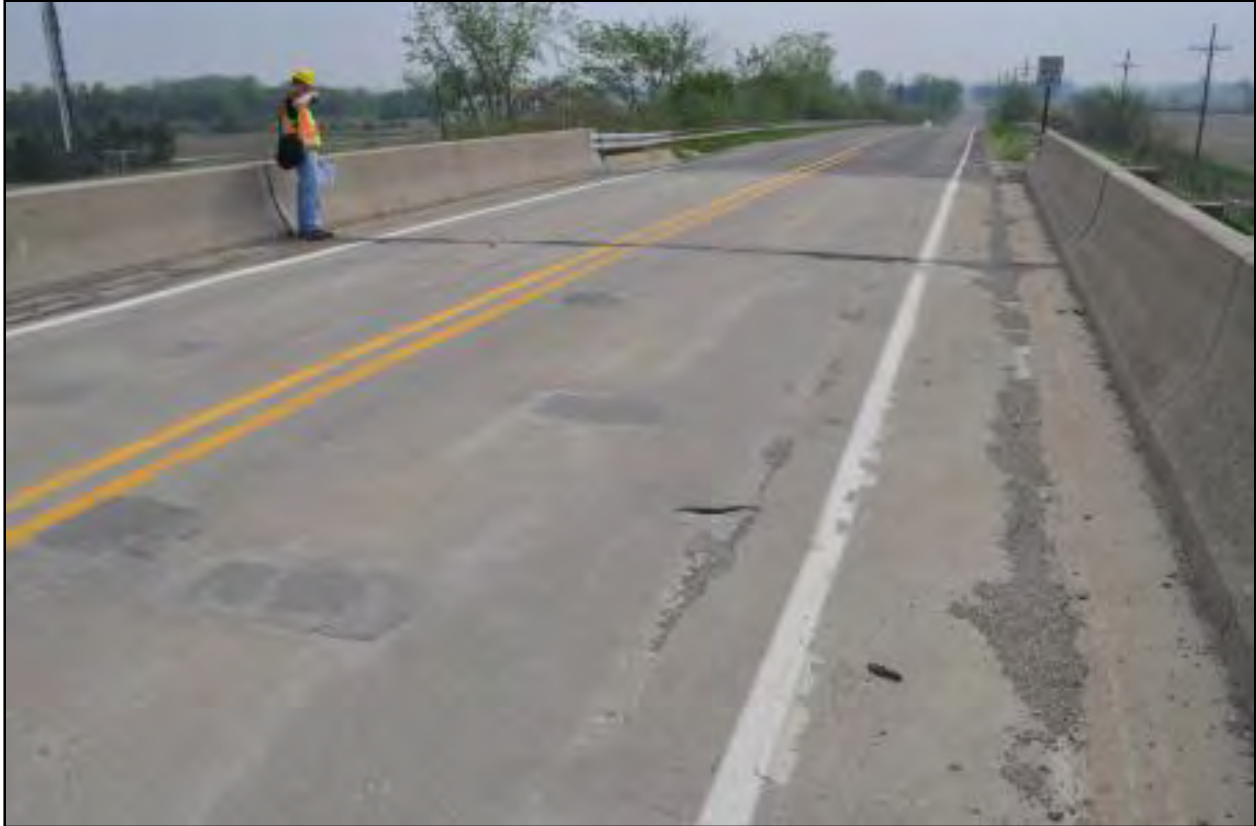
Figure 3-5: Willow Road bridge deck condition.

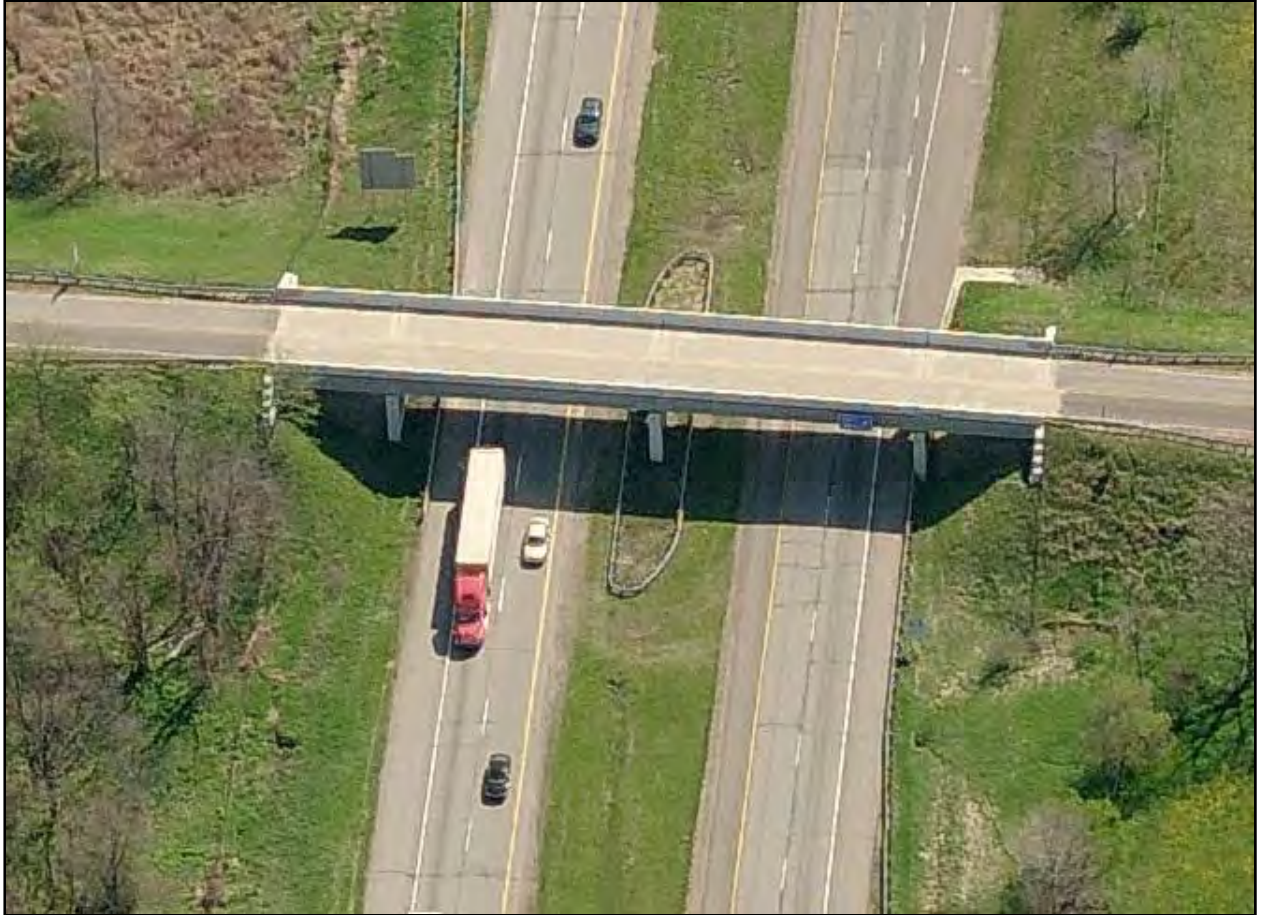
**Figure 3-6: "Satisfactory" bridge selection – Freer Road.**

Lastly, the “Satisfactory” bridge was chosen to be the MDOT structure n<sup>o</sup> 10940 – Freer Road over I-94, located in Washtenaw County, approximately 1 mi east of M-52 in Chelsea, Michigan. An aerial photograph of the selected site is shown in Figure 3-6.

The field demonstration candidate structure serves Freer Road; a “Major Collector” road. The bridge was constructed in 1960 and is a 4-span prestressed concrete multiple I-beam composite structure. The structure is 209 ft in length and 30.83 ft in width, which translates into 26 ft of open roadway riding surface with no shoulder. During 1997, the ADT over the structure was found to be 150 with 3% being commercial (MDOT 2011).

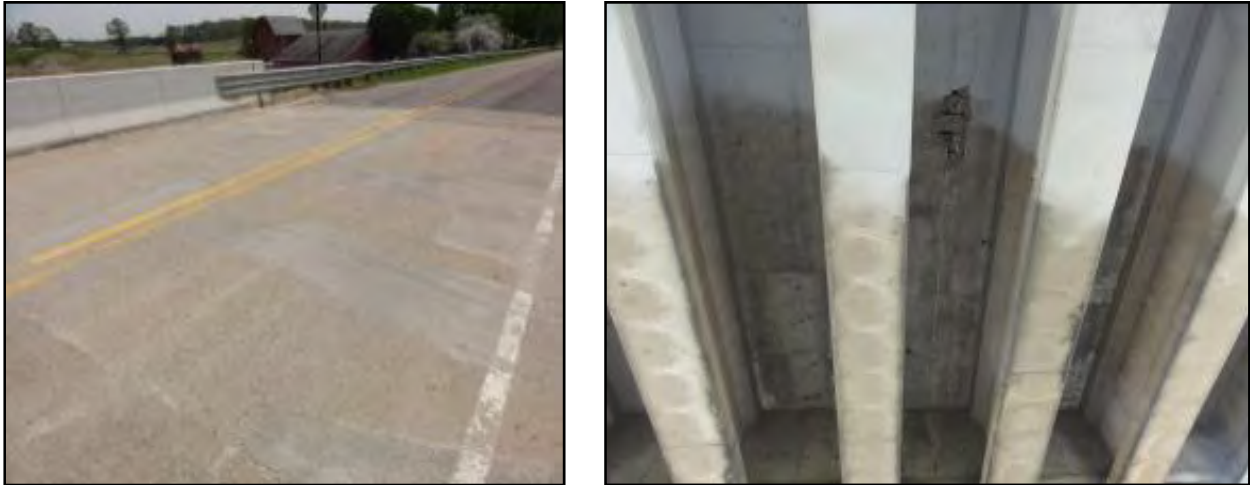
Figure 3-7: Freer Road bridge top and bottom surface conditions.

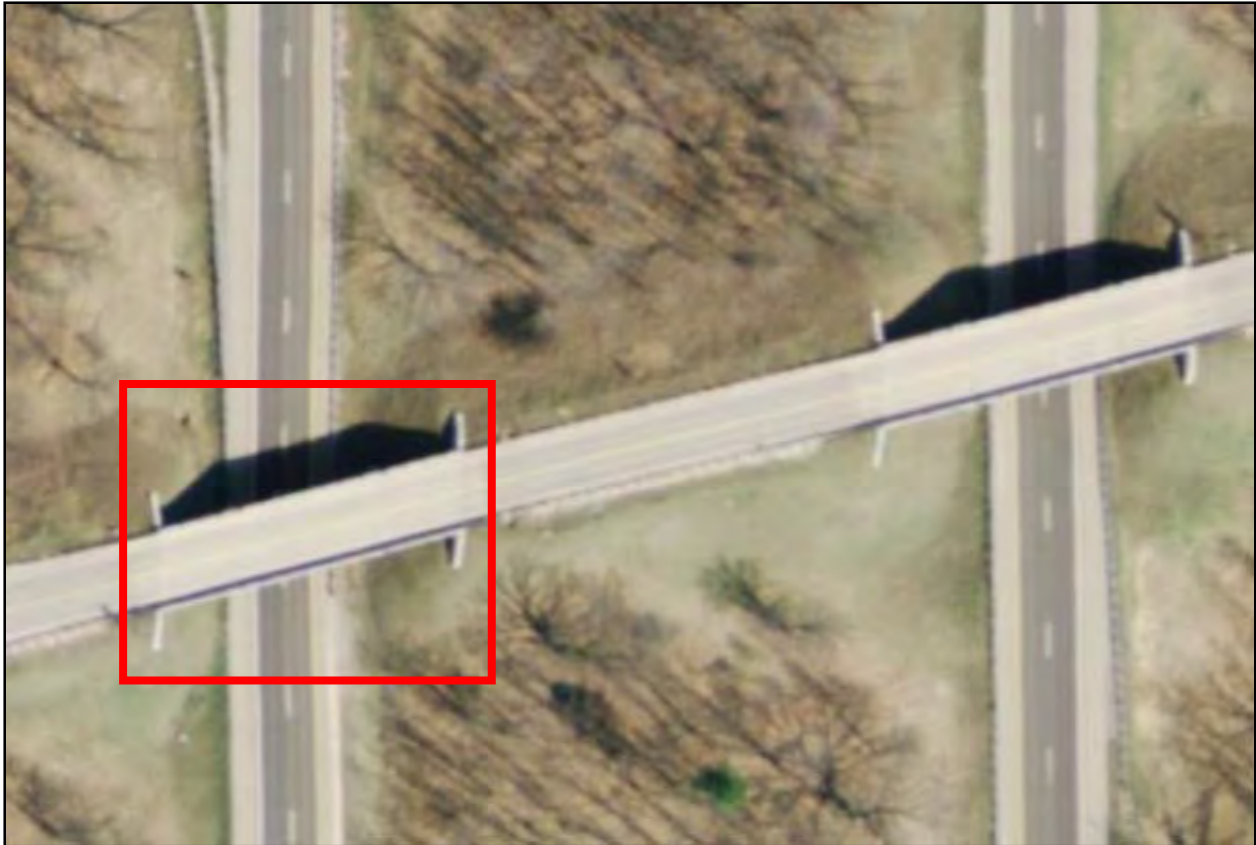
**Figure 3-8: "Supplemental" bridge selection – Mannsiding Road SB.**

The “Supplemental” bridge selection, MDOT structure n<sup>o</sup>1712 – Mannsiding Road over US-127 south bound is located in Clare County approximately 10 mi north of Clare, Michigan and was not originally in the scope of work for the field demonstration. However, the close proximity of the bridge to the “Poor” selection location allowed for data acquisition with no additional traffic disruption and permitting. An aerial photograph of the selected site is shown in Figure 3-8.

The field demonstration candidate structure serves Mannsiding Road; a “Major Collector” road. The bridge was constructed in 1966 and is a 3-span prestressed concrete multiple I-beam composite structure. The structure is 130.92 ft in length and 31.17 ft in width, which translates into 26 ft of riding surface. During 1996, the ADT over the structure was found to be 1,000 with 3% being commercial (MDOT 2011).

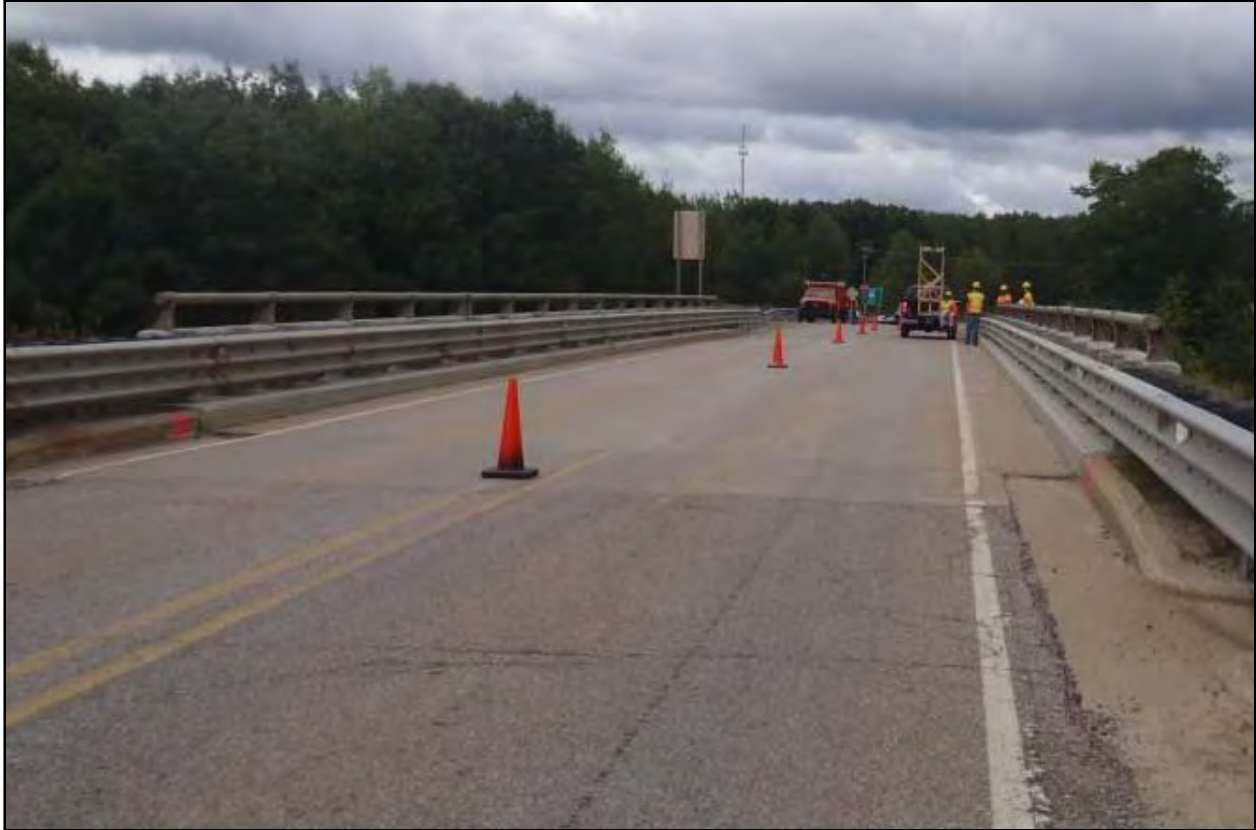
Currently the bridge has no posted speed limit restrictions. The crossing spans south bound US-127; a NHS route that is not within any federal-aid urban boundary. The bridge does not meet the desired minimum vertical clearance for NHS routes. The field demonstration location was located 2.3 mi south of M-61 (approximately 5.5 mi south of Harrison on US-127). The structure is part of an interchange serving the greater Harrison area, which is considered to be a rural environment. Figure 3-9 shows the general surface condition of the bridge deck.

When comparing the condition of the concrete deck surface, top and bottom, of the "Supplemental" and "Poor" bridge selections drastic differences in the state of deterioration were noted. The two bridges had been constructed at the same time, but large variations in the deteriorated state on the concrete deck are documented. An inspection conducted on this bridge in 2010, classified the deck with a NBI rating of "7" (MDOT 2011). The inspection notes stated that minor cracking and shallow scaling on the deck surface was present, however was not substantial enough to cause structural issues. When comparing the "Supplemental" bridge deck rating of "7" to the "Poor" bridge selection's deck rating of "4" on the NBI scale, questions of construction procedure, inspection consistency and environmental effects were raised.

Figure 3-9: Mannsiding Road bridge SB.

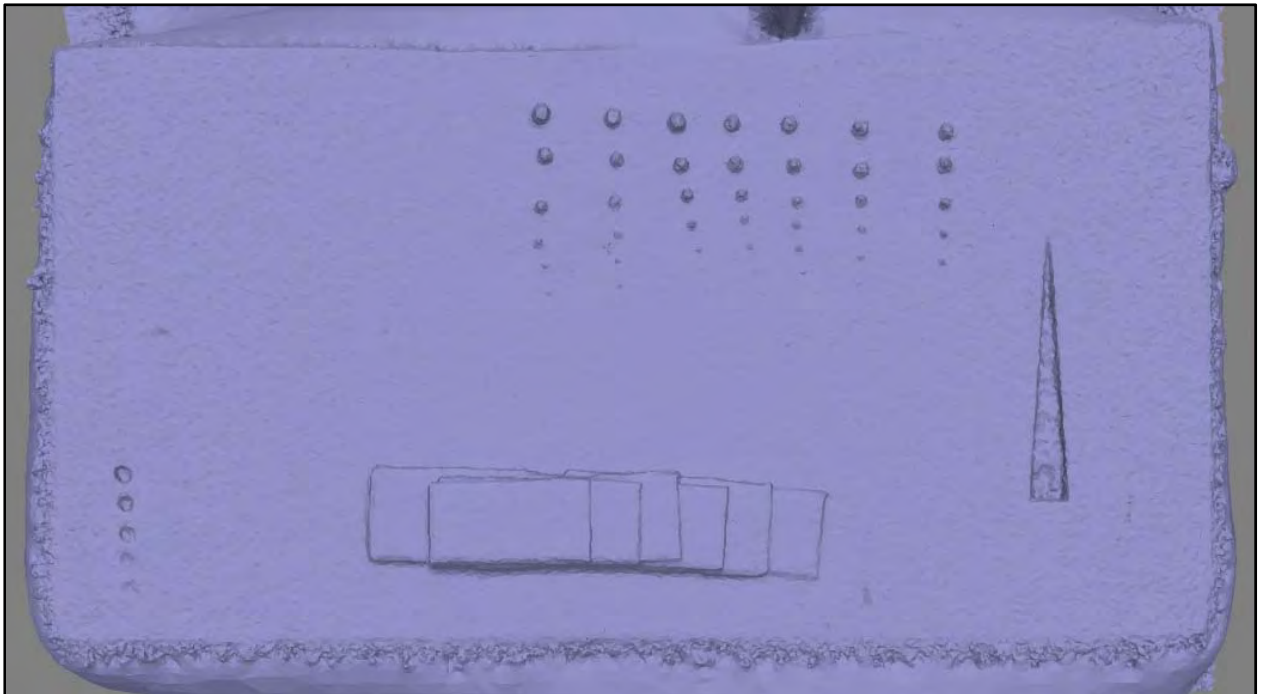
Figure 4-2: The resulting PhotoScan model. A total of five photos were used to generate this model.

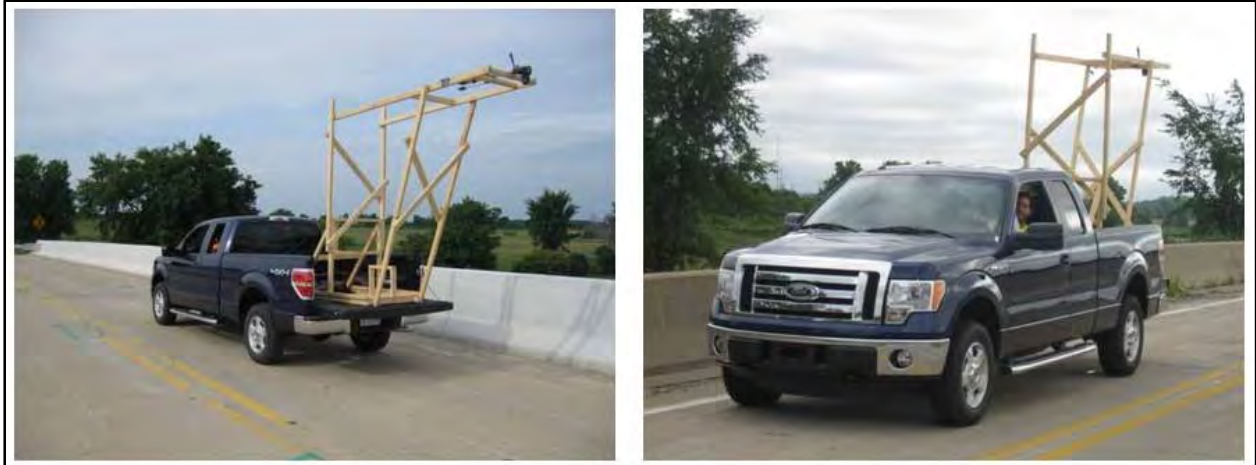
From this initial hand held concept, a vehicle mount was constructed for use on a bridge deck (Figure 4-5). Calculations were made to determine the height necessary for the system to cover one lane per pass. For the Nikon D5000 DSLR (digital single-lens reflex) camera with a resolution of 12.3 MP and a 27 mm focal length lens, to cover a 12 ft wide lane, the camera needed to be mounted 9 ft above the bridge deck. In order to achieve this height a wooden vehicle mount was constructed to fit into the bed of a standard pickup truck. During field collections a programmed control board automated the camera to take pictures at a rate of one per second. At this rate, the truck was driven across the bridge deck at a speed of about 1 mph. This ensured that we captured a 60% overlap between the photos. However, faster speeds can be reached using higher-end, faster cameras. A full bridge deck was collected by driving each lane of the bridge.

Figure 4-5: 3DOBS vehicle mount in the bed of a pickup truck. The image on the left was taken on Willow Road bridge and the one on the right on Freer Road bridge.

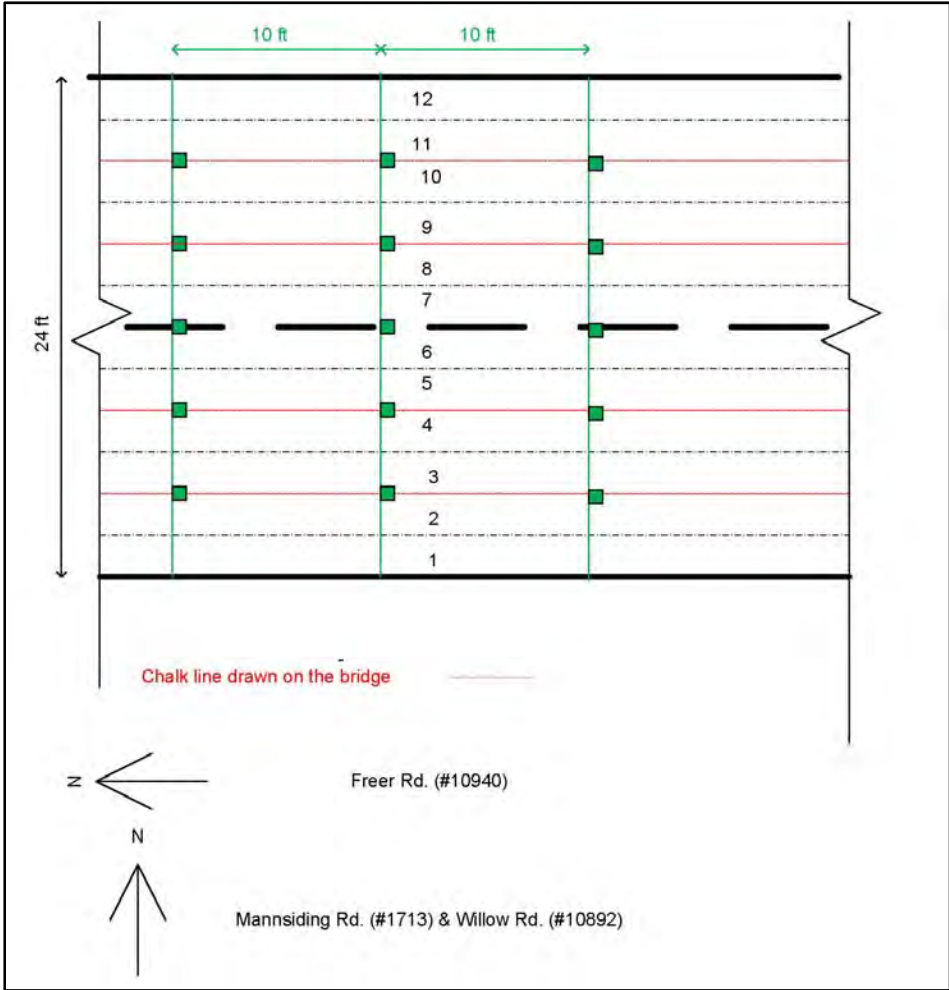
Figure 4-6: Diagram illustrating the grid pattern used for reference on all field demonstration bridges. The chalk line on the bridge deck was used for the Thermal IR data collects.

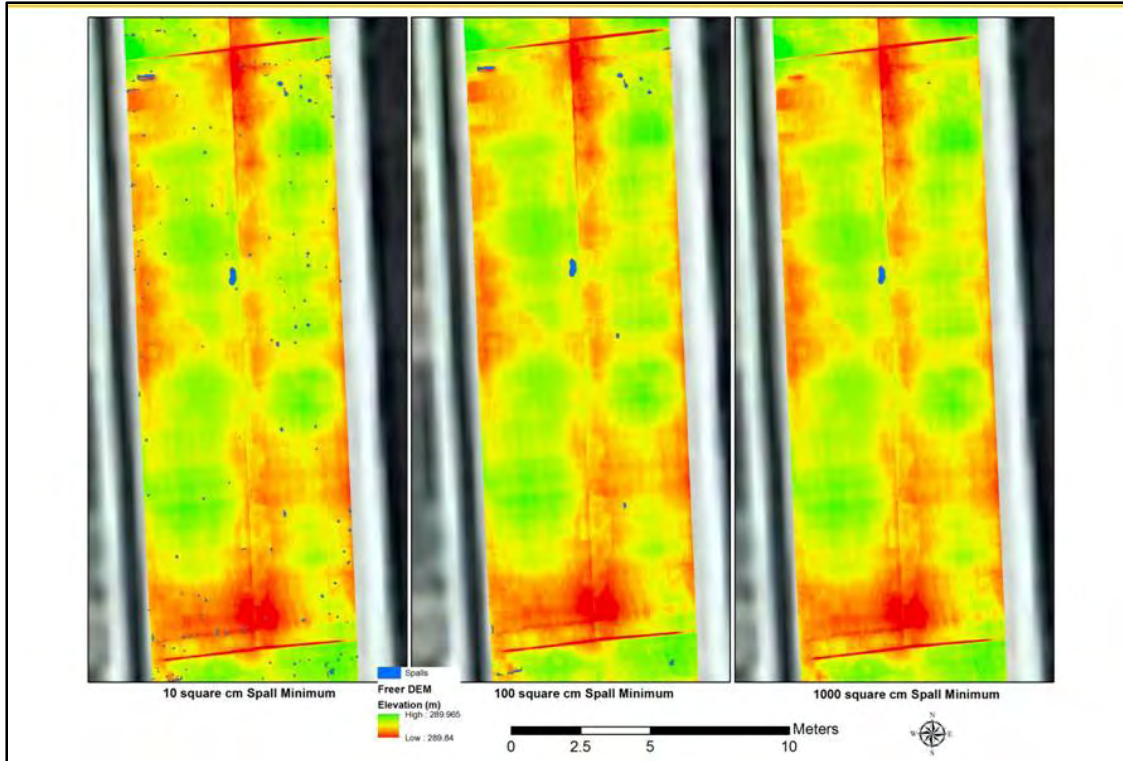
Figure 4-8: Differences in minimum spall sizes as from the spall detection algorithm. Starting on left, the images depict spalls larger than 10 cm<sup>2</sup>, 100 cm<sup>2</sup>, 1,000 cm<sup>2</sup> respectively. Data from Freer Road bridge.

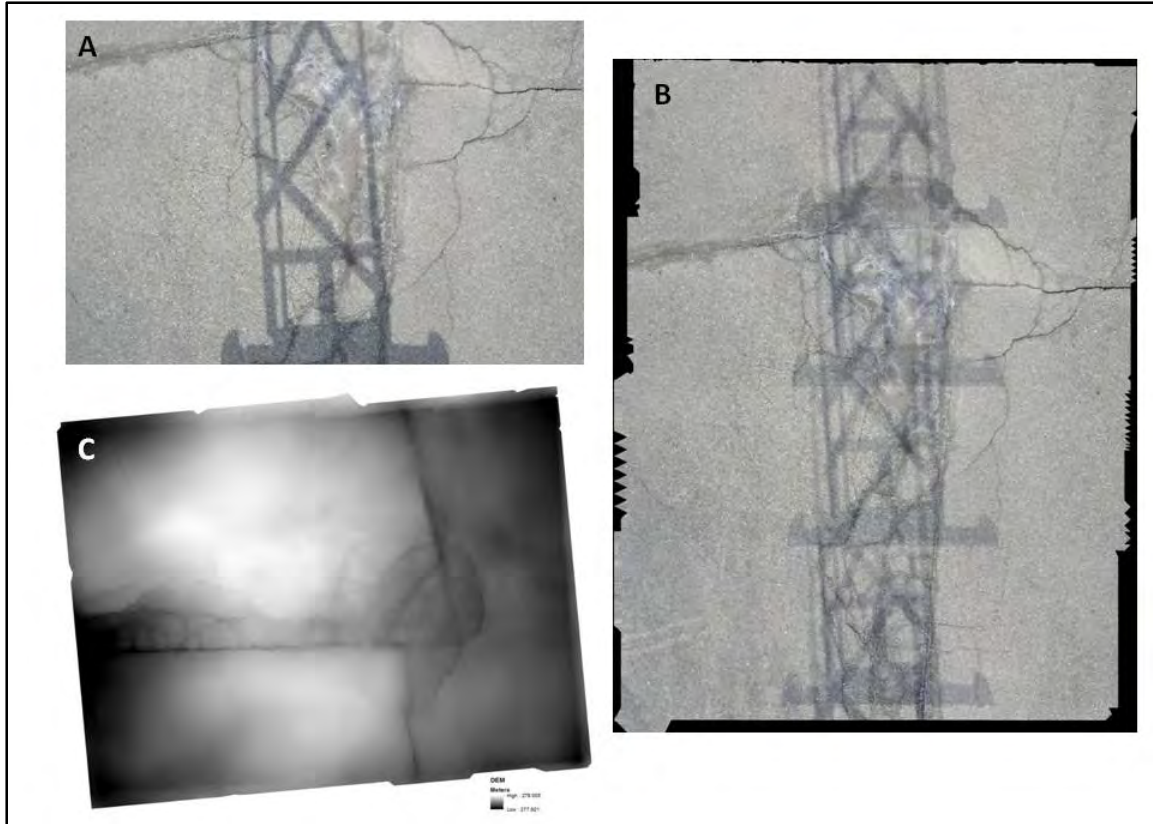
Figure 4-13: Photos captured by 3DOBS contained the shadow from the vehicle mount as shown in A. Despite the shadow PhotoScan was able to align the photos (B) and generate an accurate DEM (C) of the parking lot surface.

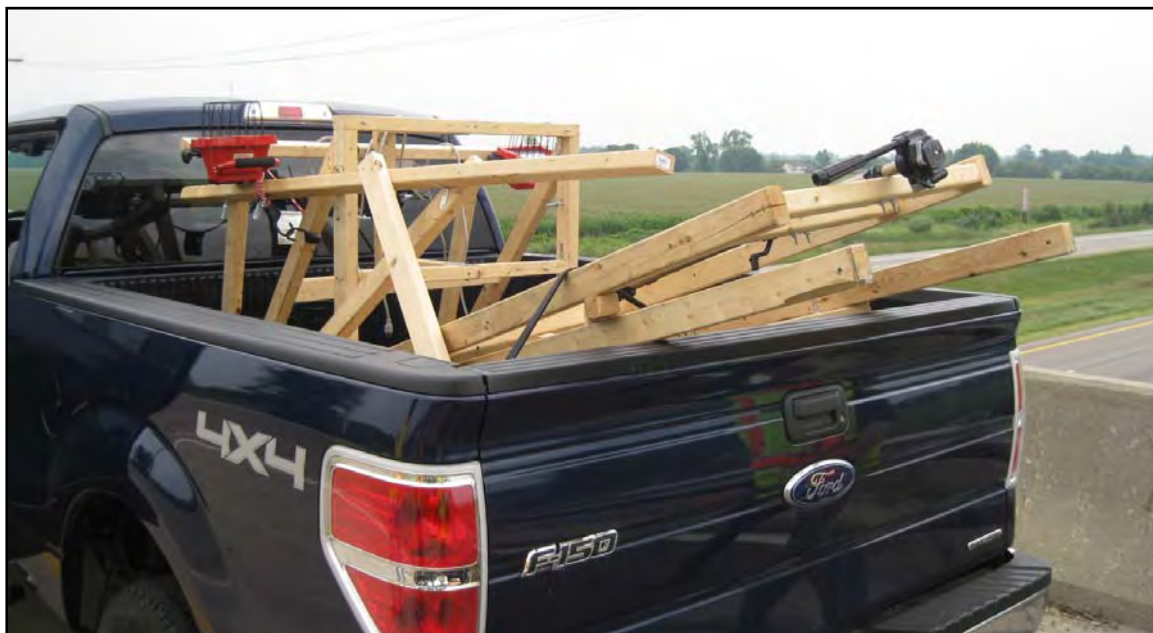
During the field demonstrations at each of the selected bridges it was determined that it took about 30 minutes to collect one bridge. This time included 10 minutes for setup, 10 minutes for collecting the imagery and 10 minutes for break down. The vehicle mount was constructed so that it could easily be broken down and transported to different sites in the bed of a truck (Figure 4-14).

Figure 4-14: 3DOBS being transported in the bed of the collection vehicle.

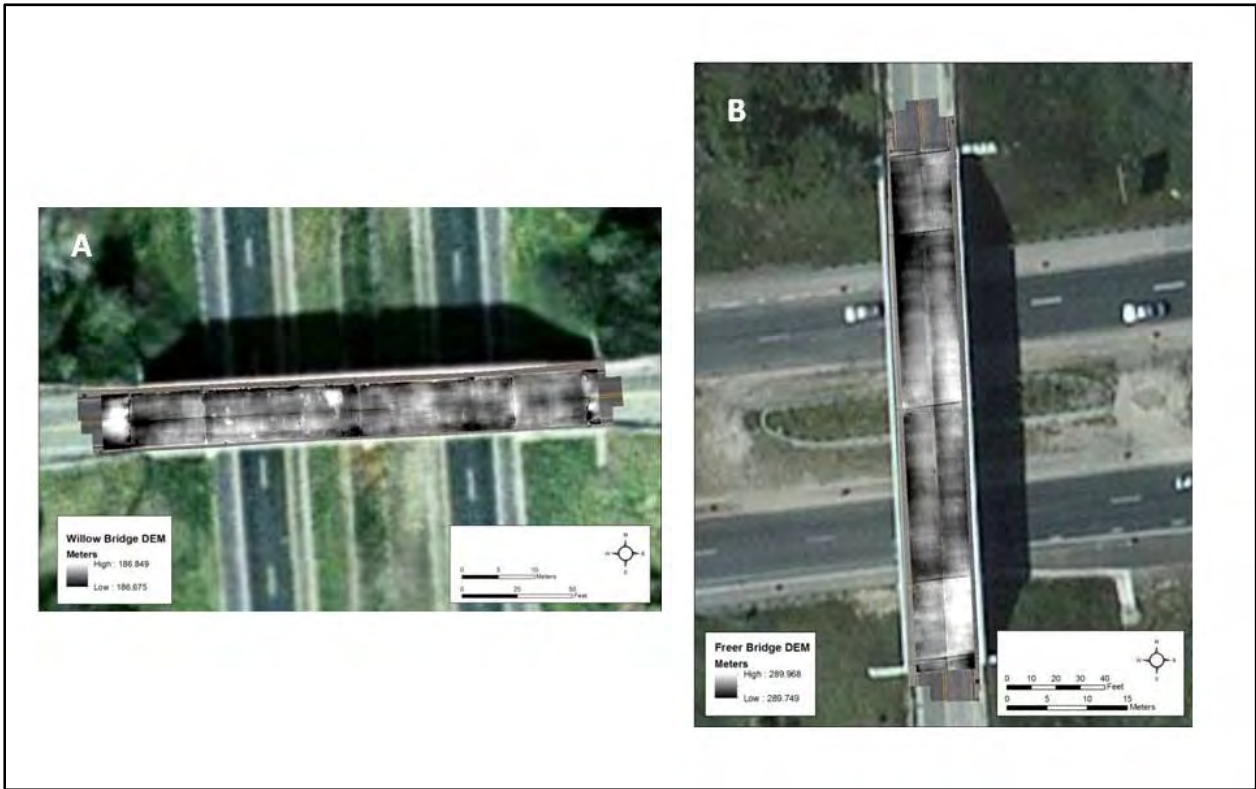
The DEMs produced from PhotoScan (Figure 4-17 and Figure 4-18) had a resolution of 5 mm horizontal and 2 mm vertical. During the study, PhotoScan made several updates to PhotoScan which helped to get better than expected vertical resolution. The DEM was, however, restricted to 5 mm even though it could be produced at the same resolution as the overview image. This was done to reduce the size of the TIF (Tagged Image File) data file generated. Initial results were exported at a horizontal resolution of 1 mm but the file size for one lane was about 1.8 GB in size. The resolution was reduced to 5 mm, which still provided a high resolution product, but the file size for one lane was reduced to 73 MB.

Figure 4-17: DEMs generated by 3DOBS of Willow Road (A) and Freer Road (B) bridges.

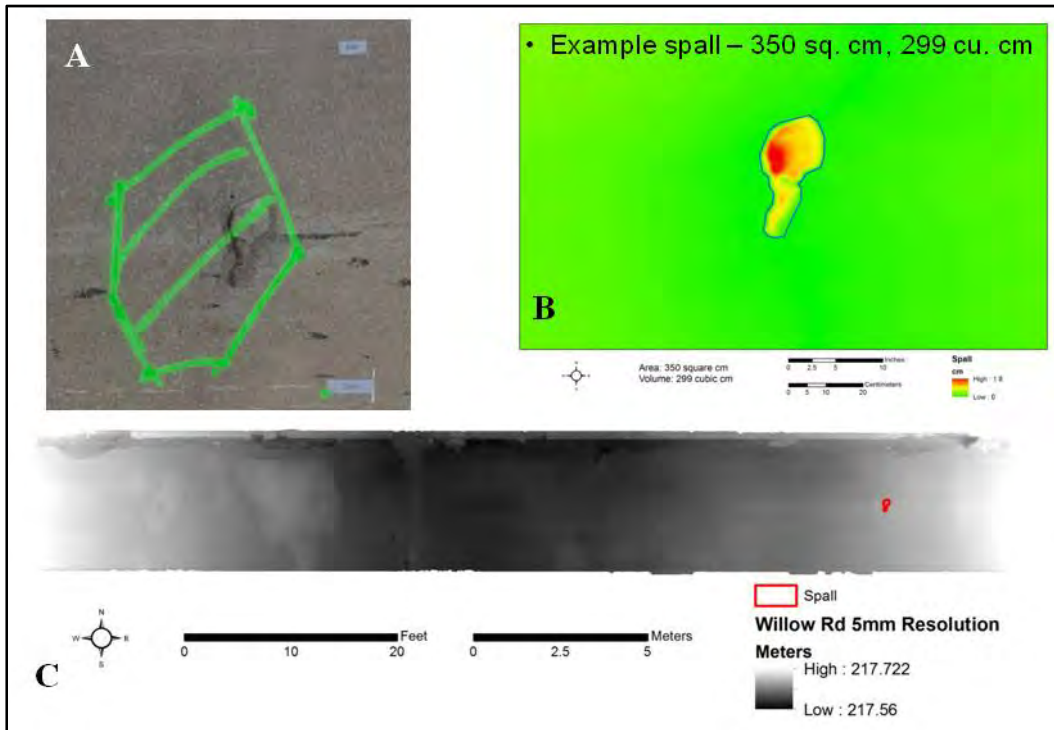
Figure 4-19: An example of manually deriving a spall from 3DOBS data. One of the original photos from 3DOBS is shown in image A and the digitized spall is shown in image B. An overview of the DEM of the lane the spall was found in is displayed in image C.

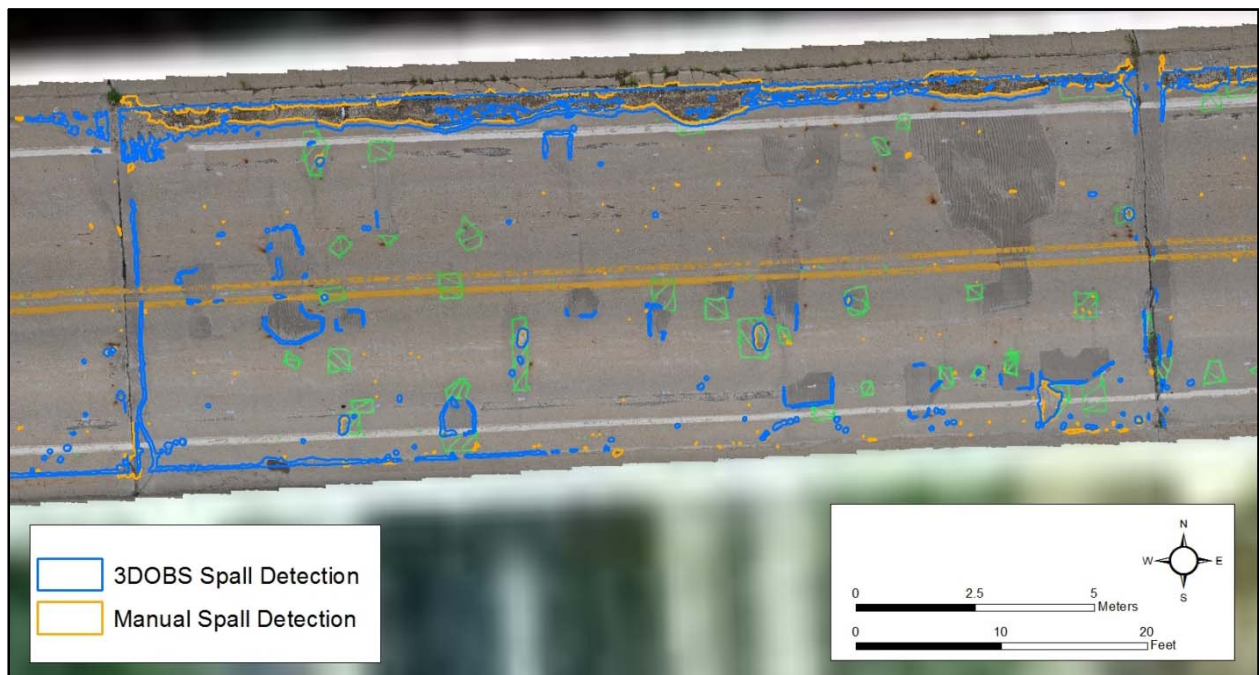
**Figure 4-20: A Willow Road bridge comparison of 3DOBS detected spalls (blue polygons) and manual digitizing of spall locations (orange polygons). The green polygons were painted on to the bridge deck by MDOT personnel and represent delaminated areas as detected by the hammer sounding.**

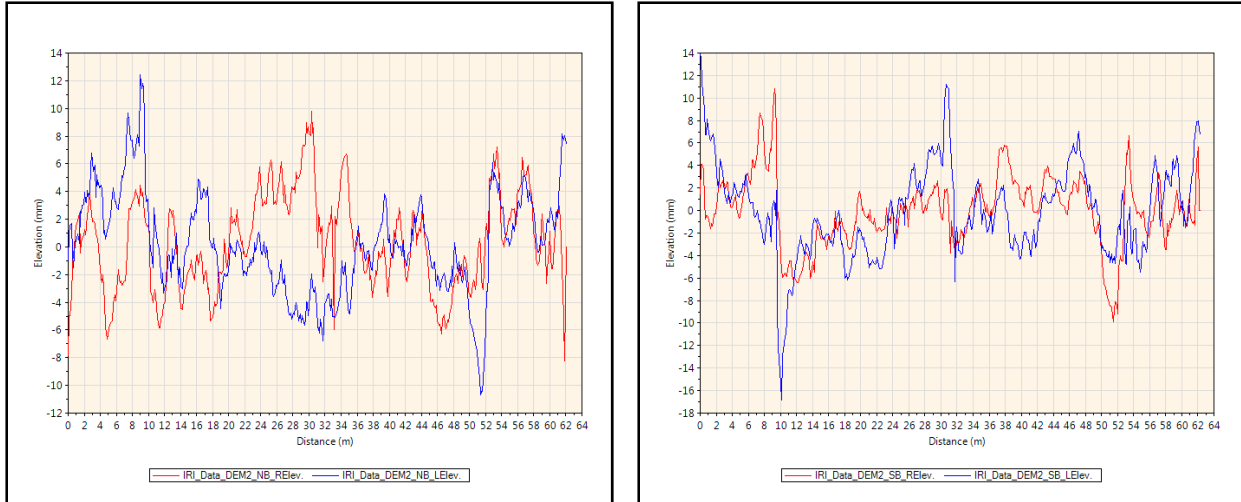
**Figure 4-21: The longitudinal profiles of the NB (left) and SB (right) lanes of the Freer Road bridge.**

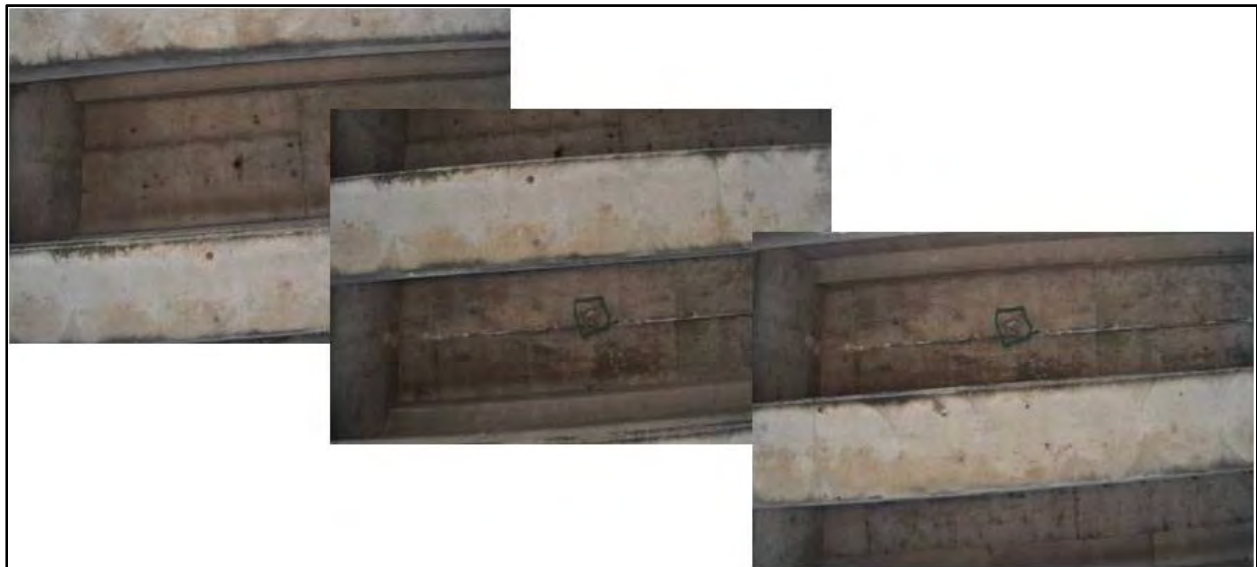
**Figure 4-22: A series of photos taken during a bridge underside collect with the 3DOBS system.**

Generating a photo inventory of the underside of a bridge was successful as the photos taken had some overlap and covered the entire lane from underneath. One issue that remains is that there still needs to be more powerful lights. If the conditions are mostly sunny the system is able to collect photos of the bridge underside but this is not the case for cloudy conditions. Figure 4-22 show a series of photos that was collected at Freer Road. These photos could not be used to generate a DEM since they do not contain any markings for PhotoScan to create a coordinate system.

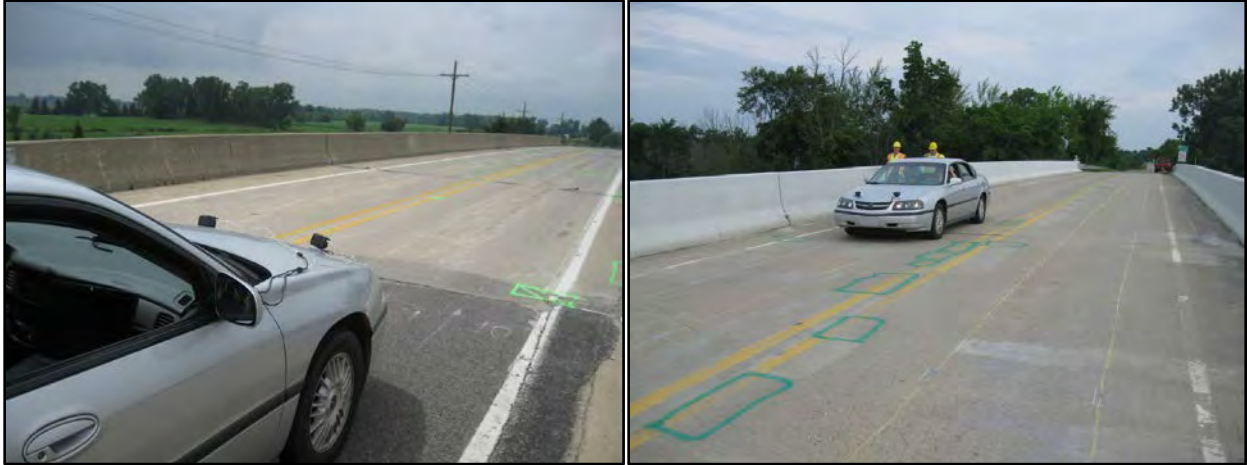
The cameras were mounted to the front of the vehicle and oriented so that the overall field of view would capture an entire lane width (Figure 5-1). The vehicle was driven at a speed of less than 5 mph while the cameras took pictures once every 4 seconds in order to capture the entire bridge using the inexpensive Canon cameras (Figure 5-1). This allowed the team to ensure that the digital photographs were not blurred and the detail of the bridge deck was preserved through in-focus photographs. Lighting conditions at the bridge did not affect the quality of the photos captured; these conditions ranged from sunny to completely overcast skies. This system can be and was set up, deployed, and broken down within 30 minutes during field demonstration at the three bridges.

Figure 5-1: BVRCS being deployed on Freer Road to capture a bridge photo inventory.

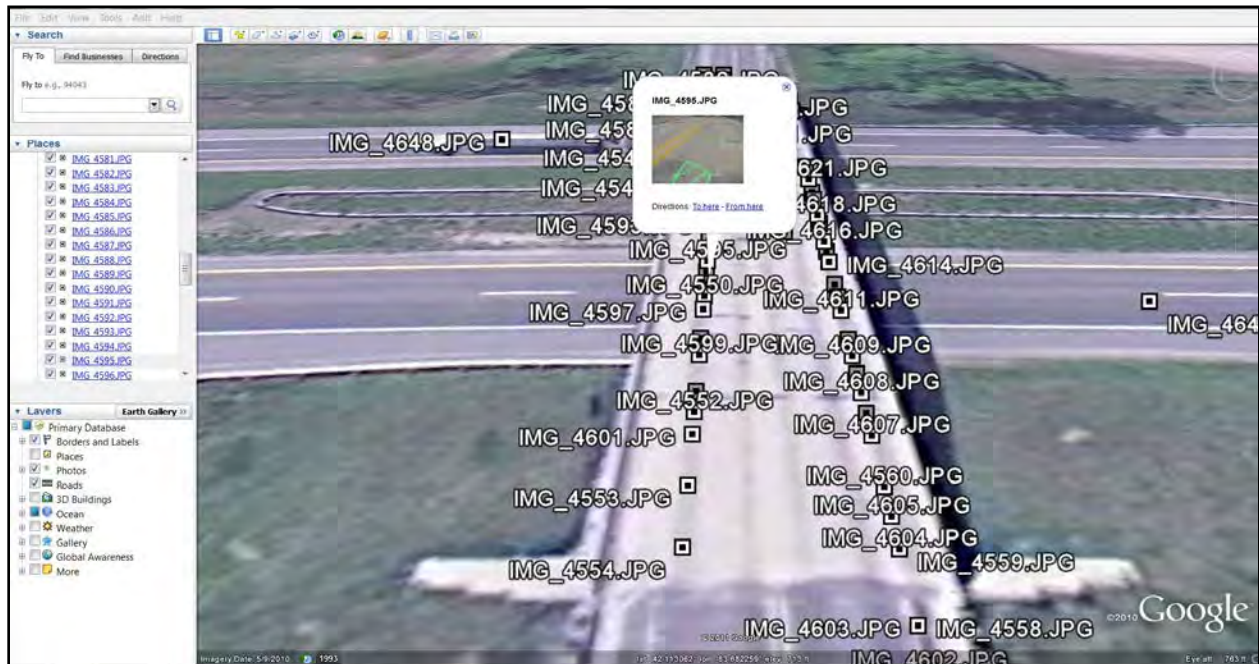
watermarked photos with user friendly geospatial environments such as Google Earth. Figure 5-5 shows the BVRCS photos being displayed in Google Earth. There were about 100 photos taken of each bridge and after processing the photos, each bridge used about 58 MB of space. These photos have also been integrated into the project's DSS. The DSS user can click on the photo point and bring a full-resolution picture taken at that location. As geo-tagged photo inventories are taken over time, such as during regular inspections every two years, these can be used to track and understand changes in the bridge deck condition.

**Figure 5-5:** Example of the location of the digital photographs being displayed in Google Earth; each box contains a hyperlink to a full-resolution view of the photo taken at that location.

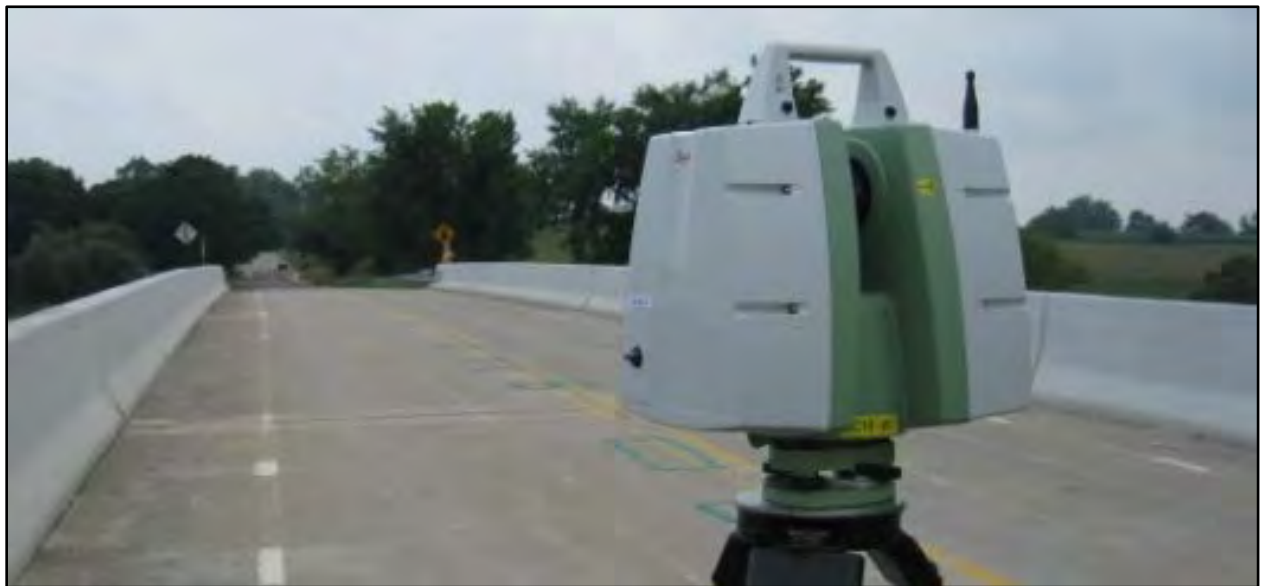
Terrestrial LiDAR uses a scanner unit, often mounted on a tripod, to scan a target area from a single vantage point at a time (Figure 7-2). When the scan is complete the unit is moved to the next pre-determined location until the project is complete. Scans are then registered to align the data using survey-grade GPS data (<10 cm accuracy) collected as part of the LiDAR effort, and then the scans are saved as a 3D point cloud which can be viewed using software capable of viewing LiDAR data. The multiple setups required to scan a structure or area take time but all sides of a structure such as a bridge or building can be represented in high definition.

**Figure 7-2: An example terrestrial LiDAR scanner used to collect 3D data of the project’s demonstration bridges. The unit was deployed by the project’s Michigan DOT partners.**
