**BRIDGE CONDITION ASSESSMENT  
USING REMOTE SENSORS**

United States Department of Transportation  
Research and Innovative Technology  
Administration

Michigan Technological University

**Volume I of II – Main Body**

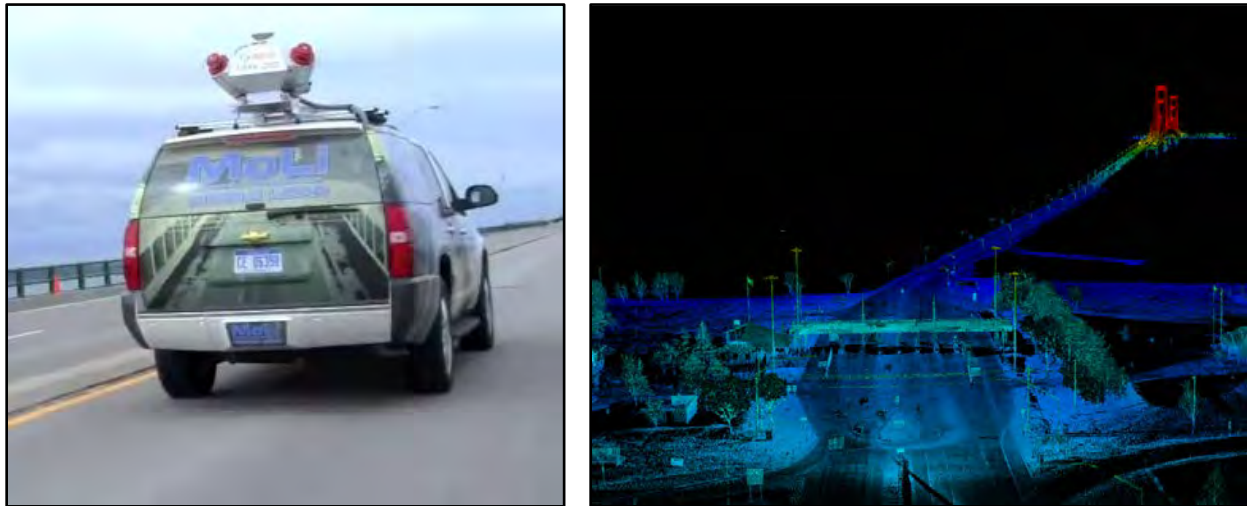
Mobile LiDAR is an adaptation of airborne LiDAR and terrestrial LiDAR hardware and software that allows LiDAR scanners to be mounted on a van or boat and collect data while the sensor is

in motion over a road, railway or waterway (Figure 7-3). Some of the advantages of using mobile LiDAR for data collection are faster data collection, data can be collected at off-hours, improved safety for survey crews and a reduced necessity for lane closures which minimizes the impact of data collection on traffic.

**Figure 7-3: SSI Surveying Solutions Mobile LiDAR (MoLi) truck and LiDAR scan of the Mackinac Bridge and toll plaza.**

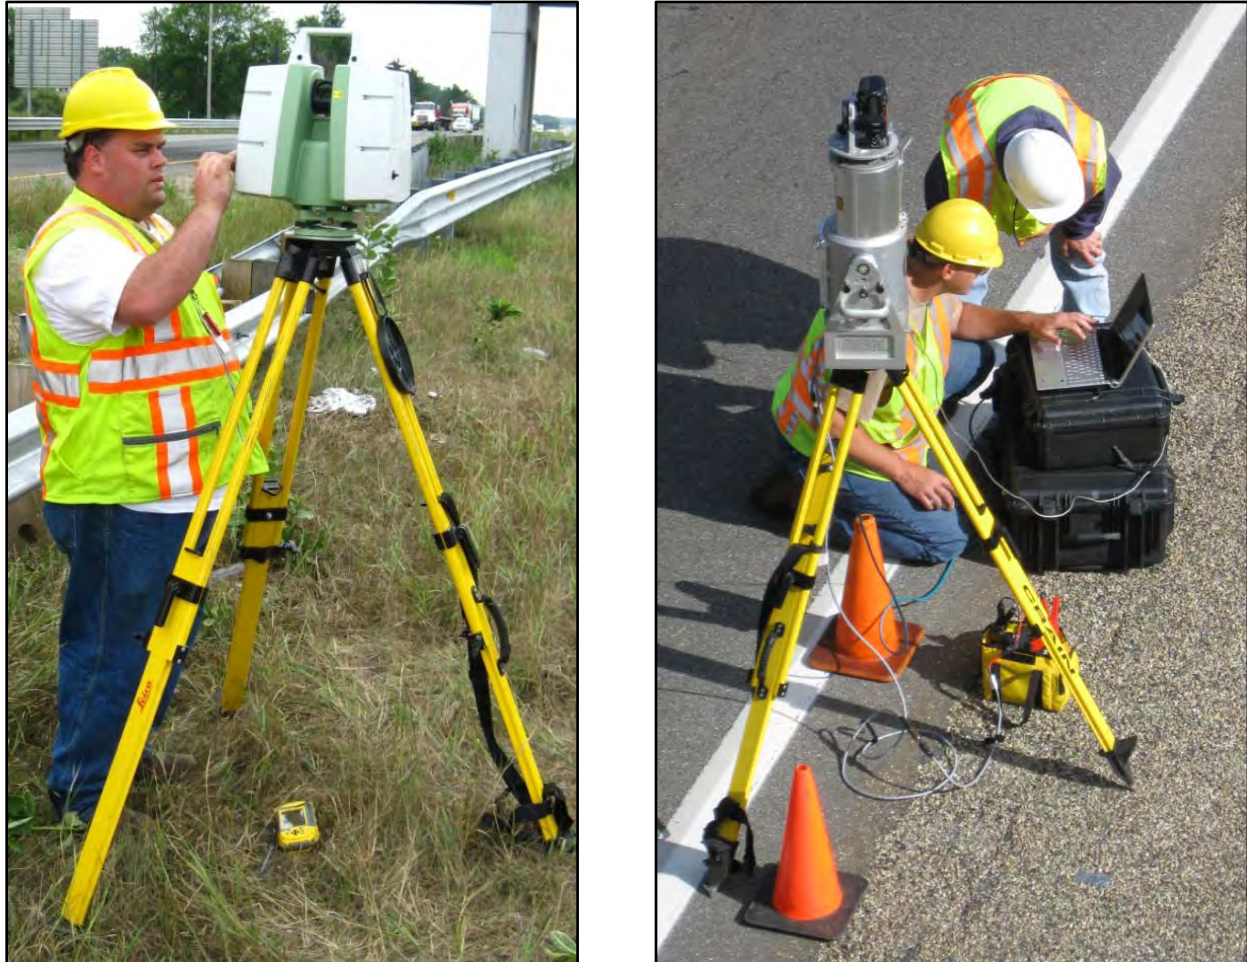
LiDAR scans of the study areas were performed by an MDOT LiDAR crew during the field campaigns in August 2011 at the Freer Road, Willow Road, and the two Mannsiding Road bridges (Figure 7-4, left image). Twenty scanner setups were performed at the Freer Road site, eighteen setups were performed at Willow Road, and twelve setups each were performed for Mannsiding Road over NB (eastern lanes) and SB (western lanes) lanes of US-127. A ScanStation C10 terrestrial scanner owned by MDOT was used by the survey crew to collect LiDAR data for this study. Scanner setup locations were selected to provide the best possible coverage of the bridge structure with the fewest shadowed areas. Retroreflectors used by the survey crew to register the scans to each other were placed around the bridges. The location of each retroreflector and scan site was recorded using high resolution, survey-grade Leica GPS tied to the State of Michigan CORS (Continuously Operating Reference Station) network (for more information on CORS, see Snay and Soler 2008). Field sketches were made by the survey crew that documents the relative location of the retro-reflectors and scanner setups to each bridge (Figure 7-5). The sketches also contain information about the scanner settings at each scan setup. The LiDAR scans acquired from setups at each study site were merged together into a single registered and geo-referenced point cloud by the MDOT survey crew using Leica Cyclone software. MDOT provided the LiDAR data for each bridge to MTRI as a single registered, geo-

**Figure 7-4: Typical terrestrial LiDAR units; MDOT’s ScanStation C10 and MTU’s Riegl LMS-Z210ii.**

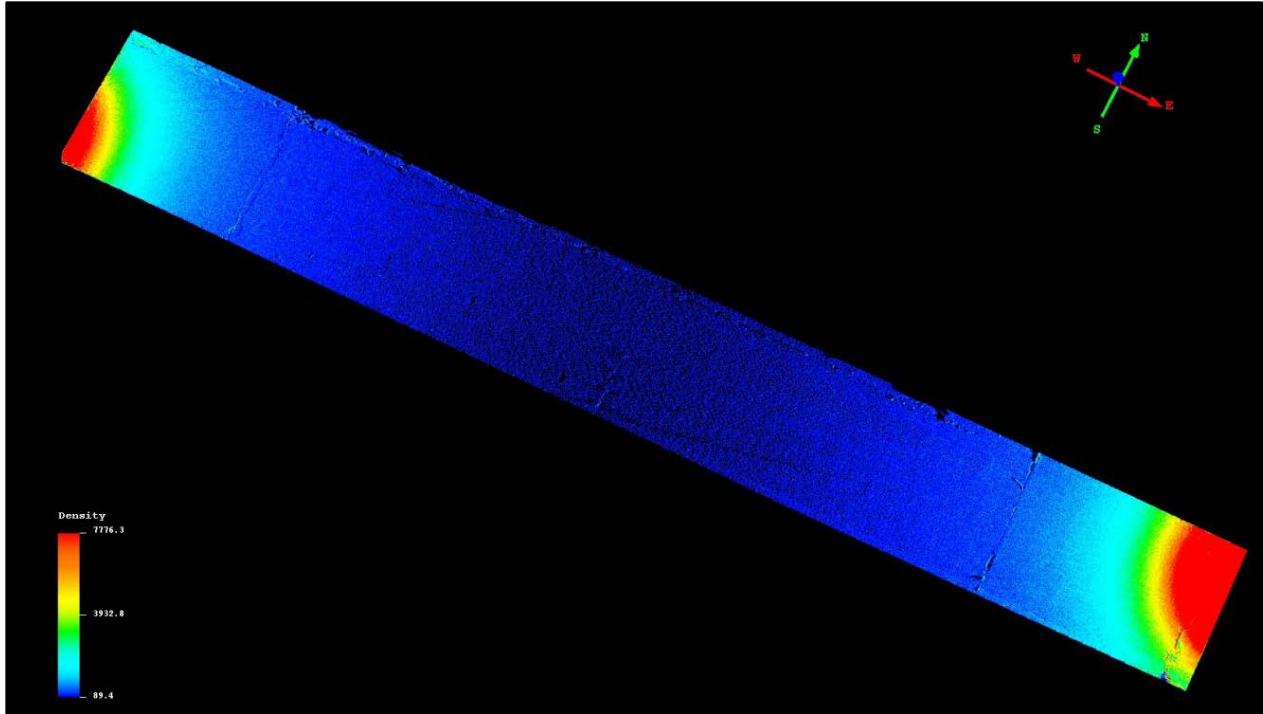
**Figure 7-9: Point cloud density image of Willow Road bridge span over US-23. Note the dramatic fall-off in density of points from ends to center (red to blue, high to low). Features in the blue central areas are unlikely to be able to be resolved successfully.**

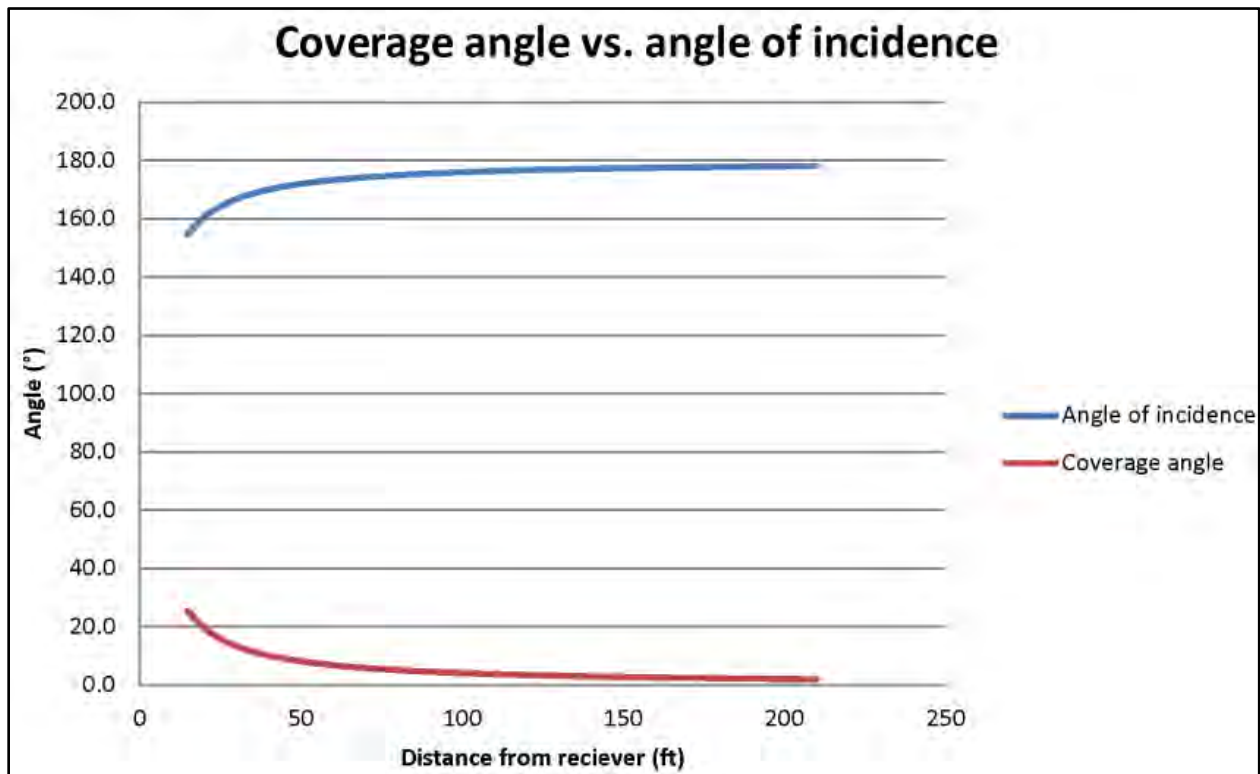
Figure 7-19: The coverage angle and angle of incidence as the distance from the scanner increases.

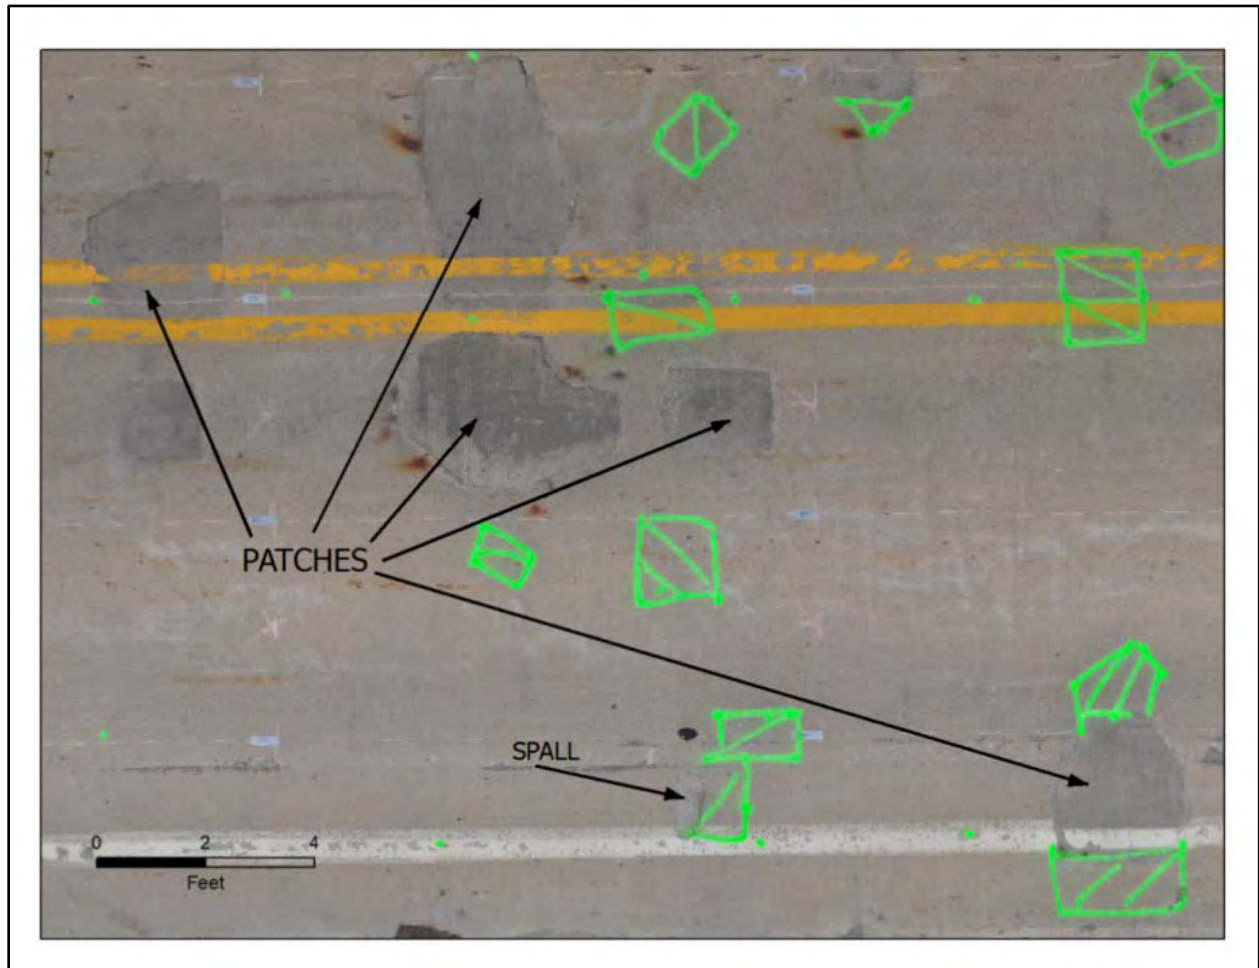
**Figure 7-20: Section of the ortho-photo of the Willow Road bridge deck illustrating patches and a spall. The green pavement markings outline areas of subsurface delamination as determined by inspection performed by MDOT bridge inspectors using the hammer (metal rod) sounding technique.**

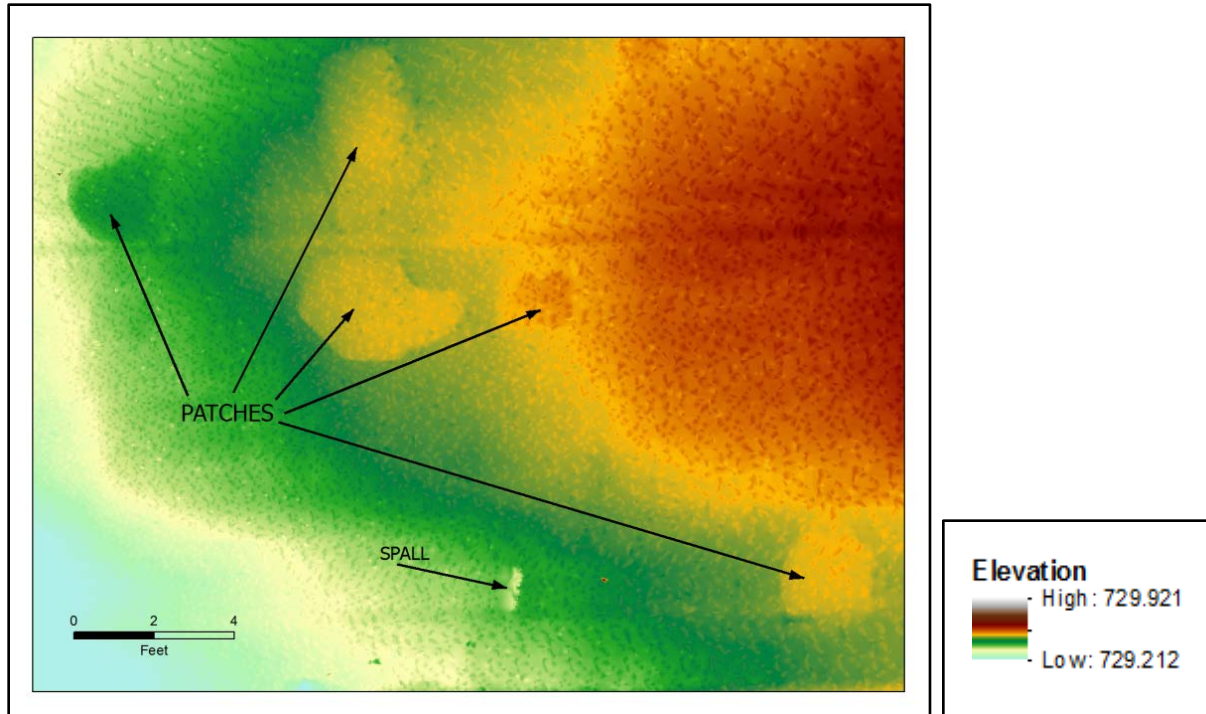
**Figure 7-21: DEM with a color ramp applied of the same area of the Willow Road bridge deck. Note that the higher areas of the concrete patches and missing material from the spall correlate well between the ortho-photo and DEM. The patches (correctly) appear higher than the surrounding bridge deck and the spall appears lower than surrounding deck.**

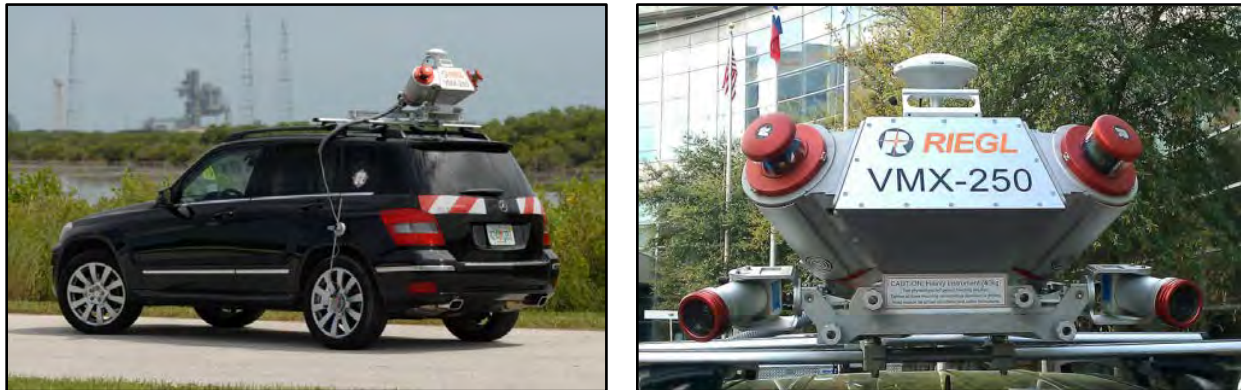
Mobile LiDAR is a vehicle-mounted LiDAR data collection system that creates a point cloud along a path followed by the scanning vehicle (Tao and Li 2007). A typical mobile LiDAR scanning unit consists of two LiDAR scanners, an Inertial Navigation System (INS), and a high accuracy GNSS (Global Navigation Satellite System, such as GPS, the US-run Global Positioning System) receiver mounted on a vehicle. The integrated scanning unit is most often mounted on the roof of a full size vehicle, although the systems can be mounted on boats or rail equipment, depending on the requirements of the project (Figure 7-23). The scanners are mounted at an angle that allows each scanner to “see” areas not visible to the other, which improves the coverage of the LiDAR point cloud. A data cable runs between a control unit mounted inside the vehicle and the roof mounted measuring head which contains the scanners, GNSS and INS (Figure 7-23, right).

**Figure 7-23: The VMX-250 scanner mounted on an SUV. Image on the right shows a close-up of the scanner heads, GNSS receiver, and Processing/Inertial Navigation Unit.**

the sensor can be detected. A typical working range is 75-100 m, but the density to detect most spalls is likely to be shorter. Point cloud density and sample rate can be adjusted based on project requirements; some scanner setups can collect up to ~500,000 pps (two scanners at 250,000 pps each, such as the Riegl VQ-450 and VMX-250).

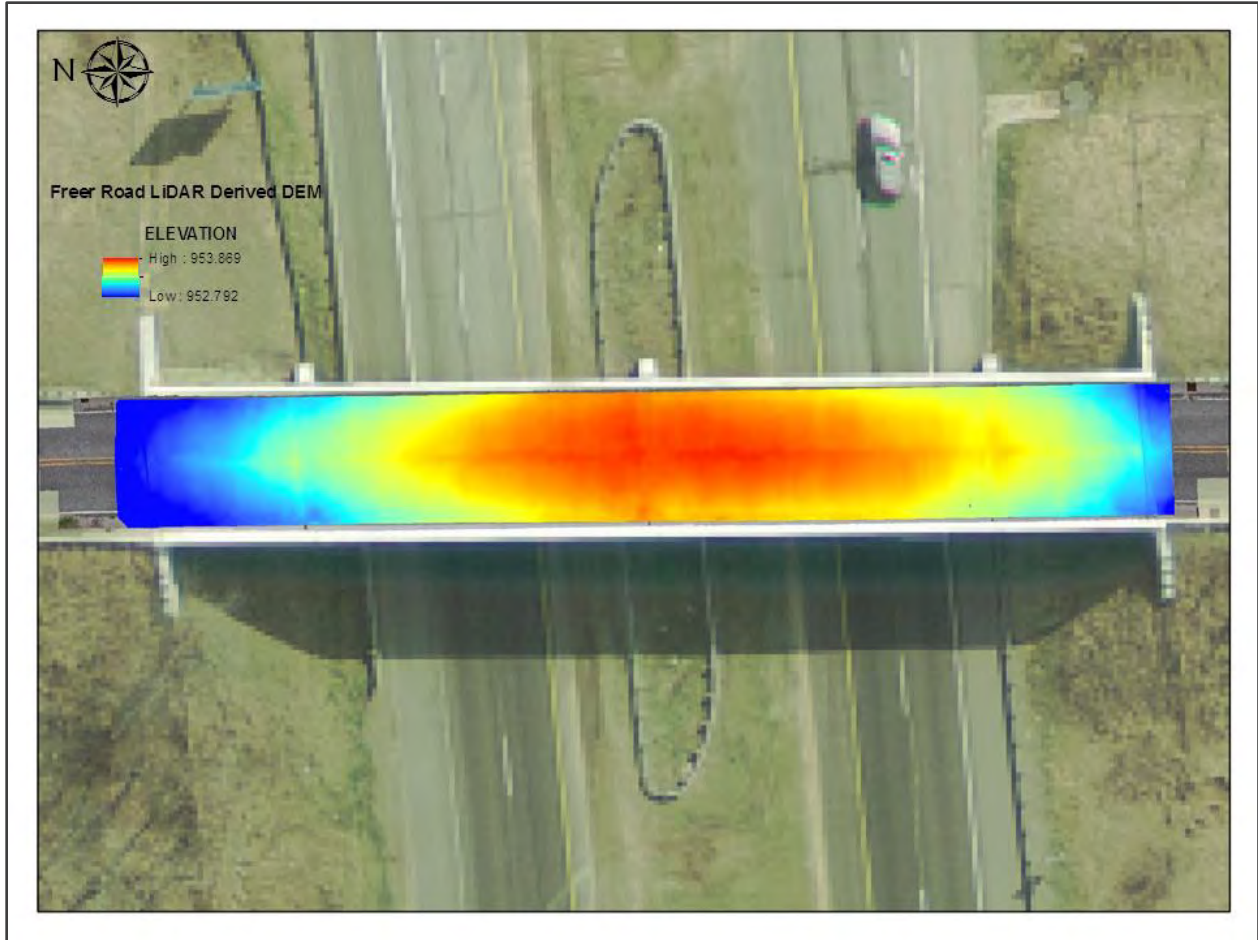
**Figure 7-28: The Freer Road bridge deck DEM over one foot per pixel aerial imagery and the high resolution orthophoto of the Freer Road bridge deck. The DEM is approximately 220 ft long with a spatial resolution of 3 cm per pixel.**

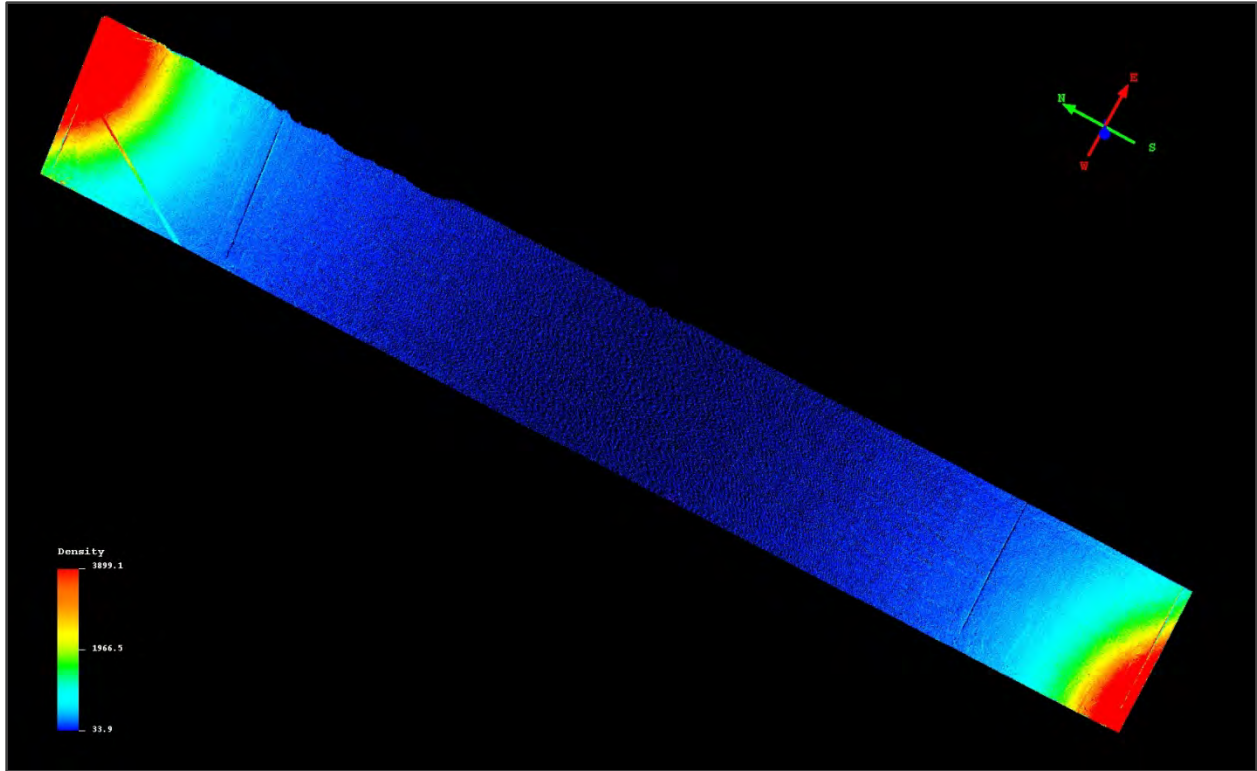
**Figure 7-29: Freer Road bridge deck point cloud density map. The rapid falloff in point cloud density (red high density to blue low density) with distance from the LiDAR scanner is clearly visible.**

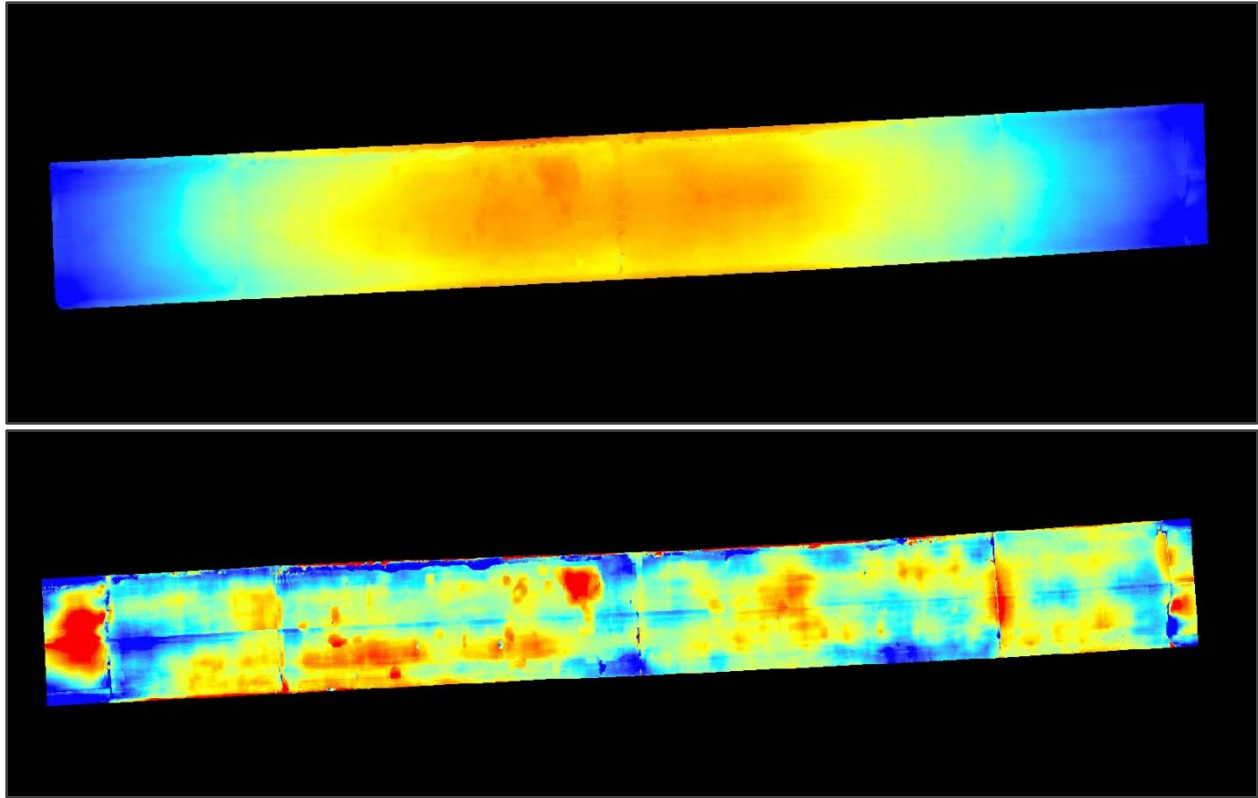
**Figure 7-30: A comparison of DEMs derived from LiDAR data (top) and the 3DOBS close range photogrammetry system (bottom).**

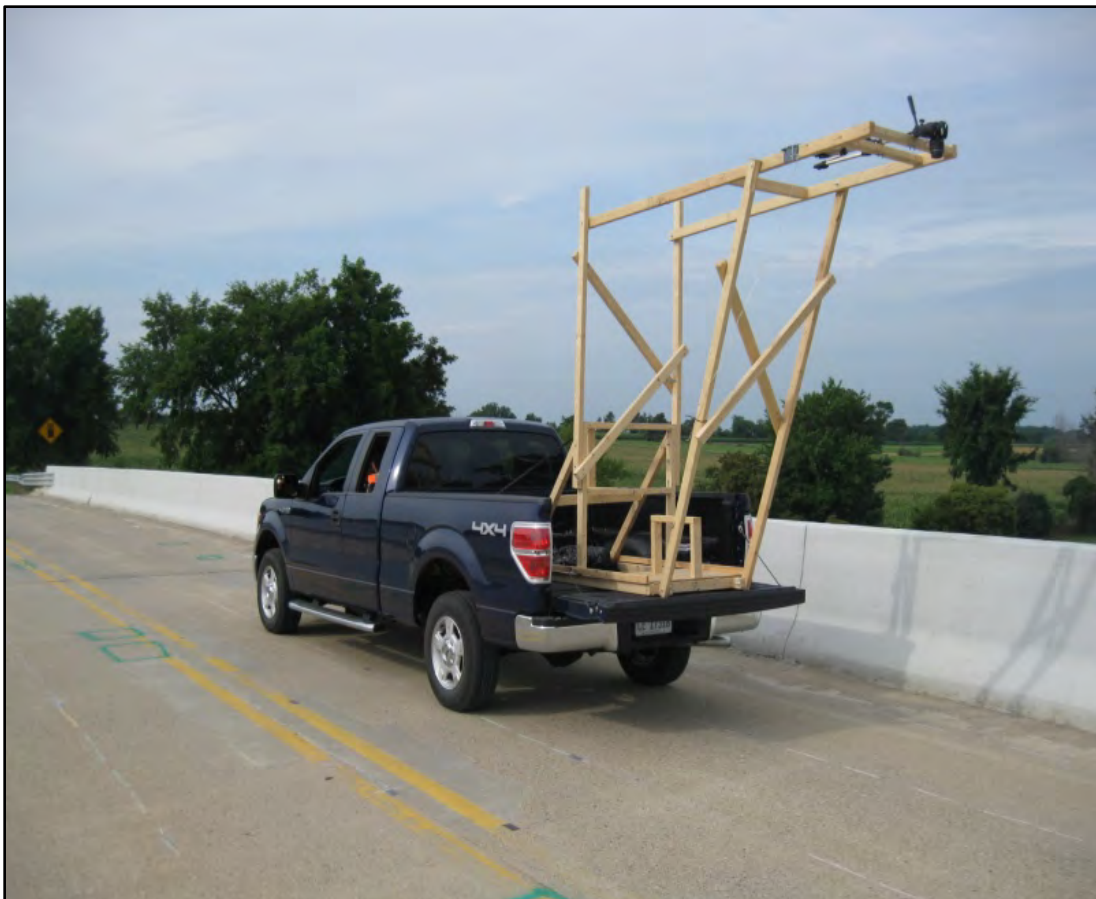
High resolution DEMs created through 3DOBS, were used to compare to the LiDAR DEMs. 3DOBS utilizes close range photogrammetry to generate 3D models from stereo pairs of electro-optical (EO) imagery. The developed models provide depth and height information that could not otherwise be determined from individual EO images. A DSLR, high-quality camera is the main component of the field system. The system implemented during the field demonstration consisted of a D5000 DSLR camera, vehicle mount and a camera triggering device as shown in Figure 7-31 (de Melo e Silva and Brooks 2011).

**Figure 7-31: 3DOBS data collection system field demonstration**

MTRI conducted laboratory testing on 3DOBS; the results showed that the technology is capable of detecting vertical changes 0.079 in (2 mm) in depth, and even smaller with certain configurations. With the current bridge inspection standard of 0.25 in (6.35 mm) for minimum consideration criteria of an elevation change to be a potential spall, the 3DOBS technology exceeds the established criteria (de Melo e Silva and Brooks 2011).

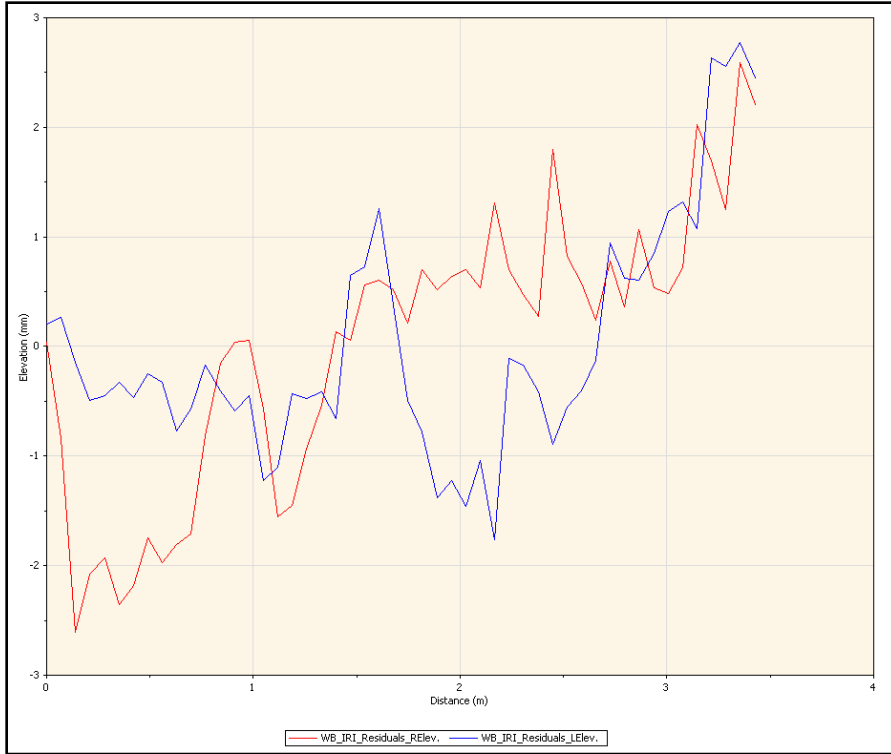
File	Profile	IRI (m/km)
➤ WB_IRI_Residuals	LElev.	1.38
	RElev.	1.17

Figure 7-39: The residual longitudinal profile and IRI values of Willow Road Bridge.

The first revision incorporated residuals calculated from the LiDAR longitudinal profiles. The residual plots were meant to represent the bridge deck surface roughness and therefore lower the IRI values. However, after completing the analysis the IRI values were reduced to 1.38 m/km and 1.17 m/km; values associated with airport runways and superhighways (Figure 7-39). A potential source of IRI error in the LiDAR measurements is the decrease in point cloud density with distance from the scanner as discussed previously. As the distance from the sensor increases, the point cloud density decreases. As a result, the problem may exist because as the profile line transects the data, it is not able to collect as much data towards the middle of the bridge. To resolve this, elevation data was collected closer to the sensor's location and in a smaller quantity. This was demonstrated by using a line segment of 3 m located near the highest point density. Once the shorter segment data was extracted from the DEM and processed through the two models, the IRI results improved to more likely values, similar to the 3DOBS results. The longitudinal profile still looked different from the 3DOBS profile, but produced IRI values of 4.56 m/km and 4.86 m/km (Figure 7-40). Both of these values would place the deck surface into the older pavement category.

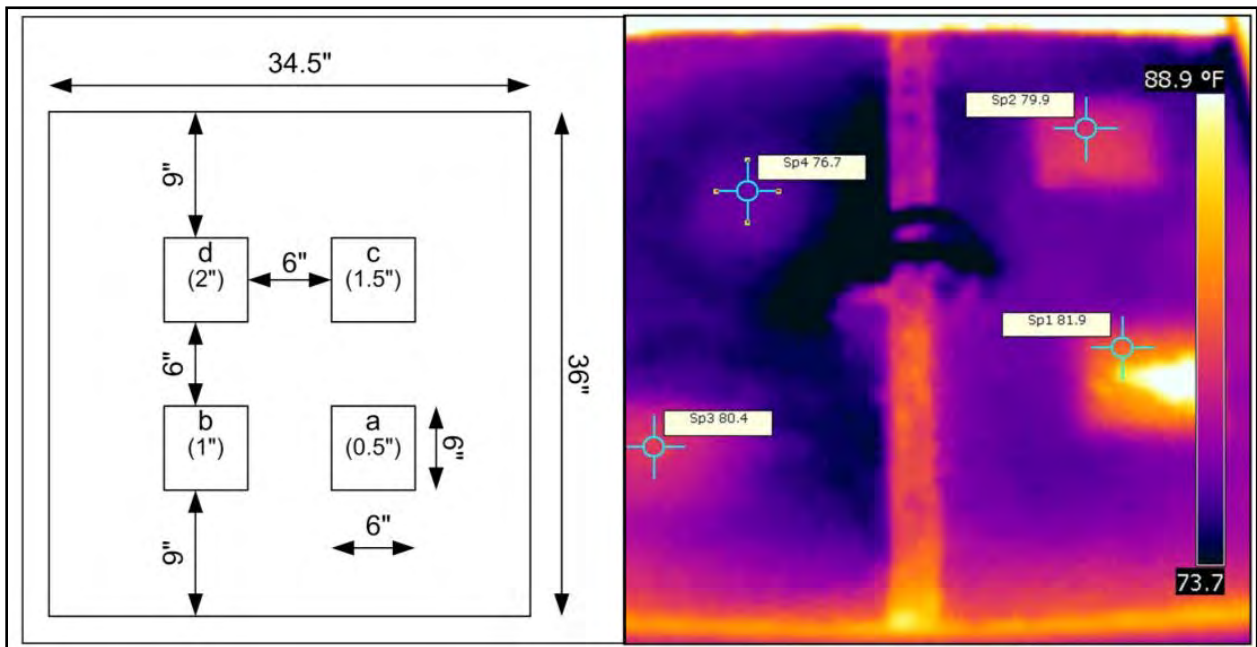
Figure 8-6: Plan layout of the concrete slab with simulated delaminations and the thermal IR image showing the temperature data placed at different depths; 0.5, 1, 1.5 and 2 in.

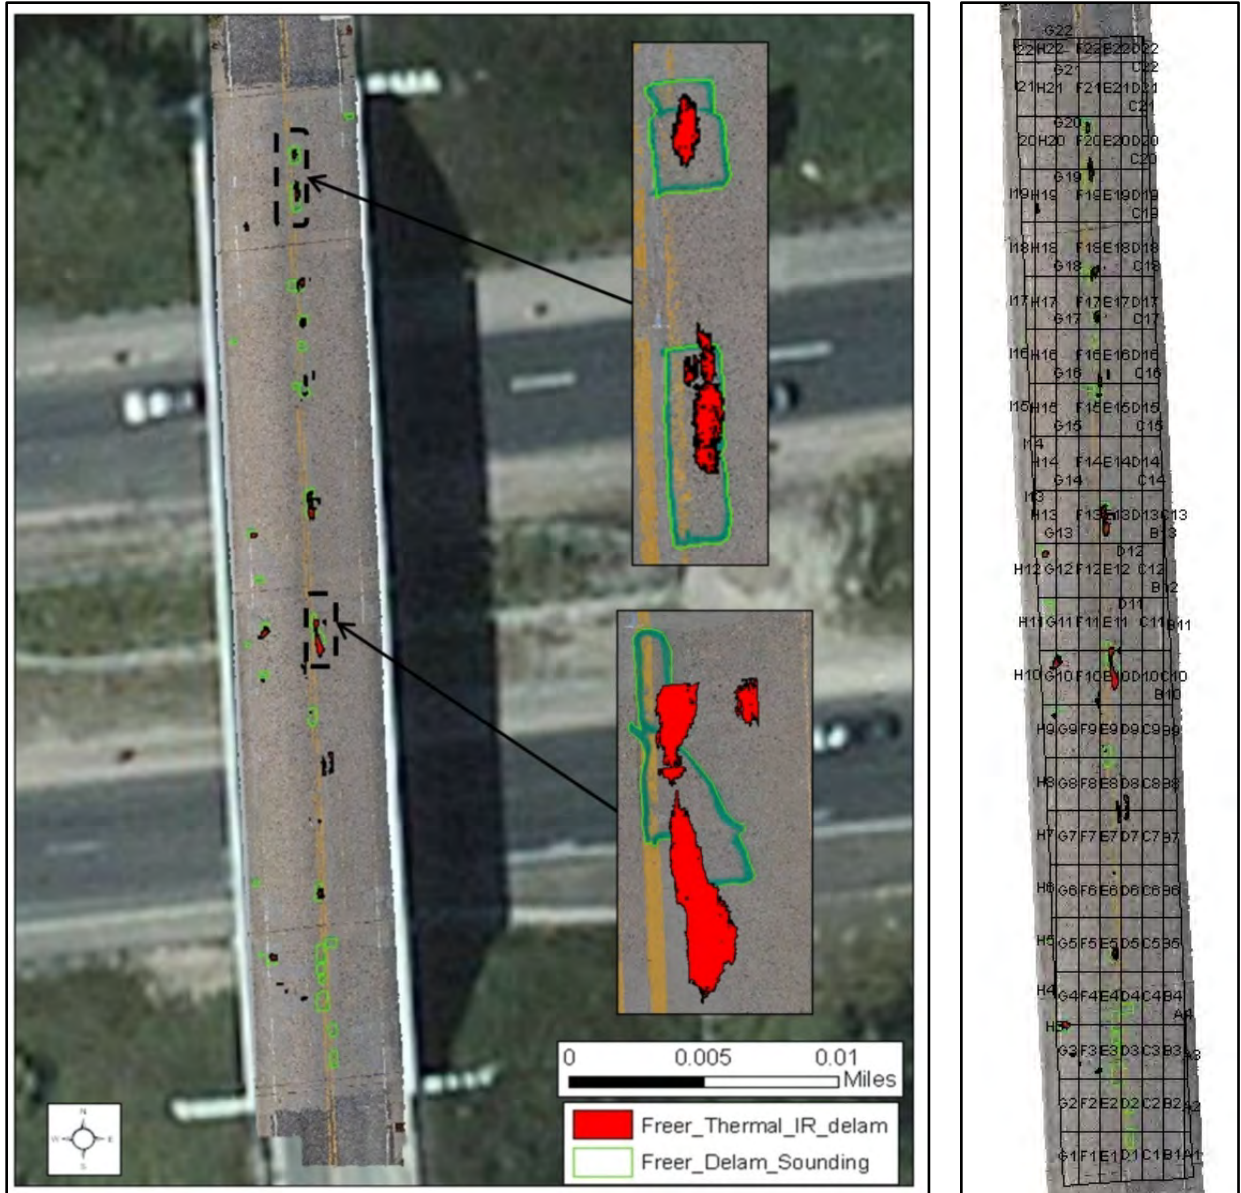
Figure 8-14: Thermal IR and sounding delamination map and the virtual grid pattern over the Freer Road bridge displayed on ArcGIS.

Figure 8-14 shows the thermal IR and hammer sound delamination maps for Freer Road bridge displayed as two layers on ArcGIS. The main cause of variation between the results of the MDOT and Thermal IR surveys on the Freer Road bridge is that most of the delaminations on this bridge were around the construction joint and overlapped with the painted centerline on the bridge deck. Reflective paint on the bridge deck has lower emissivity than concrete; therefore, it will appear on the thermal IR image with lower temperature and cause some difficulties in detecting delaminations in those areas. Also, delaminations are most likely to occur around spalled or patched areas, which can help to detect exact location of delaminations based on the thermal IR and optical images.

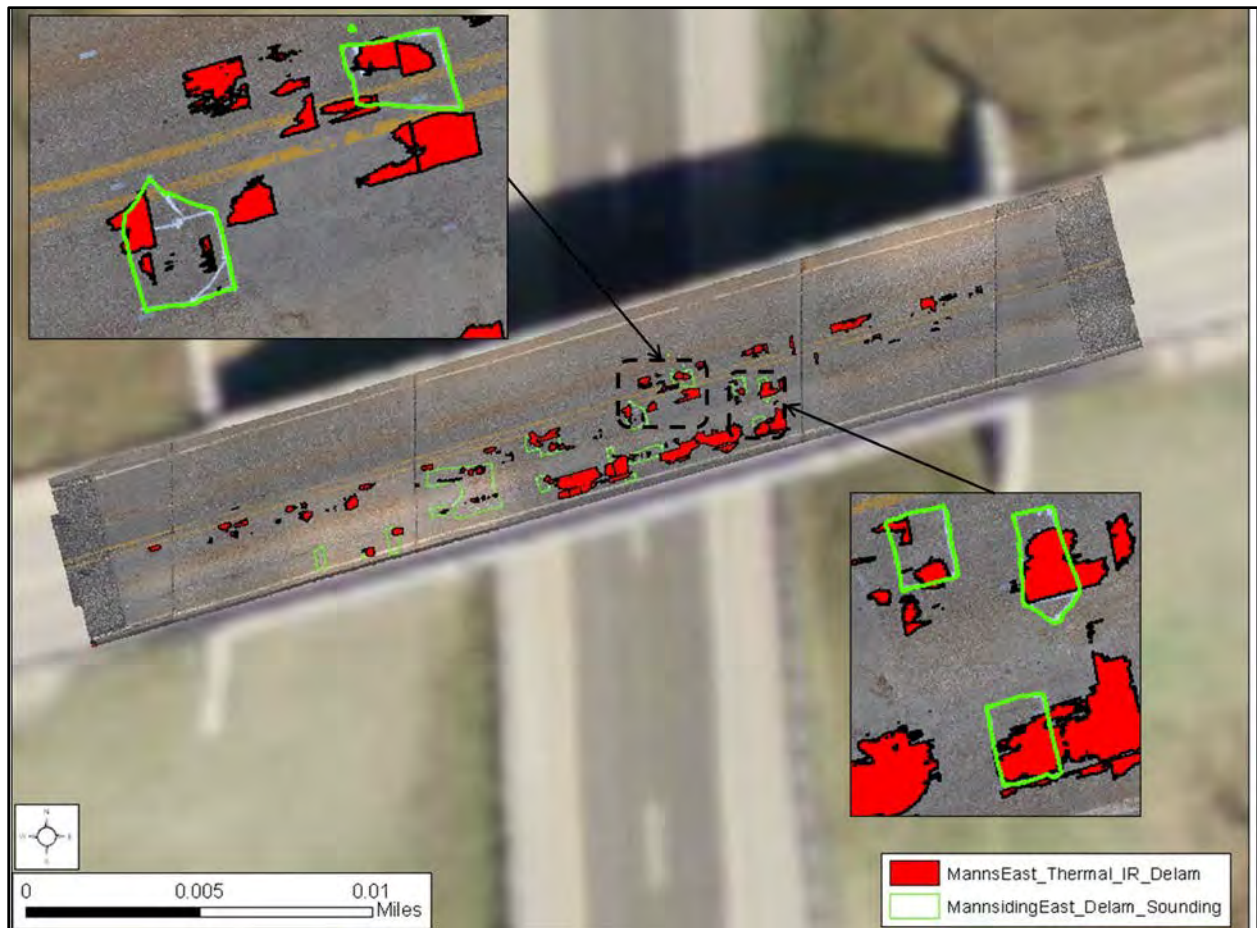
Figure 8-17: Thermal IR delamination map and sounding delamination map of Mannsiding Road bridge displayed in ArcGIS.

Figure 8-17 shows thermal IR and hammer sound delamination maps for Mansiding Road NB on ArcGIS. Similar to the other two bridges, there are some variances between the results of these two techniques that are demonstrated in this figure. A virtual grid pattern, similar to the aforementioned bridges, was created on ArcGIS to compare the results of the two inspection methods considered in this study (Figure 8-18).

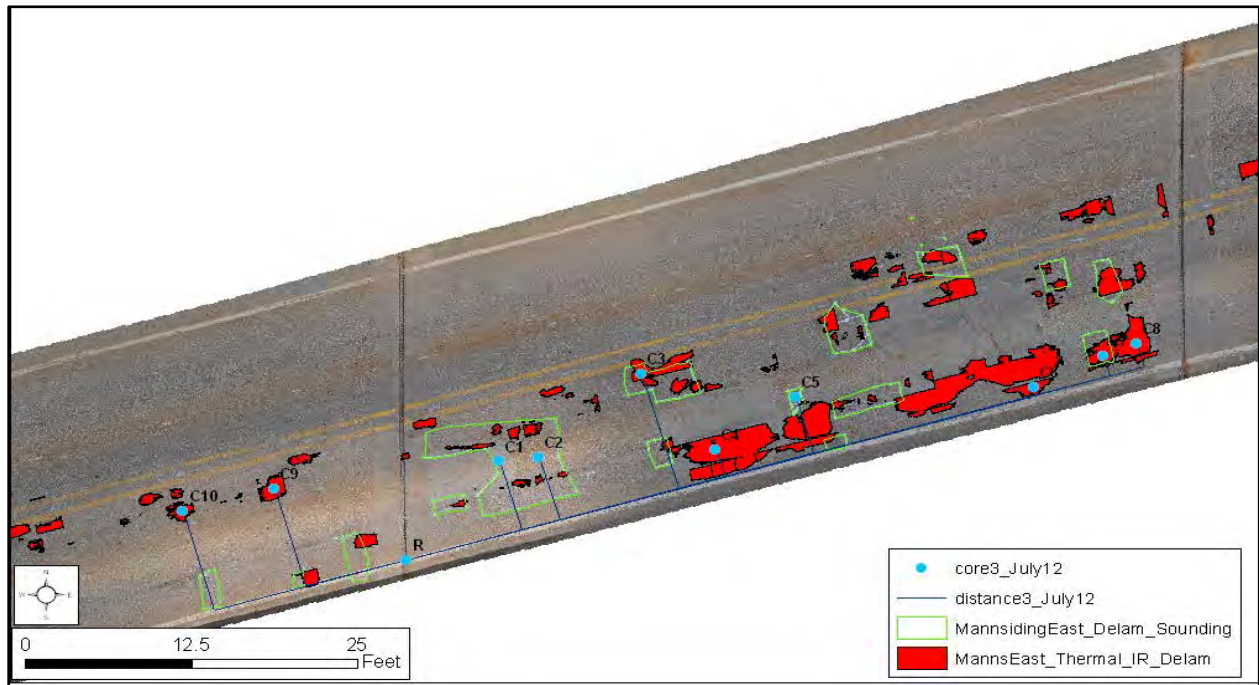
Figure 8-20: Coring plan (blue dots) for Mannsiding Road bridge.

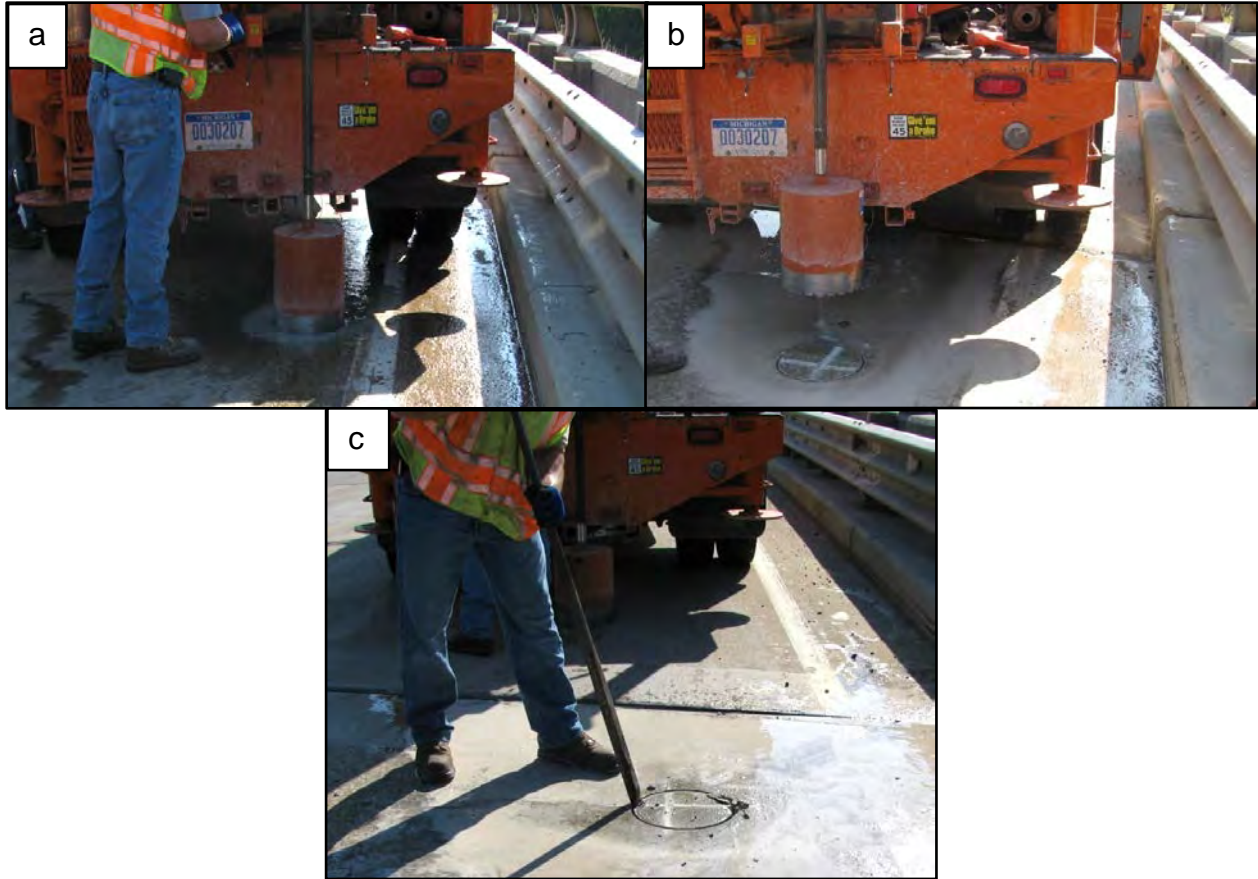
Figure 8-21: Drilling a core on the bridge deck (a), pulling out the drill (b), and pulling out the core with a pry bar (c).

Cores were obtained on the bridge deck by drilling the concrete and pulling out the core with a pry bar. On those locations that no delaminations were present, MDOT inspectors were not be able to extract the cores out. Figure 8-21 shows the coring procedure and Figure 8-22 shows the cores extracted from the bridge deck.

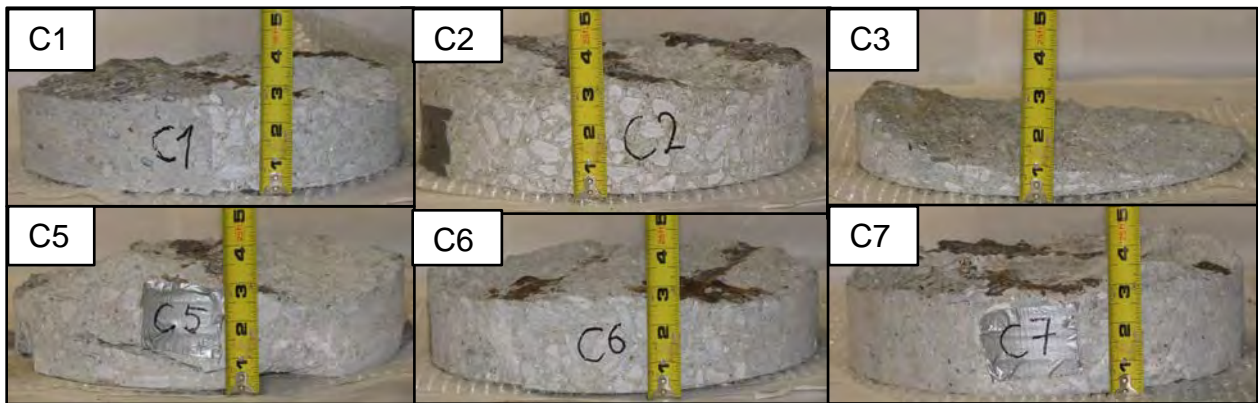
Figure 8-22: Six of the 10 cores extracted from the Mannsiding Road bridge deck.

The depth of delamination and repair condition for each core is summarized in Table 8-4. Seven out of the 10 cores showed visible damage. Four out of seven delaminated cores were evident in Thermal IR results. Cores C2 and C5 were 3 in or deeper (3.125 in), thus no delaminations were detected with Thermal IR. This result may be due to the effects of time of data collection and/or overcast conditions.

Cores C4, C9 and C10 were intact (therefore not included in Figure 8-22) and no delaminations were found within the 3.5 in of the top surface for these locations. The reasons for not properly distinguishing between the delaminated and solid (sound) areas in these locations (C4, C9, and

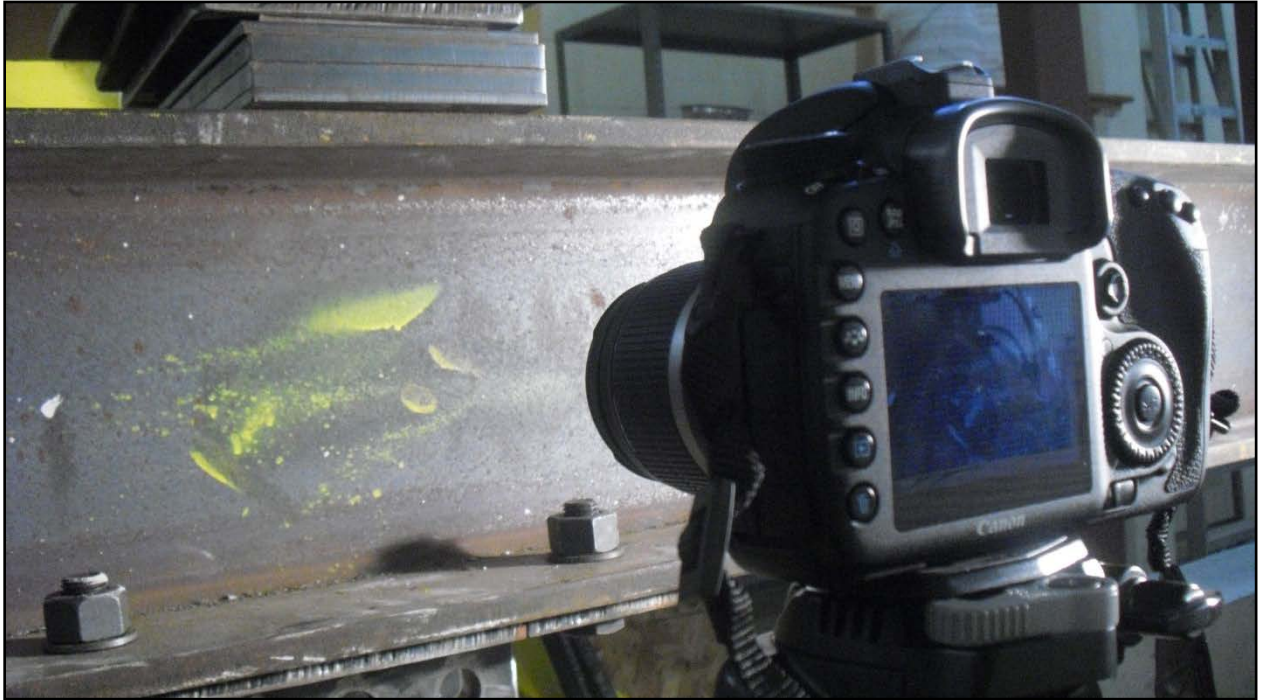
Figure 9-9: DIC Setup for steel W shape (I beam).

Therefore, several tests were done to obtain these measurements. A 16 ft simply supported W10 x 60 steel beam (I-shaped) was subjected to simple flexural tests in the laboratory at varied frequencies and loading capabilities. There was a speckle pattern sprayed on the surface for detection of the pixels during the computer processing. The EOS 7D camera was used with a lens at a focal length of 55 mm. This can be shown in Figure 9-9. This DIC results showed results that agreed well with a linear variable differential transformer (LVDT) that was placed at the mid span location where images were taken. A figure of the sample results from test can be

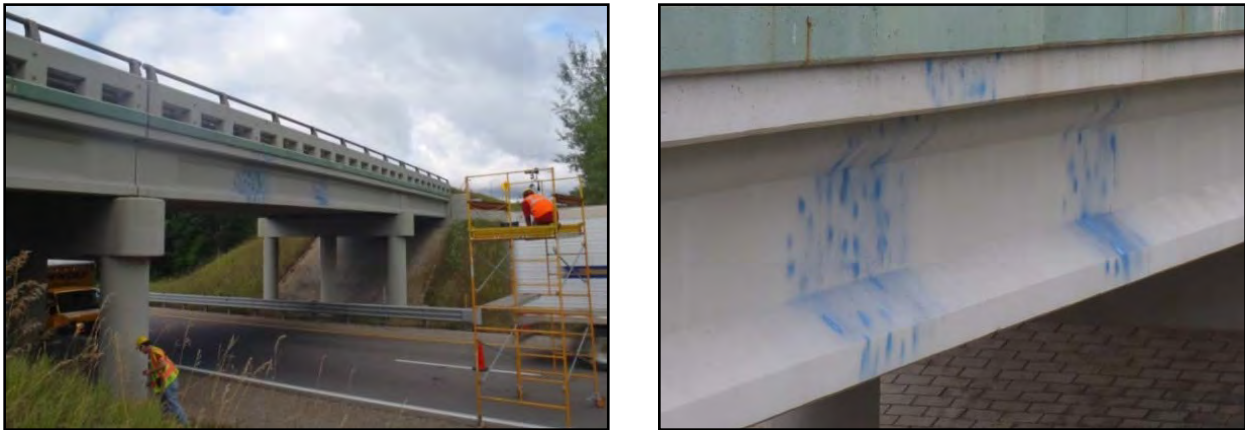
Figure 9-12: DIC setup at Mannsiding Road bridge and detail of girder with speckle patterns.

A MDOT bucket truck was used for the creation of these larger and smaller refined marks constituting the speckle pattern which are necessary for tracking pixel movement using DIC (Figure 9-12). A washable water-based spray paint was used for the creation of a speckle pattern on the exterior girder.

The EOS 7D camera was placed at a 20 ft standoff distance from the target surface on a rigid tripod (4.25 ft) located on a scaffolding platform (10 ft). The overall height of 14.25 ft placed the camera perpendicular with the exterior girder (Figure 9-12 and Figure 9-13). The predetermined bridge span was stressed by both a quasi-static and dynamic live-load generated by a live-load test truck. A live load truck with a weight of 57 kip (Figure 9-13) was used during load testing. The truck was guided along the exterior lane path at a crawl speed below 10 mph.

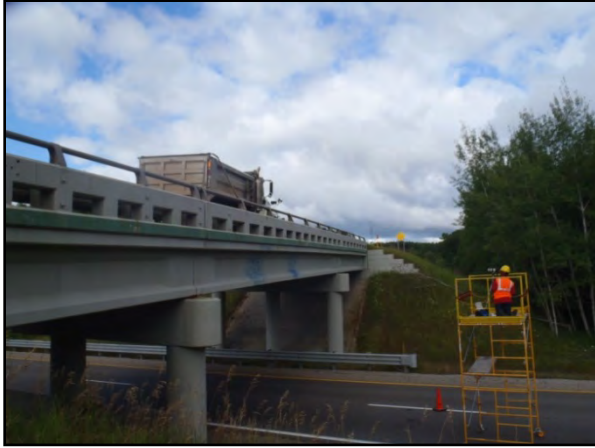
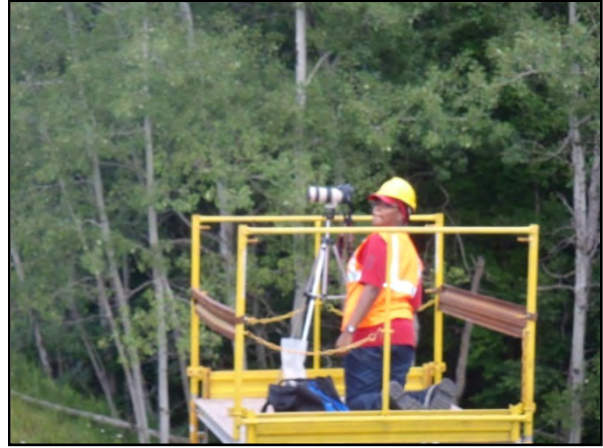
**Figure 9-13: Load truck going over bridge (left) and close-up of camera and tripod setup on scaffolding (right).**

During loading, images were captured by the EOS 7D camera with an EF 70-200 mm lens on the exterior girder at the quarter span and mid-span location. This test was repeated three more times with two of those cases remaining at focal length of 85 mm and the third was at a focal length of 140 mm.
