**BRIDGE CONDITION ASSESSMENT  
USING REMOTE SENSORS**

United States Department of Transportation  
Research and Innovative Technology  
Administration

Michigan Technological University

**Volume I of II – Main Body**

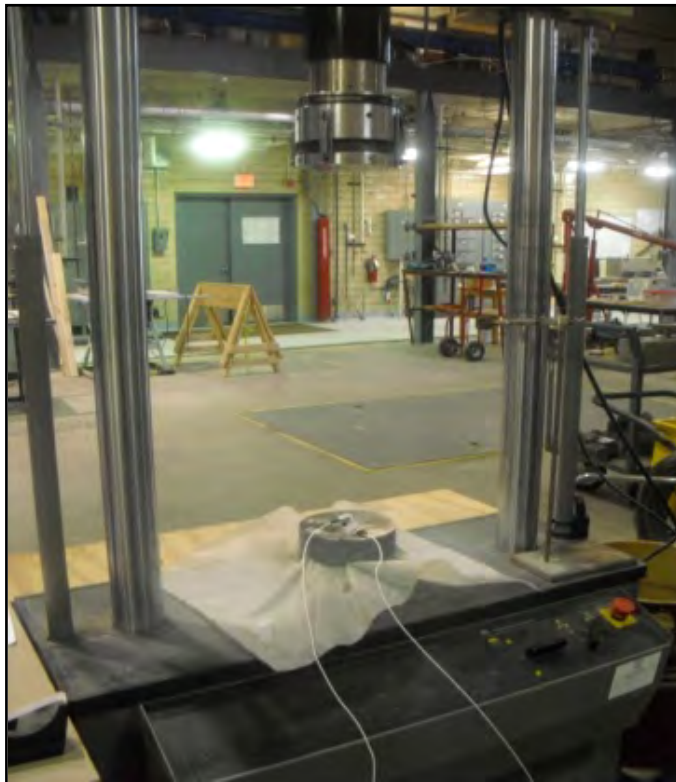
**Figure 9-20: Accelerometers on the 810 Material Test System.**

The challenges related to equipment stability prompted further investigation into the processing algorithms and a more stable data collection system. The 810 Material Test System was used again to monitor movement with a PCB Piezotronics 333B50 piezoelectric accelerometer and transform (integrate) those readings into displacement (Figure 9-20). Using the 810 Material Test System, a known displacement measurement can be used and therefore an easier integration into displacement measurements can be obtained. Measuring this data can enable a measurement of environmental noise (e.g., vibration or movement on the camera) that can be factored out to capture the true bridge movement measurement (Figure 9-20). The accelerometers were connected to a Campbell Scientific CR9000X Measurement and Control System in which results were collected, filtered through, and presented graphically.

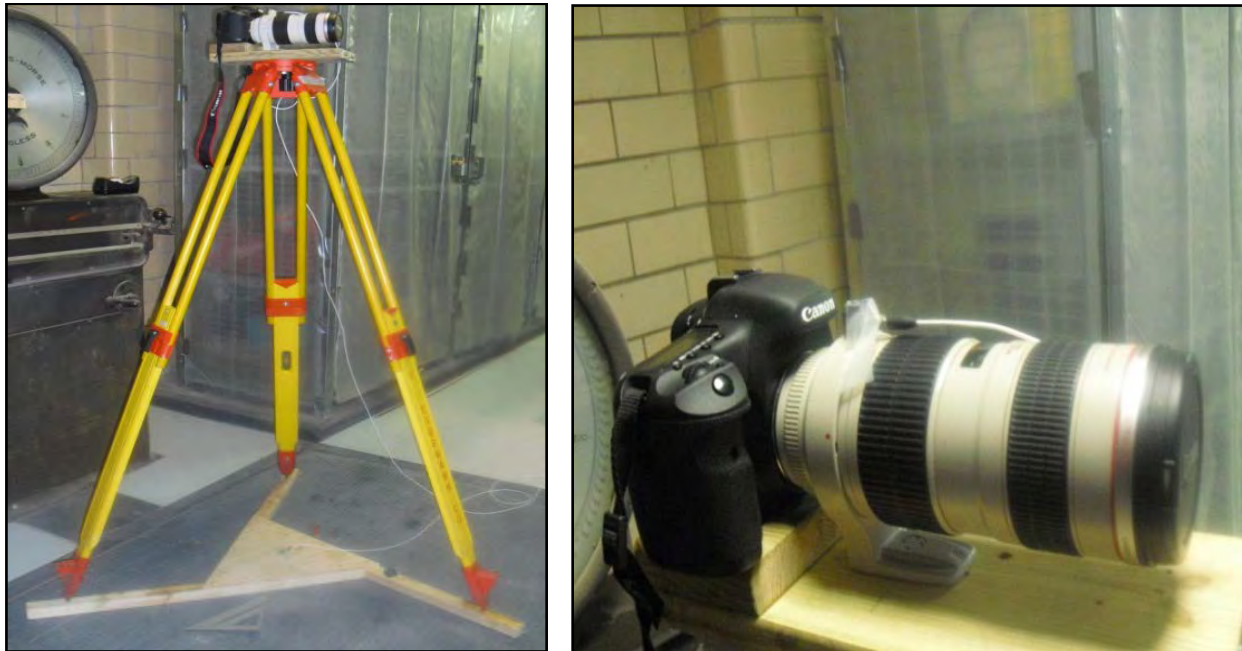
**Figure 9-23: Camera on stable tripod (left) and detailed of mounted accelerometer (right).**

system (as used in DIC system) was connected with an accelerometer in order to measure the excessive movement endured and computed the movement as displacement. In this setup, a more stable and heavier surveying tripod as well as a wooden base ensuring a flat secure platform for the camera–lens system was employed. An additional accelerometer was also placed at the bottom of the tripod for location comparisons at the top and bottom of the tripod. These figures of the tripod and camera-lens setup can be shown in Figure 9-23.

The measurements of the camera movement(s) have shown similar results as in the testing system’s data, but there were more unknown factors to consider in the acceleration measurement. The calculated position (displacement) measurement for this scenario reveals some alteration in what is expected and other parameters may have to be recognized in the setup.

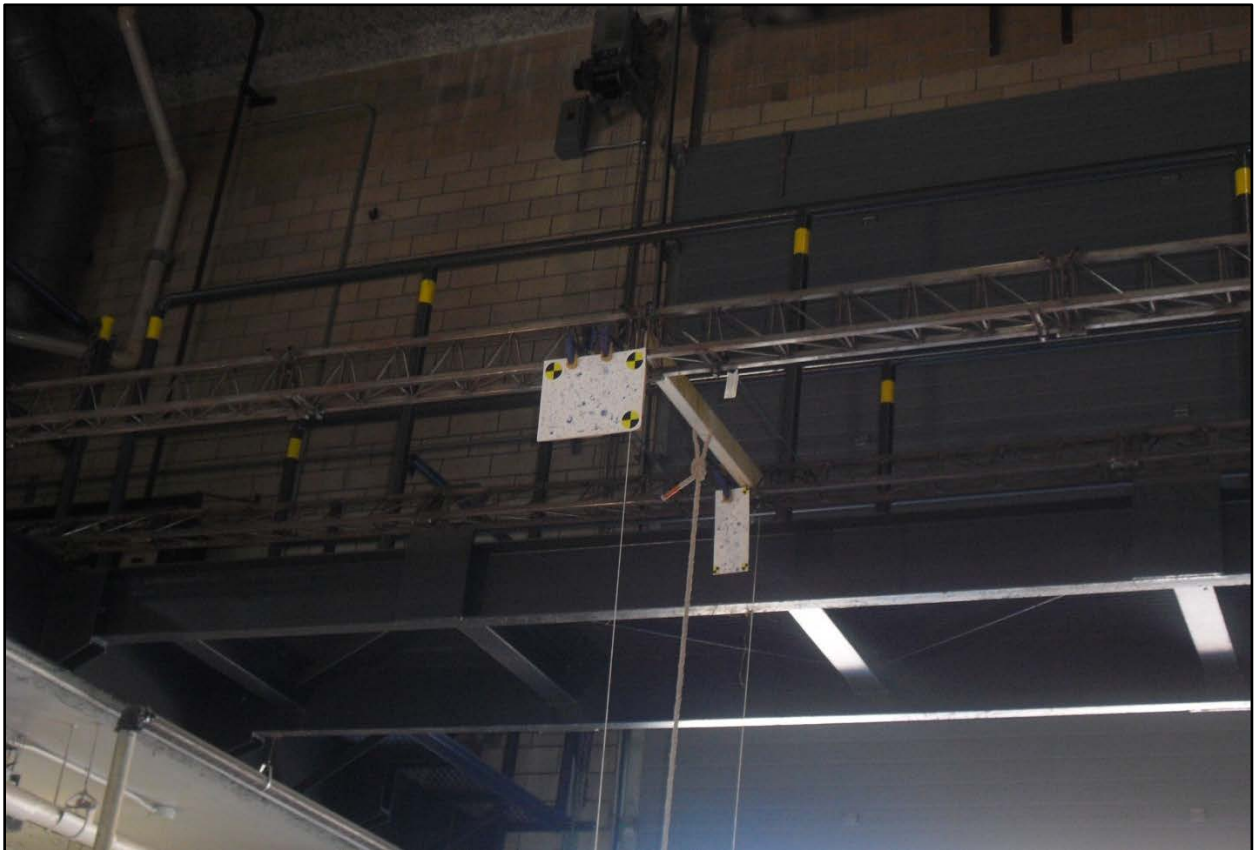
Figure 9-26: Steel bridge specimen used for continued investigations.

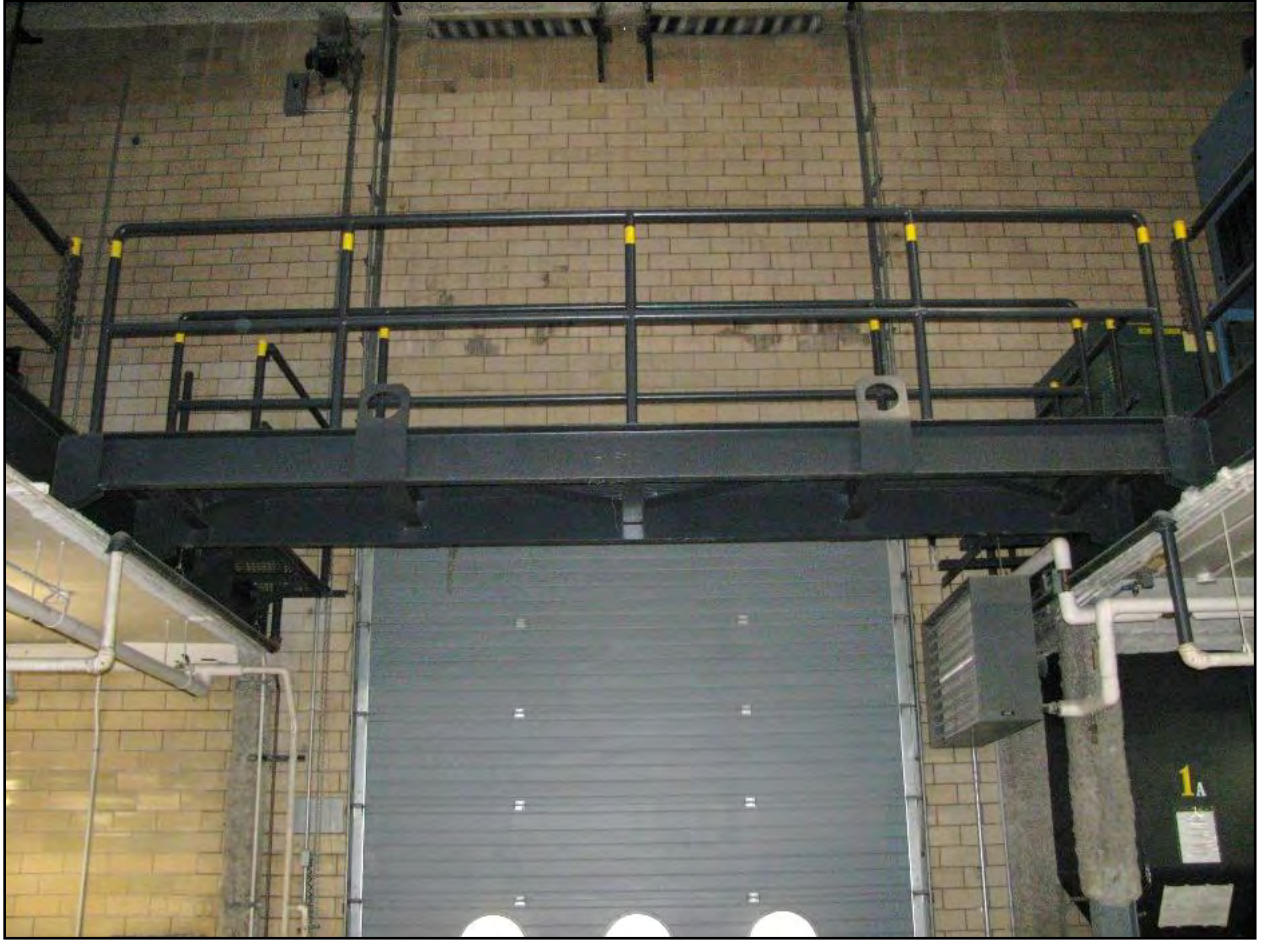
**Figure 9-27: Walking bridge located in Benedict laboratory at MTU.**

This DIC investigation is an ongoing study of this technology to employ better configurations for the field deployment environment. This will lead to re-investigation of parameters in the laboratory setup, including a newly created algorithm and an accountability of change ( $\Delta$ ) in position of image coordinates relationship development for DIC. This will enable a percent error scope of how rotations and simulated noise movement influence the DIC measurements. For future bridge comparison, a steel truss bridge as shown in Figure 9-27 located in Benedict Laboratory would provide a test case for implementation for testing alterations and variations of the DIC system and developed algorithms. For this testing scenario, traditional electro-mechanical instrumentation (e.g., LVDTs, deflectometers) will be used as the ground truth for the test. Dynamic loading will be evaluated with a dynamic shaker exciting the bridge and vibration or the live load deflection will be monitored.

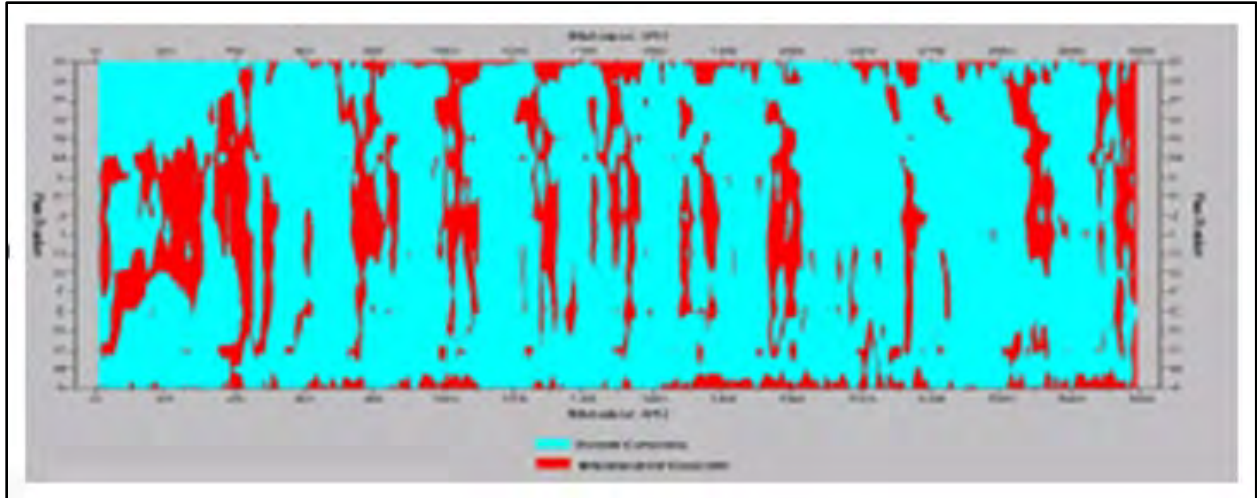
**Figure 10-1: Typical GPR bridge deck delamination map produced with IRIS hardware and software. Red areas show locations of delaminated concrete.**

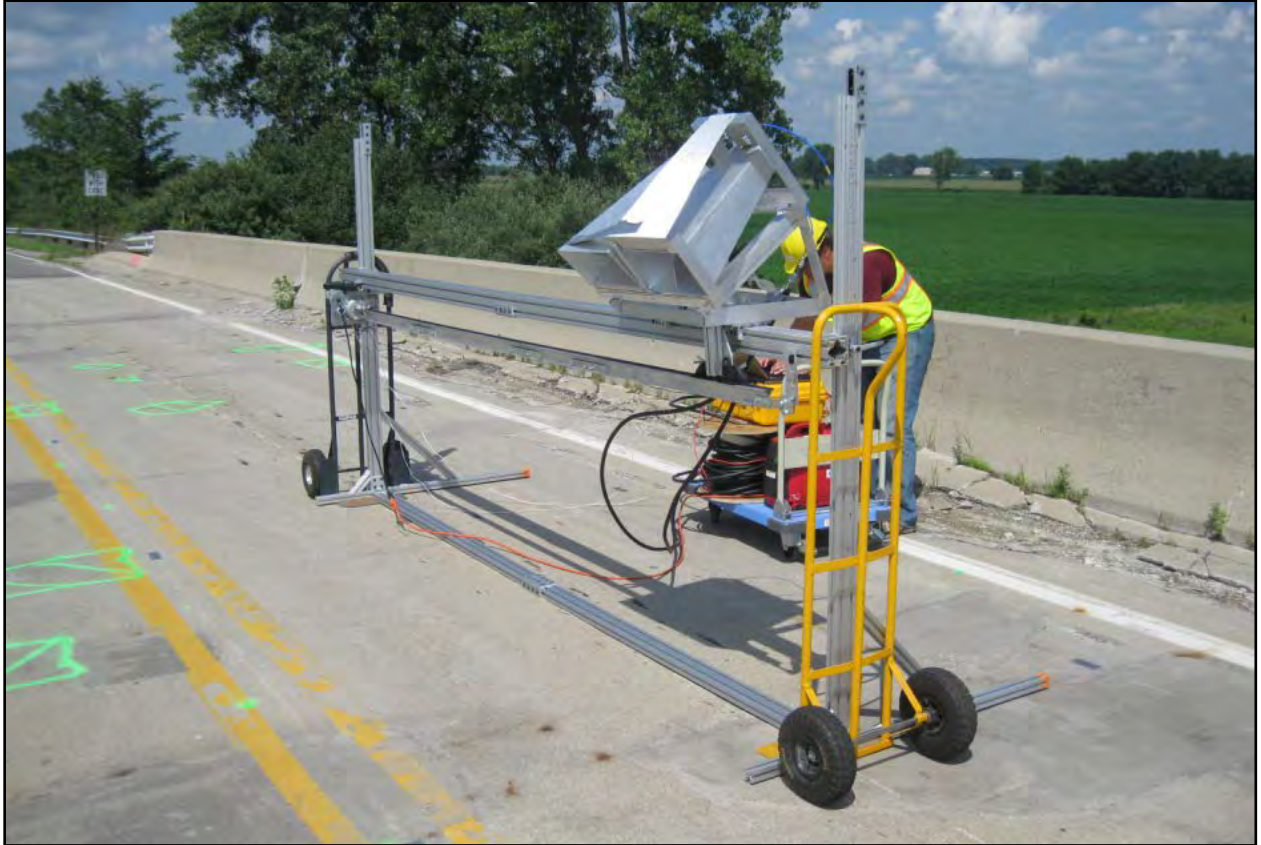
**Figure 10-4: More "mobile" translator apparatus and RaDAR equipment, which could be adapted for moving vehicle-based deployment.**

limited by the current size of the side support rails and motor drive mechanism. The system is shown in Figure 10-3. A more mobile apparatus, shown in Figure 10-4, was used to make a series of data collections along the entire bridge deck.

At both test sites, 2D measurements of the entire bridge deck were made by setting up the translator apparatus shown in Figure 10-4 in its vertical orientation such that the RaDAR antenna would be moved parallel to the direction of travel on the road. A measurement was taken with 3 fiducial corner reflectors set in the area to be imaged, and then this measurement was repeated with the fiducials removed. The translator apparatus was then moved 10 ft further along the bridge deck and these measurements were repeated. This method of moving the translation apparatus along the road at intervals also served to simulate mounting of the RaDAR to a vehicle and driving in one lane while imaging another. Note that the measurements of the deck with the fiducial targets provided a method of assessing image quality and RaDAR system performance. Since these targets rested on the deck surface, the RaDAR return from these fiducial targets should be localized and focused if the RaDAR system was functioning correctly.

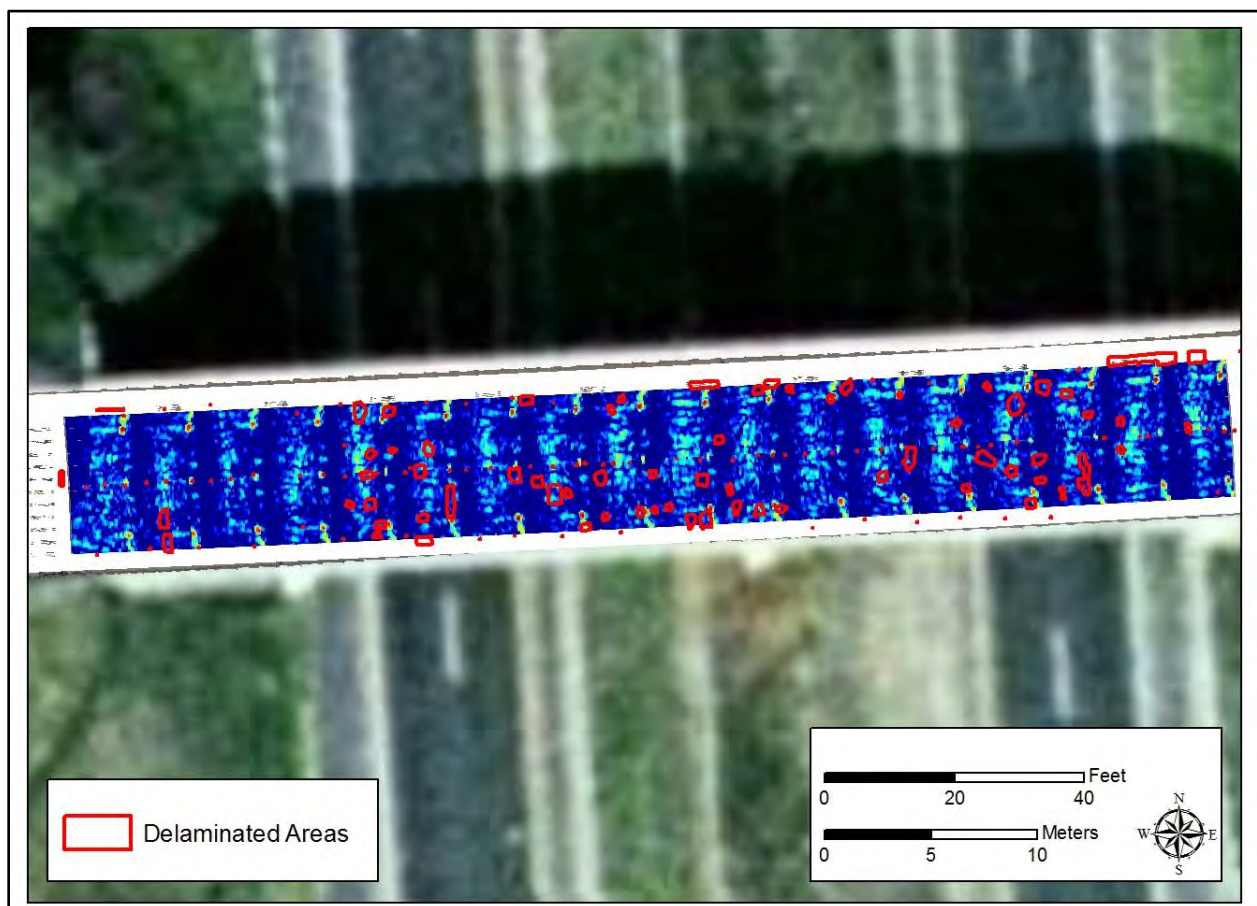
**Figure 10-10: Image of Willow Road bridge with georegistered RaDAR image overlaid on optical image. The red outlines indicate suspected areas of delamination.**

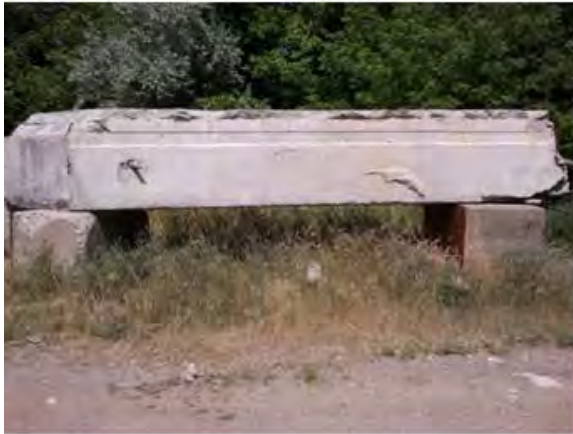
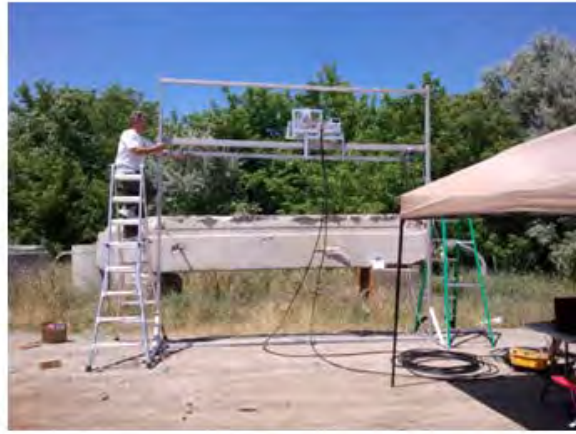
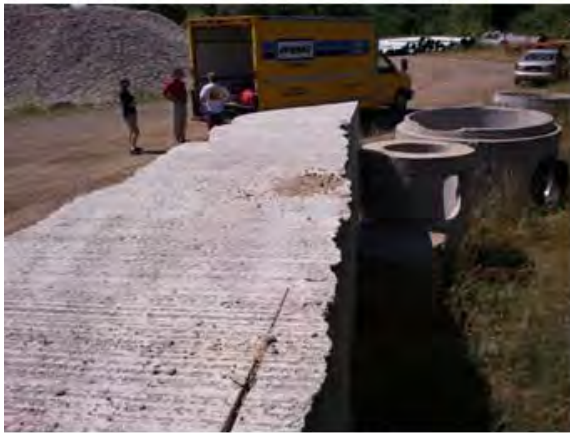
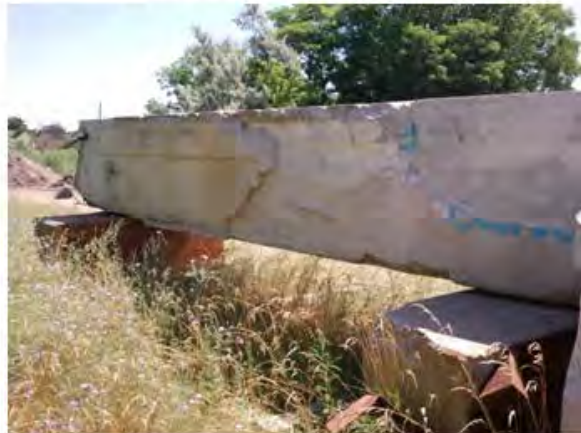
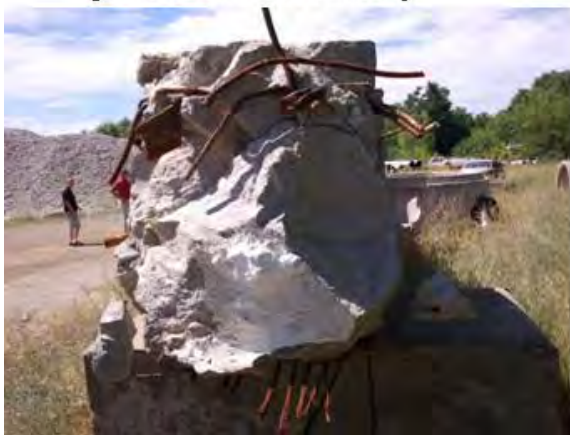
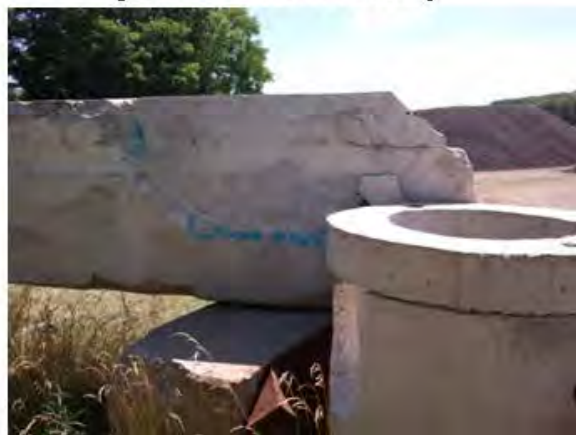
**Front Face of Box Beam  
(closest to radar)**

**Radar Deployed in Front of Beam**

**Top Surface of Box Beam**

**Rear Face of Box Beam**

**Right End of Box Beam  
(viewed from radar)**

**Left End of Box Beam  
(viewed from radar)**

**Figure 10-12: Photographs of the salvaged box beam used in the 3D GPR imaging experiments.**

Photos of the salvaged box beam are shown in Figure 10-12. The front side of the beam viewed from the RaDAR is shown, along with the top and rear sides. The ends of the beam are also shown. Specifically, the right end shows a rough cross-sectional cut of the beam, which gives a general indication of the location of the foam insert and rebar reinforcement.

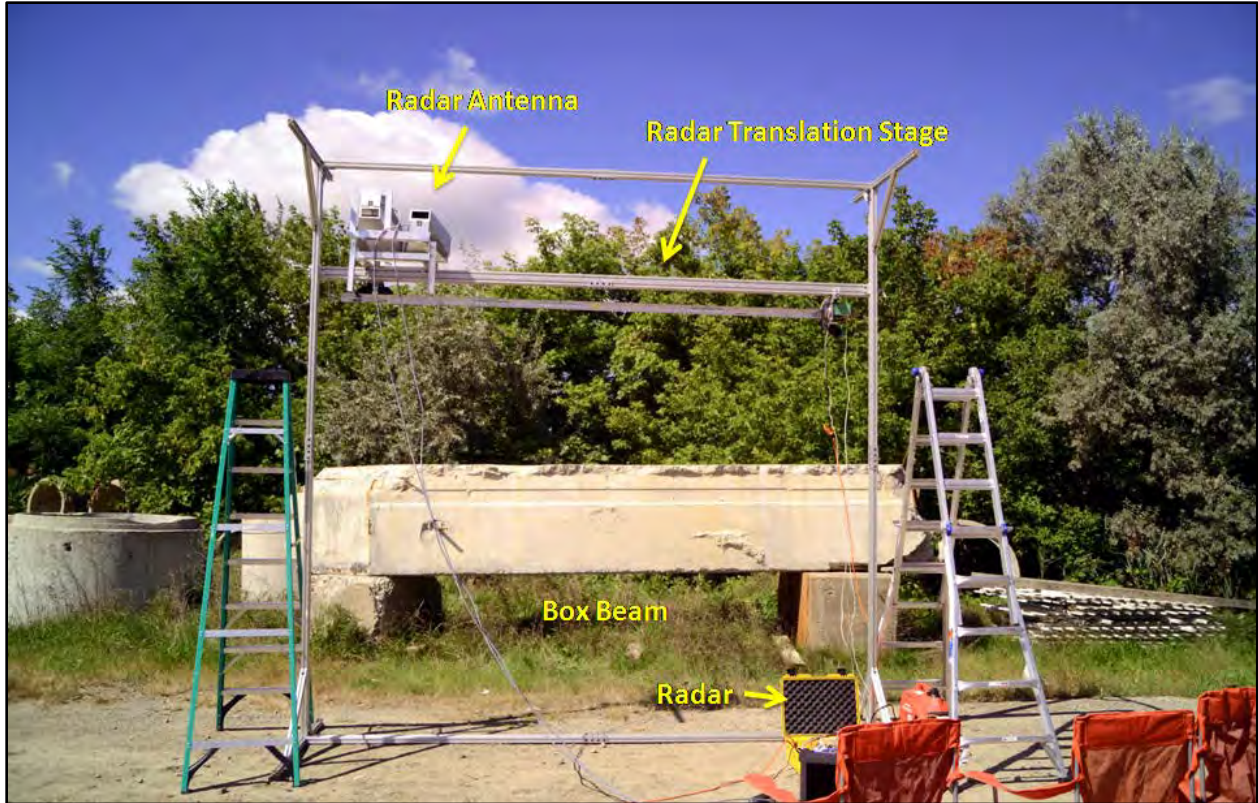
Figure 10-13: Portable imaging RaDAR mounted on a 2D Translation stage parallel to side of Salvaged concrete box beam at measurement site at Oakland County Road Commission site in Waterford, MI.

The portable aluminum frame used to scan the RaDAR antenna over a 2D plane (horizontal and vertical to the ground) parallel to the side surface of the beam is shown in Figure 10-13 in the position used to image the beam.

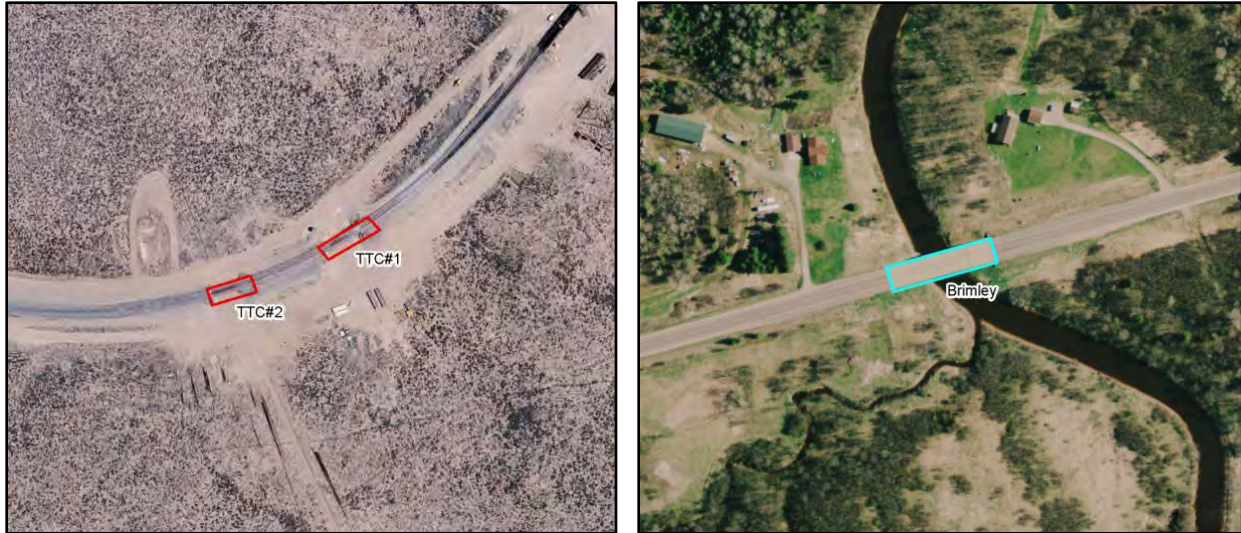
Figure 11-1: Study bridges used to evaluate InSAR for detection of bridge settlement.

For each 'before' and 'after' date and location, ERS-1, ERS-2, or ENVISAT SAR imagery was acquired for InSAR analysis. For TTC#2, SAR imagery was not available for the 'after' date, but since it is located adjacent to TTC#1 (Figure 11-1), it still held value as a control site. From the Brimley bridge, no SAR imagery was available for the location after 2006, so the analysis team attempted InSAR analysis for a 'before' image from 2001 and an 'after' image from 2006.

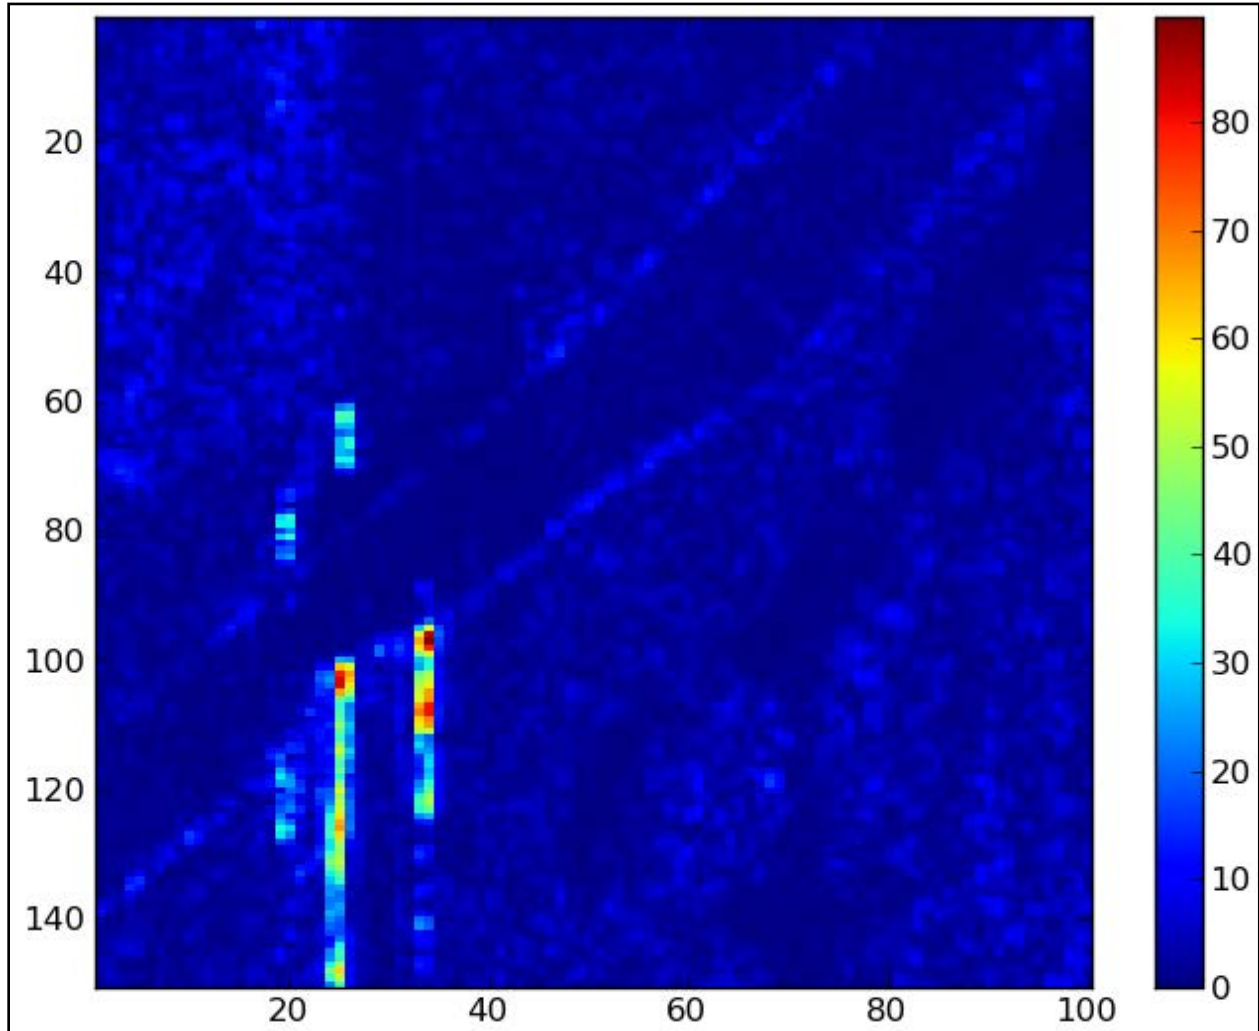
Figure 11-3: Close-up of the Mannsiding Road NB bridge; the bright pixels in vertical lines likely correspond to vehicle traffic beneath the bridge, which can be seen outlined by lighter pixels on the edges of the deck and approach (color bar has arbitrary units).

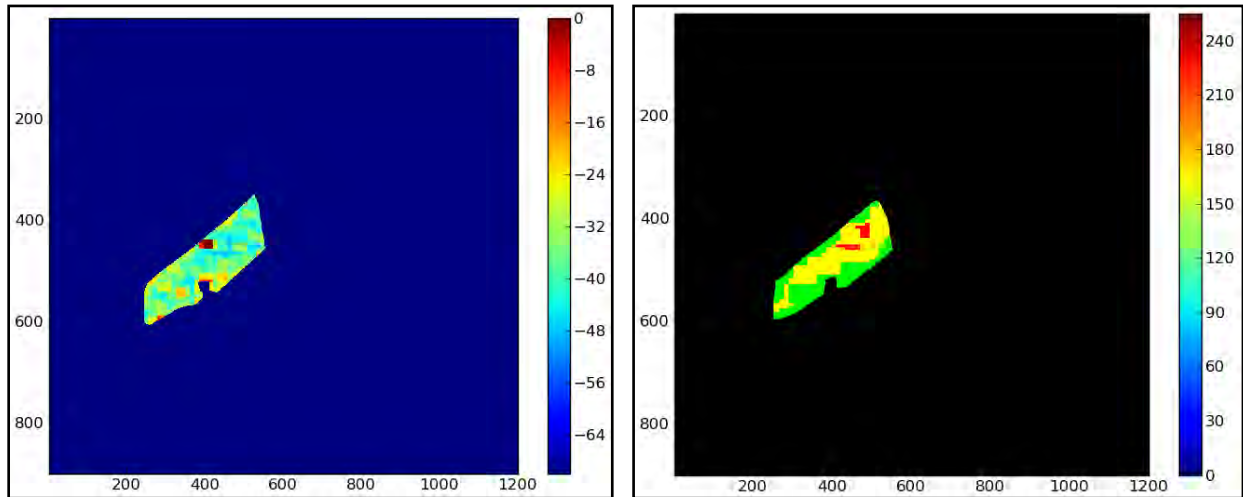
**Figure 11-4: Pixels extracted from Mannsiding Road NB image shown after speckle contrast enhancement with dB color scale (left) and after pixel value classification into a "stoplight" decision support image (right).**

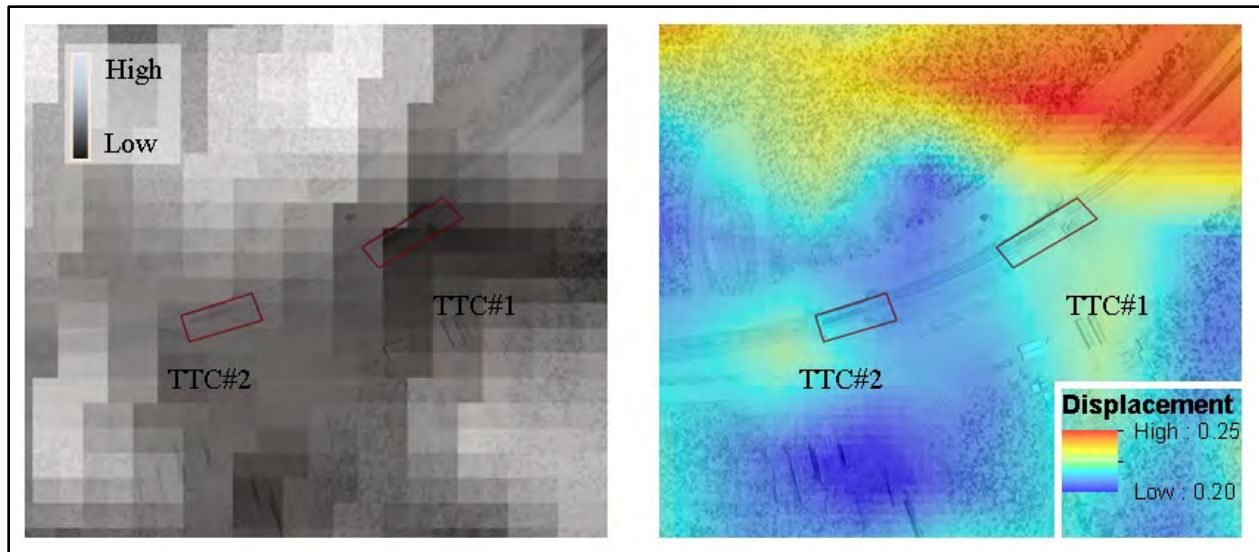
Figure 11-5: TTC bridges – coherence on left image and displacement on right image. Expected change; 10 cm increase (TCC-1) and no change (TCC-2). Observed change; TTC-1 ~0.5 cm increase relative to TTC-2.

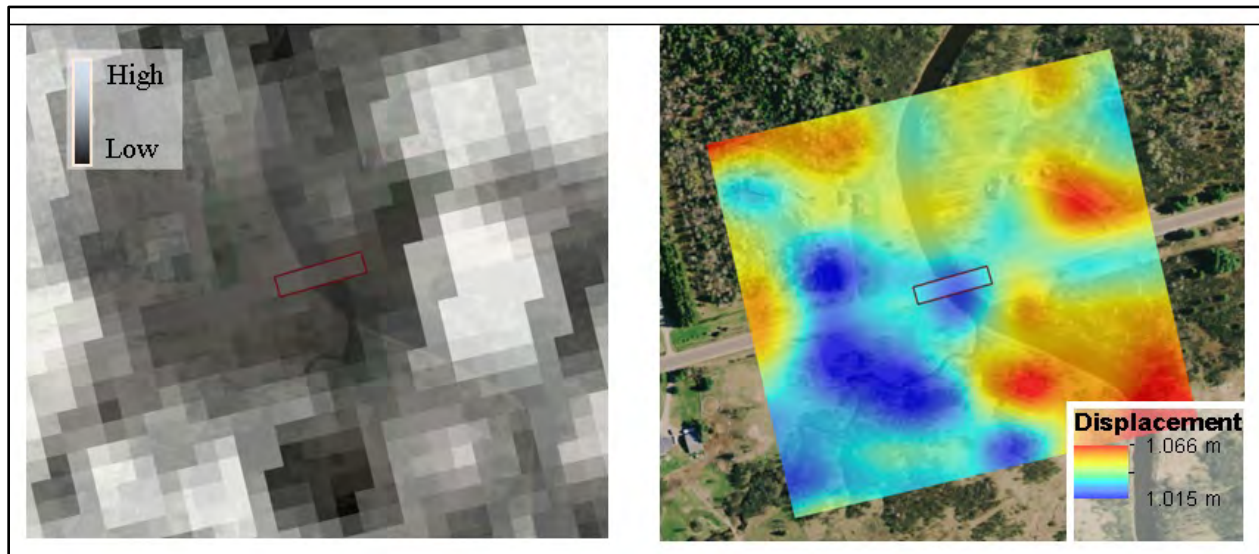
Figure 11-6: Brimley area bridge, Michigan. Coherence on left image and displacement on right image. Expected change; 0-5 cm decrease. Observed change; ~2 cm decrease relative to background.

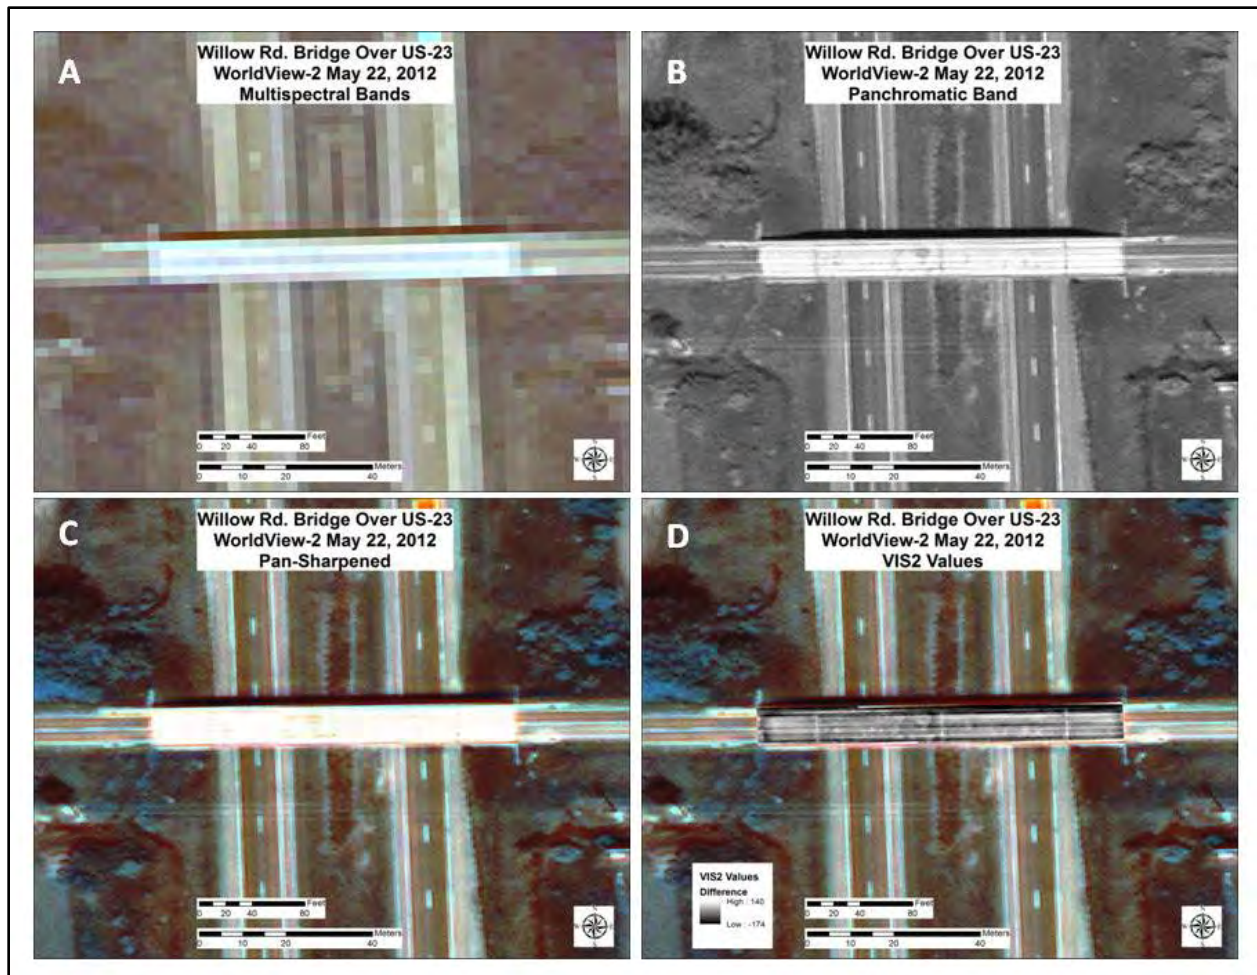
Figure 12-1: WorldView-2 image of Willow Road. Multispectral bands (A) have a resolution of 1.85 m while the panchromatic band (B) has a resolution of 0.5 m. The pan-sharpened (C) band has a resolution of 0.5 m. The derived VIS2 pixel values for Willow Road are shown in image D.

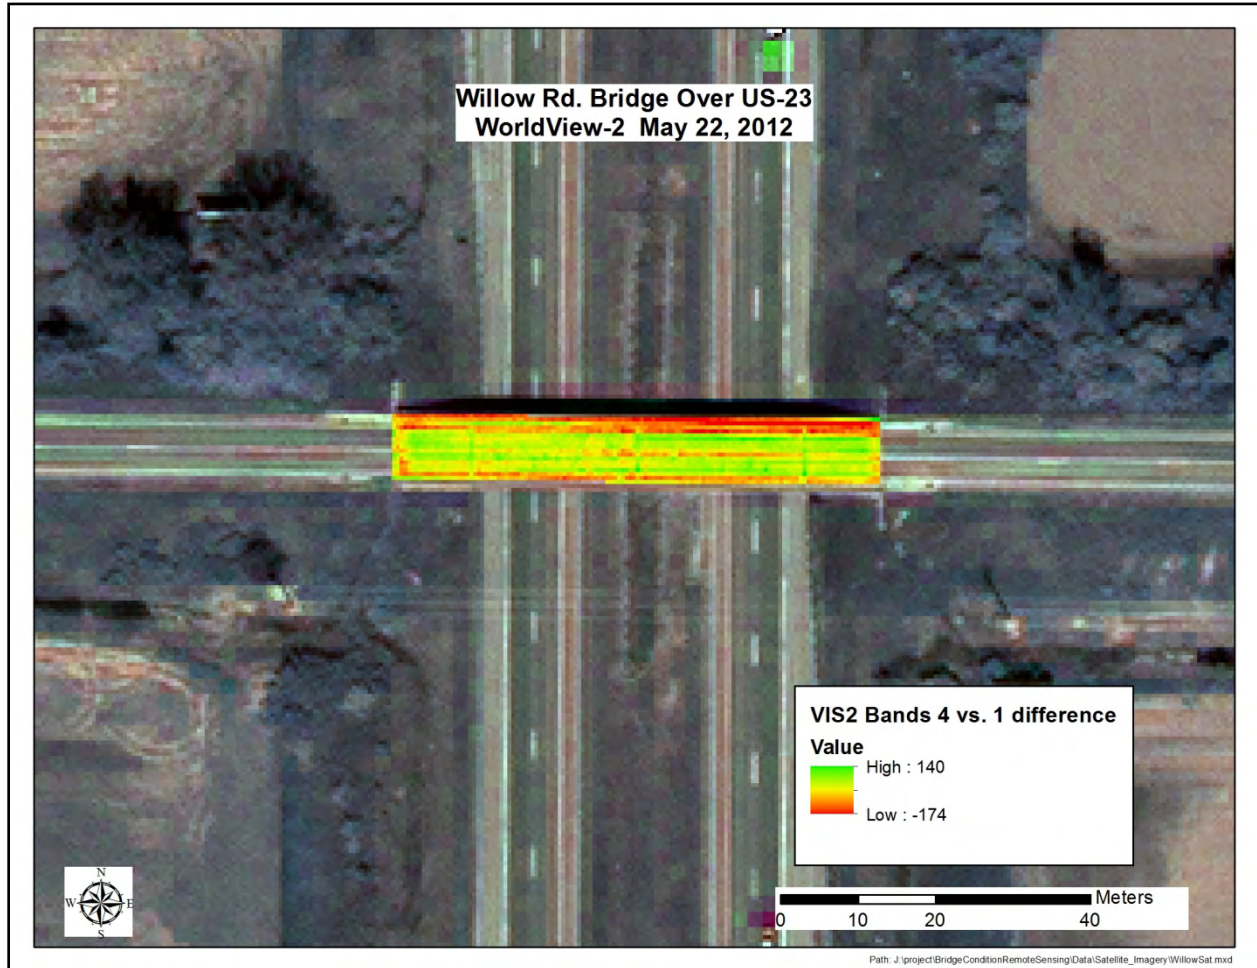
**Figure 12-2: The VIS2 calculation displayed in color for the Willow Road bridge using WorldView-2 commercial high-resolution satellite imagery. Red and green areas (relatively low and high values) show high contrast between the blue and infrared spectral band information.**
