ASSESSMENT OF URETEK DEEP INJECTION PROCESS

Initial Report 2015 – 09

Reporting on Work Plan 2012-R-04

STATE OF VERMONT
AGENCY OF TRANSPORTATION

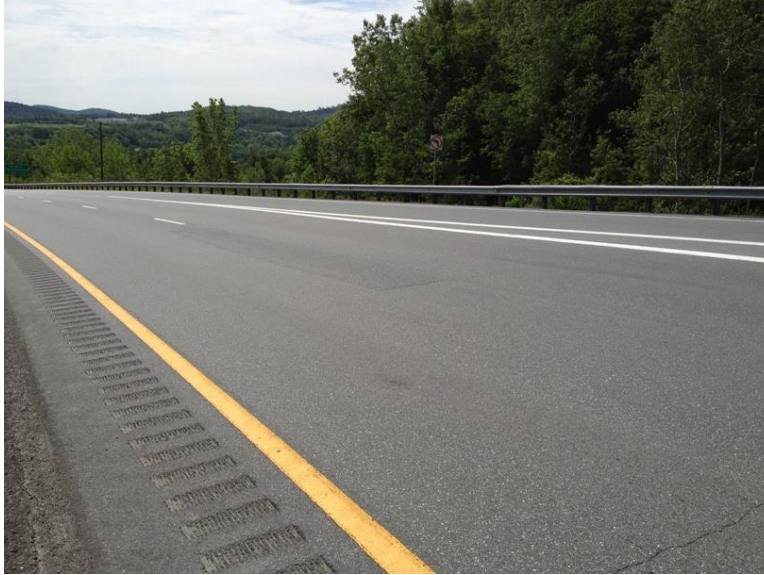
A stretch of Interstate 89 southbound from mile marker 0.124 to 0.153 in Hartford, VT has been showing signs of substructure instability for over two decades. The annual average daily traffic is amongst the highest in eastern Vermont, averaging 38,000 vehicles per day. Historically, the roadway section was originally constructed in the 1950's and it is believed that the majority of the fill material used was taken from the rock cut sections in the connecting ramps on the south side of the I-89/I-91 interchange (3). The site is shown in Figure 1.

Figure 1: Deep Injection Site – Prior to Injection.

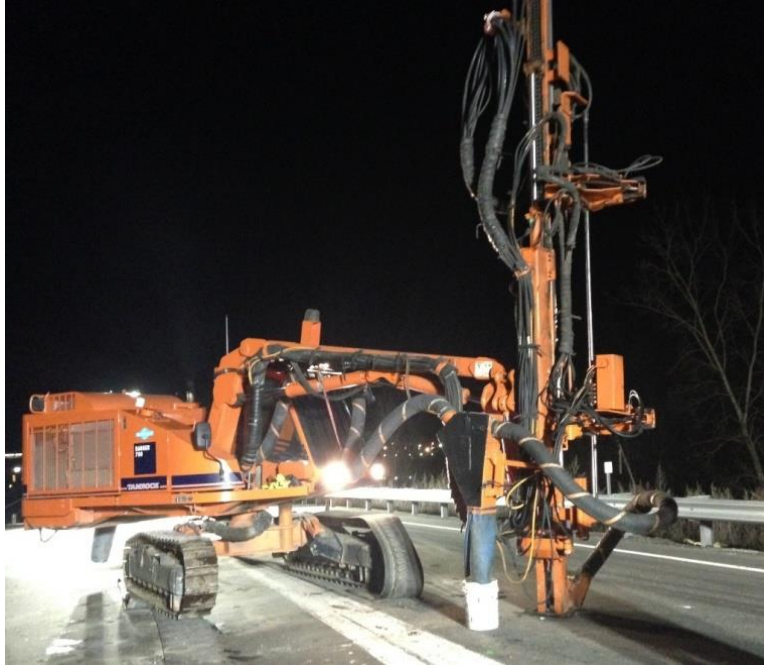
J. A. McDonald, the prime contractor drilled all injections holes using a Tamrock Ranger 700 Drilling Rig, a hydraulic, self-propelled, self-contained, crawler based surface drilling rig equipped with a cabin and rod handling system. The Contractor began drilling the 2-inch diameter injection holes 20 feet in depth in the travel lane on October 29, 2013 once the injection plan based on DCP testing was approved. Once drilling commenced, vibration from drilling operation paired with the undersized drilling equipment caused unstable material along the shaft to collapse into the hole (11). The Contractor ceased operations until the following day and began drilling 2½-inch diameter holes in order to expedite drilling, produce a straighter hole, and reduce sloughing of the material into the holes (12). Drilling operations continued through November 4. Some holes had to be redrilled because URETEK encountered problems with inserting the injection tube bundles. The Contractor redrilled holes on November 5 and 6 and then inserted some injection tube bundles for the Subcontractor. The passing lane holes were drilled without incident from November 19 to 21 (11).

Figure 4: Tamrock 700 Drill Rig – Drilling 2.5-inch Injection Holes.

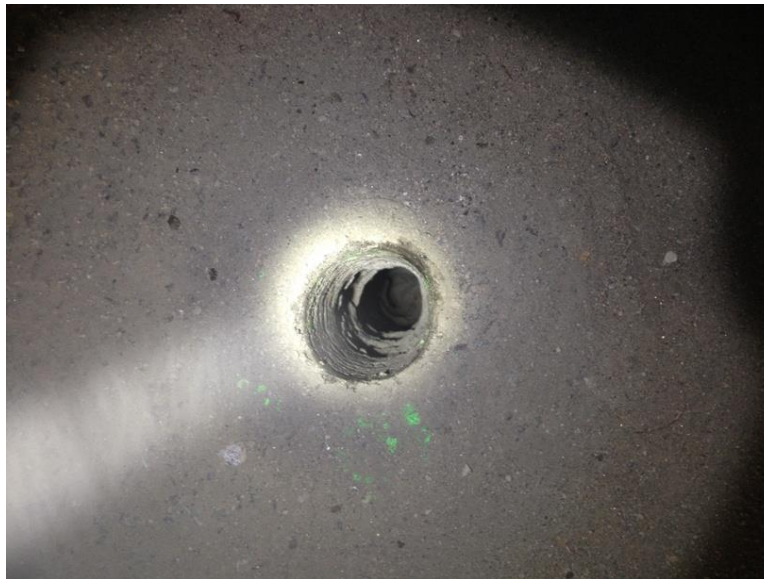
Figure 5: Drilled Injection Hole (2.5 inches x 20 feet)

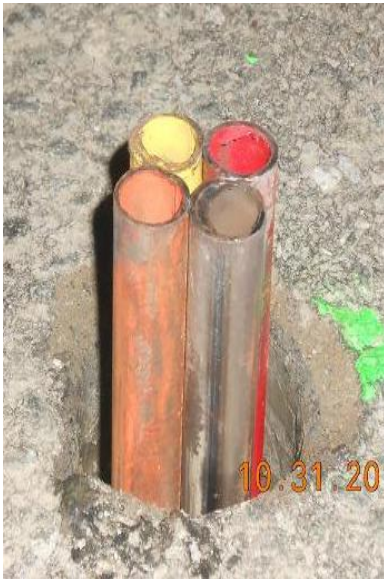
Figure 8: Injected Tubes.

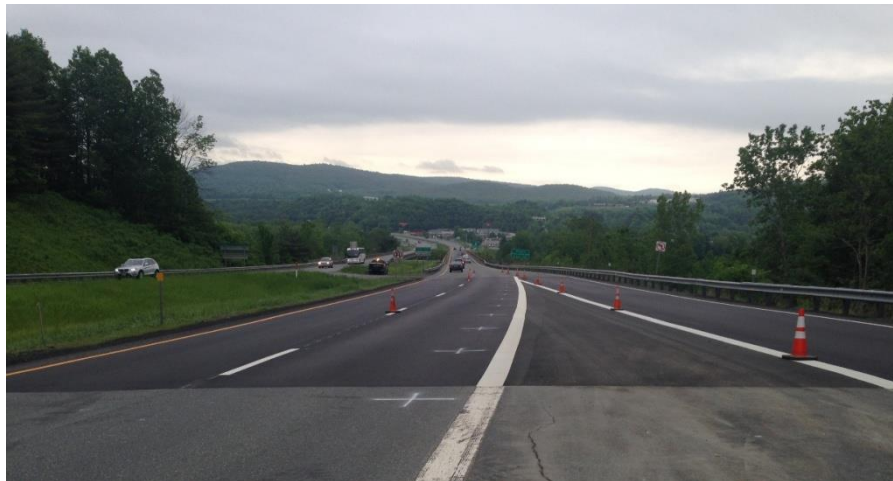
Due to the late season injection phase, all cold planing and paving activities were postponed until the spring of 2014. J.A. McDonald hired subcontractor Frank W. Whitcomb Construction of Colchester, Vermont to complete cold planing and paving operations, completed on May 29 and May 30, 2014. Figure 10 below shows the site after paving while conducting Falling Weight Deflectometer (FWD) testing.

Figure 10: Deep Injection Site – Post Paving.
