| 4. Title and Subtitle<br>PERFORMANCE OF LAP SPLICES IN LARGE-SCALE COLUMN SPECIMENS AFFECTED BY ASR AND/OR DEF—EXTENSION PHASE | | 5. Report Date<br>Published: March 2015 | | | |

Report 0-5722-2  
Project 0-5722  
Project Title: Lap Splice and Development Length Performance in ASR and/or DEF Damaged  
Concrete Elements

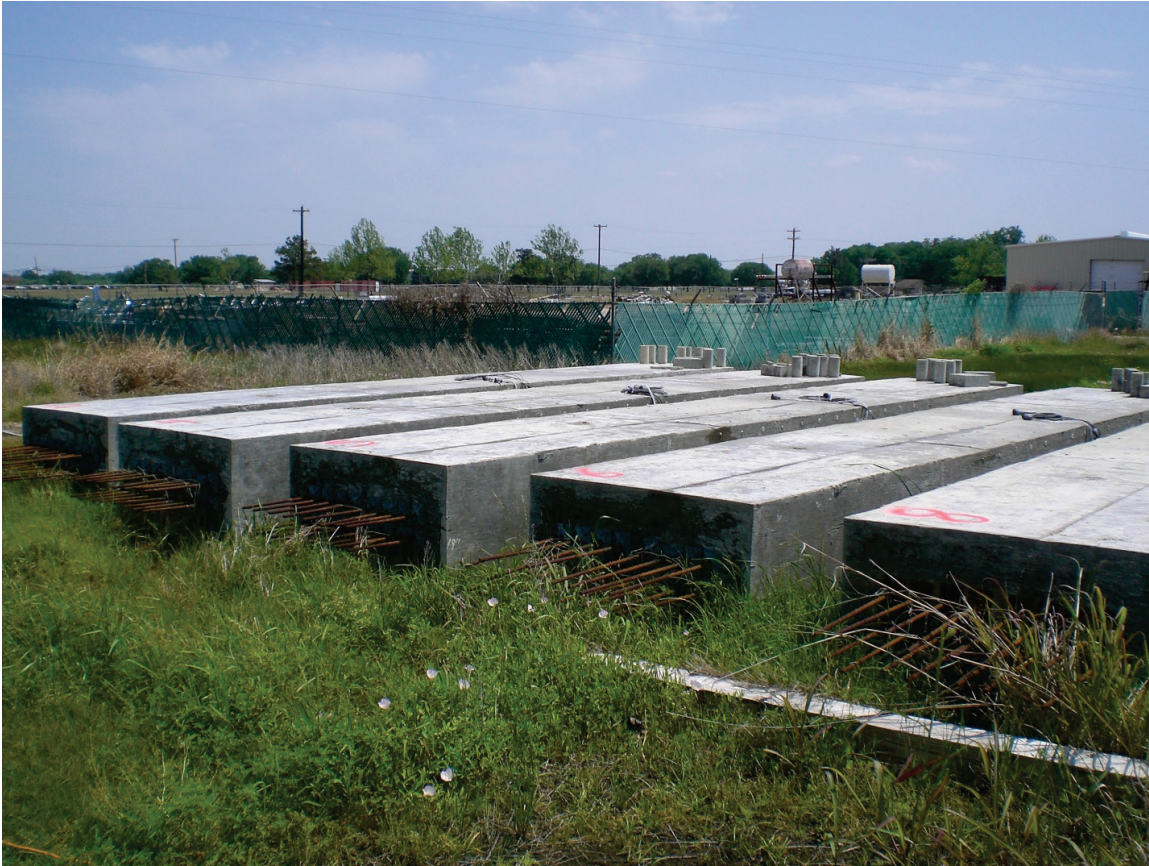
**Figure 3-2. LSC Specimens at the Riverside Campus during the 3rd Orientation.**

After the LSC specimens were rotated 90° for the third and final orientation, Large Face 1 was placed on the bottom (Figure 3-1). Figure 3-2 shows the LSC specimens during the third orientation with Large Face 2 on top. The distance between each specimen in this orientation was approximately 1 ft. Since Small Face 1 and Small Face 2 were now mostly in the shaded and in tight conditions, no surface data were measured on these faces during the third orientation. Figure 3-3 shows the DEMECs on Large Face 2 in a 5 × 5 grid, resulting in four transverse (TS1, TS2, TS3, and TS4) and five longitudinal (LS1, LS2, LS3, LS4, and LS5) averaged strains measured along the splice length of the LSC specimens.

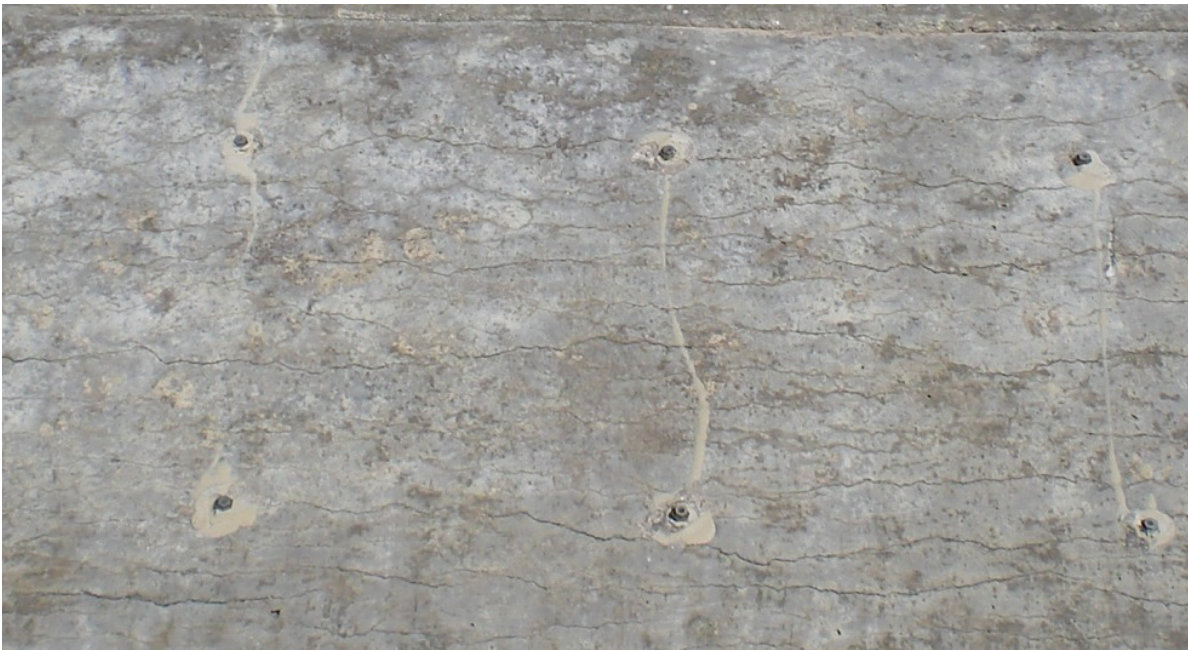
**Figure 3-8. Typical Longitudinal Crack in Specimens.**

In existing bridge columns, cracks can be measured quite easily using crack width card indicators or crack width measuring devices, while other strain data are more difficult to obtain since instrumentation was not installed prior to bridge construction. However, in this research, the surface strains calculated using the DEMEC points more accurately represent the total surface expansion, since crack width card indicators cannot measure small cracks and concrete expansion between the cracks due to ASR/DEF. Therefore, the strains from crack width measurements in the large-scale specimens were compared to the strains computed using the DEMECs. Figure 3-8 shows that typical surface cracks develop primarily in the longitudinal direction of the LSC specimens, noting that the DEMEC points shown are approximately 10 inches (0.25 m) apart. Therefore, only longitudinal crack widths were measured in this research using a crack width card indicator. This card can be used to measure crack widths as small as 0.004 inches (0.1 mm) to as large as 0.06 inches (1.5 mm). Figure 3-9 shows a larger longitudinal crack on specimen LSC4 with a crack width of about 0.04 inches (1.0 mm). For specimens LSC4 and LSC12, the largest crack width measured was about 0.12 inches (3.0 mm) and 0.06 inches (1.5 mm), respectively.

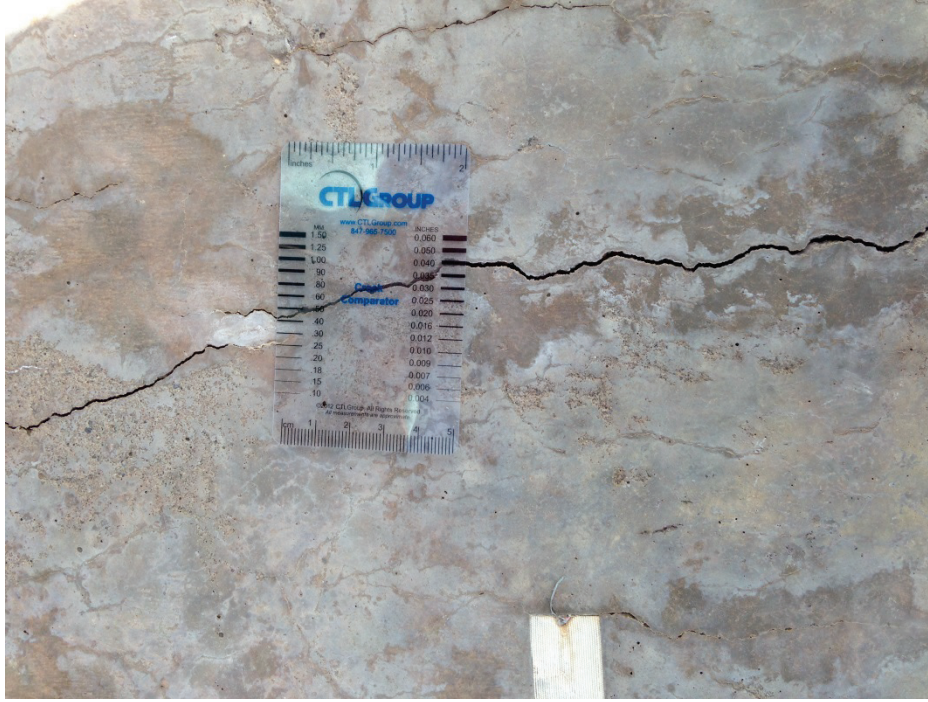
**Figure 3-9. Larger Longitudinal Crack Width on Specimen LSC4.**

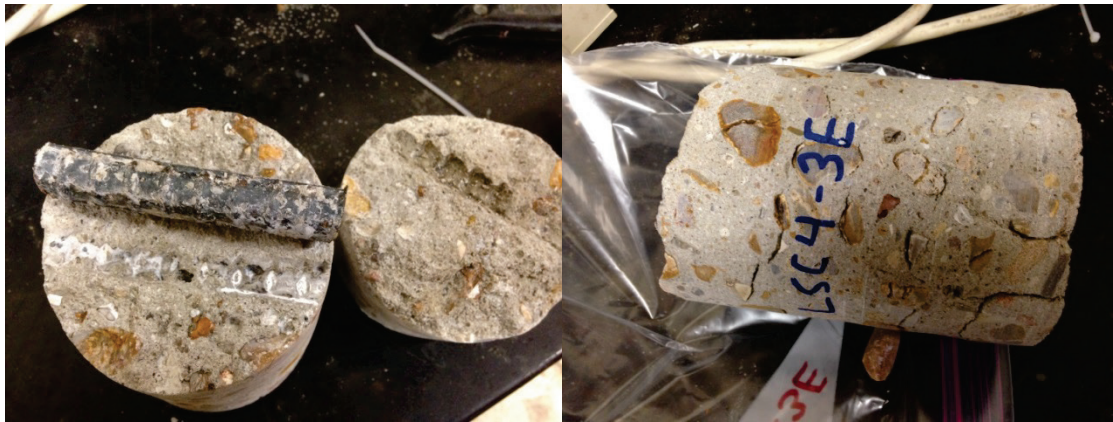
**(a) Side Face Core from LSC4**

**(b) End Core from LSC4**

Cores taken from LSC4 and LSC12 has surface crack widths of about 0.04 inches (1 mm) that extended up to 2.75 inches (70 mm) into the concrete core, which is the approximate location of the transverse and longitudinal reinforcement. Figure 3-12 shows that ASR gel had accumulated at the interface of the transverse reinforcing and surrounding concrete. In addition, Appendix A includes microscopic documentation that provides evidence of primarily ASR-caused micro damage and distress, and recent evidence of some DEF distress in the concrete cores.

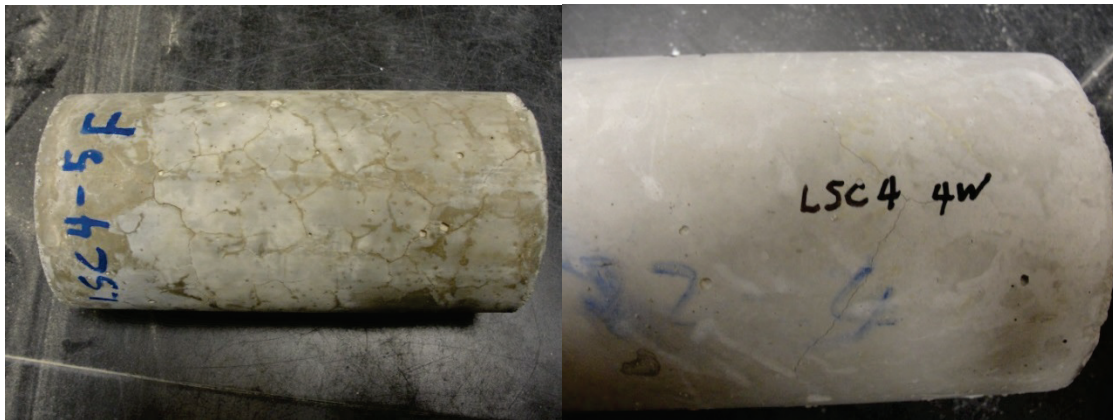
(a) LSC4—Exposure Site Storage

(b) LSC4—Wet Room Storage

Figure 3-13 shows sample concrete cylinders that were cast with the same concrete used to construct specimens LSC4 and LSC12, and were exposed to different environmental conditions. Some cylinders were stored on top of the LSC specimens at the exposure site in the presence of weather and supplemental watering, while the others were stored in a humidity-controlled wet

room. The figure clearly shows that the extent and width of concrete surface cracking was greater on cylinders stored at the field exposure site as compared to the wet room (maximum widths of about 0.01 and 0.006, respectively). However, the extent of this map cracking and the width of surface cracking in all cylinders were significantly less than what developed in the LSC specimens (see Figure 3-8, Figure 3-9, and Figure 3-13).

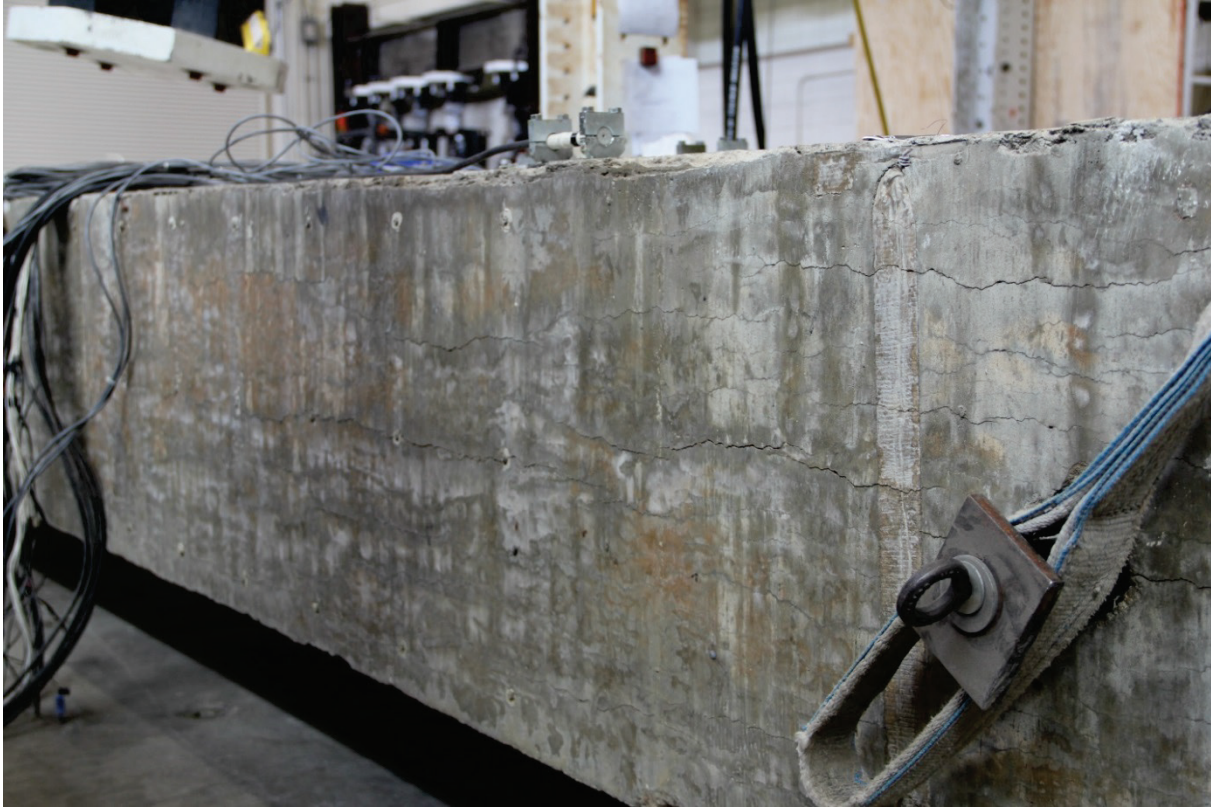
**Figure 4-3. Cracking of Specimen #12 prior to Structural Load Testing.**

Figure 4-1, Figure 4-2, Figure 4-3, and Figure 4-4 show sample cracking that developed throughout the exposure phase for Specimens #1, #8, and #12, with about 2.3, 3.0, and 5.8 years of exposure, respectively. The figures show that substantial cracking resulted and the cracking pattern was similar between the specimens, even though the exposure periods of the specimens varied. Specimens #1 and #8 had similar crack widths; however, Specimen #12 had much larger crack widths (about twice that in Specimens #1 and #8, as reported in Table 3-3). Note that the specimen cracking as shown in Figure 4-5, Figure 4-6, Figure 4-7, Figure 4-8, and Figure 4-9 is comparable to the cracking in actual field structures affected by ASR (see Bracci et al. 2012).

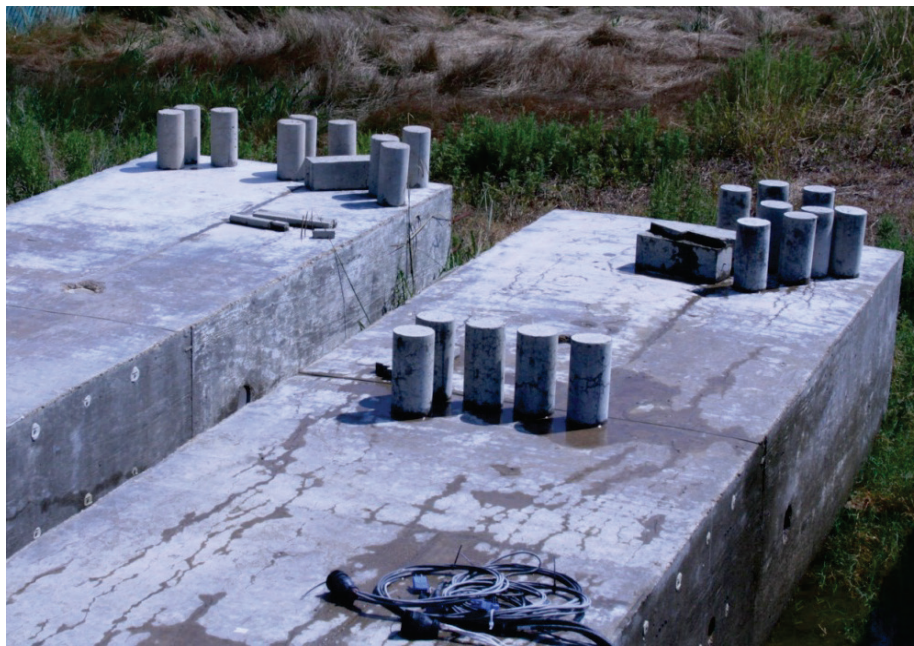
**Figure 4-13. Cylinders at the Riverside Campus.**

Figure 3-13 compares cylinders from the batch of specimens LSC4 and LSC12. Some were stored in the humidity controlled wet room and others were stored at the exposure site on top of specimens (see Figure 4-13). The figure shows that very few, small surface cracks developed in the cylinders stored in the wet room. The largest crack width measured on these cylinders was about 0.006 inches (0.15 mm) for LSC4 and LSC12 concretes. Note that some cylinders from all concrete LSC specimens had a white residue that leached from cracks. In comparison, cylinders stored at the exposure site in the same environmental conditions as the LSC specimens (exterior weather conditions and supplemental watering four times a day) had more numerous, larger surface cracking than the cylinders taken from the wet room. The largest crack width on these cylinders was about 0.01 inches (0.25 mm).
