1. Report No. FHWA/TX-15/0-6686-2		2. Government Accession No.		3. Recipient's Catalog No.	
4. Title and Subtitle IMPROVING DMS 9210 REQUIREMENTS FOR LIMESTONE ROCK ASPHALT – FINAL REPORT				5. Report Date Published: March 2015

IMPROVING DMS 9210 REQUIREMENTS FOR LIMESTONE ROCK ASPHALT – FINAL REPORT

Report 0-6686-2

Project Title: Improving DMS 9210 Requirements for Limestone Rock Asphalt

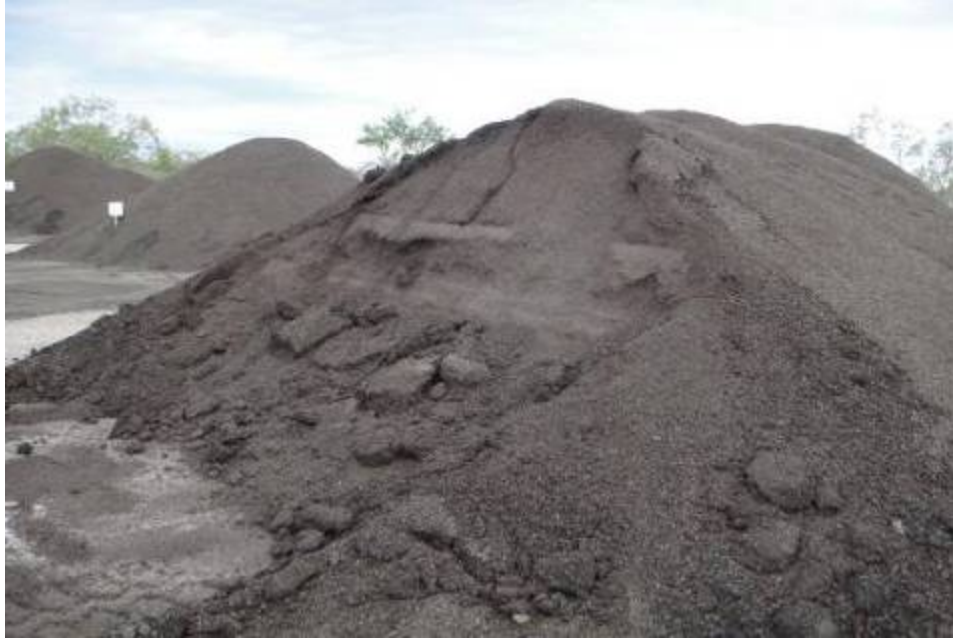
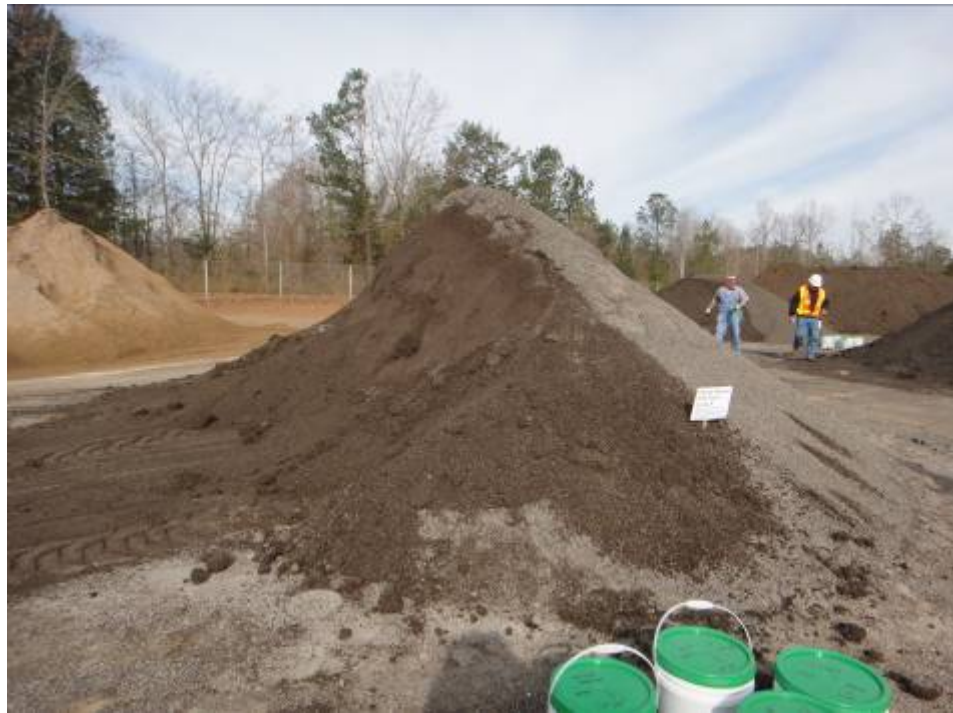
Figure 5. Four Stockpiles of Material (Two per Supplier) Shipped to Four Districts.

(a) San Antonio District – Uvalde Maintenance.

(b) Atlanta District – Jefferson Maintenance.

- Worked with TxDOT to obtain shipments of materials from Martin Marietta and Vulcan to be sent to four different districts (Figure 5)
 - San Antonio.
 - Childress.

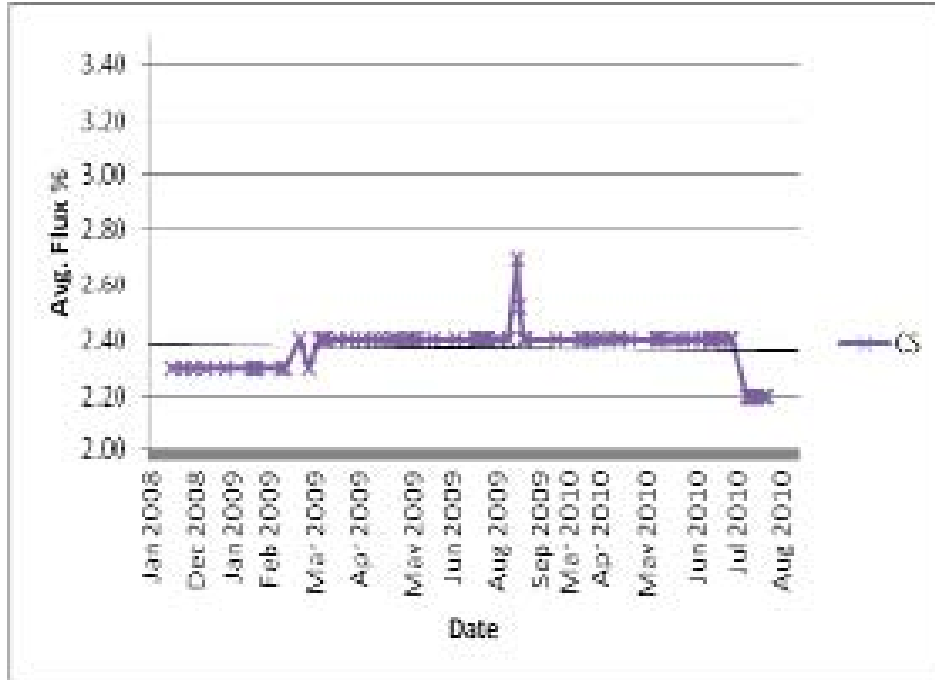
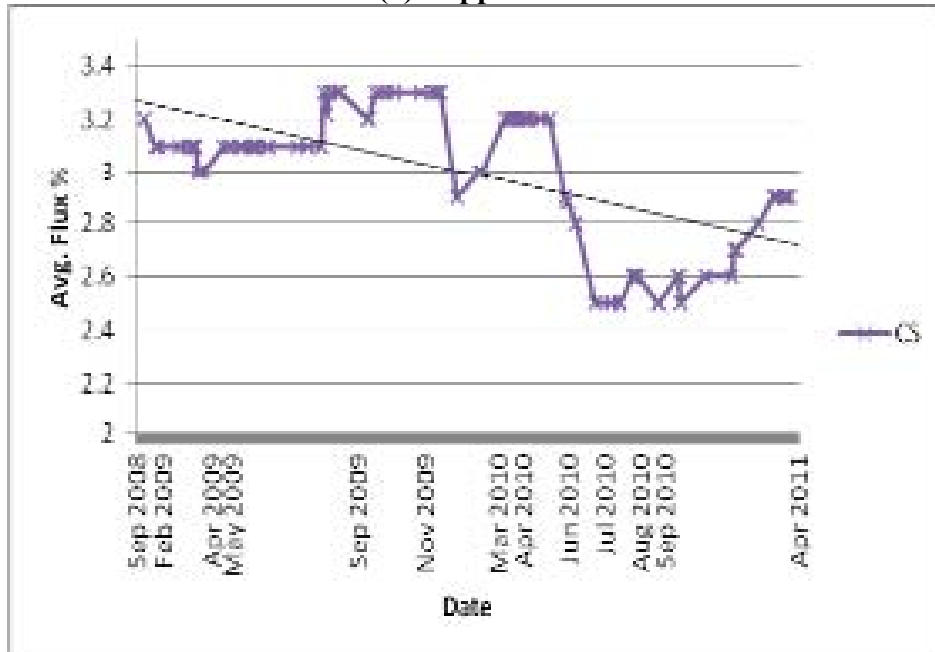
Figure 8. Item 330, Type CS Mixture Production Data, Average Flux Oil Content, % by Wt.

(a) Supplier A

(b) Supplier B

TTI processed and graphed the production data from the data cards from 2009 through 2011 and the main conclusion from this was that one of the suppliers was altering the production process by making significant changes to the amount and possible type of flux oil. This variation in flux oil was noted for all of the LRA mixture types coming from this supplier during the time-frame in question. An example of the difference in the two suppliers is shown in Figure 8 for LRA Type CS.

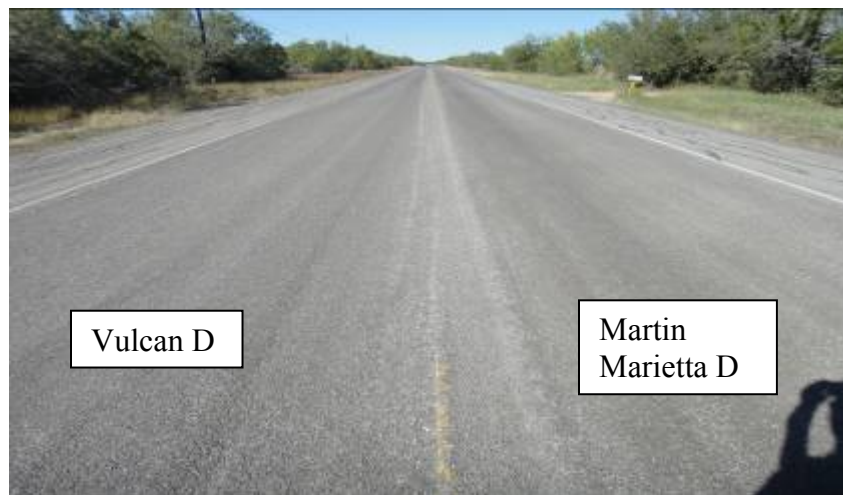
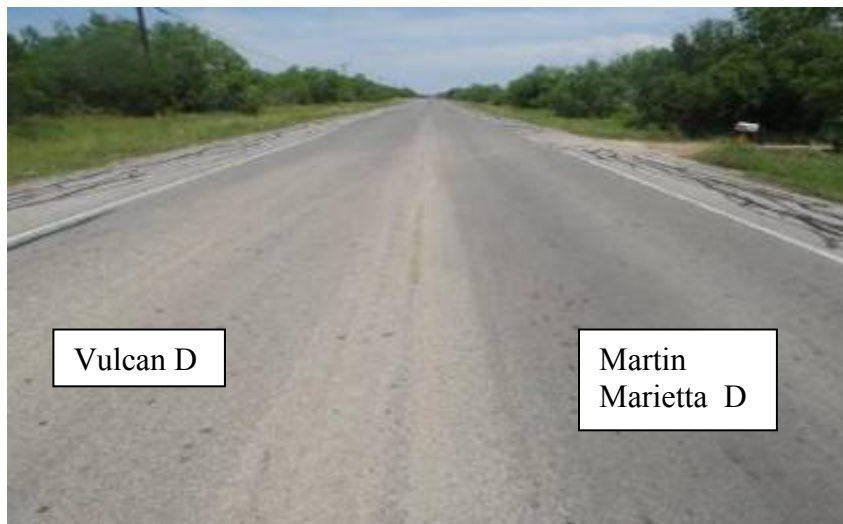
Figure 10. Uvalde Test Patches Typical of Acceptable Performance in All Test Sections.

(a) Age One Day

(b) Age Six Months

- No performance problems were identified throughout 2011 and 2012.
- Twenty-eight test sections were constructed in four districts, fall 2011 and spring 2012 construction.
 - Martin Marietta D.
 - Martin Marietta DS.
 - Vulcan D.
 - Vulcan DS.
- All exhibited minor raveling in day 1.
- No major performance problems after 12+ months in service (see Figure 10).
- District survey in fall 2012 identified no new field performance problems.
