## CRASH TEST AND *MASH* TL-3 EVALUATION OF THE TxDOT SHORT RADIUS GUARDRAIL

**Test Report No. 0-6711-1**

**TEXAS A&M TRANSPORTATION INSTITUTE  
COLLEGE STATION, TEXAS**

**TEXAS DEPARTMENT OF TRANSPORTATION**

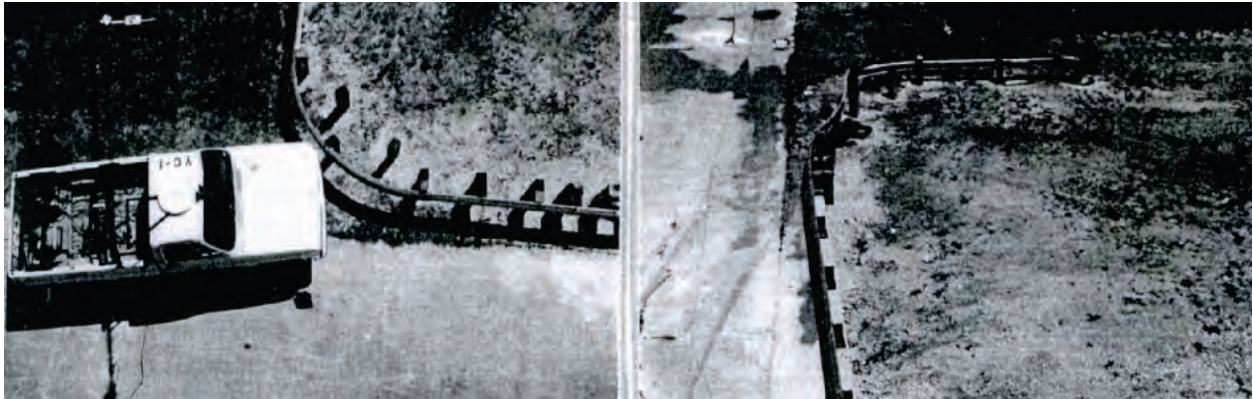
**Figure 1.1. Impact Conditions and System Damage for YC-1 (3).**

The purpose of Test YC-1 was to test for vehicle spearing or vaulting caused by the guardrail when a pickup truck impacts the system in line with the bridge rail. The 5376-lb pickup impacted the system at a speed of 45 mph and an angle of 1.4° (refer to Figure 1.1). Figure 1.2 shows that the barrier successfully redirected the vehicle without any contact to the bridge rail. Post 5 was fractured, and posts 6 through 8 were deflected during impact. Only the first post on the primary side was fractured while the second, third, and fourth were displaced. The vehicle was deflected with minimal damage and acceptable values for occupant risk and ridedown acceleration. Therefore, the system was acceptable according to *NCHRP Report 230* guidelines.

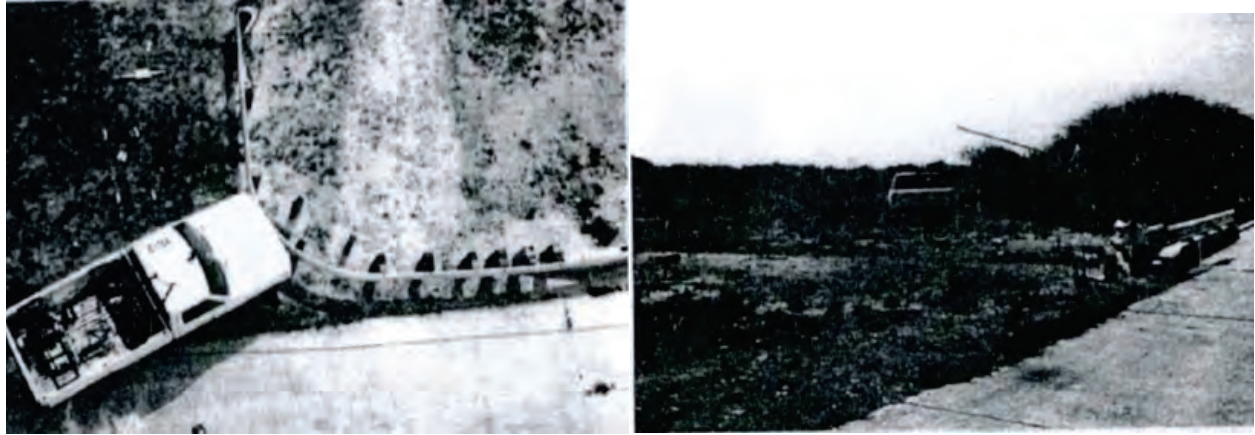
**Figure 1.5. Impact Conditions and System Damage for YC-3 (3).**

The purpose of Test YC-3 was to determine whether a pickup truck would be contained if it strikes the system at the curved section, which was 12 ft from the edge of the roadway. The 5380-lb truck impacted the rail at an impact speed of 44.8 mph and an impact angle of 19.7° (refer to Figure 1.5). Figure 1.6 shows sequential photographs of the crash test. The centerline post immediately fractured, and the rail deformed inward. The guardrail wrapped around the front and sides of the vehicle as it continued through the system. The end anchorage holding the rail in place fractured, which allowed the vehicle to continue without capture. The test was not successful according to *NCHRP Report 230* because the system failed to contain the vehicle.

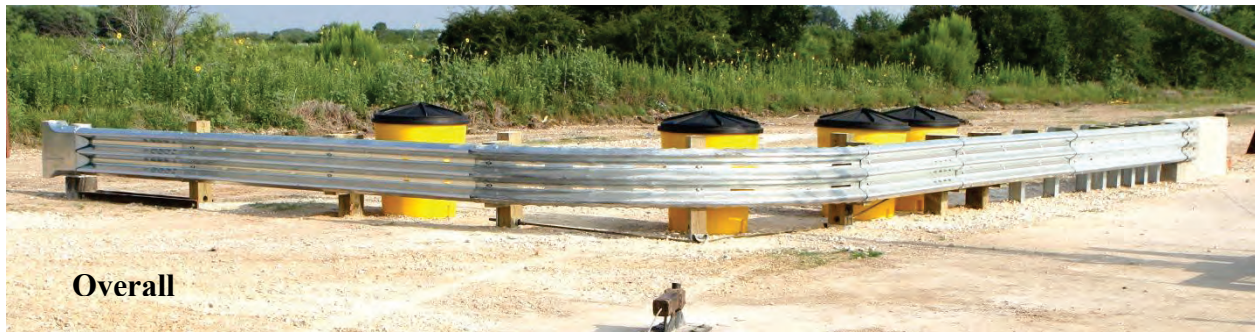
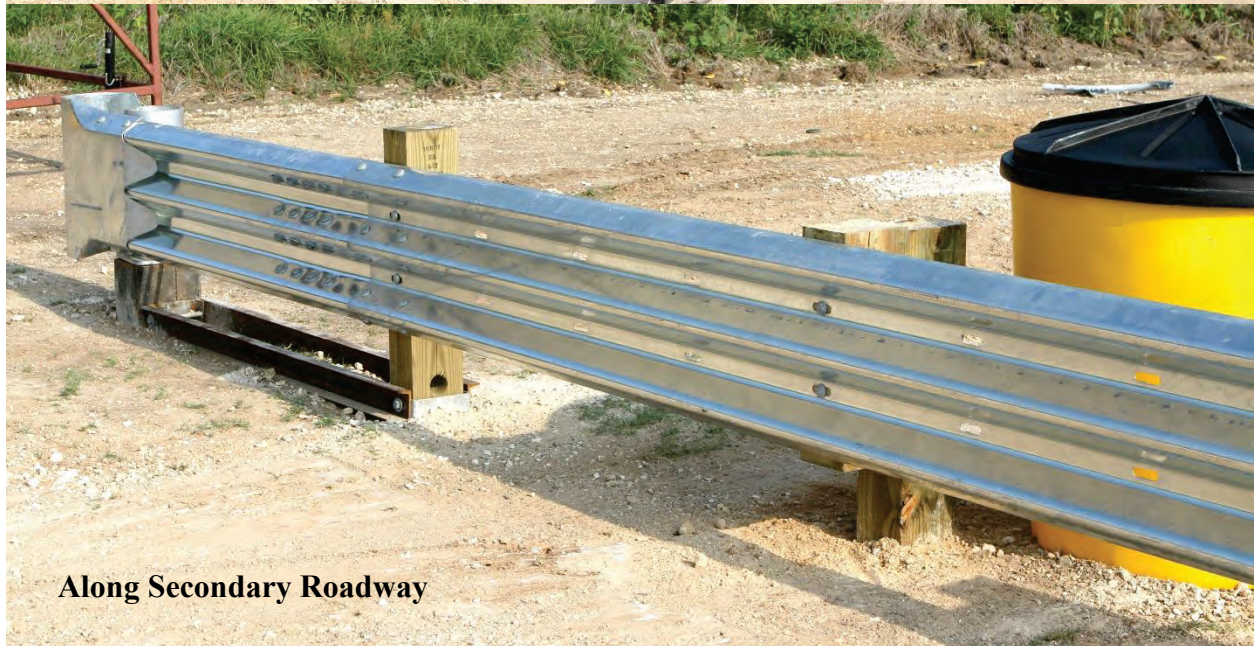
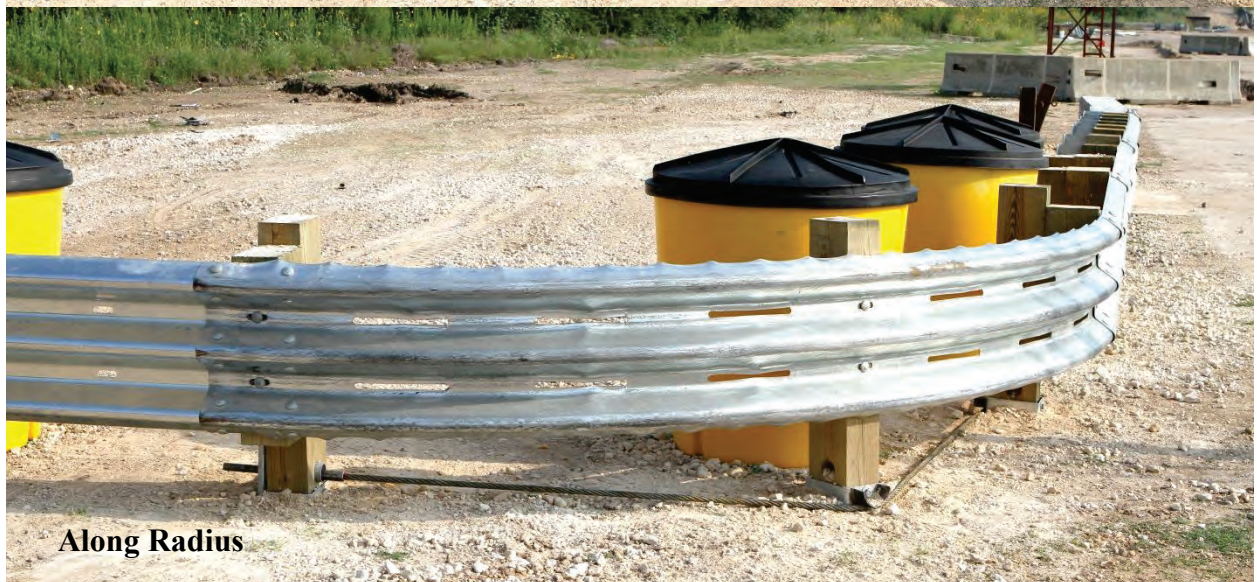
**Figure 5.3. Short Radius Guardrail (Overall, Secondary Road, and Radius) prior to Test Nos. 467114-3 through 467114-6.**

**Overall**

**Along Secondary Roadway**

**Along Radius**

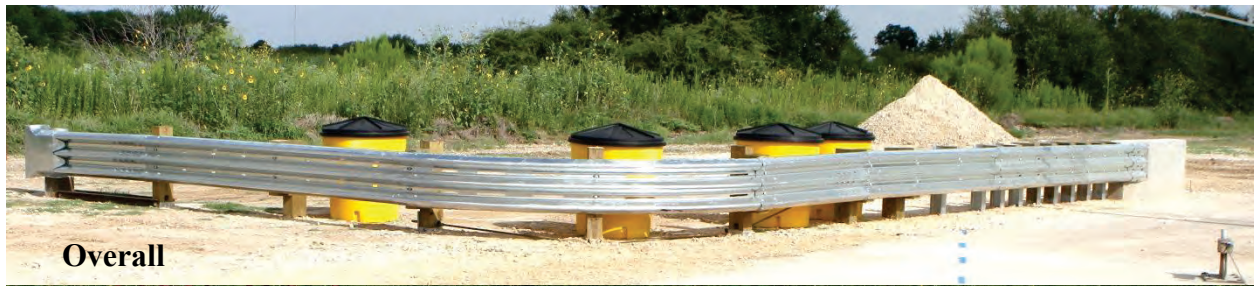
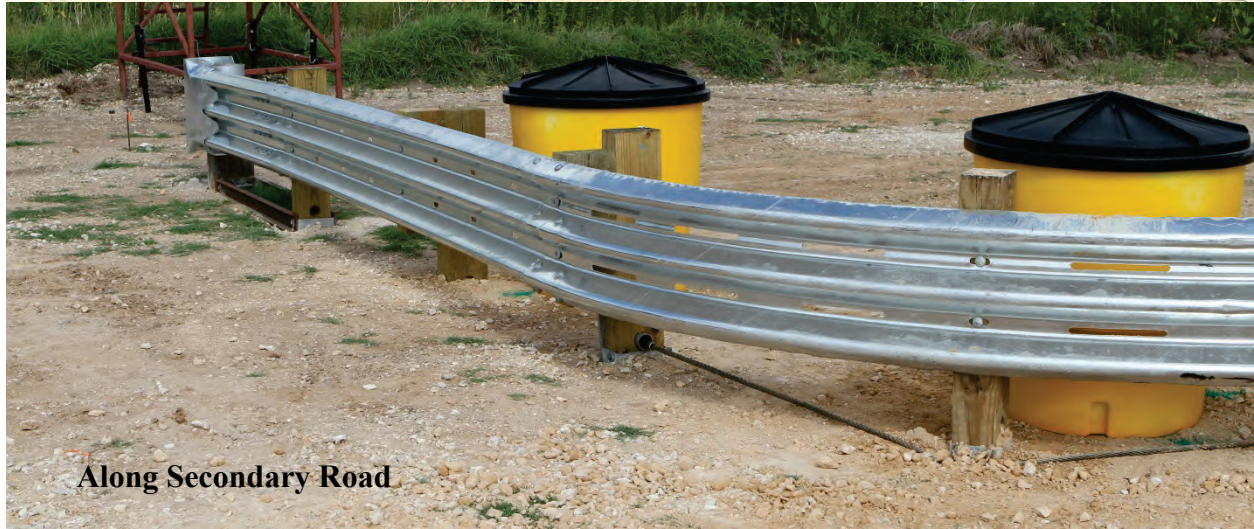
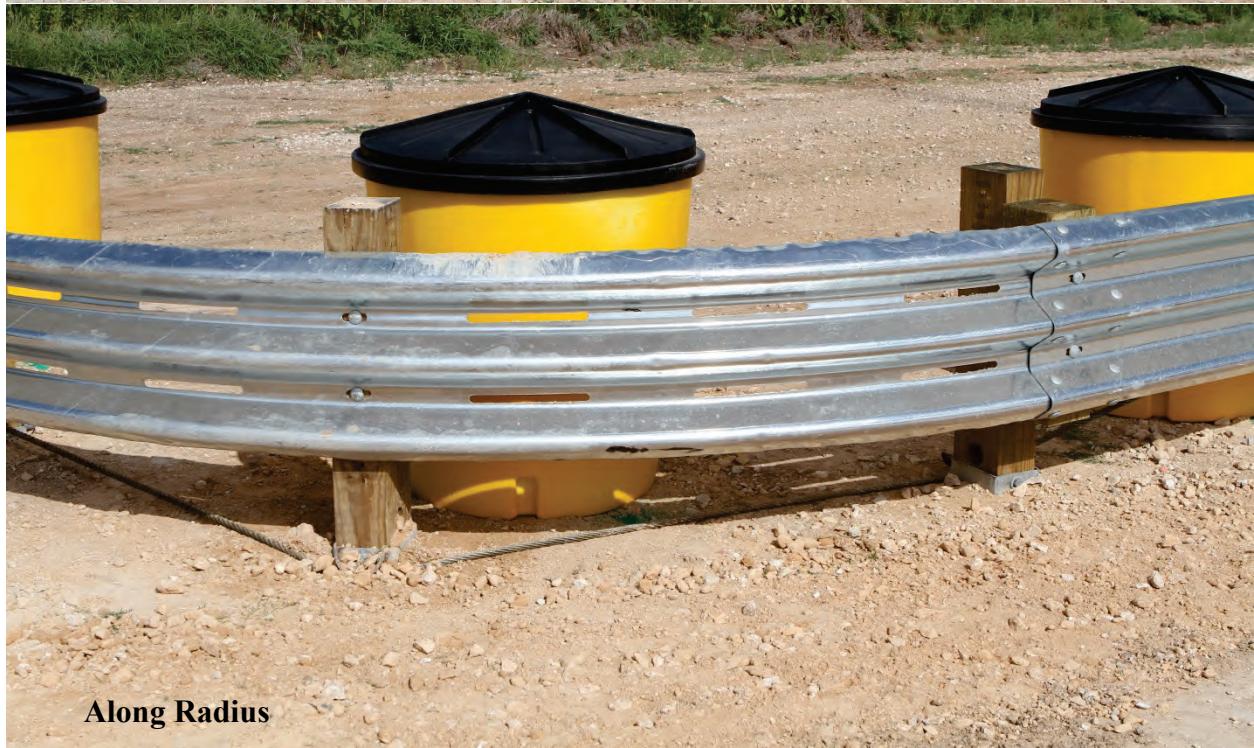
**Figure 5.7. Short Radius Guardrail (Overall, Secondary Road, and Radius) prior to Test No. 467114-7.**

**Overall**

**Along Secondary Road**

**Along Radius**

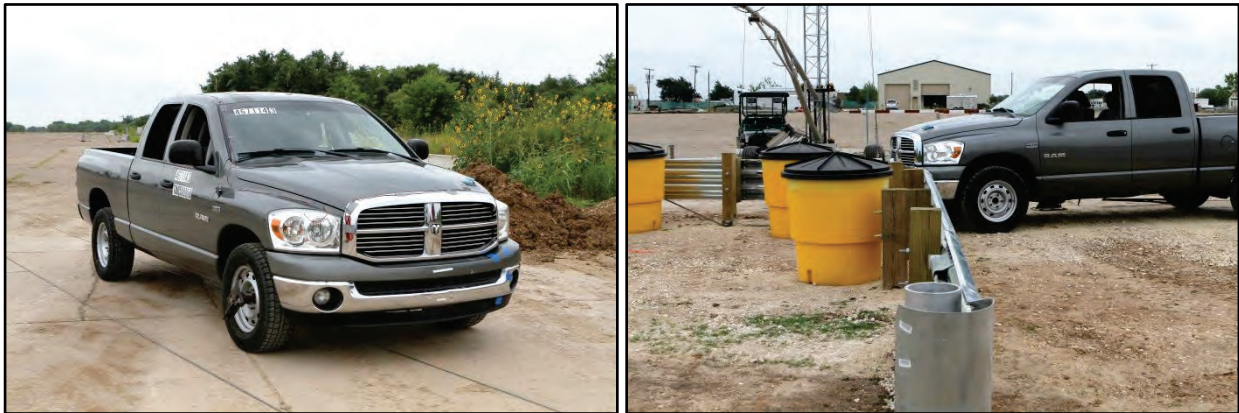
Figure 7.1. Vehicle/Installation Geometries before Test No. 467114-3.

Figure 7.1 shows the 2008 Dodge Ram 1500 Quad Cab pickup truck used for the crash test. Test inertia weight of the vehicle was 5041 lb, and its gross static weight was 5041 lb. The height to the lower edge of the vehicle bumper was 15.25 inches, and it was 26.75 inches to the upper edge of the bumper. The height to the vehicle's center of gravity was 28.38 inches. Tables D1 and D2 in Appendix D give additional dimensions and information on the vehicle. The vehicle was directed into the installation using the cable reverse tow and guidance system, and was released to be freewheeling and unrestrained just prior to impact.

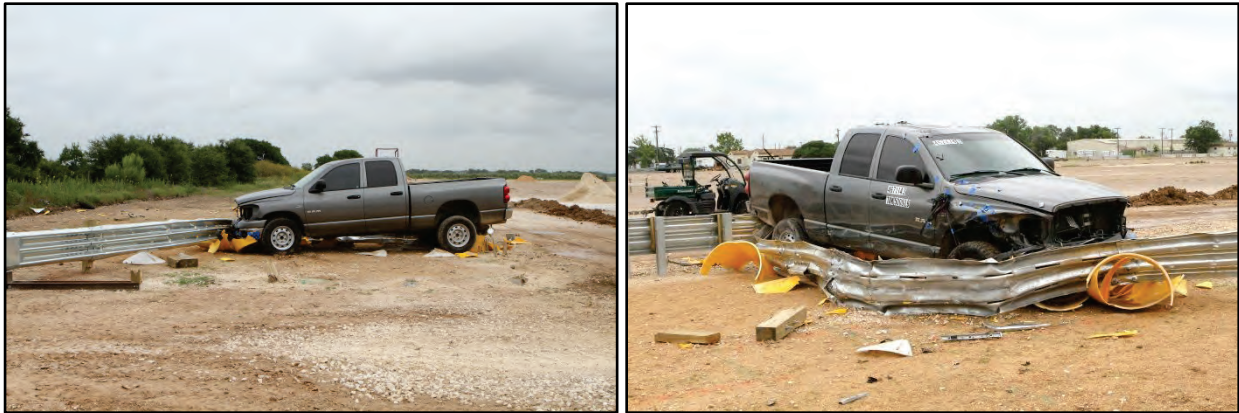
**Figure 7.2. Vehicle/Installation after Test No. 467114-3.**

The 2008 Dodge Ram pickup truck, traveling at an impact speed of 62.8 mph, impacted the radius of the Short Radius Guardrail at an impact angle of 14.4° (relative to the traffic face of the parapet). At 0.024 s after impact, the front of the vehicle contacted the sand barrel in the center of the radius (barrel no. 2), and at 0.053 s, the vehicle began to yaw counterclockwise. The rail element contacted the sand barrel near post 3 (barrel no. 1) at 0.094 s, and the right front corner of the bumper contacted the sand barrel between posts 6 and 7 (barrel no. 3) at 0.109 s. At 0.110 s, the rail element began to push on barrel no. 1, and at 0.113 s, the barrel began to tear. Barrel no. 3 began to tear at 0.121 s, and the barrel then contacted the sand barrel between post 7 and 8 (barrel no. 4) at 0.161 s. At 0.240 s, barrel no. 4 began to tear open. The vehicle began to roll clockwise at 0.599 s, and reached a maximum roll of 45° at 1.242 s. Brakes on the vehicle were not applied, and the vehicle subsequently came to rest upright. Figure D1 in Appendix D show sequential photographs of the test period. Figure 7.2 shows the vehicle at rest.

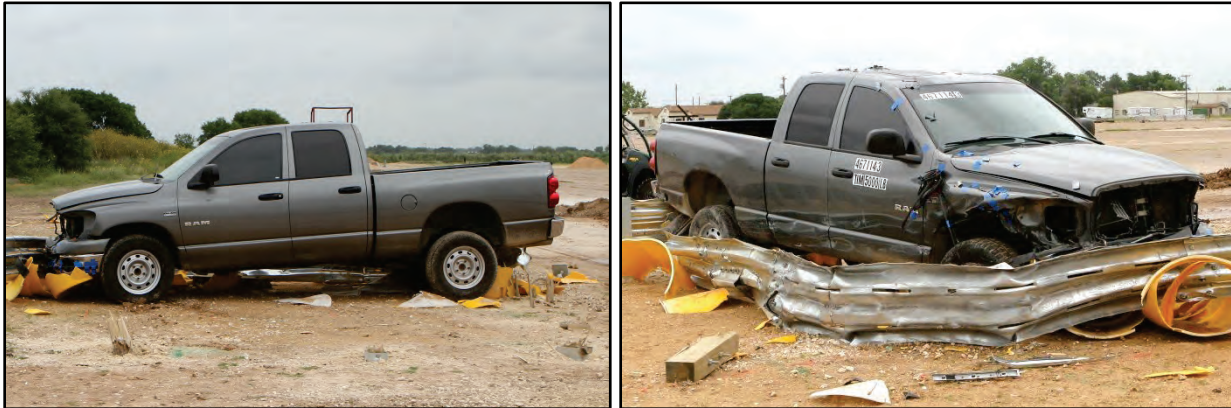
**Figure 7.4. Vehicle after Test No. 467114-3.**

Figure 7.4 shows the vehicle after the test. The front bumper, radiator and support, grill, hood, right front tire and wheel rim, right front fender, right front and rear doors, right rear exterior bed, and rear bumper were damaged. Maximum exterior crush to the vehicle was

7.75 inches in the front plane at the right front corner of the bumper at bumper height. No occupant compartment deformation was noted. Figure 7.5 shows the impact region of the interior of the vehicle after the test. Exterior crush and occupant compartment measurements are provided in Tables D3 and D4 of Appendix D.

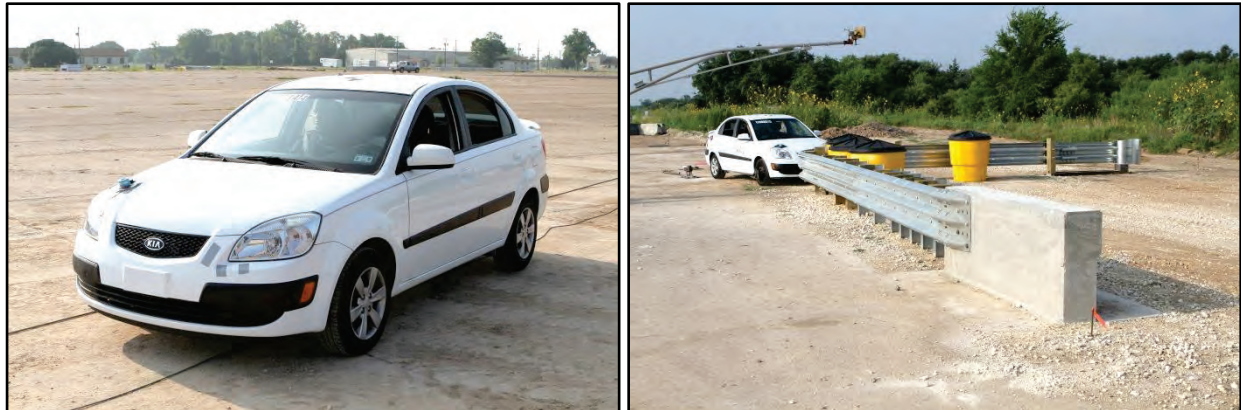
**Figure 7.7. Vehicle/Installation Geometries before Test No. 467114-4.**

Figure 7.7 shows the 2009 Kia Rio that was used for the crash test. Test inertia weight of the vehicle was 2424 lb, and its gross static weight was 2589 lb. The height to the lower edge of the vehicle bumper was 8.5 inches, and it was 21.5 inches to the upper edge of the bumper. Tables E1 and E2 in Appendix E give additional dimensions and information on the vehicle. The vehicle was directed into the installation using the cable reverse tow and guidance system, and was released to be freewheeling and unrestrained just prior to impact.

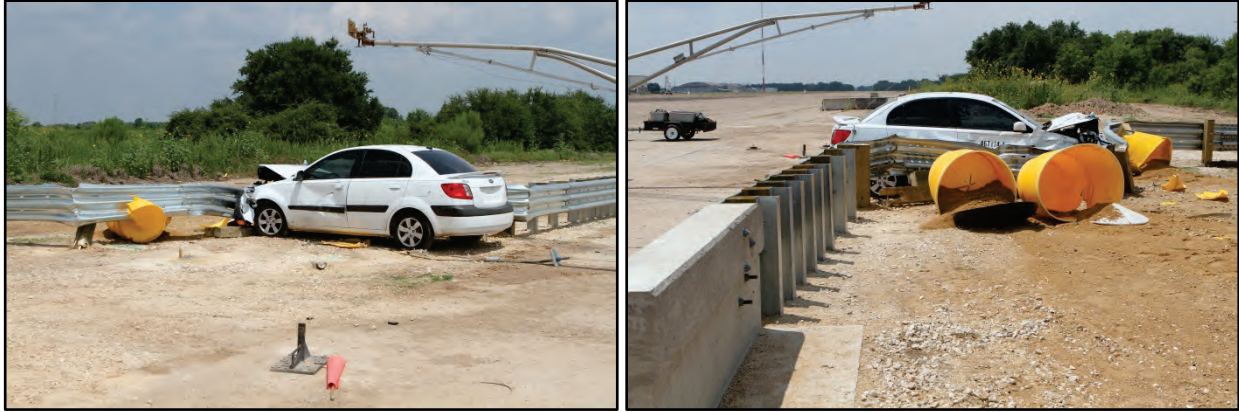
**Figure 7.8. Vehicle/Installation after Test No. 467114-4.**

The 2009 Kia Rio, traveling at an impact speed of 62.1 mph, impacted the center of the radius of the Short Radius Guardrail at an impact angle of 14.8° (relative to the traffic face of the parapet). At approximately 0.024 s after impact, the vehicle began to yaw counterclockwise, and at 0.034 s, the front of the vehicle contacted the barrel in the center (barrel no. 2) of the radius near post 5. The rail element contacted the side of barrel at post 3 (barrel no. 1) at 0.106 s, and the barrel began to move toward the field side at 0.127 s. At 0.189 s, the rail element contacted the barrel between post 6 and 7 (barrel no. 3), and at 0.230 s, the barrel began to move toward the field side. The side of barrel no. 3 contacted the barrel between posts 7 and 8 (barrel no. 4) at 0.276 s, and the blockout at post 7 contacted barrel no. 4 at 0.366 s. At 0.445 s, barrel no. 4 began to rotate clockwise and move toward the field side, and at 0.495 s, the rear of the vehicle contacted the rail element. Brakes on the vehicle were not applied, and the vehicle came to rest 14.0 ft toward the field side of the parapet (‘primary roadway’) and 14.6 ft toward the field side relative to the traffic face of the rail on the ‘secondary roadway’ side. Figures E1 and E2 in Appendix E show sequential photographs of the test period. Figure 7.8 shows the vehicle at final rest.

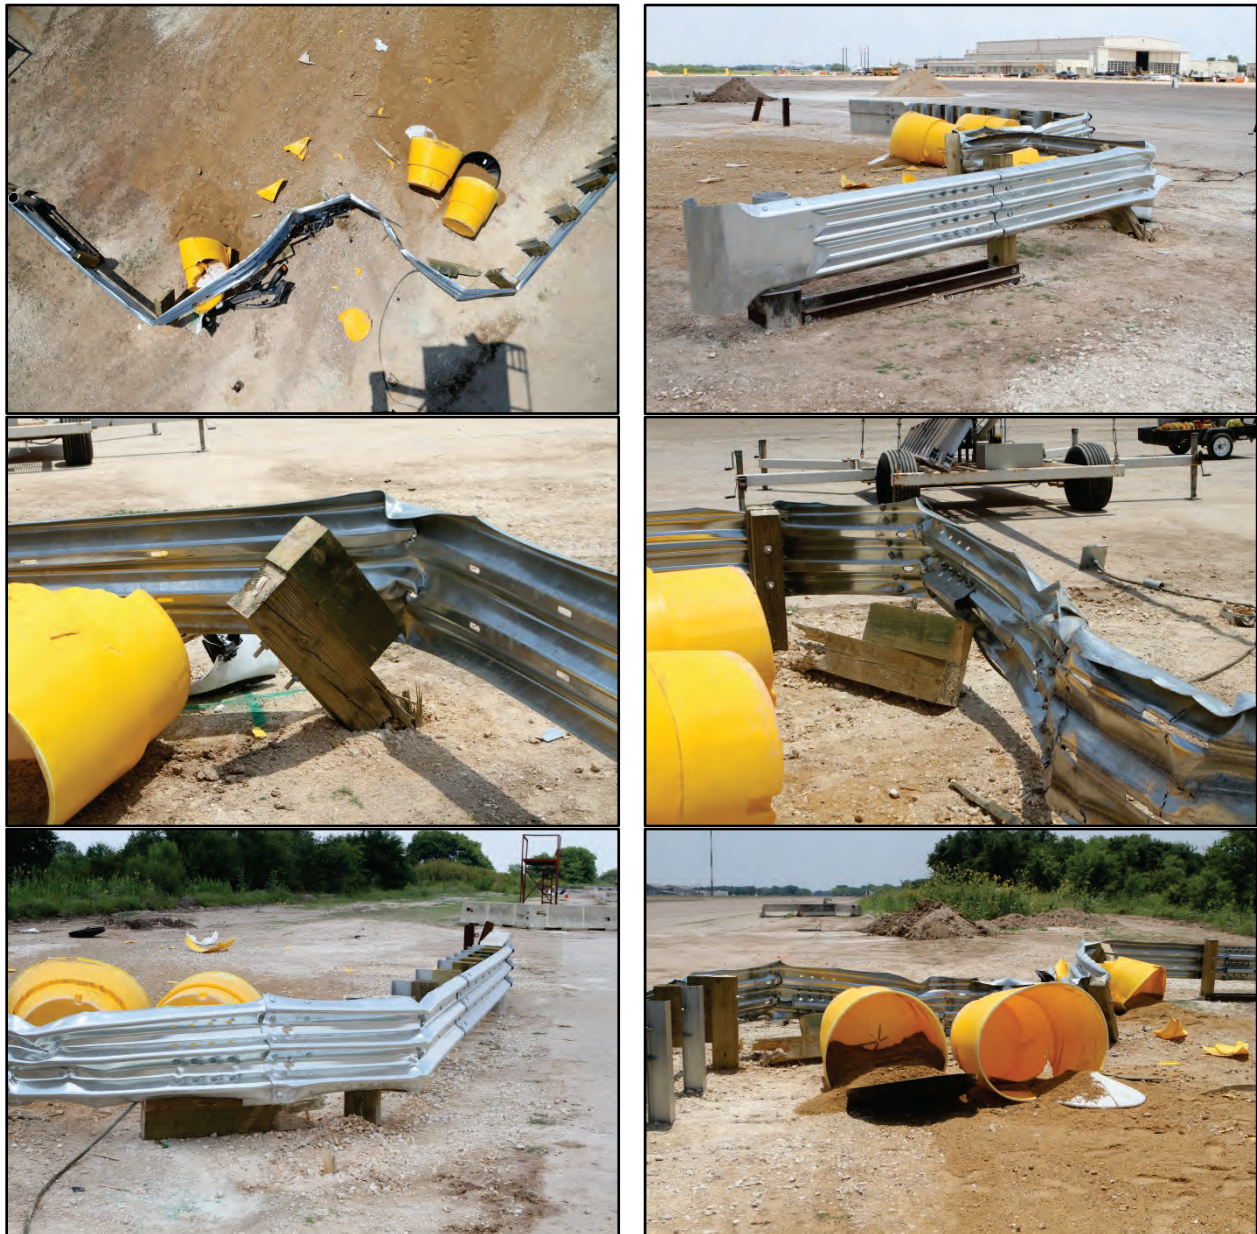
**Figure 7.9. Installation after Test No. 467114-4.**

Figure 7.9 shows the damage to the Short Radius Guardrail. The anchor plate between post 1 and 2 was pulled downstream 0.12 inch, and post 2 deflected through the soil 2.5 inches. Post 3 fractured at ground line and remained in place, but separated from the rail element. Post 4 fractured at ground line and was resting 32 ft toward the field side. Post 5 and 6 fractured at ground line and were resting at the left front tire and right front tire of the vehicle, respectively. Post 7 fractured at ground line and was resting 31 inches toward the field side. Post 8 displaced 0.25 inch toward the field side. Posts 9 and 10 were disturbed, and no movement was noted at the remaining posts.

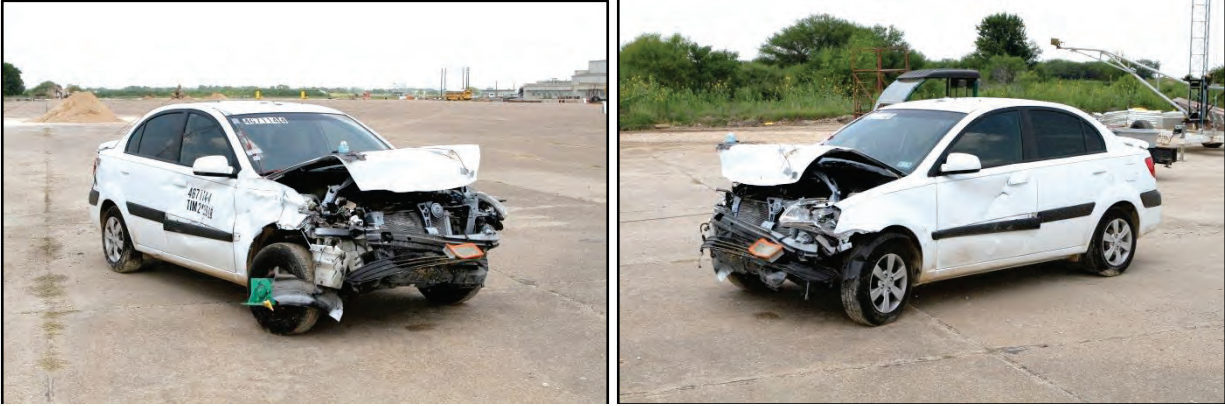
**Figure 7.10. Vehicle after Test No. 467114-4.**

Figure 7.10 shows damage sustained by the vehicle. The front bumper, grill, radiator and support, hood, right and left front fenders, and right and left front doors were deformed. The windshield sustained stress fractures. Maximum exterior crush to the vehicle was 10.0 inches in the front plane just left of center front of the vehicle at bumper height. Maximum occupant compartment deformation was 0.5 inch in the right side front passenger door at hip height. Figure 7.11 shows the interior of the vehicle after the test. Exterior crush measurements and occupant compartment deformation are provided in Tables E2 and E3 in Appendix E.

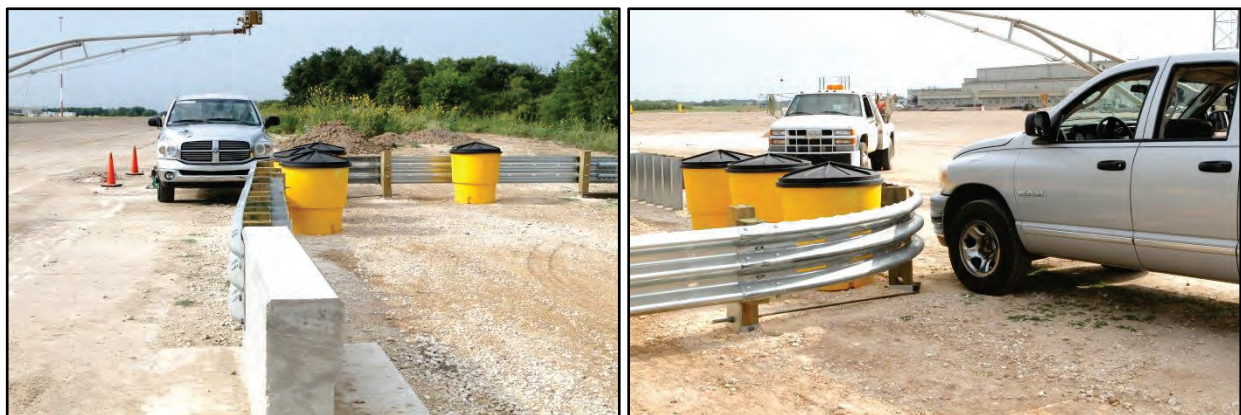
**Figure 7.13. Vehicle/Installation Geometrics before Test No. 467114-5.**

Figure 7.13 shows a 2008 Dodge Ram 1500 pickup that was used for the crash test. Test inertia weight of the vehicle was 5023 lb, and its gross static weight was 5023 lb. The height to the lower edge of the vehicle bumper was 16.0 inches, and it was 27.0 inches to the upper edge of the bumper. The height to the vehicle's center of gravity was 28.9 inches. Tables F1 and F2 in Appendix F give additional dimensions and information on the vehicle. The vehicle was directed into the installation using the cable reverse tow and guidance system, and was released to be freewheeling and unrestrained just prior to impact.

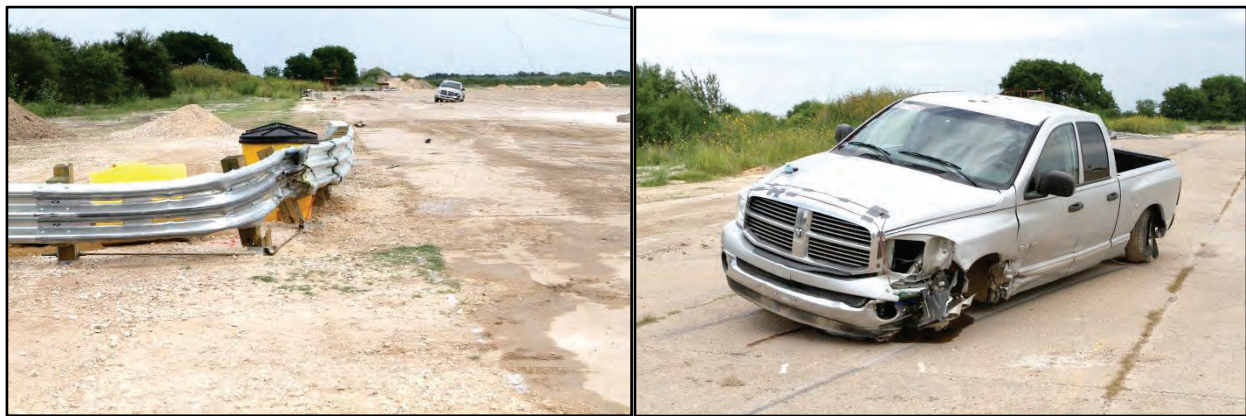
**Figure 7.14. Vehicle/Installation after Test No. 467114-5.**

The 2008 Dodge Ram 1500 pickup, traveling at an impact speed of 63.5 mph, contacted the guardrail 39.7 inches upstream of post 6 at an impact angle of 0° relative to the face of the concrete parapet. At approximately 0.026 s after impact, the vehicle began to yaw clockwise, and at 0.043 s, the left front bumper contacted post 6. The left front tire contacted post 6 at 0.054 s, and the rear of the guardrail contacted barrel 2 at 0.058 s. At 0.067 s, the rear of the guardrail contacted barrel 3, and at 0.069 s, the left front tire snagged on post 6 and blew out. The left front bumper of the vehicle contacted barrel 3 at 0.077 s, and post 7 began to deflect toward the field side at 0.104 s. The left front bumper contacted post 7, 8, and 9 at 0.111 s, 0.152 s, and 0.185 s, respectively. At 0.282 s, the left rear tire snagged on post 7 and blew out; at 0.293 s, the rear of the vehicle contacted the guardrail. The vehicle lost contact with the guardrail at 0.366 s, and was traveling at an exit speed and angle of 54.8 mph and 7.8°. Brakes on the vehicle were applied at 2.1 s after impact, and the vehicle subsequently came to rest 42 ft downstream of impact and 32 ft toward traffic lanes. Figures F1 and F2 in Appendix F show sequential photographs of the test period. Figure 7.14 shows the vehicle at final rest.

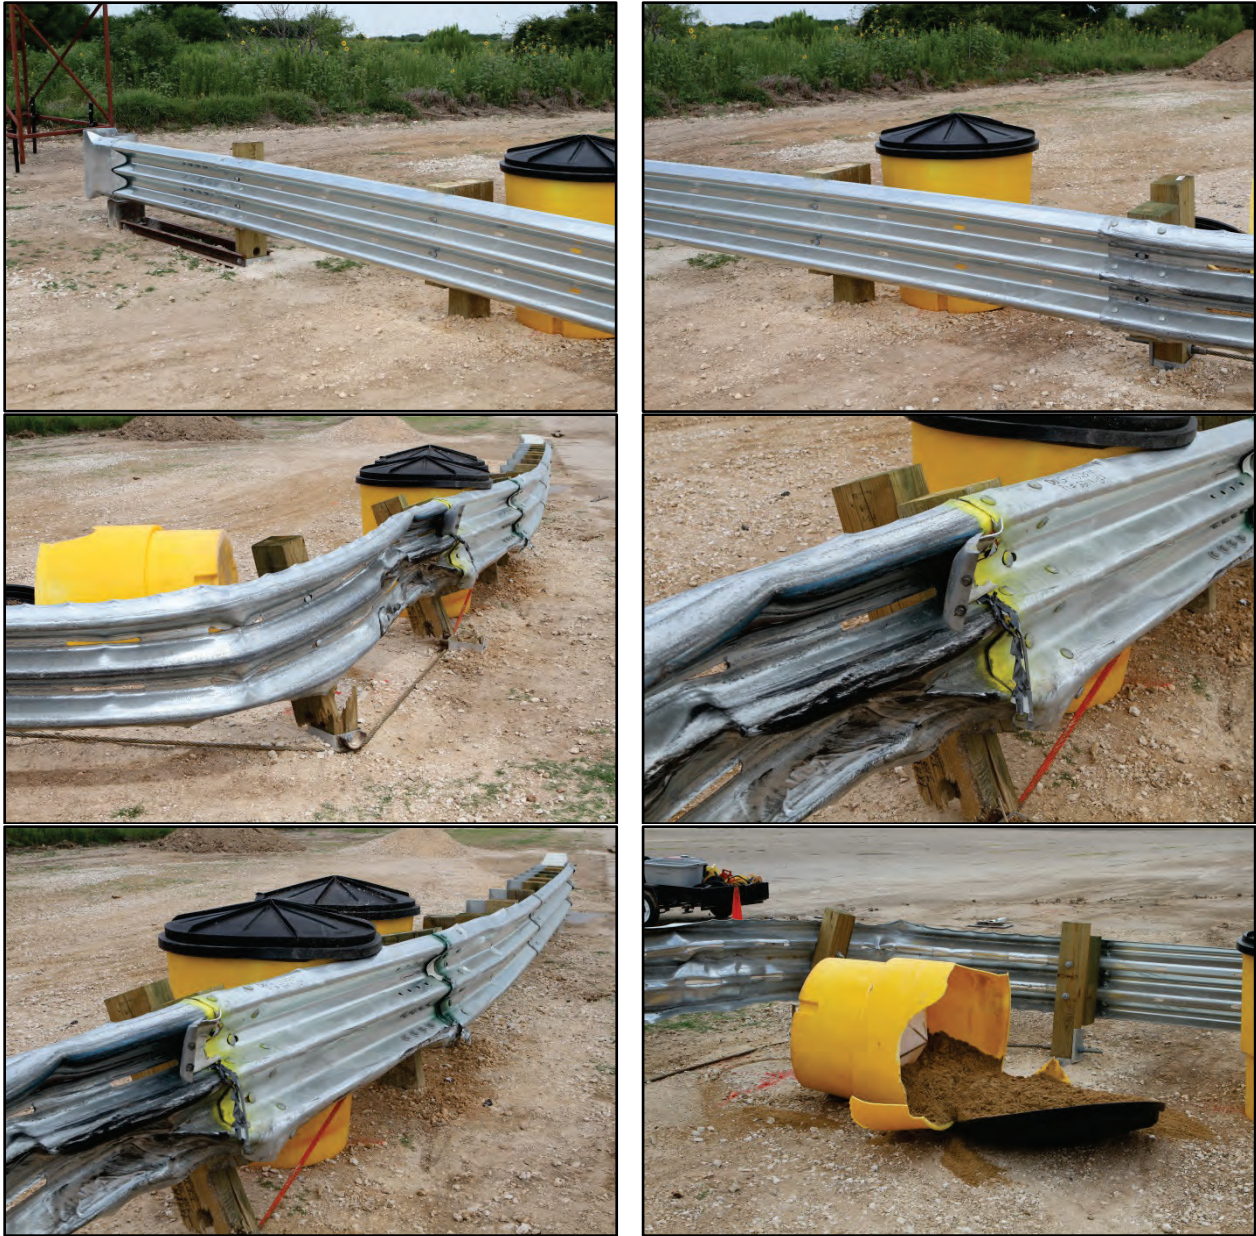
**Figure 7.15. Installation after Test No. 467114-5.**

Figure 7.15 shows damage to the installation. Post 4 was leaning upstream 6°. Posts 5 and 6 fractured at ground level and were leaning upstream 12°, and toward the field side 8° and 12°, respectively. Posts 7 and 8 fractured below ground level and were leaning toward field side 13° and 5°, respectively. Post 7 had displaced through the soil by 0.75 inch and post 8 by 0.5 inch. The soil around post 9 was disturbed. A small amount of orange paint from post 6 was found on the left front tire, which separated from the vehicle and was resting 90 ft downstream of impact and 40 ft toward traffic lanes. Total length of contact with the rail element on the ‘primary roadway’ was 20.25 ft. Maximum dynamic deflection of the rail element during the test was 34.1 inches, and maximum permanent deformation of the rail element was 15.0 inches. Maximum working width was 36.0 inches, and maximum vehicle intrusion was 16.0 inches.

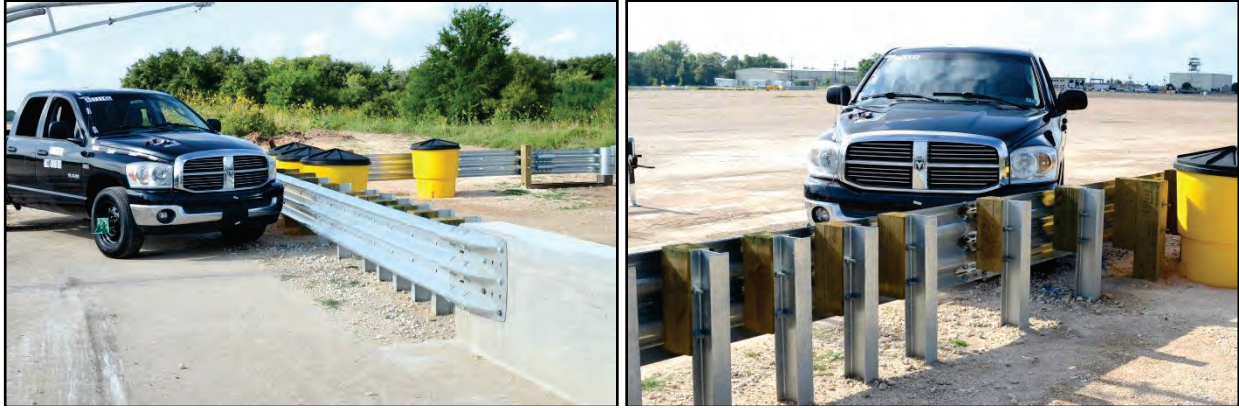
**Figure 7.19. Vehicle/Installation Geometrics before Test No. 467114-6.**

Figure 7.19 shows the 2008 Dodge Ram 1500 pickup that was used for the crash test. Test inertia weight of the vehicle was 5016 lb, and its gross static weight was 5016 lb. The height to the lower edge of the vehicle bumper was 15.5 inches, and it was 27.0 inches to the upper edge of the bumper. The height to the vehicle’s center of gravity was 28.88 inches. Tables G1 and G2 in Appendix G give additional dimensions and information on the vehicle. The vehicle was directed into the installation using the cable reverse tow and guidance system, and was released to be free-wheeling and unrestrained just prior to impact.

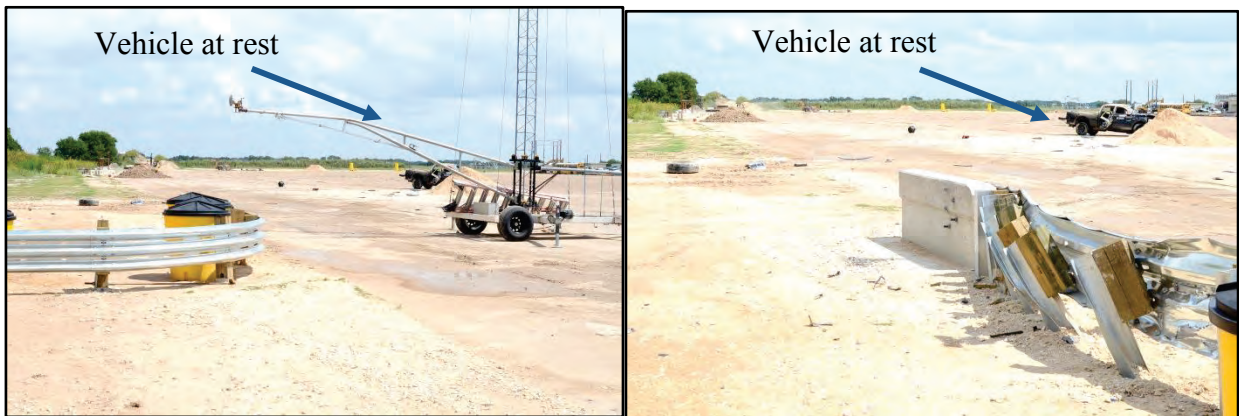
**Figure 7.20. Vehicle/Installation after Test No. 467114-6.**

The 2008 Dodge Ram 1500 pickup, traveling at an impact speed of 62.6 mph, contacted the Short Radius Guardrail 12 inches upstream of post 9 at an impact angle of 25.1°. At approximately 0.016 s after impact, posts 9 and 10 began to deflect toward the field side; at 0.023 s, the vehicle began to redirect and post 11 began to deflect toward the field side. Post 12 through post 14 began to deflect toward the field side at 0.029 s, and the left front corner of the bumper contacted post 10 at 0.033 s. The bumper reached posts 11 and post 12 at 0.062 s and 0.075 s, respectively. At 0.091 s, the rail element began to buckle at the upstream side of post 15, and the bumper reached post 13 at 0.095 s. At 0.115 s, post 15 began to deflect toward the field side and the bumper reached post 14. The bumper reached post 14 and post 15 at 0.146 s and 0.170 s, respectively. At 0.187 s, the left front corner of the bumper reached the upstream end of the concrete parapet; at 0.194 s, the vehicle was traveling parallel with the parapet. The rear of the vehicle contacted the rail 0.211 s. At 0.410 s, the vehicle began to roll clockwise, rolled three complete revolutions, and came to rest upright 145 ft downstream of impact and 85 ft toward traffic lanes. Figures G1 and G2 in Appendix G show sequential photographs of the test period. Figure 7.20 shows the vehicle at final rest relative to the Short Radius Guardrail.

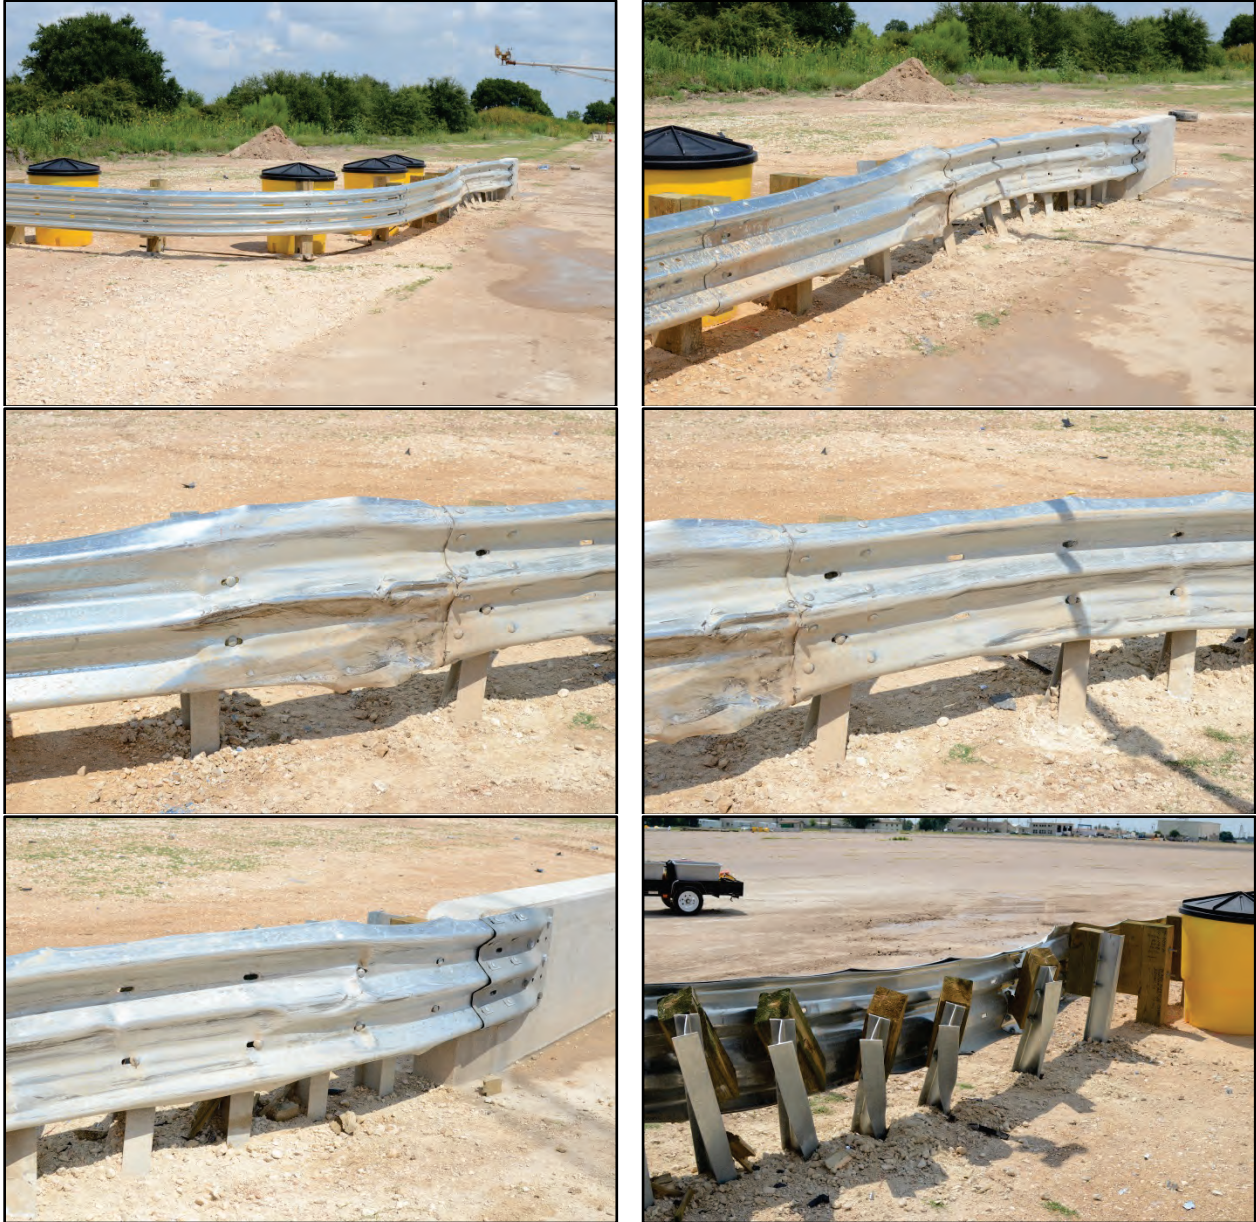
**Figure 7.21. Installation after Test No. 467114-6.**

Figure 7.21 shows damage to the Short Radius Guardrail. Post 7 was pulled downstream 0.25 inch and displaced through the soil toward the field side 0.12 inch. Post 8 was pulled downstream 0.25 inch and displaced through the soil toward the field side 0.5 inch. Post 9 was leaning toward field side 7° and displaced through the soil toward the field side 0.5 inch. Posts 10 through 14 rotated 45° clockwise, leaning downstream 25°, and the top guardrail bolt pulled through the rail element. Post 15 rotated 20° clockwise and leaned downstream 10°. Post 16 was displaced through the soil 0.12 inch toward the field side. Total length of contact of the vehicle with the guardrail was 15 ft. Maximum dynamic deflection during the test was 21.1 inches, and maximum permanent deformation was 16.25 inches. Working width was 24.1 inches, and vehicle intrusion was 29.6 inches.

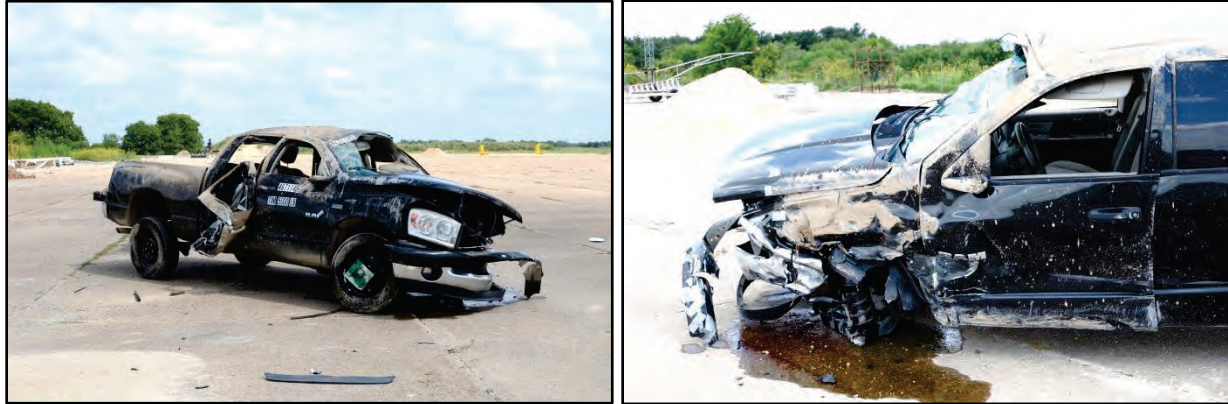
**Figure 7.22. Vehicle after Test No. 467114-6.**

Figure 7.22 shows damage to the vehicle. The front bumper, radiator and support, hood, grill, left front fender, left front tire and wheel rim, left upper and lower ball joints, left rear door, left rear exterior bed, and rear bumper were damaged in the impact with the Short Radius Guardrail. The remaining damage was sustained in the rollover. Maximum exterior crush to the vehicle was 24.0 inches at the left front corner at bumper height. Maximum occupant compartment deformation related to the impact with the Short Radius Guardrail was 3.25 inches in the lateral area across the cab in the driver side kickpanel area. Maximum occupant compartment deformation related to the rollover was 9.5 inches in the floor to roof area in the left rear occupant compartment. Table G3 and Table G4 in Appendix G present the vehicle exterior crush and occupant compartment deformation measurements, respectively.

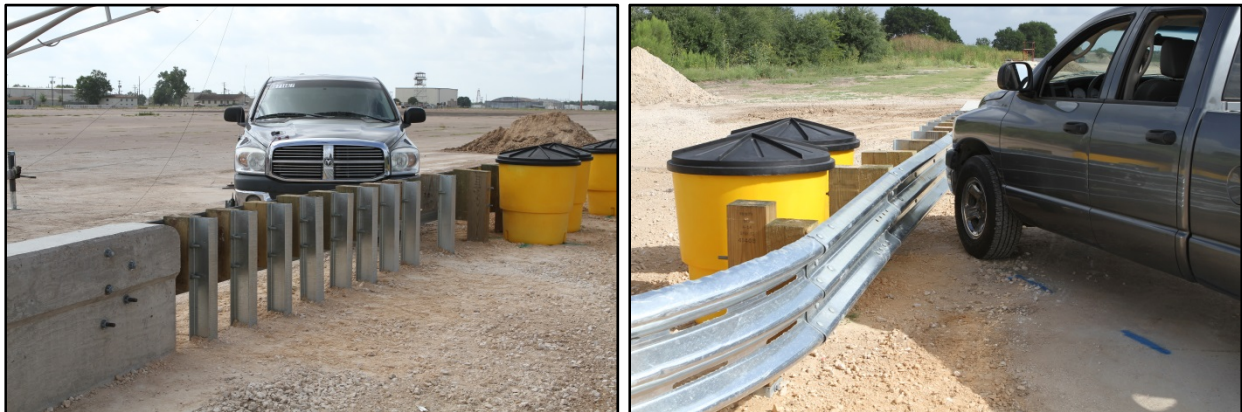
**Figure 7.24. Vehicle/Installation Geometries for Test No. 467114-7.**

Figure 7.24 shows the 2008 Dodge Ram 1500 pickup that was used for the crash test. Test inertia weight of the vehicle was 5014 lb, and its gross static weight was 5041 lb. The height to the lower edge of the vehicle bumper was 15.5 inches, and it was 27.0 inches to the upper edge of the bumper. The height to the vehicle's center of gravity was 28.0 inches. Tables H1 and H2 in Appendix H give additional dimensions and information on the vehicle. The vehicle was directed into the installation using the cable reverse tow and guidance system, and was released to be freewheeling and unrestrained just prior to impact.

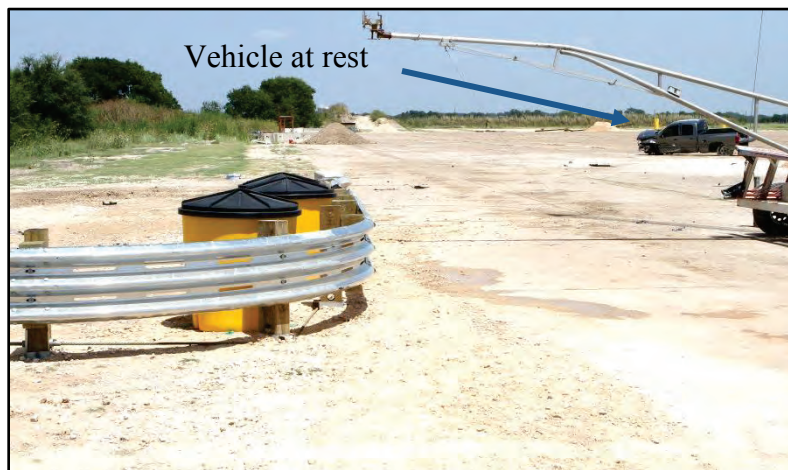
**Figure 7.25. Vehicle/Installation after Test No. 467114-7.**

The 2008 Dodge Ram 1500 pickup truck, traveling at an impact speed of 64.5 mph, impacted the Short Radius Guardrail at post 9 at an impact angle of 25.2°. Shortly after impact, post 9 began to deflect toward the field side, and at 0.011 s, post 10 began to deflect toward the field side. Posts 10, 11, and 12 began to deflect toward the field side at 0.011 s, 0.018 s, and 0.026 s, respectively. At 0.032 s, the left front corner of the bumper contacted post 10 and post 13 began to deflect toward the field side. At 0.037 s, the vehicle began to redirect and post 13 began to deflect toward the field side. The bumper contacted post 11 at 0.044 s, and post 14 began to deflect toward the field side at 0.048 s. At 0.057 s, the front bumper contacted post 12, and at 0.071 s, the left front tire and wheel assembly separated from the vehicle. The bumper contacted post 13 at 0.073 s, and post 15 began to deflect toward the field side at 0.077 s. At 0.088 s, the bumper contacted post 14 and post 16 began to deflect toward the field side. The bumper contacted post 15, 16, and 17 at 0.104 s, 0.132 s, and 0.157 s, respectively. The bumper reached the end of the parapet at 0.143 s, and the rear of the vehicle contacted the guardrail at 0.186 s. At 0.208 s, the vehicle was traveling parallel with the parapet, and at 0.423 s, the vehicle began to roll counterclockwise. The vehicle lost contact with the parapet at 0.451 s and was traveling at an exit speed and angle of 40.6 mph and 31.1°. Brakes on the vehicle were applied at 2.5 s after impact, and the vehicle subsequently came to rest upright 160 ft downstream of impact and 58 ft toward traffic lanes from the traffic face of the parapet. Figures H1 and H2 in Appendix H show sequential photographs of the test period. Figure 7.25 shows the vehicle at final rest relative to the Short Radius Guardrail.

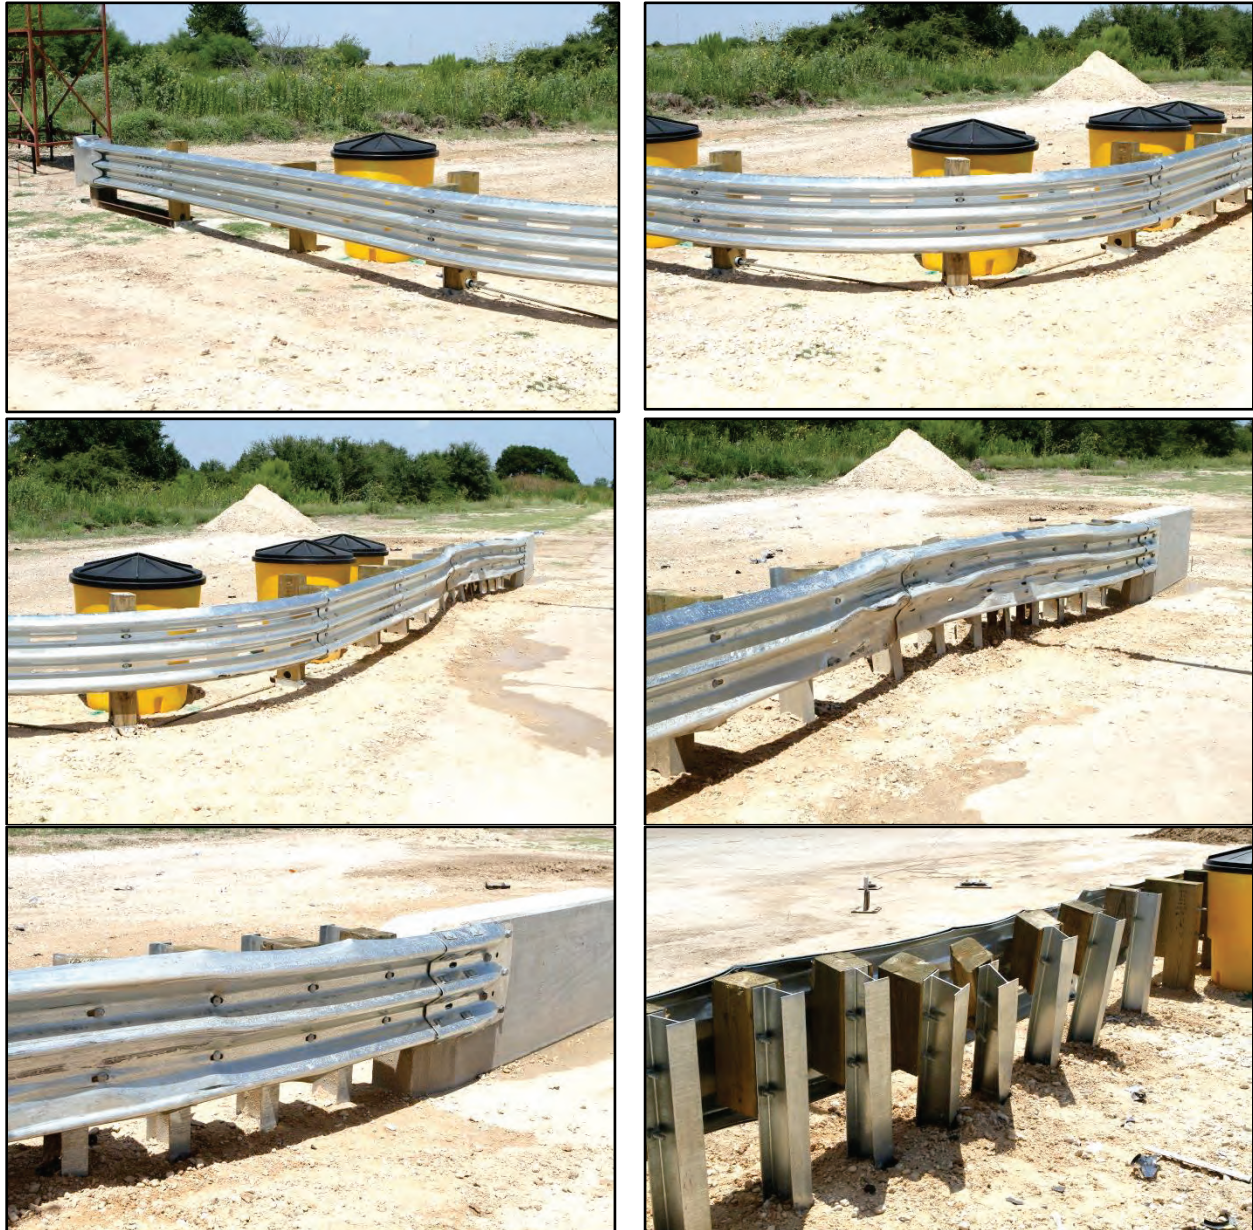
**Figure 7.26. Installation after Test No. 467114-7.**
