## CRASH TEST AND *MASH* TL-3 EVALUATION OF THE TxDOT SHORT RADIUS GUARDRAIL

**Test Report No. 0-6711-1**

**TEXAS A&M TRANSPORTATION INSTITUTE  
COLLEGE STATION, TEXAS**

**TEXAS DEPARTMENT OF TRANSPORTATION**

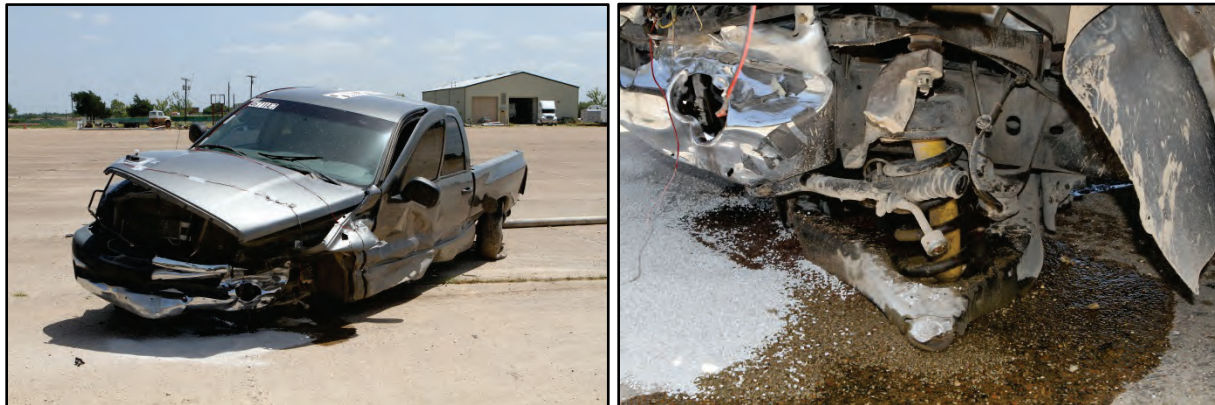
**Figure 7.27. Vehicle after Test No. 467114-7.**

Figure 7.27 shows the vehicle after the test. The left upper and lower ball joints, left frame rail, and left rear U-bolts were damaged. Also damaged were the front bumper, radiator and support, left front tire and wheel rim, left front and rear doors, left rear exterior bed, left rear tire and wheel rim, rear tailgate, and rear bumper. Maximum exterior crush to the vehicle was

24.0 inches in the front and side planes at the left front corner at bumper height. Maximum occupant compartment deformation was 2.5 inches in the left firewall area near the toe pan.

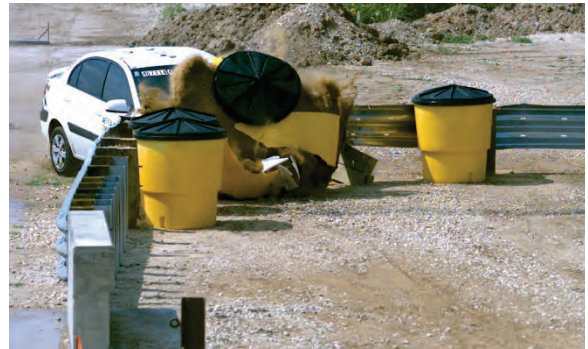
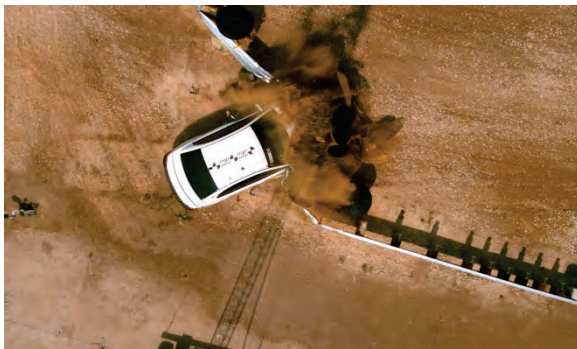
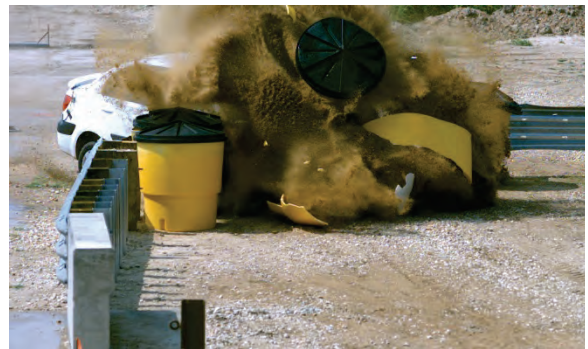
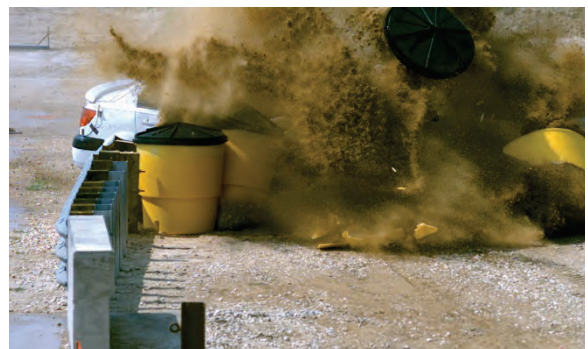
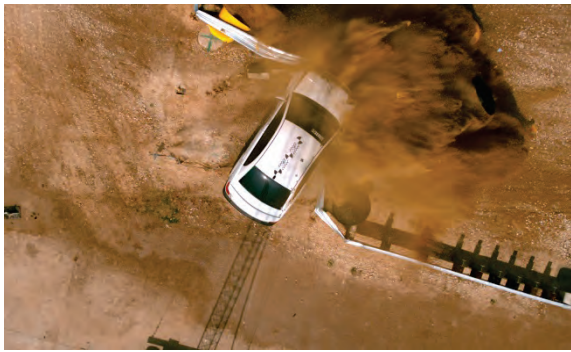
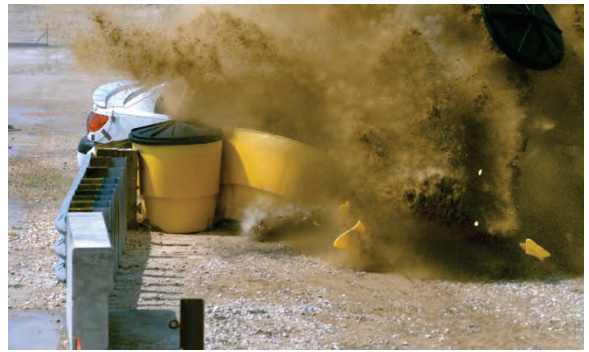
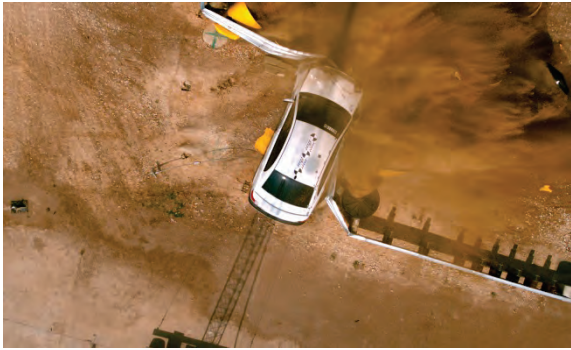
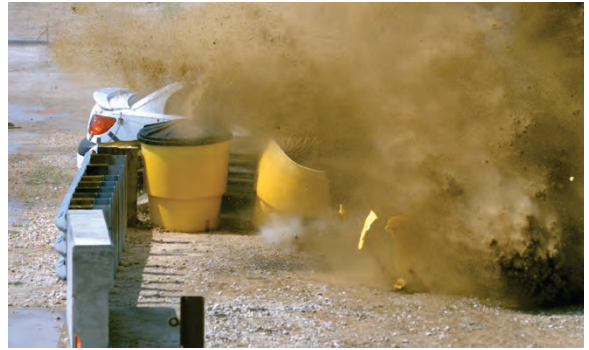
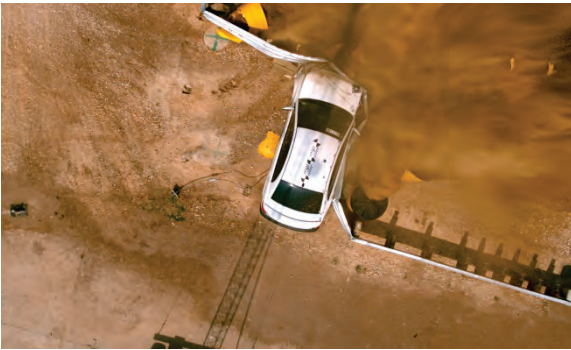
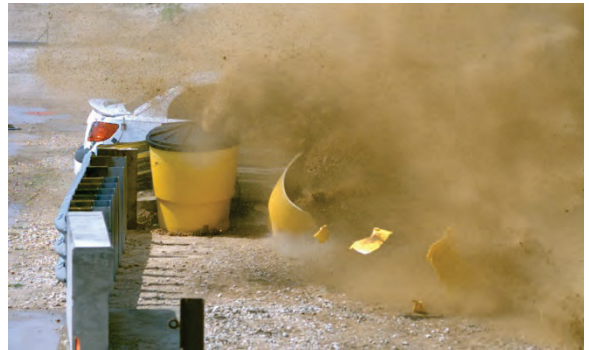
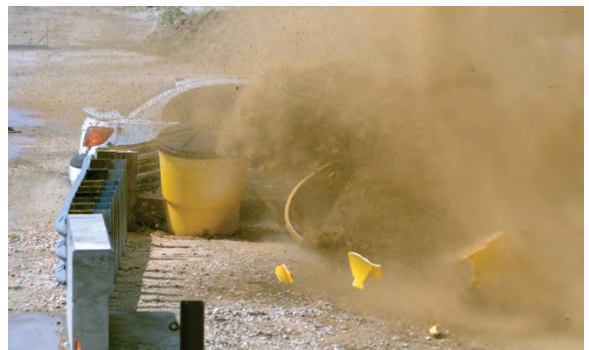
**Figure F1. Sequential Photographs for Test No. 467114-4  
(Overhead and Frontal Views).**

**Figure F1. Sequential Photographs for Test No. 467114-4  
(Overhead and Frontal Views) (Continued).**

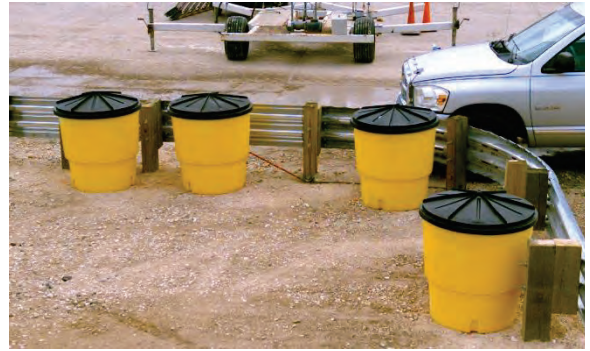
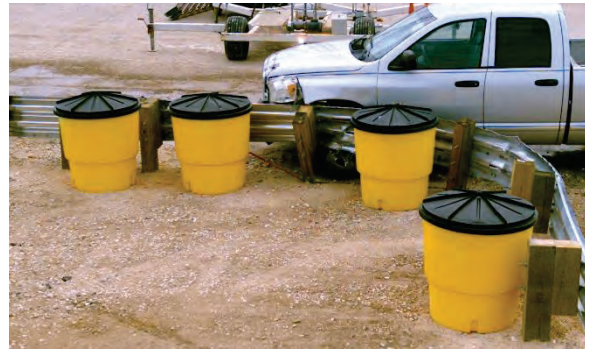
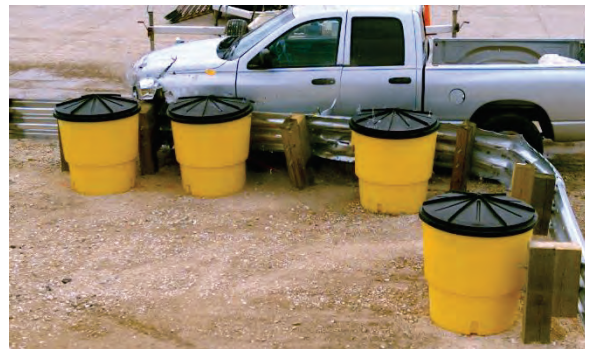
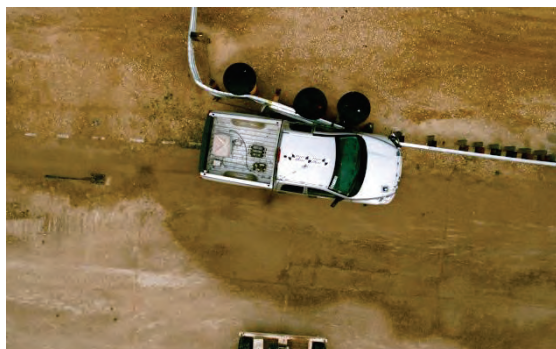
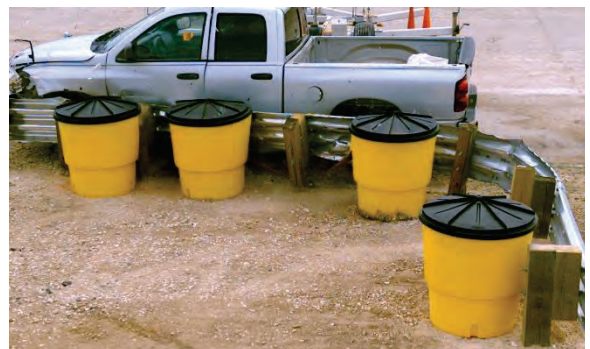
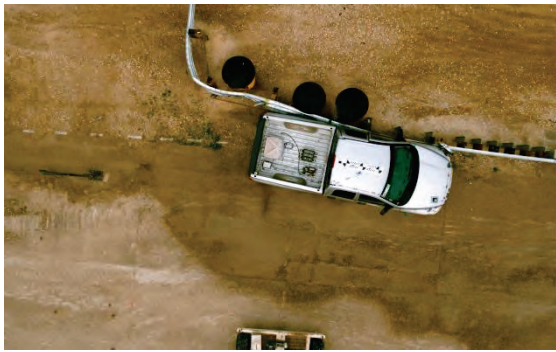
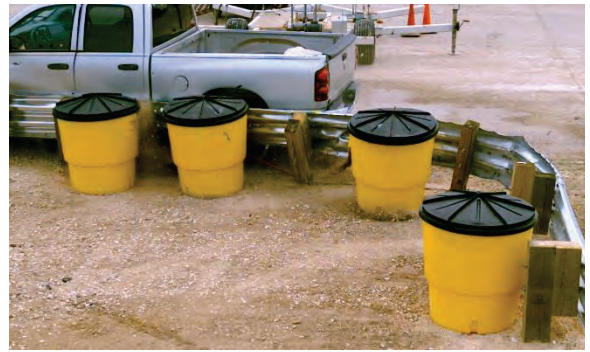
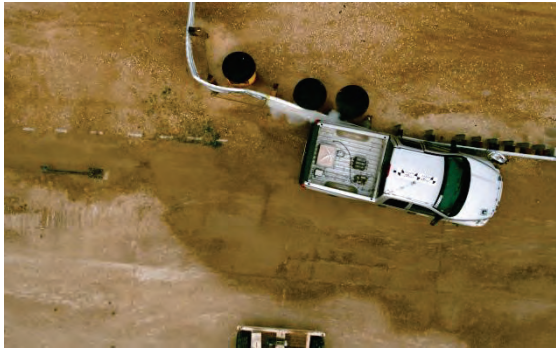
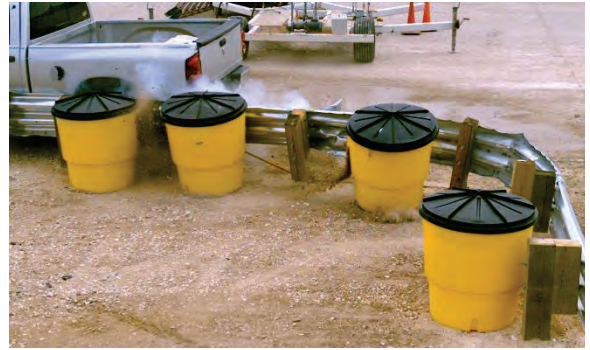
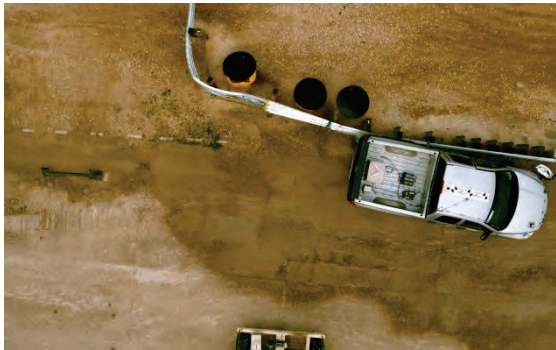
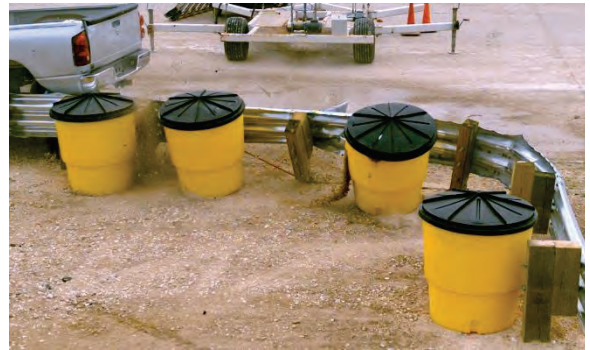
**Figure G1. Sequential Photographs for Test No. 467114-5  
(Overhead and Rear Views).**

**Figure G1. Sequential Photographs for Test No. 467114-5  
(Overhead and Rear Views) (Continued).**
