[Evaluating Roadway Subsurface Drainage Practices – Phase II](#)

Iowa Highway Research Board
(IHRB Project TR-662)
Iowa Department of Transportation
(InTrans Project 13-473)

tech transfer summary

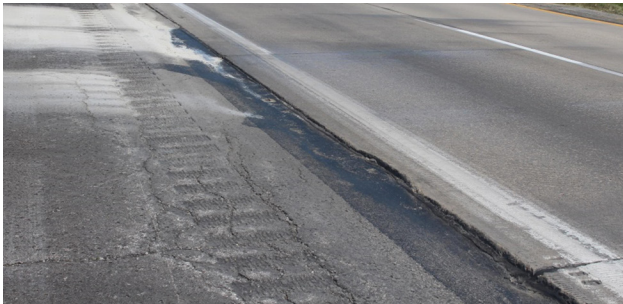
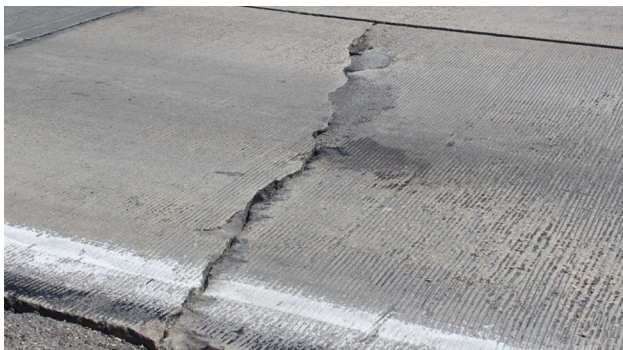
Moisture-related distresses on JPCP where no drainage outlets located at site

- Moisture-related pavement surface distresses were observed in sections where no drainage outlet could be located.
- At the JPCP sites, slightly more outlets were observed with blockage and associated surface distresses in summer 2013 than in fall 2012. However, these differences are not significant.

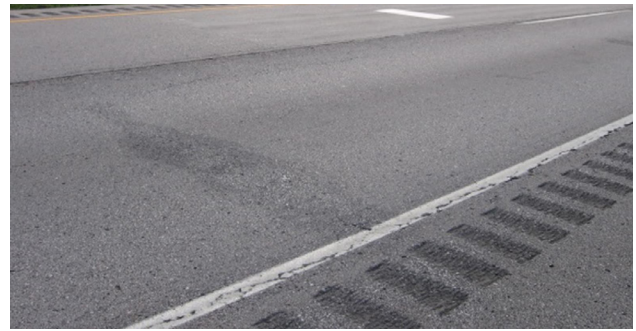
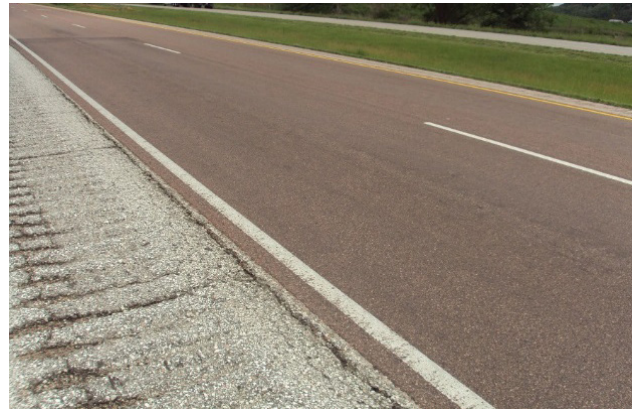
Moisture-related distresses on HMA over JPCP-type composite pavement system where no drainage outlets located in the field

- At HMA over JPCP sites, moisture-related distresses were observed more frequently near blocked than clear drainage outlet locations. Compromised drainage outlet performance may therefore accelerate the development of moisture-related distresses in HMA over JPCP.

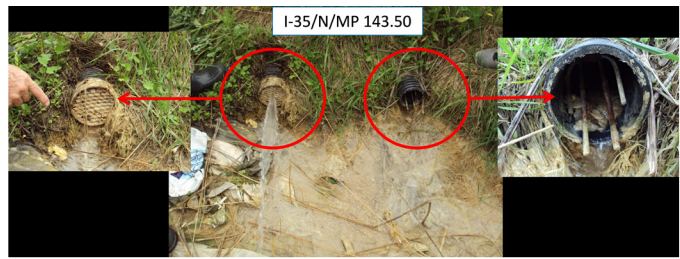
Mesh screen type rodent guards (left) exacerbated outlet clogging by blocking free flow of draining water while fork-shaped rodent guards (right) did not

- Use of a gate or mesh screen rodent guard may cause outlet blockage. Because very little rodent evidence was observed during field investigations, it is highly recommended that rodent guards not be used to cover drainage outlets.

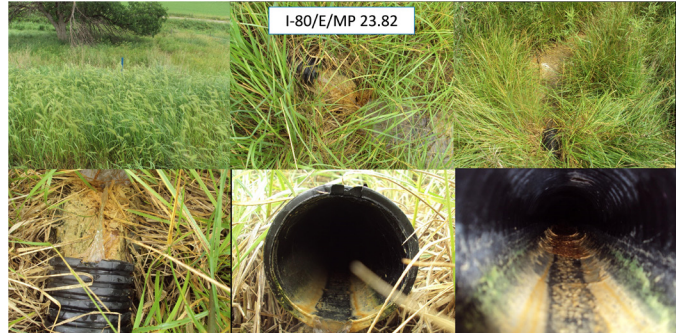
Removal of rodent guards from plastic outlet pipe often mitigated tufa blockage problem

- Less tufa formation due to the recycled PCC base is observed with the use of plastic outlet pipe without a gate screen rodent guard.
- Screening recycled PCC before using it in foundation layers can reduce the potential for fine material deposits to accumulate in pavement drainage systems. Studies have shown that selective grading or blending with virgin aggregates significantly reduces precipitation potential. Further research is recommended on this issue.
