# Differential Settlement of a Geosynthetic Reinforced Soil Abutment: Full-Scale Investigation

**ANDREW KOST, E.I.**  
Graduate Student

Virginia Tech

Final Report VCTIR 15-R3

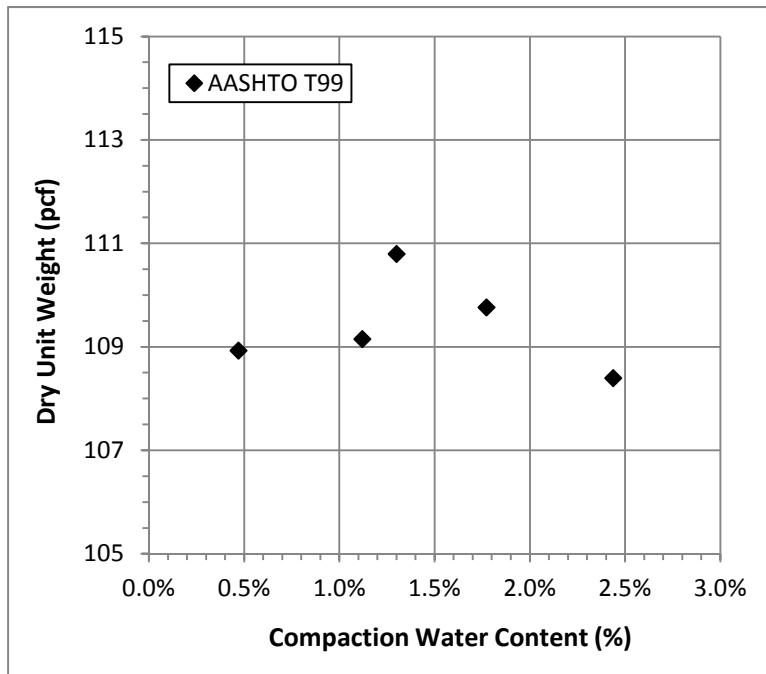
Figure 5. Moisture-Density Compaction Curve for ASTM No. 8

A crushed rock fill is the primary structural component of a GRS system. The FHWA guidelines allow for use of either a well-graded fill or an open-graded fill. To date, the vast majority of GRS-IBS projects have used an open-graded fill, and therefore an open-graded fill (ASTM No. 8) was also selected for this project. The No. 8 fill has a maximum particle size of 0.5 in and less than 5% passing the No. 16 sieve. The gradation of the fill used for these experiments is shown in Figure 4. Figure 5 shows the moisture-density relationship for this fill, as determined by AASHTO T 99.

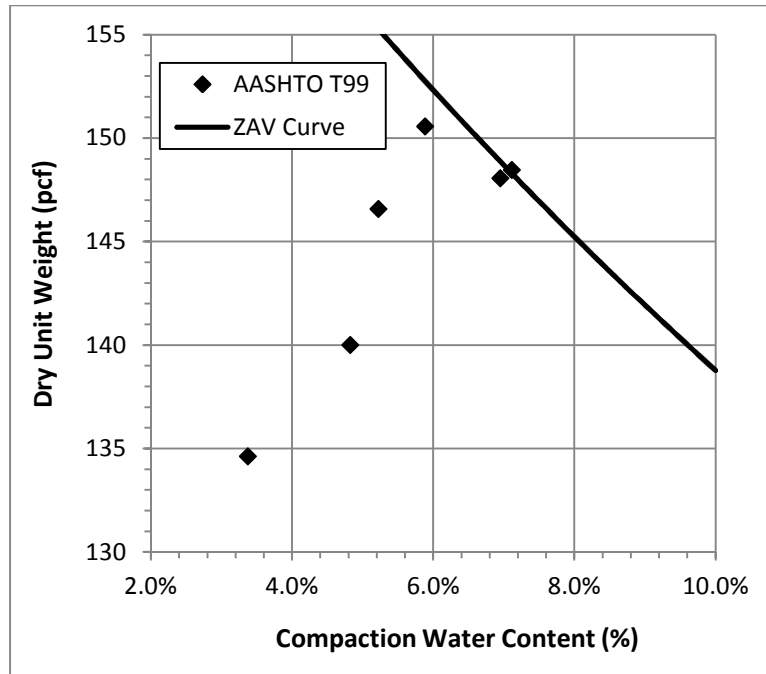
Figure 6. Moisture-Density Compaction Curve for VDOT No. 21A, With ZAV Curve Shown for  $G_a = 2.86$

A well-graded fill must be used for the RSF, according to the FHWA guidelines. For this project, VDOT No. 21A crushed rock, which has a maximum particle size of 2 in and fines content between 6% and 12%, was selected for the RSF. The gradation of the fill used for these experiments is shown in Figure 4. Figure 6 shows the moisture-density relationship for this fill, as determined by AASHTO T 99, plotted with the zero air voids (ZAV) curve. Steven Smith of Acco Stone provided the authors with the results of VDOT quality assurance tests on coarse aggregates from the quarry (personal communication). Using the dry bulk specific gravity and absorption from these tests, the apparent specific gravity ( $G_a$ ) was calculated to be 2.86. A small measurement error may be observed in either the highest-moisture-content compaction point of the curve in Figure 6 or the  $G_a$  value.

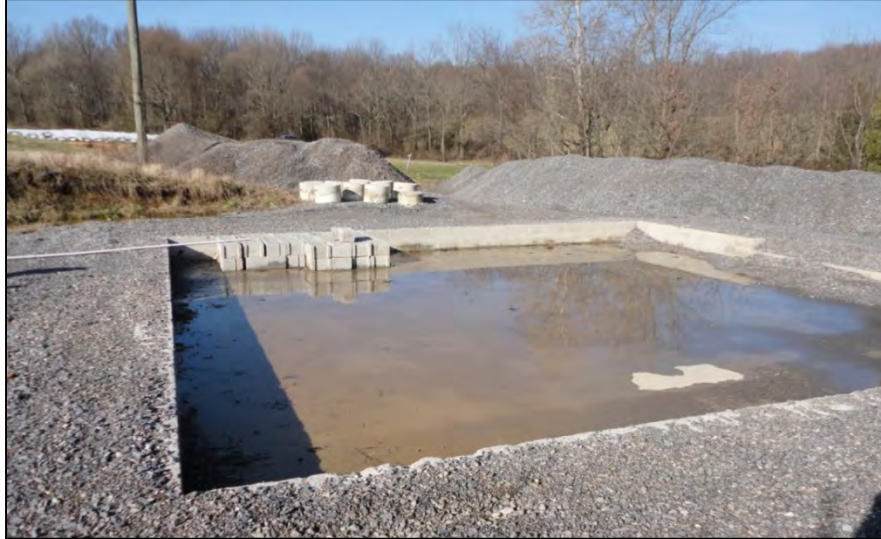
**Figure 7. Testing Site Prior to Construction**

The abutment was constructed at Virginia Tech's Kentland Farm, located about 10 miles west of the Blacksburg campus. At the farm, the researchers have access to a 30-ft-square, 12-in-thick concrete mat foundation. The mat is enclosed by a 16-in-high CMU wall, with the top of the wall at grade with the adjacent ground surface. Figure 7 shows the concrete mat foundation in the winter prior to construction. The mat provides a stable foundation for the abutment and ensures that all measured deformations are the result of the induced differential settlements rather than consolidation of the underlying natural soils.

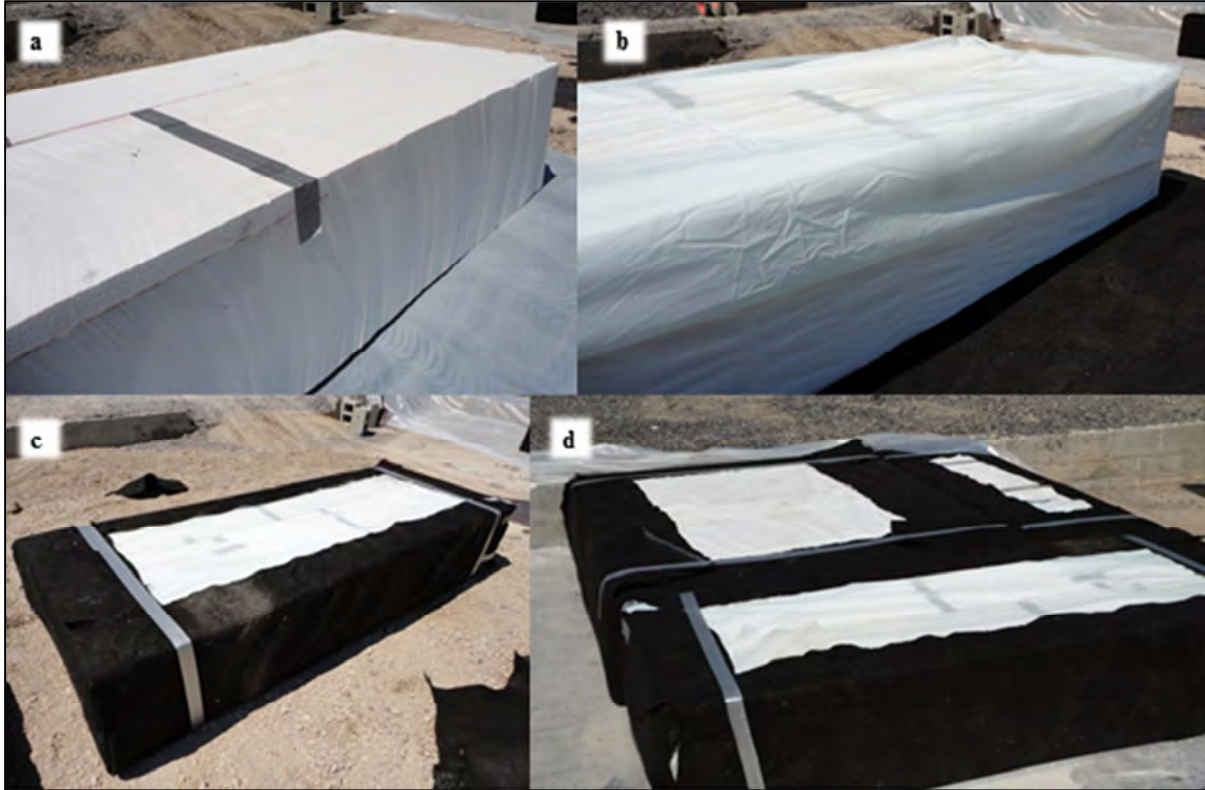
**Figure 8. (a) Placing Geofoam on Top of Geonet and Plastic; (b) Wrapping Geofoam in Plastic; (c) Wrapping Geofoam and Plastic in Non-Woven Geotextile; (d) Arranging Packaged Geofoam in Testing Configuration**

First, a large section of 6-mil plastic was spread on the concrete foundation. Care was taken not to step on the plastic to prevent puncturing or tearing the material. Next, a section of geonet that was approximately 1 in less than the geofoam dimensions in all directions was placed on top of the plastic. The edges of the geonet were covered with duct tape to prevent them from tearing the plastic. The geofoam was then placed on top of the geonet so that it overhung the geonet by approximately 0.5 in on each side. At the corner of the geofoam where the solvent would be introduced, approximately 1 in of foam was trimmed to provide a path for the solvent to reach the geonet.

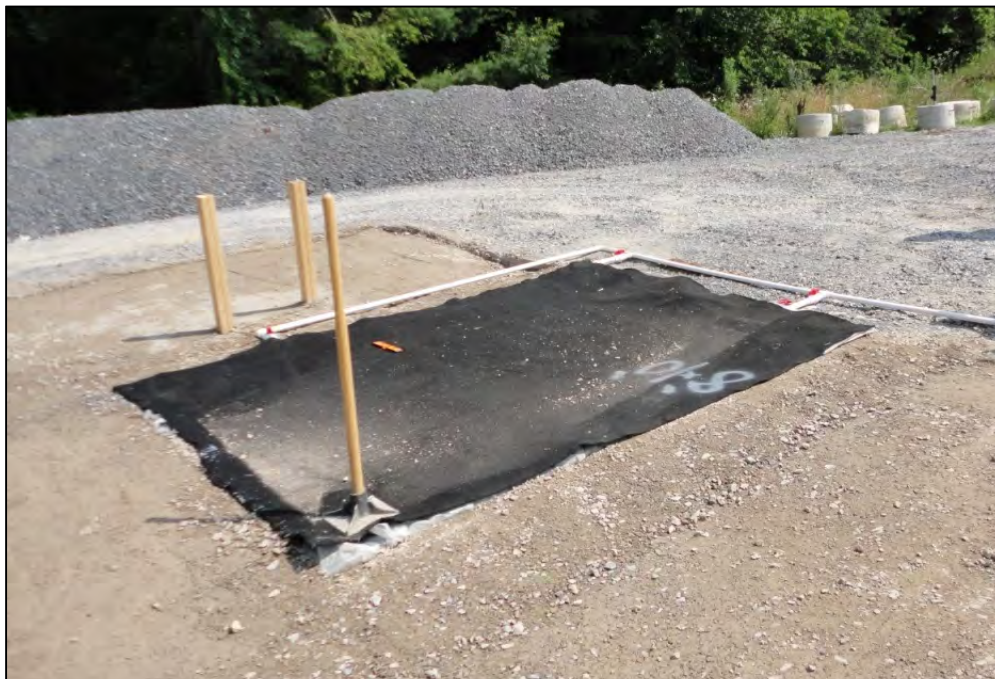
**Figure 9. Fill Compacted Around Geofoam on Side b, Solvent Delivery System in Place, and Foam Covered With Protective Non-Woven Geotextile**

Finally, 1-in PVC pipes for delivering the solvent were positioned at the delivery points. The geofoam packages were covered with a final sheet of 6-mil plastic and secured to prevent infiltration by rainwater. A section of non-woven geotextile was placed over the plastic and geofoam packages as a final protective layer. Figure 9 shows the foam regions beneath Side B ready for construction of the RSF.

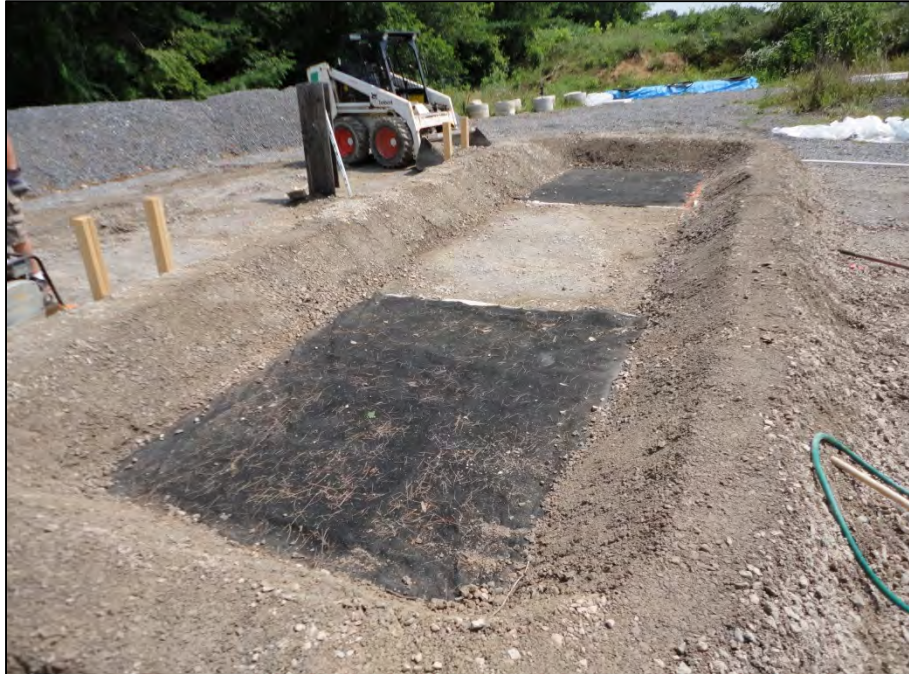
**Figure 10. Berm to Construct RSF**

The GRS test abutment and retained soil were constructed from the ground surface upward, rather than the usual scenario of constructing the GRS from the bottom of an excavation upward. Consequently, in order to represent a normal RSF geometry, a berm of fill was first placed to create a compaction form for the RSF, as shown in Figure 10. Prior to placing the berm, which covers the solvent delivery tubes shown in Figure 9, the valves to the delivery points were closed and covered with a piece of non-woven geotextile for protection.

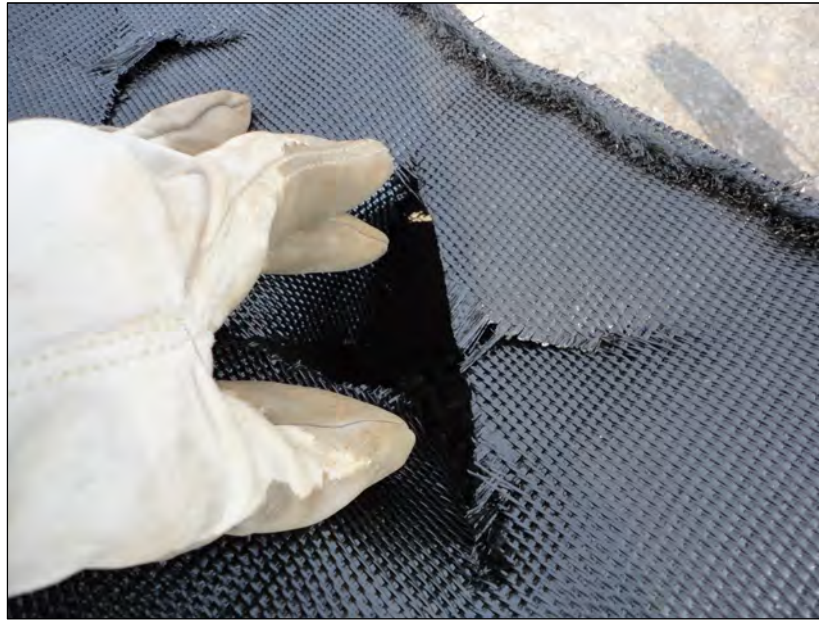
**Figure 13. “X”-Shaped Slit in Reinforcement at Level 15**

construction, as illustrated in Figure 13. Following completion of the bridge bearing bed, the hollow cores of the upper three levels of CMUs were filled with a high-slump 4,000 psi concrete, which was rodded into place. A 20-in-length of No. 4 rebar was vertically inserted into each hollow core to pin the CMUs together.

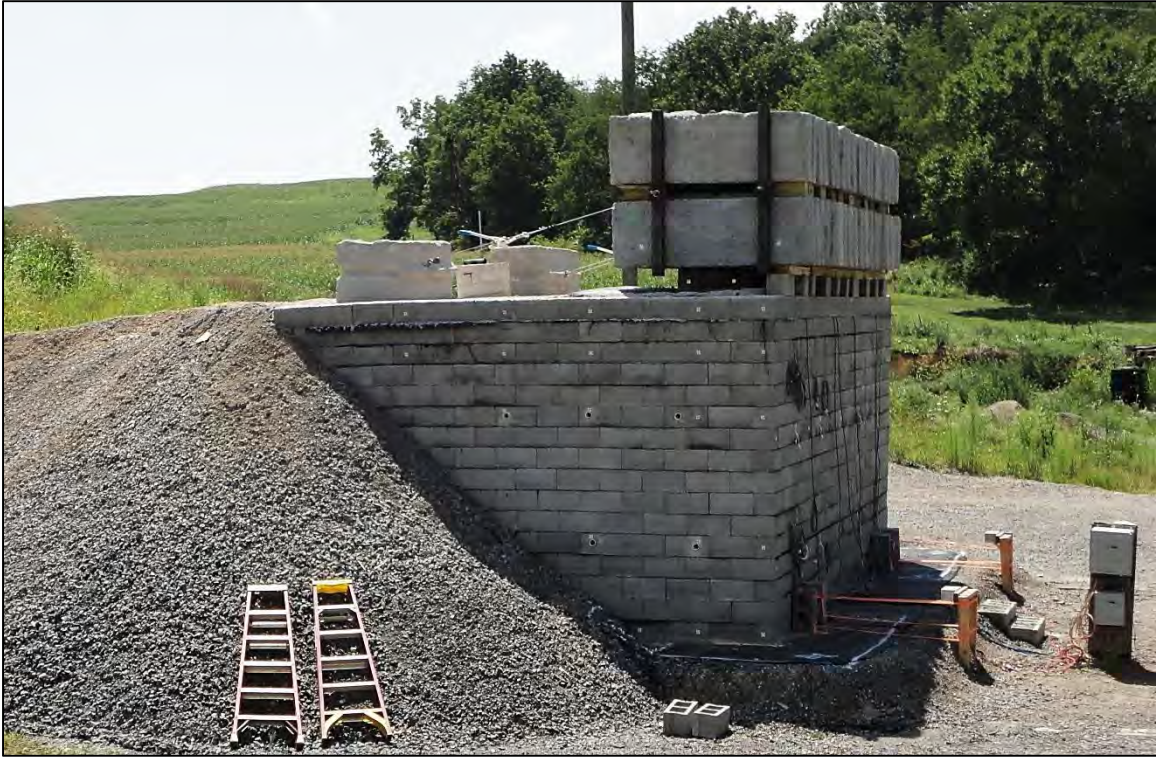
**Figure 15. Completed Abutment**

In total, construction and instrumentation of the abutment, including placement of the surcharge load, took 35 days of work. A photograph of the completed abutment is shown in Figure 15.

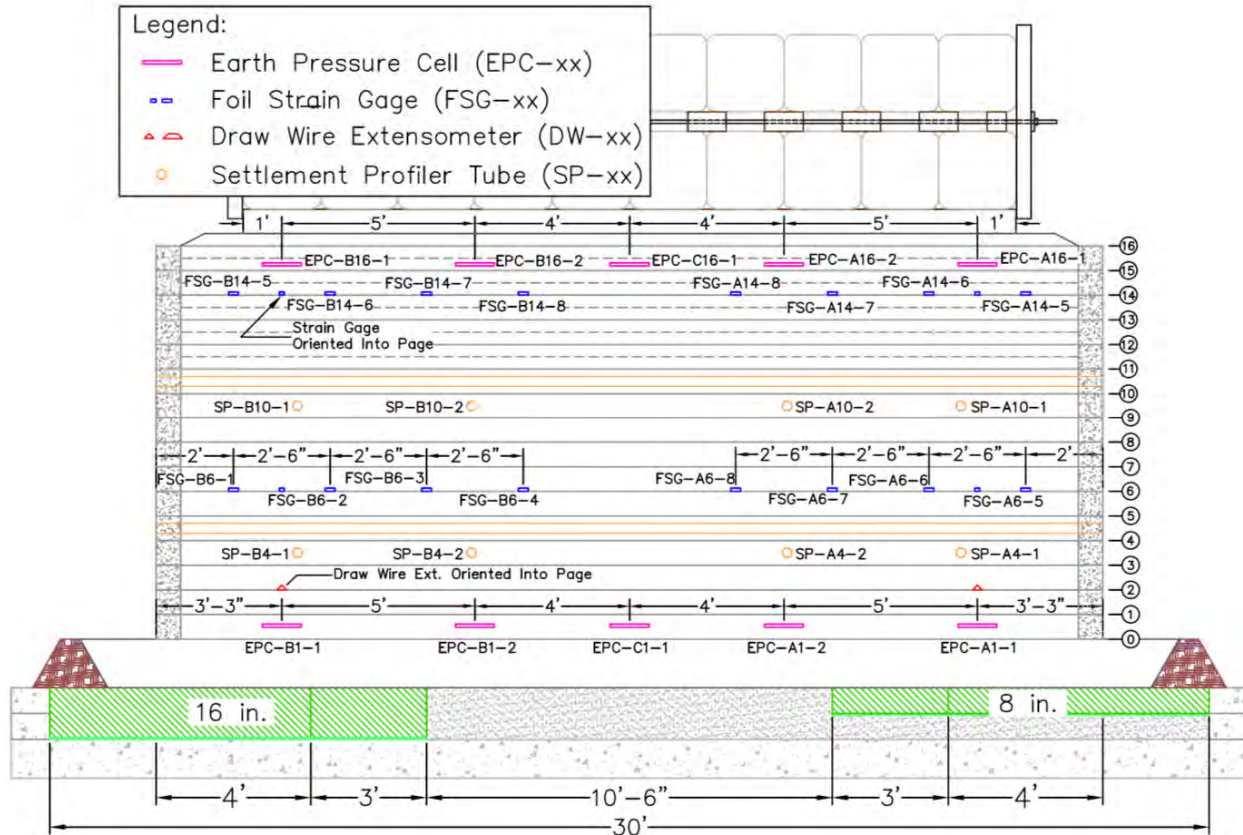
Figure 16. Front View of Instrumentation Configuration

The identification number for each instrument begins with a three-letter code identifying the type of instrumentation—e.g., “EPC” identifies an earth pressure cell. The codes are provided in a legend with each figure. The three-letter code is followed by a dash, a letter, a number, a second dash, and a final number. The letter identifies whether the instrument is on Side A (A), Side B (B), or in the center of the abutment (C). For the settlement profiling tubes that run the length of the abutment, this letter is omitted altogether. The subsequent number identifies the abutment level where the instrument is located. This number is followed by a dash and a final number, which identifies the particular instrument at the indicated level. Instruments are numbered from the face toward the back of the abutment, or from the wing wall toward the center of the abutment, depending on the configuration. As an example, EPC-B1-2 denotes the earth pressure cell located on Side B of the abutment, within the Level 1 fill, second instrument from the wing wall.

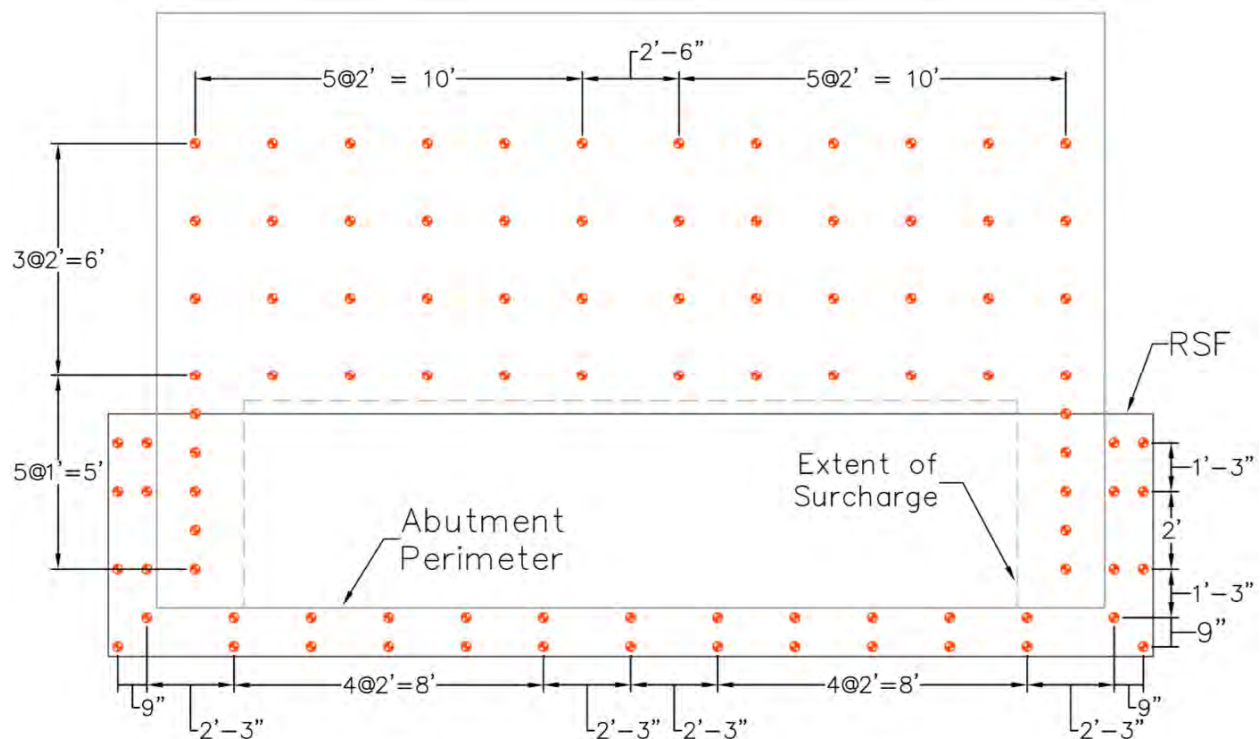
Figure 18. Plan View of Survey Points on Top Surface of Abutment and RSF

Reflective survey targets were placed on the facing CMUs to monitor three-dimensional displacements using a total station. Targets were also placed on the wooden surcharge foundation and on the large concrete surcharge blocks, and points were marked on the surface of the abutment and the RSF to survey using a handheld rod. The locations of these survey points are shown in Figures 18 through 20. Targets were placed symmetrically on the wing walls of the abutment; only one of the wing walls is shown in Figure 20. Where survey targets and settlement profiling tubes are shown at the same location in these figures, the survey target was placed on the CMU facing block directly above the profiling tube. In total, 214 survey points on the abutment were monitored throughout the testing sequences. Three benchmarks were established around the abutment from which to take survey measurements.

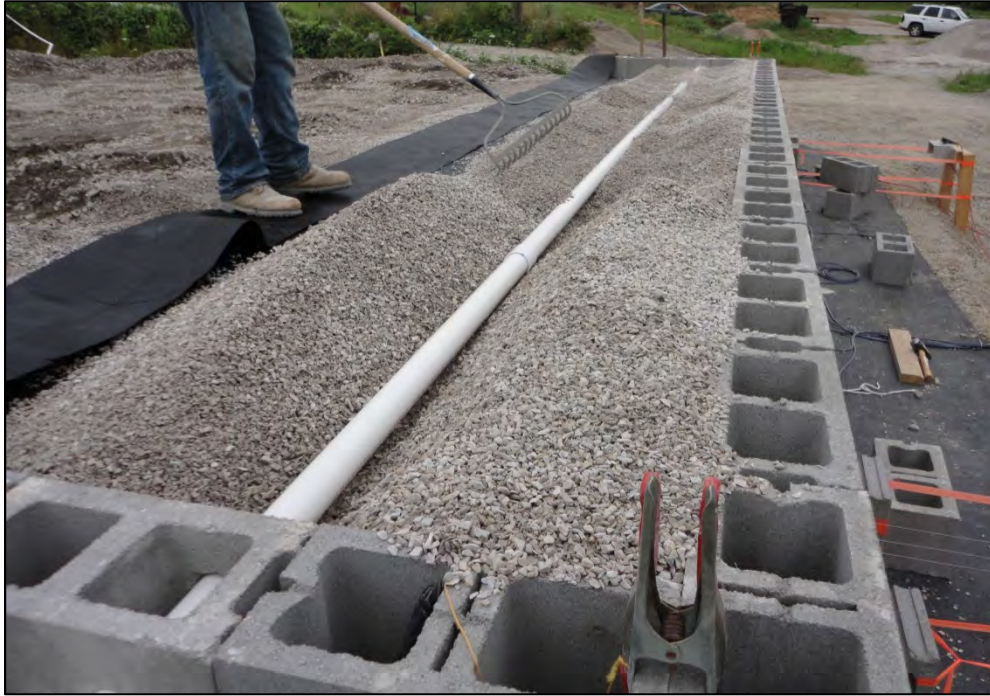
**Figure 21. Example of Settlement Profiling Tube**

To monitor the settlement of the reinforced fill within the abutment, 2-in-diameter PVC pipes were placed within the fill at Levels 4, 5, 10, and 11, at the locations shown in Figures 16 and 17. The 2-in inside-diameter is large enough to allow the profiling instrument to pass even after experiencing significant deflections. The pipes were placed approximately level in the middle of the fill prior to compaction. Holes were drilled through the facing CMUs to allow the pipes to pass through. An example of one of these settlement profiling tubes is shown in Figure 21.

The settlement profiling instrument is a vibrating wire piezometer connected to a length of flexible plastic tubing that is filled with a mixture of water and antifreeze. The tubing is connected to a container placed above the elevation of the PVC pipes to maintain a constant elevation head. As the profiling device is pulled through the settlement profiling tubes, any changes in elevation are recorded by the piezometer as changes in fluid pressure. The instrument used for these experiments was a Geokon 4651-1-170KPA.

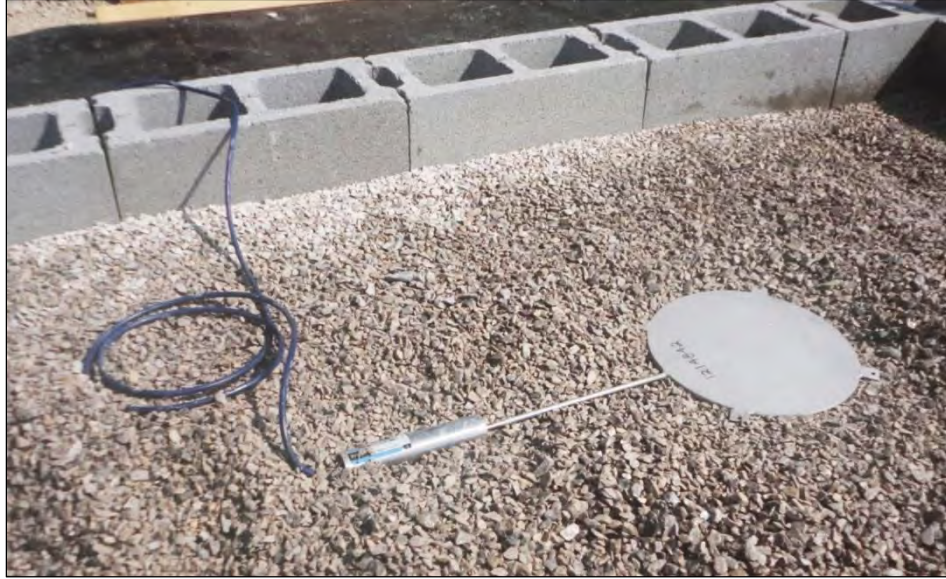
Figure 22. Example of Earth Pressure Cell in Level 1 Fill

Earth pressure cells (EPCs) were employed to monitor changes in the stress distribution within the fill. An EPC consists of two circular, stainless steel plates that are welded together around the perimeter. The thin chamber between the plates is filled with de-aired oil and connected to a vibrating wire pressure transducer. External pressures induce an equal pressure in the oil medium and can be measured by the pressure transducer. For this application, ten Geokon 4800-1-170KPA pressure cells were embedded in the abutment fill. These cells are 6 mm thick and 230 mm in diameter (0.24 in by 9.06 in) and can accommodate pressures as high as 170 kPa (24.7 psi) with an accuracy of  $\pm 0.12$  psi and a resolution of 0.006 psi. Five were placed at the midpoint of the lowest lift (Level 1), and five were placed in the highest lift (Level 16) at the midpoint between the primary reinforcement and the secondary reinforcement. The location of the cells is depicted in Figures 16 and 17. An example of an EPC within the Level 1 fill is shown in Figure 22.

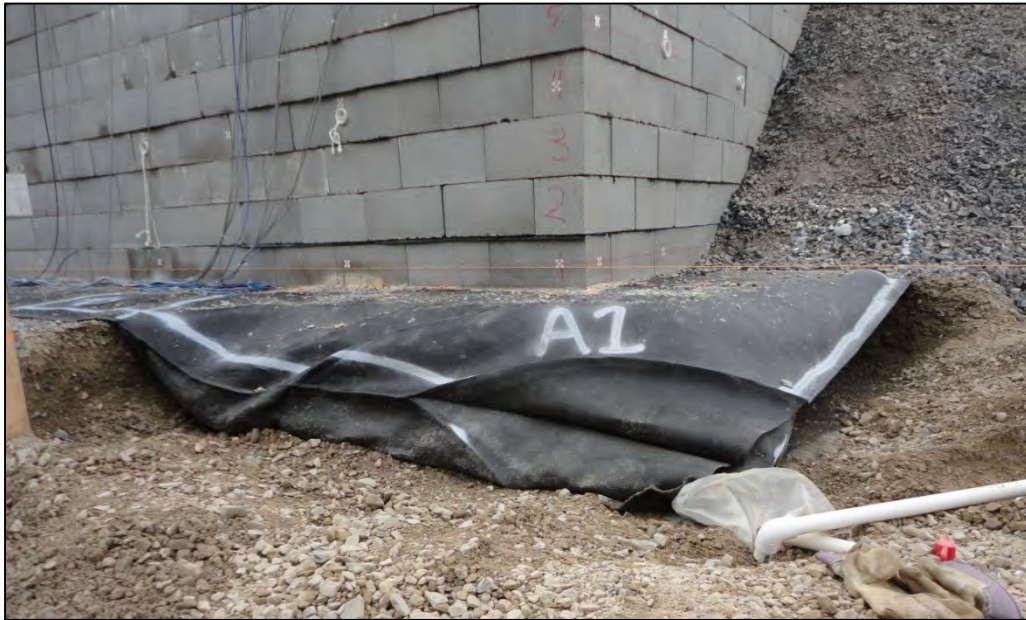
**Figure 24. RSF Berm Removed for Test A1**

Prior to each test, the soil berm used in construction of the RSF was excavated and removed from the perimeter of the area where support would be removed. The intent of removing this berm was to account for the loss of this additional support to the RSF that would occur in some cases of differential settlement, such as scour-induced settlements. Figure 24 shows this berm removed prior to Test A1.

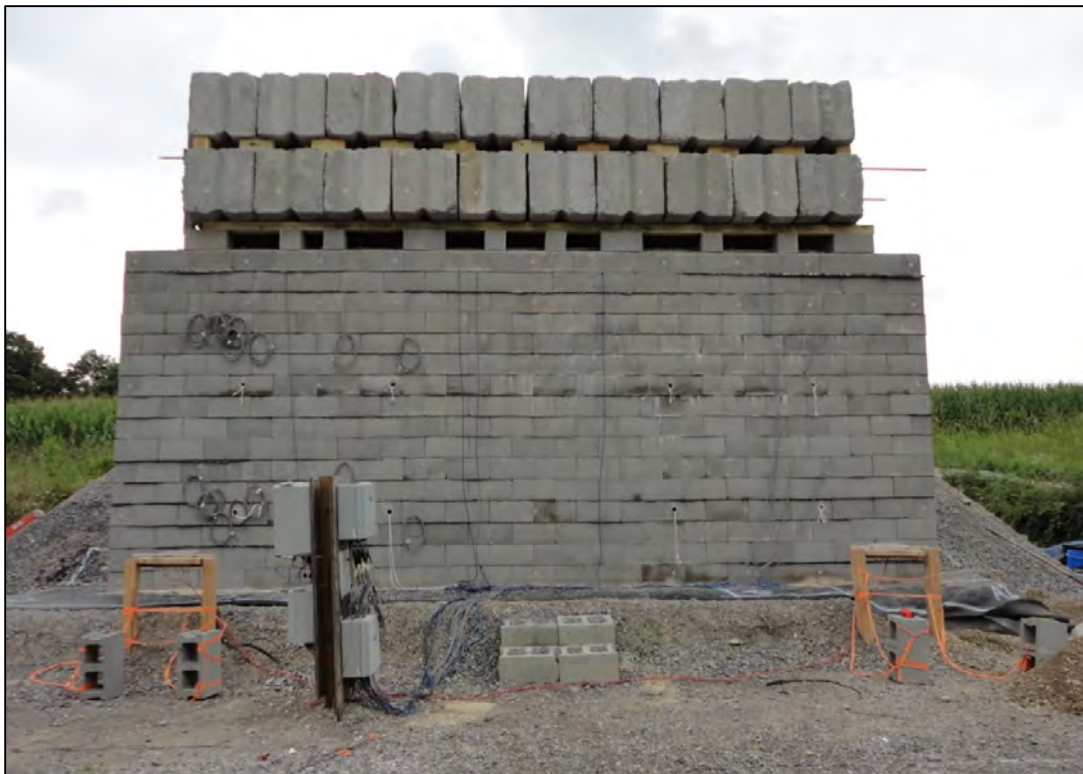
**Figure 25. Front View of Abutment Before Testing, RSF Removed Around Region A1**

Post-testing deconstruction of the abutment revealed that the geofoam inclusions had been fully dissolved during the testing process. Figure 25 shows the abutment prior to testing. The RSF at Region A1 has been dug out prior to testing, but no solvent had been introduced at that time. Black lines can be noticed between some of the CMU courses; these lines are short lengths of reinforcement extending past the front of the CMUs and are not gaps. On the left side of the abutment, coiled gray wires from the strain gages on Side B can be seen. The wires were waterproofed and were connected to the multiplexor prior to testing on Side B.

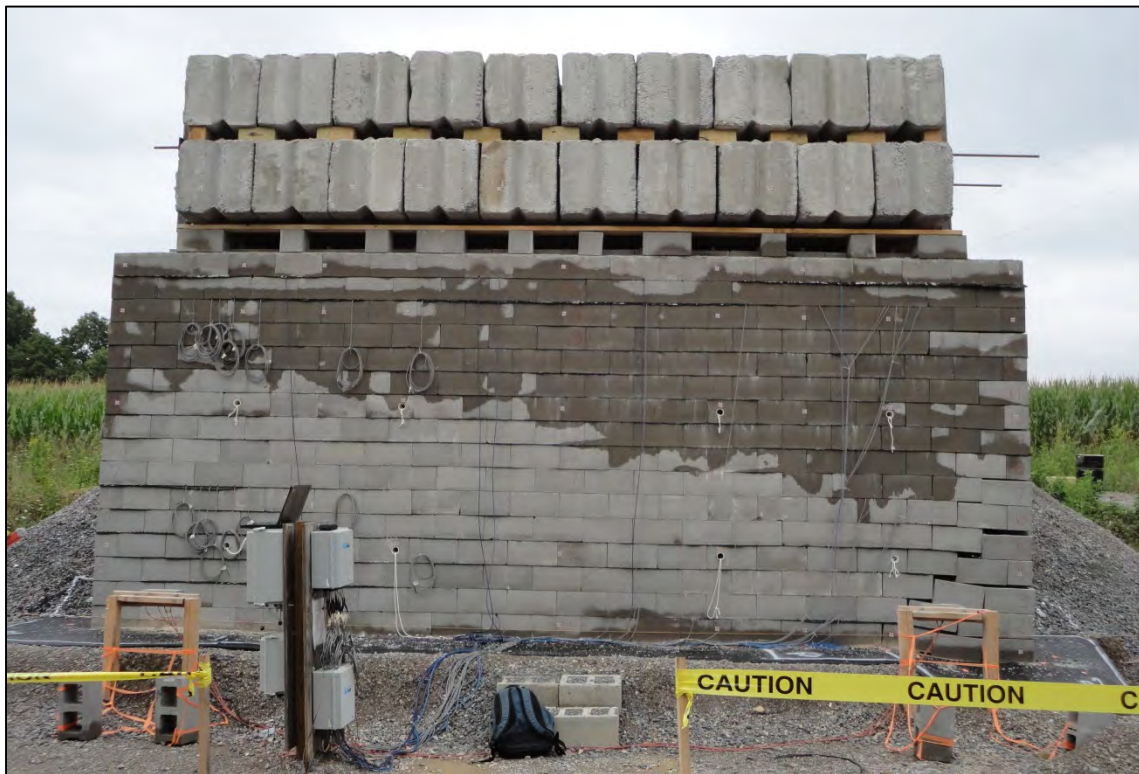
**Figure 26. Front View of Abutment After Test A1**

The blocks at and near the corners of the abutment appear vulnerable after they have experienced settlements. This observation is particularly apparent following tests on Side B, as shown in Figure 31 and Figure 33. This experiment tested only the response of the abutment to differential settlements. If water action were introduced, as would occur in a scenario of scour-induced settlement or of heavy stream flow after large differential settlements due to foundation compression, it is quite conceivable (and perhaps likely) that the combined effects of buoyant and viscous water forces could remove some of these blocks and expose the fill to erosion. This scenario could lead to serious damage or failure of the abutment. Some considerations to mitigate this potential hazard are discussed later in this report.

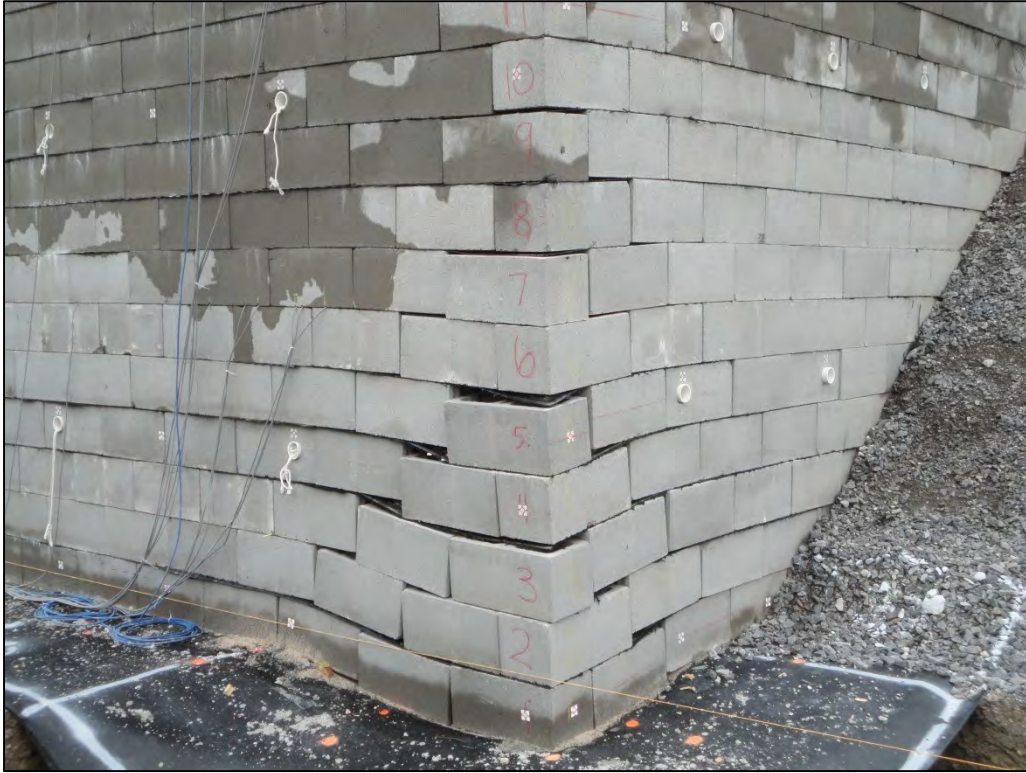
**Figure 27. Corner a of Abutment After Test A1**

Photographs documenting the performance of the abutment through all four stages of testing are presented in Figures 26 through 33. While viewing the photographs, it should be remembered that the area and magnitude of settlements induced on the structure represent very extreme loading conditions for this abutment geometry. Two photographs are shown of the abutment following each test. One photograph shows the abutment from the front, and the other shows a close-up view of the affected corner. Photographs of the corners of the abutment often show white lines painted on the RSF; these lines mark the lateral extent of each geofoam region. Recall that the upper three courses were filled with concrete and pinned together, which caused them to behave similar to a cantilevered beam. While difficult to identify in these photographs, vertical cracks formed through the concrete-filled CMUs, which led to small settlements. The vertical cracks were most noticeable following Tests A2 and B2 directly above the interface between the compacted fill subgrade and the geofoam dissolved in Tests A2 and B2.

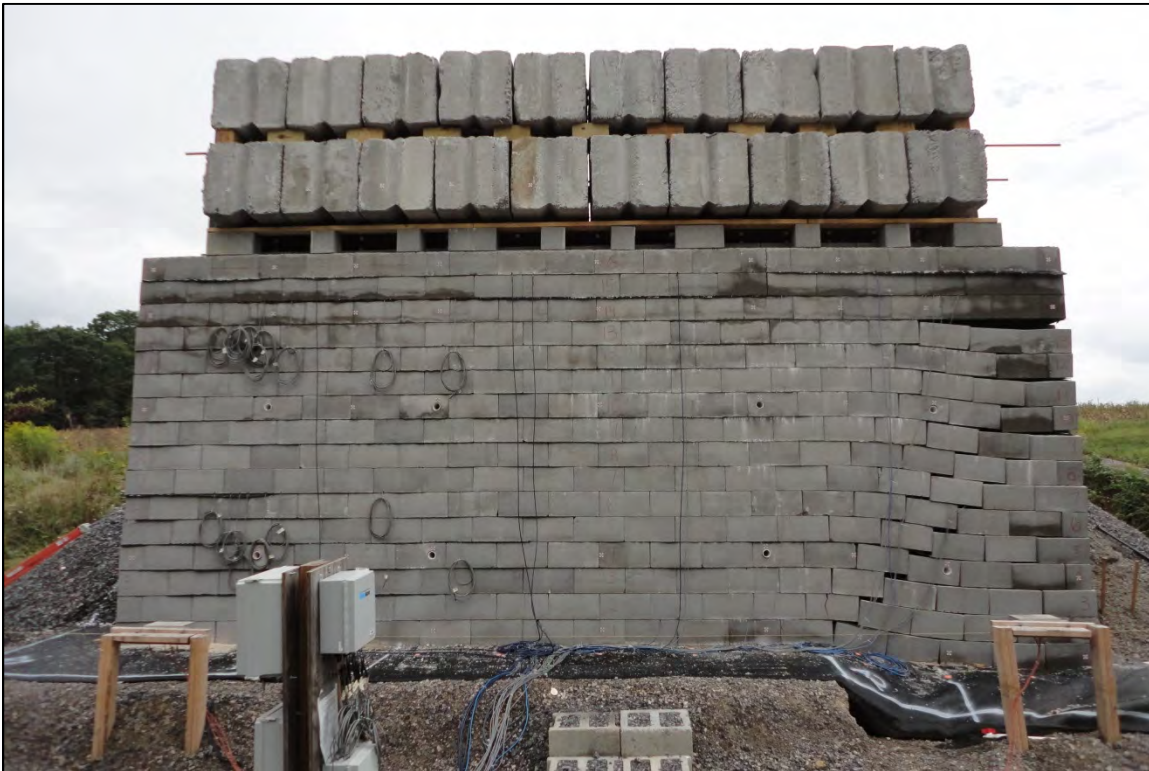
**Figure 28. Front View of Abutment After Test A2**

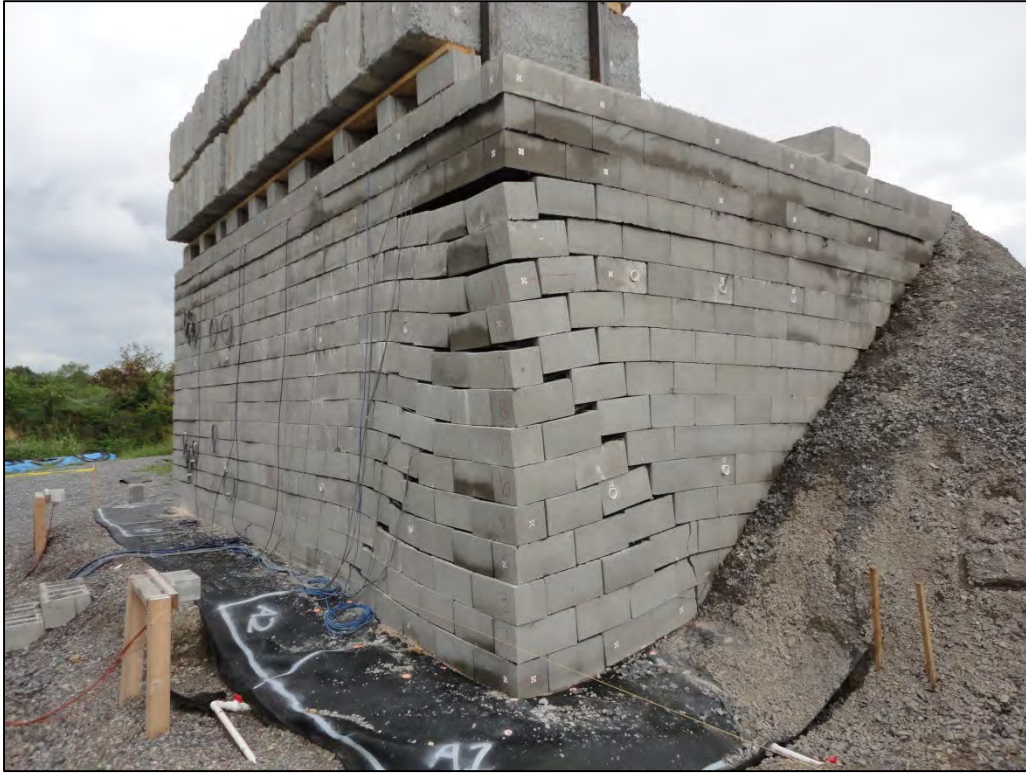
**Figure 29. Corner a of Abutment After Test A2**

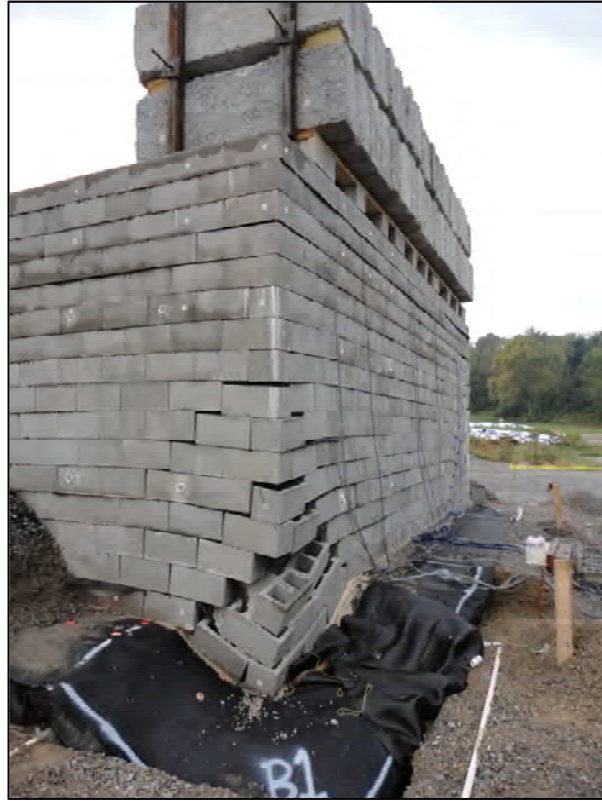
**Figure 31. Corner B of Abutment After Test B1**

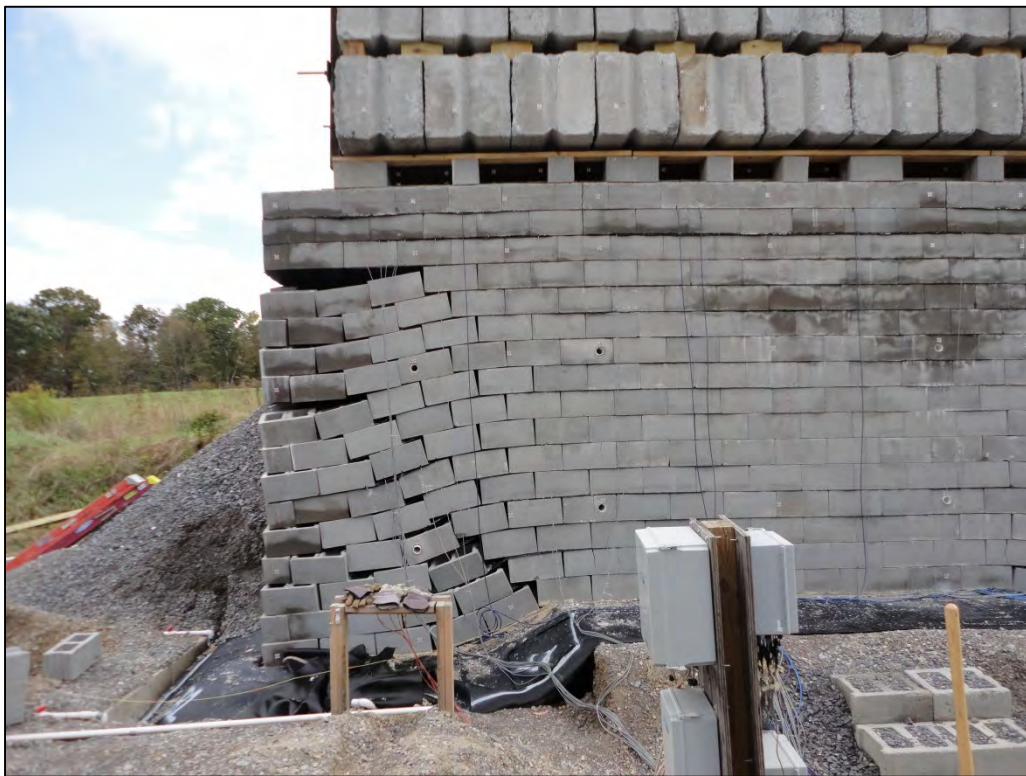
**Figure 32. Front View of Abutment After Test B2**

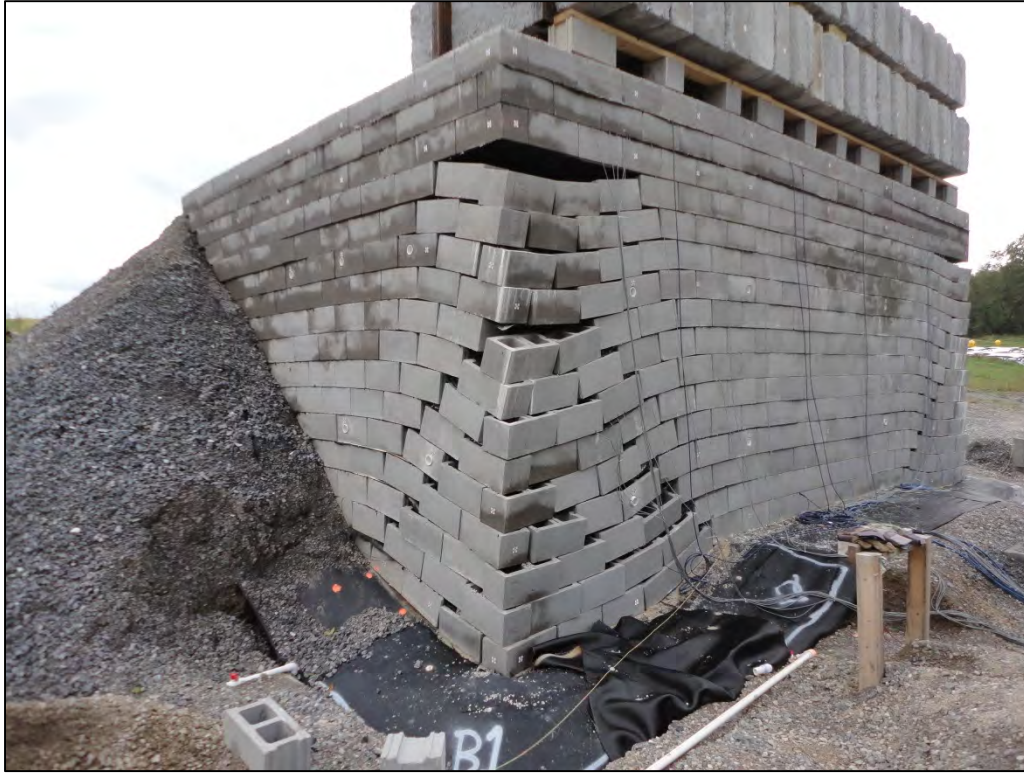
**Figure 33. Corner B of Abutment After Test B2**

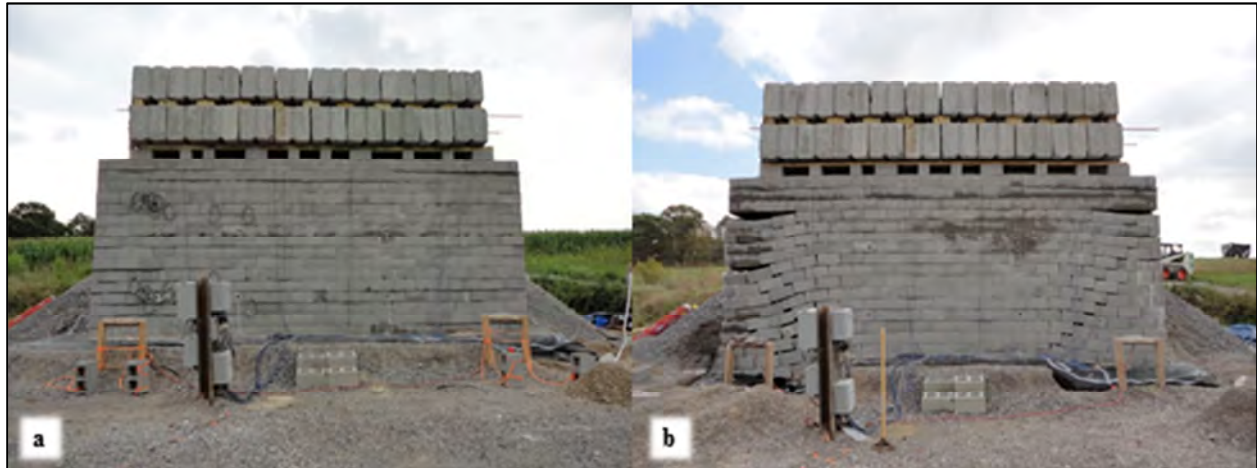
**Figure 34. Comparison of Abutment (a) Before and (b) After All Testing Sequences**

Figure 34 presents a side-by-side comparison of the abutment prior to and after all testing sequences. The figure is not intended to show the details of the deformation patterns, but rather to demonstrate that, despite removing support beneath much of the foundation area, the abutment was still able to adequately support the surcharge load. Clear space was maintained between the surcharge load blocks and the front safety blocking through all tests.

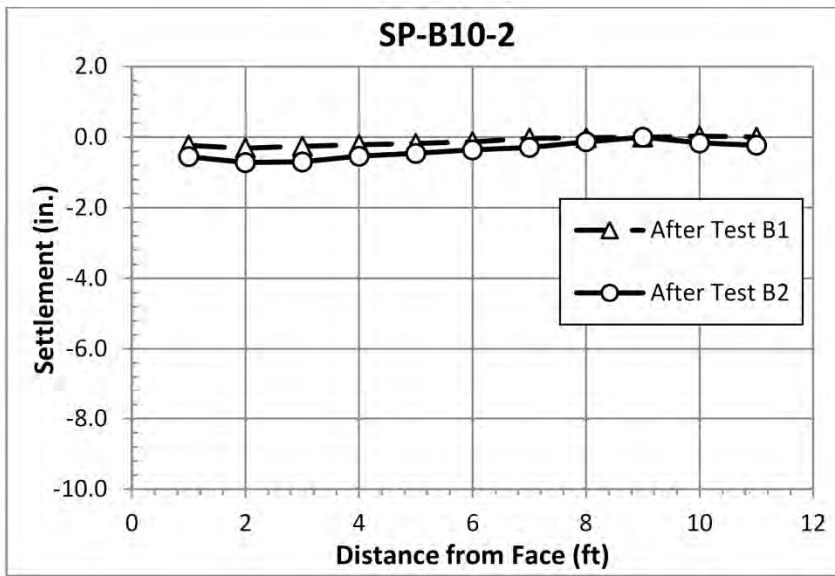
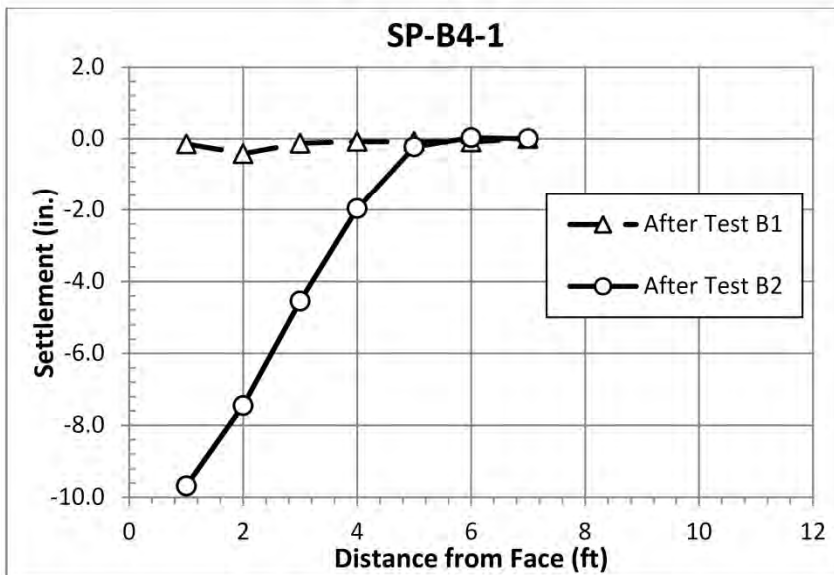
Figure 43. Settlement Profiler Data for Tubes Perpendicular to Abutment Face on Side A

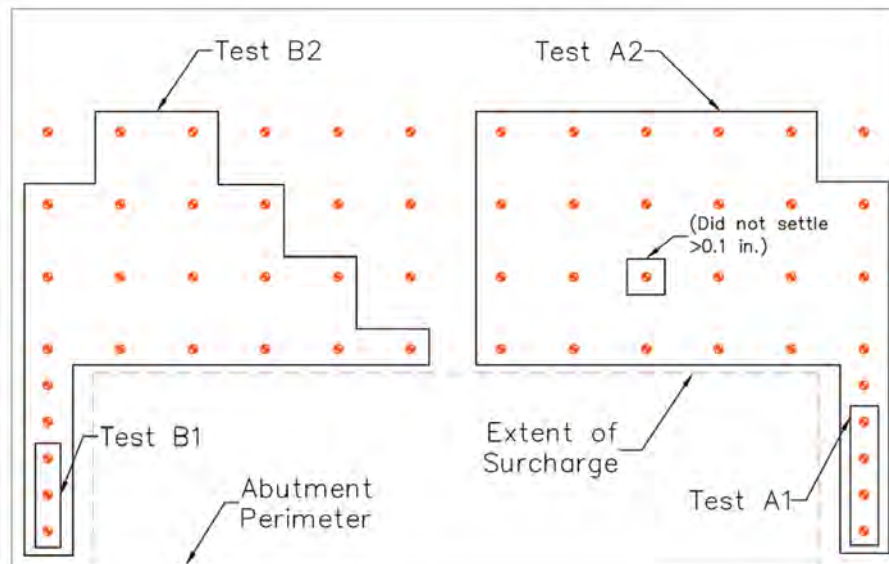
**Figure 50. Survey Targets on Surface of Abutment That Settled More Than 0.1 in**

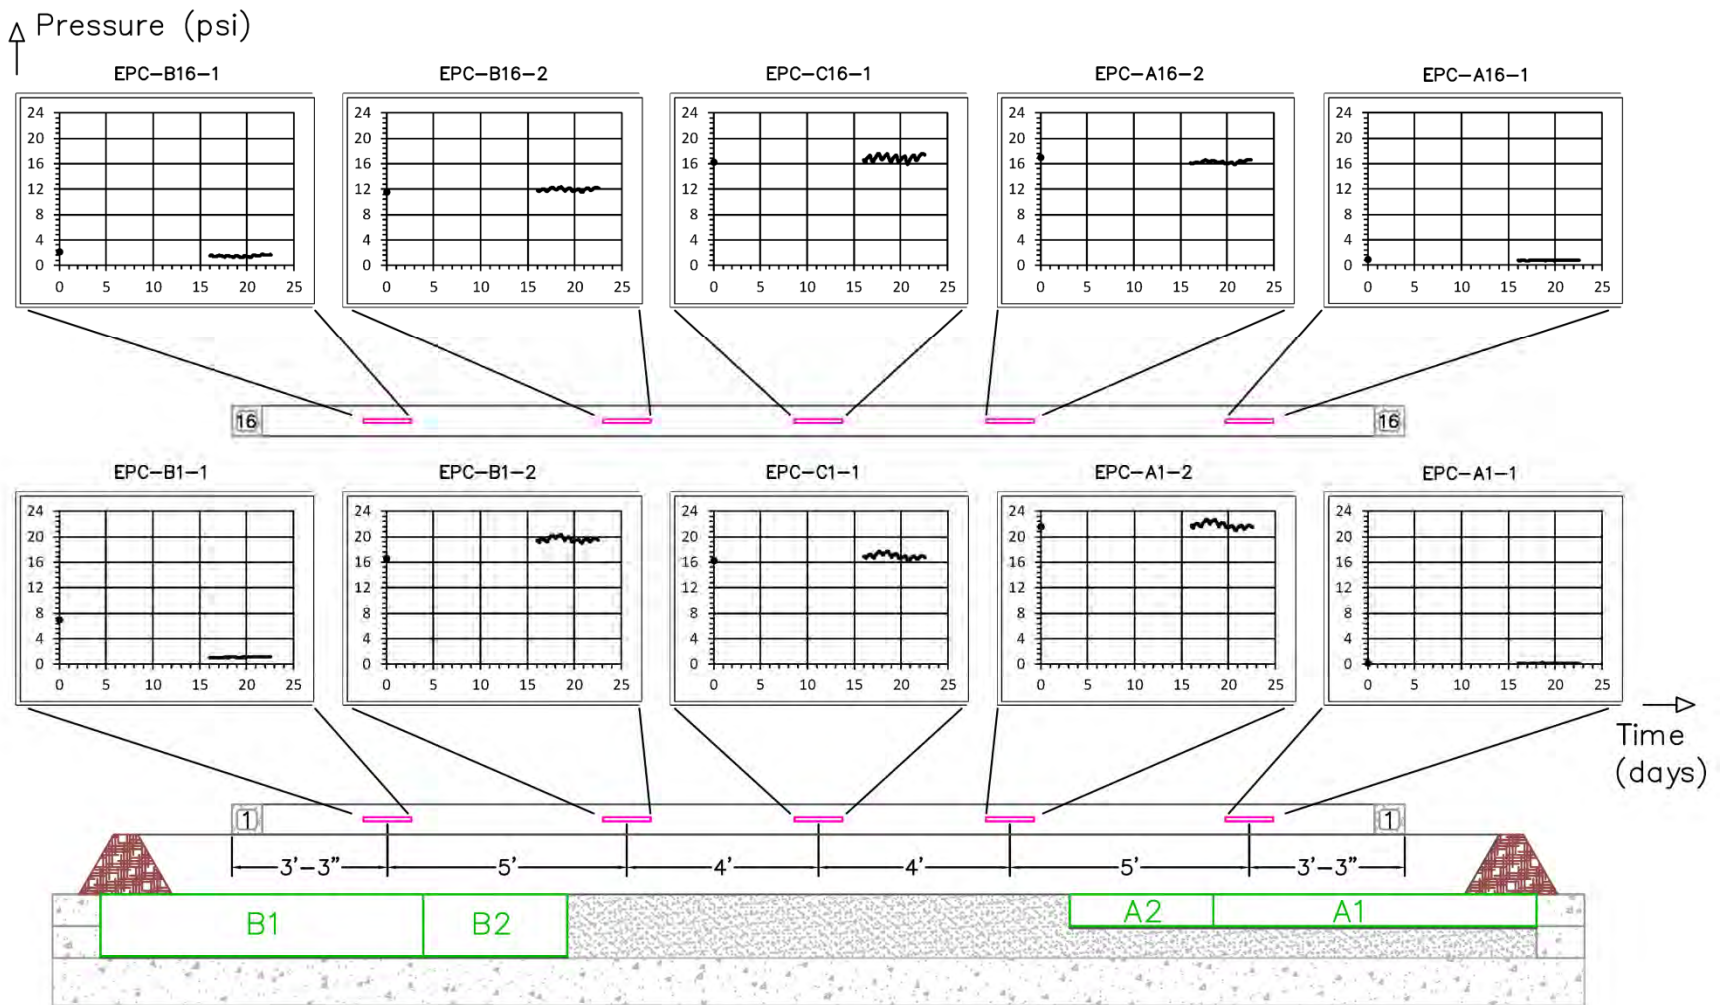
Figure 58. Stresses During Test B1
