# Differential Settlement of a Geosynthetic Reinforced Soil Abutment: Full-Scale Investigation

**ANDREW KOST, E.I.**  
Graduate Student

Virginia Tech

Final Report VCTIR 15-R3

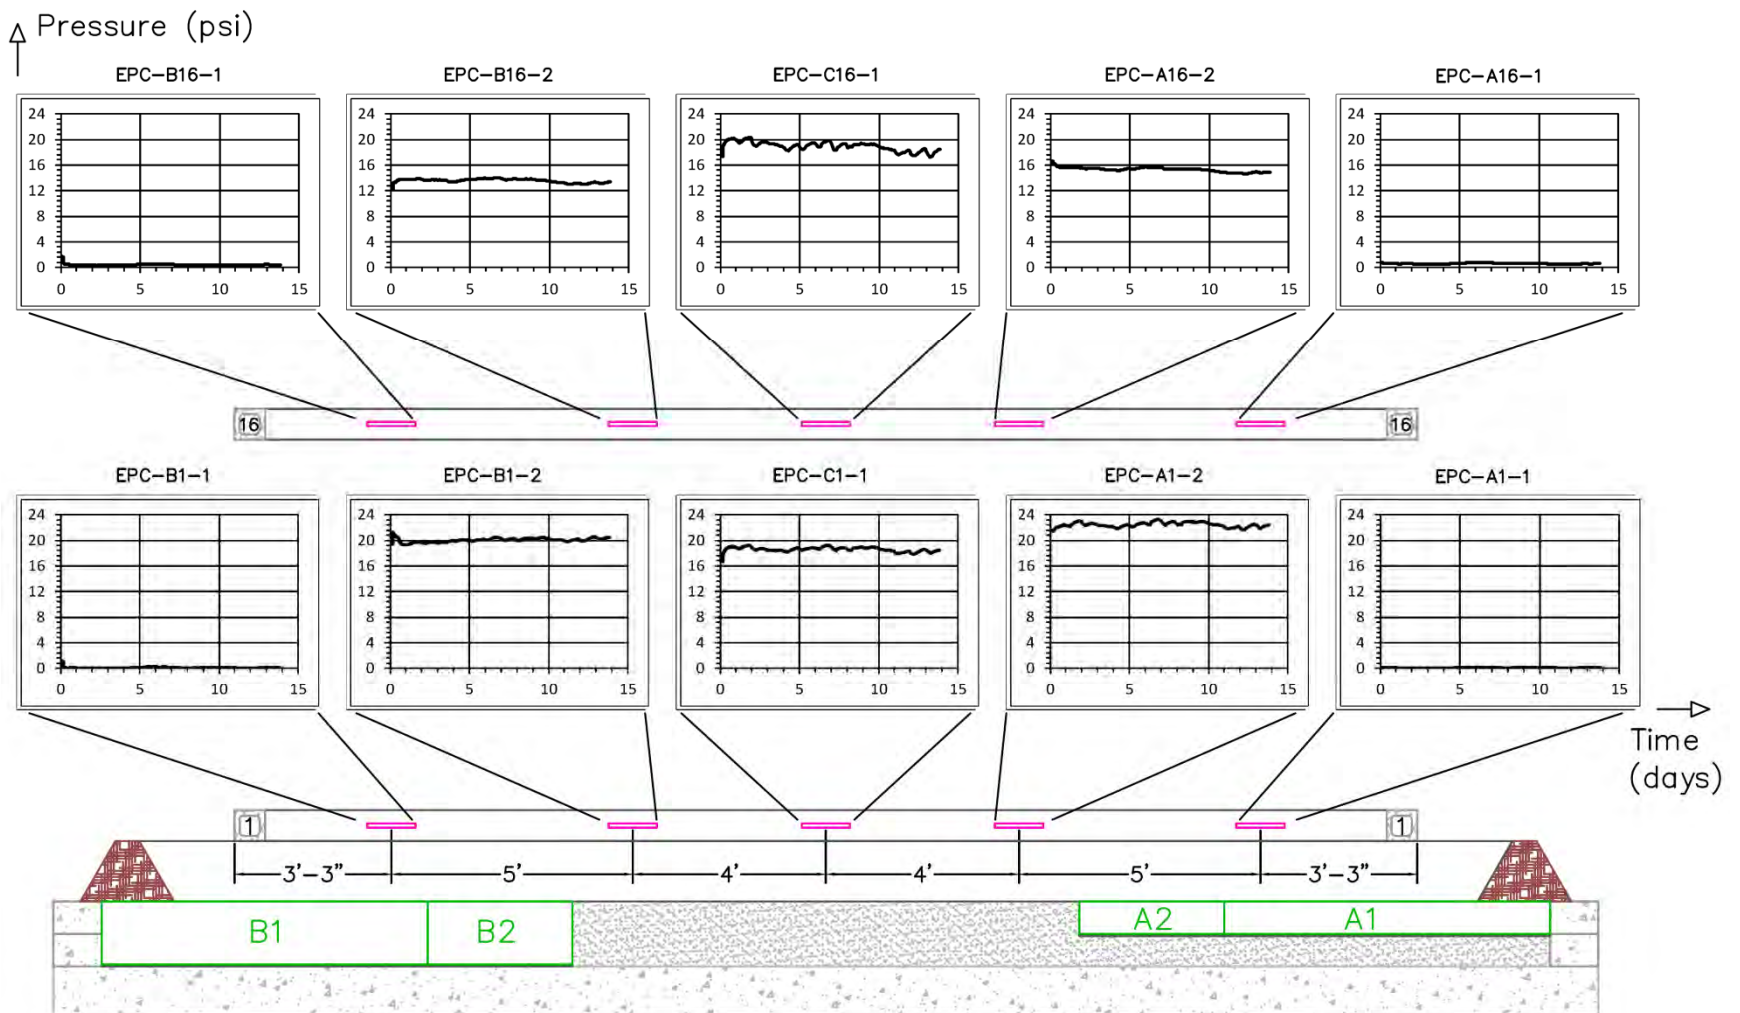
Figure 60. Stresses During Test B2

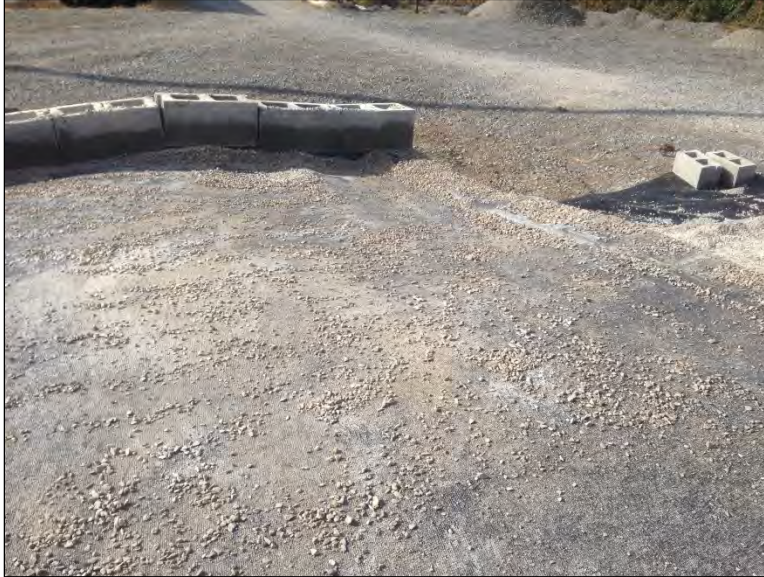
**Figure 80. Side A, Level 5 During Deconstruction**

Figures 80 and 81 provide visual confirmation that the curvature of the reinforcement follows these patterns. Disturbance has likely altered the exact deformation patterns to some extent, but the overall trends should be consistent with the post-testing state. Therefore, the authors believe that, in most cases, strain decreases during testing are the result of reinforcement curvature rather than relaxation.

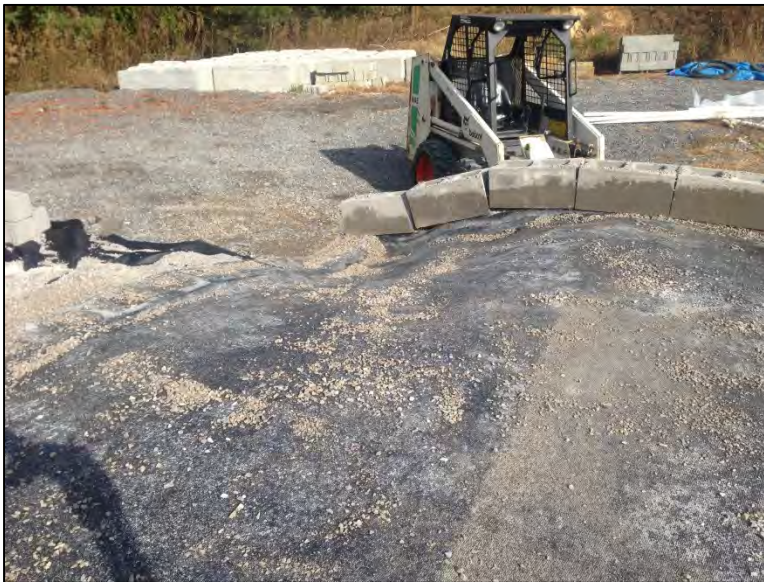
**Figure 81. Side B, Level 5 During Deconstruction**

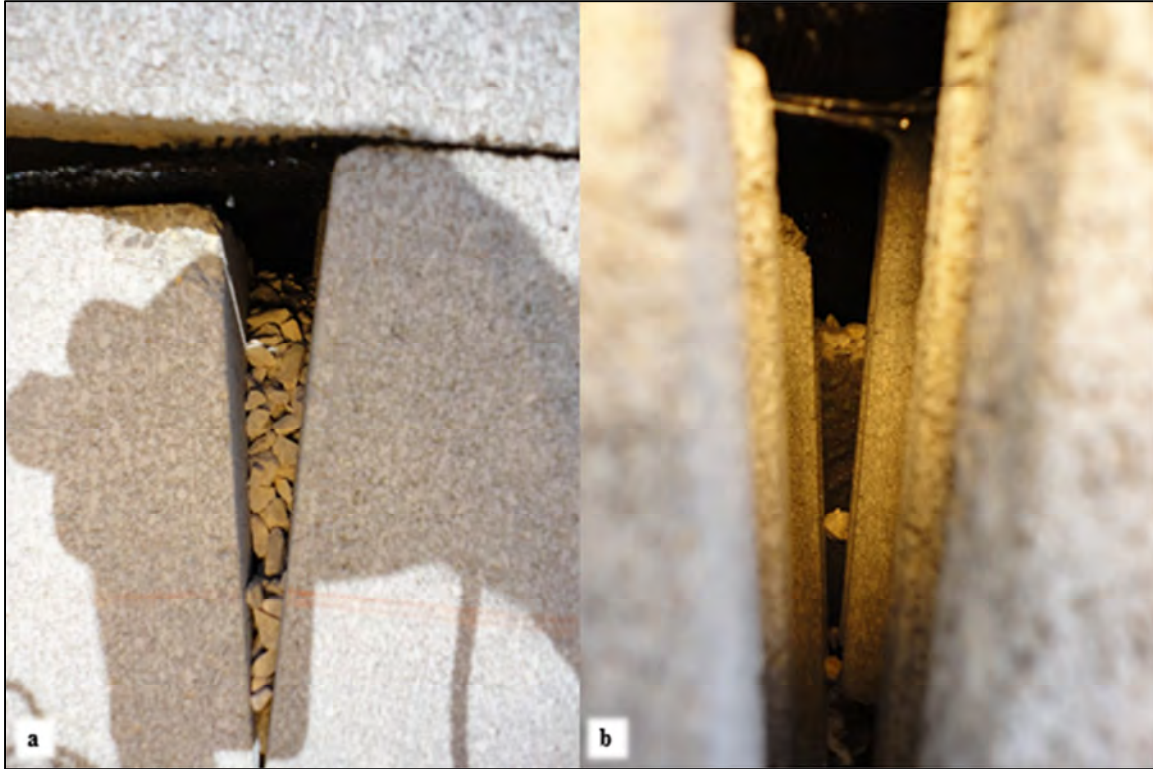
**Figure 100. Second Comparison of Unwrapped and Wrapped Fill. (a) Unwrapped Fill at Wing Wall A, Level 5 Near Corner A; (b) Wrapped Fill at Level 6, Above and to the Left of the Vertical Gap in (a).**

Figure 100 also compares the exposure of the fill when vertical gaps opened between two adjacent blocks near Corner A. In Figure 100(a), a vertical gap between two adjacent blocks at Level 5 of Wing Wall A allowed reinforced fill to spill through to the front of the CMU face. In Figure 100(b), the black geotextile is visible through a vertical gap located at Level 6, just above and to the left (closer to the corner) of the gap in Figure 100(a). The fill is effectively contained by the geotextile, with only a few particles of the aggregate used to increase the interface friction visible.

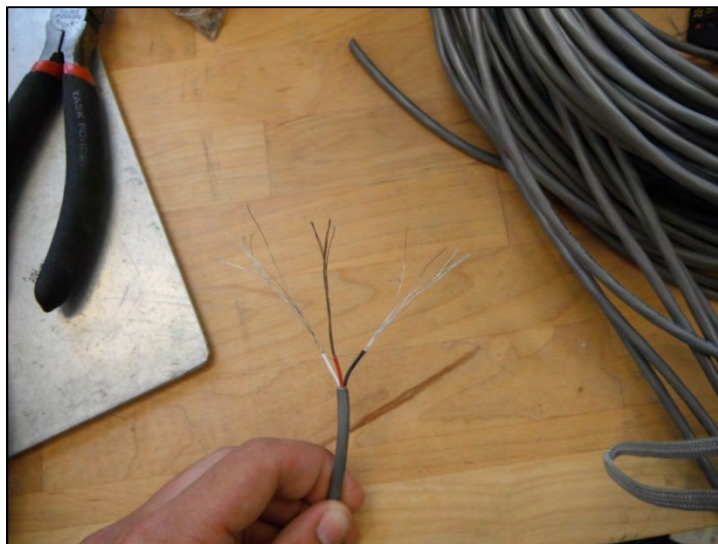
**Figure A-2. Stripped 22 AWG Wire**

**Step 2:** Three-wire 22 AWG wire was selected to connect the strain gages to the data collection unit in the field. The wire was cut to the proper length in the laboratory and stripped, as shown in Figure A-2.

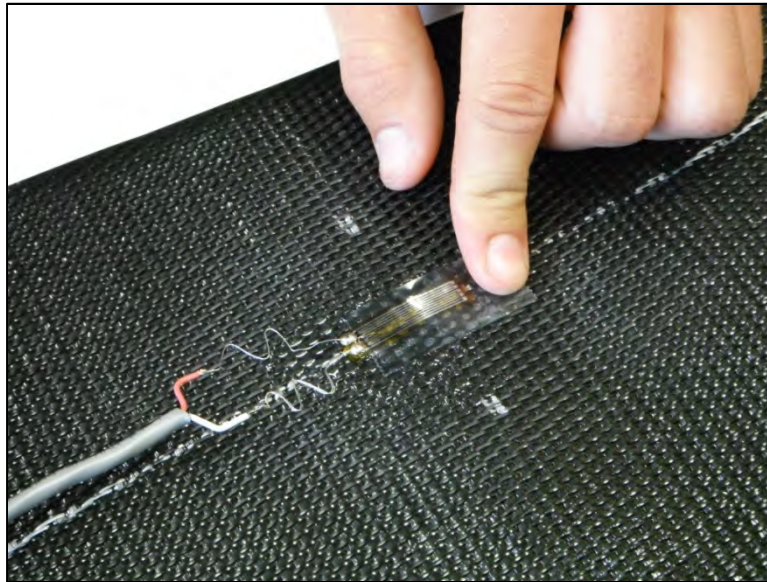
**Figure A-8. Positioning the Strain Gage on the Geotextile**

**Step 4:** Using the tape that had secured the gage to the index card, the strain gage was then lifted from the index card, a thin layer of adhesive was applied to the back, and the gage was positioned on the fabric in line with the guide marks, as shown in Figure A-8. A small piece of parchment paper was placed over the strain gage (Figure A-9). On top of the parchment paper, a piece of rubber gasket material was placed to allow a uniform bonding pressure (Figure A-10). Finally, a 1.5 in by 2 in piece of plywood was placed on top of the gasket, a length of dimensional framing lumber was placed over two adjacent gages, and a 42-lb CMU block was positioned on top to apply the bonding pressure (Figures A-11 through A-13). Note that in

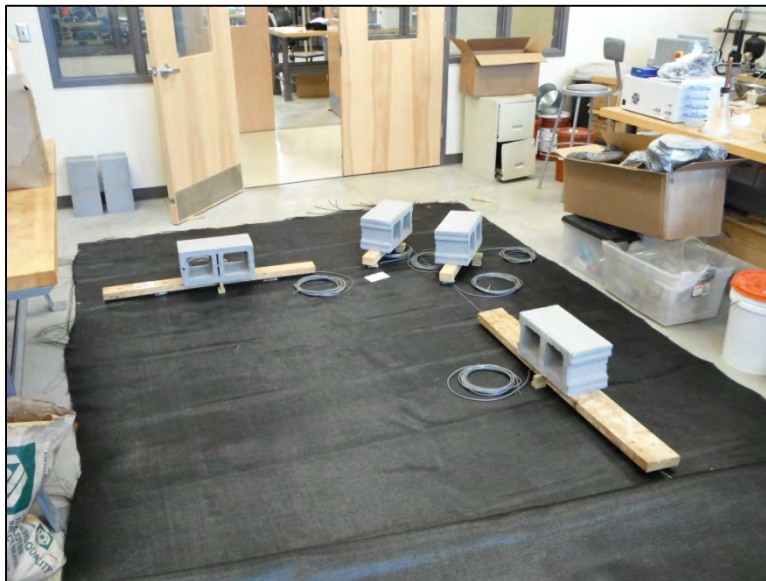
**Figure A-13. Spacing and Configuration of 8 Strain Gages Installed at One Time**

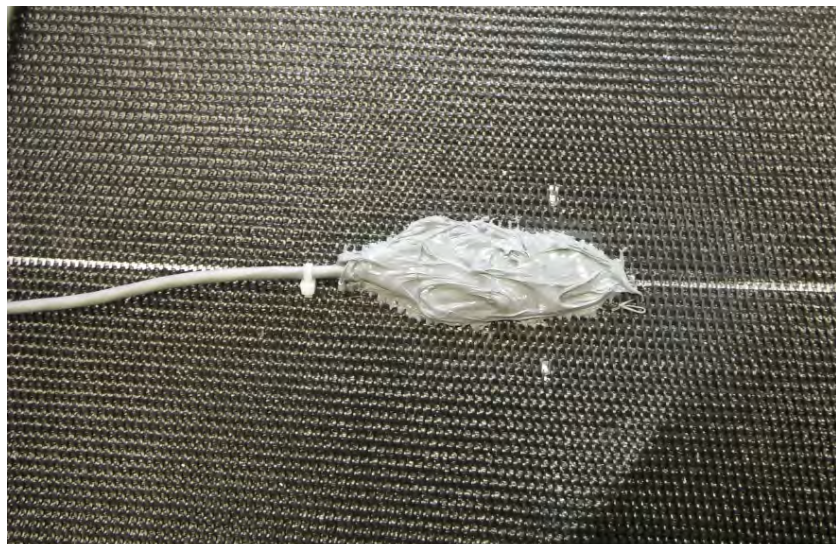
**Figure A-15. Finished Strain Gage Protected by RTV**

When applying the RTV, the exposed wires were not in contact with one another, and the strain relief bends were maintained. A toothpick was used to lift the wires while RTV is placed between the wires and the fabric. The wires were then lowered into the RTV. Additional RTV was placed over of the exposed wires and over the strain gage itself. At least 0.25 in of cover was provided over the gage and wires, extending approximately 0.5 in around the gage and beyond the unstripped wires over the grey protective wiring sheath.

The RTV was allowed to set for at least 24 hours before proceeding to the next step. Figure A-15 shows a gage after it has been protected with a coating of RTV.

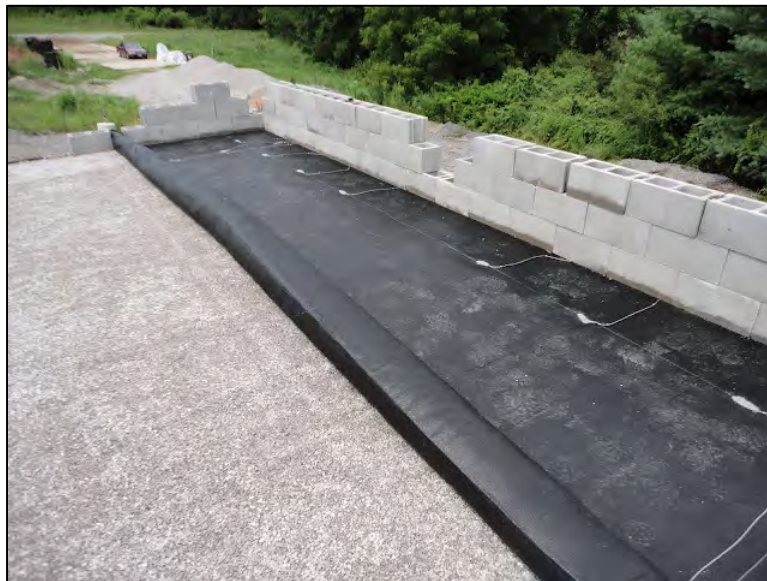
**Figure A-23. Installing Geotextile Fabric With Attached Strain Gages**

After the fabric was placed, the gages were connected, and zero readings were obtained. A small shovel of the No. 8 fill was placed over each gage for additional protection while placing the fill for the lift. The No. 8 fill was subsequently placed and compacted using the standard placement procedure discussed previously in the “Methods” section. During this compaction
