Differential Settlement of a Geosynthetic Reinforced Soil Abutment: Full-Scale Investigation: Summary Report

**The Charles E. Via, Jr. Department of Civil and Environmental
Engineering**

Final Report VCTIR 15-R4

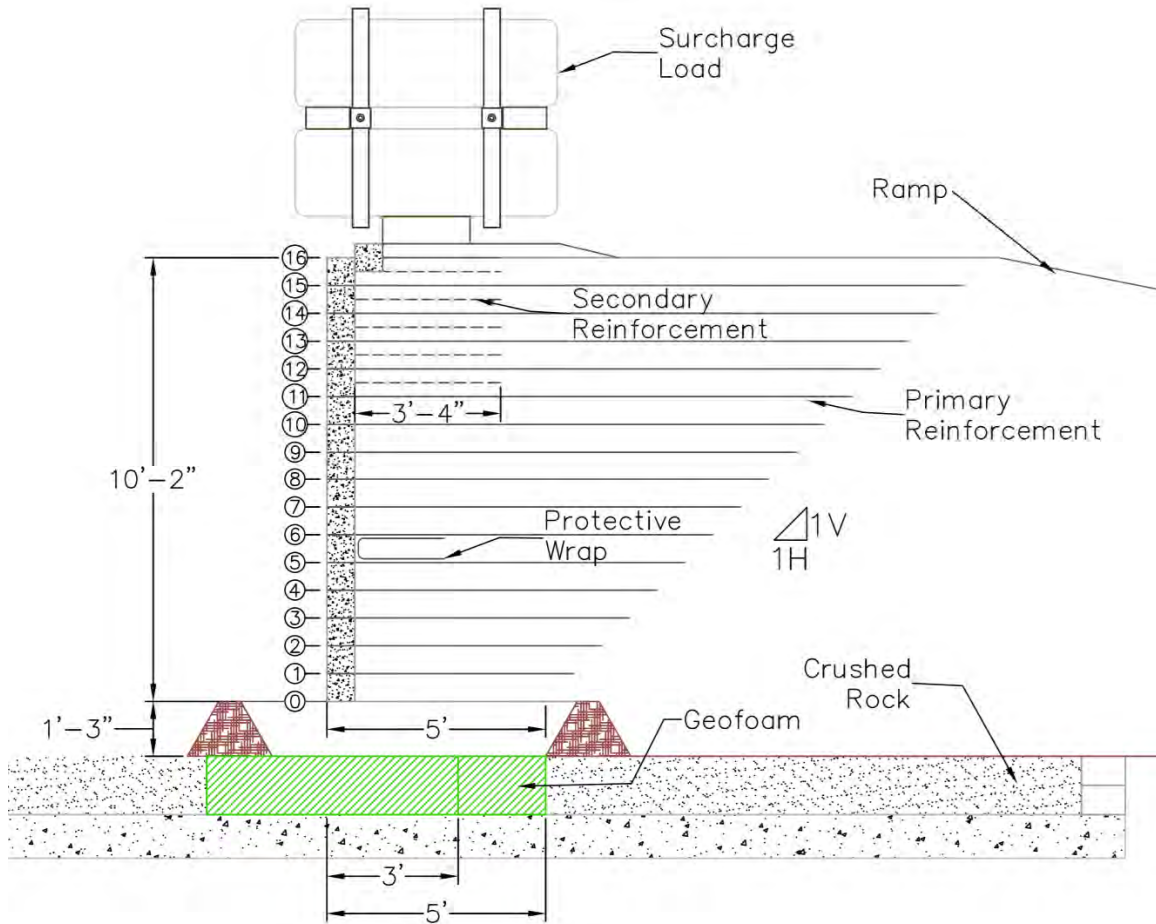
Primary reinforcement was spaced at 8-in vertical intervals throughout the abutment. Secondary reinforcement was placed in the upper five levels at the midpoint of primary reinforcement, resulting in a combined spacing of 4 in for the primary and secondary reinforcement, as shown in Figure 2. The secondary spacing and bearing bed for the surcharge load were detailed in accordance with FHWA guidelines, although some non-structural detailing was omitted. The integrated approach was also omitted from the test abutment.

The RSF extended a minimum of 0.25 times the base width, or 15 in, from the abutment at the face and both wing walls and was 15 in deep. Adams et al. (2011) indicate that reinforcement is commonly spaced at 12 in within the RSF. In order not to exceed this recommendation, one sheet of primary reinforcement was placed within the RSF at a distance of 7.5 in from the bottom and top of the RSF.

Figure 2. Side View of Abutment Configuration, Showing Reinforcement Spacing

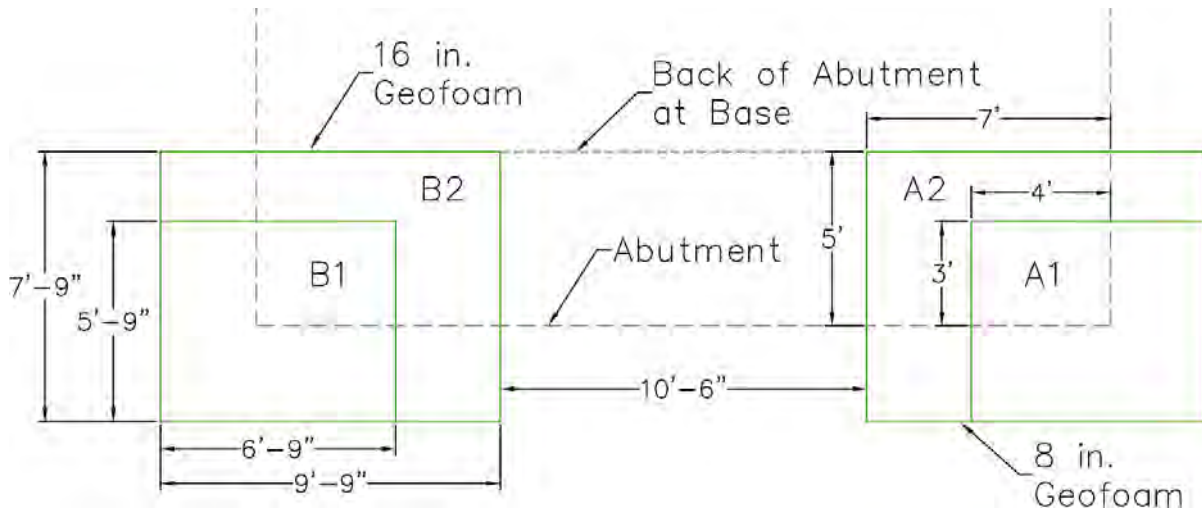
investigated in this research. Consequently, considerable care was taken in selecting the dimensions of these inclusions. Figure 3 shows a plan view of the geofoam inclusions.

Figure 3. Location of Geofoam Inclusions

The thickness of the geofoam inclusions was selected to ensure that settlement at the base was large enough to result in measureable deformations at the surface of the abutment. The testing site could accommodate geofoam up to 16 in thick, and therefore this thickness was selected for the inclusions on one side (Side B) of the abutment. The inclusions on the opposite side (Side A) were half the thickness of Side B at 8 in thick.

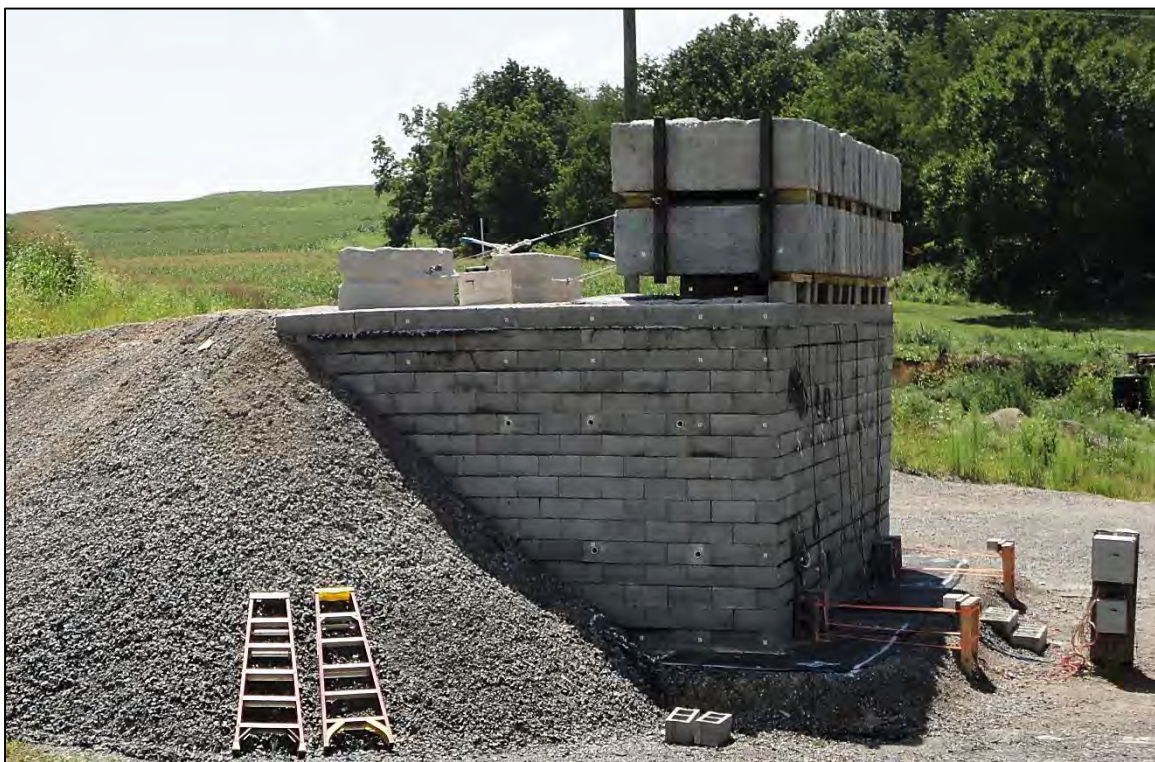
Construction of the subgrade underlying the test abutment comprised the first phase of construction. Each region of geofoam was carefully packaged in plastic to isolate the geofoam from surrounding regions and to contain the solvent and dissolved EPS. The RSF and the abutment were then constructed over the subgrade, following the guidelines established by the FHWA (Adams et al., 2011). Finally, the surcharge load was placed and tensioned together to provide additional stability to the load and to reflect the composite stiffness of a concrete box-beam superstructure. Additional details of the construction process are provided in the final project report (Kost et al., 2015). The completed abutment is shown in Figure 4.

Figure 4. Completed Abutment

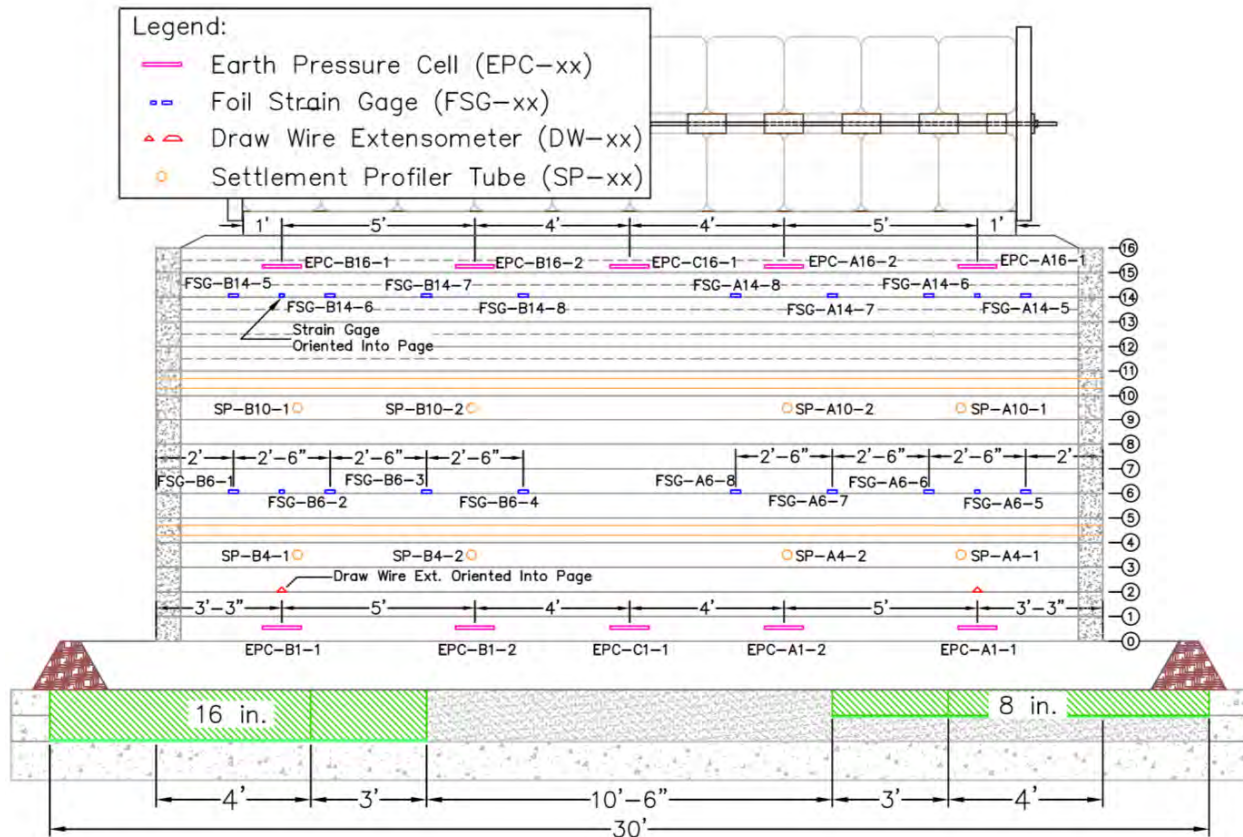
During construction, five types of instrumentation were installed to monitor the behavior of the abutment. Instrumentation included survey targets, PVC tubing for settlement measurements, earth pressure cells, draw-wire extensometers, and resistance strain gages. With the exception of the survey targets, the location of each instrument is shown in Figure 5 and Figure 6. Survey targets were placed on the CMU blocks comprising the face and wing walls, and survey points were established on the surface of the RSF and the abutment. Some of these survey targets are visible in Figure 4. A total of 214 survey points and targets were placed to provide comprehensive coverage of the abutment.

Figure 5. Front View of Instrumentation Configuration

The identification number for each instrument begins with a three-letter code identifying the type of instrumentation—e.g., “EPC” identifies an earth pressure cell. The codes are provided in a legend with each figure. The three-letter code is followed by a dash, a letter, and a number. The letter identifies whether the instrument is on Side A (A), Side B (B), or in the center of the abutment (C). For the settlement profiling tubes that run the length of the abutment, this letter is omitted altogether. The subsequent number identifies the abutment level where the instrument is located. This number is followed by a dash and a final number, which identifies the particular instrument at the indicated level. Instruments are numbered from the face toward the back of the abutment, or from the wing wall toward the center of the abutment, depending on the configuration. As an example, EPC-B1-2 denotes the earth pressure cell located on Side B of the abutment, within the Level 1 backfill, second instrument from the wing wall.

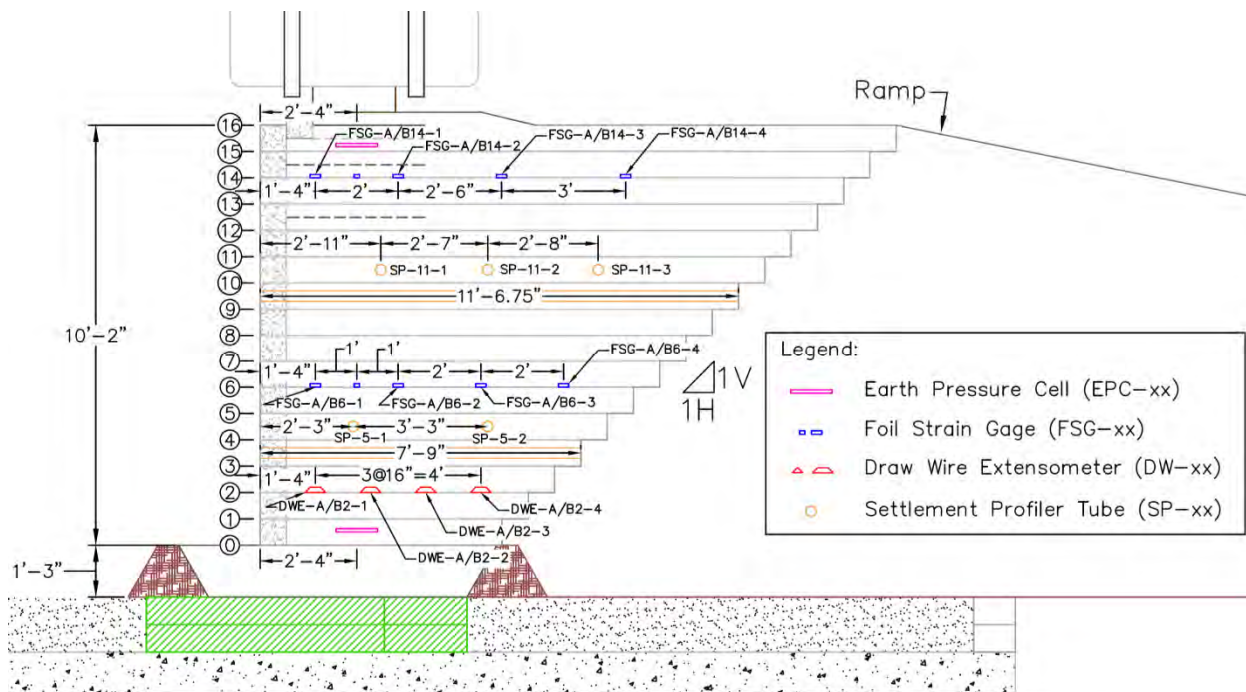
Figure 6. Side View of Instrumentation Configuration

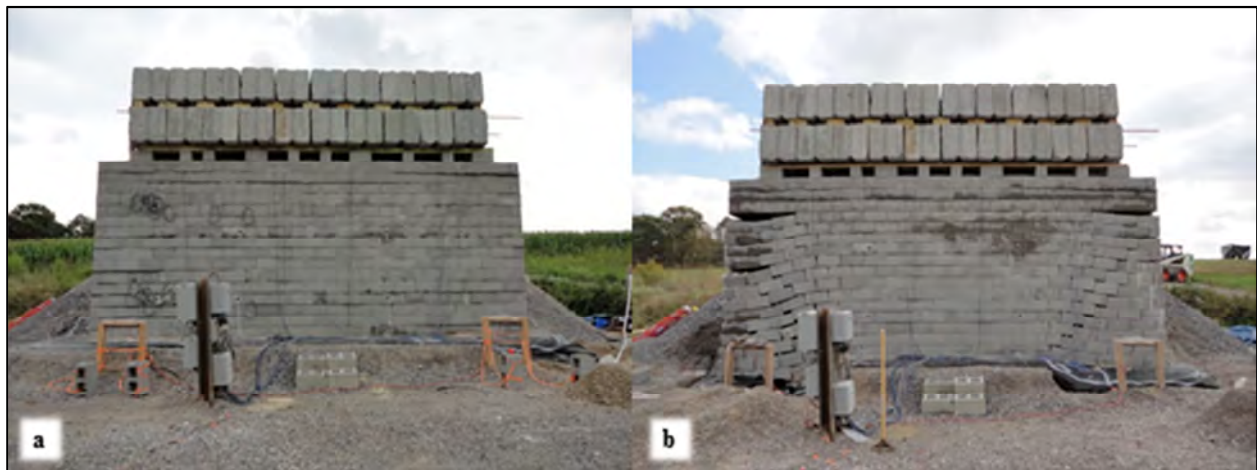
Post-testing deconstruction of the abutment revealed that the geofoam inclusions had been fully dissolved during the testing process. Figure 7 compares the abutment prior to and after all testing sequences. The figure is not intended to show the details of the deformation patterns, but rather to demonstrate that, despite removing large amounts of support from beneath much of the foundation area, the abutment was still able to adequately support the surcharge load. The CMUs and lengths of lumber placed on top of the abutment wall and beneath the surcharge load were a precautionary measure in the event that the load began to tip toward the face. The surcharge load experienced virtually no tipping during the tests, and clear space was maintained between the surcharge load and the precautionary blocking through all tests.

Figure 7. Comparison of Abutment (a) Before and (b) After All Testing Sequences

The deformation pattern of the facing blocks demonstrates a predictable, stair-step pattern that begins at the edge of the region where support is removed. Particularly for smaller regions of support removal, the CMUs are able to bridge over the region of support loss and minimize settlements of the overlying CMUs. This pattern roughly mirrors the support condition within the reinforced fill, which is able to support the full width of the surcharge load even after support beneath a large portion of the foundation has been removed. On Side A, the deformation patterns induced by Test A1 are erased by the patterns of Test A2, suggesting that the same deformation pattern would be seen if the support of Regions A1 and A2 had been removed at one time rather than in two steps. The behavior on Side B suggests similar trends, although the larger magnitude of settlement increases the difficulty of predicting the settlement had Regions B1 and B2 been removed at the same time.

The blocks at and near the corners of the abutment appeared vulnerable after experiencing settlements. This experiment tested only the response of the abutment to differential settlements. If water action were introduced, as would occur in a scenario of scour-induced settlement or of heavy stream flow after large differential settlements due to foundation compression, it is quite conceivable (and perhaps likely) that the combined effects of buoyant and viscous water forces could remove some of these CMU blocks and expose the backfill to erosion. This scenario could lead to serious damage or failure of the abutment. Some considerations to mitigate this hazard are discussed later in this report.

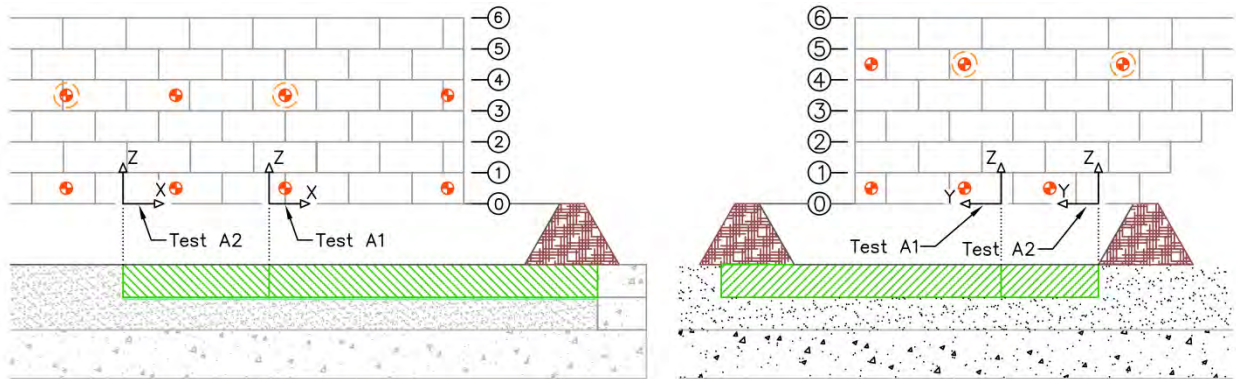
A predictive equation was developed using the survey data from the CMU facing blocks. Equation 1 can be used to estimate the settlement of the CMUs if the geometry and magnitude of the region of support loss is known. The XYZ coordinate system is shown in Figure 8. Although an attempt was made to formulate the predictive equation in normalized terms, it is not yet known if this normalization would apply to other configurations. So, at present, the predictive equation is specific to the conditions of this test set-up.

- where:
- S = settlement at the desired point
 - S_b = magnitude of support loss beneath RSF
 - t_{RSF} = thickness of the RSF
 - X = horizontal distance from edge of support loss to desired point, measured in the plane parallel to abutment face
 - Y = horizontal distance from edge of support loss to desired point, measured in the plane perpendicular to abutment face
 - Z = vertical distance from top of RSF to desired point

Figure 8. Coordinate System for Predictive Equation
