# **Evaluation of a Rectangular Rapid Flashing Beacon System at the Belmont Ridge Road and W&OD Trail Mid-Block Crosswalk**

Final Report VCTIR 15-R22

**EVALUATION OF A RECTANGULAR RAPID FLASHING BEACON SYSTEM  
AT THE BELMONT RIDGE ROAD AND W&OD TRAIL MID-BLOCK CROSSWALK**

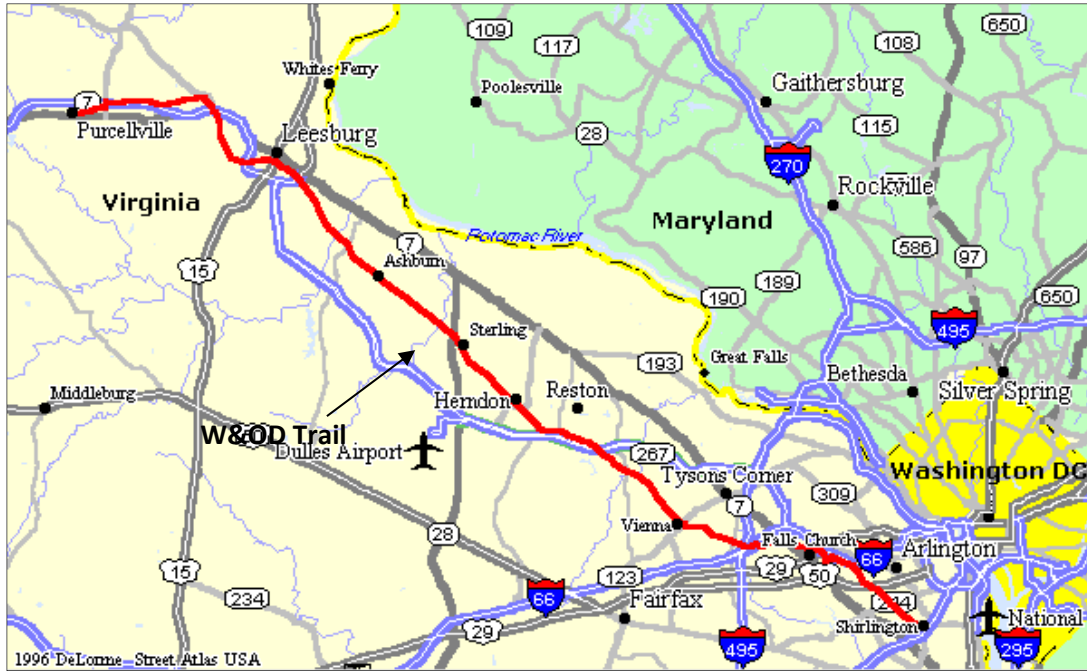
Figure 1. The 45-Mile W&OD Trail<sup>9</sup>

The W&OD Trail is a completed rail-to-trail project in Virginia. The trail is 45 miles long and begins in the Shirlington area of Arlington County and terminates in Purcellville.<sup>9</sup> Figure 1 shows the trail and its intersections with various towns and cities along the Route 7 corridor. The W&OD Trail is currently used regularly by bicyclists and pedestrians; between 2 million and 3 million people use it each year, thus making the W&OD Trail one of the most successful rail-trails in the nation.<sup>10</sup>

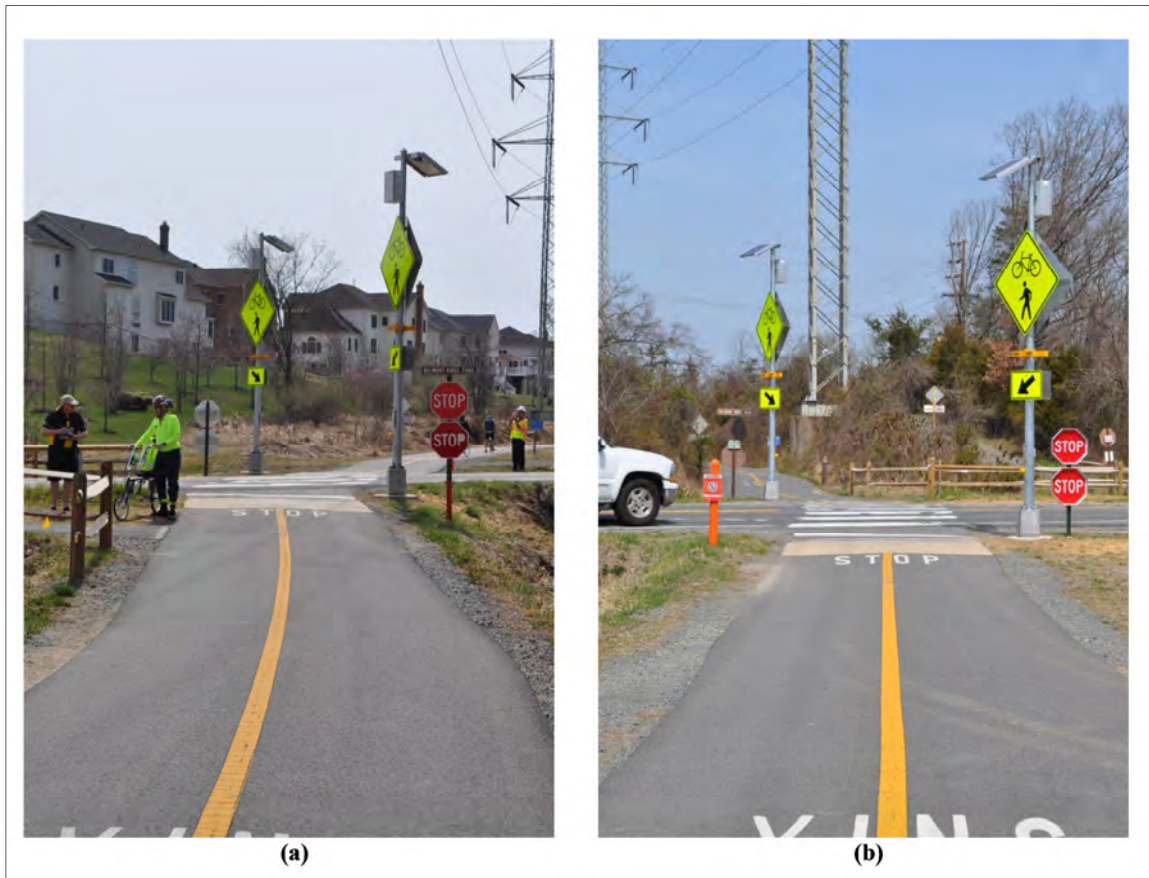
Figure 2. Eastbound Approach (a) and Westbound Approach (b) of W&OD Trail at Belmont Ridge Road

The trail, which runs east/west in relation to Belmont Ridge Road, has yellow skip lines that run down the centerline of the trail. As the trail approaches the road crossing in both directions, the skip lines become solid lines. In addition to the centerline, other pavement markings on both approaches of the trail include advance rumble strips, stencils of “ROAD XING” and “STOP,” and a STOP bar. Signage on the trail includes an advance STOP warning sign with a placard stating “CAUTION HIGH SPEED HIGH VOLUME TRAFFIC CROSSING AHEAD” and double-mounted STOP signs at the crossing. A high-visibility zebra crosswalk exists where the trail crosses Belmont Ridge Road. Figure 2 shows the eastbound and westbound approaches of the W&OD Trail.

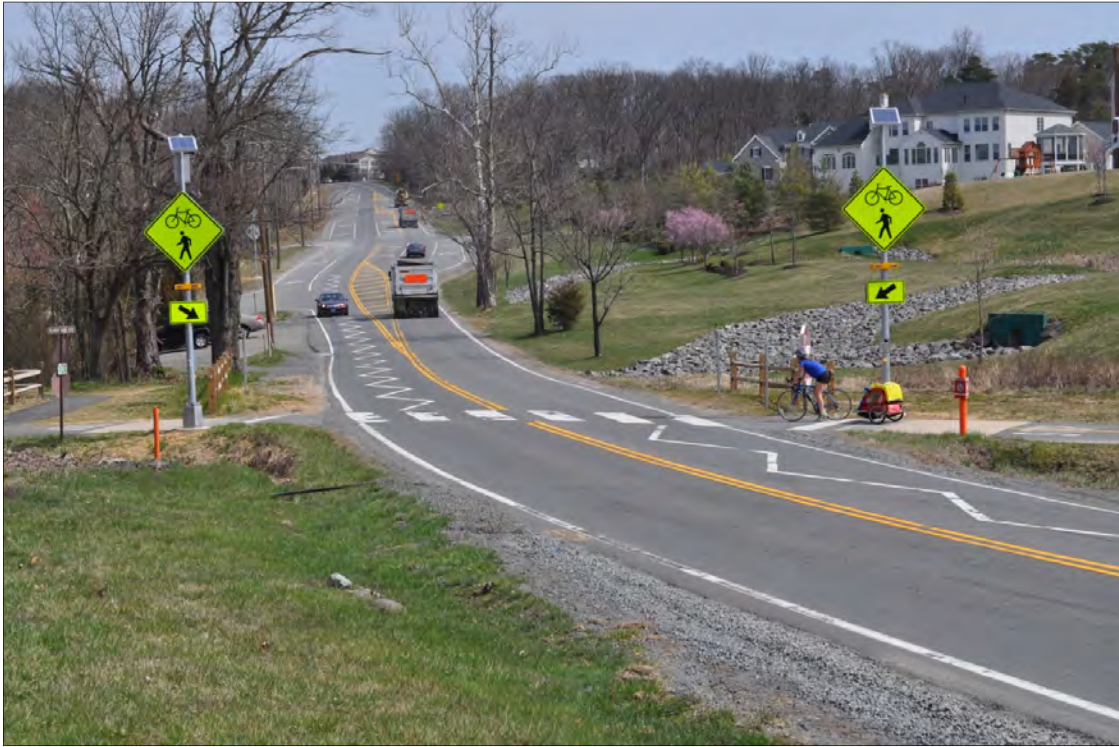
**Figure 5. RRFBs and Signage at W&OD Trail Crossing**

The RRFB system includes two poles located on the east and west side of Belmont Ridge Road at the intersection with the W&OD Trail crosswalk (see Figure 5) and two poles in advance of the crossing located 553 and 520 feet from the crosswalk in the northbound and southbound travel directions, respectively. At the crosswalk, each pole is mounted with double-sided W11-15 fluorescent yellow-green bicycle/pedestrian signs; W16-7P arrow signs; and high performance SB345 RRFBs. In addition, each pole has an SC315 network controller, a solar

panel to power the network controller for wireless transmission to RRFBS on the upstream poles, and a pressure activated push button that is compliant with the Americans with Disabilities Act (ADA) and MUTCD. Above the push button is an R10-25 push button sign (see Figure 6).

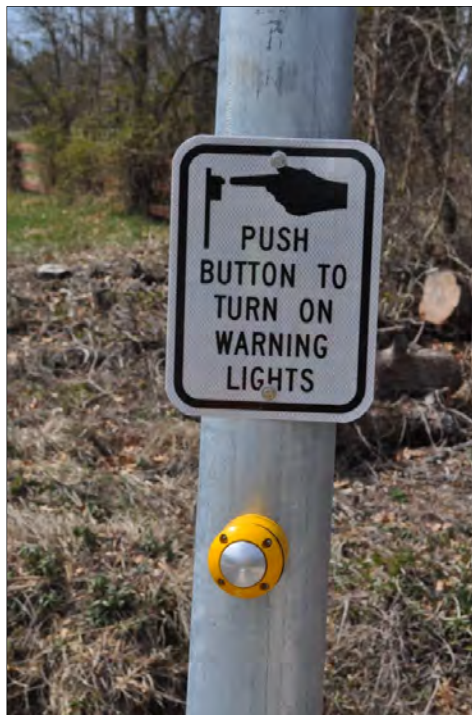
**Figure 6. RRFB Push Button and Sign**

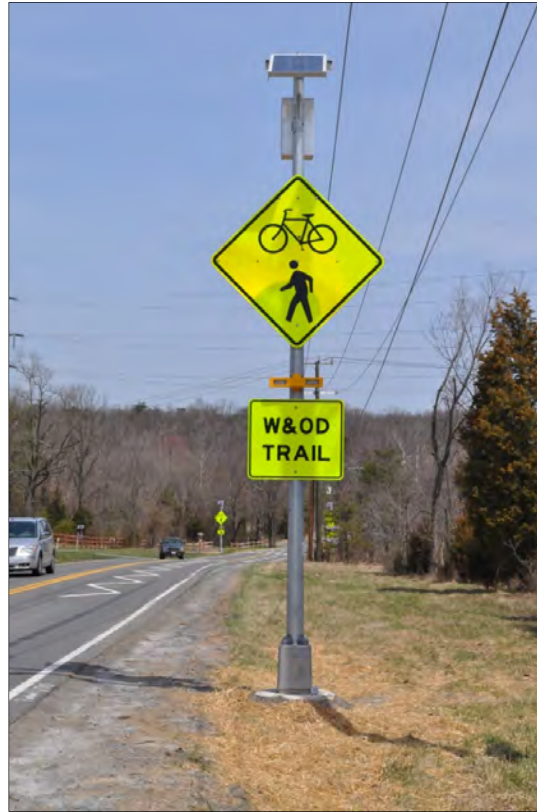
**Figure 7. Advance Warning RRFB and Signage on Northbound Approach of Belmont Ridge Road**

The upstream poles are mounted with W11-15 fluorescent yellow-green bicycle/pedestrian signs, W&OD TRAIL placards, and high performance SB345 RRFBs. Similar to the poles at the crossing, each upstream unit has an SC315 network controller and a solar panel to power the network controller for wireless communication transmission from the units at the crossing. Figure 7 shows the advance warning device on the northbound approach. A schematic of all the units on Belmont Ridge Road is shown in Appendix C.

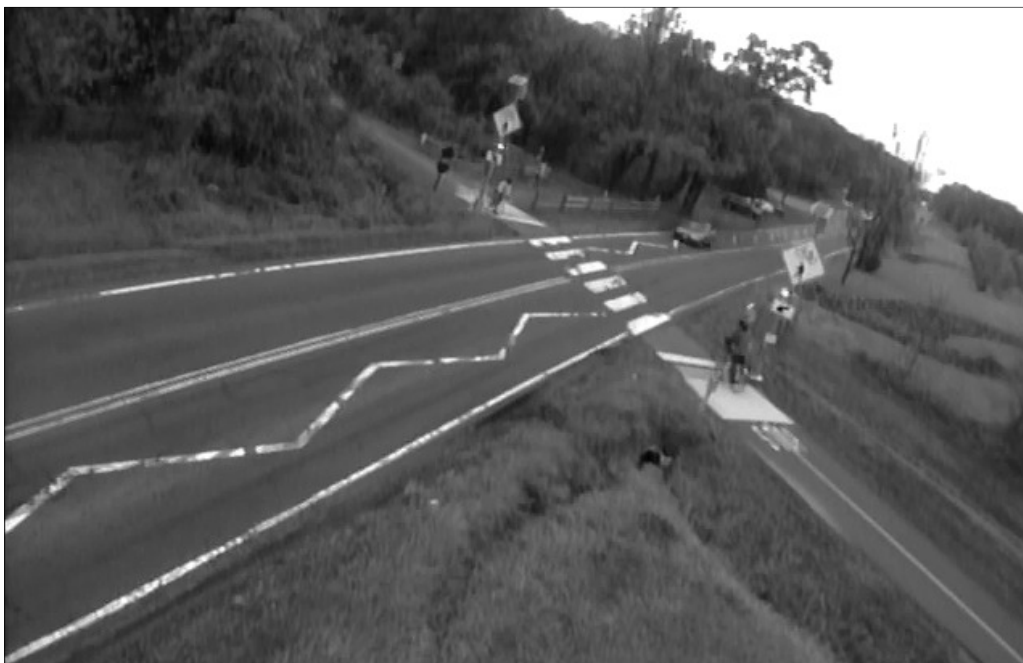
**Figure 8. Camera View of Intersection of Belmont Ridge Road and W&OD Trail**

With the assistance of VDOT’s on-call contractor, trail and roadway activity on each approach was analyzed via inconspicuously mounted cameras 3 weeks, 5 months, and 1 year after installation of the RRFB system. A black and white camera was elevated on a tripod with a 10-foot pole and placed approximately 150 feet south of the trail on the east side of Belmont Ridge Road. The height of the camera allowed for viewing the RRFBs and all four approaches of the intersection of the W&OD Trail and Belmont Ridge Road. Figure 8 shows the camera view of the intersection. The camera is attached by a cable to two self-contained digital video recorders (DVRs) in a waterproof case and a battery providing 120 hours of continuous recording. SD cards were inserted in the DVR as the recording media for the video.

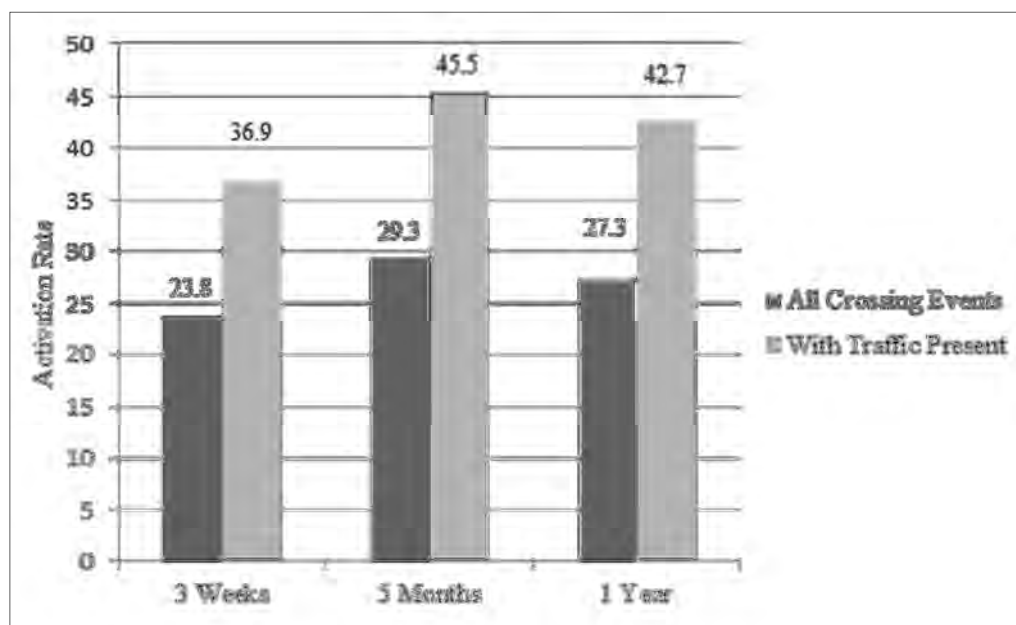
**Figure 9. Comparison of RRFB Activation Rate for all Crossing Events Versus Crossing With Traffic Present**

After the numbers of potential RRFB activations by mode were determined, the data were analyzed to find the RRFB activation rate. The rate was simply determined by dividing the number of actual trail user RRFB activations by the number of crossing instances defined as potential RRFB activations events (as found in Table 3). Of particular interest was how the activation rate changed over time for each mode. Table 4 shows the results of this analysis. For pedestrian only crossings, the activation rate increased over time from 13.7 to 33 percent. For bicycle only crossings, the activation rate increased from 23.5 percent in the 3-week after period to 28.4 percent in the 5-month after period. The activation rate then dropped to 24.9 percent in the 1-year after period. For pedestrians and bicyclists crossing together, the activation rate increased from 35 percent in the 3-week after period to 46.9 percent in the 1-year after period.

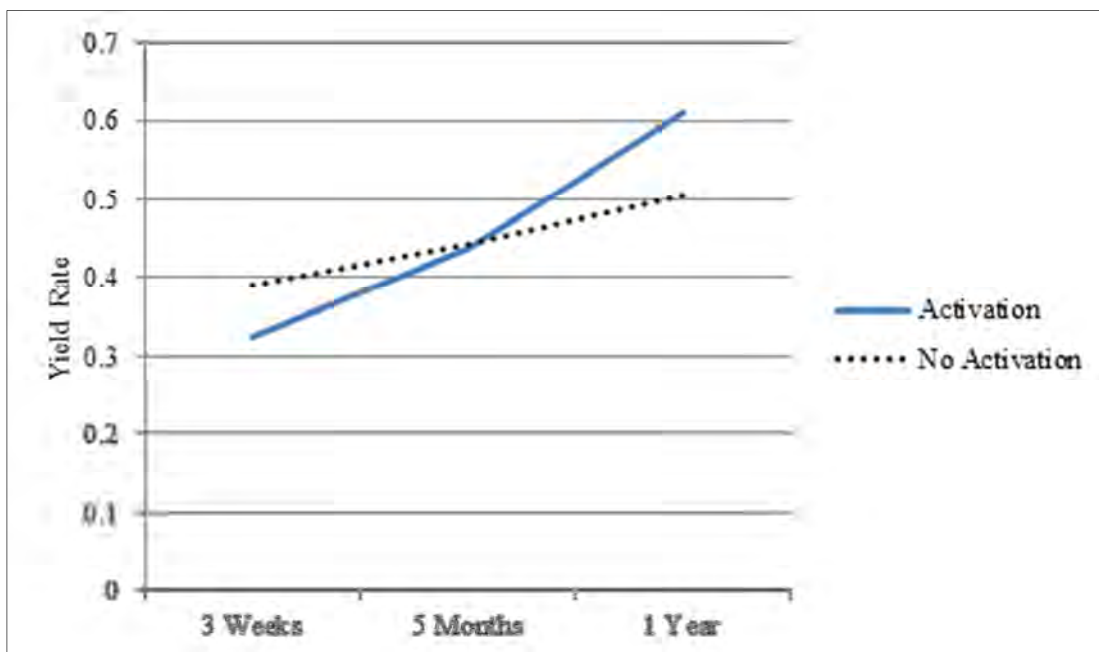
Figure 10. Comparison of Yield Rate With Activation Versus No Activation

A comparison plot of no activation versus activation yield rates over time for all modes combined is shown in Figure 10. As can be seen, the yield rate increases in both scenarios from 39 to 51 percent with no activation and from 32 to 61 percent with activation. The yield rate when the flashers were activated surpassed the rate when the flashers were not activated in the 1-year after period. This analysis should be interpreted with caution because of the random nature of vehicle arrivals and vehicle platoons.

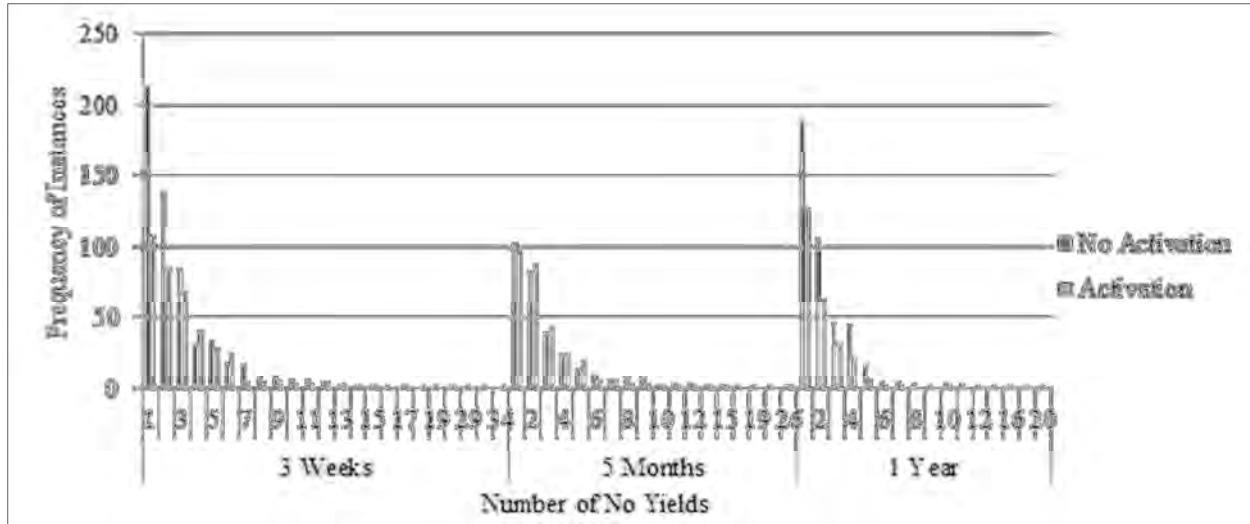
**Figure 11. Frequency of Number of No Yields When Flashers Were Activated Versus Not Activated**

Video and on-site observations showed that leading motorists can have an influence on the behavior of trailing motorists especially if the vehicles are in close proximity to each other. For example, in situations where there was a platoon of vehicles progressing toward the crosswalk, there may have been a very low yield rate whether or not the flashers were activated. To analyze the effect of flasher activation versus non-activation on vehicle platoons, Figure 11 shows the frequency of the number of “no yields” when flashers were activated versus not activated for all crossing modes combined. For each grouping of “number of no yields” in the 1-year after period, the frequency of instances of no yields without flasher activation was greater than the frequency with activation.

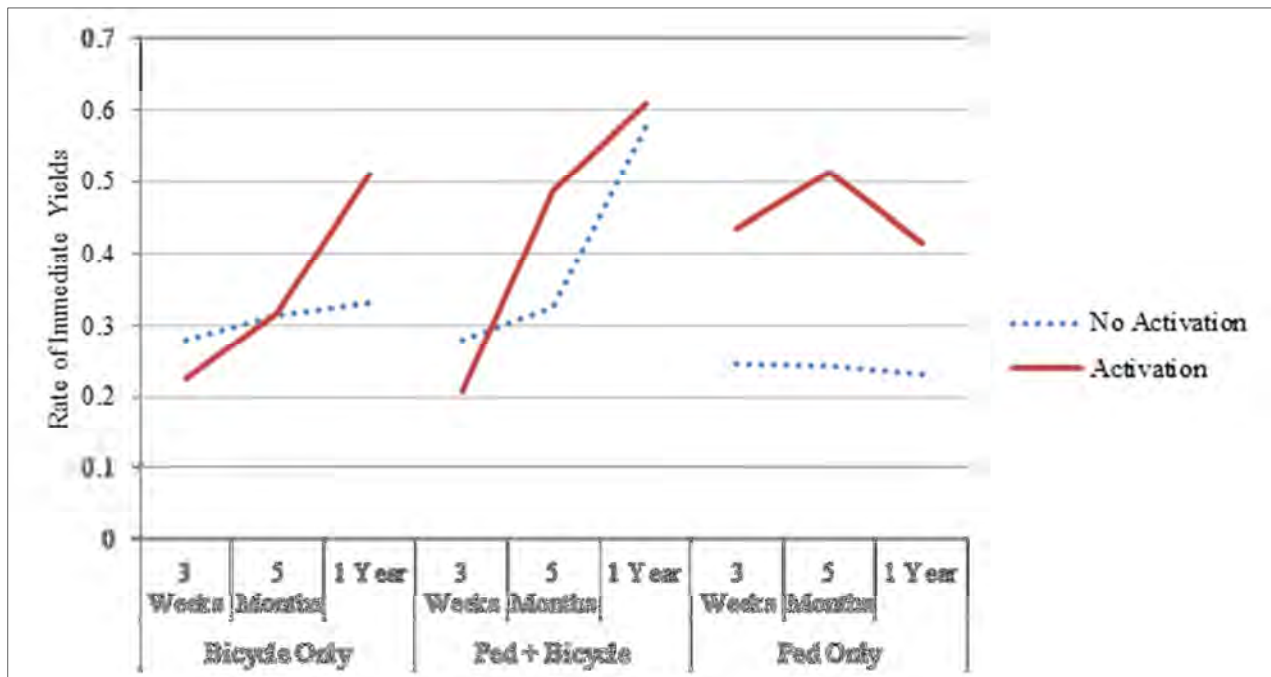
**Figure 12. Rates of Immediate Yields per Crossing Mode With and Without Activation**

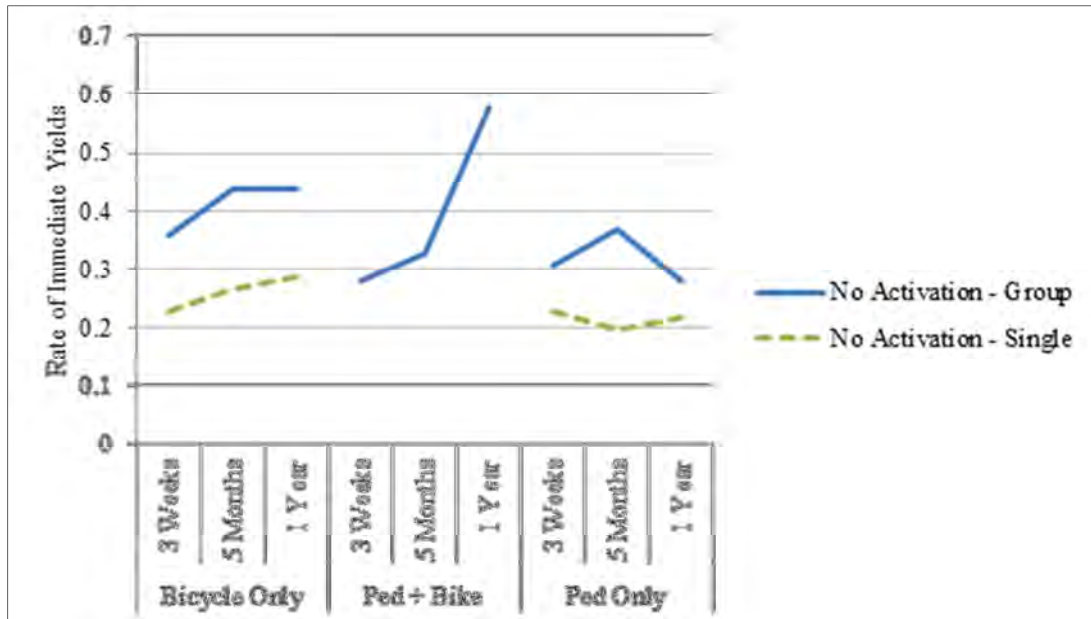
Figure 13. Rate of Immediate Yields With No Activation for Groups and Single Crossers

Additional analyses were performed that compared the effect that groups of crossers had on immediate yields versus single crossers both with and without activating the RRFB system. Figures 13 and 14 show the no activation and activation cases, respectively. A comparison of the two figures shows that except for the 3-week after period, the immediate yield rates with activation for both groups and single crossings remained consistently higher than the immediate yield rates with no activation. Further, and as expected, groups of crossers tended to influence motorist behavior more than single crossers whether or not the flashers were activated. It is interesting to note that from the 3-week to 1-year period, groups of crossers in the Bicycle Only and Ped + Bicycles modes had steep increases in the immediate yield rate when the flashers were activated (0.24 to 0.58 percent and 0.21 to 0.61 percent, respectively), whereas the Ped Only mode had a steep decrease in immediate yield rate over time (0.76 to 0.47 percent).

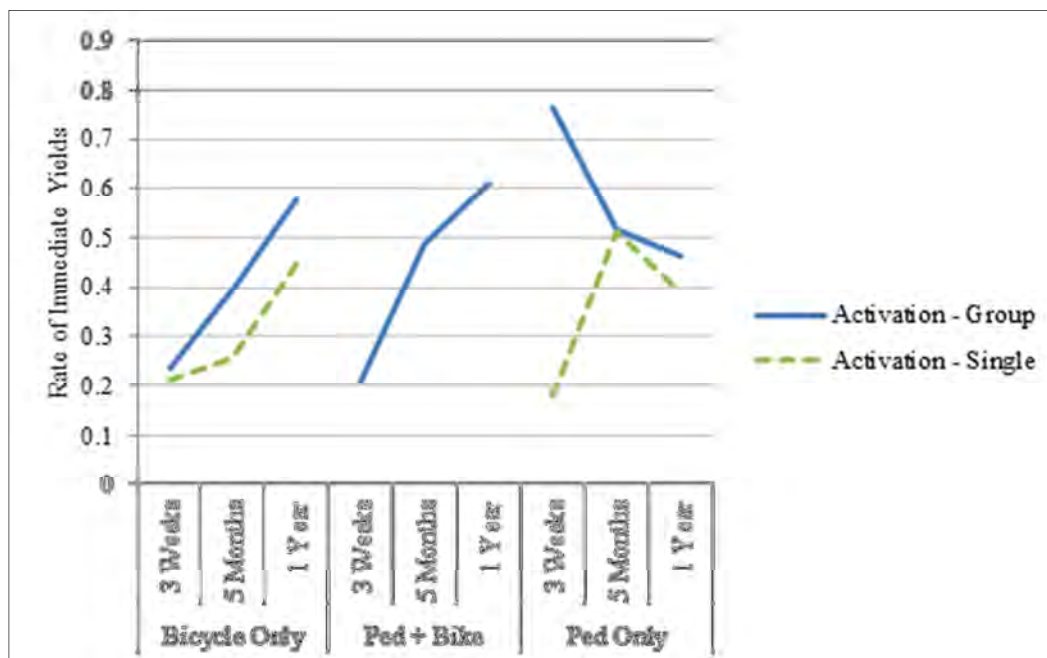
Figure 14. Rate of Immediate Yields With Activation for Groups and Single Crossers

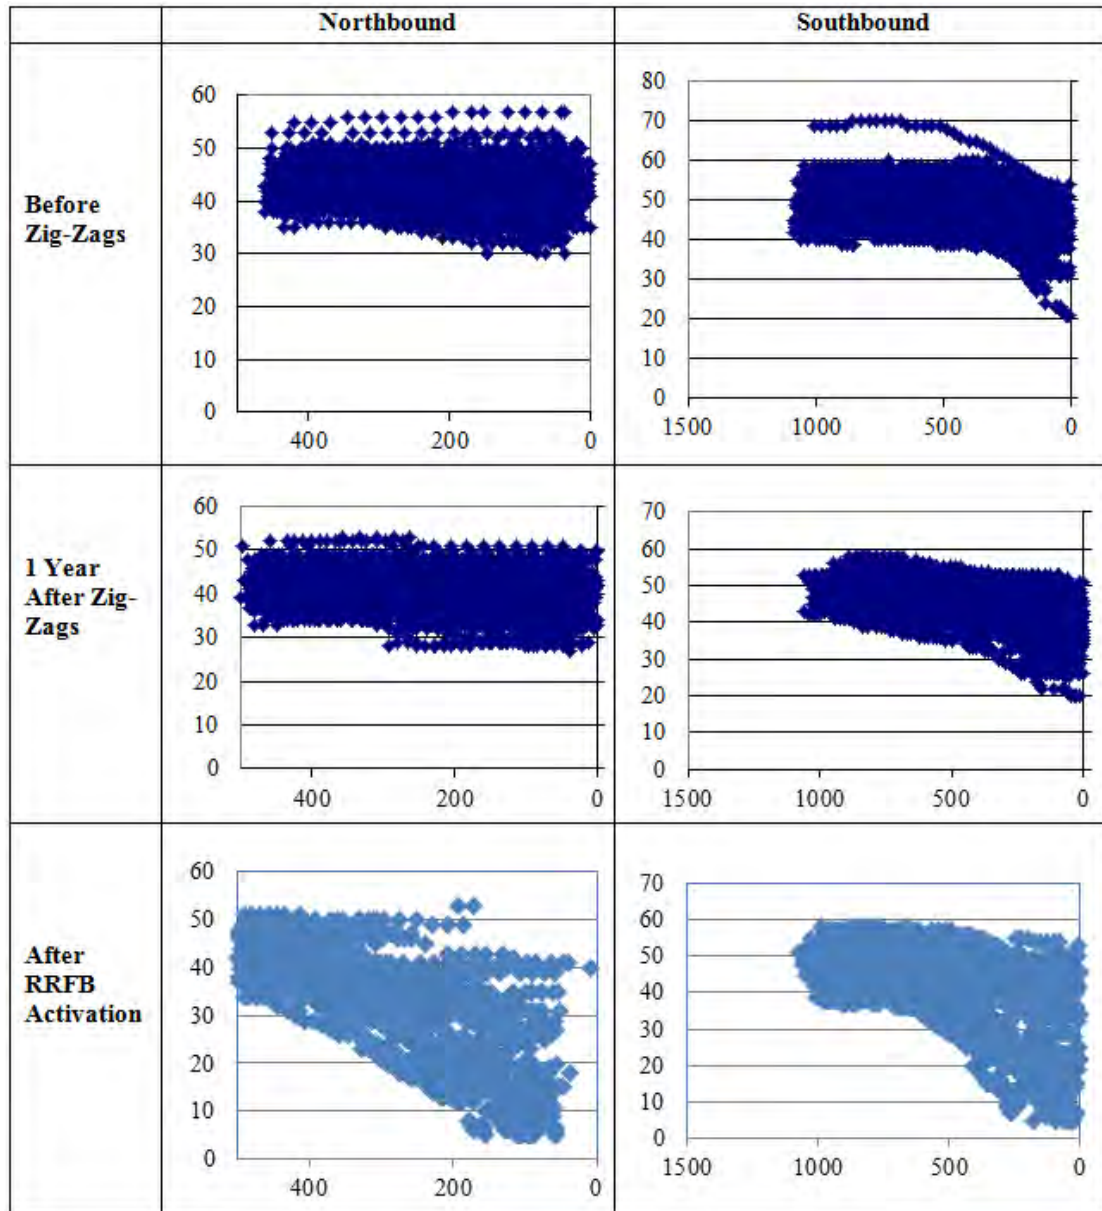
Figure 15. Scatter Plot of Speed Data Points

To obtain more information on motorist behavior and reaction when the RRFs were activated, vehicle speeds were obtained by an observer using a LIDAR gun as vehicles progressed toward the crosswalk in both the northbound and southbound travel directions on Belmont Ridge Road. Speed data were recorded as a text file and exported to an Excel spreadsheet. Figure 15 shows a scatter plot comparison of individual data points (speed and range) for all vehicles tracked before the zig-zag markings were installed, 1 year after zig-zag

installation, and after RRFB activation. The y-axis on each embedded scatter plot is speed in miles per hour and the x-axis is the distance in feet from the crossing. As can be seen from the scatter plots, RRFB activations had a much larger effect on motorists' speed as they approached the crosswalk. It should be noted that the number of individual speed data points was much lower in the "RRFB activation" period because of the high number of yielding events that occurred when the system was activated. As previously discussed, the intent was to capture vehicle speeds as motorists progressed through the crosswalk. Therefore, data points were excluded when there were yielding events. Because of the higher yield rates, the sampling of valid data points was lower.

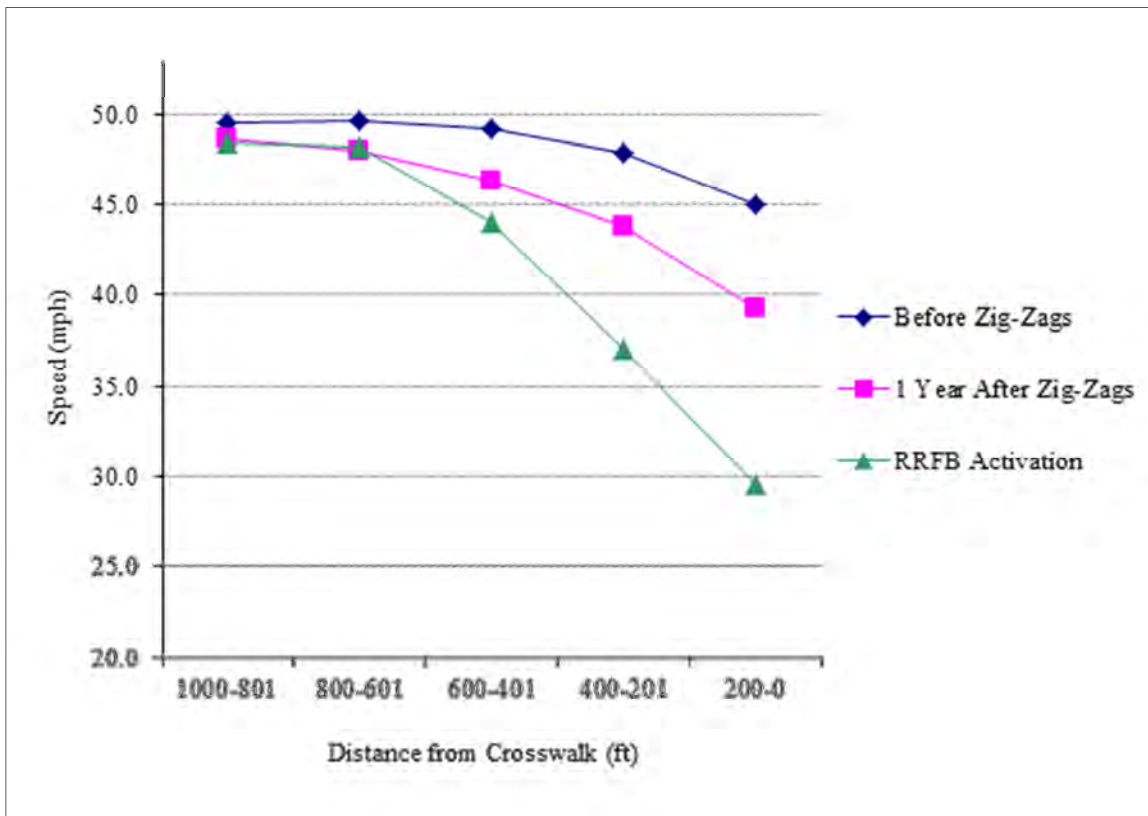
**Figure 17. Mean Speed Profiles From LIDAR Data on Southbound Approach of Belmont Ridge Road****Table 12. Mean Speed Over Time per Distance Bin on Southbound Approach of Belmont Ridge Road**
