FHWA-WY-15/01F

## INVESTIGATION OF APPROACH SLAB AND ITS SETTLEMENT FOR ROADS AND BRIDGES

Department of Civil & Architectural Engineering  
University of Wyoming  
1000 E. University Avenue, Dept. 3295  
Laramie, Wyoming 82071

December 2014

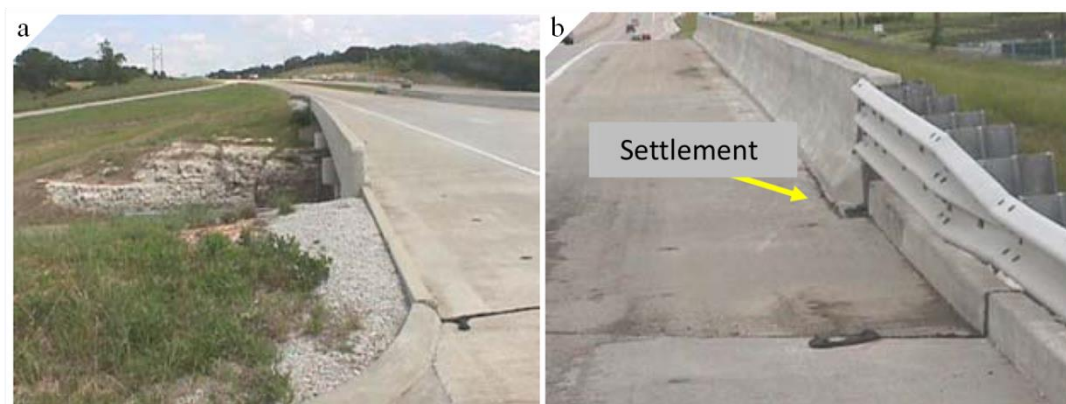
**Figure 2(a) No settlement on bridge approach slab with unused mudjack holes shown, and (b) Differential settlement occurred on a bridge approach slab (Petry et al., 2002)**

was observed. On the other hand, thick embankment fill with no drainage led to settlement (figure 2).
