**NYSDOT
SPR Project # C-08-15**

**Determining Binder Flushing Causes
in New York State**

Final Report

**Center for Advanced Infrastructure and
Transportation (CAIT)**

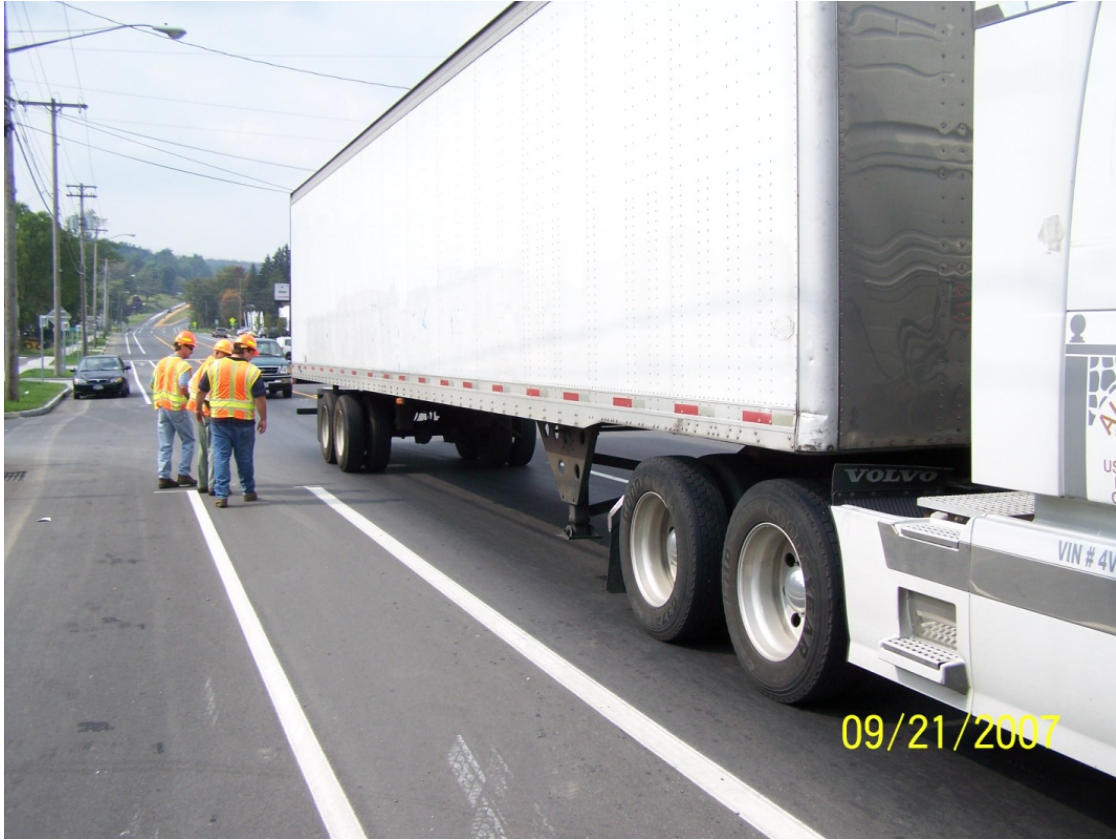
Figure 2 - Flushing at Intersection of Rt 20 (< 30 Million ESAL's)

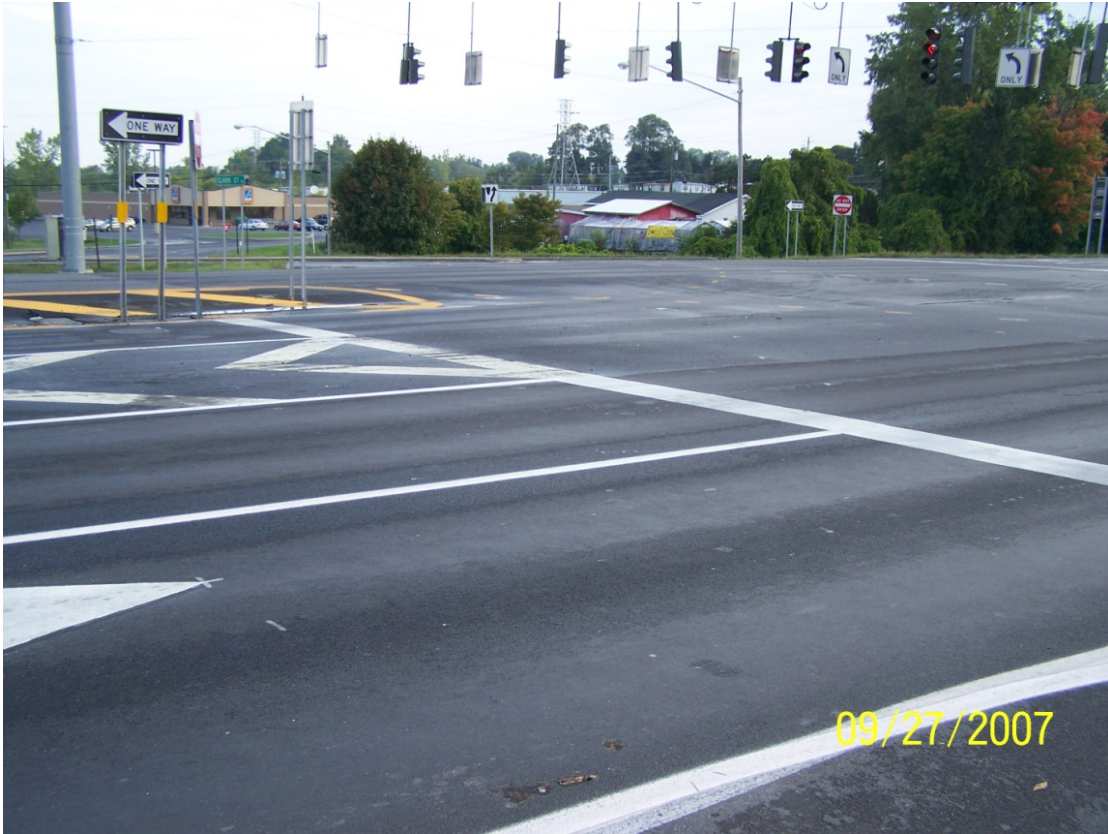
Figure 4 - Flushing at Intersection of Rt 5 (< 30 Million ESAL's)

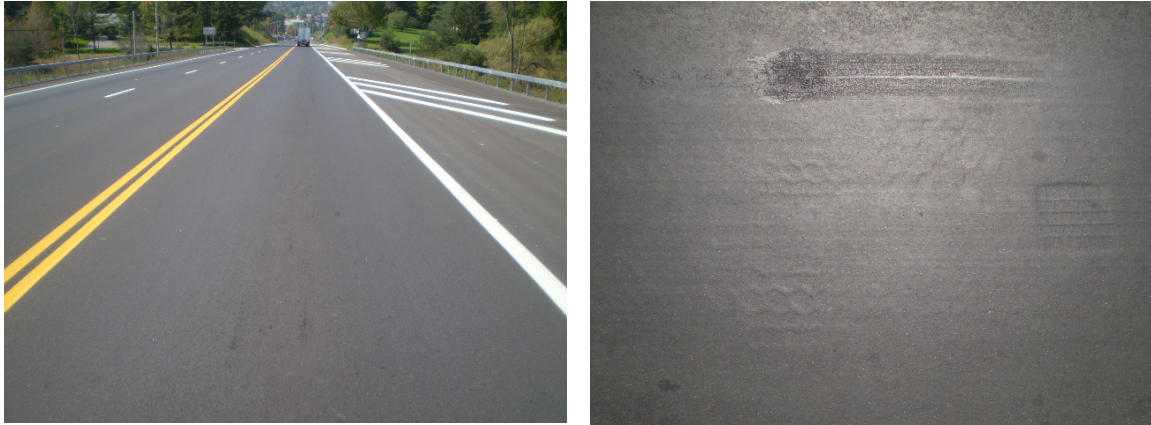
Rt 20 in Morrisville, NY was another pavement section that had traffic levels of 10 to 30 million ESAL's. The areas with extensive flushing were located at an incline/decline area (Figure 6).

Figure 6 – Flushing Located on Rt 20 in Morrisville, NY

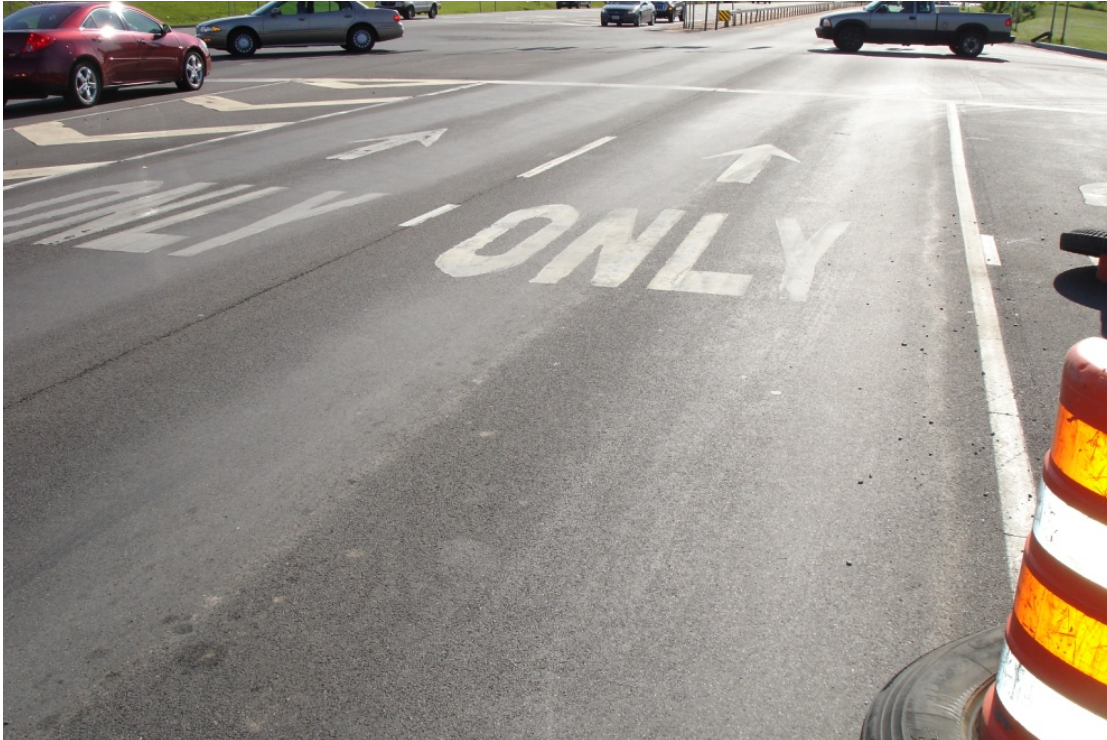
Another 10 to 30 million ESAL pavement section, the flushing and slight rutting on Rt 5 again occurred at an intersection (Figure 7). LTPPBind 3.1 was used to determine the correct PG grade used for the climatic and traffic conditions located in this area. Table 10 shows the results for this pavement section. Similar to the previous 10 to 30 million ESAL areas, the appropriate PG grade for this location should have been a high temperature grade of PG70. However, a PG64-28 asphalt binder was specified and utilized.

Figure 7 – Flushing at Intersection on Rt 5

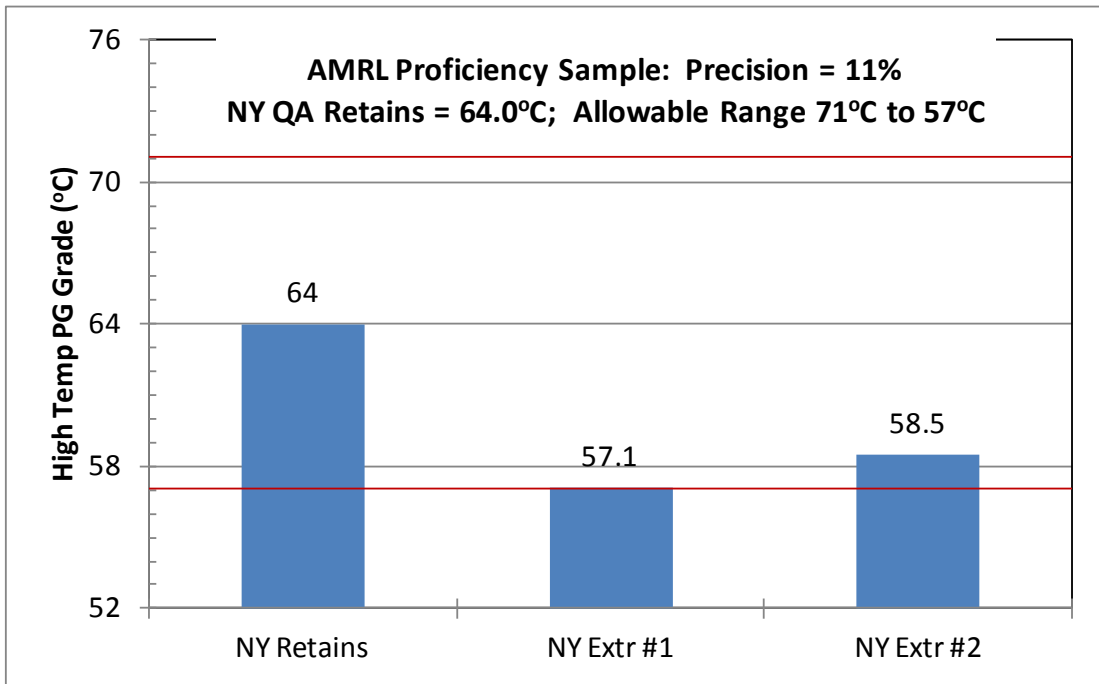
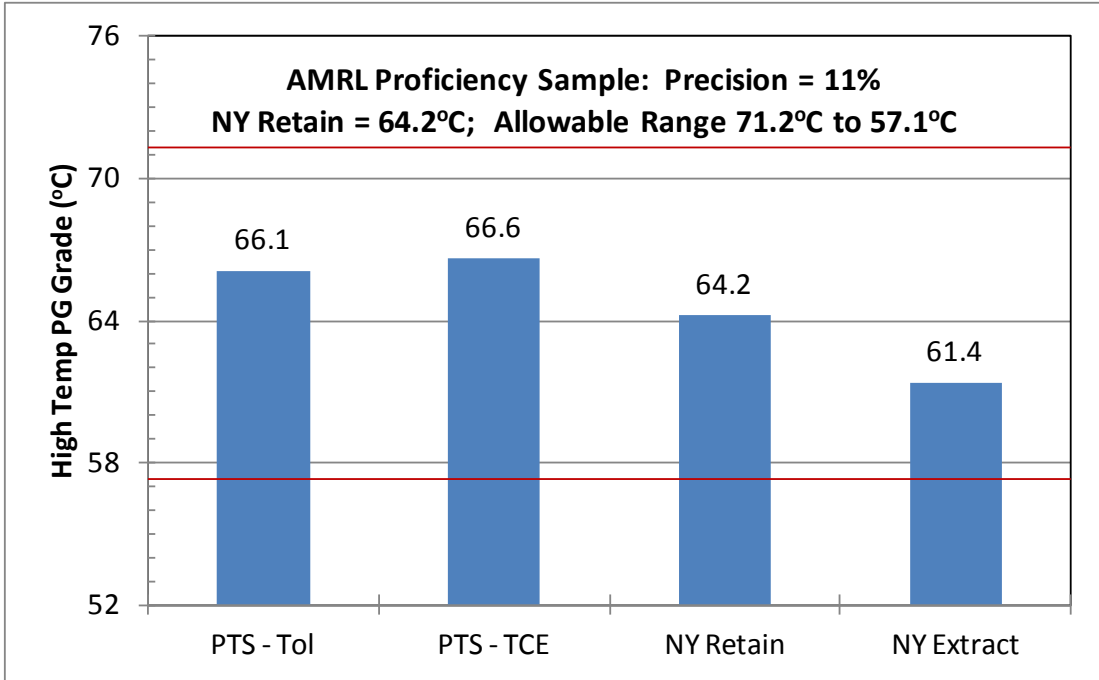
2. The figures clearly show that the resultant range of acceptable test results, based on the 11% coefficient of variation of the Retain values, surrounds the high temperature PG grade results for the extracted/recovered asphalt binders. All but 2 test results (two from Rt 365) from the NYSDOT and PTS extracted/recovered are found to be within the acceptable range. This would indicate that even though the NYSDOT resulted in extracted/recovered high temperature PG grades that fell below 64° C, the test results were within the expected range of repeatability.

Figure 10 – Comparison of High Temperature PG Grade for Rt 921C, Utica, NY (Genesee Street)

Figure 11 – Comparison of High Temperature PG Grade for Rt 20, Morrisville, NY

Figure 12 – Comparisons of High Temperature PG Grade for Rt 315, Deansboro, NY

Figure 13 – Comparison of High Temperature PG Grade for Rt 12B, Oriskany Falls, NY

Figure 14 – Comparison of High Temperature PG Grade for Rt 365, Rome to Barneveld, NY

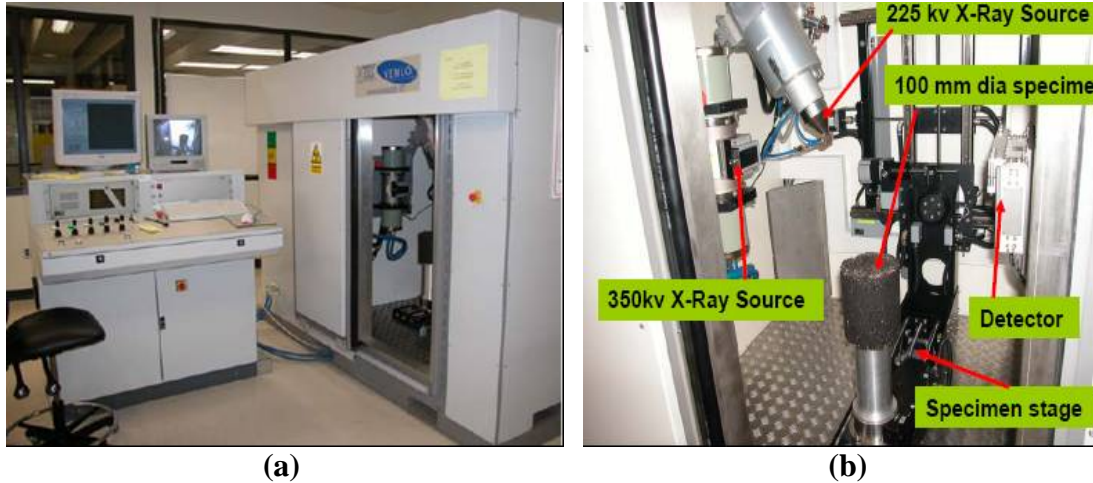
In an attempt to efficiently quantify the entire core, and not just a “slice”, X-ray Computed Tomography (CT) testing was conducted on selected cores from both flushed and unflushed sections of the pavement (in and outside the wheelpath). X-ray CT is a nondestructive test to capture the internal structure of materials. The X-ray CT setup at Texas A&M University is shown in Figures 16a and b. This setup includes two separate systems placed in the same shielding cabinet. The mini-focus system has a 350 kV X-ray source and a linear detector, while the micro-focus system has a 225 kV X-ray source and an area detector. The mini-focus source can penetrate thicker and denser specimens than the micro-focus source. The micro-focus system, however, has a better resolution than the mini-focus system. All the experimental measurements in this study shall be conducted using the mini-focus 350 kV X-ray source system. This system has the necessary power and resolution to penetrate the asphalt mix specimens and provide good quality images for air void/structural analysis.

Figure 16 - a) Overall X-ray CT System and Shielding Cabinet; b) Mini- and Micro-focus System

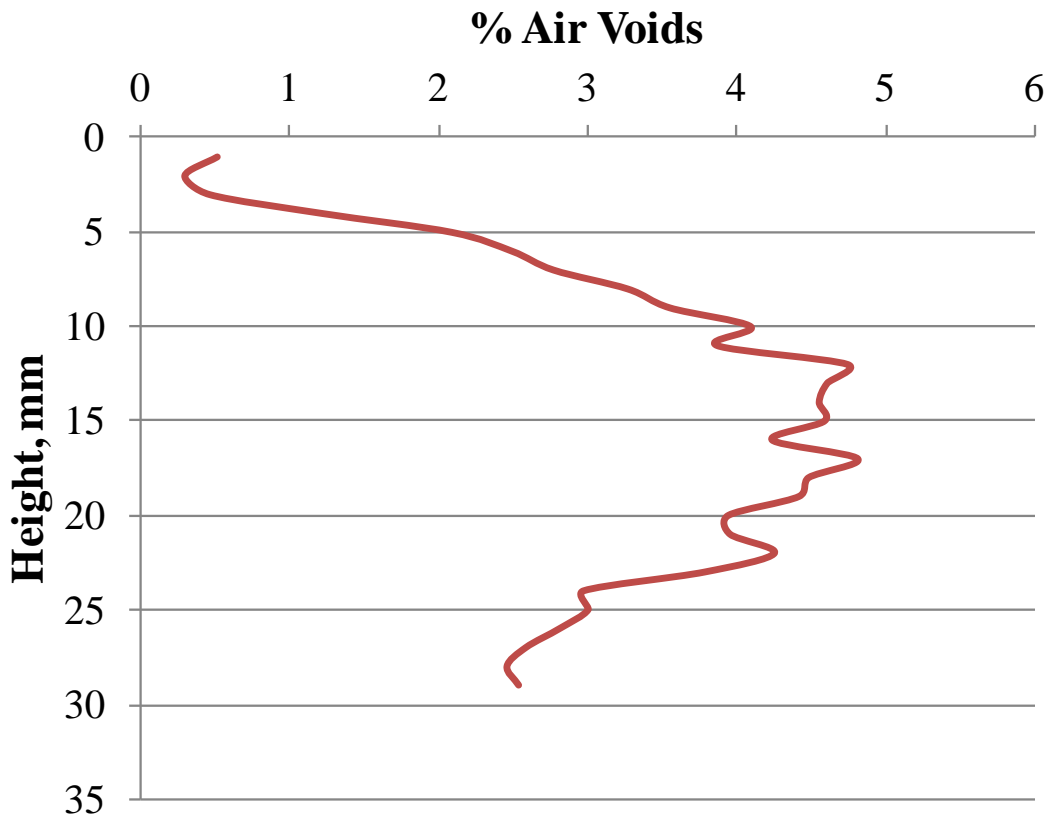
The X-ray tomography result for pavement areas where flushing was identified (wheelpath areas) are shown through Figures 17 to 19. What is consistent in all of these sections is that the air void distribution is lowest at the top of the core and increases with depth. This would indicate a decrease in air voids at the top part of the pavement core, either due to consolidation or asphalt binder migration to the top area of the pavement surface/core. The plots of air voids vs height also indicates that a majority of the consolidation/binder migration took place in the upper 10 to 15 mm (0.4 to 0.6 inches) of the pavement. Below this depth, the air void distribution returns to expected levels (greater than 4% air voids).

Figure 17 - Air Void Distribution of Core from the Wheelpath of Rt 315

Figure 18 - Air Void Distribution of Core from the Wheelpath of Rt 96B 1095-15

Figure 19 - Air Void Distribution of Core from the Wheelpath of Rt 96B 1095-40

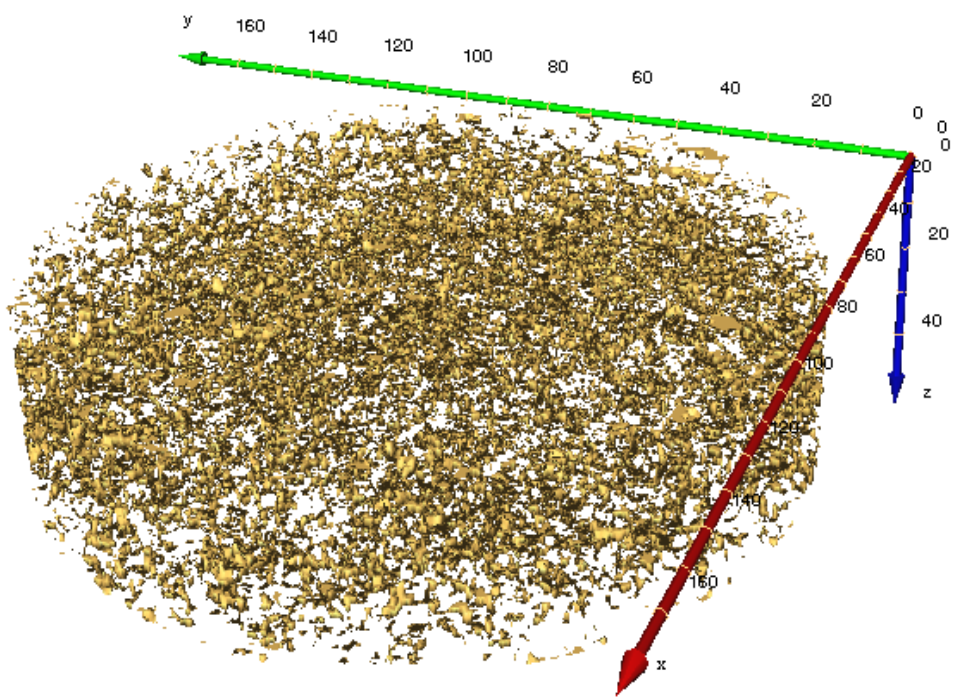
A 3-D representation of two field cores from Rt 96B, from inside and outside of the wheelpath, are shown in Figures 26 and 27. Both cores show a well distributed amount of aggregate within the core matrix. Although only one pavement location was evaluated, there is evidence suggesting that the visual observation made by Reinke (2009) may have been to just looking at a single saw cut and not represent the 3-D perspective of the field core.

Figure 26 – 3-D Representation of Rt 96B Field Core Taken from the Wheelpath

Figure 27 – 3-D Representation of Rt 96B Field Core Taken Outside of Wheelpath

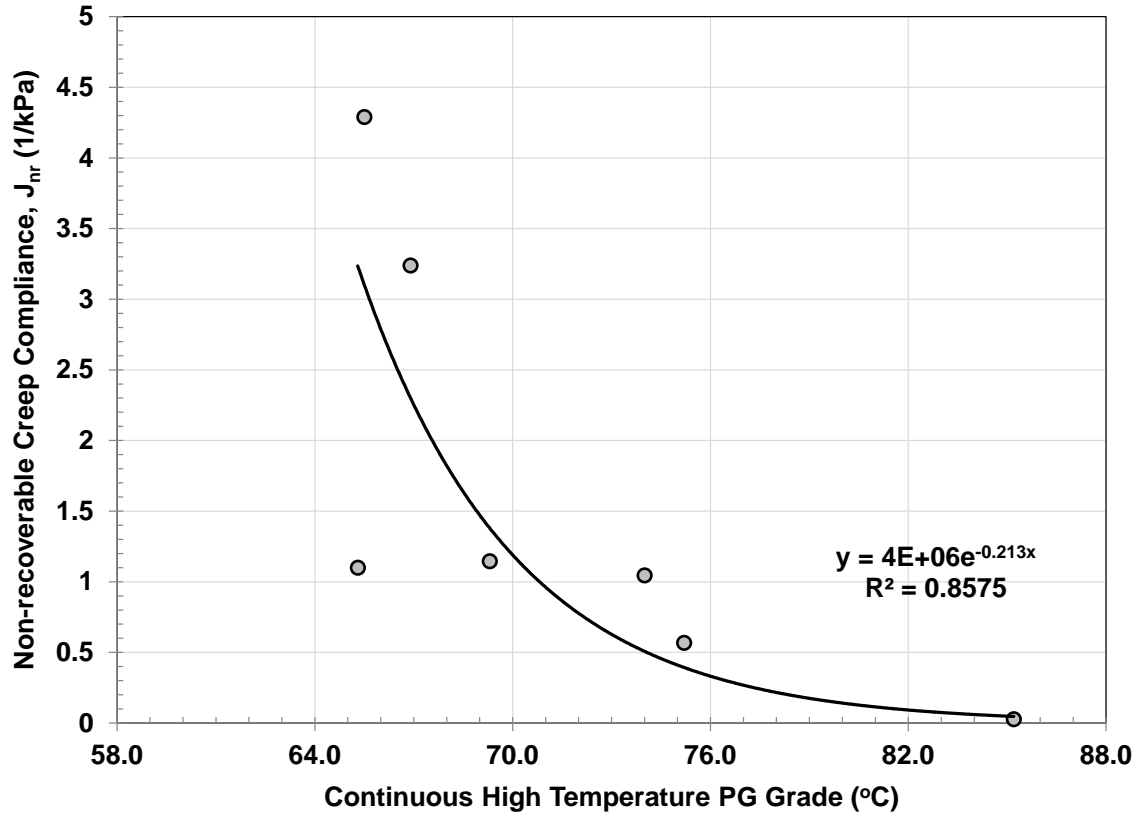
Figure 28 – Relationship Between High Temperature PG Grade and Multiple Stress Creep Recovery Jnr at 64°C

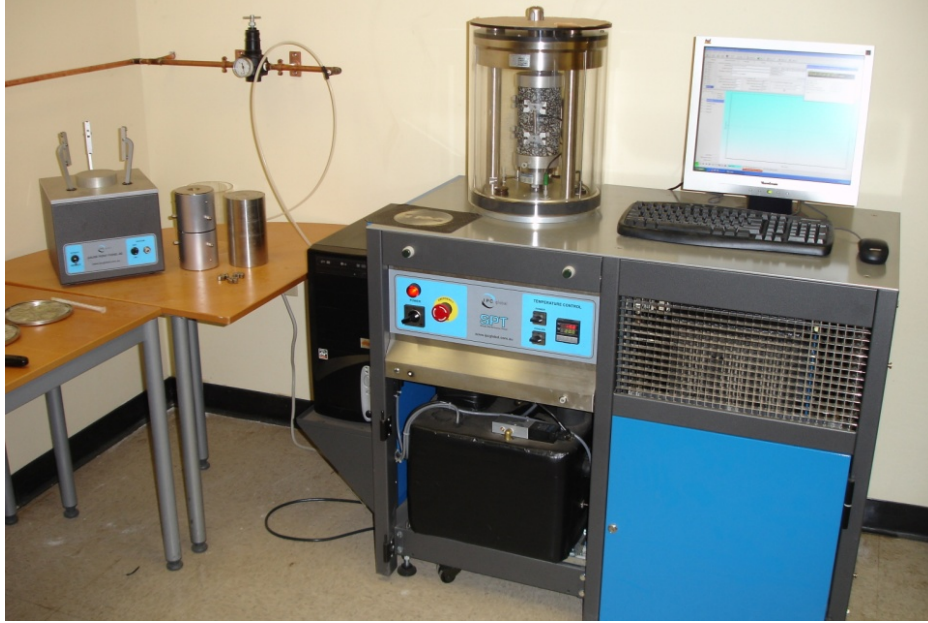
The collected modulus values of the varying temperatures and loading frequencies were used to develop Dynamic Modulus master stiffness curves and temperature shift factors using numerical optimization of Equations 1 and 2. The reference temperature used for the generation of the master curves and the shift factors was 20°C.

Figure 29 – Photo of the Asphalt Mixture Performance Tester (AMPT) at Rutgers University

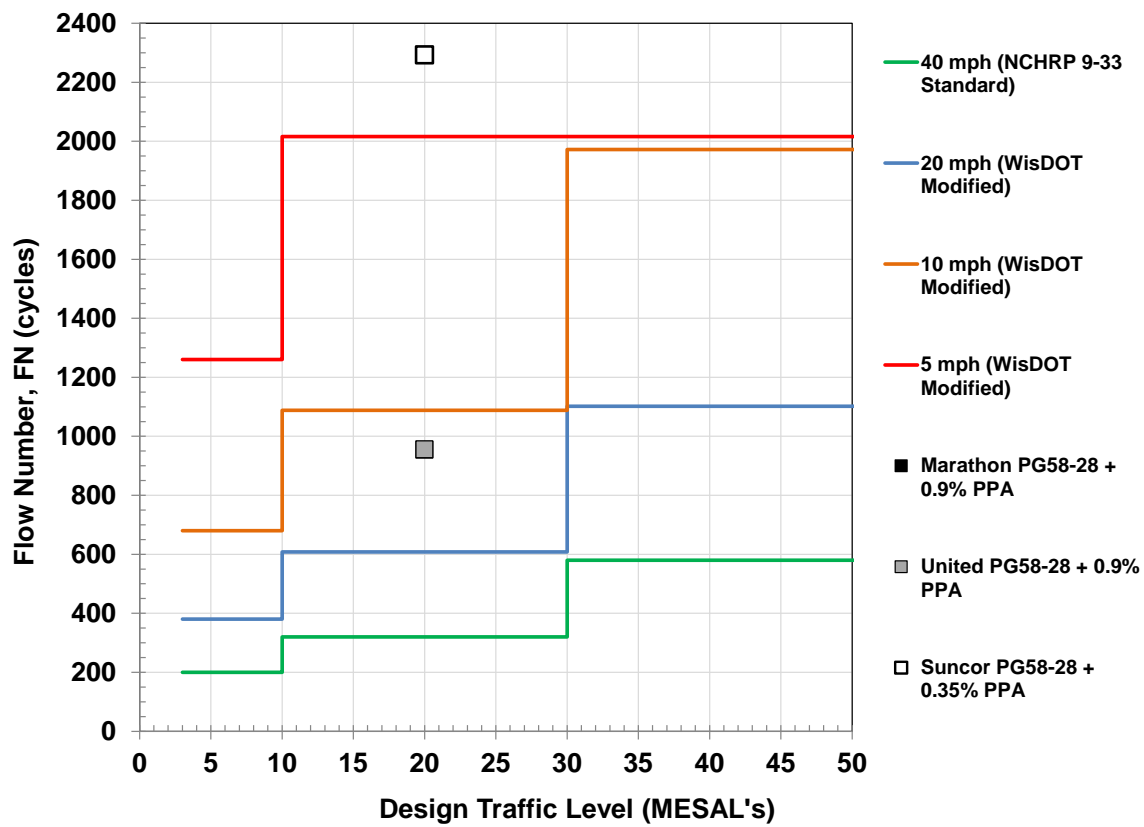
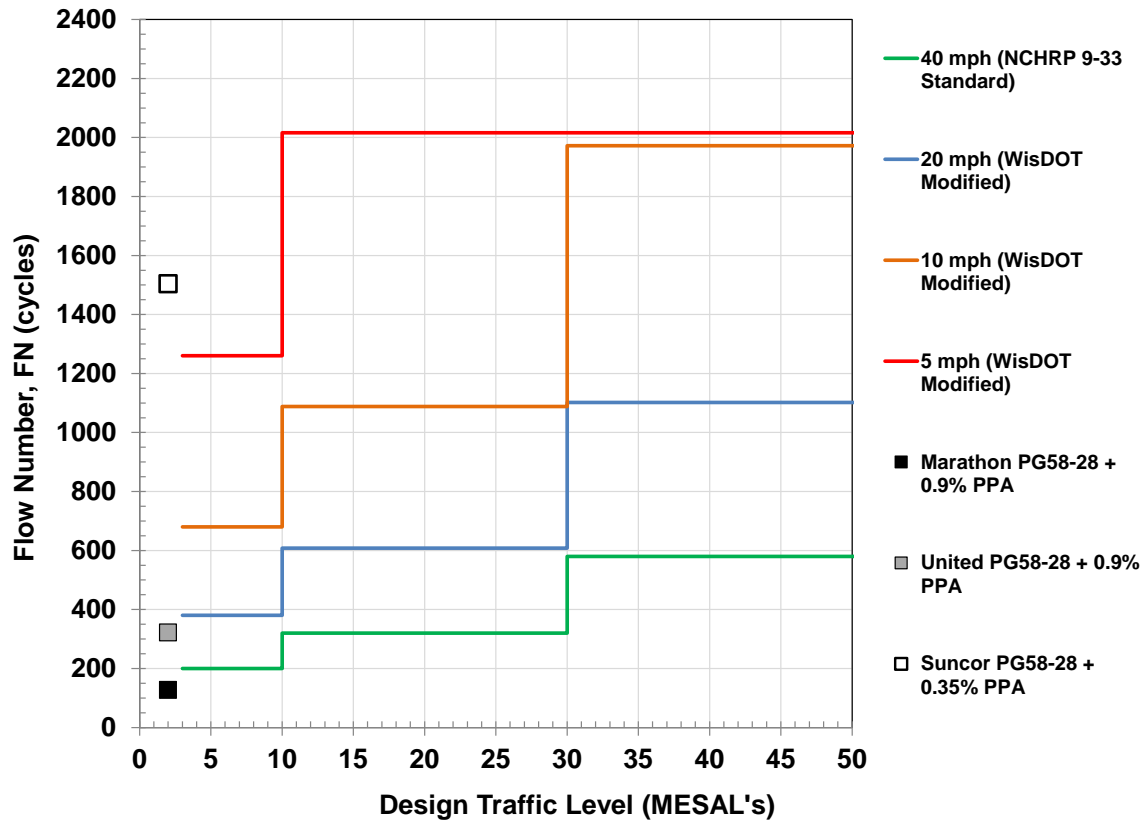
Figure 51 – Hanson Aggregates Region 2: Minimum AMPT Flow Number Results as a Function of Traffic Level and Vehicle Speed Adjustment with Laboratory Test Results

Figure 52 – Rochester (Dolomite) Region 3: Minimum AMPT Flow Number Results as a Function of Traffic Level and Vehicle Speed Adjustment with Laboratory Test Results

Figure 53 – Suit Kote Region 3: Minimum AMPT Flow Number Results as a Function of Traffic Level and Vehicle Speed Adjustment with Laboratory Test Results

Figure 54 – Hanson Aggregates Region 7: Minimum AMPT Flow Number Results as a Function of Traffic Level and Vehicle Speed Adjustment with Laboratory Test Results

Figure 55 – Morlyn Asphalt Region 9: Minimum AMPT Flow Number Results as a Function of Traffic Level and Vehicle Speed Adjustment with Laboratory Test Results

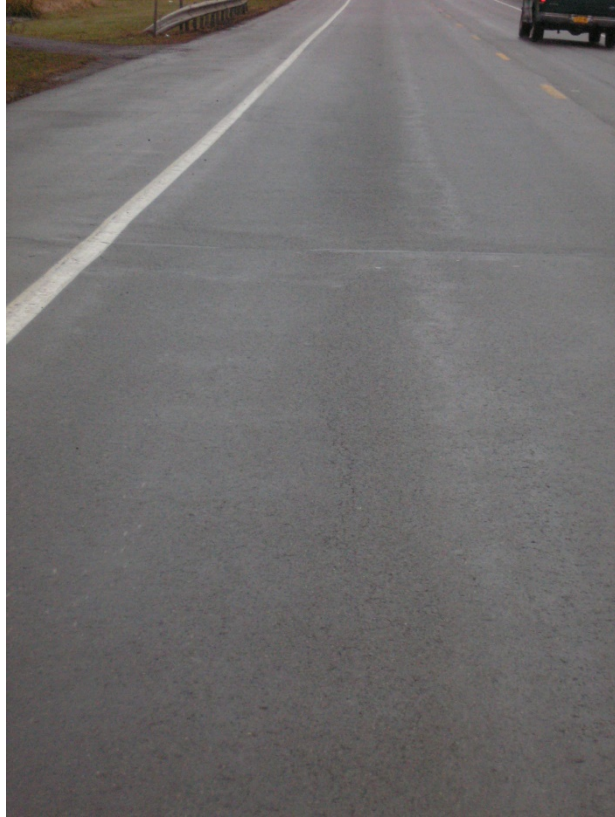
Figure 56 – “Wash-boarding” of 9.5 mm Surface Course in Region 3 (Rt 96B)
