Low-Cost Rural Surface Alternatives: Demonstration Project

**Final Report
June 2015**

IOWA STATE UNIVERSITY
Institute for Transportation

Sponsored by
Iowa Highway Research Board
(IHRB Project TR-664)
Iowa Department of Transportation
(InTrans Project 13-479)

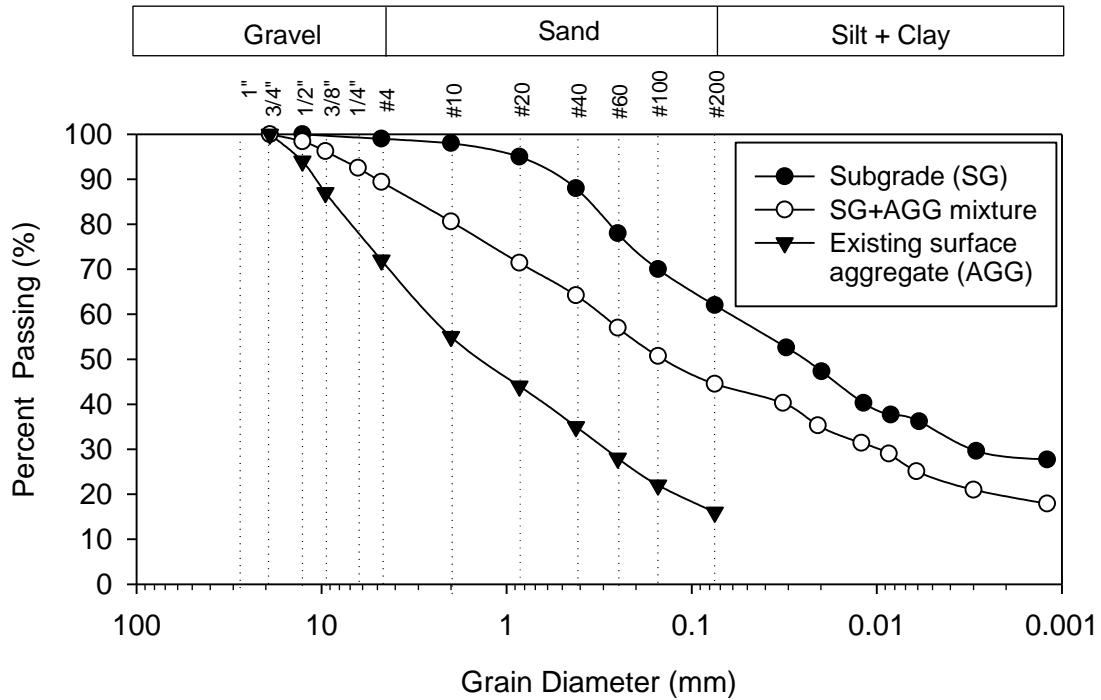
Figure 28. Particle size distribution curves of existing subgrade, surface aggregate, and subgrade-aggregate mixture

Table 5 summarizes the soil index properties of the subgrade. Hydrometer test were performed to determine the silt and clay content of the subgrade and SG+AGG mixture. The particle size distribution curves of the two materials are shown in Figure 28. The subgrade material contains 29% clay and 31% silt. The clay and silt contents of the SG+AGG mixture were 19.6% and 24.9%, respectively.
