Technical Report 15-01

Bridge-in-a-Backpack™

Task 4: Monitoring and Load Rating

Final Report – Task 4, January 2015

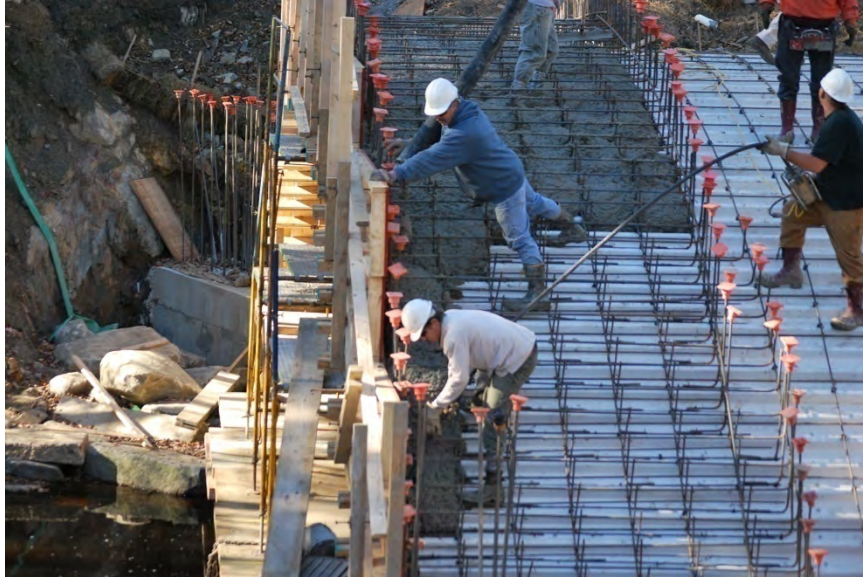
Figure 1: Concrete placement at base of headwall (Perkins Bridge)

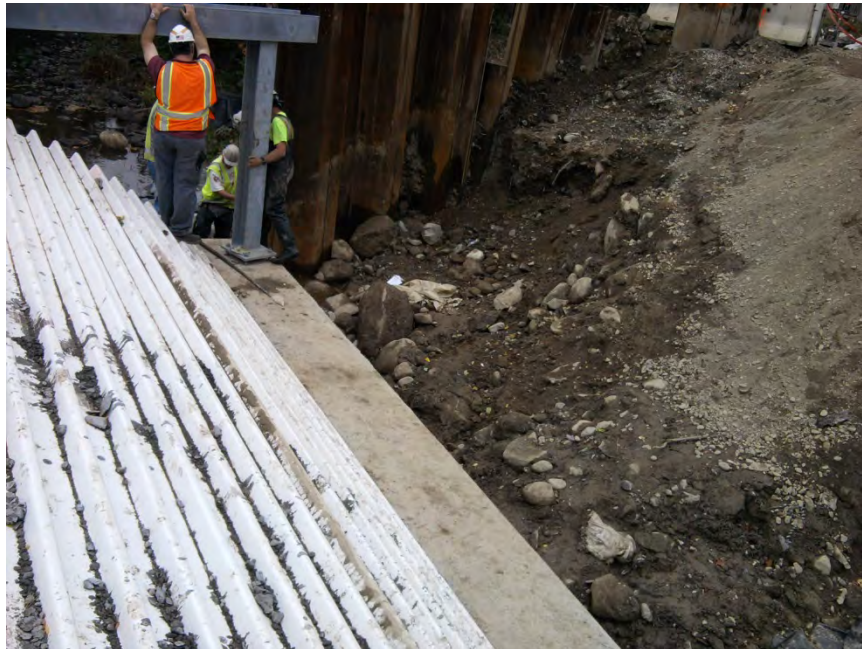
Figure 4: Headwall frame construction at Jenkins Bridge

The Jenkins Bridge was constructed in the summer and fall of 2010. This bridge is a pile supported 28ft 6inch span bridge with a skew of 19 degrees. Unlike the Royal River Bridge or the Perkins Bridge, the Jenkins Bridge in Bradley had a hybrid FRP headwall. The headwall is a concrete filled pultruded FRP panel that is self-reacting with a steel frame and tie rods. The base of the steel frame behind each wall is supported at the foundation as seen in Figure 4.

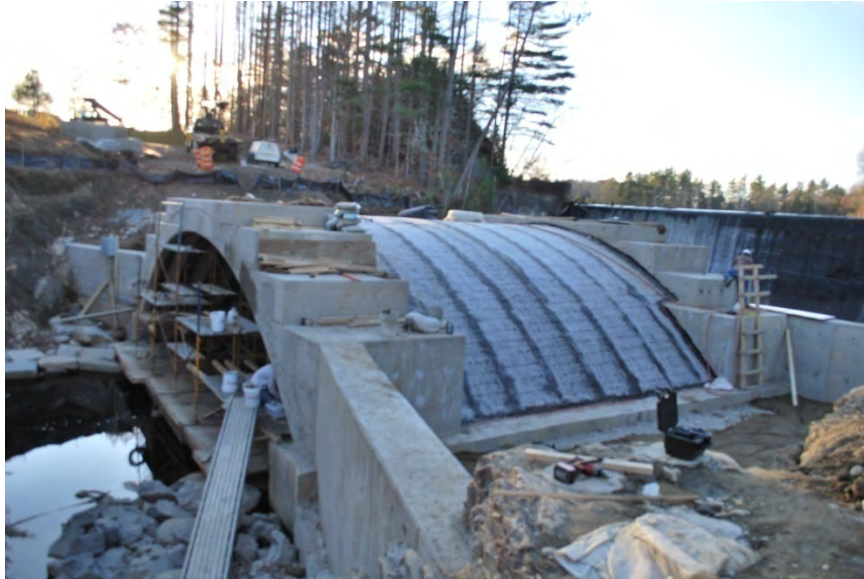
Figure 5: Perkins Bridge prior to backfilling of the superstructure

Data was collected during significant steps in the construction process including the filling of hollow tubular FRP arches with self-consolidating concrete, deck placement, and backfilling. The data included strain in the FRP tubes, vertical and horizontal deflections of discrete points in selected arches and soil pressures behind the decking. Greater details of the instrumentation and data are available in Walton 2011. Data was collected for all sensors throughout the construction and some data were not usable due to excessive noise, unreadable data levels, or other data collection problems. Clear data is presented for hollow tube fill as well as the soil pressure data up to Elevation 52 feet. The final grade at the bridge centerline is approximately 57.96 feet. The bridge can be seen during backfilling in Figure 5.

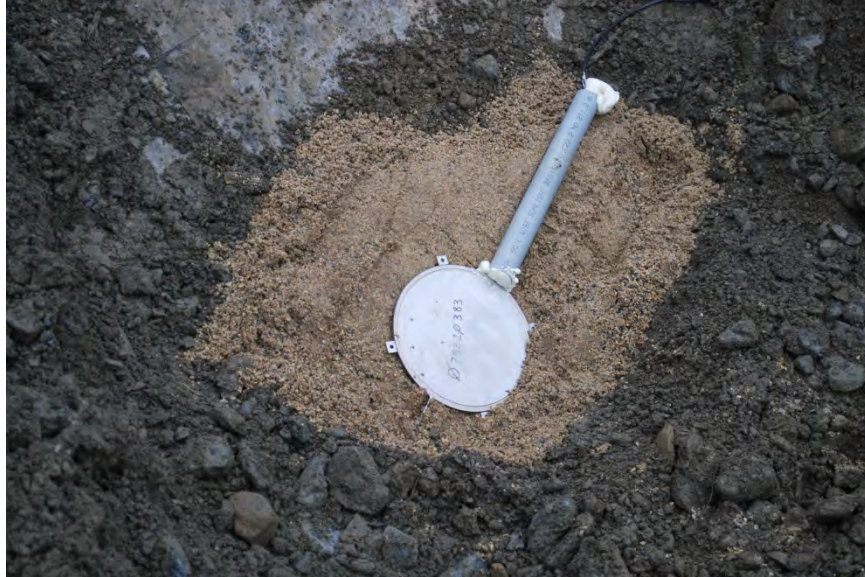
Figure 7: TPC in place prior to backfilling

Strain gages and string potentiometers were attached to selected arches under the bridge and are described in detail in Walton (2011). Total pressure cells (TPC's) were used to measure soil pressure along the centerline arch at five elevations (43ft, 46ft, 49ft, 52ft and 55ft). A diagram and photograph of a typical TPC sensor and installation buried in soil can be seen in Figure 6 and Figure 7 respectively.

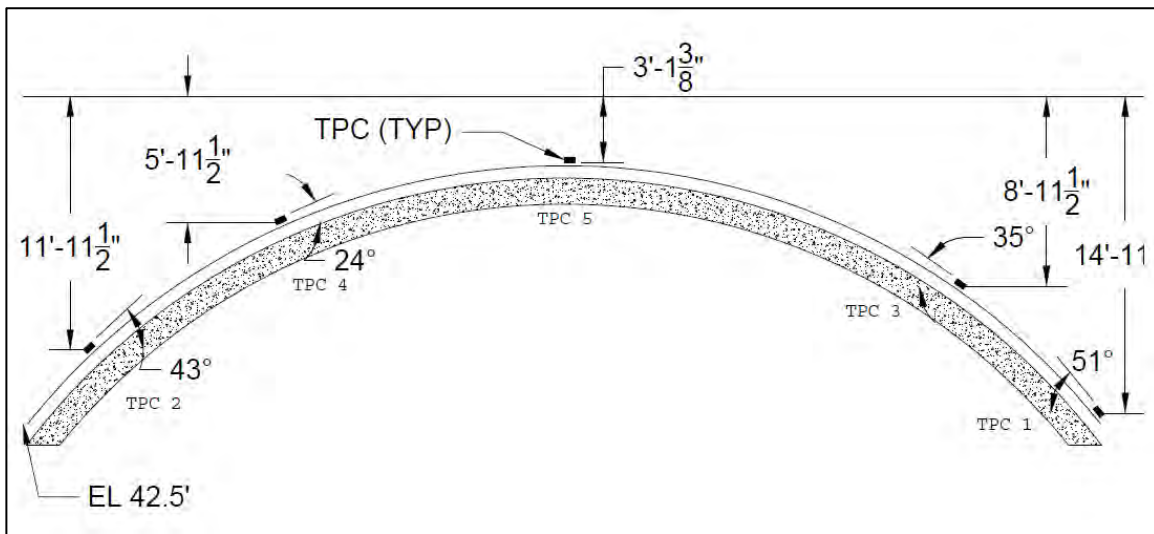
The location of each of the TPCs can be seen in Figure 8. Sensors were placed to measure radial pressures applied to the arches.

Figure 8: TPC Locations along centerline arch

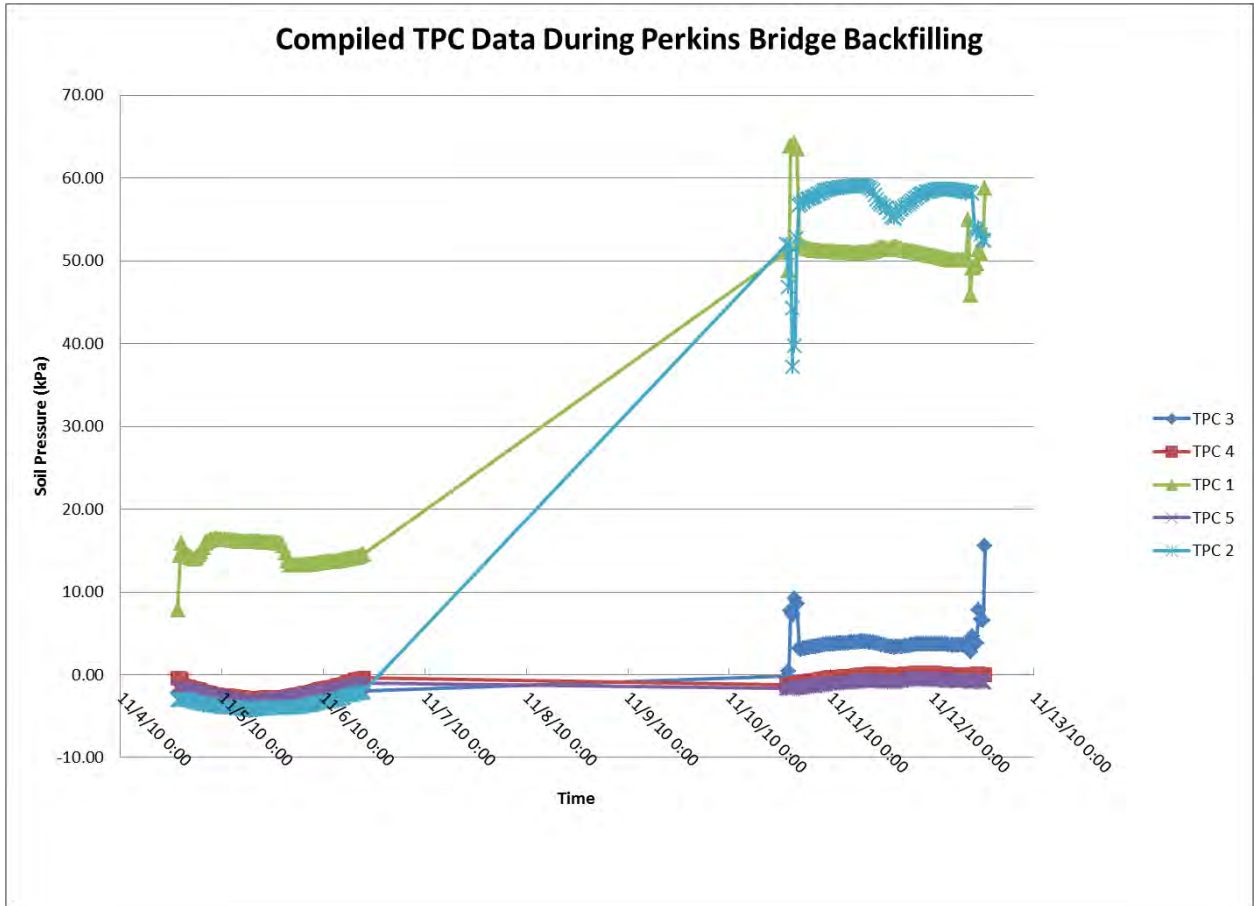
Attempts were made to collect data during concrete deck placement but data values were very small and within the noise of the signal. Soil pressure data and strain data were collected during backfilling. Usable data included TPC data up to EL 52ft. Data collection was a problem for the remaining 5 ft of cover. Predictions for each of the sensors are given in Table 1 and a plot of the soil pressure data versus time is given in Figure 13. There is no data presented between November 8th and 10th so the straight line should not be interpolated in that region.

Figure 13: Available soil pressure data from backfilling

Peak soil pressures agreed well with the predicted values for radial soil pressures for backfilling to EL 52ft. Many variables that were not captured in the predictions contribute to variations from measurements to predictions. These include non-uniform backfilling elevations, non-uniform compaction and densities around sensors, inaccurate elevations of sensors and backfill, and differences in the angle of the sensors. Predictions were made with an assumed at-rest coefficient of 0.47 and compacted soil density of 145pcf (Maine DOT 2008).

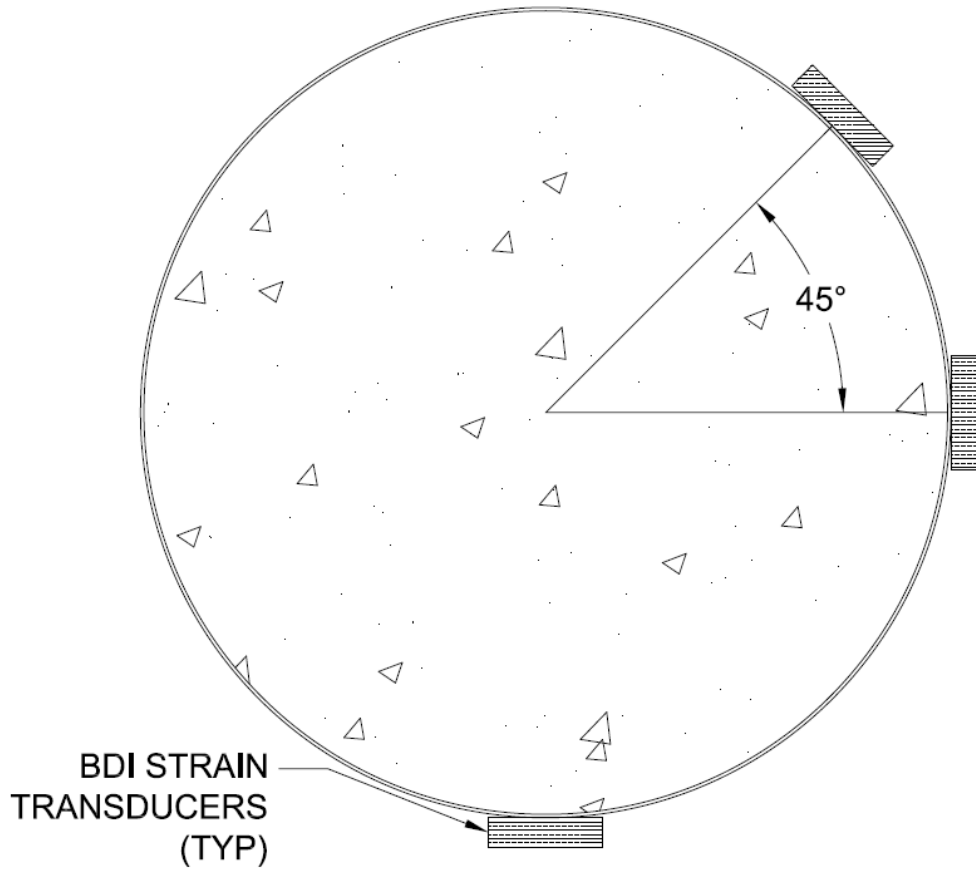
Strain and soil pressure data were collected with the newly acquired BDI wireless structural testing system and total pressure cells (TPCs) respectively. Twenty four strain gages were installed at various positions on various arches as seen in Figure 14. Each position on the arch had three gages installed at seen in Figure 15.

Figure 15 - Strain gage location in cross section

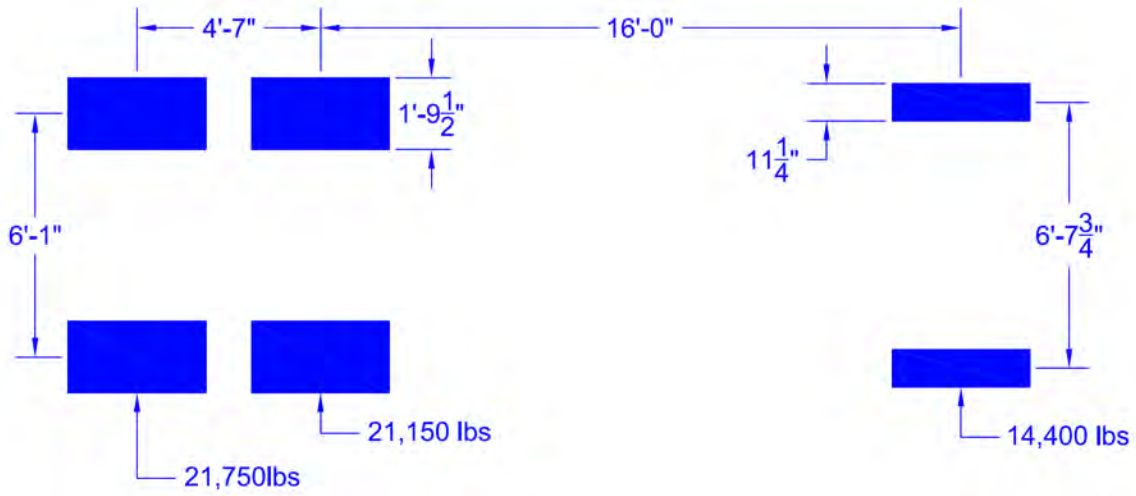
Two loaded tandem rear axle dump trucks were used to load the bridge in a series of longitudinal and static tests. Their weights and dimensions can be seen in Figure 16 and Figure 17.

Figure 16: Truck 1 (T01-214) dimensions and axle weights

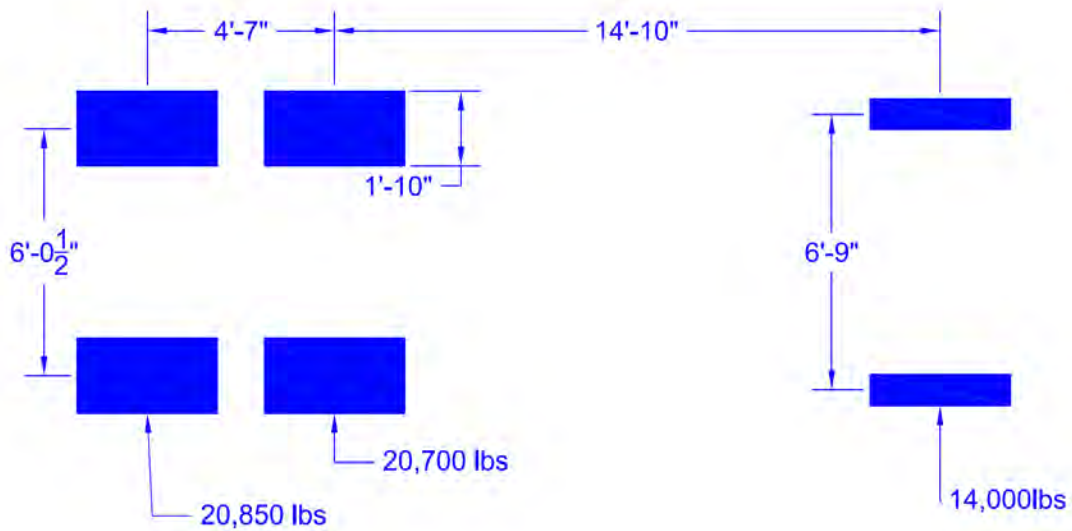
Figure 17: Truck 2 (T01-117) dimensions and axle weights

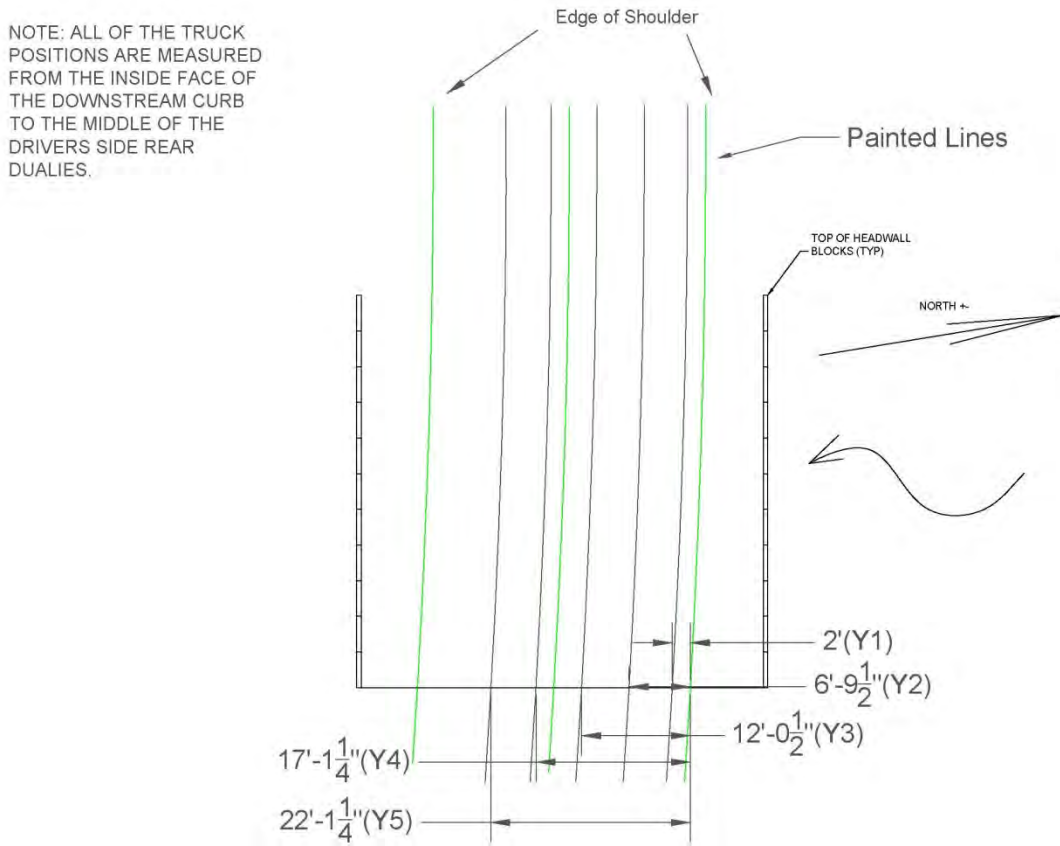
There were six rolling and five static truck positions. Five of the rolling positions (Y1 through Y5) used a single truck at different transverse positions on the bridge and their locations are shown in Figure 18. In Y6, two trucks were each placed in a lane 2 feet off centerline and driven at the same speed across the bridge. The static positions can be seen in Appendix B.

Figure 18: Truck Positions Y1 to Y5

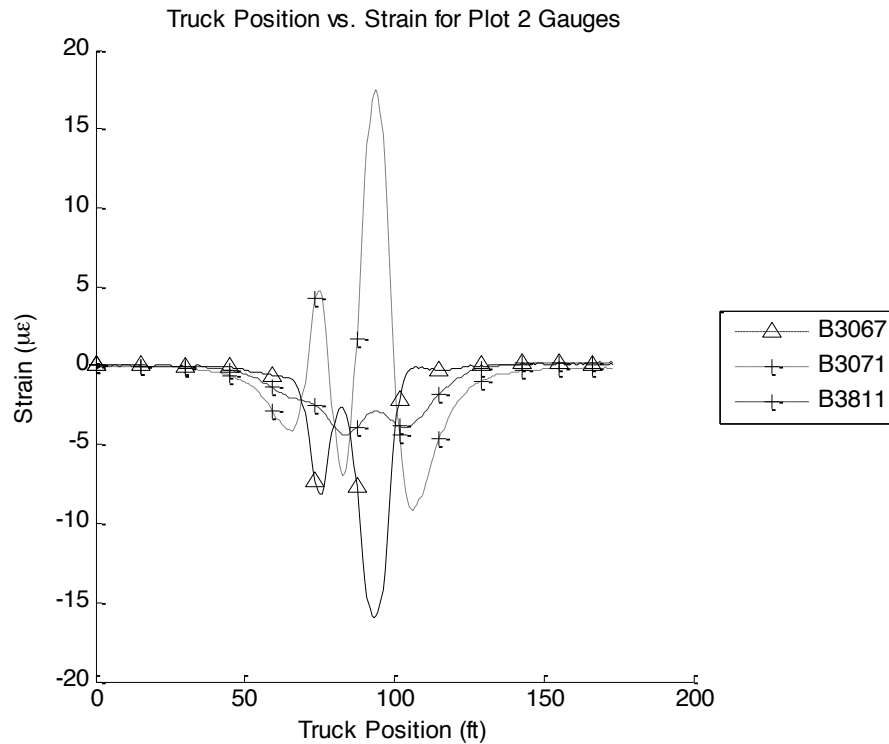
Peak strain values for each of the truck positions are given in Table 2. A peak strain value of 18.0 microstrain was recorded with both lanes loaded with one truck in each at midspan. Plots for peak strain are shown in Figure 19, Figure 20, and Figure 21.

Figure 19: Y6 Cross-Section 2 Strain Values

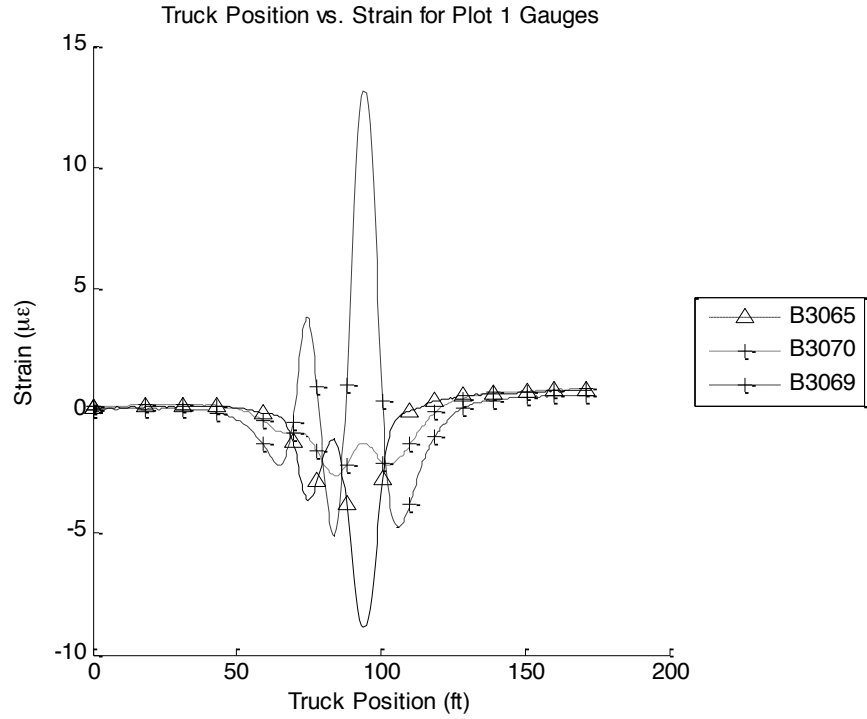
Figure 20: Y1 Section 1 Strain Values

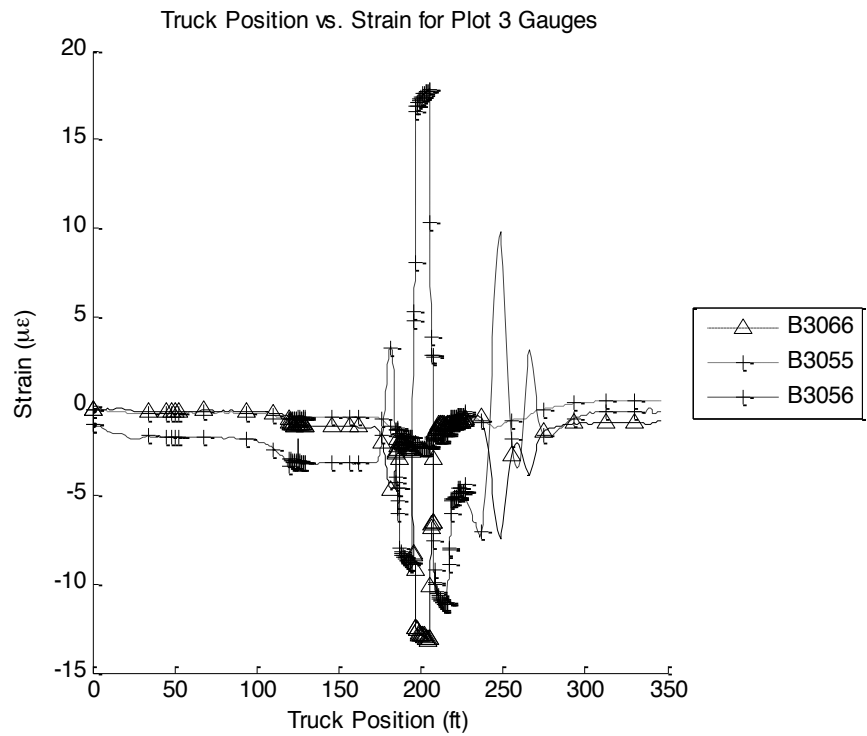
Figure 21: Y7-Y9 Section 3 Strain Values

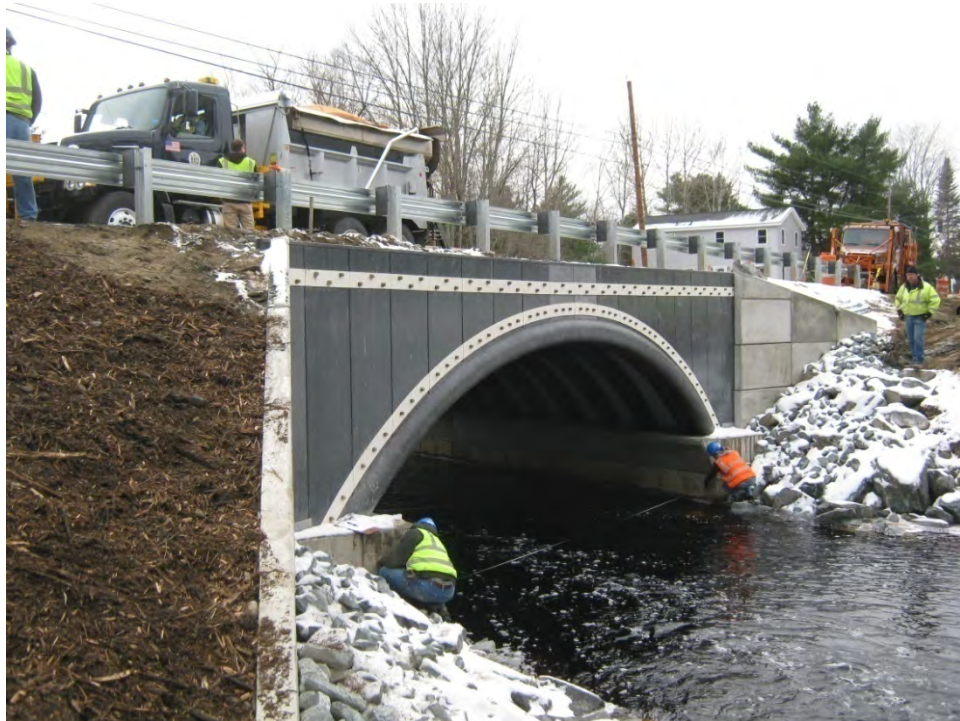
Three sets of instruments were installed on the structure. They included foil resistance strain gages to measure bending strains in the FRP tubes, vibrating wire (VW) total pressure cells (TPCs) to measure soil pressures behind the foundation during construction and during loading, and PK nails on the exposed foundation to measure any foundation movements. A steel surveyors tape was used to take measurements between PK nails. Figure 22 shows the PK nail measurement during bridge loading. PK nail data from before and after backfilling is presented with the live load test data.

Figure 22: PK Nail measurements during loading

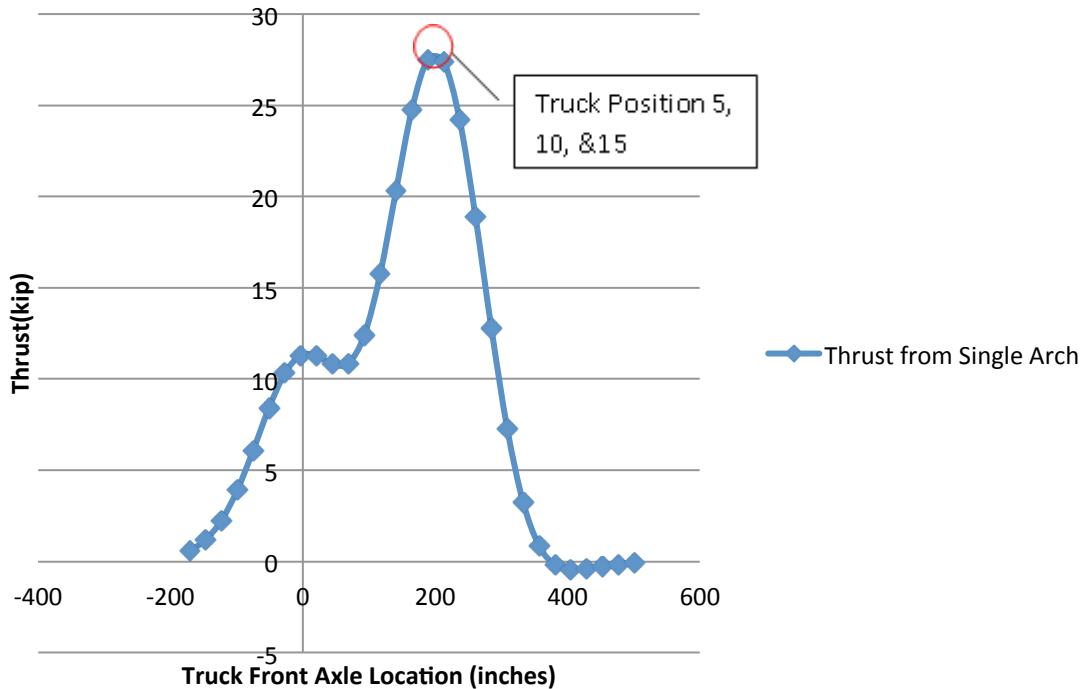
Figure 24: Influence line for thrust from single arch

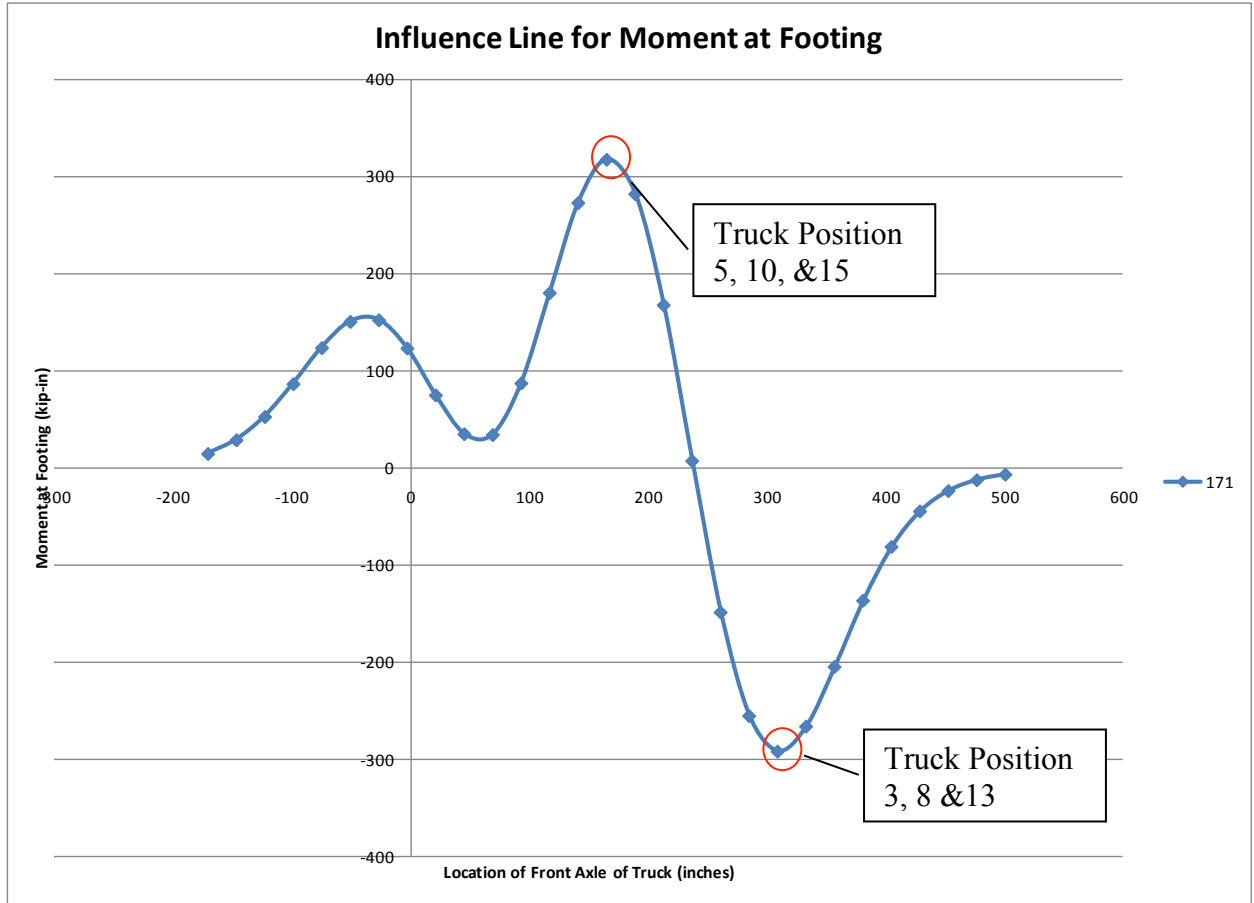
Figure 25: Influence Line for Moment at Footing of Arch

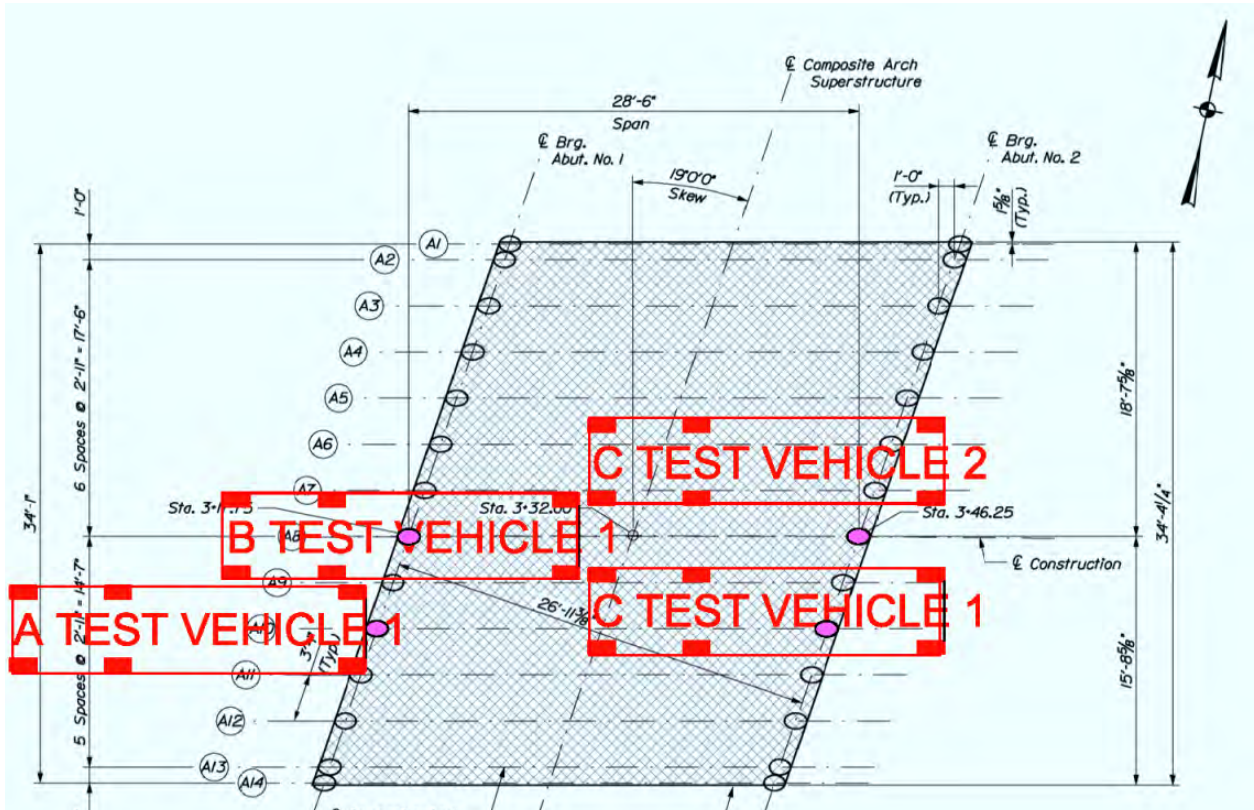
Approximate lane positions are also shown graphically in Figure 26. Single truckload cases are shown A and B transverse lane positions. The trucks were side by side in the

third transverse lane positions as shown in figures label C Test Vehicle in Figure 26. Predicted live load strains are shown in Table 4.

Figure 26: Truck lane positions (3) during testing

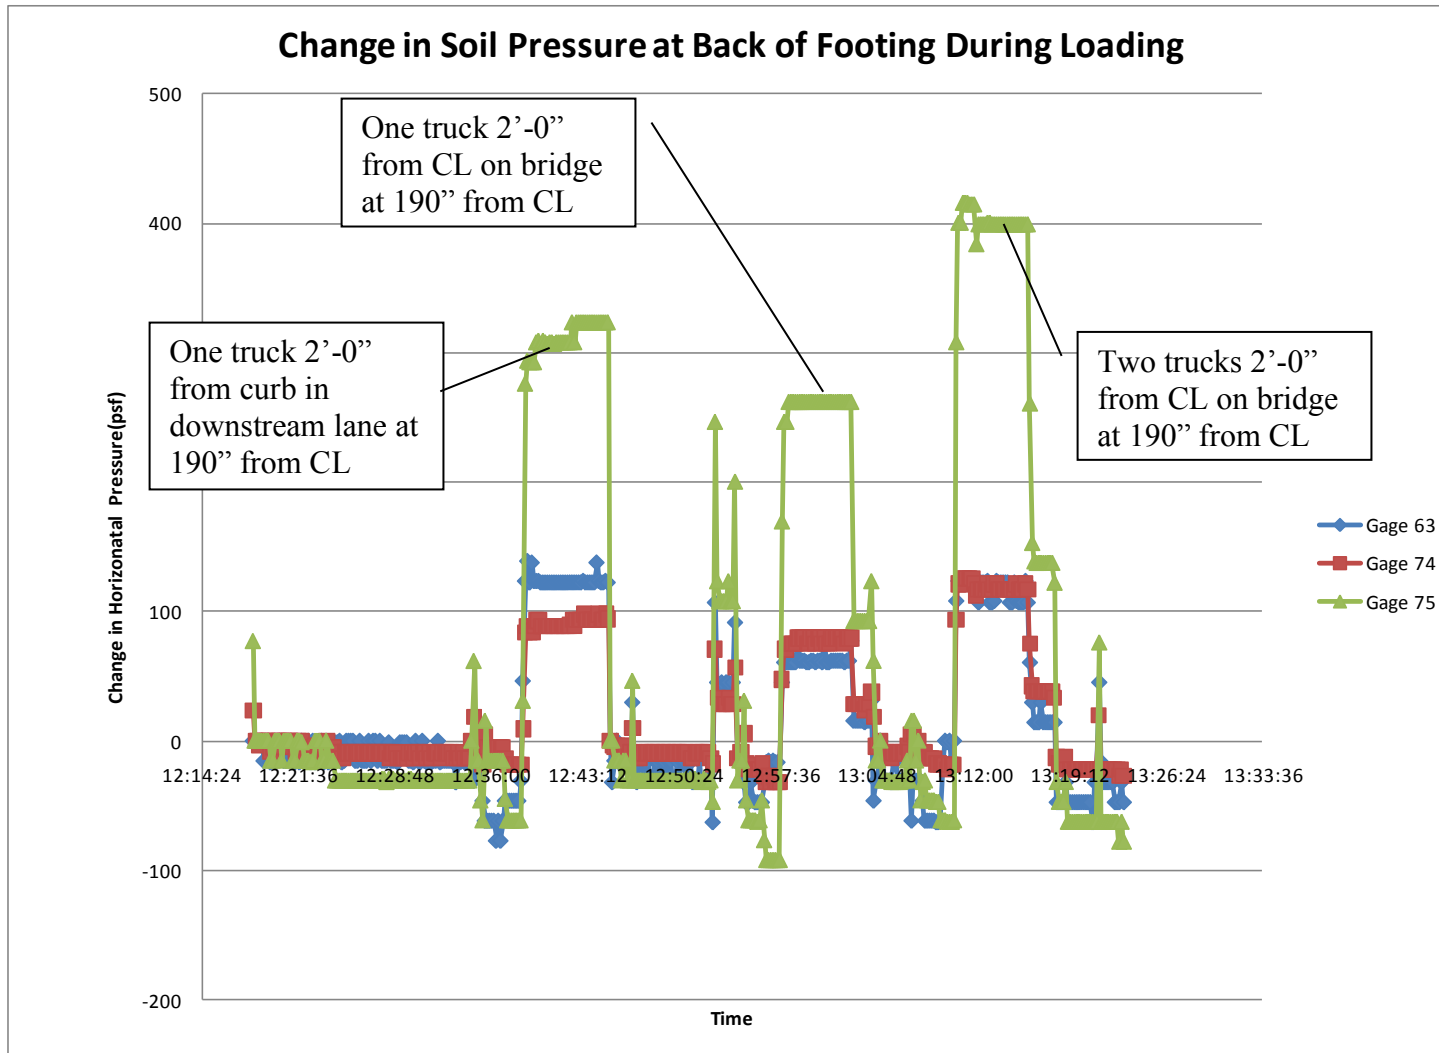
In general, some outward movement of the foundations was measured (peak of 0.025ft relative spreading of both footings) along with some inward movements of other sections of similar magnitude (.03ft). Peak soil pressure measurements with two lanes loaded was 400 psf.

Figure 27: Recorded change in soil pressure (thrust) from TPCs behind foundation

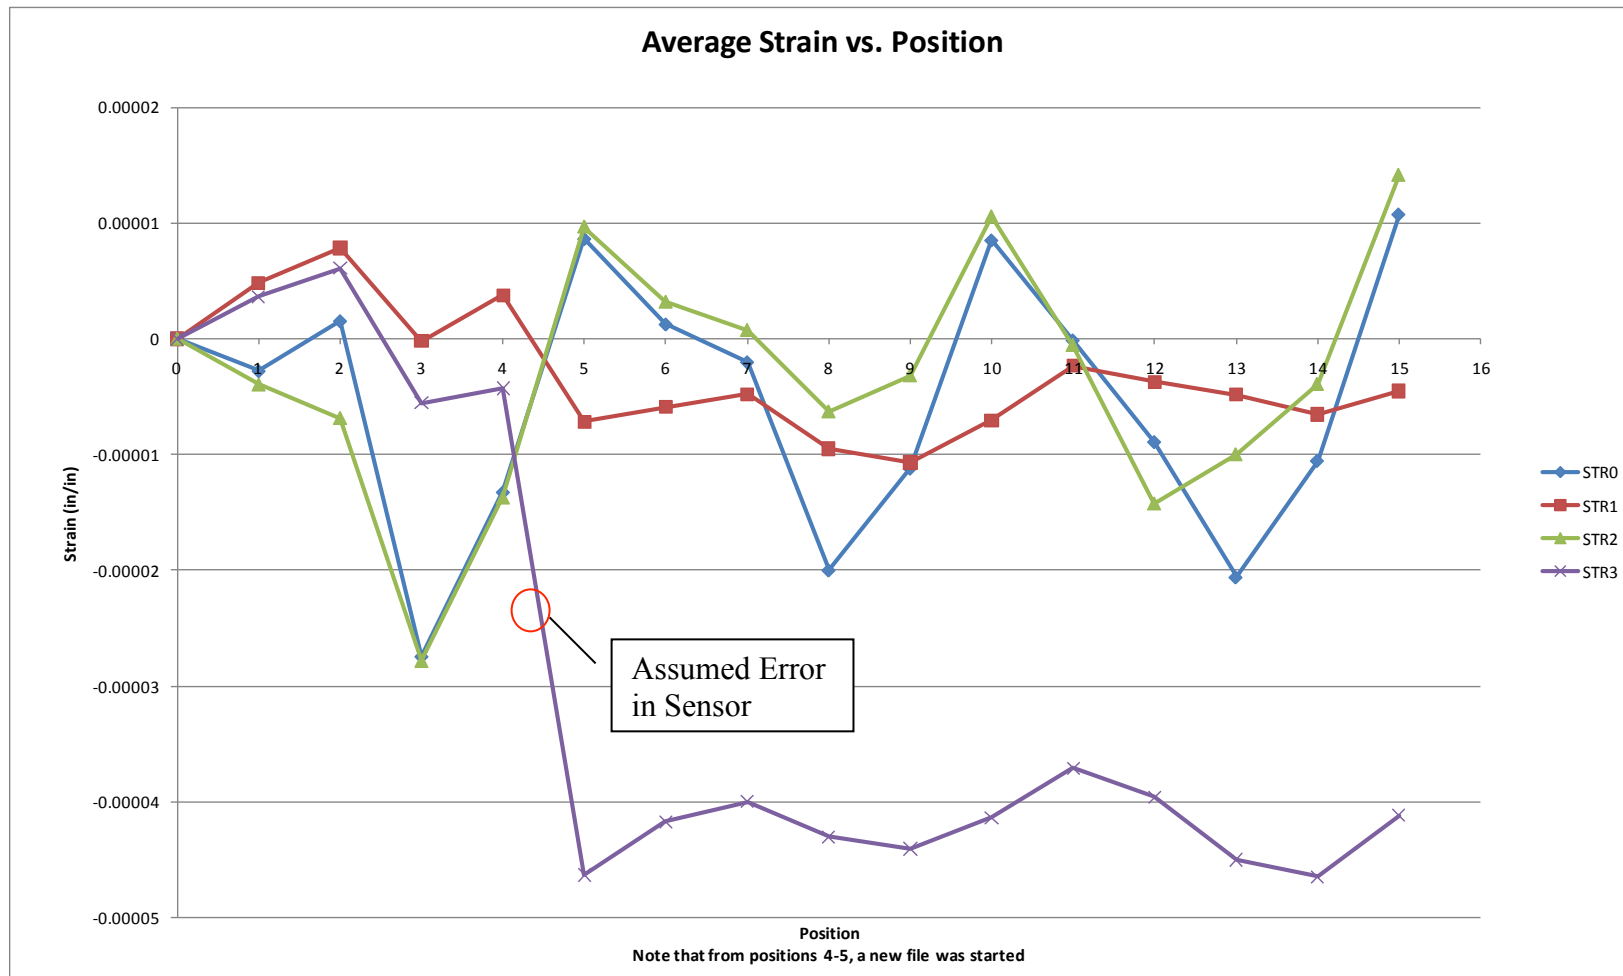
Figure 28: Plot of strain values during bridge loading

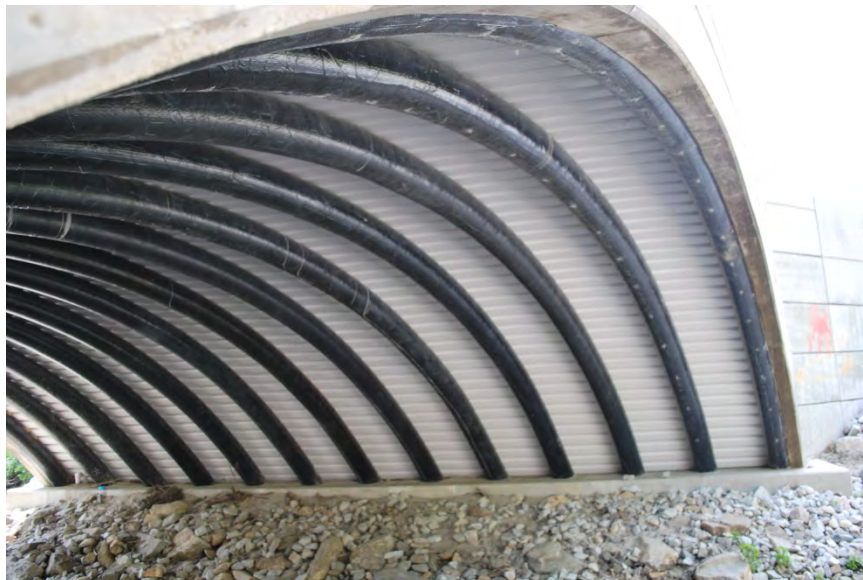
A visual inspection was conducted looking mainly at the FRP tubular arches, decking and headwalls. An overall view of the underside of the bridge is given in Figure 29.

Figure 29: Underside of bridge

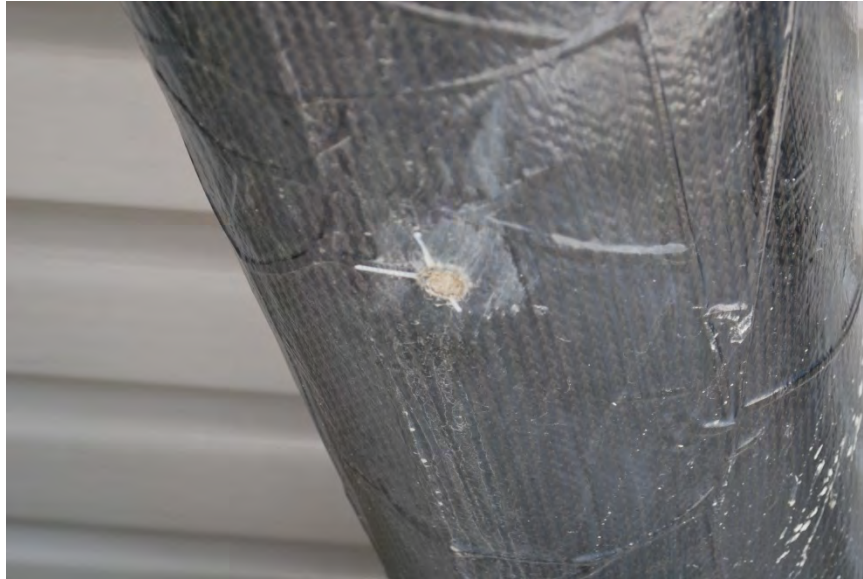
A very noticeable detail is the holes used to attach the formwork for the headwall concrete detail. It is understood by UMaine that these holes were allowed to be drilled and then plugged after formwork removal as seen in Figure 30. These holes can be expected to negatively impact strength and durability of the hybrid FRP member to an unknown degree but if other details are available it is recommended not to use this method in the future.

Figure 30: Plugged hole in tube

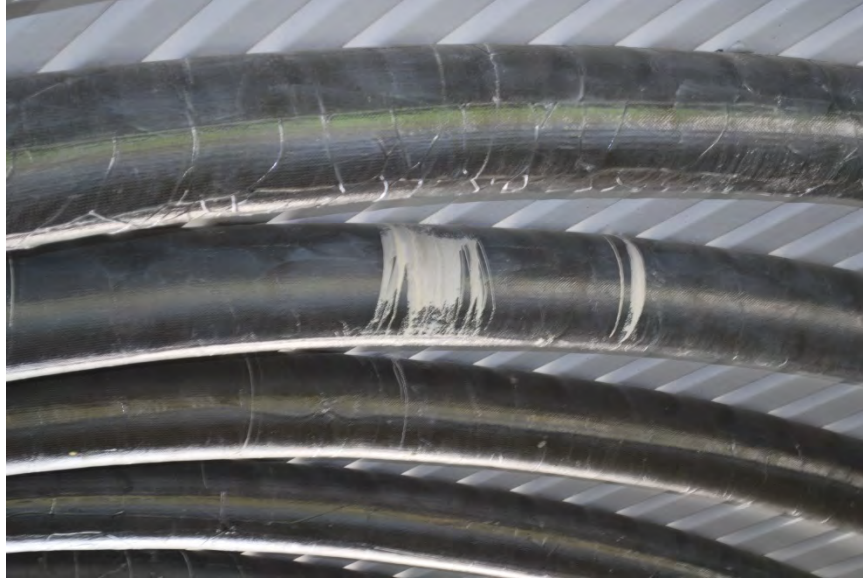
Concrete spillage around the filling hole has been observed in most of the bridges constructed to date to varying degrees (Figure 31). Though mostly cosmetic it is expected minor steps can be taken during placement of the deck to mostly eliminate this and keep SCC in the tube or on the deck.

Figure 31: Concrete leakage near crown

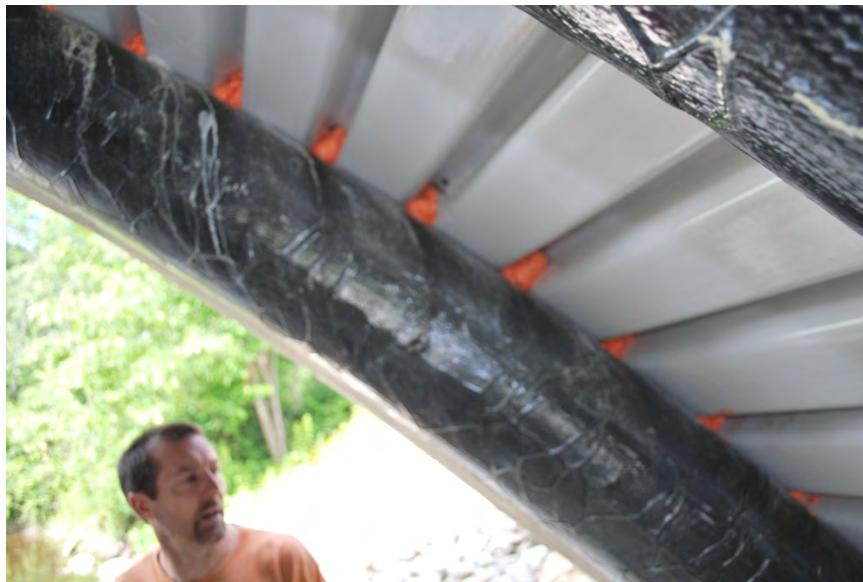
The detail of the headwall attachment and closure around the exterior arch required concrete placement up to the end of the corrugated FRP. In this case orange expanding foam was used to seal the underside of the corrugations. Alternative details or colors would help the aesthetics of the bridge as seen in Figure 32.

Figure 32: Colorful foam backer

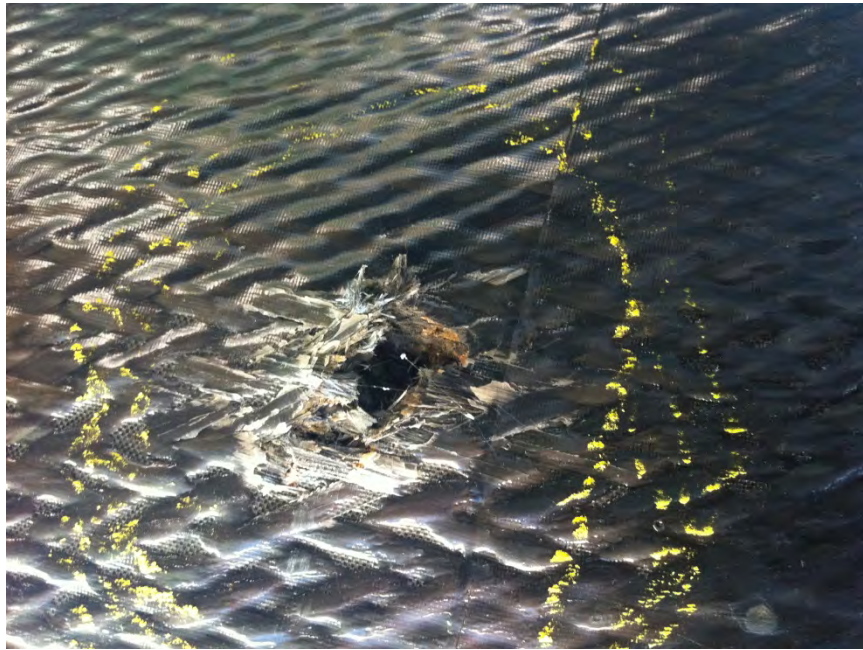
Figure 33: Hole in tube

High water events were noticed during construction and have occurred at this site since construction was completed. A puncture was noticed in one of the tubes as seen in Figure 33. This was in the first upstream tube. It was marked and mentioned to AIT engineers. Debris was also seen in the heavy rip rap, higher than expected as seen in Figure 34.

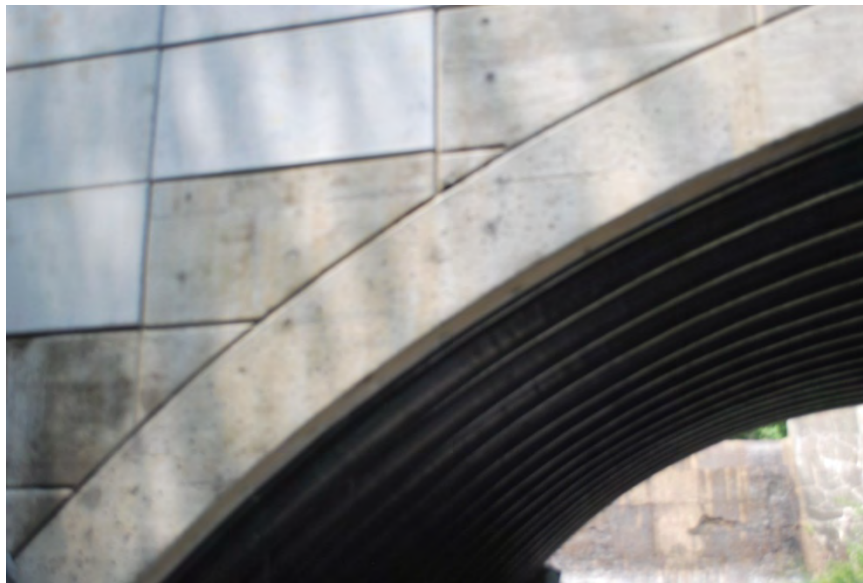
Figure 35: Concrete discoloration between T-Wall and CIP concrete

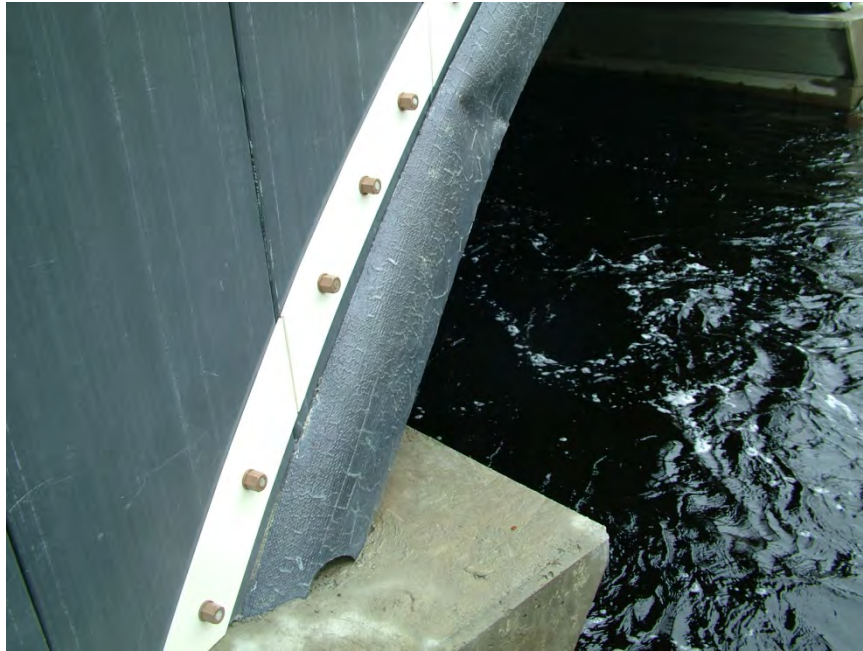
The exterior FRP tube has an additional tube bonded to it to support the base of the headwall and is the only critical point for this inspection. Shortly after construction of the bridge, high water and debris caused some damage as seen in Figure 36. This hollow tube is susceptible to damage, but was also easily repaired as seen in Figure 37. There was no apparent damage to the FRP tubes, decking or debris seen between the tubes (Figure 38).

Figure 36- Damaged outside arch (2011)

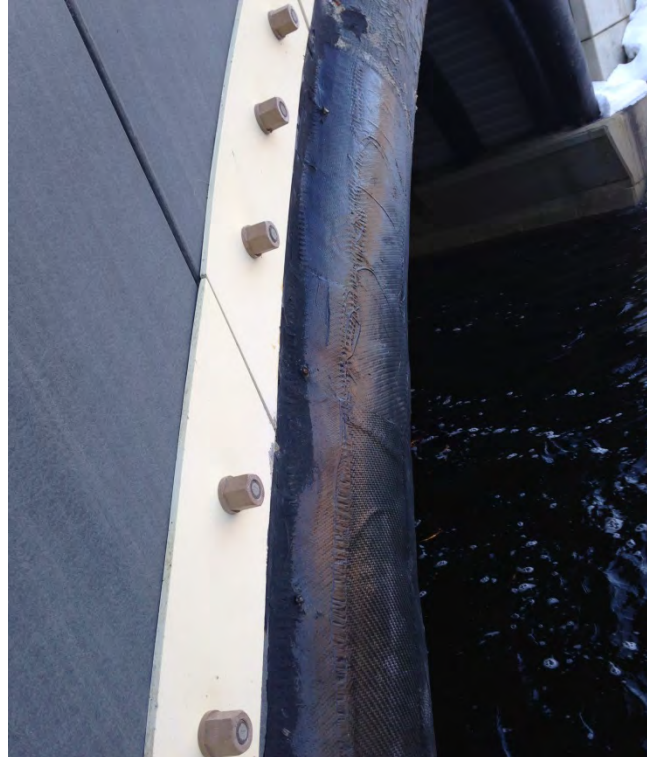
Figure 37 - Close up View of Repair on Upstream Tube (2014)

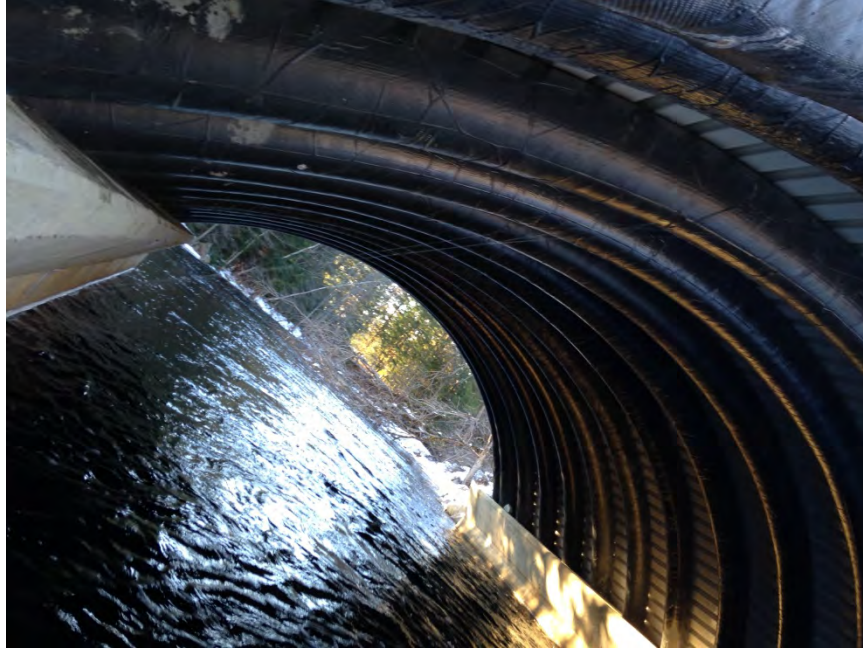
Figure 38 – Underside of Jenkins Bridge (2014)

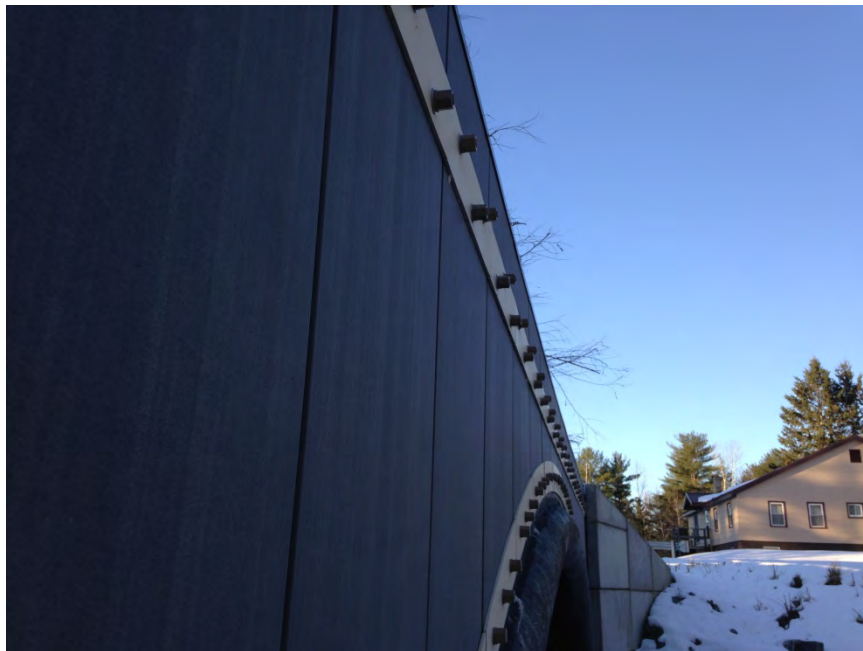
Figure 39 - Headwall of Jenkins Bridge (2014)

The self reacting FRP headwall is attractive and was inspected for deflections. None were seen visually (Figure 39). Some large vegetation was seen on the bridge span near the headwall that could be addressed in the future as seen in Figure 40.
