Technical Report 15-01

Bridge-in-a-Backpack™

Task 4: Monitoring and Load Rating

Final Report – Task 4, January 2015

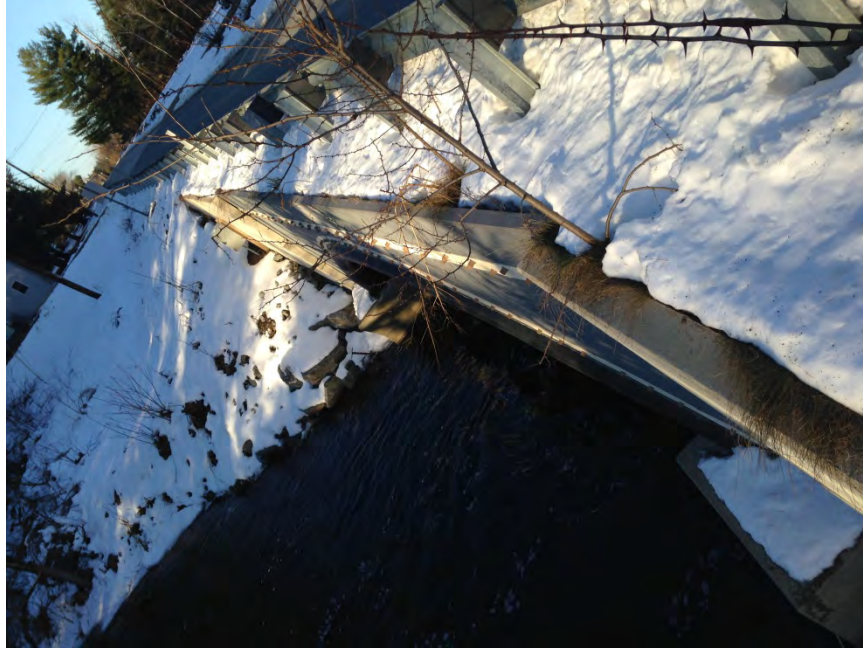
The self reacting FRP headwall is attractive and was inspected for deflections. None were seen visually (Figure 39). Some large vegetation was seen on the bridge span near the headwall that could be addressed in the future as seen in Figure 40.

Figure 40 - Vegetation Behind Headwall of Jenkins Bridge
