## Transportation Research Division

*Experimental Evaluation and Design of  
Unfilled and Concrete-Filled FRP  
Composite Piles*

*Task 3 - FRP Composite Pile Flexural  
Testing*

*Final Report – Task 3, June 2014*

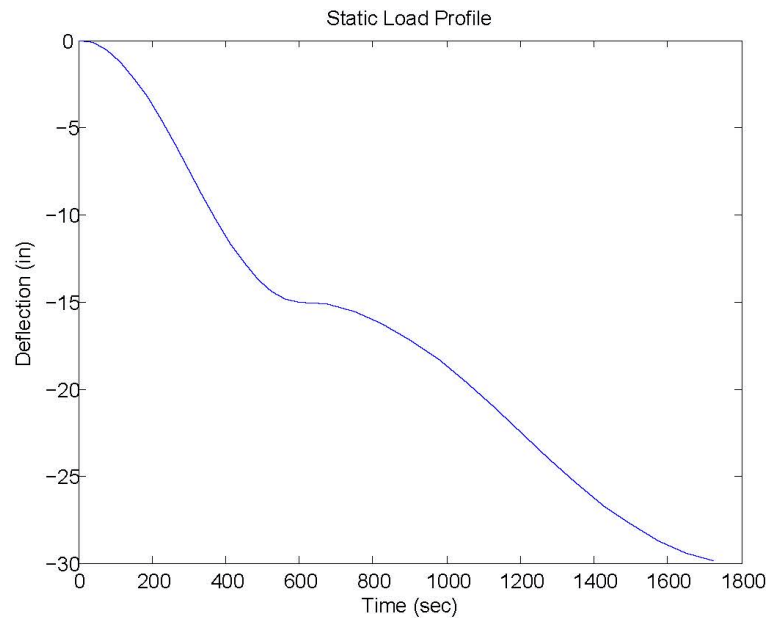
Figure 3: Static Loading Profile

Static piles were loaded to failure by controlling the rate of displacement. Piles were loaded at a rate of 1.5 inches per minute for the first 15 inches of deflection. Then the loading rate was

transitioned to 1 inch per minute using a sinusoidal ramp. A plot of the loading profile can be seen in Figure 3.

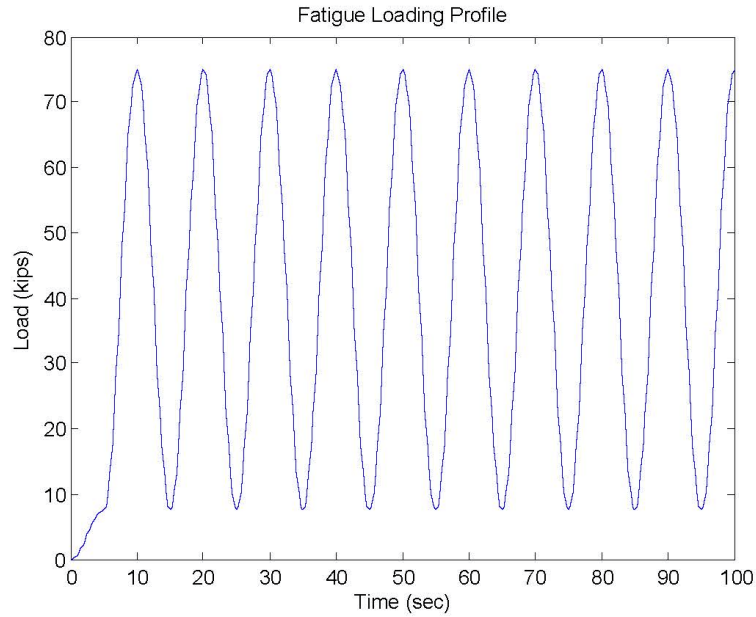
Figure 4: Cyclic Loading Profile

Load-cycled piles were loaded to 50 percent of the average ultimate load of the previously tested piles. This load was determined to be 75 kips. The piles were cycled between 7.5 kips and 75 kips for 10,000 cycles at a frequency of 0.05 Hz. After 10,000 cycles, the piles were rotated 180 degrees about their longitudinal axis and subjected to an additional 10,000 cycles. Then, the piles were tested statically to failure. Strain and displacement measurements were taken at the maximum and minimum load of each cycle. Data was collected over the entire loading cycle for 10 cycles every 1,000 cycles. A plot of the loading profile can be seen in Figure 4.

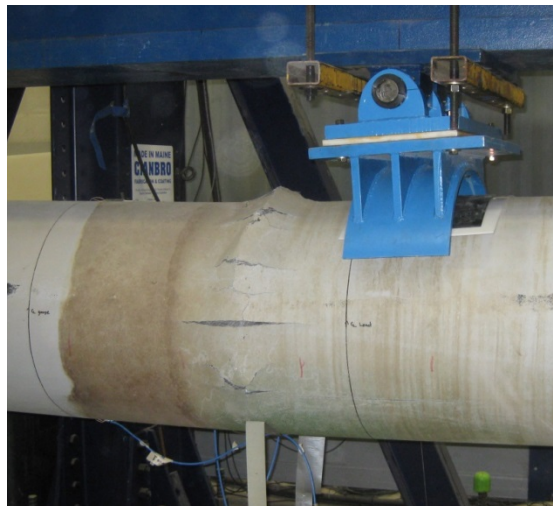
Figure 14: Compression Failure of Pile B-8PB

Pile B failed by compression at a load of 109 kips and a corresponding moment of 599 kip\*ft. It is believed that the layers of E-glass reinforcement delaminated, and then buckled locally. The failure occurred approximately 1 foot from the nearest loading point (inside the constant moment region) can be seen in Figure 14. Upon further investigation, this pile contained both folds in the reinforcing fabric and pockets of high resin content located near the failure. This is pictured, and discussed further in Section 6.4.

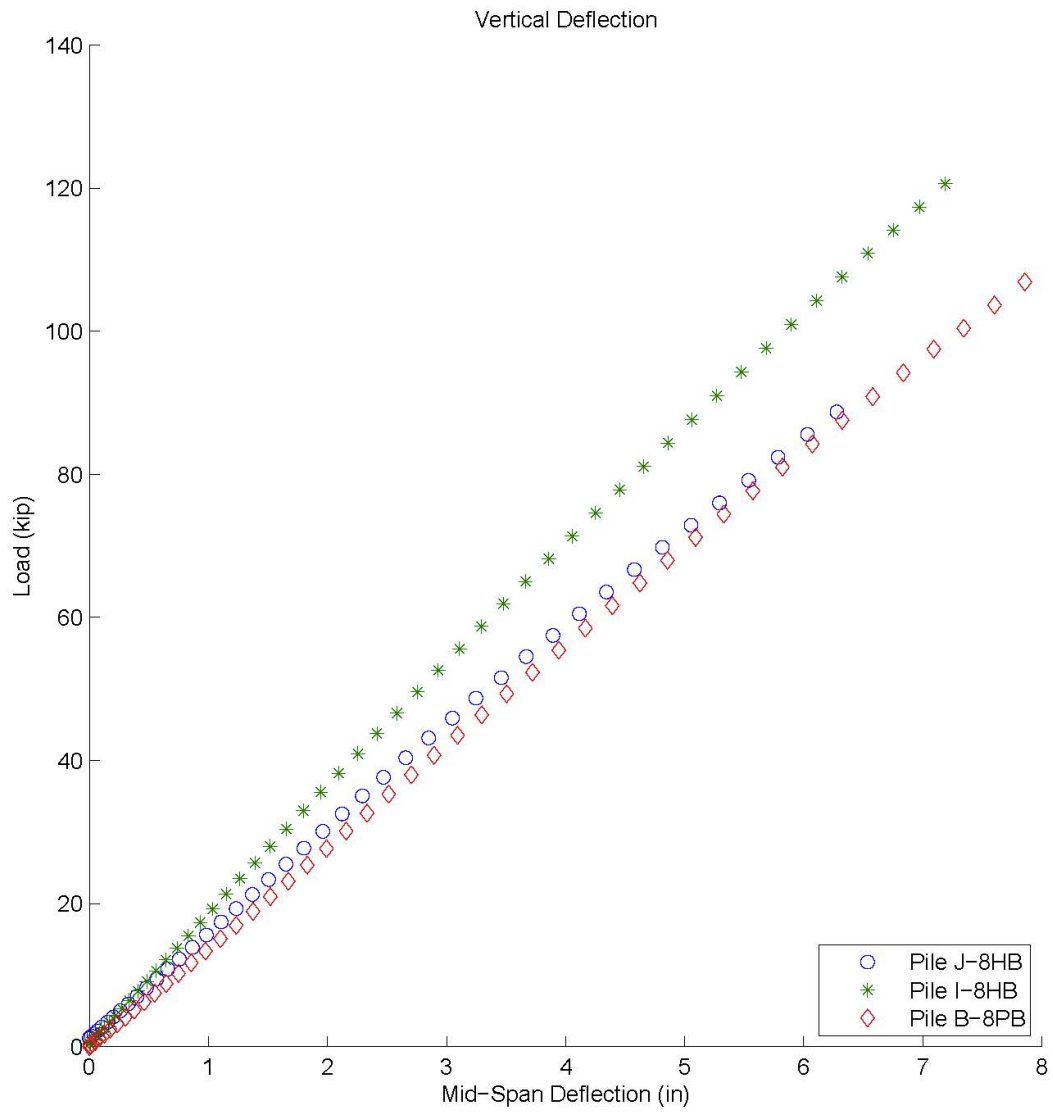
Figure 15: Load-Deflection of Hollow Piles

The following plots compare the flexural test results of the hollow piles. Load-deflection relationships can be seen in Figure 15, and moment-curvature relationships can be seen in Figure 16.

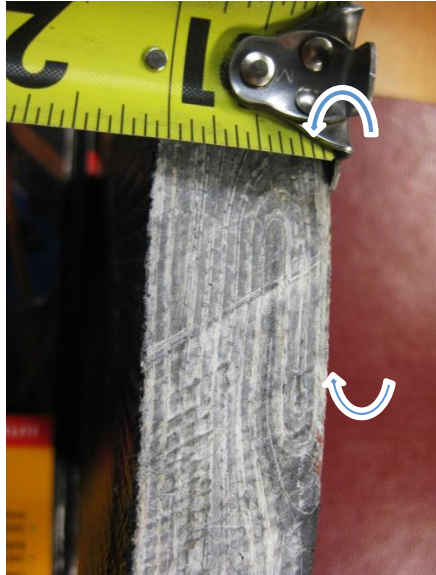
of Pile B

Defects in the pile could create stress concentration as a load is distributed through the pile. This could be caused by folds in the reinforcing fabric, as seen in Figure 17, or misalignment of fibers, as seen in Figure 18. The misalignment of fibers in Figure 18 led to a reduction in coupon tensile strength of 34.6 percent coupled with 3000 hours of water absorption conditioning at 100 degrees Fahrenheit. Similar coupons without misaligned fibers and identical conditioning lost 13.1 percent of their capacity compared to baseline tests.

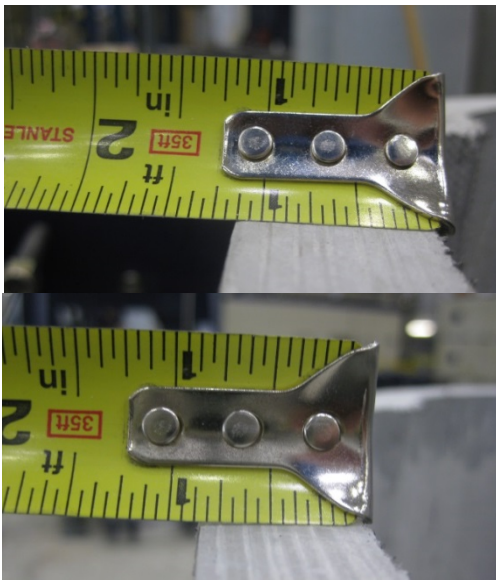
Figure 19: Variation in Thickness

Variations in wall thickness could represent areas with less reinforcing than others. This may be caused by shifting of the reinforcing fabric during fabrication, as seen in Figure 19, or areas of high resin content, as seen in Figure 20.

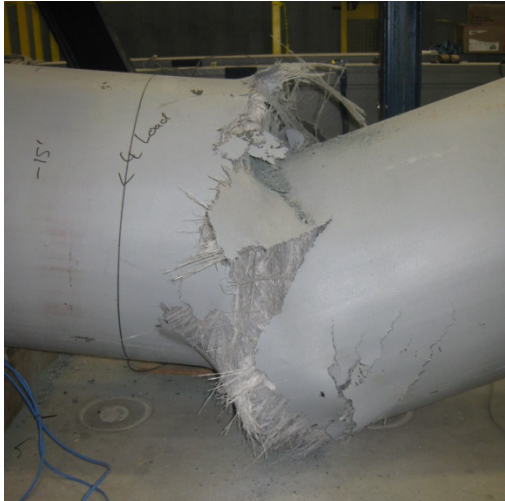
Figure 21: Tension Failure of Pile G-4FB

Pile G failed at a load of 200 kips and a corresponding moment of 1,099 kip\*ft. when fibers on the tension face appeared to rupture. The failure occurred approximately 1 foot from the nearest loading point (outside the constant moment region) and can be seen in Figure 21, and Figure 22.

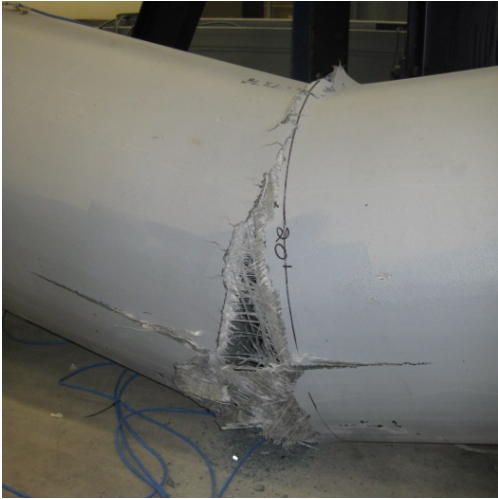
Figure 23: Tension Failure of Pile H-4FB

Pile H failed at a load of 119 kips and a corresponding moment of 652 kip\*ft. when fibers on the tension face appeared to rupture. The failure occurred at the midspan of the pile and can be seen in Figure 23, and Figure 24.

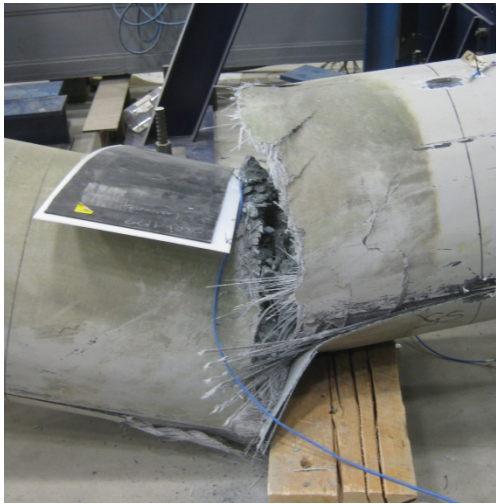
Figure 25: Tension Failure of Pile A-4FB

Pile A failed at a load of 174 kips and a corresponding moment of 958 kip\*ft. when fibers on the tension face appeared to rupture. The failure occurred approximately 2 feet from the nearest loading point (inside the constant moment region) and can be seen in Figure 25, and Figure 26.

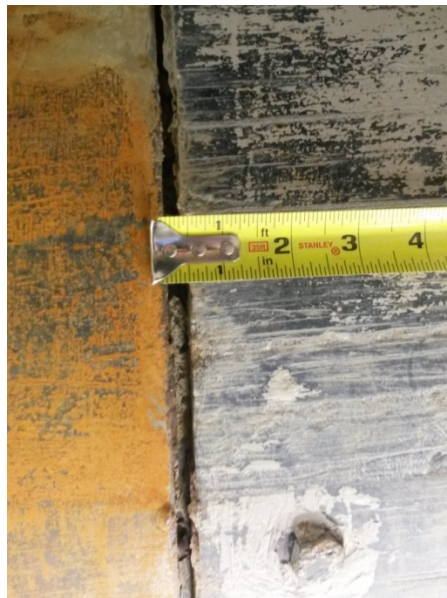
Figure 29: Loss of Composite Action in Pile A

When this compression wrinkle occurred, the concrete moved with respect to the shell of the pile. The concrete displacement measurement during the test was unreliable, but the concrete displacement measured after the test was 0.245 inches at the end of the pile. The movement at the end of the pile can be seen in Figure 29.

Pile A and C both lost composite action during flexural testing. These were the only piles driven while filled with concrete. Pile A was filled with concrete prior to initial driving and was not restruck. Pile C was initially driven hollow then filled with concrete prior to being restruck. It is believed that tensile forces during driving caused cracking in the concrete, which created a failure plane for the concrete to slide at. It is also possible that cracks through the cross section of Pile C are the result of rotating the pile 90 degrees for its third test.

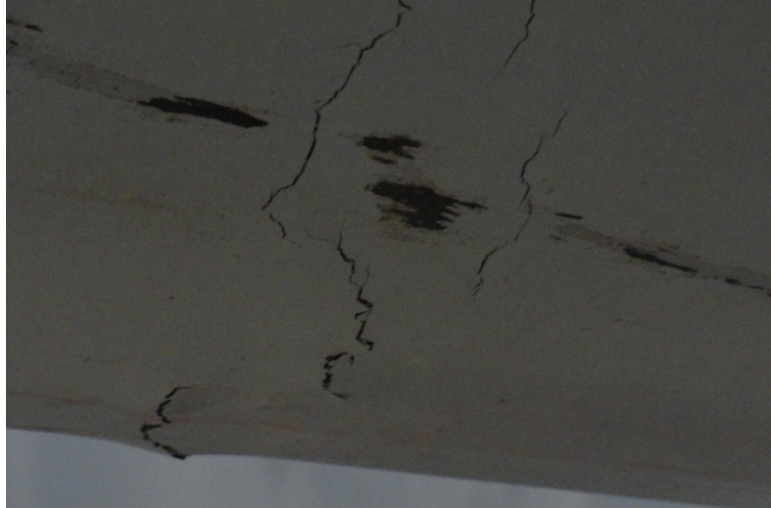
Figure 30: Cracks Due to Cyclic Loading

Pile E was cycled according to the procedure described in 4.2. During cyclic loading, Pile E developed small cracks along the tension face. These cracks can be seen in Figure 30.

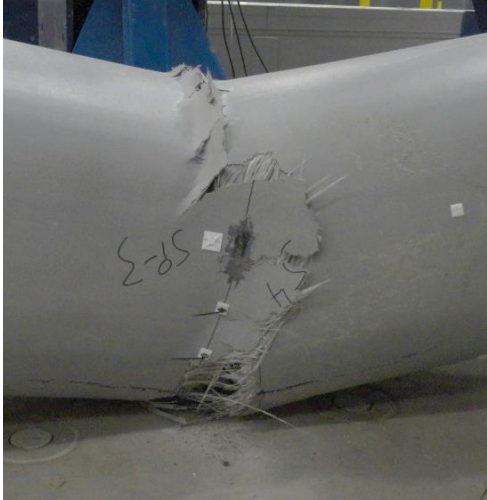
Figure 31: Tension Failure of Pile E-4FB

During the static test to failure after cyclic loading, Pile E initially showed a compression failure at 158 kips and the load dropped to 149 kips. The load started to rise again to 158 kips and a corresponding moment of 871 kip\*ft. where the pile appeared to fail in tension. The failure occurred at the midspan of the pile and can be seen in Figure 31 and Figure 32.

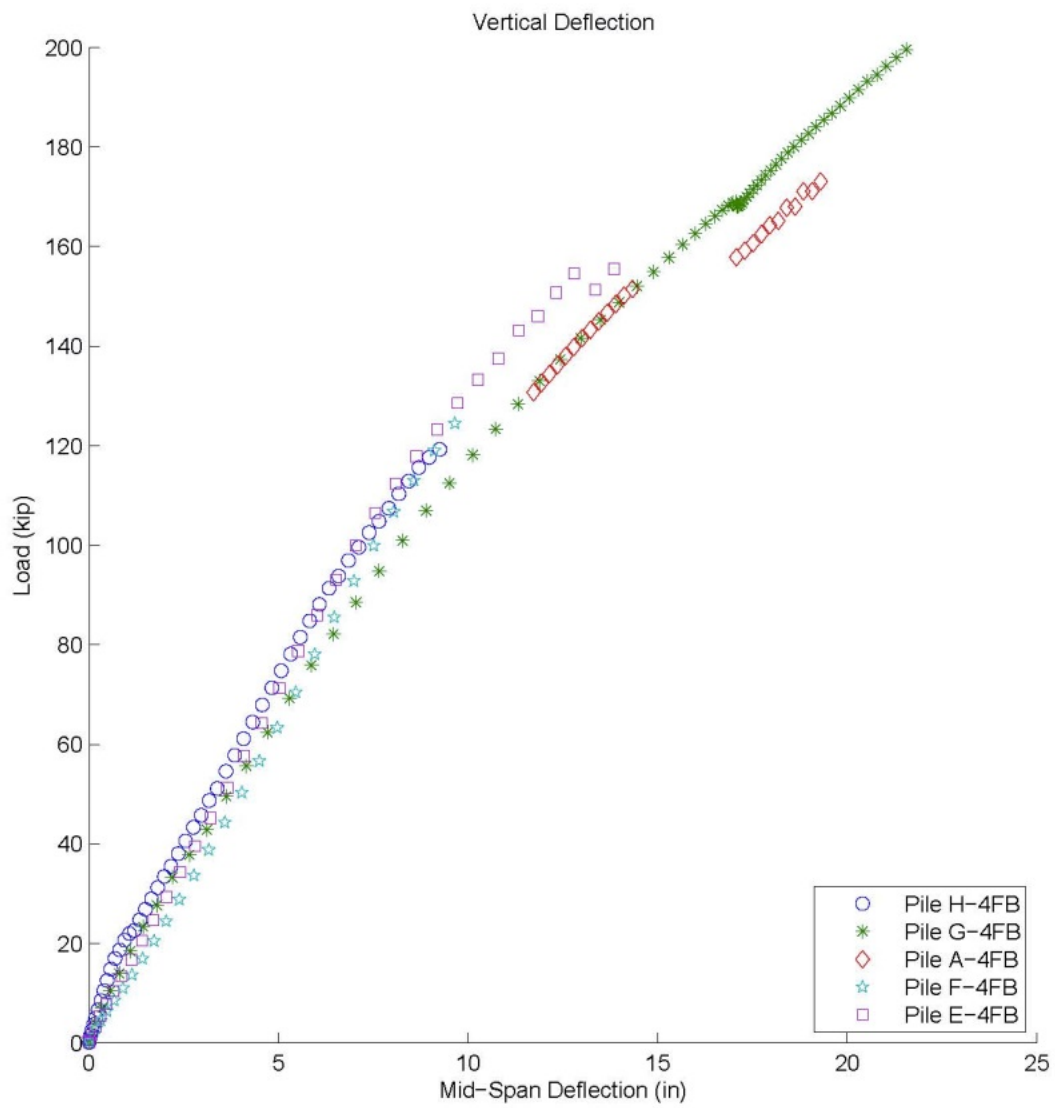
Figure 34: Load-Deflection of Filled Piles

The following plots compare the flexural test results of the concrete filled piles. Load-deflection relationships can be seen in Figure 34, and moment-curvature relationships can be seen in Figure 35.

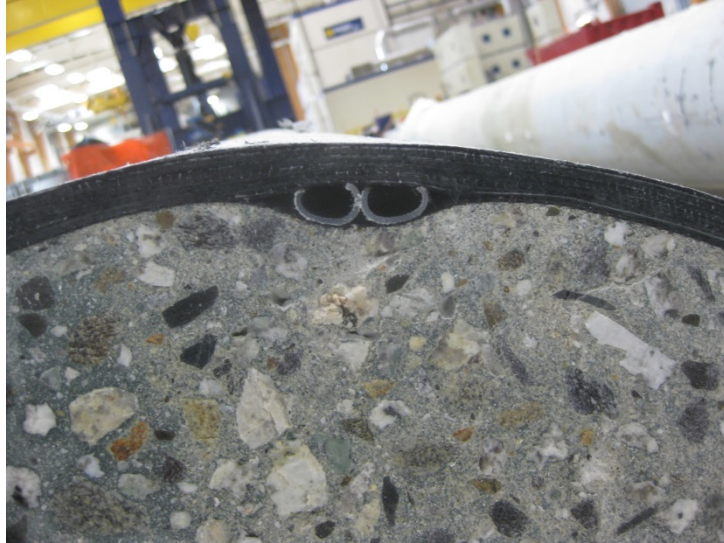
Figure 36: Concrete-FRP Interface

Concrete-filled piles were cut for disposal after testing. The cut piles showed no significant gaps between the concrete and FRP shell. It should be noted that MDOT Class A concrete with no expansive additive was used to fill the piles. A typical cut can be seen in Figure 36.

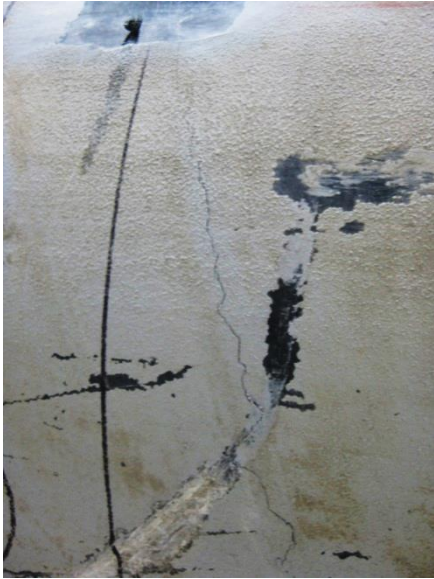
Figure 37: Cracks in Constant Moment Region

The first test of Pile C went to the capacity of the test setup. The load cell reached its capacity at an applied load of 300 kips and corresponding moment of 1650 kip\*ft., ending the test. The pile developed a series of hairline cracks along the tension face at two points: 2.5 feet from the nearest load point (inside the constant moment region) and 3.5 feet from the nearest load point (outside the constant moment region). These cracks can be seen in Figure 37, and Figure 38.

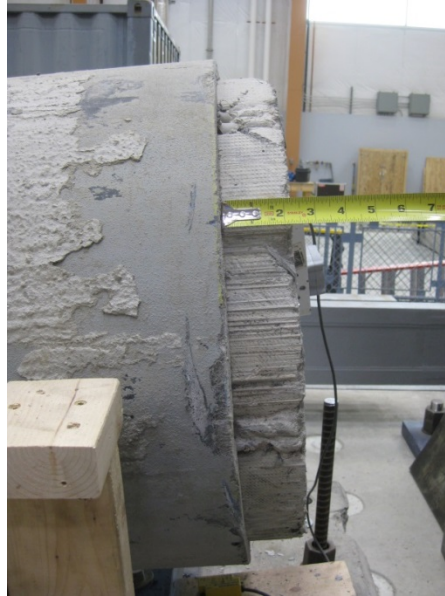
Figure 39: Loss of Composite Action in Pile C

Pile C was then tested a third time. The loading points were adjusted to 13 feet from the end supports. Composite action was lost during the test. It is believed that this occurred when there was a loud crack at an approximate load of 185 kips. The concrete displacement measurement at this load was 0.04 inches. The sliding of the concrete at failure was greater (approximately 2.25 inches), and can be seen in Figure 39.

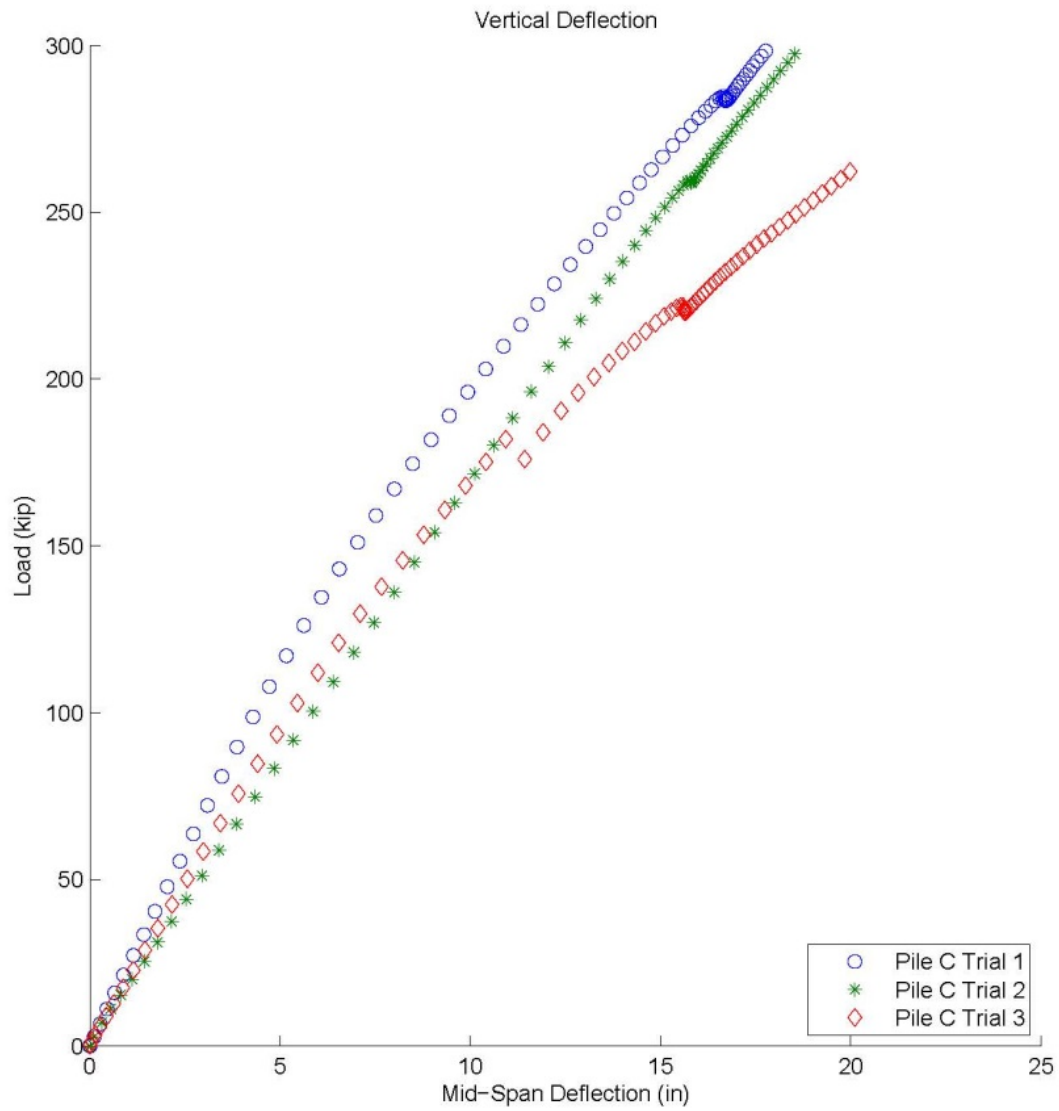
Figure 41: Load Deflection of Pile C Tests

The loading points were adjusted for each test of Pile C. This means load-deflection plots for each trial are not comparable. The plot has been included as Figure 41 for completeness.

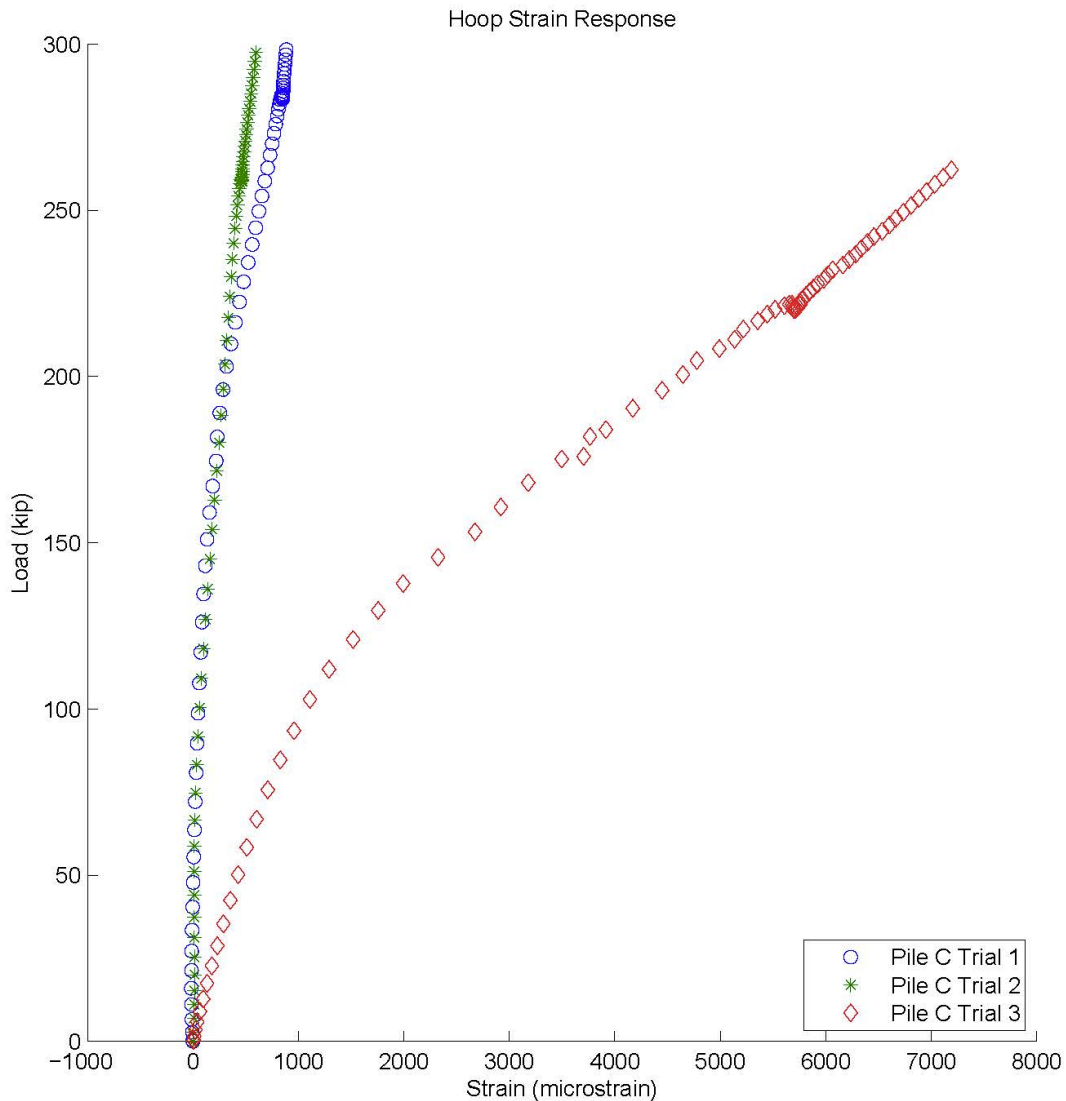
Figure 43: Hoop Strain in Pile C Tests

During the third test of Pile C, composite action was lost at an approximate load of 185 kips. This test saw higher hoop strains than the previous tests of Pile C and all other concrete-filled piles. A plot of hoop strain for Pile C tests can be seen in Figure 43.

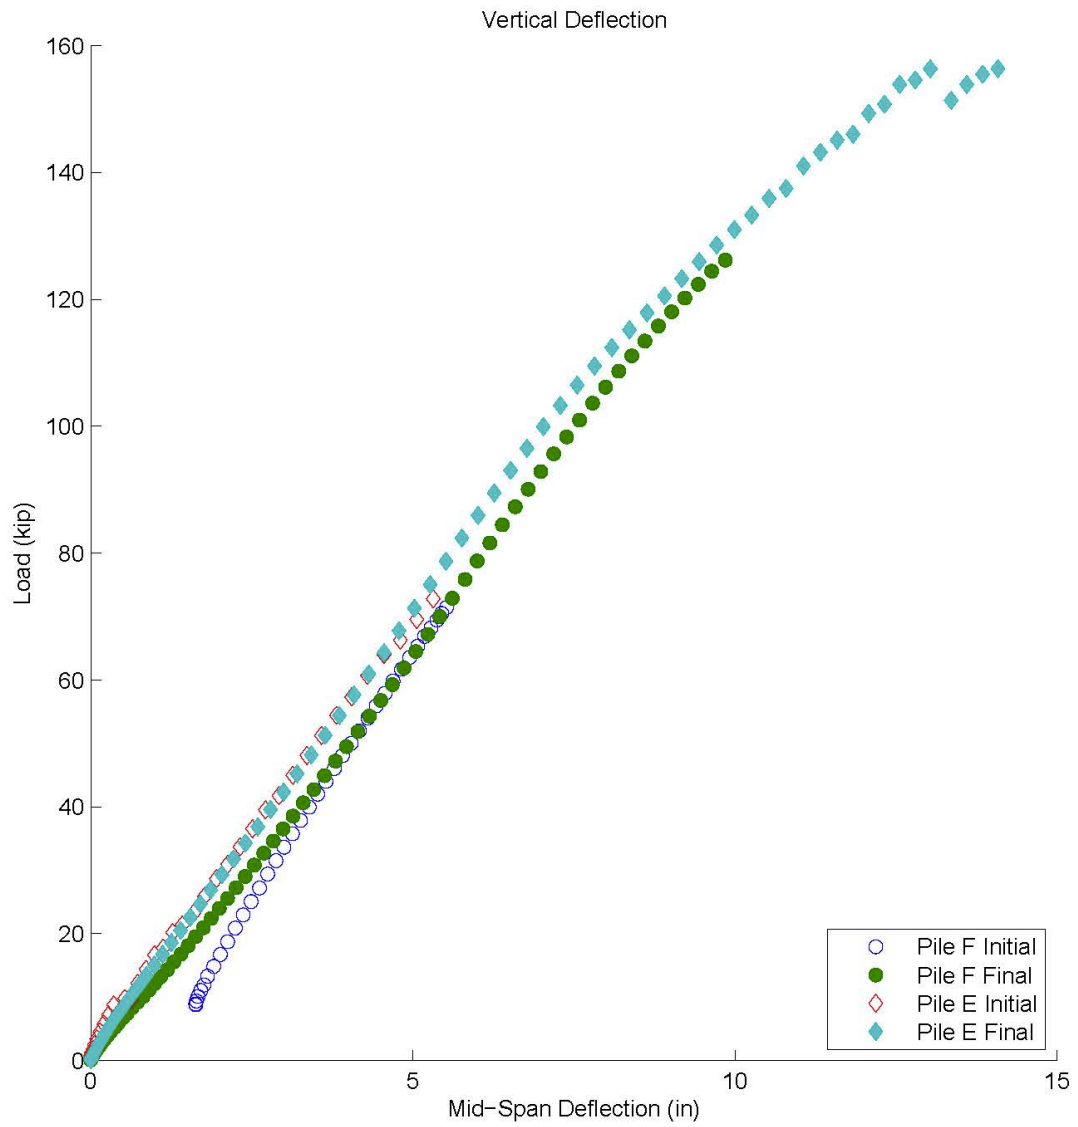
Figure 44: Load-Deflection of Load Cycled Piles

The following plots compare the flexural test results for initial and ultimate testing of load-cycled piles. Load-deflection relationships can be seen in Figure 44, and moment-curvature relationships can be seen in Figure 45. Note that the line for Pile F initial deflection is based after 10 cycles, since no static test was conducted prior to cyclic loading. The concrete cracked on the tension face during the first 10 cycles, therefore the initial apparent deflection and curvature, taken at approximately 8 kips, is higher than that of Pile E.

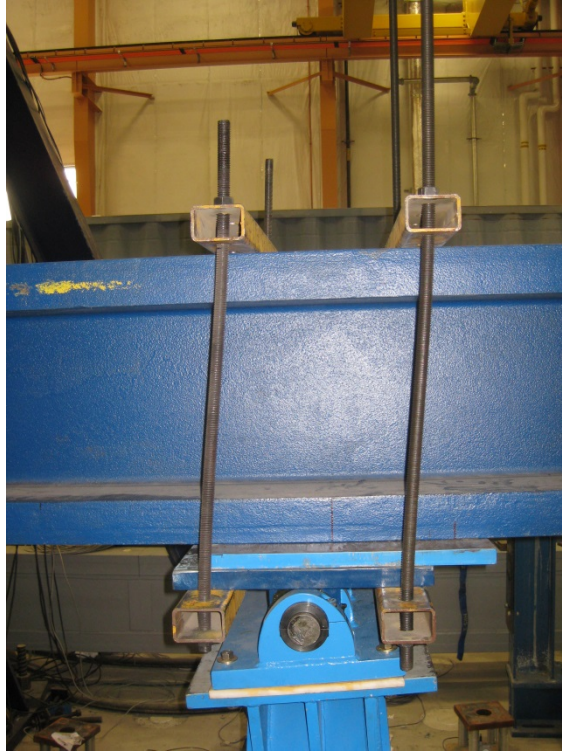
Figure 51: Movement of Saddle at Loading Point After Failure

Saddles at loading points shifted during some tests. This may have caused more loads to apply to one side of the pile. Saddles did not move more than approximately 2 inches during any test. A large portion of this saddle movement may have occurred when the piles failed and contacted the spreader beam. It is not believed that this caused a significant effect due to the relatively large span length (33 feet). The saddle movement can be seen in Figure 51.
