Evaluation of Corrosion and Corrosion Control on Interstate 89 Bridge #30 and # 31

Final Report

Prepared by CD Engineering for the
New Hampshire Department of Transportation in cooperation with the
U.S. Department of Transportation, Federal Highway Administration

Evaluation of the Cathodic Protection System on Interstate 89 Bridge #30 and Comparing the Corrosion to Control Bridge # 31

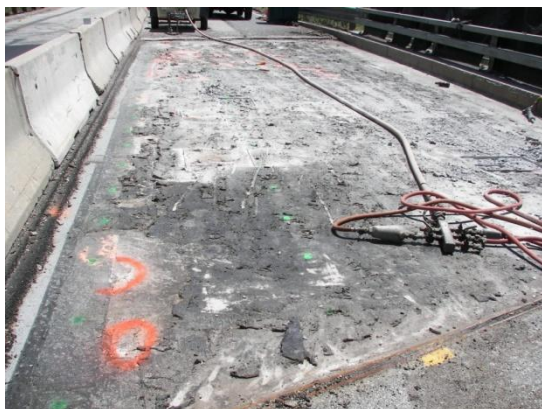
Figure 1. membrane defects

The visual survey of the Hominy Pot Road bridges noted that the membrane was disbonded, defective and punctured in several areas of the decks. The punctures were especially common at the junction of the concrete patches (Figure 1). Most cracks were also noted at these boundaries. The size and depth of the delaminations were greatest in the northbound high-speed lane followed by the northbound low-speed lane and then the southbound low-speed lane. The delamination surveys were performed using a bounce bar. Remarkable was the presence of heavy spalls and delaminations near previously patched areas. This is commonly found in bridge deck rehabilitation, where, as a result of the electrochemical nature of the corrosion process, repairs can actually accelerate corrosion. Figures 3, 4, 5 and 6, illustrates the creation of a corrosion cell between the concrete in a new **patch** and the concrete in an old patch.

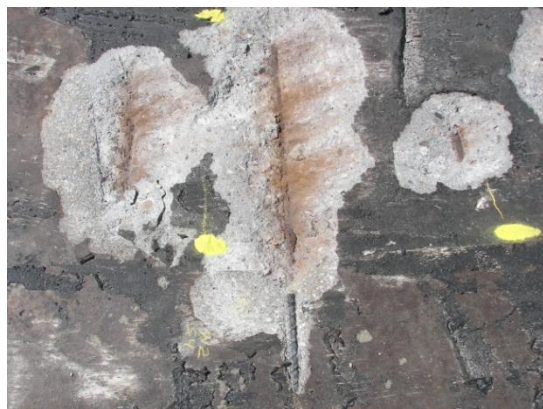
Figure 2. Anodic and cathodic rebar

It is important to consider the effect of patching practices on corrosion. The removal of loose and delaminated concrete, followed by patching of the area to restore the original surface plane, is the most frequently used method of rehabilitation. From a theoretical point of view, it would be ideal if the patch material perfectly matched the surrounding concrete composition, but this is seldom the case in practice. Whenever adjacent areas of concrete contained different electrolyte chemistry (chloride concentration, for example), a concentration cell will develop. This cell will accelerate corrosion of steel near the boundary of the patch. This accelerated corrosion soon leads to further deterioration, and patching becomes a never ending process. If the patch material is of very low conductivity, it is unlikely that the steel within the patch will experience significant corrosion. (SHRP-S-337, Pg. 58)

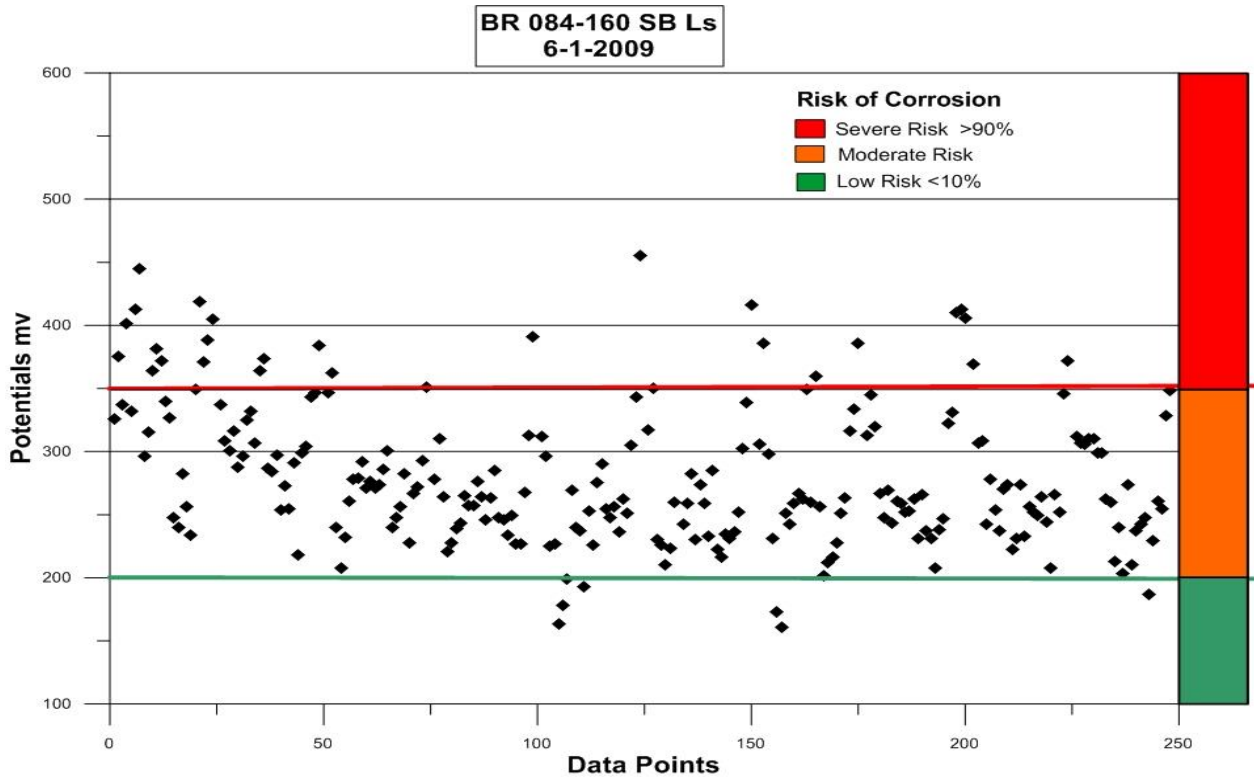
The graphs below of the data points on all three bridges tested show the corrosion probability based on the guidelines of ASTM C-876.

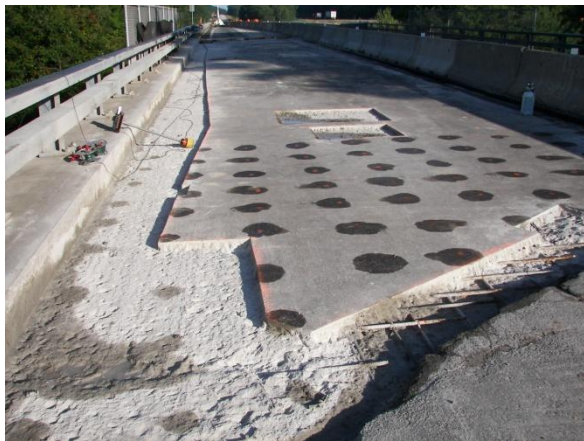
This deck had no membrane applied and was in good overall condition with the exception of the South curb where rotted concrete was noted the full-length of the deck. Three longitudinal cracks were noted at mid deck.

South curb concrete removed

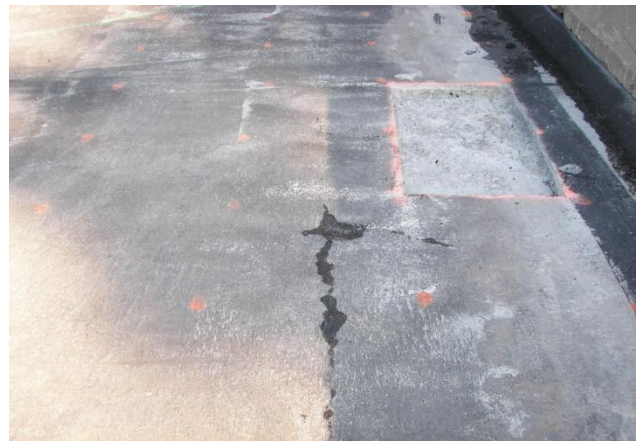
longitudinal cracks at mid deck

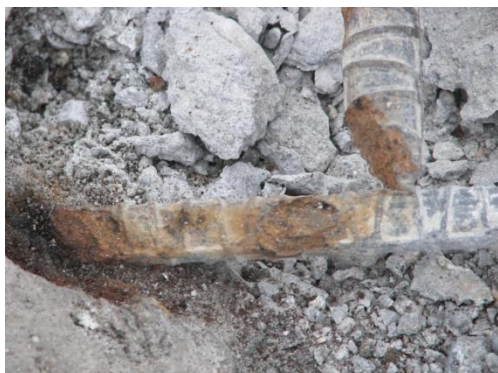
Electrical continuity test were conducted at the rectifier panel and at any exposed rebar where the concrete was removed. These tests indicated that the reinforcing steel was electrically continuous. In a couple of small isolated areas there were poor bonds between rebar causing pickup and discharge areas. (see photo below)

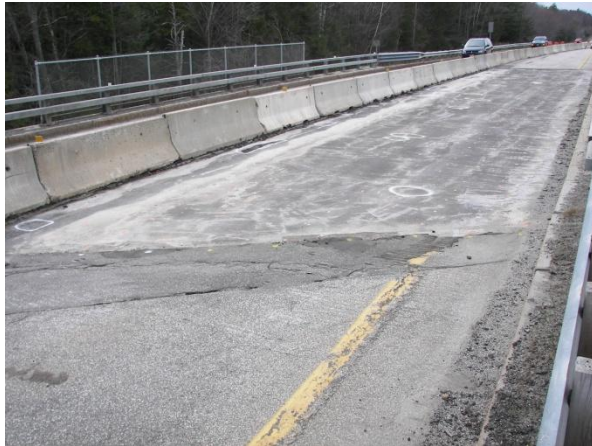
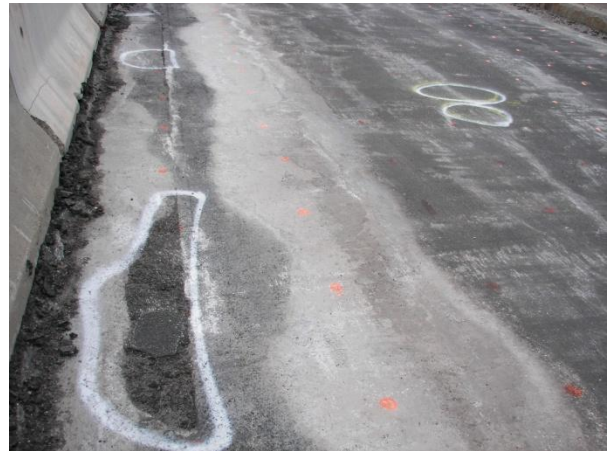
This deck had no membrane applied and was in good overall condition with the exception of the curb where rotted concrete was noted almost the full-length of the deck. The most significant crack was along the joint between the two decks. This was also the area of most delamination and most concrete removal.

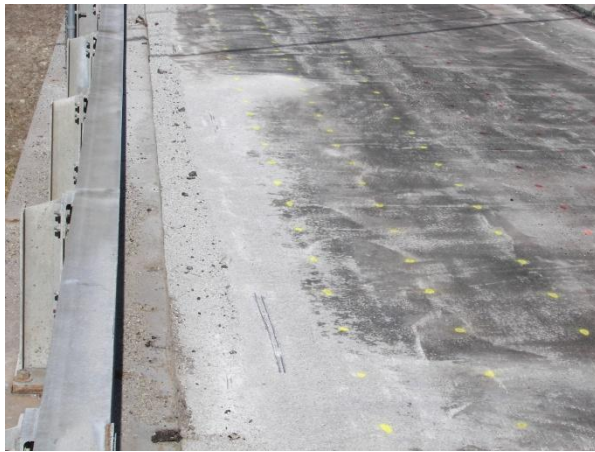
This deck had no membrane applied and was in good overall condition with the exception of the curb where rotted concrete was noted the full-length of the deck. The most significant crack was along the joint between the two decks. This was also the area of most delamination and most concrete removal.

Exposed anode strands in rotted concrete

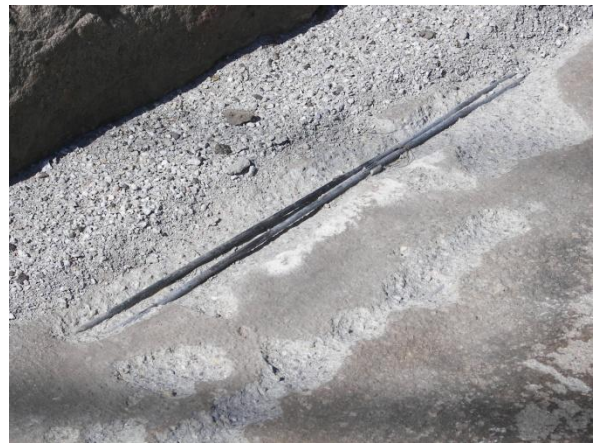
close-up of left photo, poor anode cover

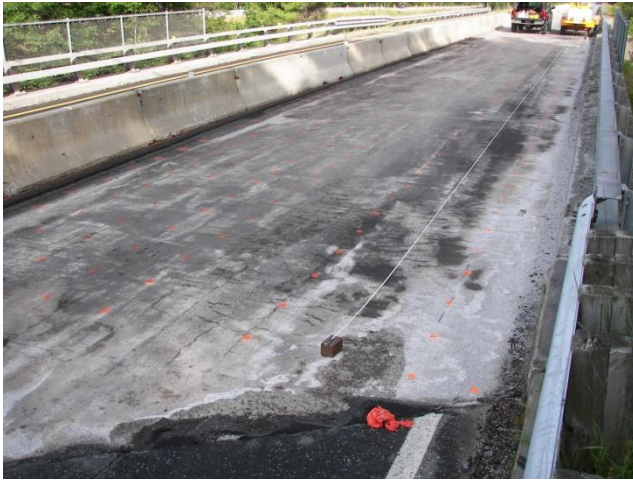
This deck had no membrane applied and looked in good overall condition with the exception of the curb where rotted concrete was noted the full-length of the deck. The deck had a significant amount of micro cracks with a well defined pattern. Anode strands were visible in areas of poor anode cover.

Deck with crack pattern

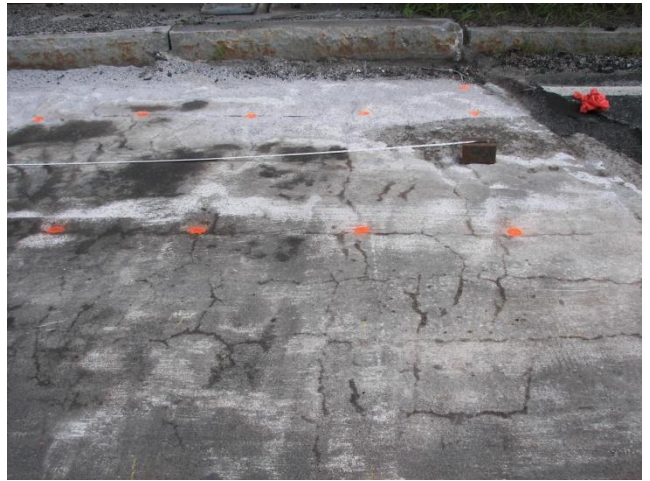
close-up of cracks

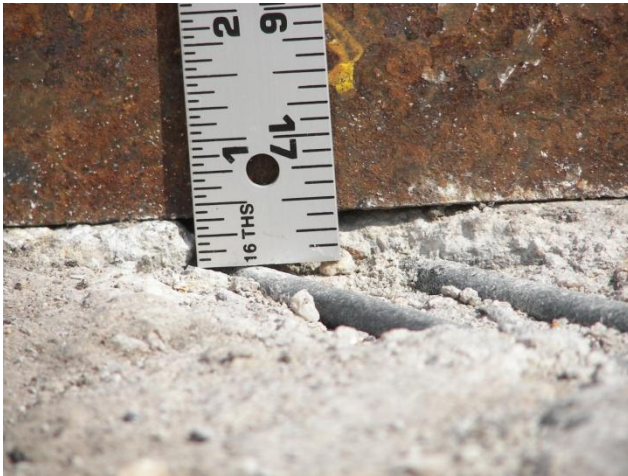
Poor anode strand cover <3/8 inch

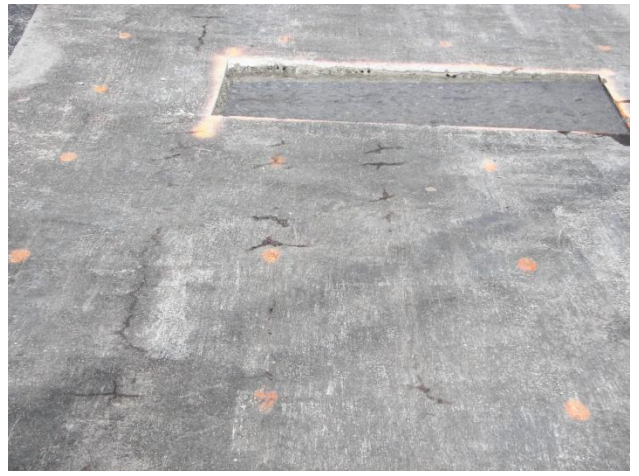
cracks caused by poor anode cover

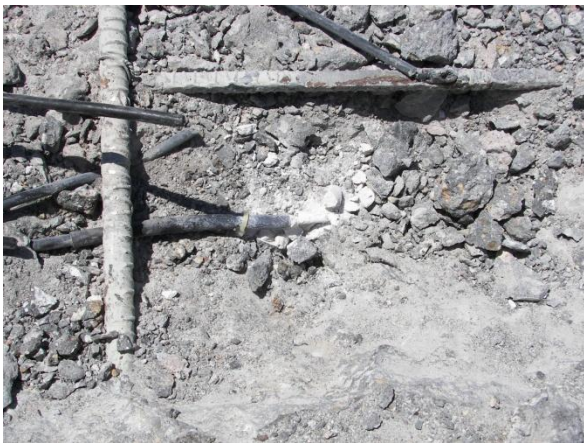
This cathodic protection system was somewhat effective for the short time it was working properly. The rebar loss on the control bridge was much more severe than on the cathodically protected bridge. The spalls and delaminations on the control bridge were deeper and larger than on the cathodically protected bridge. Rebar corrosion was not observed in many delaminated areas on the cathodically protected bridge. Chloride ion concentration was less on the cathodically protection bridge with the exception of zone two and three which had significant cracking due to poor cover over the anode strands. Maintenance and troubleshooting of the system would have benefited if drawings or information identifying the conductor numbers and their location had been made available. CDE recommended surface potential surveys in September 1998, because, for several years the system could not be monitored effectively when the embedded reference electrodes became unreliable and defective possibly do to freeze-thaw degradation. (see photo below)

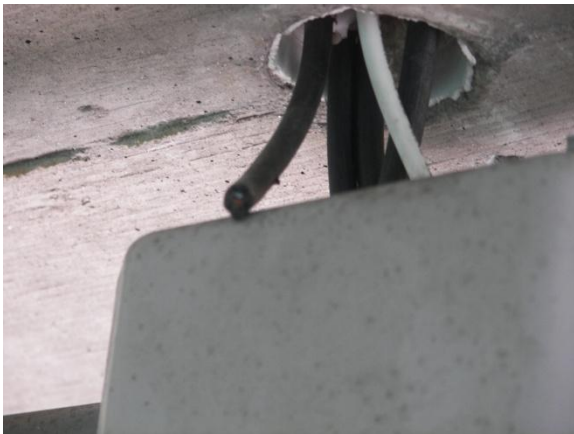
Many connections in the junction boxes were corroded, broken or disconnected through vibration.

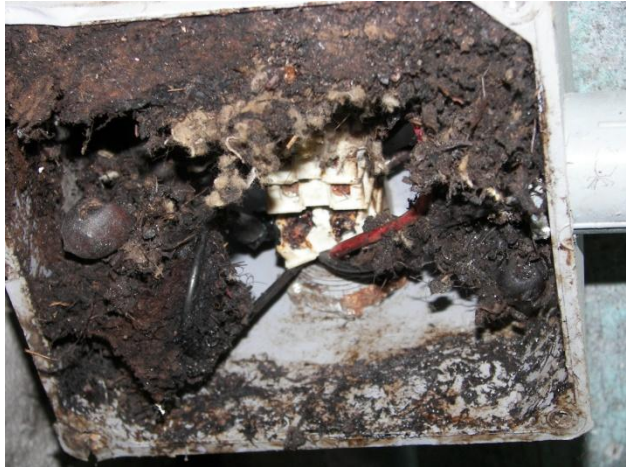
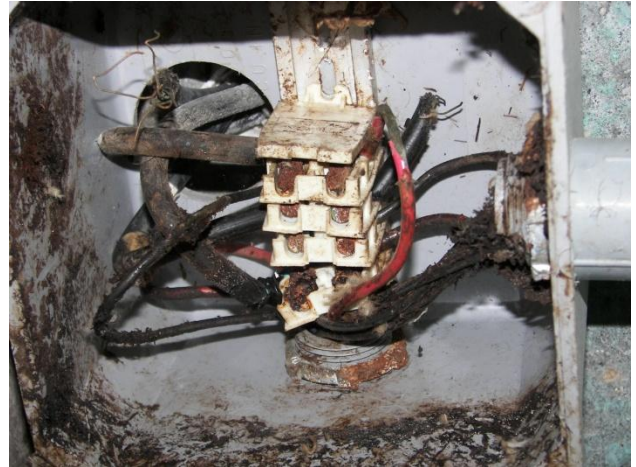
Several junction boxes were destroyed by rodents and corrosion

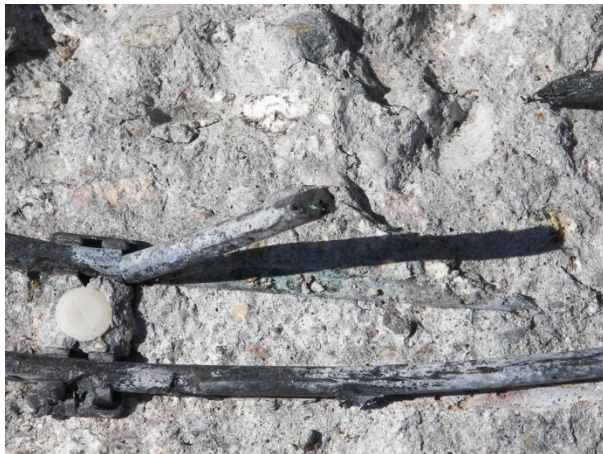
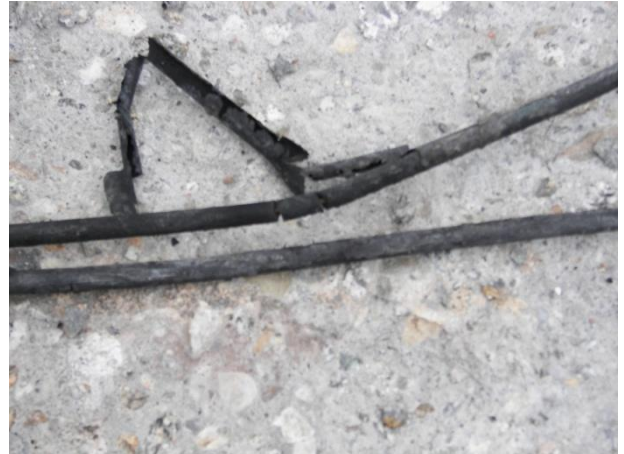
The major cause of the cathodic protection system failure, was degradation of the anode system. This was mostly due to the product itself and the poor cover and traffic stress over the anode strands.

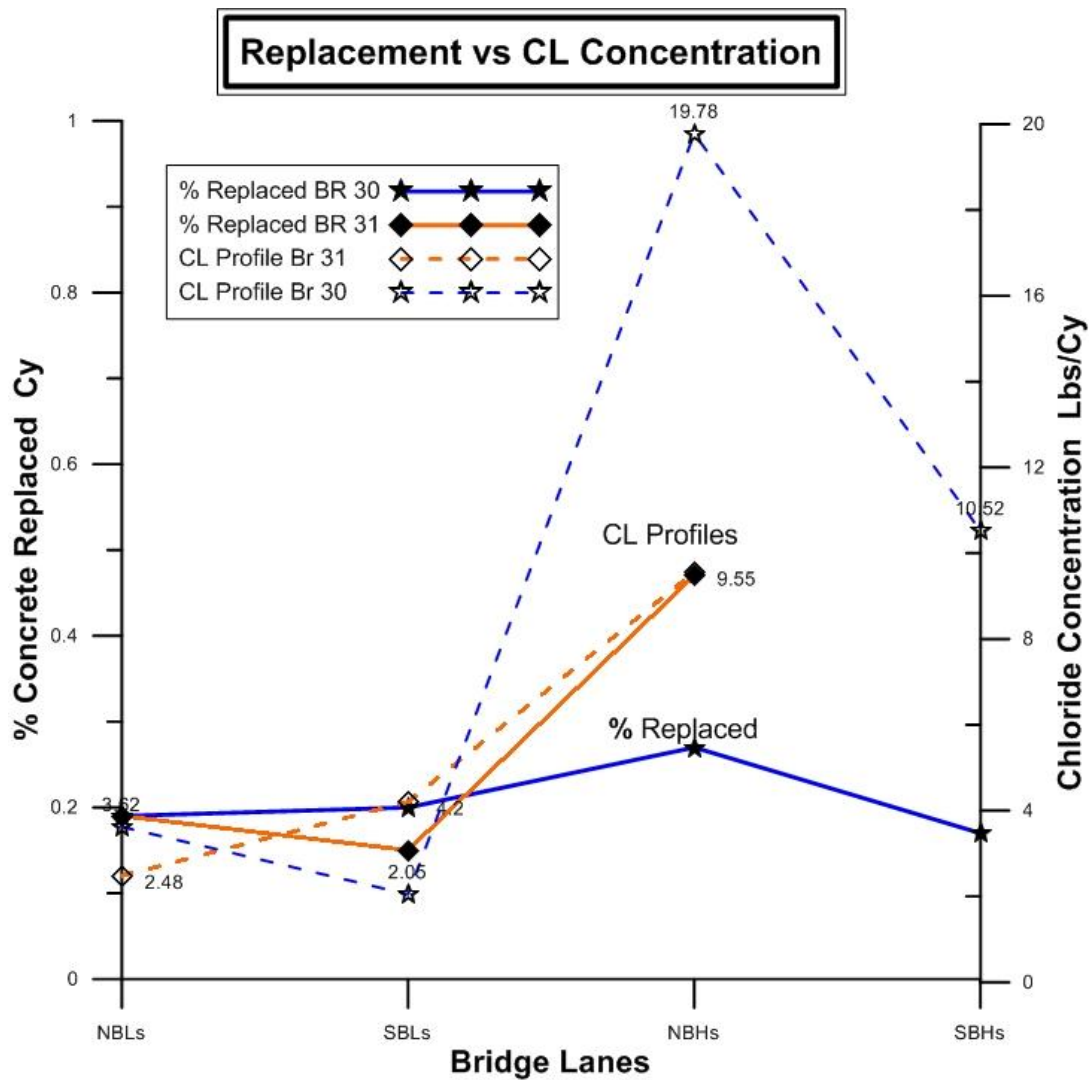
The graph below compares the concrete replacement in cubic yards versus the chloride ion concentration of the two bridge systems. It indicates that although chloride ion concentration was high for the cathodically protected bridge the concrete replacement was lower than on the control bridge. The high chloride ion concentration in zone three of the cathodically protected bridge was due to a large amount of cracking at the anode strands. This cracking was largely due to poor cover over the anode strands and traffic stresses.

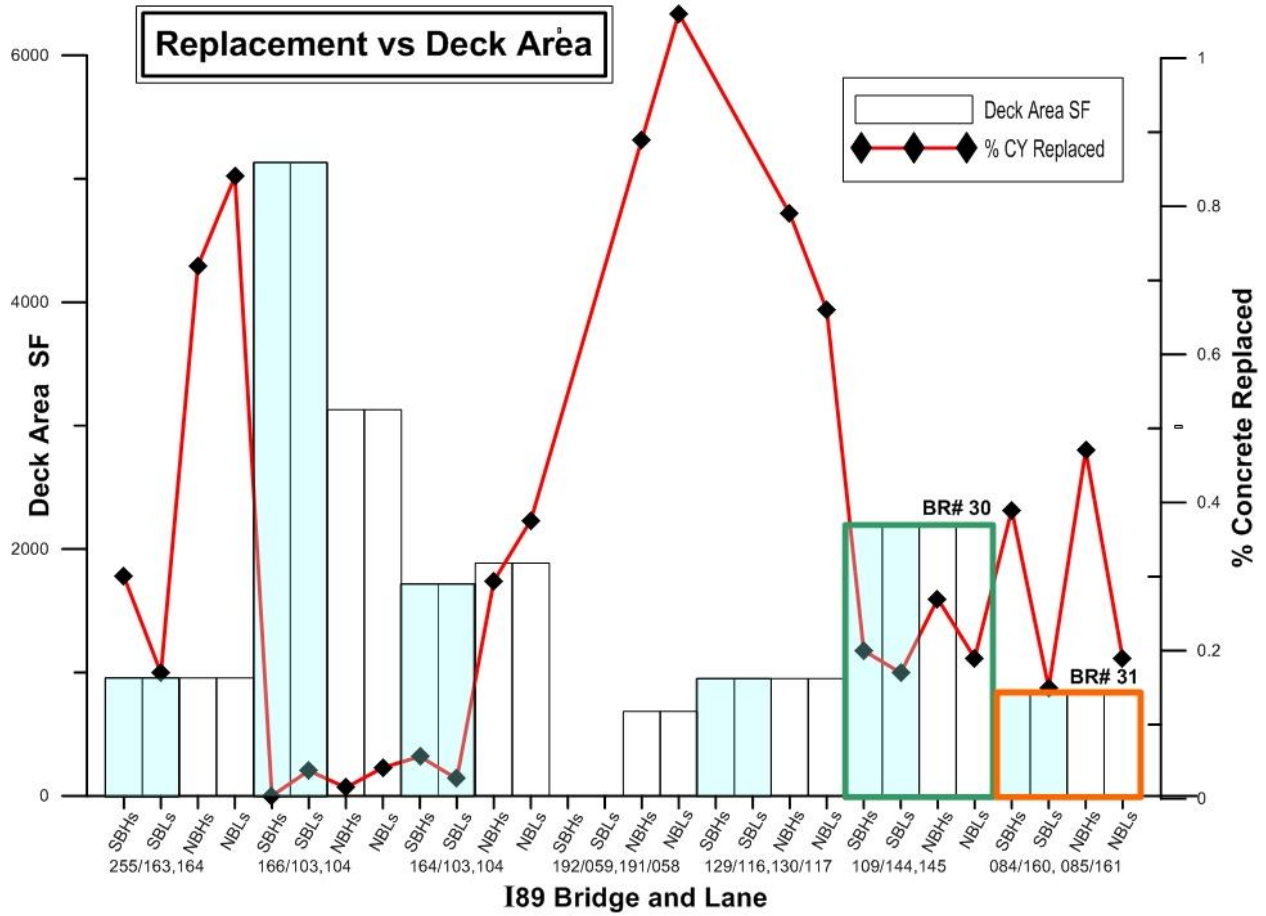
Using the bridge summary found in Appendix E for the bridges rehabilitated on the project 14511, the below graph was generated to demonstrate that based on concrete replacement versus deck area the cathodic protection on bridge number 30 was somewhat effective.

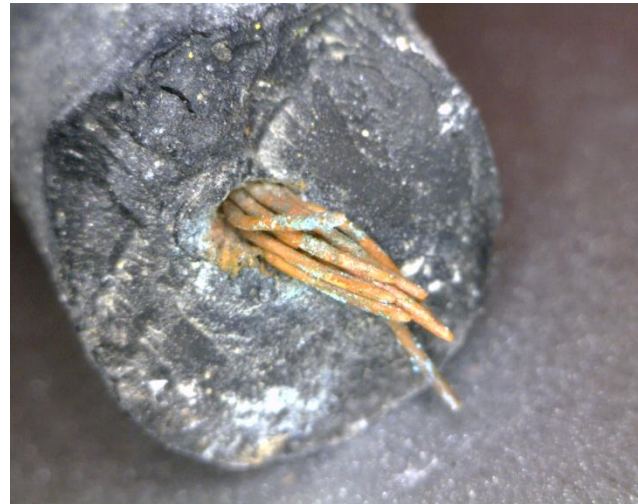
The anode used with this cathodic protection system was a Raychem FEREX 100 anode. This was one of the first commercial grid type anodes available. It consisted of a stranded copper wire encased in a proprietary flexible and electronically conductive polymer, resulting in an anode cable with a nominal diameter of approximately 8 mm. The conductive polymer outer jacket of this anode proved to be susceptible to attack by acids generated around the anode. Another disadvantage of this anode is that if the copper core wire was exposed the copper wire would corrode and cause open circuits and local loss of cathodic protection current. The FEREX 100 system was used in over 50 FHWA demonstration projects and national studies noted anode degradation and cracking was being observed in many installations. The diagram on the left below illustrates the composition of the anode. The photo on the right is a section of an anode removed from an area that was not receiving protection current.

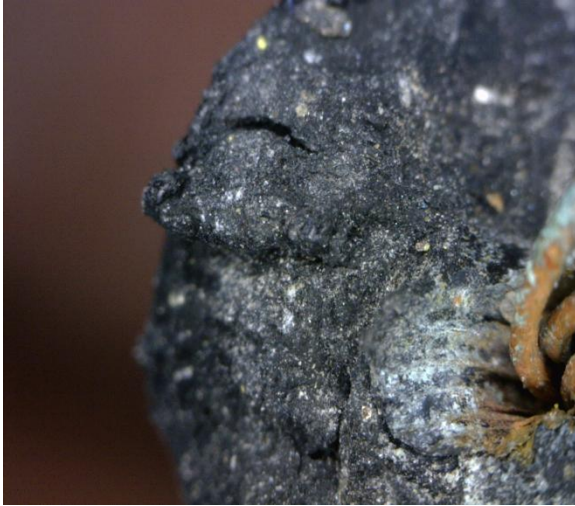
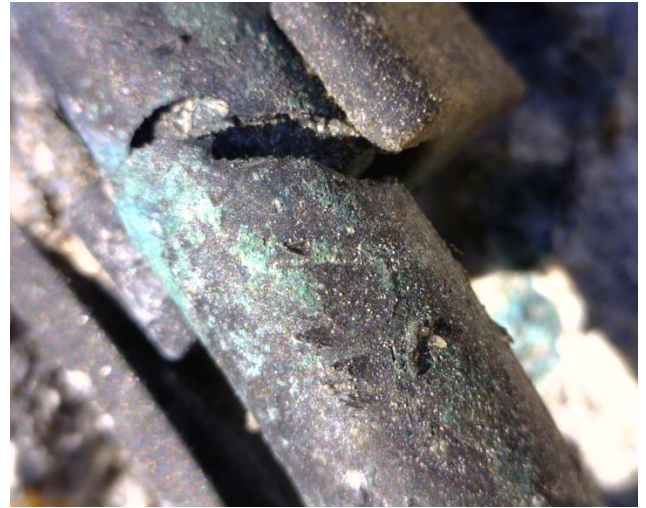
The photo on the left shows the degradation of the jacket and conductive polymer. The photo on the right also shows cracking and leaching of the copper conductor through the jacket.

It was known that the FEREX wire material would deteriorate rapidly if overpowered but could provide long life if the anode current density was limited to the design value. Although initial tests were promising in a number of installed systems, the material proved somewhat susceptible to become brittle, causing breaks especially at bends. (SHRP-S-337, Pg. 54)
