# **DESIGN OF AN IMPROVED POST FOR USE IN A NON-PROPRIETARY HIGH-TENSION CABLE MEDIAN BARRIER**

## **MIDWEST ROADSIDE SAFETY FACILITY**

MwRSF Research Report No. TRP-03-286-15

May 7, 2015

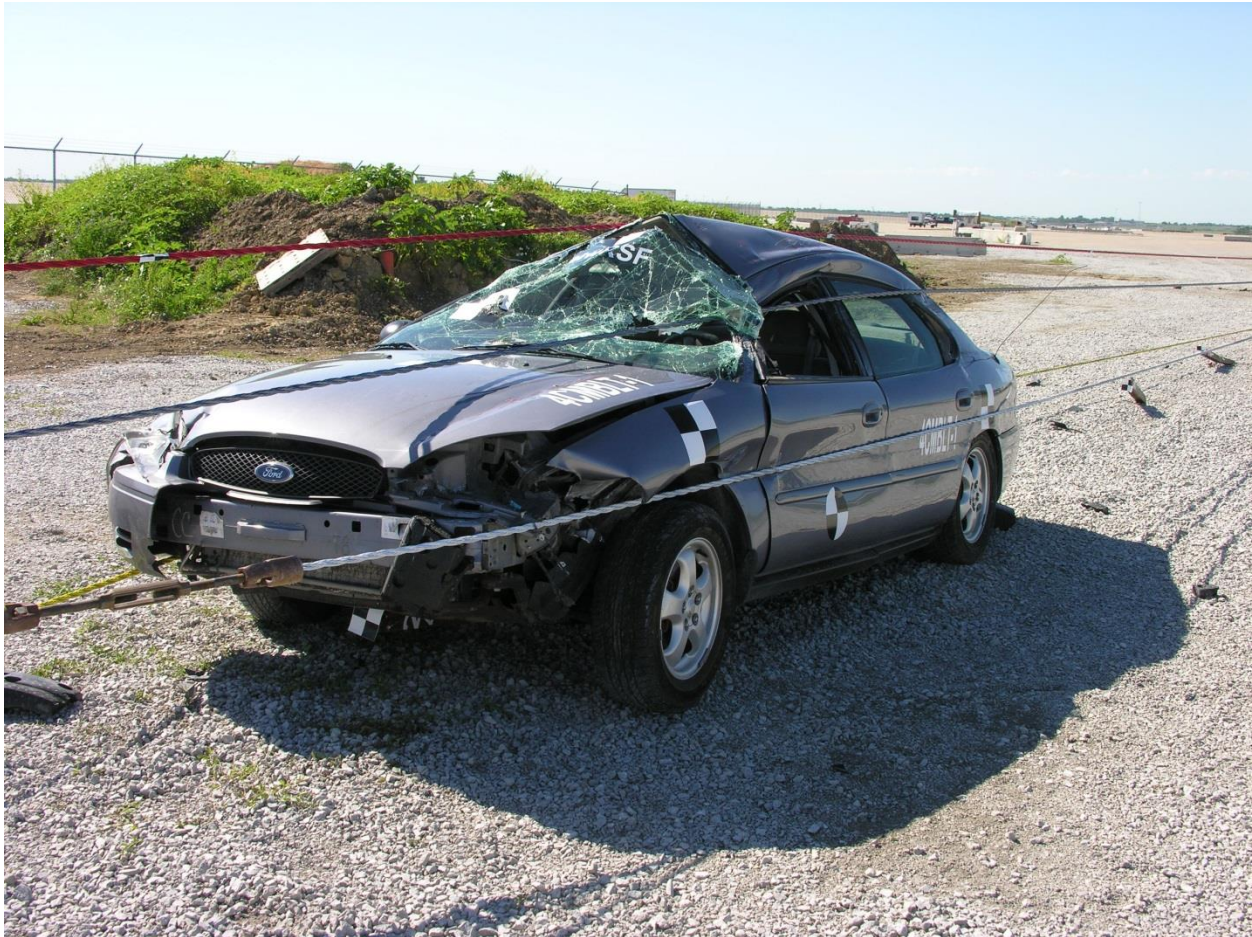
Figure 1. A-pillar Damage. Test No. 4CMBLT-1

Three design problems stood out that needed to be addressed to improve the system and meet the new TL-3 test requirements for cable median barrier found in the *Manual for Assessing Safety Hardware* (MASH). First, full-scale testing had shown that the current design of the cable median barrier had difficulty capturing vehicles when the barrier was placed down the slope. Full-scale test no. 4CMB-5 showed that impacting the system at a post and while airborne tended to pull down the top cable and compromise vehicle capture [2]. Second, full-scale test no. 4CMBLT-1 indicated that the current cable barrier system design could cause A-pillar crush in small cars and sedans, as shown in Figure 1 [3]. Review of the full-scale test results suggested that two factors contributing to the A-pillar crush were the lateral, or strong-axis, strength of the post and the release forces of the cable to post attachment. Finally, review of the behavior of the cable-to-post attachments in the current design found that the current attachment behavior was not optimized. The attachments appeared to be too strong vertically to release cables safely and effectively. With respect to the strong-axis release loads, it was observed that the strong-axis release forces were not sufficient to yield and displace the posts in the system to effectively

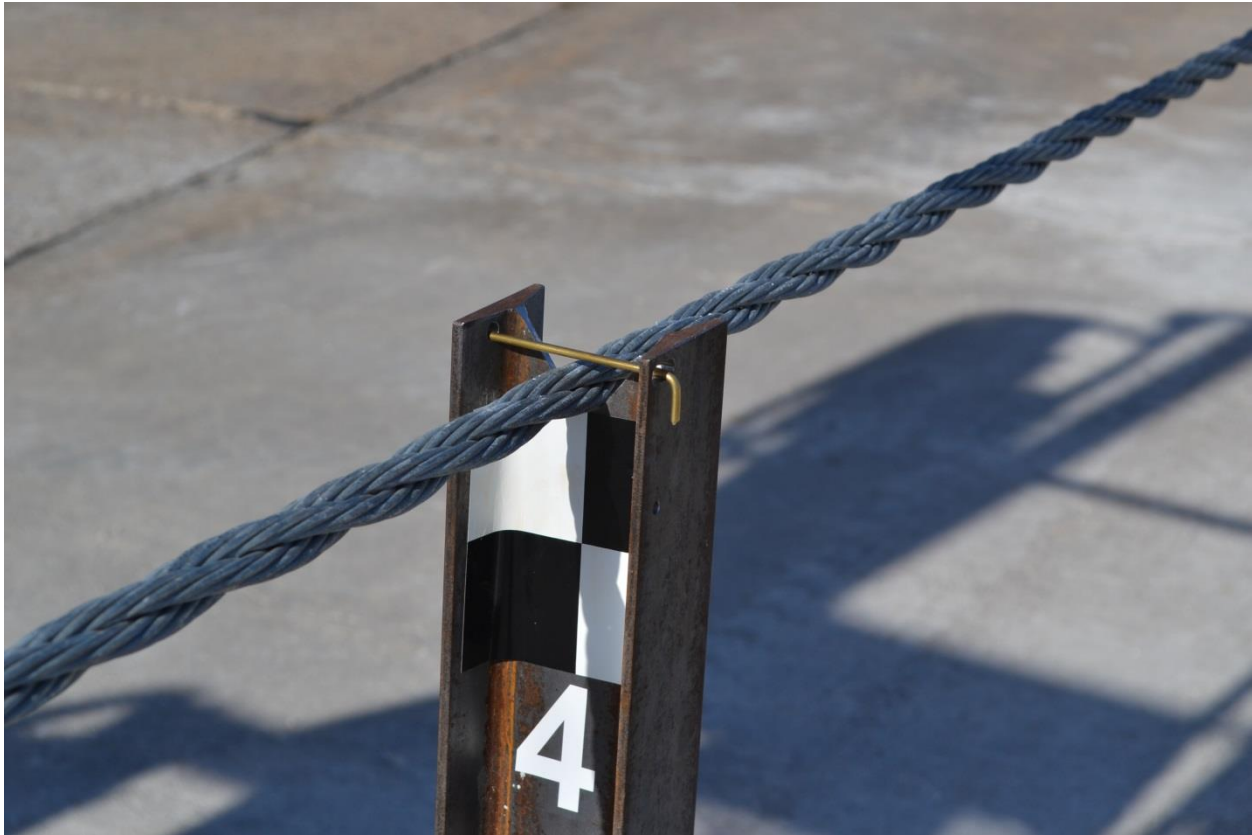
Figure 2. Previously Developed Tabbed Bracket and Top Cable-to-Post Attachments

Top Cable Attachment

3. Cable attachments
  - a. The new post section needed to have a geometry that allowed for mounting of the cable-to-post attachments developed previously, including the tabbed bracket used for the lower three cables and the top cable attachment developed in the previous study [4], as shown in Figure 2.

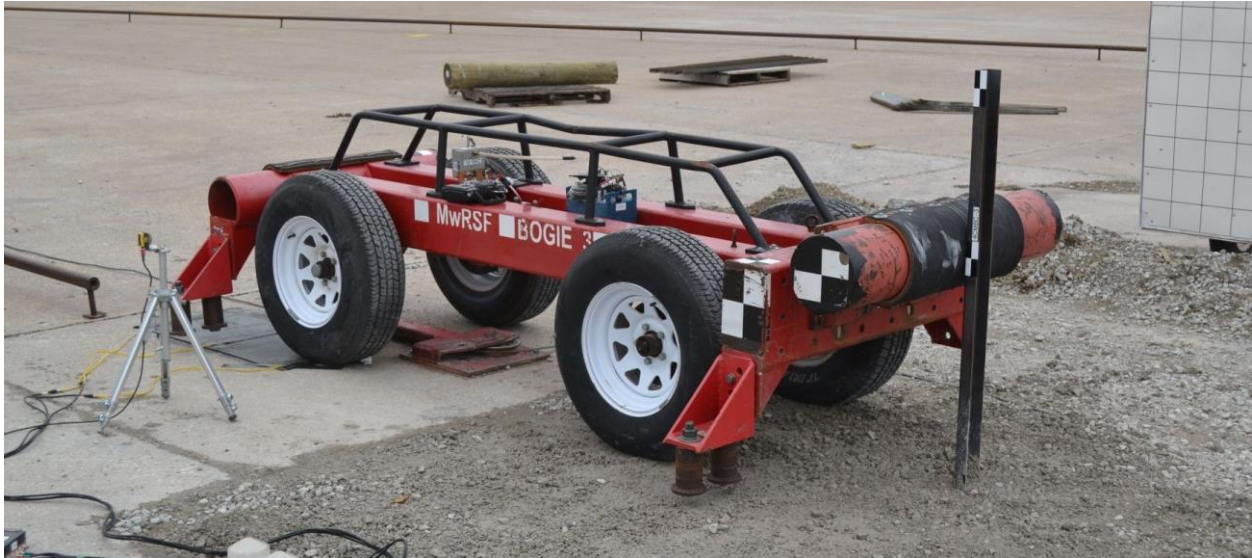
A rigid-frame bogie was used to impact the posts. A variable-height, detachable impact head was used in the testing. The bogie head was constructed of 8-in. (203-mm) diameter, ½-in. (13-mm) thick standard steel pipe, with ¾-in. (19-mm) neoprene belting wrapped around the pipe to prevent local damage to the post from the impact. The impact head was bolted to the bogie vehicle, creating a rigid frame with an impact height of 27 in. (686 mm). The bogie with the impact head is shown in Figure 4. The weight of the bogie with the addition of the mountable impact head and accelerometers were approximately 1,870 lb (848 kg).

Figure 4. Rigid Frame Bogie and Guidance Track

A pickup truck with a reverse cable tow system was used to propel the bogie to a target impact speed of 20 mph (32 km/h). When the bogie approached the end of the guidance system, it was released from the tow cable, allowing it to be free-rolling when it impacted the post. A remote braking system was installed on the bogie, allowing it to be brought safely to rest after the test.

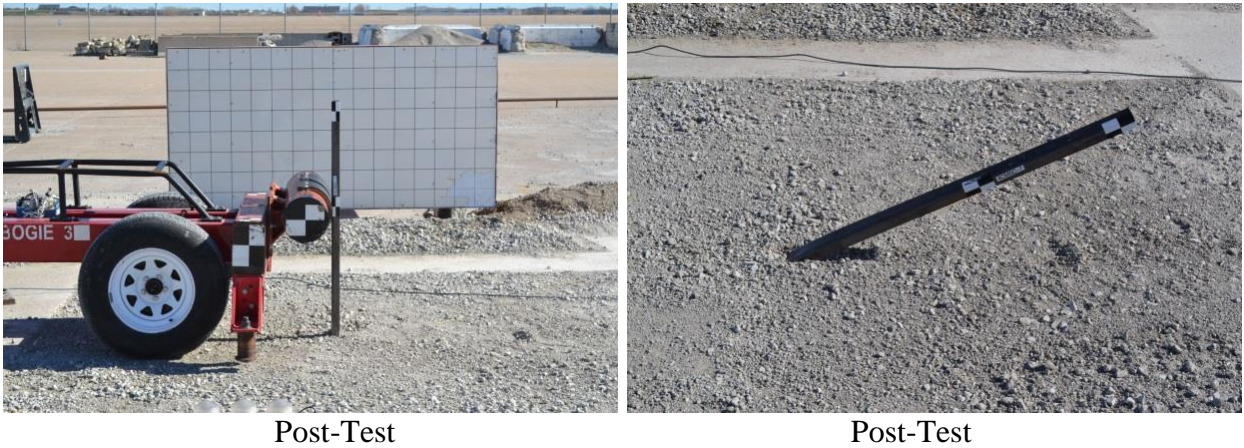
Figure 27. Pre-Test and Post-Test Photographs, Test No. 4CMBC-7

Force vs. deflection and energy vs. deflection curves created from the DTS accelerometer data are shown in Figure 26. The forces quickly rose to a peak force of 4.7 kips (20.9 kN) at 1.8 in. (46 mm) of deflection. The post provided an average resistive force of 1.5 kips (6.7 kN) through 10 in. (254 mm) of deflection and 1.4 kips (6.2 kN) through 15 in. (381 mm) of deflection. The energy absorbed by the post was 15.2 kip-in. (1.7 kJ) through 10 in. (254 mm) of deflection and 21.0 kip-in. (2.4 kJ) through 15 in. (381 mm) of deflection. Pre-test and post-test photographs are shown in Figure 27. Time-sequential photographs are shown in Figure 28.

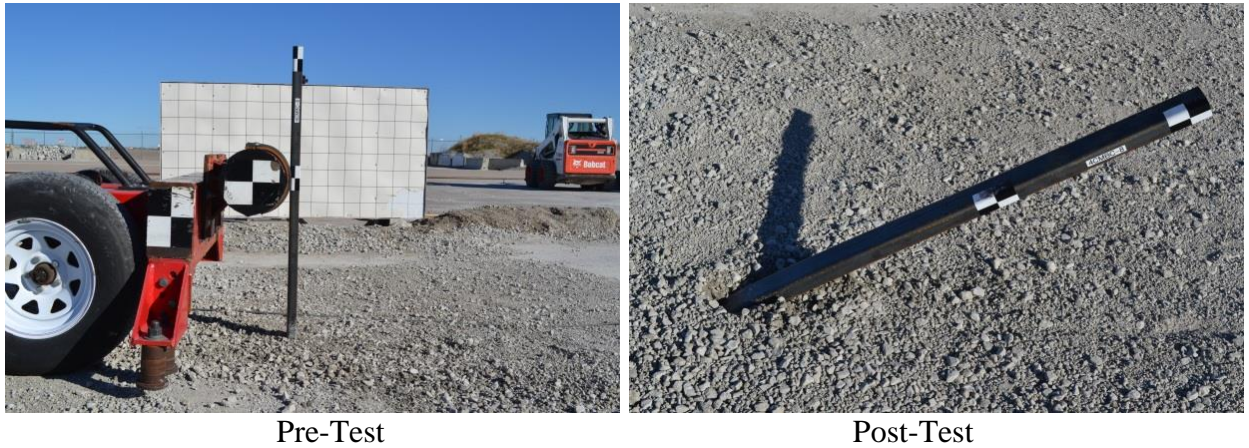
Figure 30. Pre-Test and Post-Test Photographs, Test No. 4CMBC-8

Force vs. deflection and energy vs. deflection curves created from the DTS accelerometer data are shown in Figure 29. The forces quickly rose to a peak force of 4.2 kips (18.7 kN) at 1.7 in. (43 mm) of deflection. The post provided an average resistive force of 1.3 kips (5.8 kN) through 10 in. (254 mm) of deflection and 1.1 kips (4.9 kN) through 15 in. (381 mm) of deflection. The energy absorbed by the post was 12.6 kip-in. (1.4 kJ) through 10 in. (254 mm) of deflection and 17.2 kip-in. (1.9 kJ) through 15 in. (381 mm) of deflection. Pre-test and post-test photographs are shown in Figure 30. Due to technical difficulties, time-sequential photographs could not be collected.

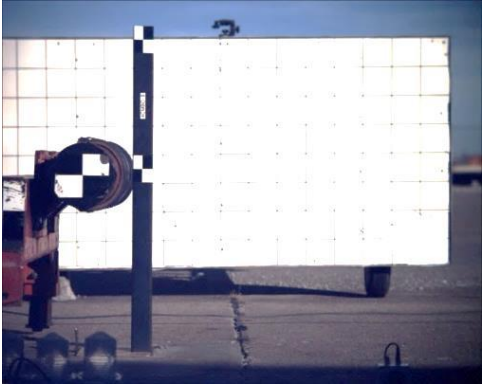
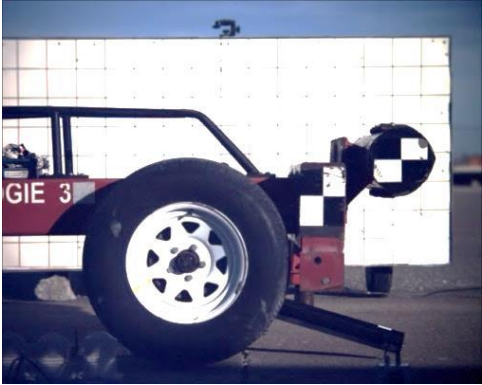
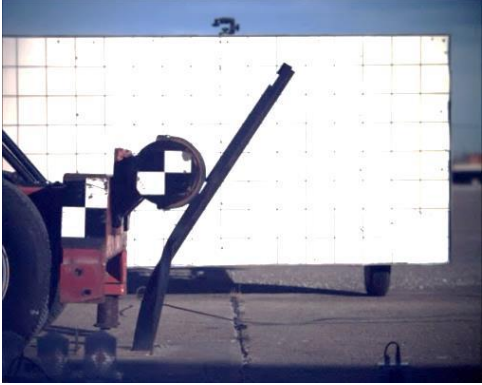
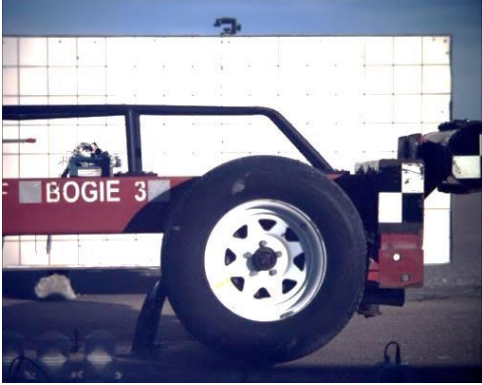
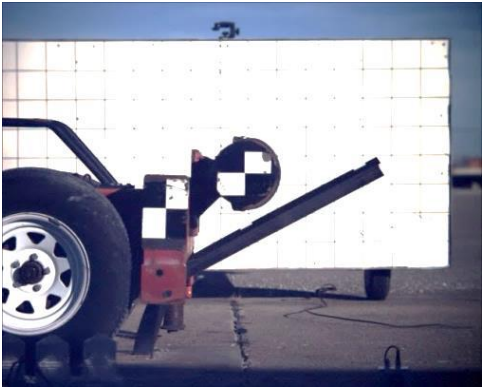
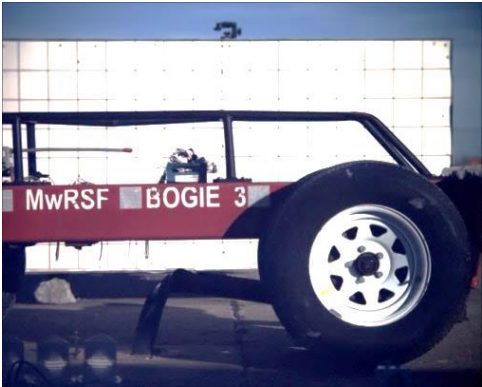
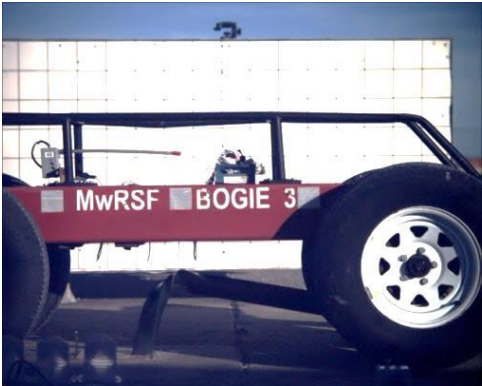
Figure 33. Sequential Photographs, Test No. 4CMBC-9

During test no. 4CMBC-9, the bogie impacted the 10-gauge C-Section steel post in a rigid sleeve at a speed of 21.1 mph (34.0 km/h). As a result of the strong-axis impact, the post bent backward, twisted, and yielded approximately 13 in. (330 mm) above the groundline. The bogie overrode the post at a maximum deflection of 18.2 in. (462 mm).

Force vs. deflection and energy vs. deflection curves created from the DTS accelerometer data are shown in Figure 31. The forces quickly rose to a peak force of 4.5 kips (20.0 kN) at 2.3 in. (58 mm) of deflection. The post provided an average resistive force of 1.9 kips (8.5 kN) through 10 in. (254 mm) of deflection and 1.5 kips (6.7 kN) through 15 in. (381 mm) of deflection. The energy absorbed by the post was 19.0 kip-in. (2.1 kJ) through 10 in. (254 mm) of deflection and 21.8 kip-in. (2.5 kJ) through 15 in. (381 mm) of deflection. Pre-test and post-test photographs are shown in Figure 32. Time-sequential photographs are shown in Figure 33.

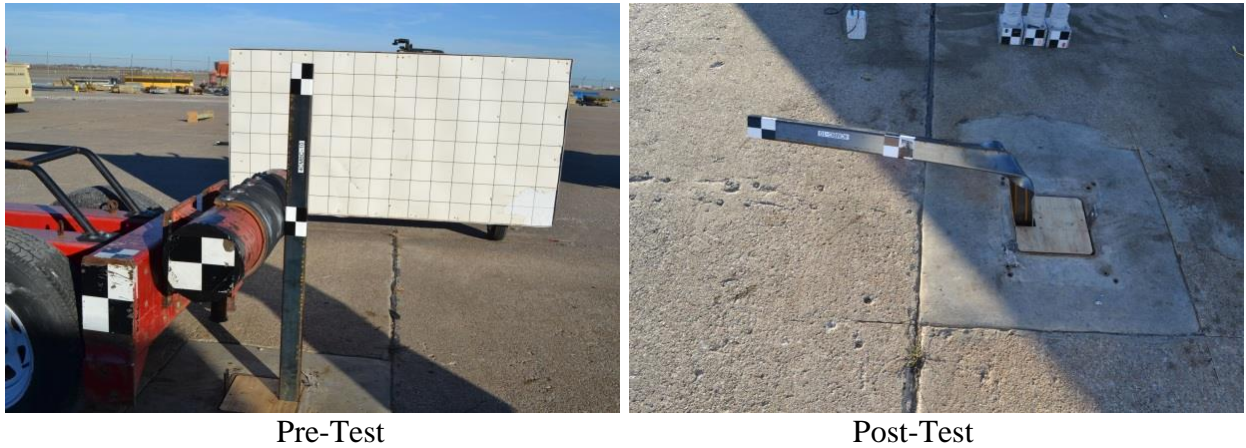
Figure 35. Pre-Test and Post-Test Photographs, Test No. 4CMBC-10

Force vs. deflection and energy vs. deflection curves created from the DTS accelerometer data are shown in Figure 34. The forces quickly rose to a peak force of 4.3 kips (19.1 kN) at 1.8 in. (46 mm) of deflection. The post provided an average resistive force of 1.8 kips (8.0 kN) through 10 in. (254 mm) of deflection and 1.3 kips (5.8 kN) through 15 in. (381 mm) of deflection. The energy absorbed by the post was 18.4 kip-in. (2.1 kJ) through 10 in. (254 mm) of deflection and 20.2 kip-in. (2.3 kJ) through 15 in. (381 mm) of deflection. Pre-test and post-test photographs are shown in Figure 35. Time-sequential photographs are shown in Figure 36.

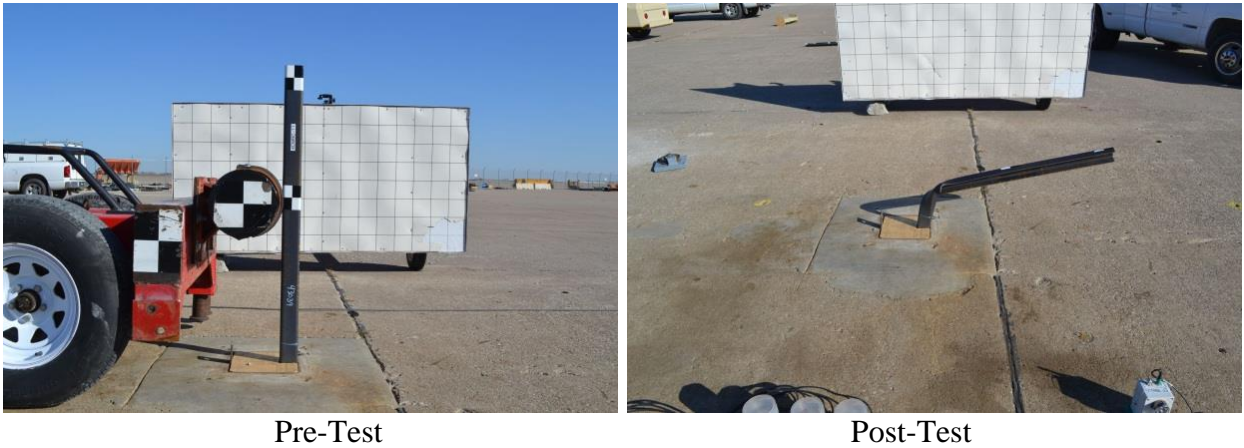
Figure 38. Pre-Test and Post-Test Photographs, Test No. 4CMBC-11

Force vs. deflection and energy vs. deflection curves created from the DTS accelerometer data are shown in Figure 37. The forces quickly rose to a peak force of 5.5 kips (24.5 kN) at 1.9 in. (48 mm) of deflection. The post provided an average resistive force of 2.5 kips (11.1 kN) through 10 in. (254 mm) of deflection and 1.9 kips (8.5 kN) through 15 in. (381 mm) of deflection. The energy absorbed by the post was 24.8 kip-in. (2.8 kJ) through 10 in. (254 mm) of deflection and 29.1 kip-in. (3.3 kJ) through 15 in. (381 mm) of deflection. Pre-test and post-test photographs are shown in Figure 38. Time-sequential photographs are shown in Figure 39.

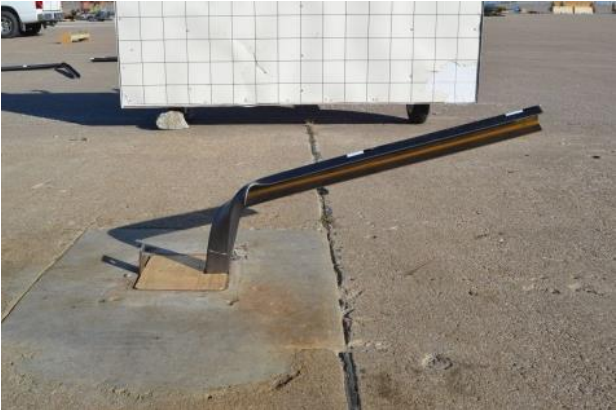
Figure 41. Post-Test Photograph, Test No. 4CMBC-12

Force vs. deflection and energy vs. deflection curves created from the DTS accelerometer data are shown in Figure 40. The forces quickly rose to a peak force of 6.2 kips (27.6 kN) at 2.3 in. (58 mm) of deflection. The post provided an average resistive force of 2.7 kips (12.0 kN) through 10 in. (254 mm) of deflection and 2.1 kips (9.3 kN) through 15 in. (381 mm) of deflection. The energy absorbed by the post was 26.9 kip-in. (3.0 kJ) through 10 in. (254 mm) of deflection and 31.6 kip-in. (3.6 kJ) through 15 in. (381 mm) of deflection. Post-test photographs are shown in Figure 41. Time-sequential photographs are shown in Figure 42.

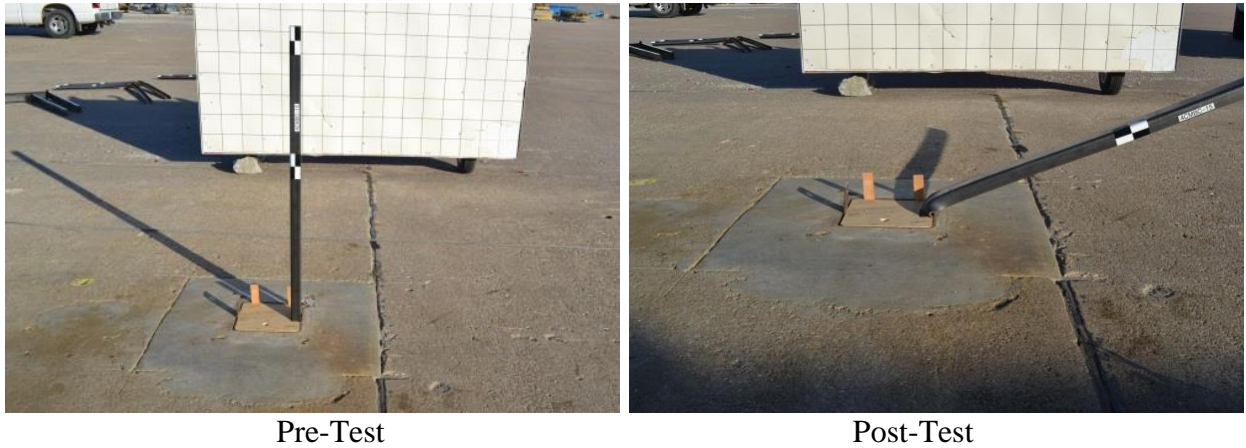
Figure 50. Pre-Test and Post-Test Photographs, Test No. 4CMBC-15

Force vs. deflection and energy vs. deflection curves created from the DTS accelerometer data are shown in Figure 49. The forces quickly rose to a peak force of 5.2 kips (23.1 kN) at 3.4 in. (86 mm) of deflection. The post provided an average resistive force of 1.6 kips (7.1 kN) through 10 in. (254 mm) of deflection and 1.3 kips (5.8 kN) through 15 in. (381 mm) of deflection. The energy absorbed by the post was 16.3 kip-in. (1.8 kJ) through 10 in. (254 mm) of deflection and 19.8 kip-in. (2.2 kJ) through 15 in. (381 mm) of deflection. Pre-test and post-test photographs are shown in Figure 50. Time-sequential photographs are shown in Figure 51.

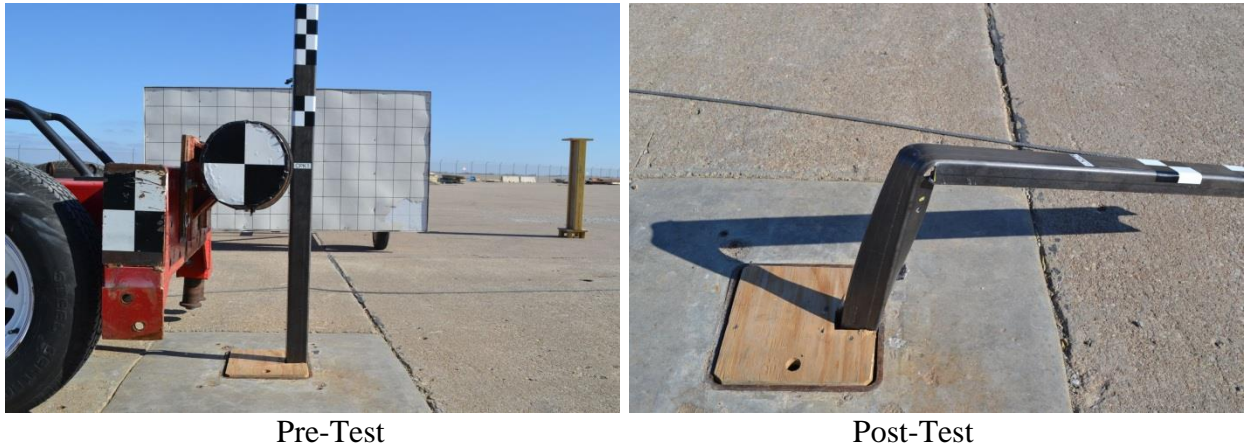
Figure 74. Pre-Test and Post-Test Photographs, Test No. CPK-1

Force vs. deflection and energy vs. deflection curves created from the DTS-SLICE accelerometer data are shown in Figure 73. The forces quickly rose to a peak force of 7.0 kips (31.1 kN) at 2.5 in. (64 mm) of deflection. The post provided an average resistive force of 2.1 kips (9.3 kN) through 5 in. (127 mm) of deflection and 2.0 kips (8.9 kN) through 10 in. (254 mm) of deflection. The energy absorbed by the post was 10.5 kip-in. (1.2 kJ) through 5 in. (127 mm) of deflection and 20.4 kip-in. (2.3 kJ) through 10 in. (254 mm) of deflection. Pre-test and post-test photographs are shown in Figure 74. Time-sequential photographs are shown in Figure 75.

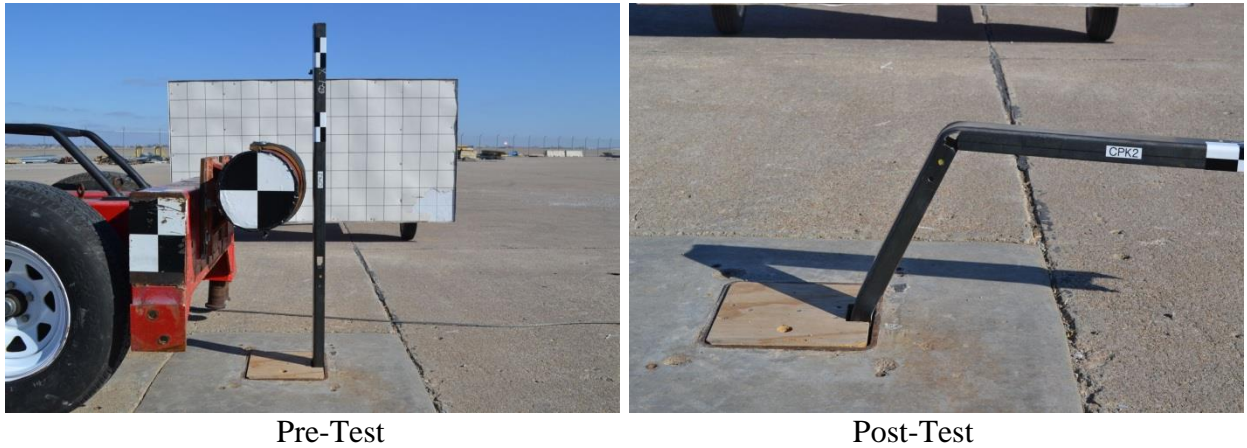
Figure 77. Pre-Test and Post-Test Photographs, Test No. CPK-2

Force vs. deflection and energy vs. deflection curves created from the DTS-SLICE accelerometer data are shown in Figure 76. The forces quickly rose to a peak force of 5.2 kips (23.1 kN) at 2.3 in. (58 mm) of deflection. The post provided an average resistive force of 2.3 kips (10.2 kN) through 5 in. (127 mm) of deflection and 1.5 kips (6.7 kN) through 10 in. (254 mm) of deflection. The energy absorbed by the post was 11.5 kip-in. (1.3 kJ) through 5 in. (127 mm) of deflection and 15.4 kip-in. (1.7 kJ) through 10 in. (254 mm) of deflection. Pre-test and post-test photographs are shown in Figure 77. Time-sequential photographs are shown in Figure 78.

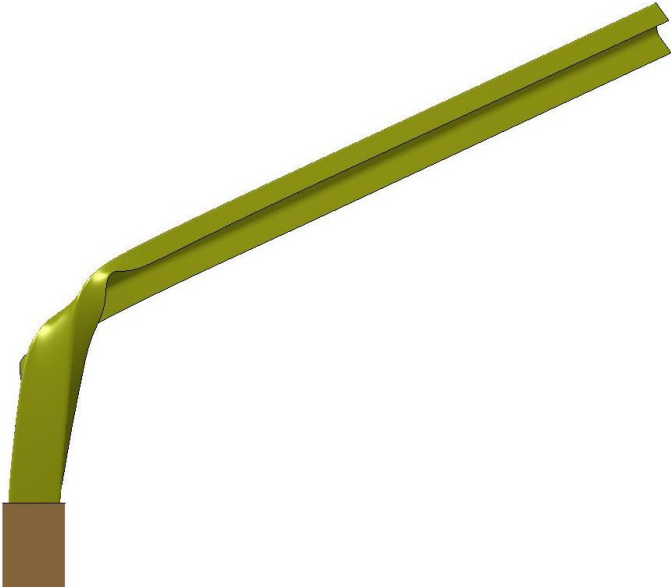
Figure 86. Deformed Post Shape, Test Nos. 4CMBC-11 and 4CMBC-12, and LS-DYNA Simulation

An initial model of the 7-gauge bent C-section post was created without keyways for comparison with test nos. 4CMBC-11 and 4CMBC-12 in order to verify that the model produced representative force and energy levels and similar deformation to the strong axis component tests, as shown in Figure 83. Sequential comparisons between the results from the simulation and the component tests are shown in Figure 84. The force vs. deflection and energy vs. deflection plots from the simulation and testing are shown in Figure 85, and the deformation and failure mode of the deformed post following the test are shown in Figure 86.

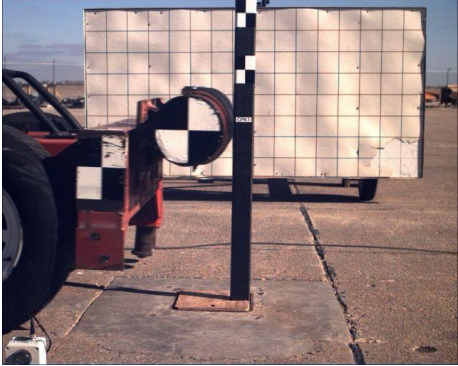
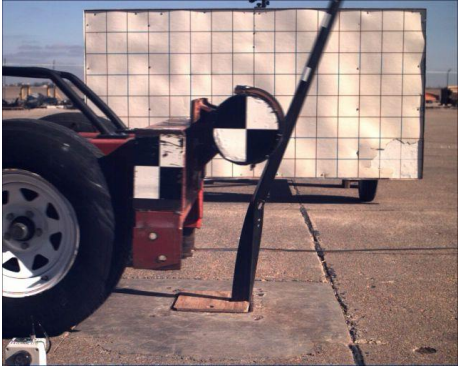
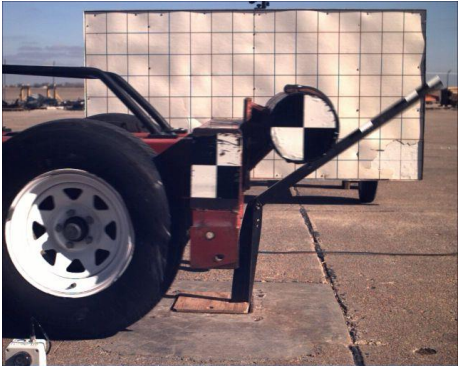
Figure 87. LS-DYNA Simulation of 7-Gauge Bent C-Section Post Strong-Axis Impact

A second model of the 7-gauge bent C-section post was created with the keyways and holes for the cable-to-post attachments, as shown previously in test nos. CPK-1 and CPK-2. The simulation model used the same general setup and model parameters as the previous C-section post model except for the addition of the keyways, as shown in Figure 87. The objective of the simulation model was to verify that the simulation model could capture the buckling of the post near the keyway that the researcher desired to eliminate. Once the model proved capable of replicating that failure mode, there would be high confidence that simulation of revised post sections would be able to indicate potential solutions.

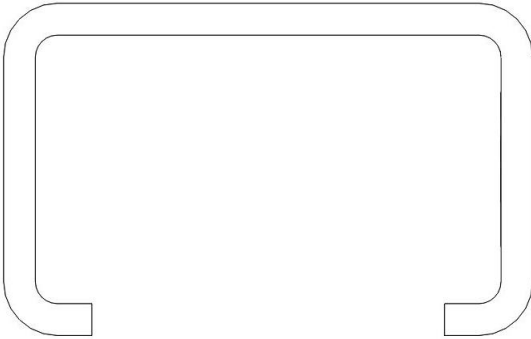
Figure 91. Proposed C-Section Post Modification, Additional Flange Tabs

Both of the proposed post section modifications were simulated, and the results for the increased flange length and the additional flange tabs are shown in Figure 92 and Figure 93, respectively. In both cases, the failure mode of the post remained buckling of the post flange near the lower keyway. This was undesirable due to the exposed post stub and the inadequate energy absorption caused by the buckling.

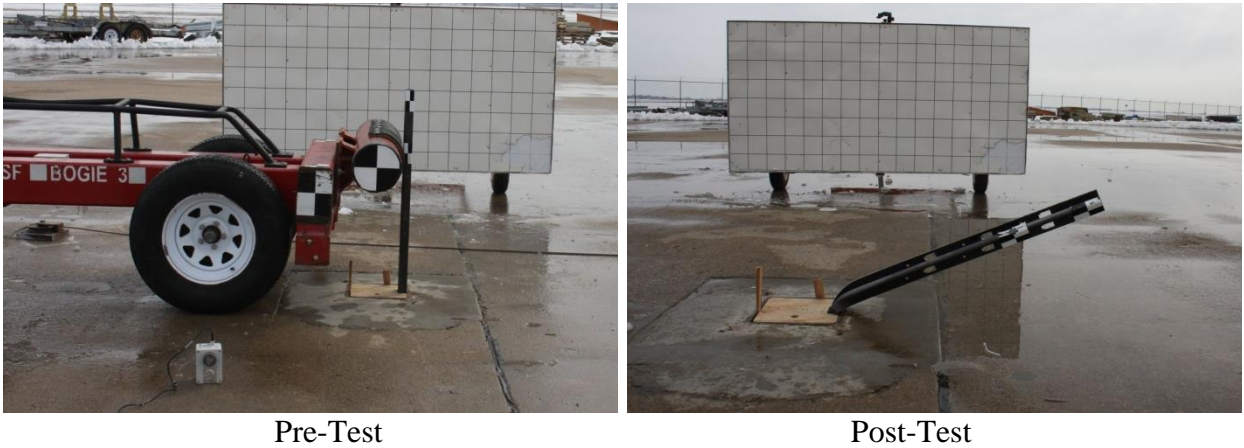
Figure 109. Force vs. Deflection and Energy vs. Deflection, Test No. CPZ-1

Force vs. deflection and energy vs. deflection curves created from the DTS-SLICE accelerometer data are shown in Figure 109. The forces quickly rose to a peak force of 4.2 kips (18.7 kN) at 1.7 in. (43 mm) of deflection. The post provided an average resistive force of 1.6 kips (7.1 kN) through both 10 in. (254 mm) and 15 in. (381 mm) of deflection. The energy absorbed by the post was 16.3 kip-in. (1.8 kJ) through 10 in. (254 mm) of deflection and 24.4 kip-in. (2.8 kJ) through 15 in. (381 mm) of deflection. Pre-test and post-test photographs are shown in Figure 110. Time-sequential photographs are shown in Figure 111.

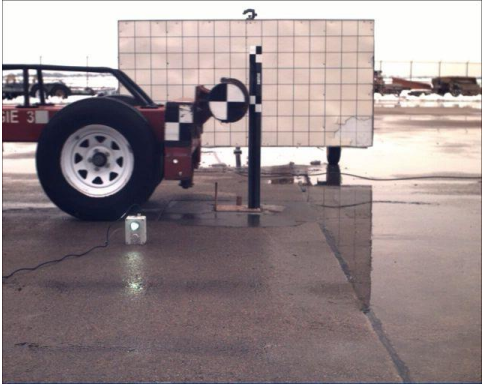
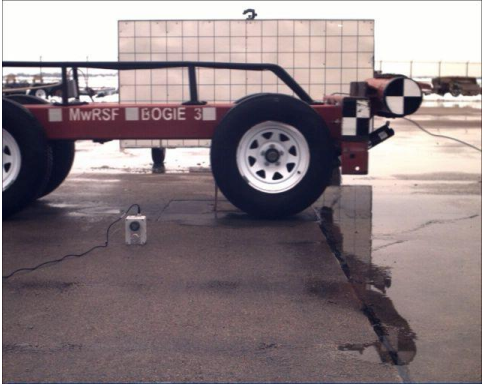
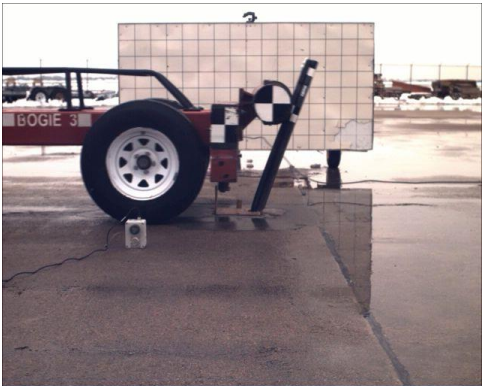
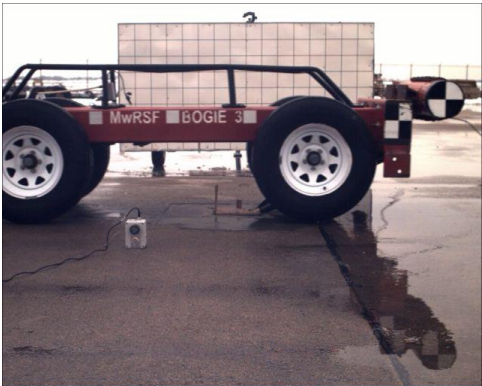
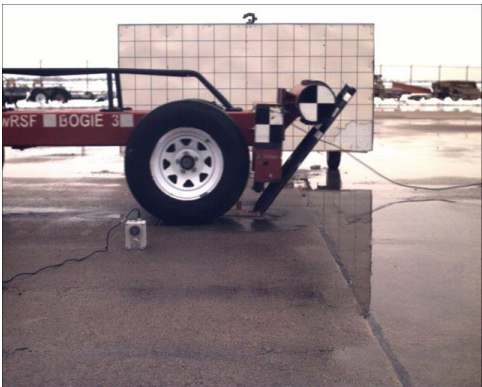
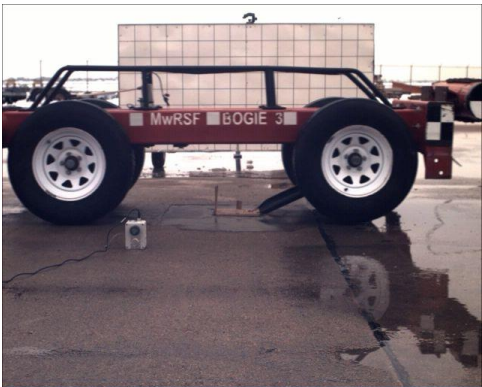
Figure 114. Sequential Photographs, Test No. CPZ-2

Force vs. deflection and energy vs. deflection curves created from the DTS-SLICE accelerometer data are shown in Figure 112. The forces quickly rose to a peak force of 4.4 kips (19.6 kN) at 1.9 in. (48 mm) of deflection. The post provided an average resistive force of 2.1 kips (9.3 kN) through 10 in. (254 mm) of deflection and 1.8 kips (8.0 kN) through 15 in. (381 mm) of deflection. The energy absorbed by the post was 20.8 kip-in. (2.4 kJ) through 10 in. (254 mm) of deflection and 27.7 kip-in. (3.1 kJ) through 15 in. (381 mm) of deflection. Pre-test and post-test photographs are shown in Figure 113. Time-sequential photographs are shown in Figure 114.

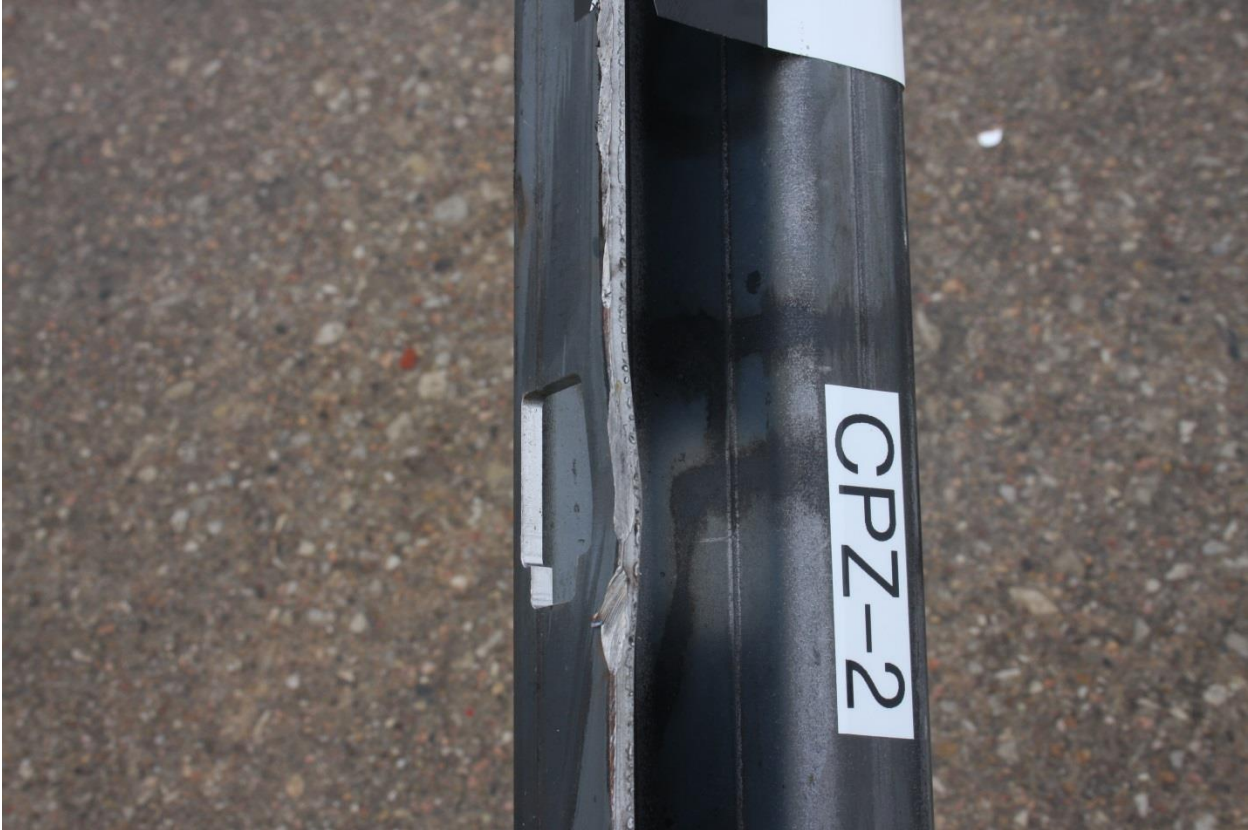
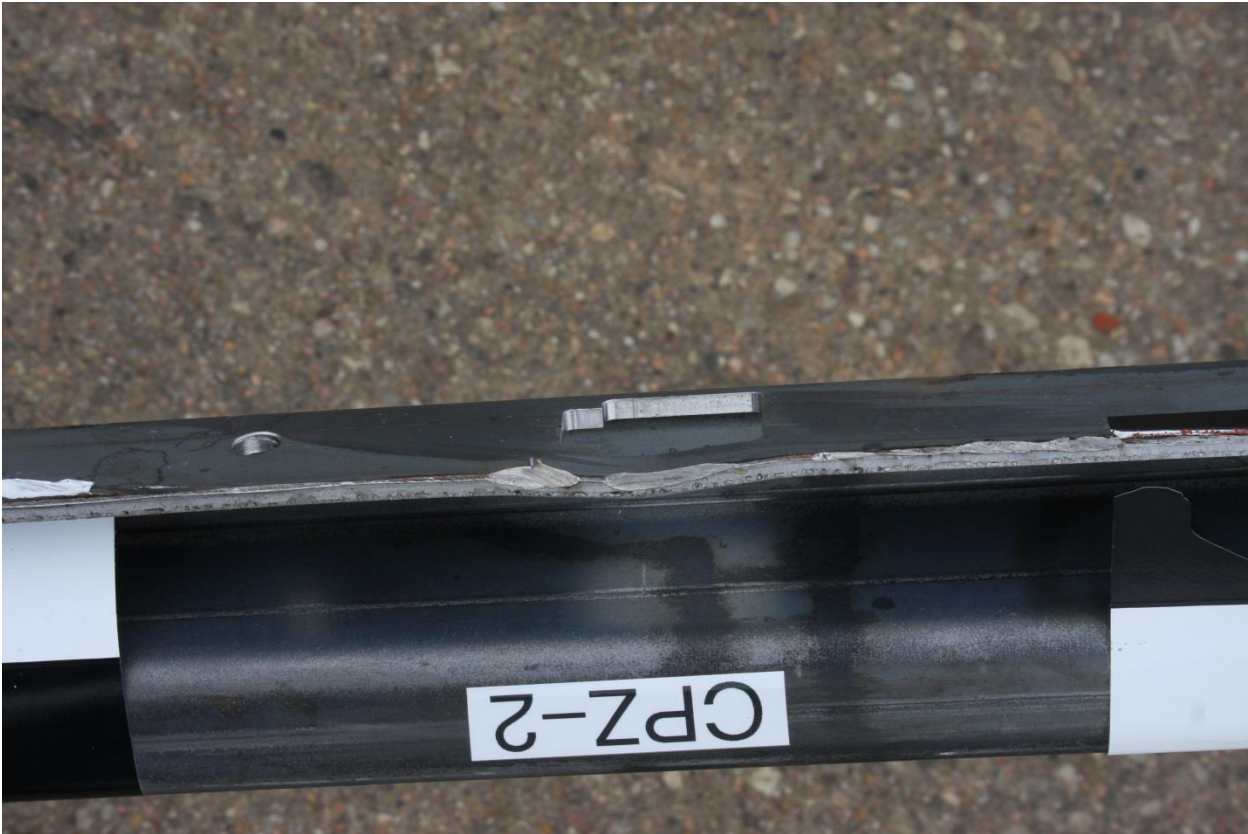
Figure 115. Localized Deformation of MWP Post Near Upper Keyway, Test No. CPZ-2

Review of the damage to the MWP post following test no. CPZ-2 found that there was some local deformation of the post in the area between the uppermost keyway and the outer edge of the post, as shown in Figure 115. This deformation of the keyway posed a potential concern that excess deformation of the post near the keyway could prevent proper function of the cable-to-post attachments due to narrowing of the keyway exit area. Thus, it was noted that a slight widening of the post flange might be warranted to strengthen that area of the post while not drastically increasing the strong and weak axis section properties of the post.

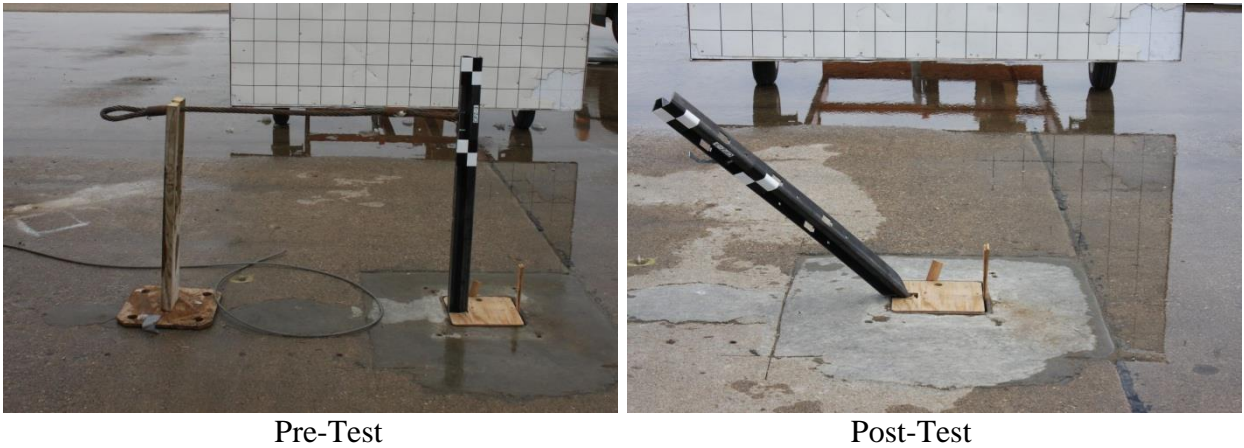
Figure 116. Force vs. Deflection, Test No. CPZ-3

Force vs. deflection data from the DTS-SLICE accelerometer data are shown in Figure 116. Due to the gradual tensioning and stretch in the cable, the deflections measured by the bogie vehicle acceleration were difficult to correlate with the actual deflection of the MWP. Thus, while the loads measured in the test were accurate, the accelerometer deflections do not align directly with the post deflections. The deflection over the first 5 in. (127 mm) to 8 in. (203 mm) was due to the bogie picking up and tensioning the cable used to load the bracket and post. The forces gradually rose to a peak force of 3.5 kips (15.6 kN). Average forces and energies for the post were not calculated, due to the deflection measurement difficulties noted above. The cable was released from the post after the post bent to approximately 56 degrees at a time of 102 msec, and no indications of buckling or post instability were noted. Pre-test and post-test photographs are shown in Figure 117. Time-sequential photographs are shown in Figure 118.

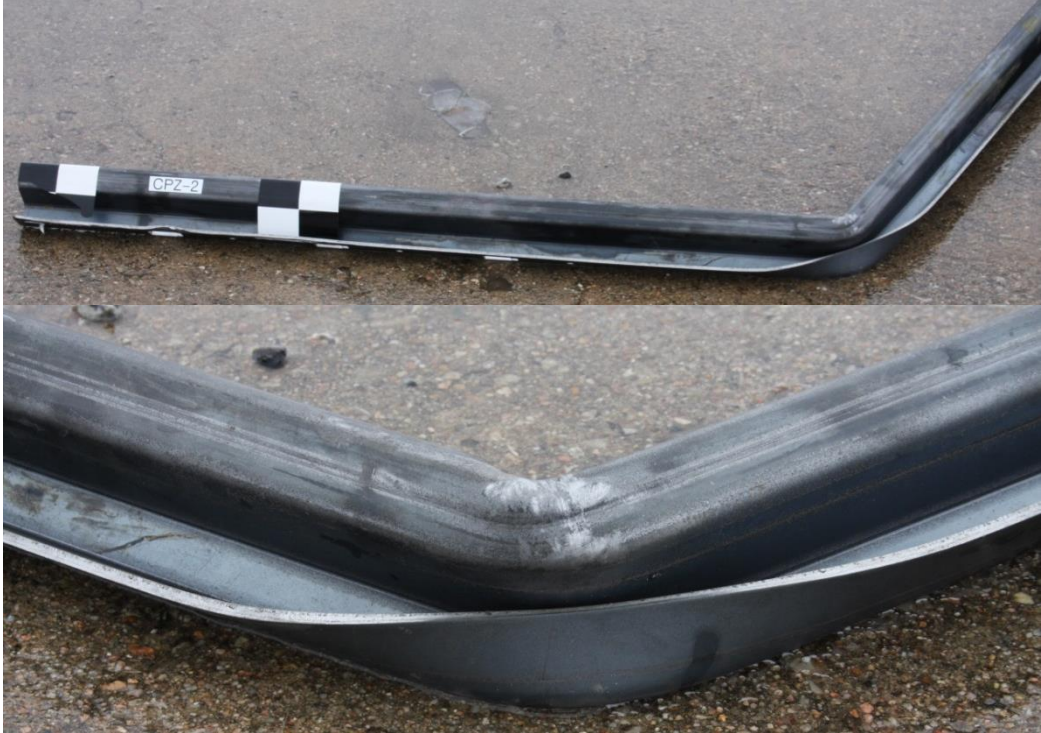
Figure 124. Force and Energy Versus Deflection, Strong-Axis Test No. CPZ-2 and LS-DYNA MWP Simulation

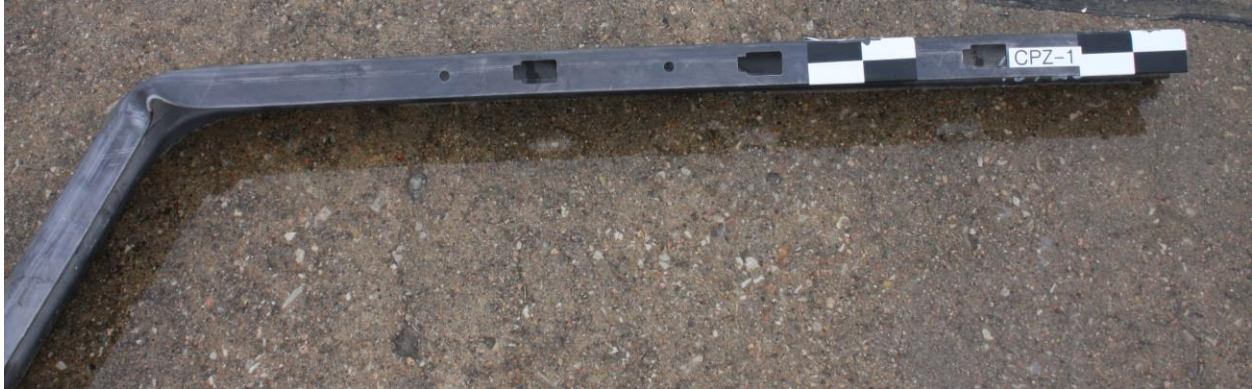
Figure 127. Force and Energy Versus Deflection, Weak-Axis Test No. CPZ-1 and LS-DYNA MWP Simulation
