Advanced Low-Floor Vehicle (ALFV) Specification Research

MNTRC Report 12-27

ADVANCED LOW-FLOOR VEHICLE (ALFV) SPECIFICATION RESEARCH

August 2015

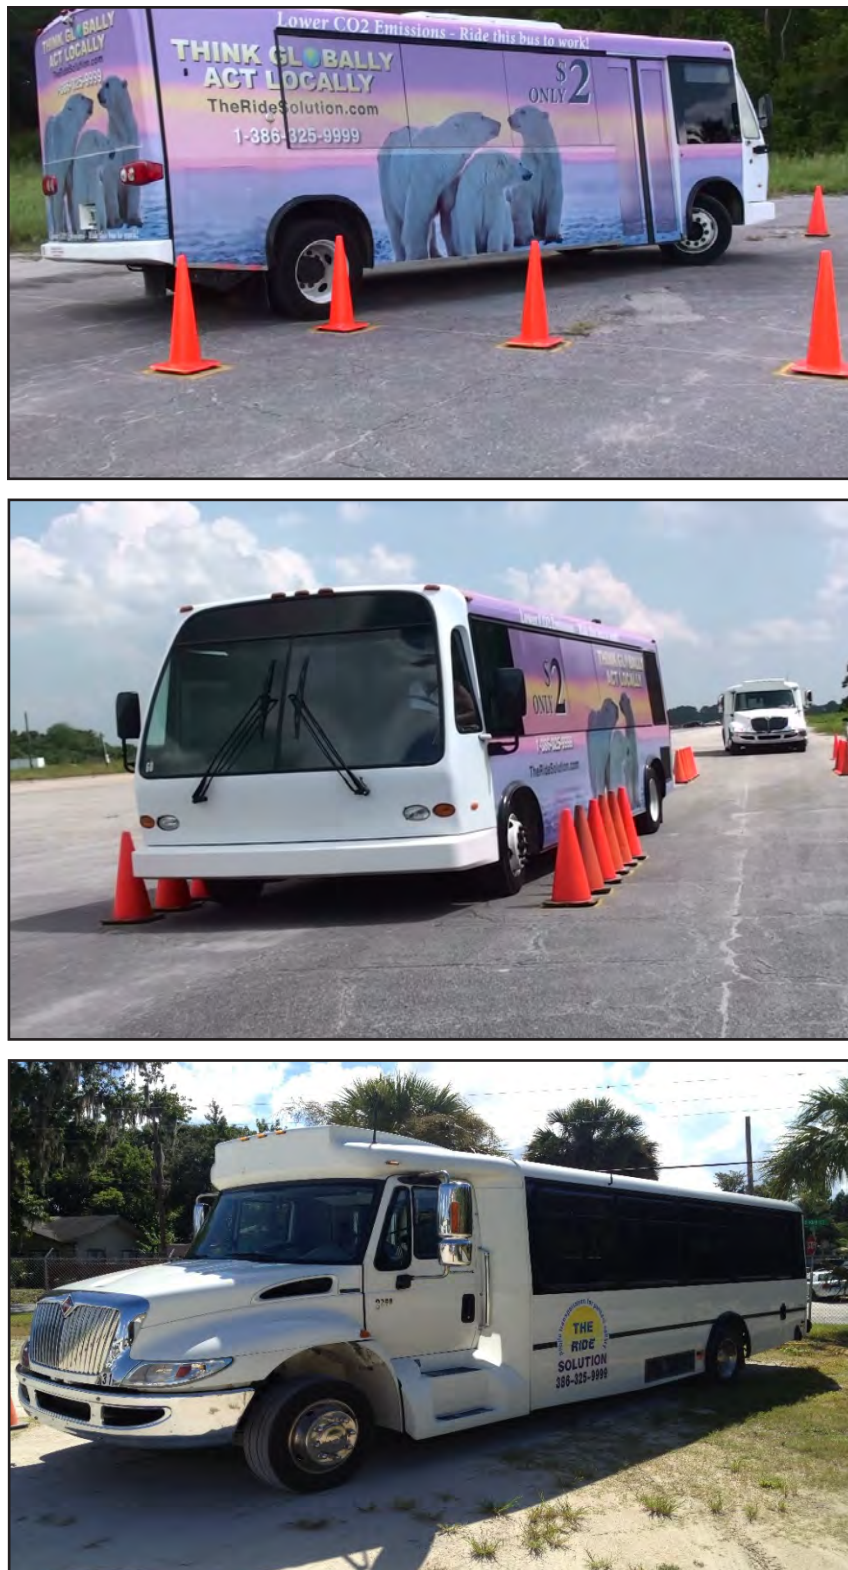
Figure 1. ALFV Operating through Two Bus Roдео Events, and Competing Bus

competing vehicle measured 31 feet (9.45 meters) long and 102 inches (2.59 meters) wide and was at a clear disadvantage in the bus Roadeo obstacles. It is the low-floor ALFV's unique ability to accommodate 25 passengers in 26 feet (7.92 meters) of vehicle length that gives it a time advantage both in the rodeo and in flex route services, which place a premium on route deviation. Vehicle agility can translate to savings due to reduced time in the operating budget and, by facilitating the flex-route format, can yield increased productivity. Photographs of the ALFV operating during one of the Bus Roadeo events and the competing vehicle are shown in Figure 1.

As shown in Figure 1, due to the better agility of the ALFV, the agility savings could add to \$1,597,709 for the 17 routes utilizing 17 vehicles over 20 years, if all the time saved during the roadeo were converted to time savings in service.

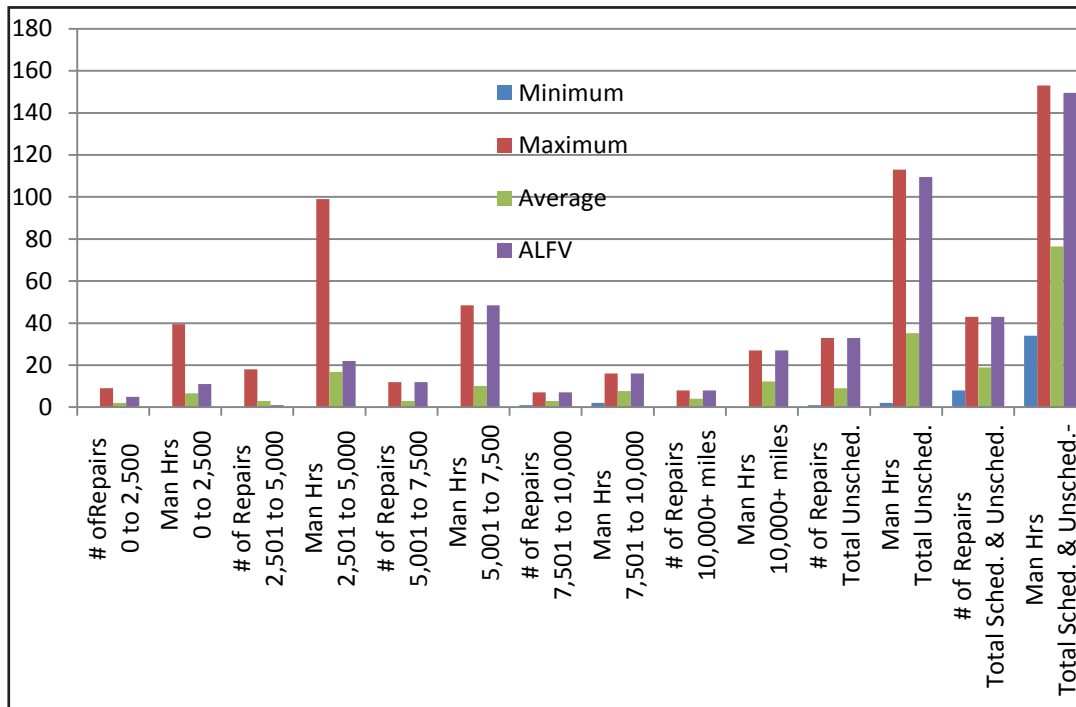
Figure 19. Comparison of Unscheduled Maintenance Minimum, Maximum, Average Repair Time and Hours

Figure 19 shows a comparison of unscheduled maintenance occurring on the vehicles. Unscheduled maintenance includes components that were unexpectedly replaced or repaired during the testing program, typically due to failure or premature wear. These data provide a closer connection to the cost of maintenance and repairs on the vehicle, as these are generally calculated by the cost of parts and labor. The total of these items often dictates the amount of the transit operator's budget for inventory (parts) and labor (mechanics' salaries). The lowest total number of unscheduled vehicle repairs of all vehicles was one repair. The highest number of unscheduled vehicle repairs was 43,

and the average for the group was 9 repairs. Fifteen vehicles had less than the average number of repairs. The total unscheduled maintenance work hours required by all 25 vehicles tested for unscheduled maintenance averaged 35.24 hours. The lowest number of work hours was 2 and the highest required (by the ALFV) was 113 work hours. The ALFV had more than five times the work hours of unscheduled repairs than the vehicle with the least number of work hours.
