Laboratory Investigation of Grouted Coupler Connection Details for ABC Bridge Projects

**Final Report
August 2015**

Sponsored by
Federal Highway Administration
Iowa Department of Transportation
(InTrans Project 12-441)

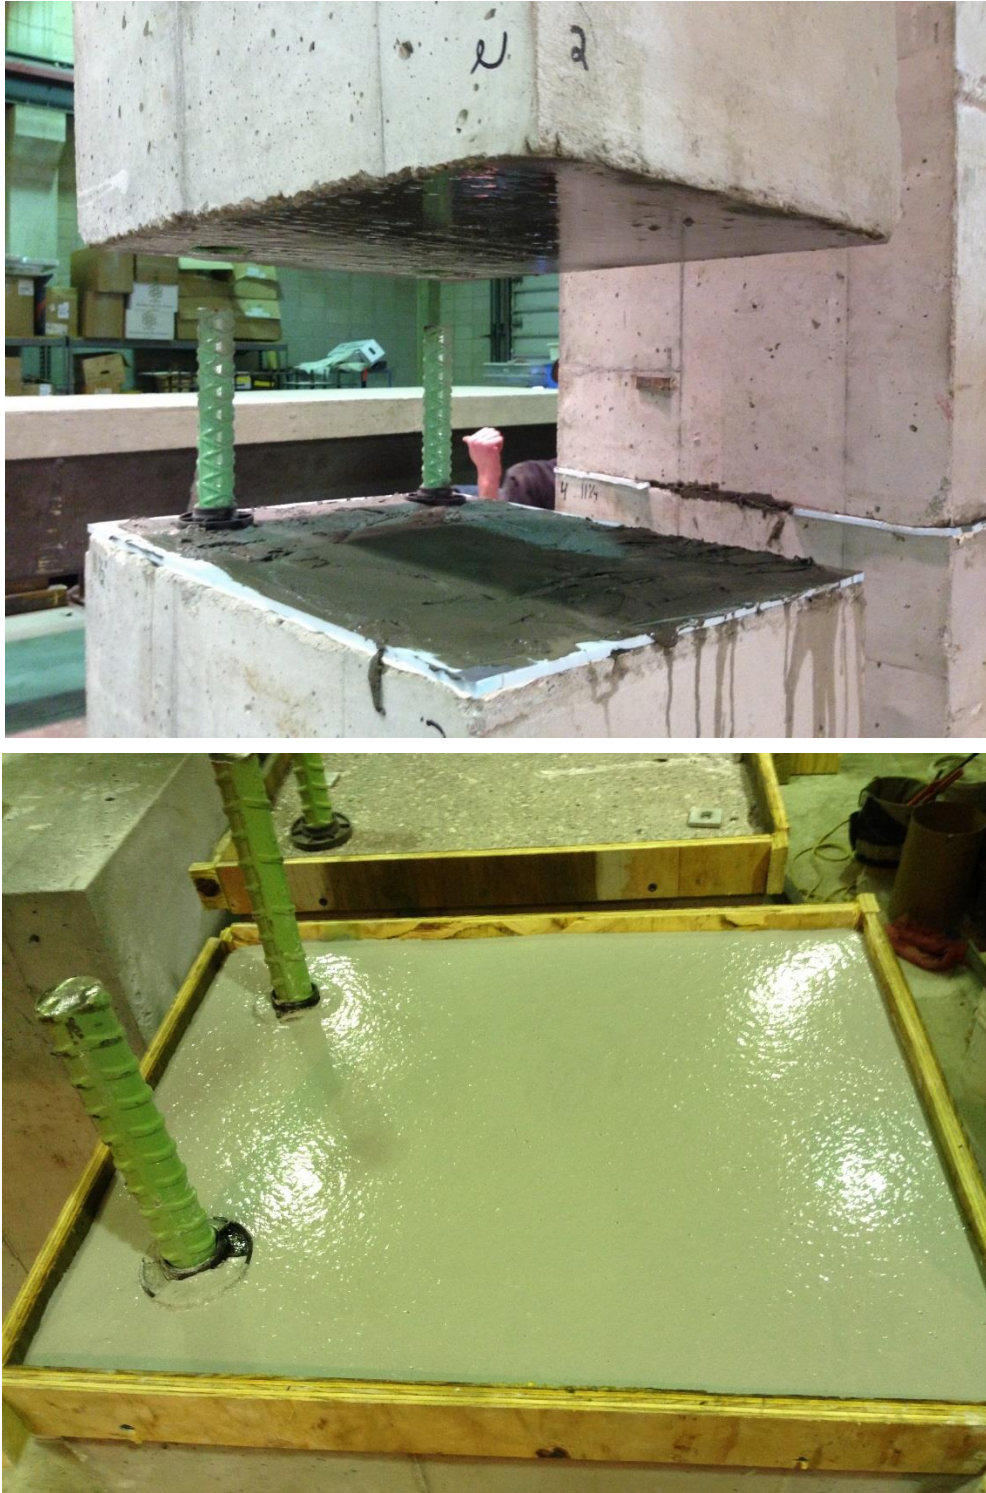
Figure 8. W. R. Meadows grout bed (top) and UHPC grout bed (bottom)

Sleeve-lock seal plugs were used on the protruding reinforcing steel to prohibit bedding grout from entering the couplers. Once all three were properly in place, the grout was placed on the top of the bottom specimen and the top specimen was carefully lowered on top (see Figure 8).

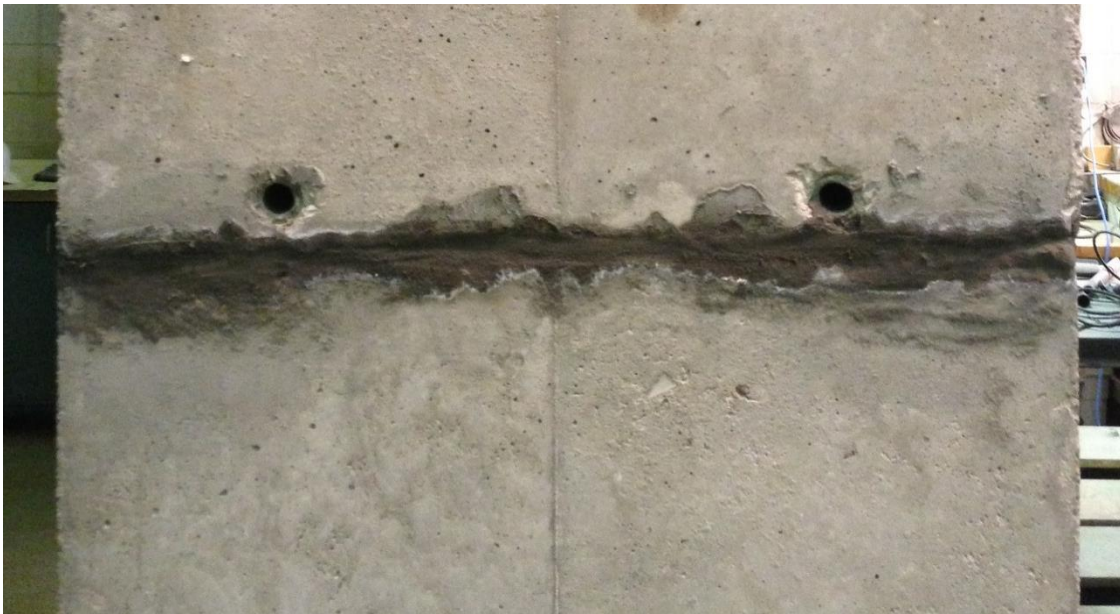
Figure 9. Specimen grout bed using W. R. Meadows 588-10k

Figures 9 and 10 show the completed grout beds for one specimen using W. R. Meadows 588-10k grout and another using UHPC as the grout bed, respectively.

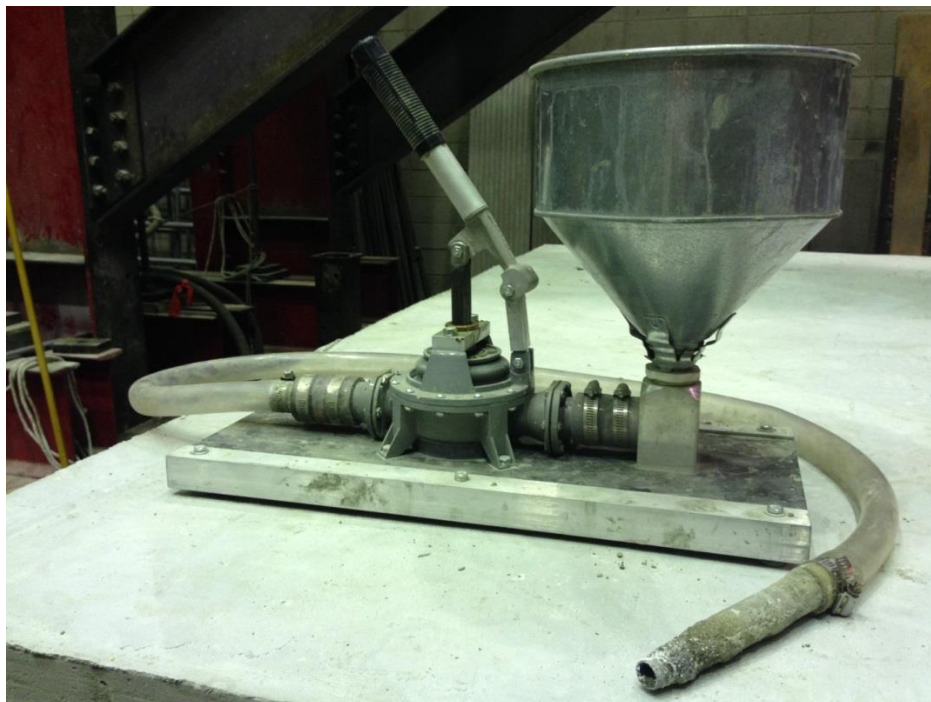
Figure 12. Grout pump used for grouting the reinforcing steel couplers

After installation of the bedding grout, the reinforcing steel couplers were grouted. The couplers were grouted using Dayton Superior Sleeve-Lock Grout and a hand pump (Figures 11 and 12).

Each batch of grout was mixed per manufacturer recommendations and pumping of the grout was completed as follows: 1) mix grout, 2) fill pump hopper with grout, 3) insert nozzle of pump into lower port of the grouted coupler, 4) slowly pump the grout into the coupler until it begins to come out of the top port of the coupler, 5) with a steady stream of grout exiting the top port, plug the top port using a port plug, 6) quickly remove the pump nozzle and plug the bottom port with a port plug. Figure 13 illustrates the ports before grouting and Figure 14 illustrates the ports after grouting with port plugs installed.

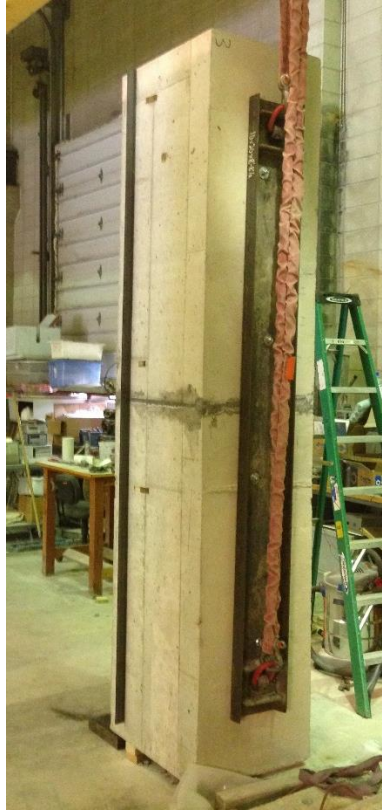
Figure 15. Vertical braced specimen before lowering to horizontal position for testing

Following curing of the bedding and coupler grout and validation of their 28-day compressive strengths, the specimens were braced in their vertical orientation by anchoring steel angles and channels to the sides and tops of the specimens. The bracing reinforced the grouted joints as the specimens were carefully lowered to their horizontal positions for testing. Figure 15 shows one specimen in its vertical braced condition prior to lowering it.

A cursory inspection of the grout joint was completed subsequent to the lowering of each specimen to ensure no cracking of the joints had occurred, and none was observed.

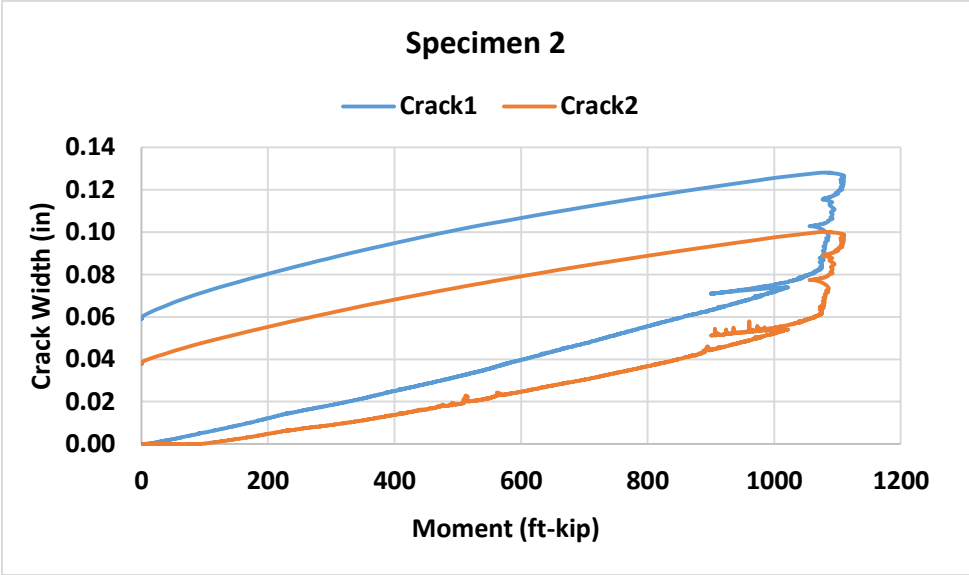
Figure 28. Moment versus crack width for Specimen 2

After testing the first specimen, the research team decided to shift the four-point loading from L/2 to L/3 to increase the moment on the joint. This decision was made in attempt to widen the crack at the joint and evaluate if it closes after removal of the load. Subsequently, Specimens 2 and 3 were tested in this configuration and the results are shown in Figures 28 and 29, respectively.

Specimen 1 and 3 both exhibited good closure of the crack after removal of the load. The Specimen 2 crack width did not close as much after unloading, although this is believed to be the result of the sustained peak load on this specimen. Peak load was temporarily maintained on

Specimen 2 for a longer period of time simply to allow for documentation of cracking and taking photographs. However, this type of loading may be more representative of the loading mechanism created by temperature affects in the field.

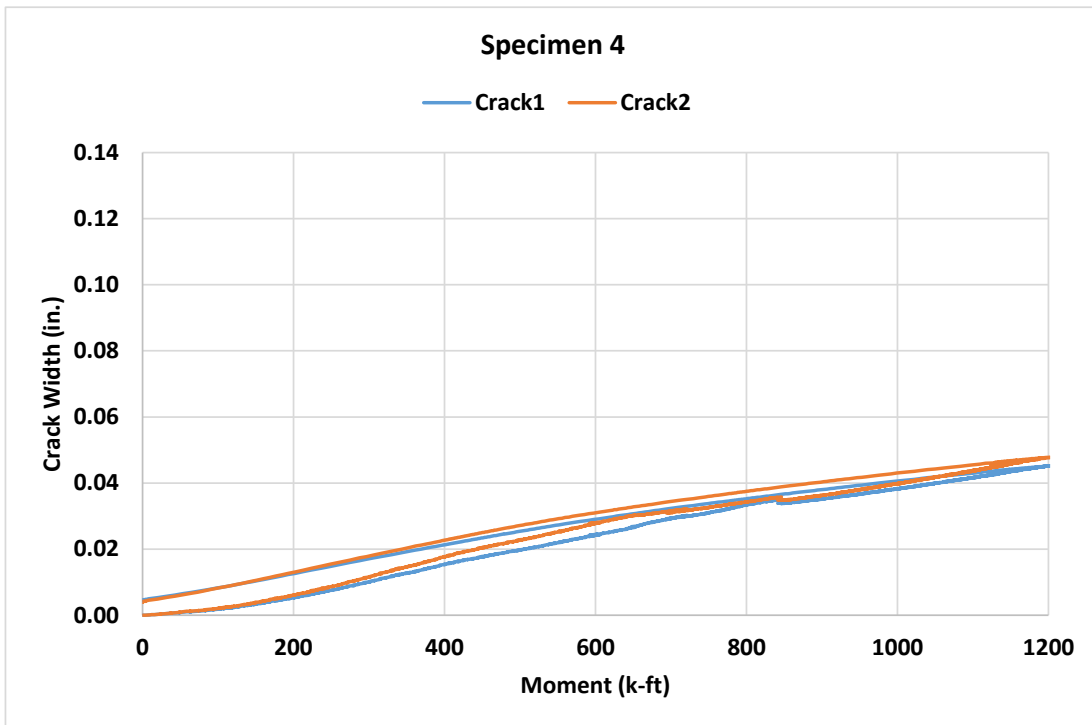
Figure 30. Moment versus crack width for Specimen 4

Following the testing of Specimens 1 through 3, Specimens 4 and 5 were instrumented and tested with an applied axial load to better represent the in-service connection detail at Keg Creek (Figure 19). Both of these specimen were loaded using the L/3 test configuration. Figures 30 and 31 show the moment versus crack width data for Specimen 4 (54k axial load) and Specimen 5 (115k axial load), respectively.

From Figures 30 and 31, it is evident that the axial loads applied to Specimen 4 and 5 only slightly decreased the crack width at the peak load when compared to Specimens 1 through 3, although there is an improvement of approximately 50 percent in the residual crack width once the load was removed.

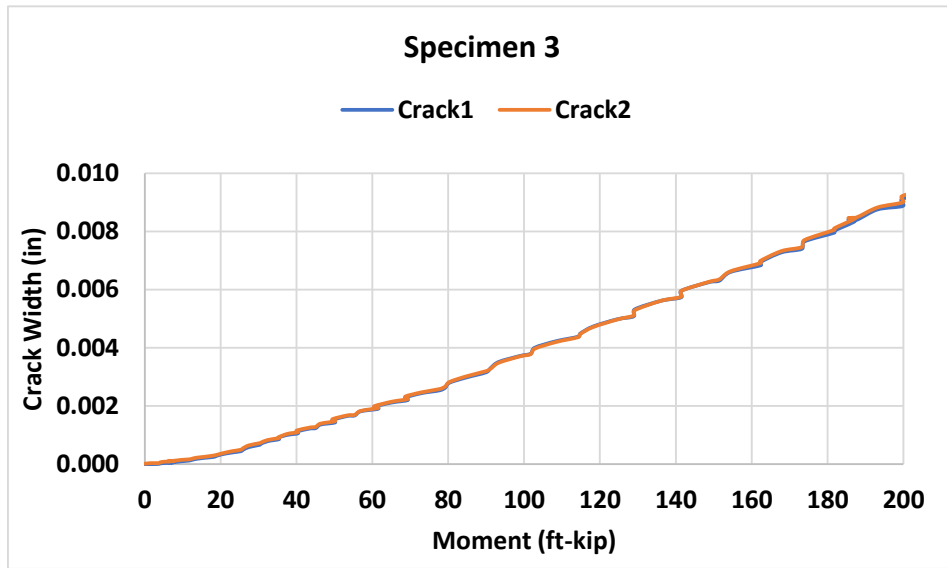
Figure 32. Typical initial crack width for specimen with no axial load, Specimen 3

For Specimens 1 through 5, cracking of the joint typically occurred on one of the interfaces between the existing concrete and the grout and started almost immediately after loading, as seen in Figures 32 and 33.

Essentially, the crack formed due to debonding of the grout.

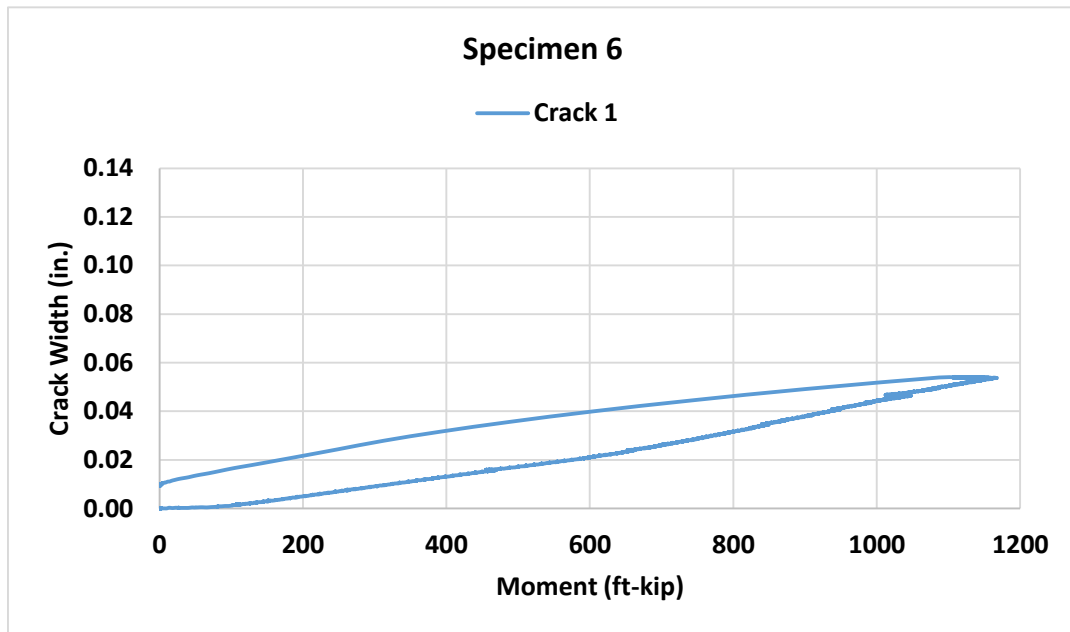
Figure 34. Moment versus crack width for Specimen 6

This setup of Specimen 6 allowed for a comparison of the data from Specimen 6 with data from Specimen 4 to evaluate the effect of the UHPC on the performance of the joint under loading. Note that one of the crackmeters malfunctioned during testing of Specimen 6; therefore, only data from one crackmeter, Crack 1, are presented. Figure 34 shows the moment versus crack width plot for Specimen 6.

Based on test data, initiation of the crack at the grout interface for Specimen 6 using the UHPC occurred at an applied moment of approximately 13 ft-k. This suggests that use of UHPC for the bedding grout in this application would slightly delay the initiation of cracking of the joint. However, there was no improvement in the degree to which the crack closed upon unloading or the magnitude of the crack width during loading when compared to Specimens 1 through 5.

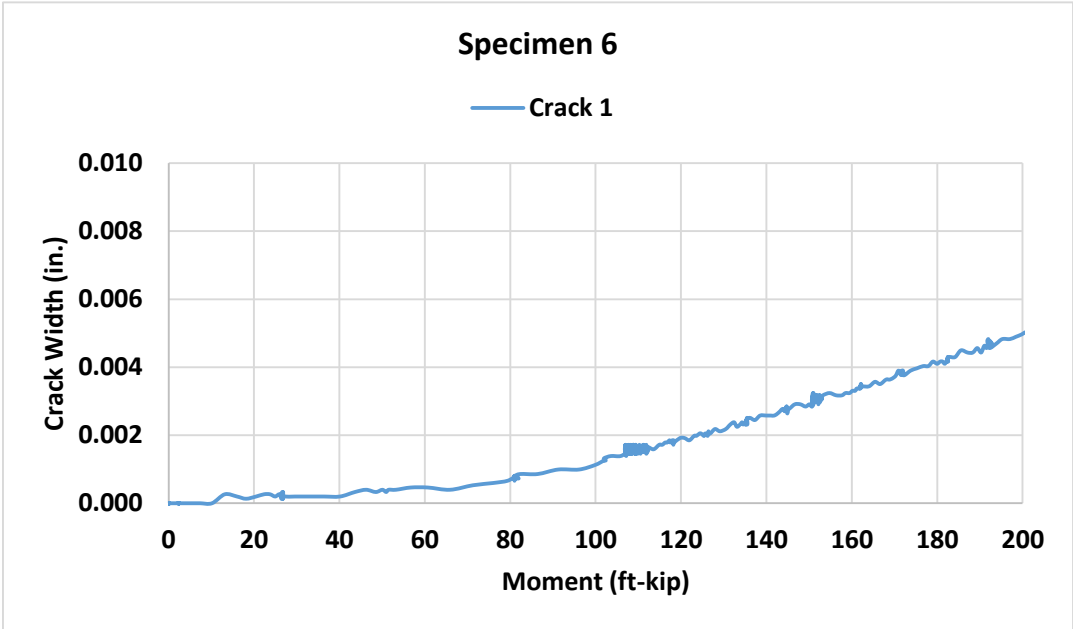
Figure 35. Initial crack width for Specimen 6

As shown in Figure 35, cracking of the joint on Specimen 6 appears to start with an applied moment of approximately 13 ft-k; whereas, cracking started almost immediately for the previous specimen.

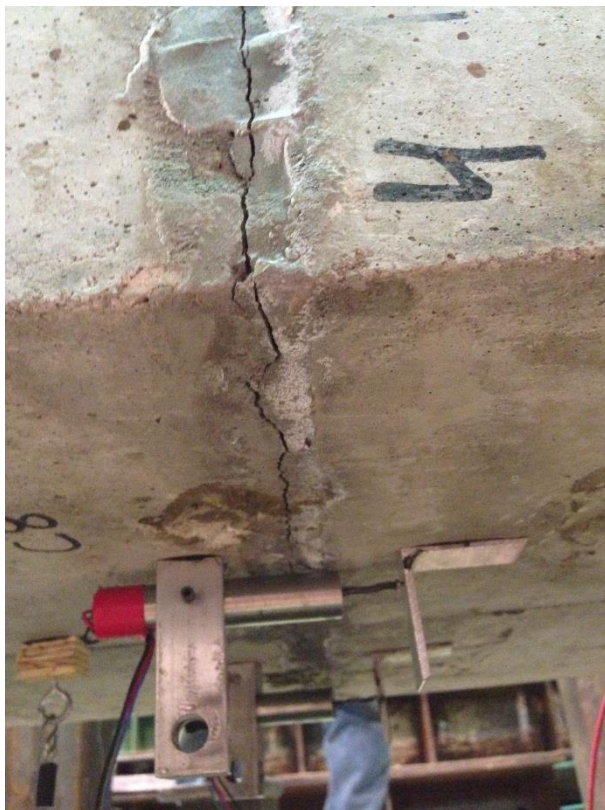
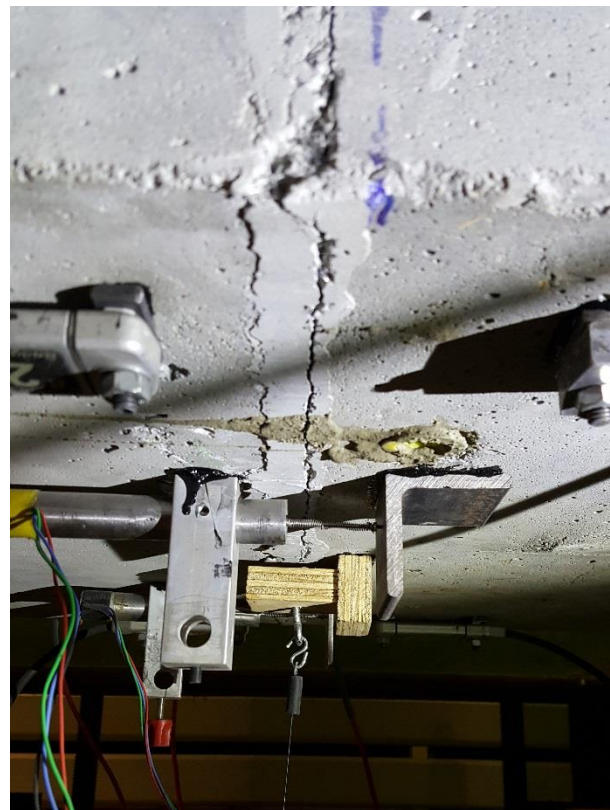
Figure 36. Crack width comparison during loading

Figure 36 shows a typical crack during loading of one specimen (Specimen 3) with standard grout (left) and Specimen 6 using UHPC (right).

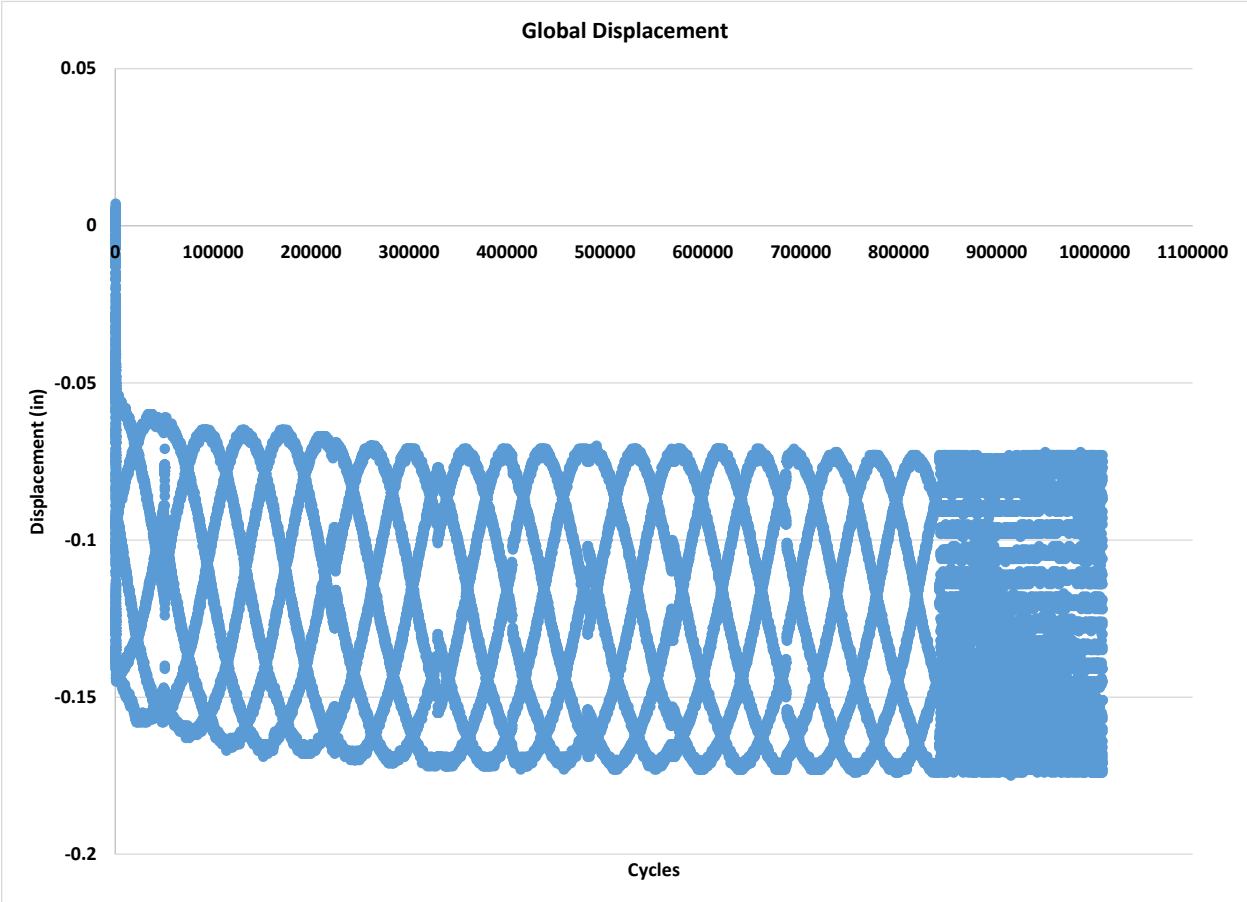
Figure 37. Specimen 7 fatigue test – global displacement

Specimen 7 was tested for fatigue up to approximately 1 million cycles. The fatigue test data indicated a well performing system with little to no creep in global deflection and/or crack width growth at the grouted interface throughout the duration of the 1 million plus cycles. In addition, upon conclusion of the testing, the global displacement and one working crackmeter returned to almost zero after unloading the system. Visibly, the cracks at the grouted joint were difficult to discern after removal of the load.

Figure 37 shows the global displacement versus cycles for the test.

The last specimen, Specimen 7, was tested in fatigue to approximately 1 million cycles using a point load of 106 kips. This was the point load calculated to produce the 18 ksi stress in the coupled #14 bars specified by the AASHTO LRFD Specification (AASHTO 2010). The fatigue test data indicated a maximum global displacement of approximately 0.18 in., which was consistent throughout the duration of the testing. Likewise, the crack width at the grouted interface remained relatively constant during the 1 million cycles and never exceeded 0.02 in.

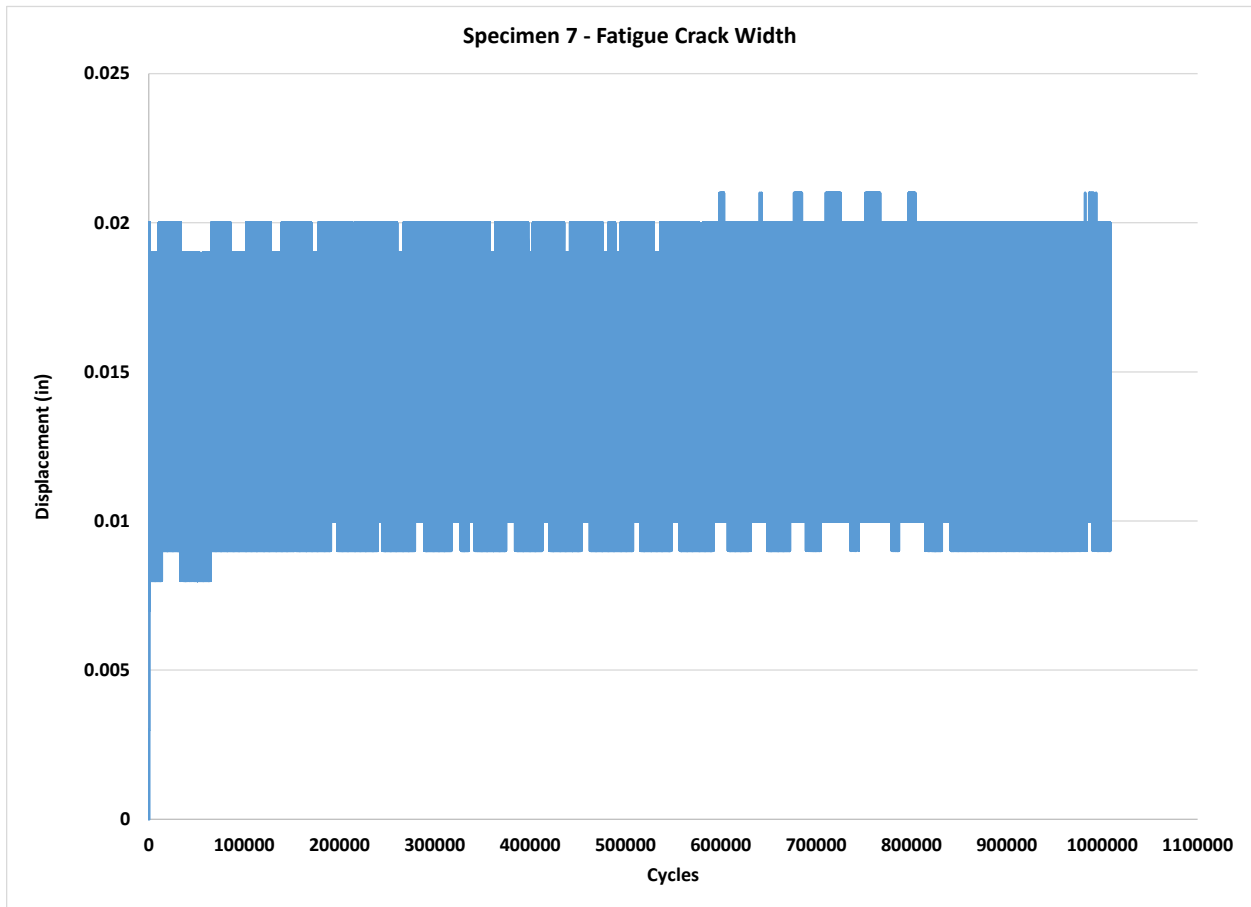
Figure 38. Specimen 7 fatigue test – crack width

Figure 38 shows a typical crack width versus cycles plot.

Note that maximum crack width measured during the fatigue testing, approximately 0.02 in., was more than half of that measured during static testing, which would be expected given the reduced loading.
