1. Report No. SWUTC/15/600451-00111-1		2. Government Accession No.		3. Recipient's Catalog No.	
4. Title and Subtitle Use of Infrared Thermography to Detect Thermal Segregation in Asphalt Overlay and Reflective Cracking Potential				5. Report Date March 2015

Use of Infrared Thermography to Detect Thermal Segregation in Asphalt Overlay and Reflective Cracking Potential

SWUTC Project No. 600451-000111

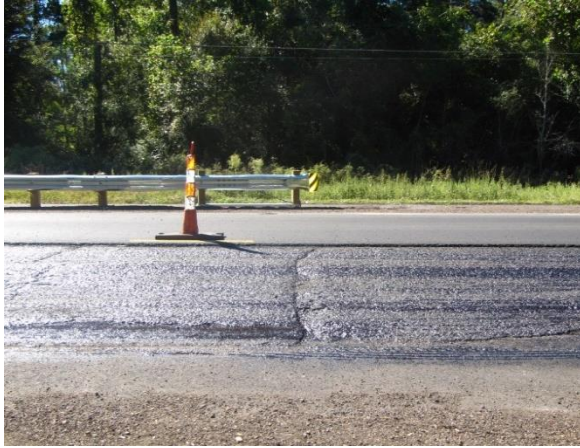
Figure 1

(a) Digital Image of a Discontinuity

(b) Infrared Image on Top of the Discontinuity (t=0)

(c) Infrared Image after compaction

Digital and Infrared Images of the Pavement Section (US 190 Field Project)

The first field project consisted of a 50.8-mm asphalt overlay that was placed over a milled asphalt concrete pavement, located on US 190 between LA 63 and LA 441. The project details are presented in Table 1. The haul distance and haul time for the project was 8.0 km and 7.0 minutes, respectively. End dump trucks were used to transport the mix. The existing milled asphalt surface was in relatively good conditions with the exception of some areas, which showed significant damage in the existing pavement. The digital and thermal images for a heavily cracked location are presented in Fig. 1. The average mat temperature was relatively uniform so generally no temperature differential was observed during paving and 30, 60, 90, 120, and 150 seconds after paving and during compaction, Fig. 1(b and c). It is noted that four locations (Sp1 to Sp4) were monitored at each point of interest (i.e., above the discontinuity and away from it). At time zero, the average temperature of the mat was 148°C with a maximum thermal differential of 2°C . After compaction, the average temperature of the mat was 132.3°C with a maximum thermal differential of 2°C . There was a reduction in HMA temperature by approximately 15°C during the period between production and placement. Based on these results, it is concluded that no thermal segregation was detected in this project. Fig. 2 presents the measured temperature profiles above and away from the discontinuity from time zero to after completion of the compaction process. As shown in this figure, the effect of the discontinuity on the mat temperature was negligible.

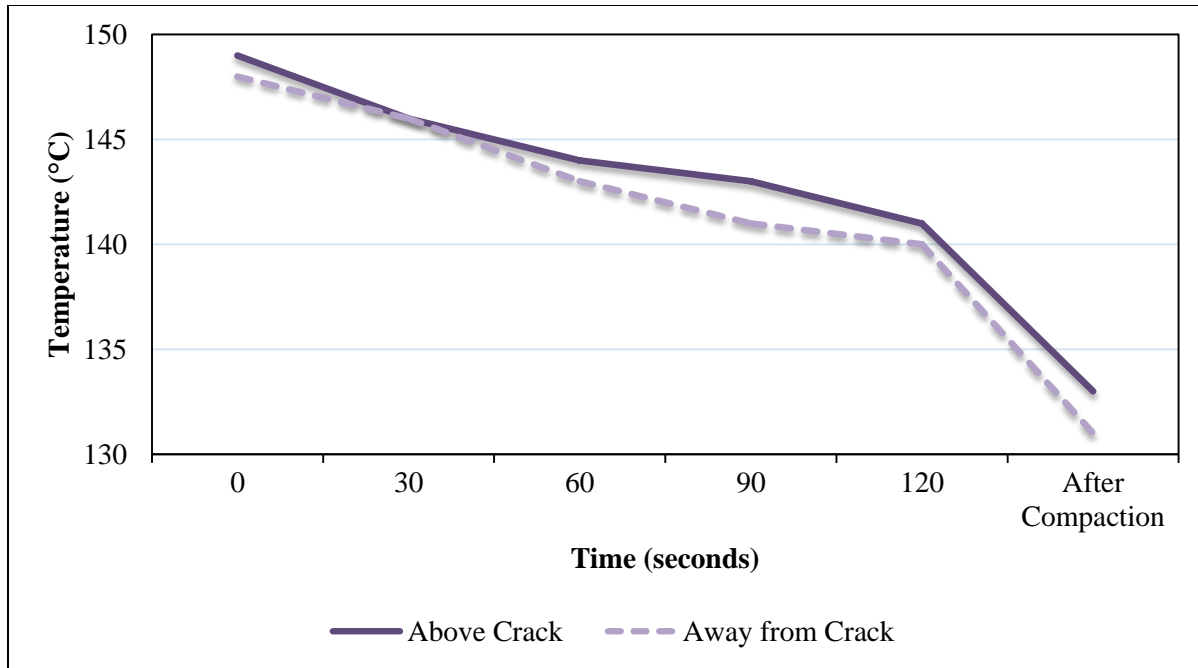
Figure 2

Variation of Temperature on the Overlay Surface with Time (US 190 Field Project)

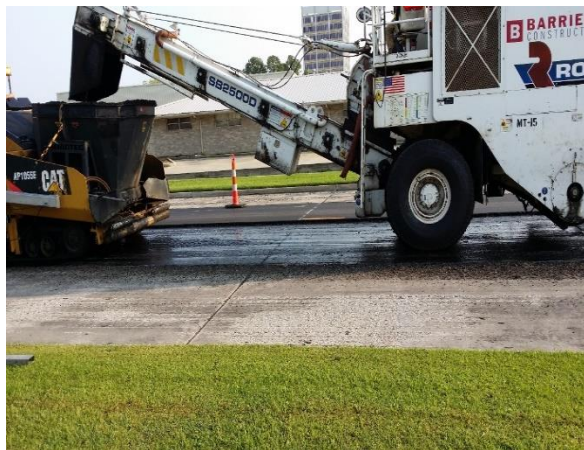
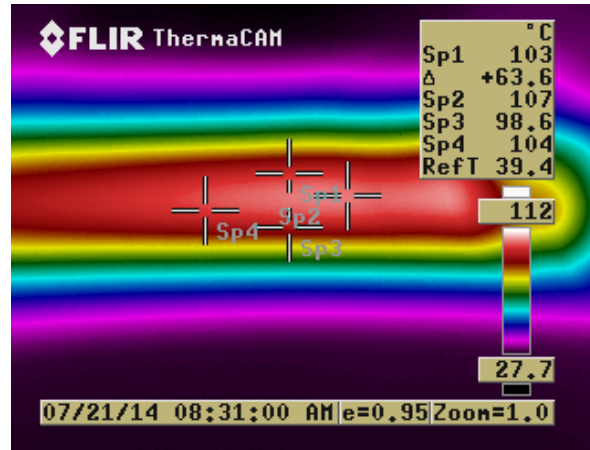
Figure 3

(a) Digital Image of a Joint Section

(b) Infrared Image above Joint (t=0)

(c) Infrared Image above Joint (t=15minutes)

Digital and Infrared Images of the Pavement Section (Tom Drive Field Project)

The second field project consisted of the resurfacing of an existing concrete pavement with a HMA overlay, located on Tom Drive in Baton Rouge (LA), Table 1. The existing concrete pavement was patched and the joints were sealed before placing the HMA overlay. The haul distance and haul time of the project were 124 kilometers and 90 minutes, respectively. On this project, a material Transfer Device (MTD) was used and the contractor used a CAT paver, a CAT steel wheel compactor, and a pneumatic tire roller for compaction. Temperature measurements were obtained from the time of paving to after completion of the compaction process, emphasizing the locations on top and away from the underlying joints. The joints were marked and located by means of GPS coordinates for future reference. For this project, the average mat temperature was 137.8°C with a maximum thermal differential of 4.1°C at time zero. After compaction, the average mat temperature dropped to 106°C with a maximum thermal differential of 2°C. Results were similar for most surveyed locations in the pavement section. However, in one area, the average mat temperatures at time zero and after compaction were 103.2°C and 76.4°C with a maximum thermal differential of 8.4°C and 5.3°C as presented in Figure 3(a and b). Based on these results and according to the recommendations of NCHRP 9-11, it is concluded that no thermal segregation was detected in this project. Digital and thermal images on top of the underlying joints are presented in Fig. 3. Fig. 4 presents the variation of the

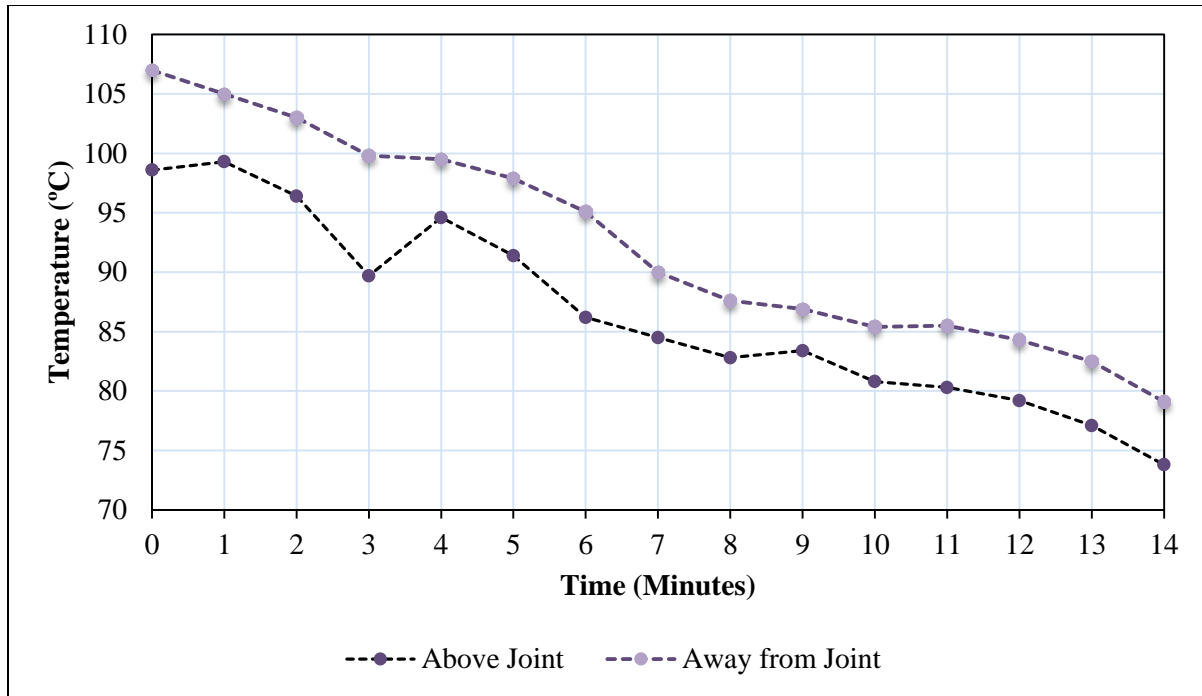
Figure 4

Variation of Temperature on the Overlay Surface with Time (Tom Drive Field Project)

temperature profiles above and away from an underlying joint from time zero to after completion of the compaction process. As shown in this figure, the temperature on top of the joint was consistently lower than away from it, which may indicate that temperature loss may occur at the joints. This trend was further investigated using finite element modeling.

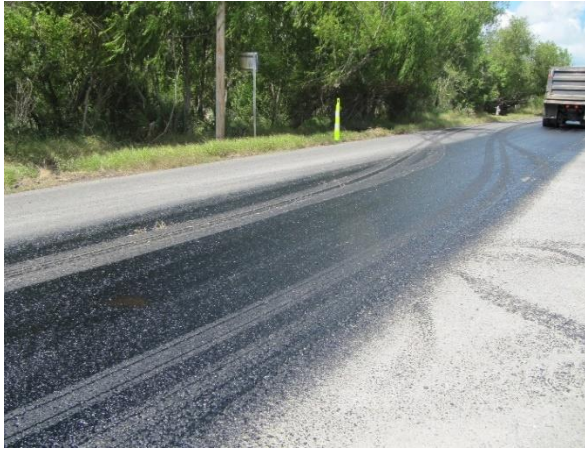
Figure 5

(a) Digital Image the Roadway

(b) Infrared Image at Overlay Surface (t=0)

(c) Infrared Image after Compaction

Digital and Infrared Images of the Pavement Section (LA 3257 Field Project)

The project consisted of a 50.8mm HMA overlay that was placed over an unmilled asphalt pavement, located on LA 3257. The existing surface was in relatively good conditions with polished aggregates and minor cracking. The average mat temperature was relatively uniform so generally no temperature differential was observed during paving and 30, 60, 90, and 120 seconds after paving and during compaction. End dump trucks were used to transport the mix. The project details are presented in Table 1. For this project, the average mat temperature was 126.8°C with a maximum thermal differential of 7°C at time zero. After compaction, the average mat temperature dropped to 100.6°C with a maximum thermal differential of 5.5°C. Based on these results, it is concluded that there was no thermal segregation detected in this project. Thermal and digital images of the pavement section are presented in Fig. 5.

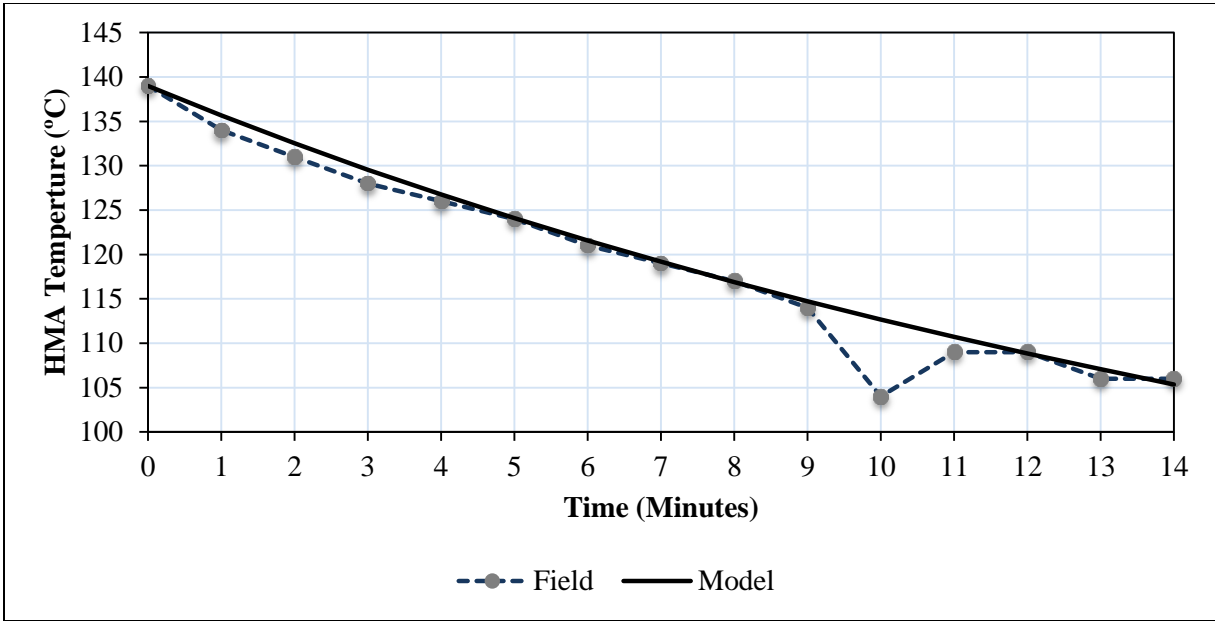
Figure 7

(a) Temperature Profile at a Point above the Joint

(b) Temperature Profile at a Point away from the Joint

Temperature Profiles for Pavement without Thermal Segregation

Results from the heat transfer analysis provided insight into the temperature gradient that develops in the pavement layers in the horizontal and vertical directions. Fig. 7 and Fig. 8 compare model prediction to field measurements for a 15-minutes time interval above and away from the joint for the pavement sections with uniform and non-uniform mat temperature. As shown in these figures, the model predicted a linear decrease in temperature after mat placement, which is in general agreement with field conditions with slight variability in the measurements. As shown in Fig. 7 and Fig. 8, the model prediction was reasonably accurate. As compared to field measurements, the error in model prediction was less 5% with the exception of when abrupt variability in the measurements occurred indicating an acceptable level of accuracy. Upon validation, results from the FE model were used to extend the scope of the experimental measurements and to provide further insight into the thermal behavior of asphalt pavement during construction as presented in the following section.

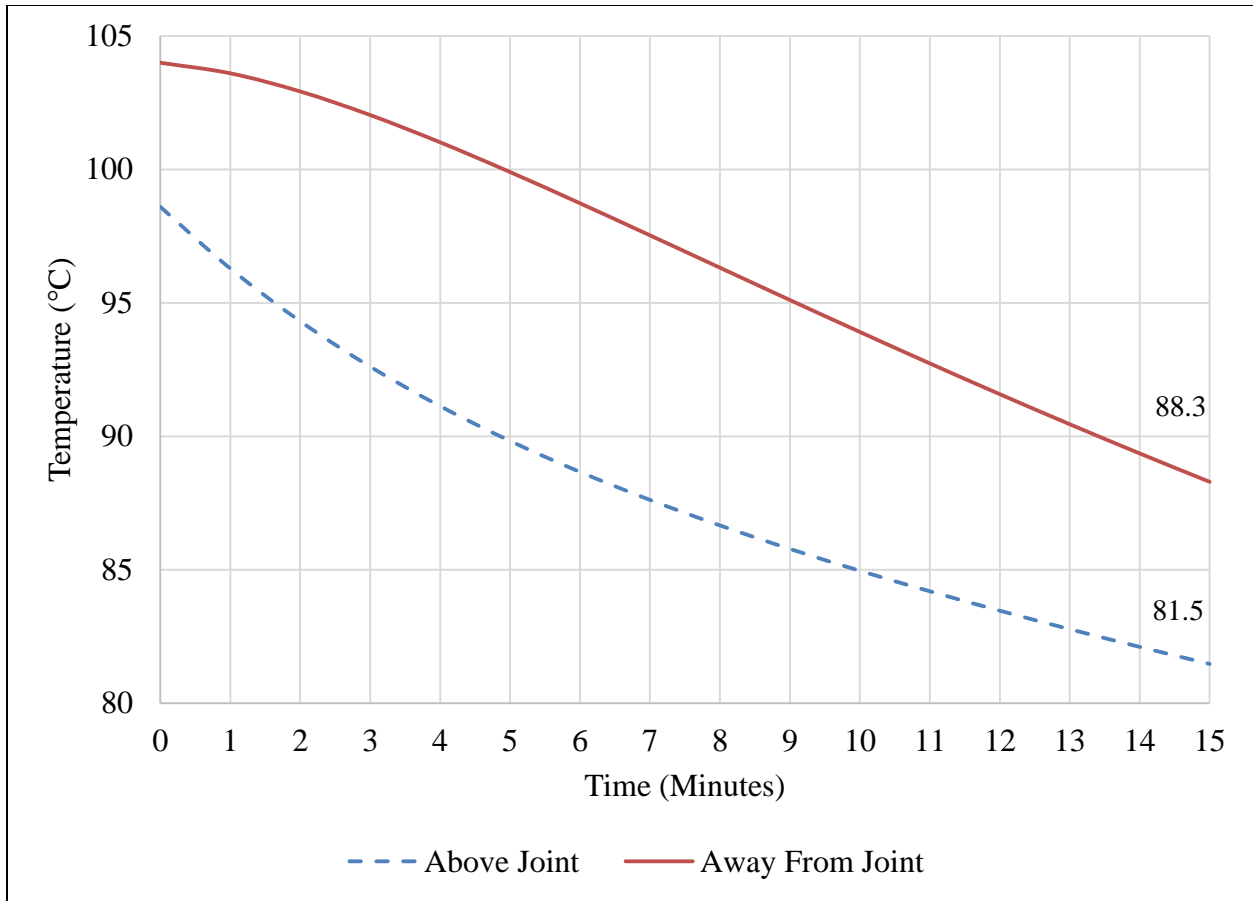
Figure 9

Temperature Distribution at the bottom of the HMA Overlay

Results of the FE model allowed to extend the scope of the experimental measurements and to provide further insight into the thermal behavior of asphalt overlays during construction. Fig. 9 illustrates the predicted temperature variation at the bottom of the overlay on top and away of the joint considering an initial temperature differential of 8.4°C at the surface. As shown in this figure, the temperature above the joint was consistently lower than away from the joint. Further, the FE model predicted a slightly higher rate of thermal decrease at the bottom of the overlay above the joint than away from it due to convection losses at the joint. After 15 minutes, the differences in final temperature at the bottom of the overlay at and away from the joint was approximately 7°C . While this difference may not be large enough to be identified as thermal segregation, it can influence the bulk properties of the overlay at the joints and promote early cracking.

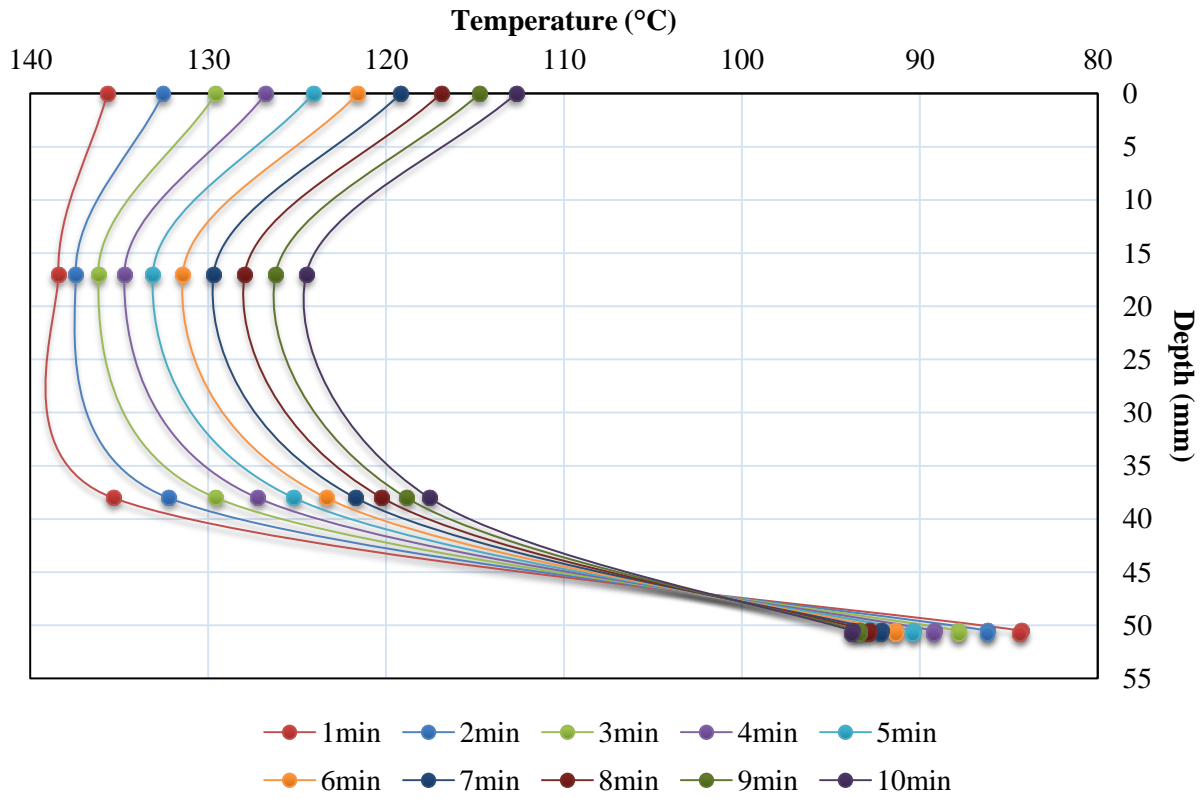
Figure 10

Vertical Temperature Profile at Various Depths in the HMA Overlay with Time

The FE model was also used to study the vertical temperature profile at various depths in the asphalt overlay. The initial mat temperature of 139°C as recorded by infrared camera in one of the sections of Tom Drive Field Project was used to calibrate the thermal model. Fig. 10 presents the variation of the temperature gradient with time through the depth of the HMA overlay. The instantaneous drop in temperature at the mat surface as compared to the temperature at mid-depth of the overlay is the consequence of convective heat transfer loss with the ambient atmosphere. At the bottom of the overlay, the effect of conductive heat transfer is maximized because of the substantial difference in temperature between the HMA layer and the top of the concrete surface. These results show that thermal differences occur in the vertical direction as well as in the horizontal direction. While vertical thermal differences have not been investigated to date, it can influence the bulk properties in the vertical direction resulting in a stiffer mix at mid-depth as compared to the top and bottom of the overlay. It can also lead to non-homogeneous properties of the mix in the field. Further investigation of vertical thermal
