JOINT TRANSPORTATION RESEARCH PROGRAM

Early Detection of Joint Distress in Portland Cement Concrete Pavements

Harris, D., Farnam, Y., Spragg, R., Imbrock, P., & Weiss, W. J. (2015). *Early detection of joint distress in portland cement concrete pavements* (Joint Transportation Research Program Publication No. FHWA/IN/JTRP-2015/09). West Lafayette, IN: Purdue University. <http://dx.doi.org/10.5703/1288284315531>

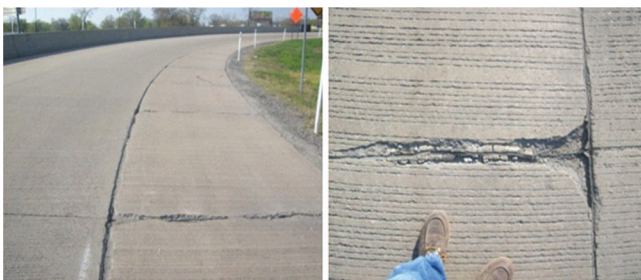
Figure 1.1 Photograph of field observation showing damage in pavement joints.

INDOT has observed that some concrete pavements show premature joint deterioration (Figure 1.1). Unfortunately, by the time that this joint deterioration is observed it is often too late and costly partial depth repairs are needed.

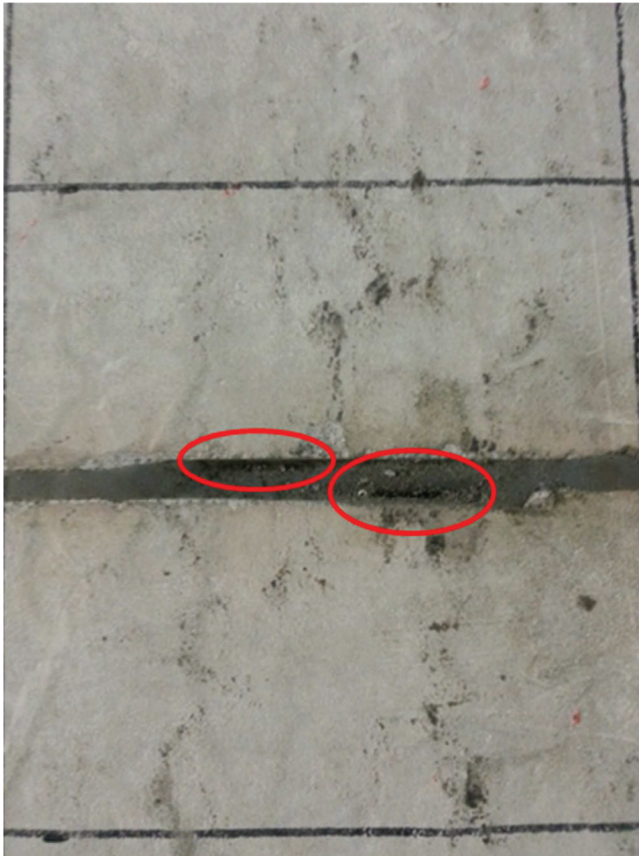
Figure 2.3 Silicone sealant debonding from concrete at the surface of a joint.

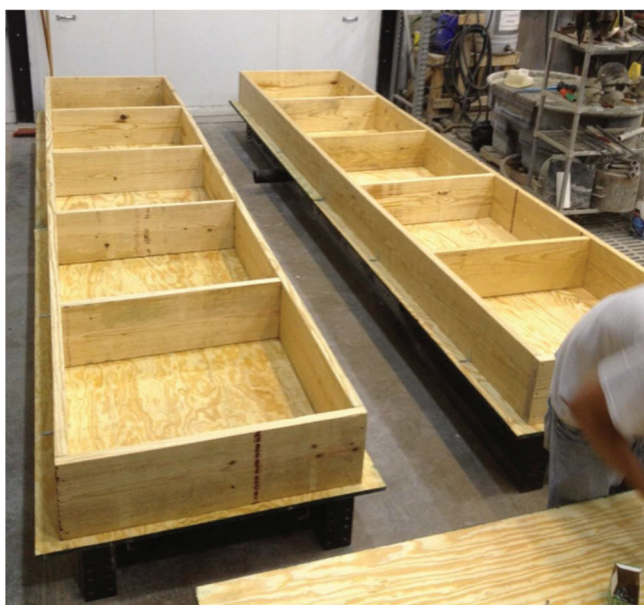
Figure 3.1 Molds for ten 3' × 3' × 10" slabs.

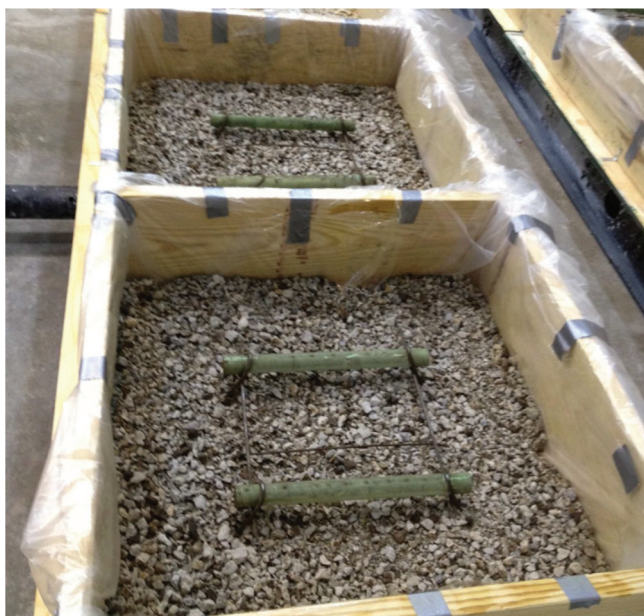
Figure 3.2 Slab molds, lined with plastic, containing 1.25" of gravel base and dowel bars.

These slabs were cast with a 10" (25.4 cm) depth, on top of a 1.25" (3.18 cm) gravel base. Each slab contains two 1" (2.54 cm) diameter dowel bars centered in the slab, orientated perpendicular to the joint, at a depth of 7" (17.78 cm) from the pavement surface. Each slab was saw-cut in two stages using a wet saw and diamond blade. First a 1/8" (0.32 cm) wide cut 4" (10.16 cm) deep, followed by a 0.25" (0.64 cm) saw cut 1.25" (3.18 cm) deep in accordance with INDOT standard practice for concrete pavement joints Indiana Department of Transportation 2011. The only differentiation between the joints in these slabs and joints cut in the field is the time of cutting. In field pavements, cuts must be made at carefully coordinated times in order to keep the pavement from cracking in undesired locations. This is not a concern in these slabs because there are small enough that cracking is not a concern. Instead of being cut 2–12 hours after casting, they were cut 48 hours after casting with the assistance of cutting team from The Concrete Surgeons, based out of Indianapolis, IN. Figures 3.1, 3.2, 3.3, 3.4, and 3.5 show these slabs through each stage of their development.

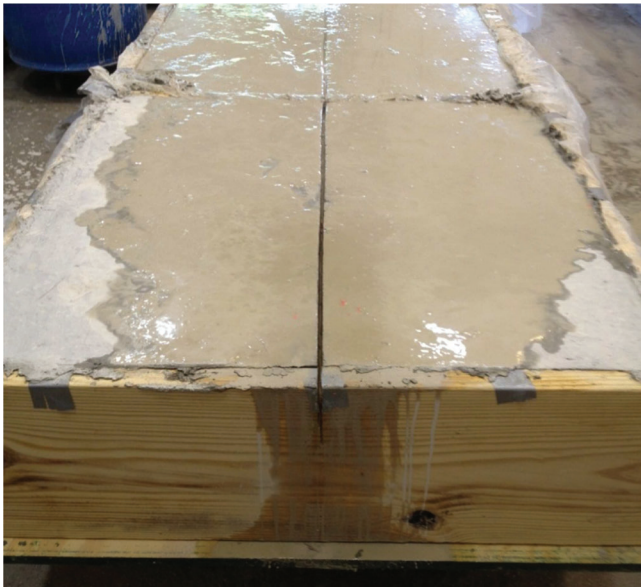
Figure 3.4 Slabs after the saw-cut joints had been made.

After casting, these slabs were covered with wet burlap and plastic for 48 hours to promote curing without the loss of moisture. After this period the joints were cut, and then the slabs were placed into an environmental chamber at 23 +/- 2°C (73.4°F) and 50 +/- 4% relative humidity to dry for 30 days. This drying period is meant to open space in the pores in order to leave the concrete vulnerable to the exposure treatments that will follow. The ten slabs were divided into two sets of five; each set was maintained in a similar fashion, with the exception that one set was covered with highly absorbent mats which had been saturated with water. This leaves five slabs with the top surface exposed to drying, and five slabs with a layer of water maintained on the top surface. The intent of this differentiation is

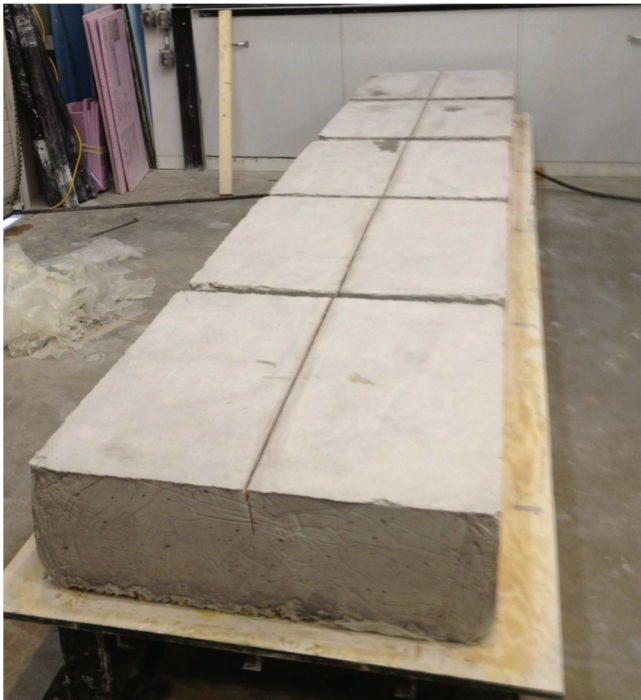
Figure 3.5 Slabs, with molds removed, after curing, and during the drying stage.

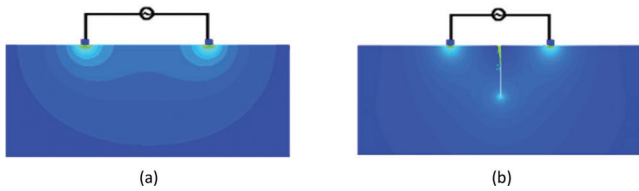
Figure 4.5 Heatmap from Finite Element Simulations showing regions of equipotential conducted on (a) plain slab specimen and (b) notched slab specimen, taken from Niemuth (2004).

A previous study conducted finite element simulations on a jointed slab specimen (Niemuth, 2004). The study investigated plain, un-notched slab specimens, shown in Figure 4.5a. The model also evaluated a notched slab specimen, shown in Figure 4.5b. The results indicate in the presence of a notch, or crack, the distribution of equipotential lines changes.

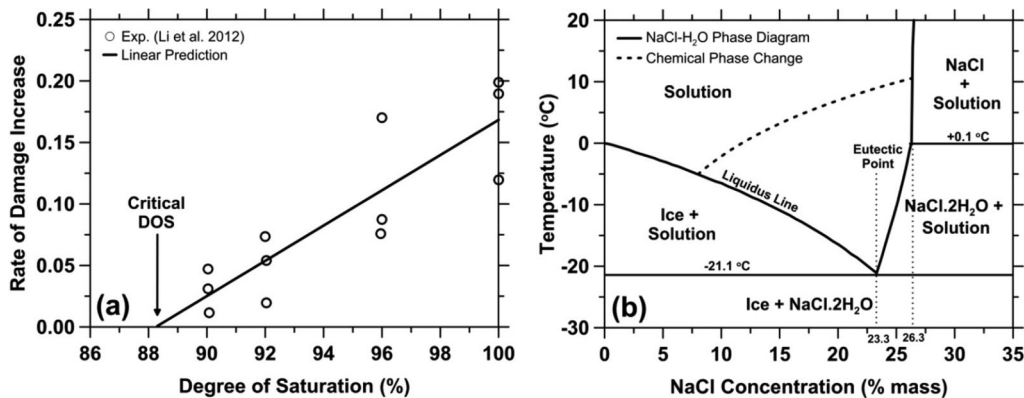
Figure 5.1 (a) Rate of decrease of relative dynamic elastic modulus (freeze-thaw damage) as a function of the degree of saturation (Li et al., 2012) and (b) comparison of NaCl-H₂O phase diagram with chemical phase transition in NaCl-H₂O-cement system (Farnam, Bentz, Hampton, et al., 2014).

Deicing chemicals can also increase the freeze-thaw damage in concrete by resulting in additional distress due to the osmotic pressure and/or the crystallization pressure (Litvan, 1976; Qian, Farnam, & Weiss, 2014; Scherer, 1999; Shi, Fay, Peterson, Yang, 2010; Valenza & Scherer 2005). Previous studies (Farnam, Bentz, Hampton, & Weiss, 2014; Farnam, Bentz, Sakulich, Flynn, & Weiss, 2014; Farnam, Dick, et al., 2014; Villani, Farnam, Washington, Jain, & Weiss, in press) identified that chemical reactions between the cementitious matrix and salt solution can result in a chemical phase change that can cause severe damage in cementitious materials. Figure 5.1b illustrates the phase diagram for a NaCl-H₂O solution.

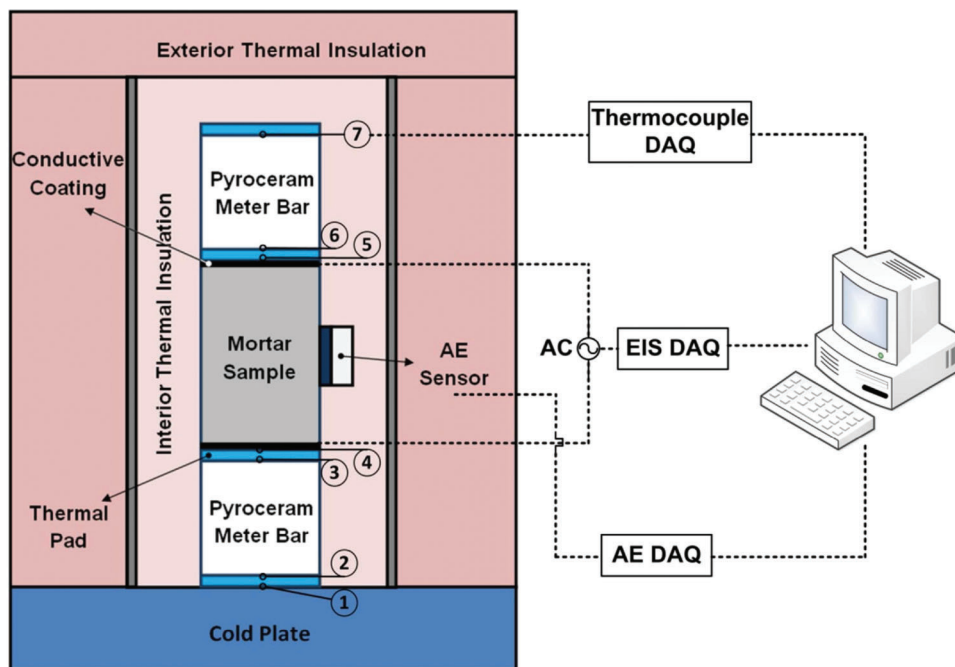
Figure 5.3 Figure illustrating the experimental setup.

The thermocouples were used to monitor temperature from which heat flow can be calculated and used to detect endothermic and exothermic behaviors due to phase changes in the system. Temperature sampling was performed at a rate of 0.05 kHz during the thermal cycle. Using the known thermal properties of the meter bar, the heat flow through the Pyroceram™ can be calculated using Equations 5.1 through 5.4. The heat flow through the mortar specimen can then be estimated by Equation 5.4. It should be noted that the heat flow measured by

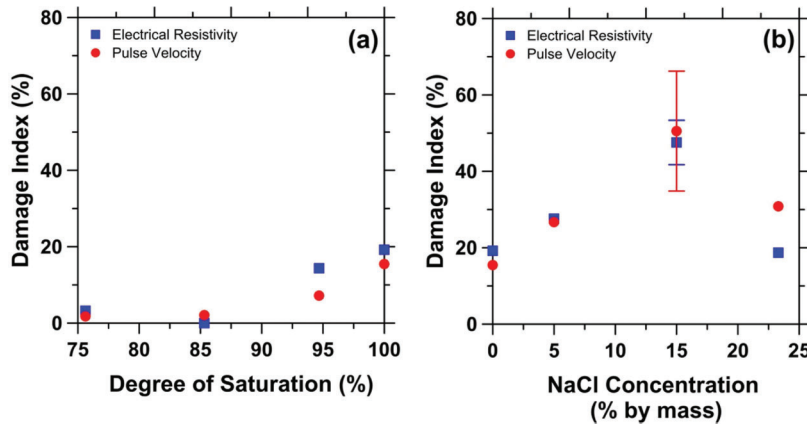
Figure 5.10 Damage index and reduction in resistivity for: (a) samples with different degrees of saturation, and (b) samples saturated with solutions containing different concentrations of NaCl.

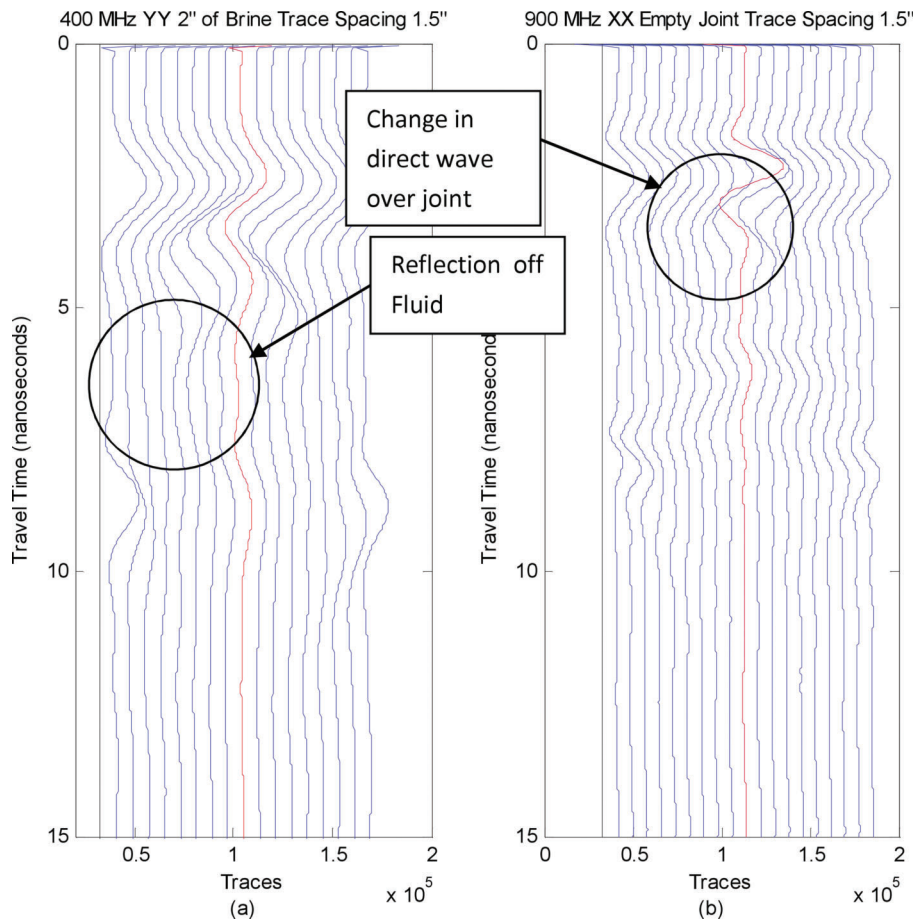
Figure 6.4 An illustration of a wiggle trace perpendicular to joint: (a) 400 MHz in the YY orientation, (b) 900 MHz in the XX orientation.

Figure 6.4 provides an illustration of a wiggle trace with every sixth trace shown. It can be noticed

of the amplitude and timing of the wave between (2 and 8 ns) which corresponds to measurements that include the effect of the fluid in the saw-cut joint. The direct wave of the 900 MHz antenna over the joint (shown in red) is also greatly changed corresponding to the joint.

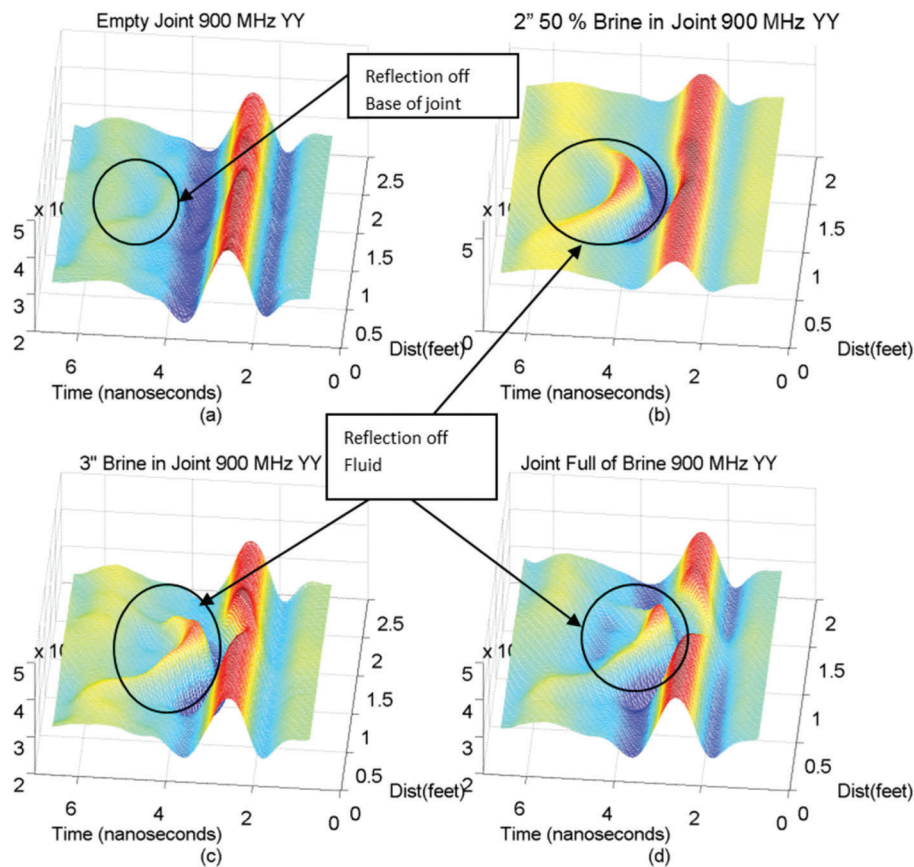
Figure 6.5 900 MHz antenna in the YY direction with the scan perpendicular to joint: (a) empty joint, (b) 2" of 50% brine in the joint, (c) 3" of brine in the joint, and (d) 4" of brine in the joint (the z axis is amplitude). The dominating red reflection at approximately 3 nanoseconds is the coupling between the antenna and the concrete surface.

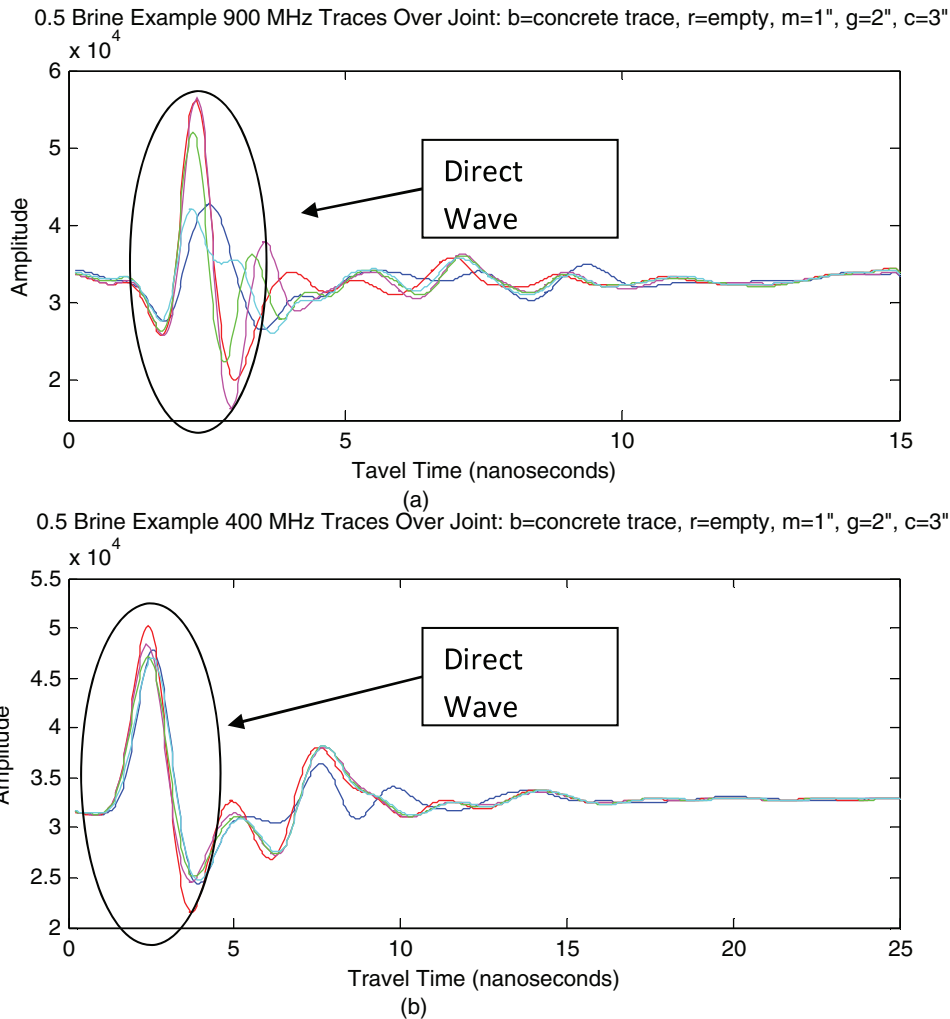
Figure 6.6 900 MHz antenna in the XX orientation: GPR traces: blue = concrete; red = empty joint, magenta = 1" of 50% brine, green = 2" of 50% brine, cayenne = 3" of 50% brine.

In examining the data from Figure 6.6 it is clear that if the entire wave form needs to be reviewed for each measurement the use of the GPR technique may

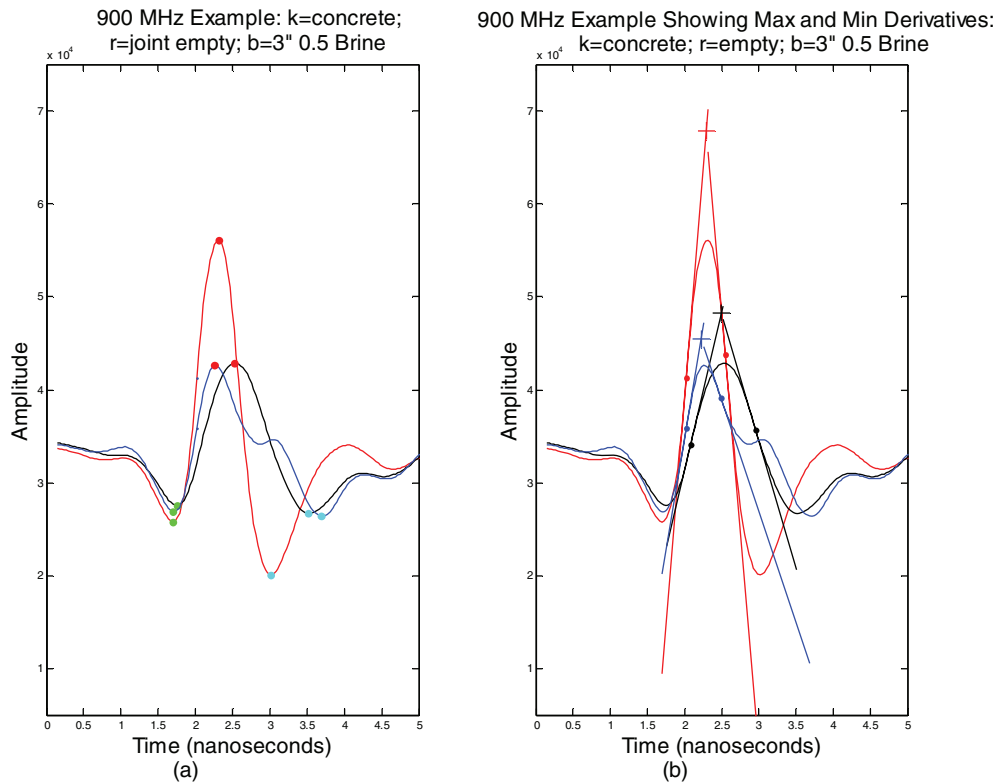
Figure 6.7 Direct wave examples showing initial group of scalars selected.

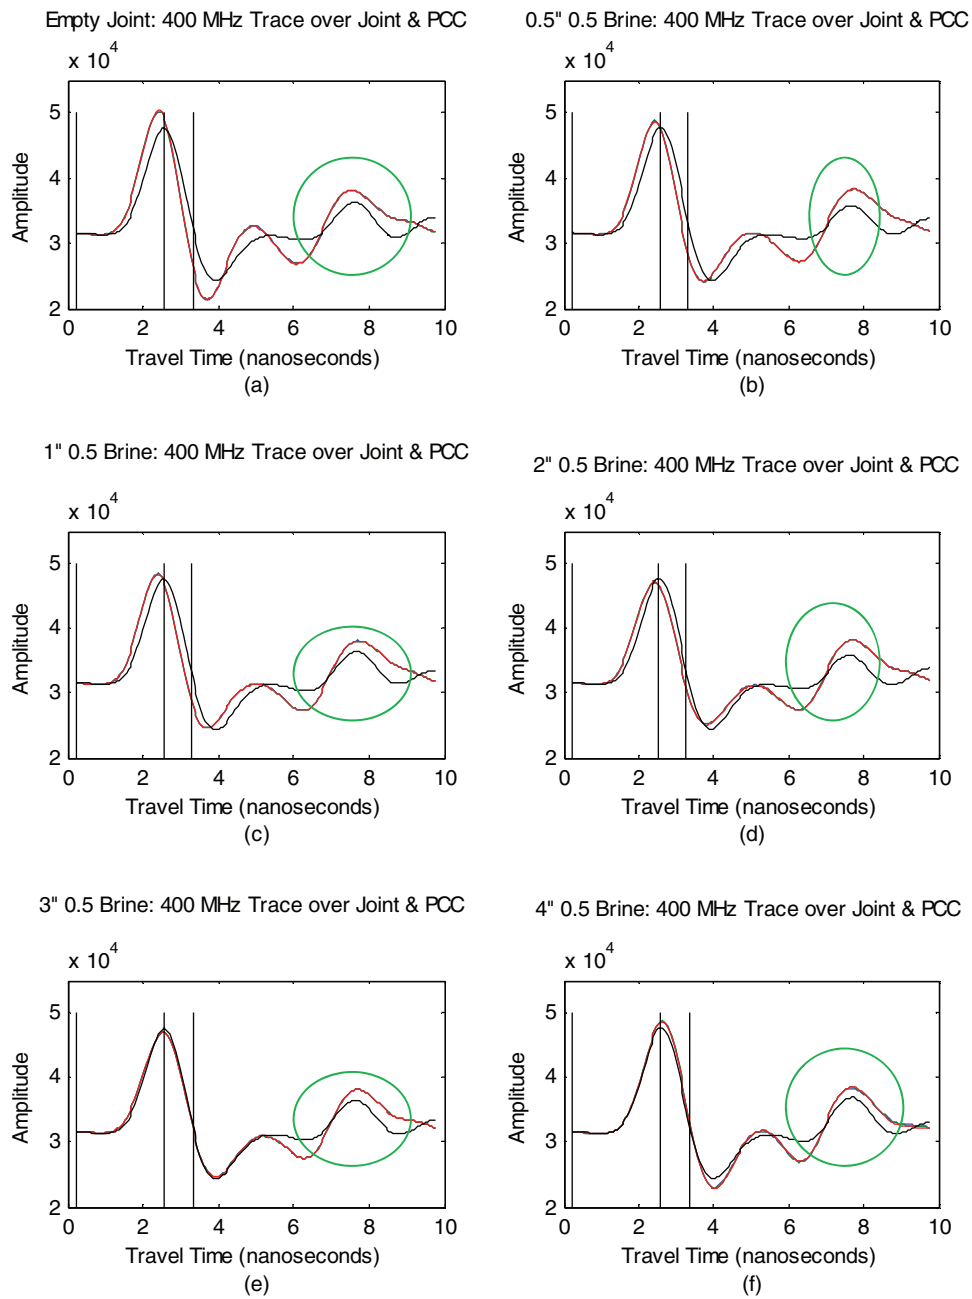
Figure 6.9 GPR collected on brine treated pad; black trace is collected on concrete, red trace collected over joint, the green ellipse shows the reflection that is due to the dowel/chair: (a) 0", (b) 0.5", (c) 1", (d) 2", (e) 3", (f) 4" of 50% brine.
