Final Report
Project Number 930-789

EVALUATION OF SCOUR POTENTIAL OF COHESIVE SOILS – PHASE 2

The Alabama Department of Transportation

JANUARY 2015

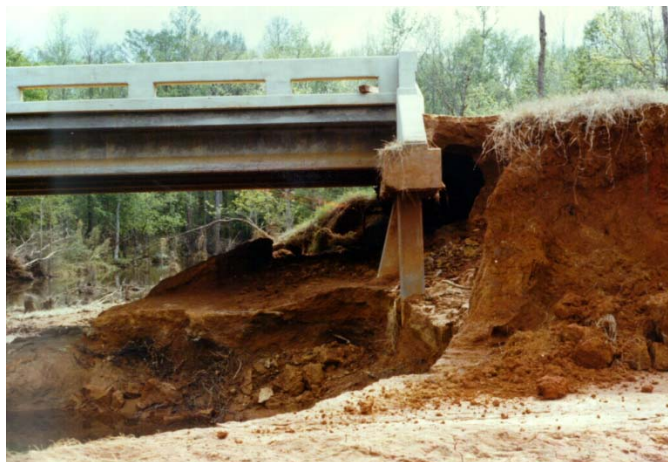
Figure 1-1. Example of Bridge Scour

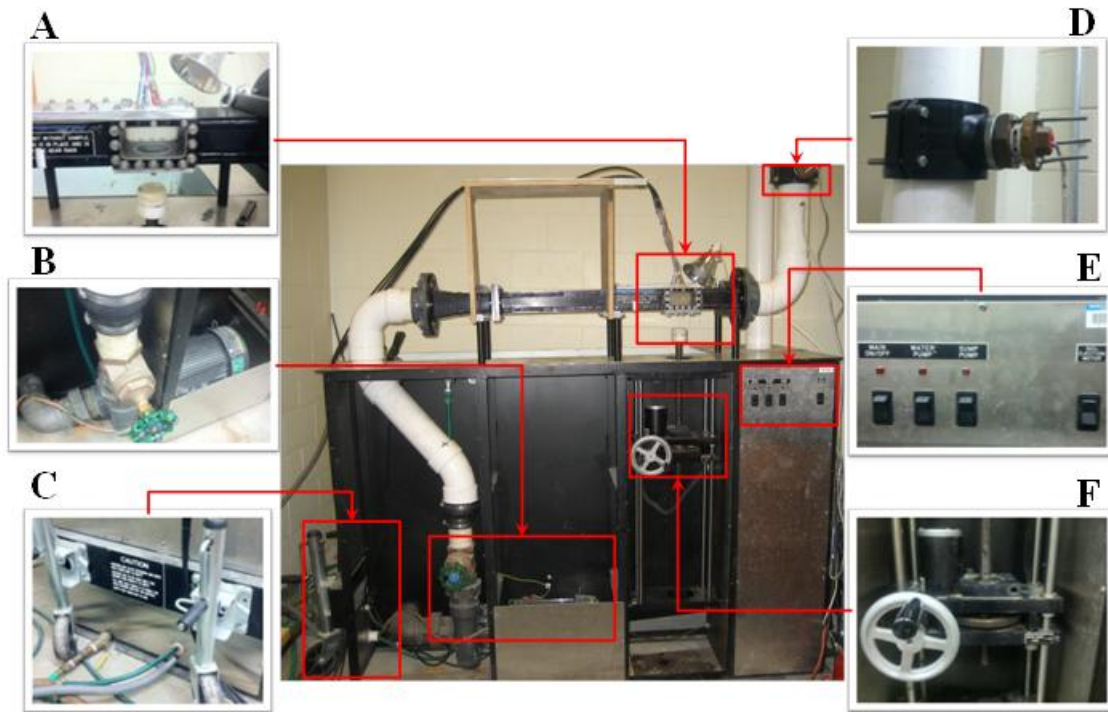
Briaud (1999) constructed the first model of the EFA at Texas A&M University to determine quantitative data related to scour rate and magnitude of different soils. Incorporating the work of Sheppard et al. (2005), Auburn University retrofitted the device to include an ultrasonic sensor for measuring the change in specimen height. Figure 2-1 shows a picture of the updated EFA at Auburn University and its critical components.

Figure 2-1. Auburn University EFA and Critical Component Diagram.

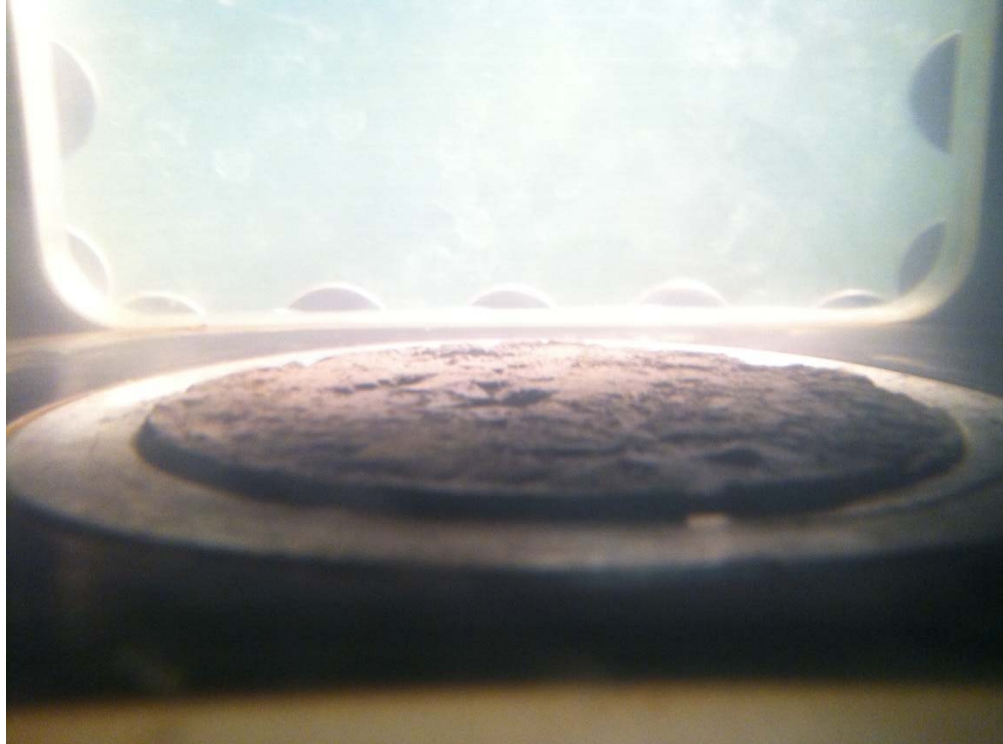
Figure 2-11. Soil Sample in EFA Advanced 1 mm.

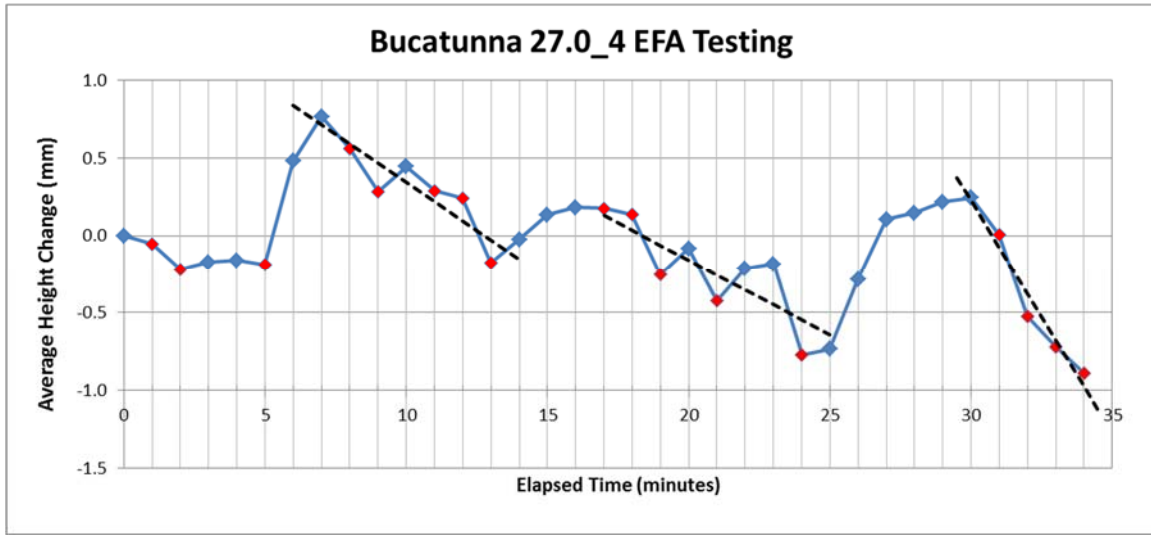
In order to determine the overall erosion rate for the soil, we decided to compute the soil eroded or the soil swelling for each minute, and then we can find out the overall soil erosion rate by summing up the erosion and swelling rates in the one-minute interval. For Buccatunna 27.0.4 EFA test results, it was found that there was 3.85 mm soil erosion and 1.96 mm swelling over a 34-minute testing period (Figure 3-5). Therefore, the overall erosion rate, which considered the impact of swelling, was determined as 6.67 mm/hr (0.1112 mm/min) over the 17-minute erosion period that is indicated as red data points on Figure 3-5.

Figure 3-5. Reanalysis of Buccatunna 27.0.4 Test Results at 0.6 m/s.

Overall scour rates considering both erosion and swelling at different testing velocities were used to develop the erosion function in the next section.

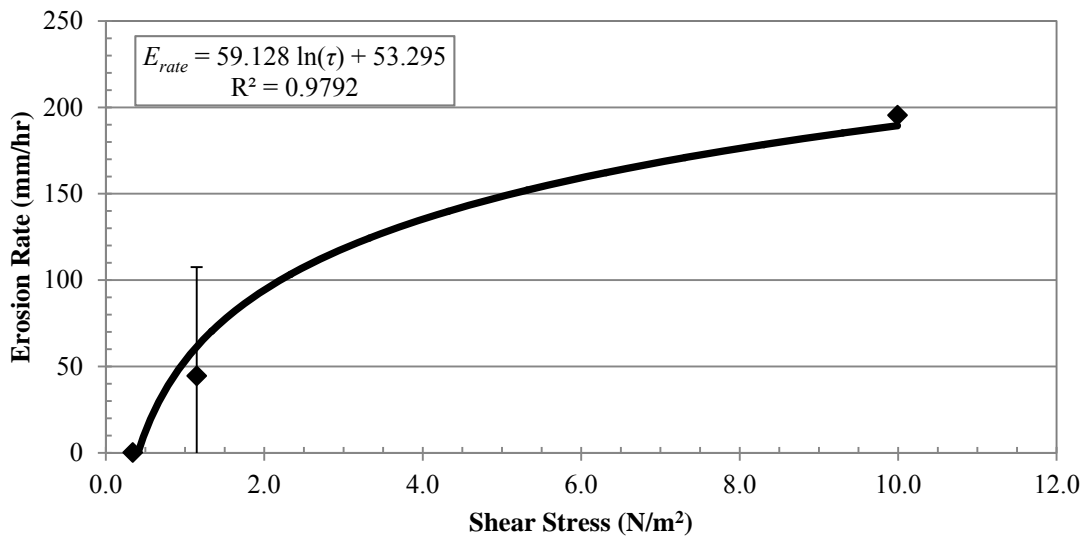
Figure 3-18. Shear Stress-based Erosion Function for **Yellow** Naheola Clay.

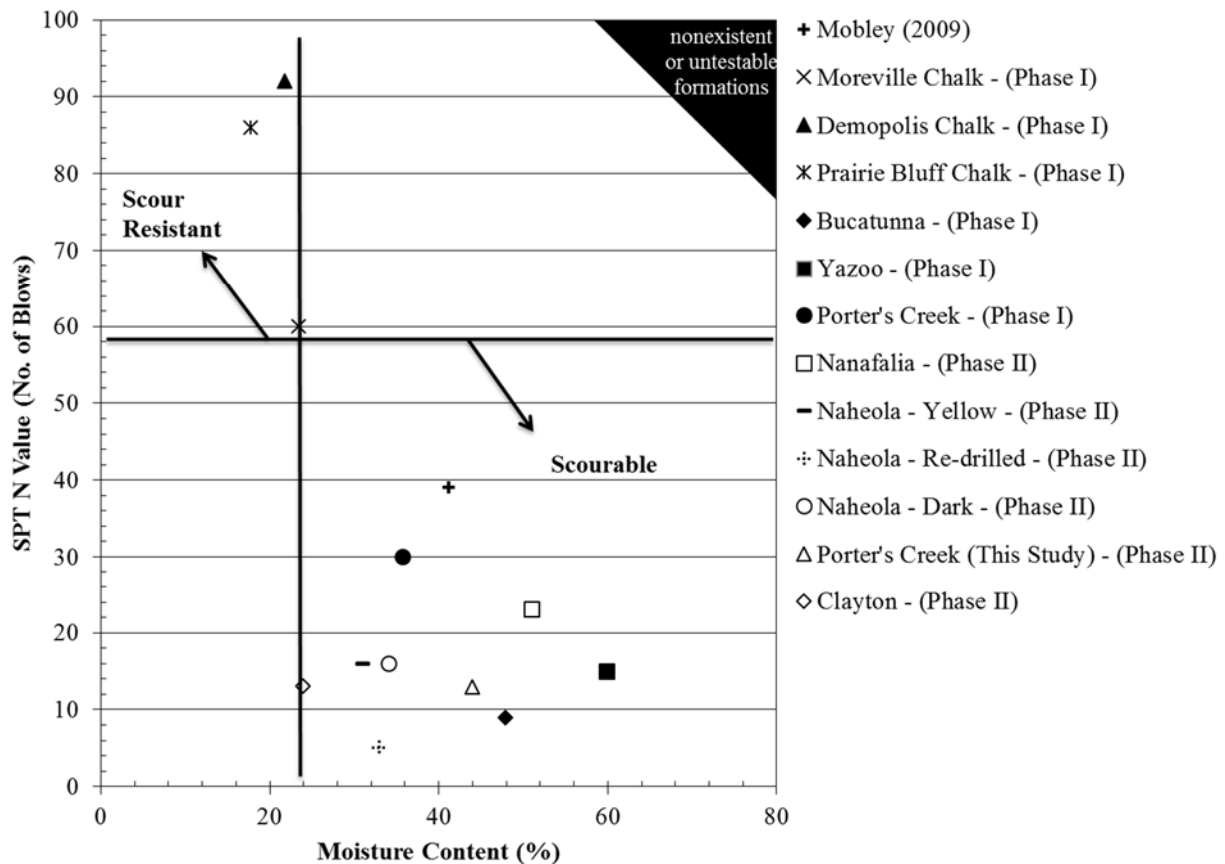
The SPT blow counts appeared to have a serious effect on scour resistance, as only N values 60 and above were scour resistant. Soils with moisture contents below 24 did not scour at velocities of 3.0 m/s and less. Figure 3-22 shows a plot of scourability as it relates to SPT N value and insitu moisture content. A general area with respect to soils that are not likely to exist or could not be evaluated using the EFA method is also shown in Figures 3-22, 3-23, and 3-24.

Figure 3-22. Scourability versus SPT N Value and Moisture Content.

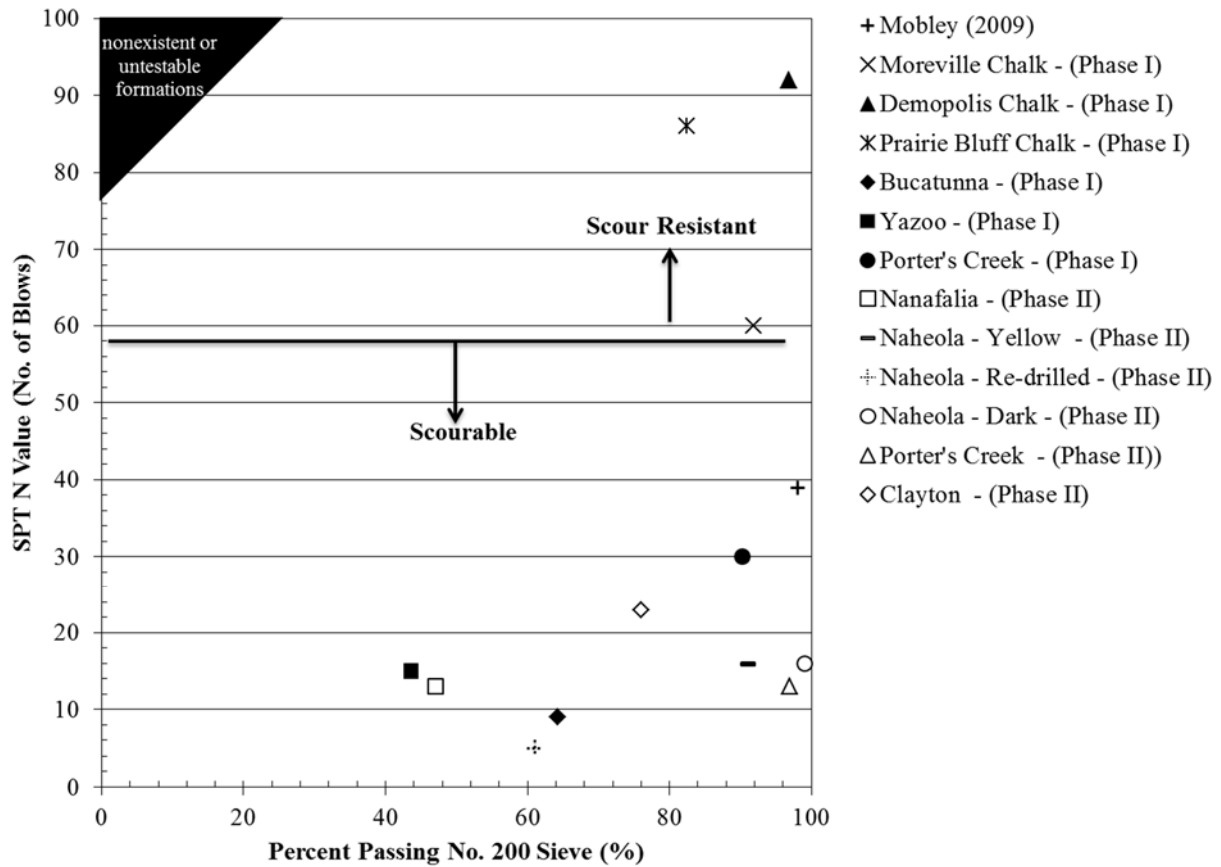
The percentage of fined grained soil (i.e., the percent passing the No. 200 sieve) did not appear to have an effect on scourability. The scour resistant soils all had fines percentages greater than about 82%, though five of the scourable materials had a fines percentage falling above this value. Figure 3-23 shows a plot of scourability as it relates to SPT N value and fines percentage.

Figure 3-23. Scourability versus SPT N Value and Percent Passing the No. 200 Sieve.

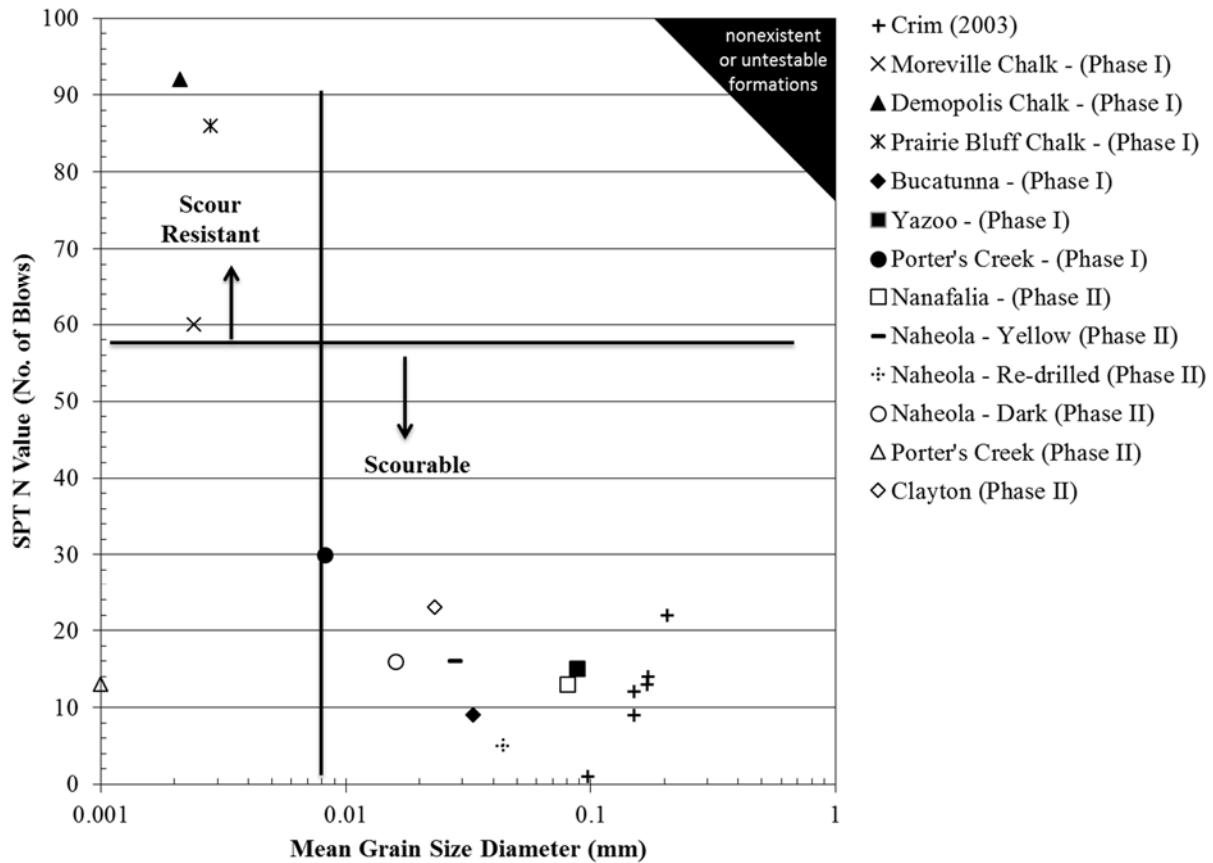
Walker (2013) observed that soils were scour resistant when the material had a mean grain size diameter less than 0.0082 mm. This correlation was seen with the exception of the Porter's Creek sample. The Porter's Creek sample tested in this study was an extremely fine material. The mean grain size diameter of the Porter's Creek material tested by Walker was approximately 0.0082 mm. As previously stated, the mean grain size diameter of the re-sampled Porter's Creek material was not determined because a 48 hour hydrometer test was not sufficient for this very fine material. Because the mean grain size was certainly less than 0.001 mm, the correlation between scourability and mean grain size cannot be made. Figure 3-24 shows a plot of scourability as it relates to SPT N value and mean grain size diameter.

Figure 3-24. Scourability versus SPT N Value and Mean Grain Size.

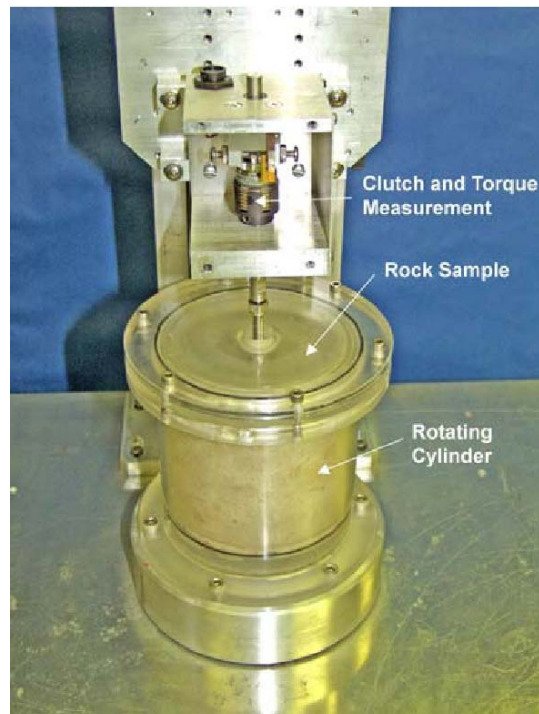
The Rotating Erosion Test Apparatus (RETA) was designed to determine the volume of erosion of stiff clay, sandstone, and limestone. A schematic of the RETA is shown in Figure A-4. The RETA performs an erosion test on a 102 mm long cylindrical soil sample with either a 61 mm inch or 102 mm diameter (Sheppard et al. 2005). A 6.4 mm diameter hole is drilled vertically through the sample and a support shaft that attaches to the RETA is inserted through the sample. The opposite end of the shaft is attached to a torque cell and clutch that is fixed to a surface (Sheppard et al. 2005). A larger diameter cylinder is placed over the sample, and water is added to fill the annulus between the sample and the outer cylinder. The outer cylinder is rotated using a motor and pulley system to create a shear stress on the surface of the sample. After a known duration of time the test is stopped and the test sample is measured radially and any eroded material is oven dried to determine the mass of the scoured soil. The shear stress is calculated by knowing the amount of torque applied to the sample along with the initial radius and length of the test specimen. The erosion rate is calculated using the change in radius, duration of the test, mass density of sample, and original sample geometry (Sheppard et al. 2005).

Figure A-4. Rotating Erosion Test Apparatus (RETA)

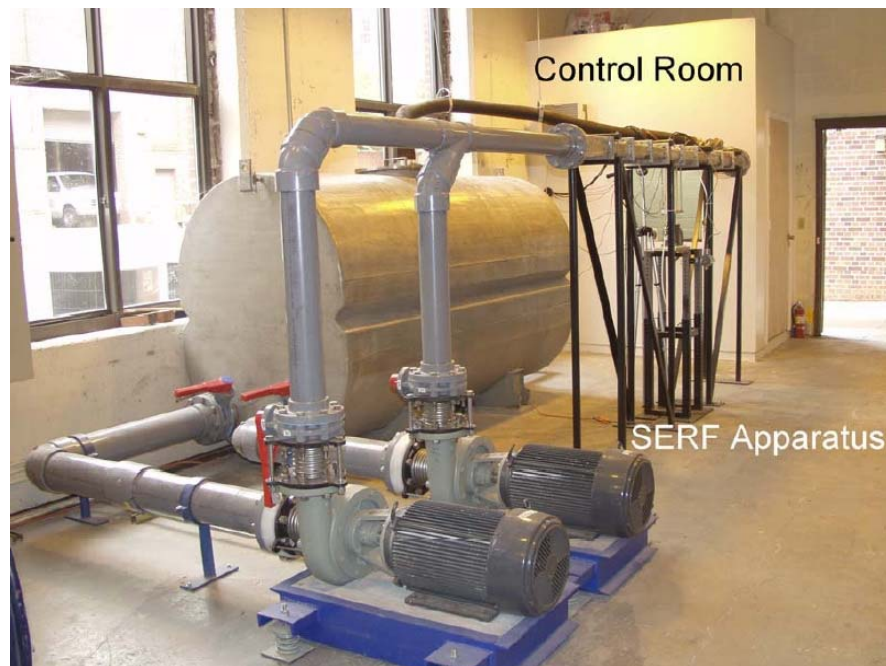
The Sediment Erosion Rate Flume (SERF) is the second apparatus created at the University of Florida for the purpose of measuring relationships between erosion rate and shear stress. The SERF functions similar to the EFA. Like the EFA, the SERF uses a flume with a rectangular cross section, a water pump, a reservoir, and a stepping motor. The SERF does have a larger water capacity than the EFA, as it utilized two pumps and has an 1100 gallon reservoir. The SERF is much more automated than the EFA, using multiple instruments and a Labview program. Images of the SERF are shown in Figure A-5 and Figure A-6.

Figure A-5. Sediment Erosion Rate Flume (SERF)

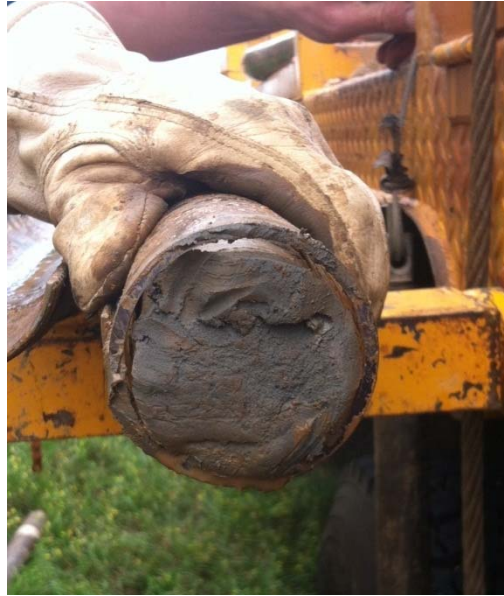
The continuous sample from 13.5 to 18.5 feet was determined to be unusable for EFA testing. The top of the sample was not usable as it had a plug missing from the Standard Penetration test taken above. The sample gathered from 13.5 to 18.5 feet meters was also smaller radially than the sample tube at the base of the sample as shown in Figure B-1.

Figure B-1. Bucatunna Clay Sample Smaller Radially than Sample Tube

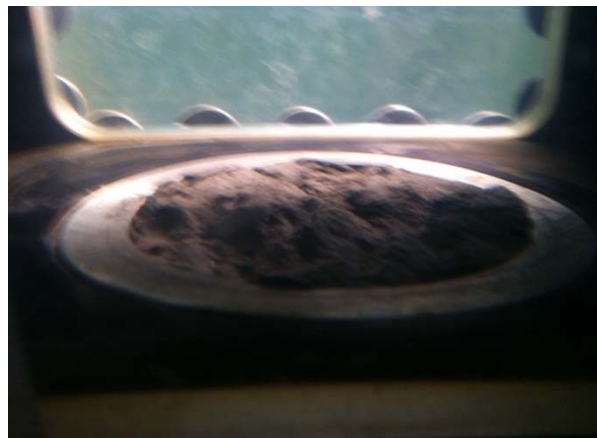
The final test performed on the Bucatunna Clay formation was aimed at determining the critical shear velocity of the formation. Since previous tests on the Bucatunna Clay formation was scour resistant, and actually swelled, at 0.3 m/s and scoured at 0.6 m/s, the critical shear velocity was located between the two velocities. The test titled “Bucatanunna 23.0_4” was started with a flow velocity of 0.3 m/s and gradually increased until scour was observed. The flow velocity was held between 0.35 and 0.4 meters per second for approximately 15 minutes, and again swelling was observed instead of scour. Slowly the flow velocity was increased between 0.45 and 0.5 m/s. At this velocity a large chunk eroded from the sample. Figure B-3 shows the sample immediately after erosion occurred. This image agrees with the ultrasonic sensor, while portions of the sample are located above the base of the flume, the majority of the sample has eroded in deep pockets below the flume. From this test it was determined that the threshold velocity was 0.45 m/s.

Figure B-3. Bucatanunna 23.0_4 After Erosion Occurred

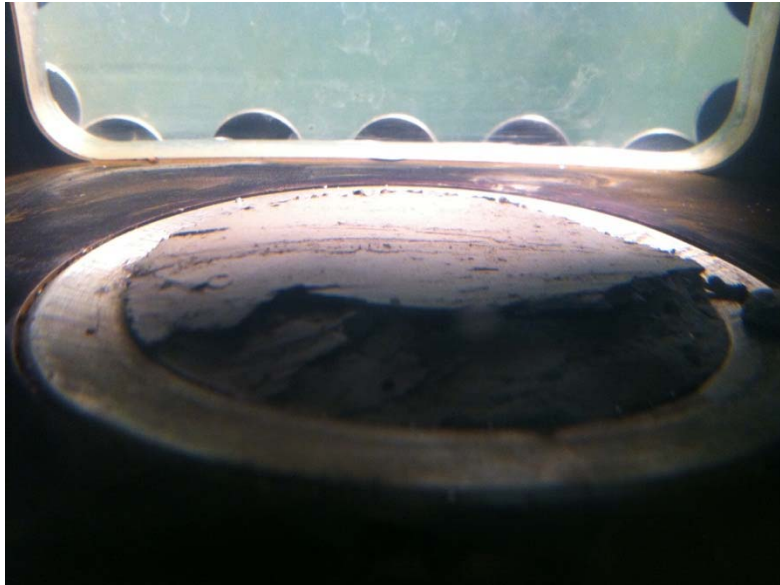
The first test performed on the Yazoo Clay formation was used to help determine the starting test velocity and was titled “Yazoo Clay 18.5_1”. The “Yazoo Clay 18.5_1” test started with a flow velocity of 0.3 m/s, and scour was not observed. After one hour the flow velocity was increased to 0.45 m/s and immediately a wedge of the sample scoured away. This wedge developed shortly after the test was started and grew in size throughout the test, and image of this wedge can be viewed in Figure B-5. However, since this method of failure had not yet been observed a second test titled “Yazoo Clay 18.5_2” was performed starting at a flow velocity of 0.45 m/s.

Figure B-5. Yazoo Clay 18.5_1 Test Failure Wedge

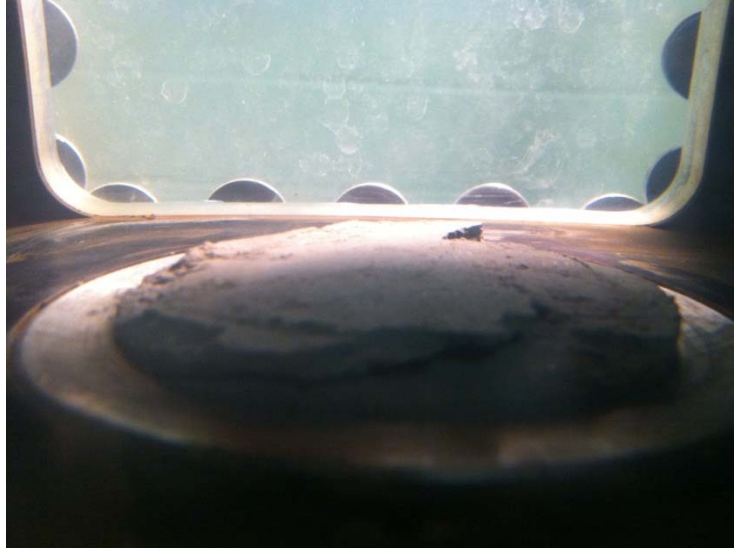
The “Yazoo Clay 18.5_2” test did not perform similarly to the previous test but exhibited a swelling characteristic similar to that observed in the Bucatunna Clay formation. The test was started at a flow velocity of 0.45 m/s and did not scour after one hour. The flow velocity was then increased to 0.6 m/s for an hour in which scour was not observed. The flow velocity was then increased temporarily to 0.8 m/s for fifteen minutes before being increased once again to 1.0 m/s. During this time the test sample rose and had average height of 1.75 millimeters, and developed a large crack in the center of the sample as shown in Figure B-6. After the test sample was exposed for 25 minutes at a flow velocity of 1.0 m/s, the sample scoured well below the bottom of flume as shown in Figure B-7. The test was analyzed and it was determined that the testing regiment should be started at a flow velocity of 1.0 m/s.

Figure B-6. Yazoo Clay 18.5_2 Test Swelling and Cracking

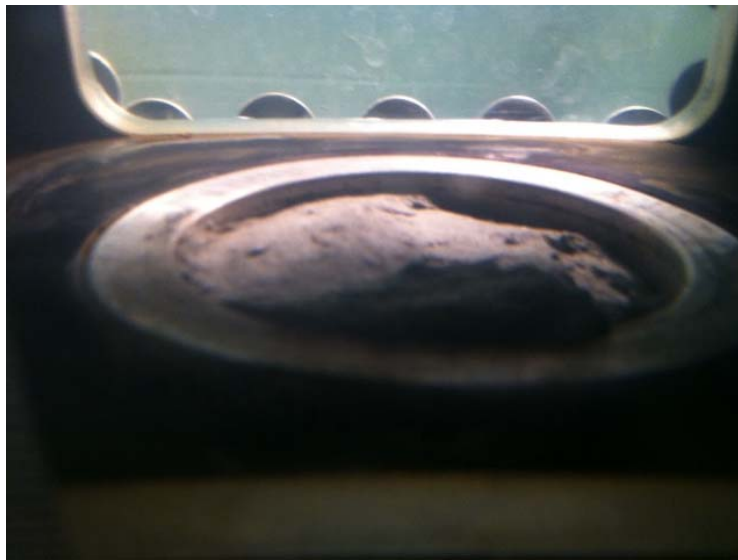
Figure B-7. Yazoo Clay 18.5_2 Test After Failure

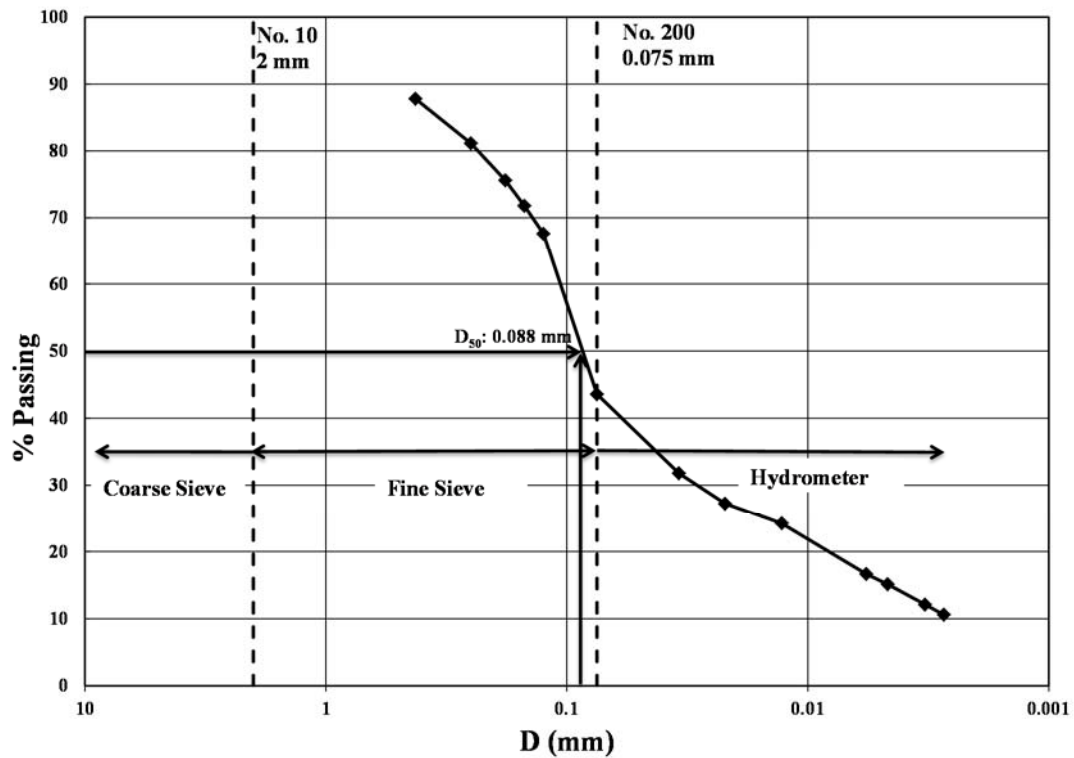
Atterberg limits were performed to complete the soil classification and geotechnical testing of the Yazoo Clay formation. The liquid limit was determined to be approximately 57, and the formation was determined to be non-plastic.

Figure B-10. Yazoo Clay Formation Grain Size Distribution

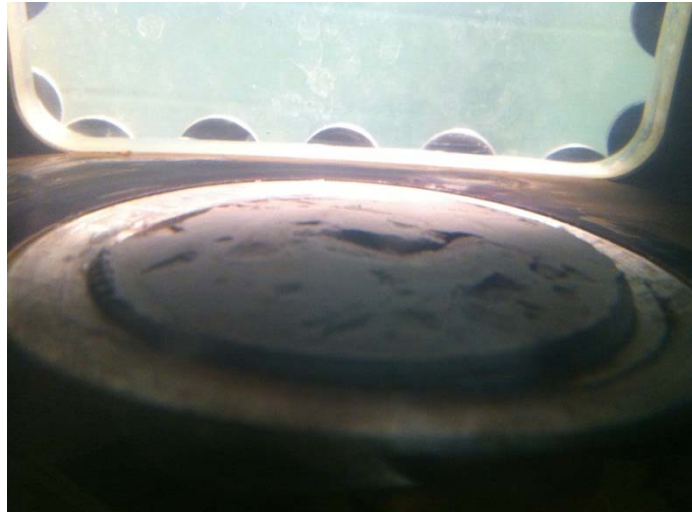
This was the first sample tested in this study that did not exhibit any scour behavior with the set testing regiment. If future testing of the Demopolis Chalk formation is necessary the remaining testable section of the formation was sealed and placed into a curing chamber to preserve field moisture conditions.

Figure B-12. DemopolisChalk19.0_5 After Testing

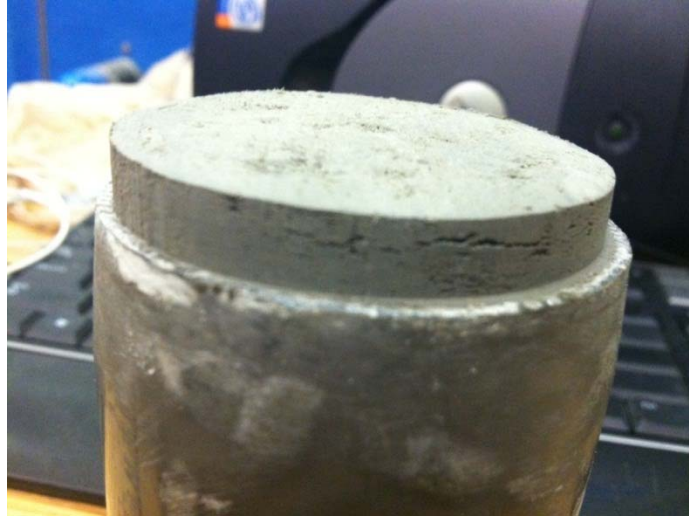
The first test on the Prairie Bluff Chalk formation started at a flow velocity of 1.0 m/s. The protrusion into the flume was calculated to be 1.51 millimeters or fifty percent higher than the height specified by Briaud. After fifty minutes a large mass chunk scoured away, the volume of the scoured section was approximately equal to five times the volume of the protrusion. It was noted during testing that the sample seemed dry and loose in some areas, and that the large scoured volume started from the loose areas of the sample. Another EFA test was performed at a flow velocity of 1.0 m/s, with a total protrusion of 1.85 millimeters. No scour was observed during this test, suggesting that the flow velocity should be increased for future tests. The idea that the test samples that had altered tubes and been manually advanced were exposed to differing stress states than initially intended during EFA testing was confirmed during testing of the Prairie Bluff Chalk formation. It was thought that these samples were exposed to shear or torsional forces during extruding. This idea was reinforced by cracking on the edges of the advanced sample as viewed in Figure B-16 and Figure B-17. These shear and torsional forces could have been developed through an eccentricity between the bowed sample tube and the extruder advancing the sample. It is unknown if these forces negatively influenced EFA testing. It was noted that these cracks that developed in the EFA sample created shear planes for scouring to occur that would not naturally exist in a stream bed.

Figure B-16. Prairie Bluff Chalk Formation Cracking Example 1

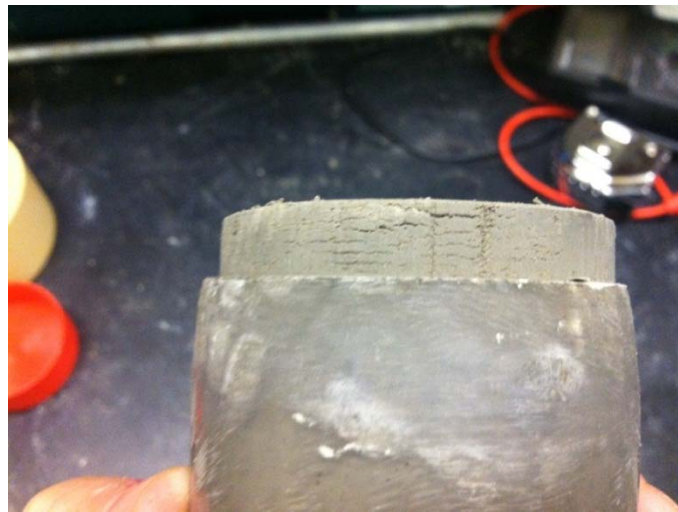
Figure B-17. Prairie Bluff Chalk Formation Cracking Example 2

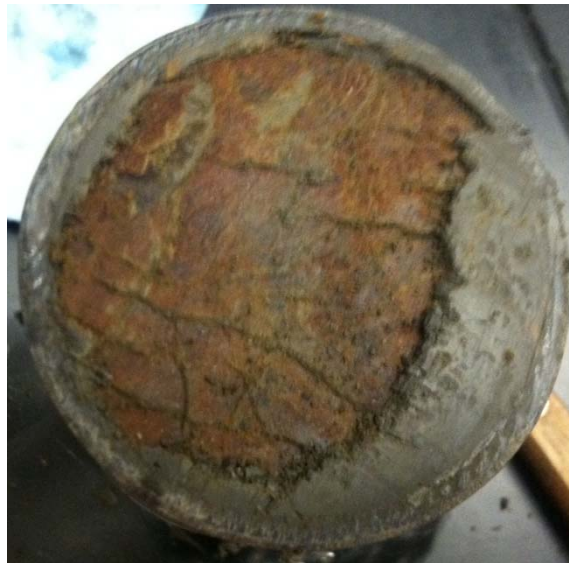
Figure B-19. Porter's Creek Clay Formation Scoured along Weathered Planes

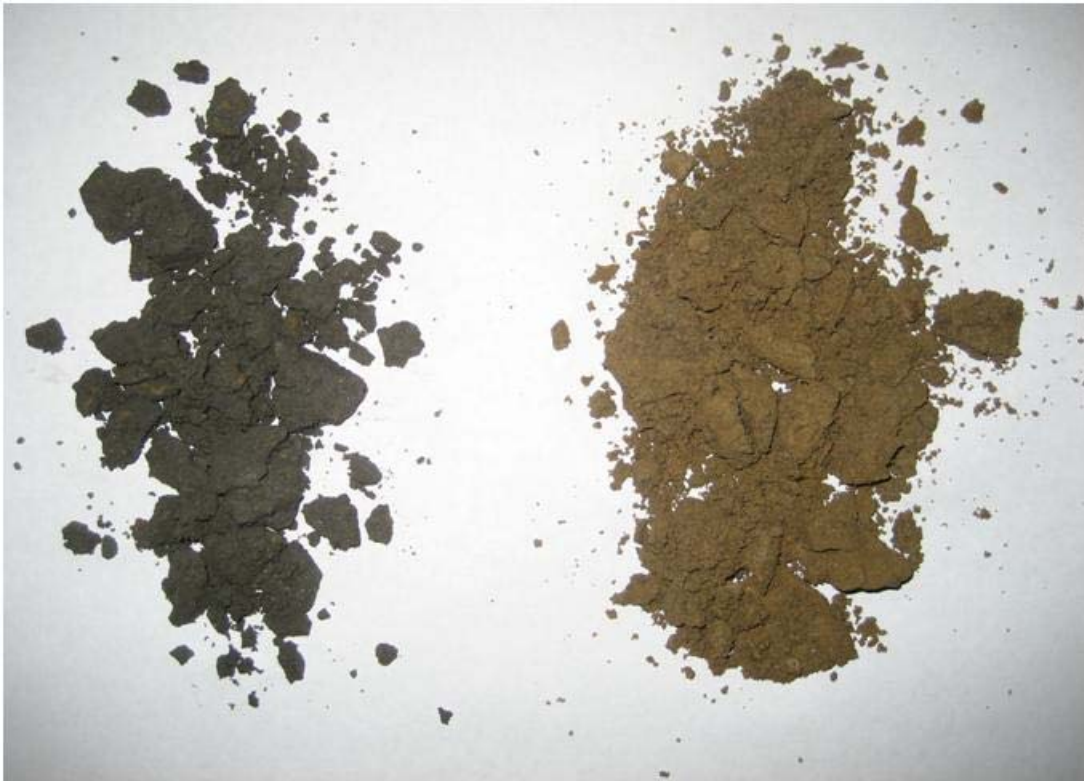
Figure C-5. Photograph of Naheola-Dark (left) and Naheola-Yellow (right) Formations.

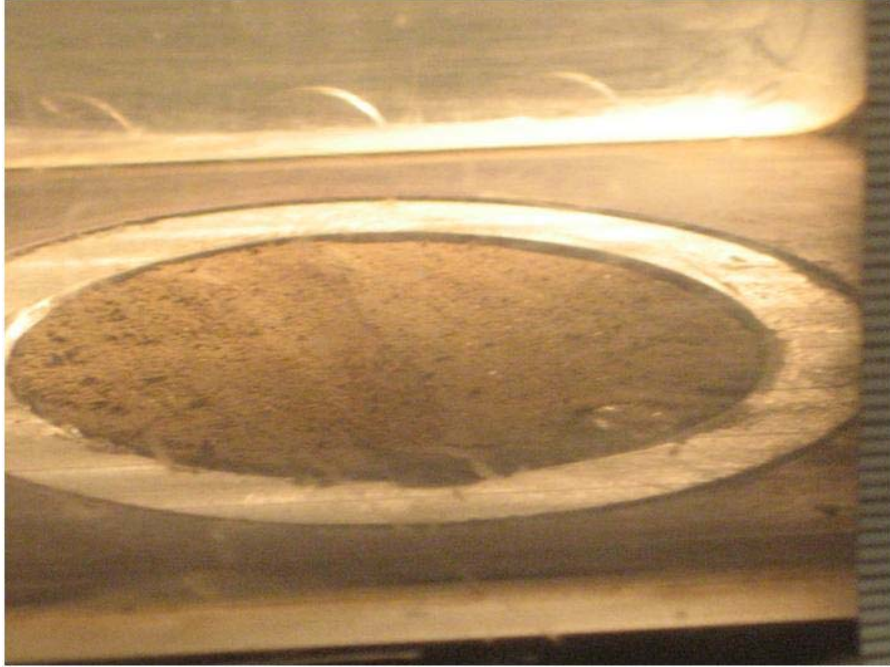
Figure C-6. Naheola Clay 17.2_1 Sample Prior to 2.0 m/s EFA Test.

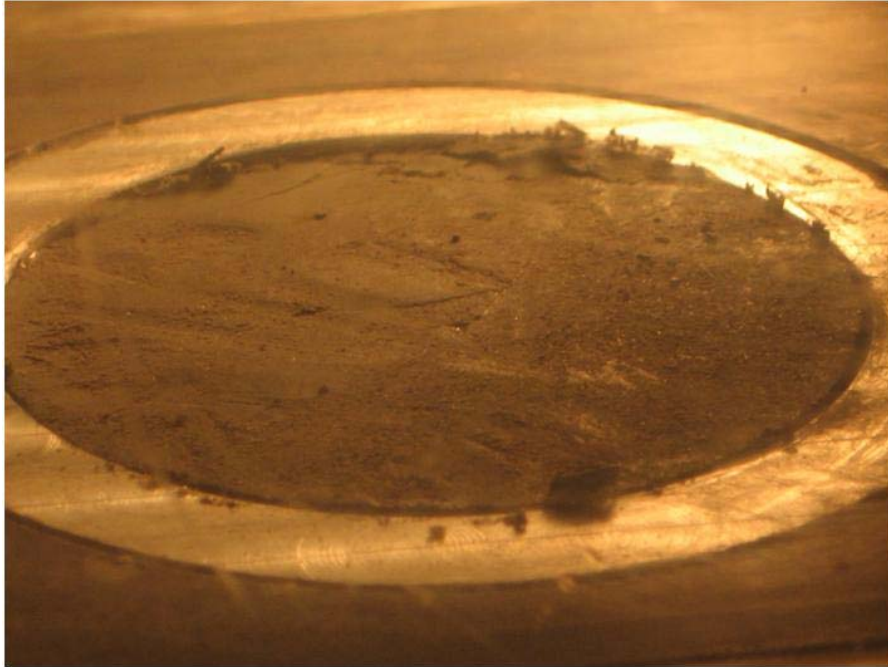
Figure C-9. Naheola Clay 16.0_1 Sample Prior to 1.5 m/s EFA Test.

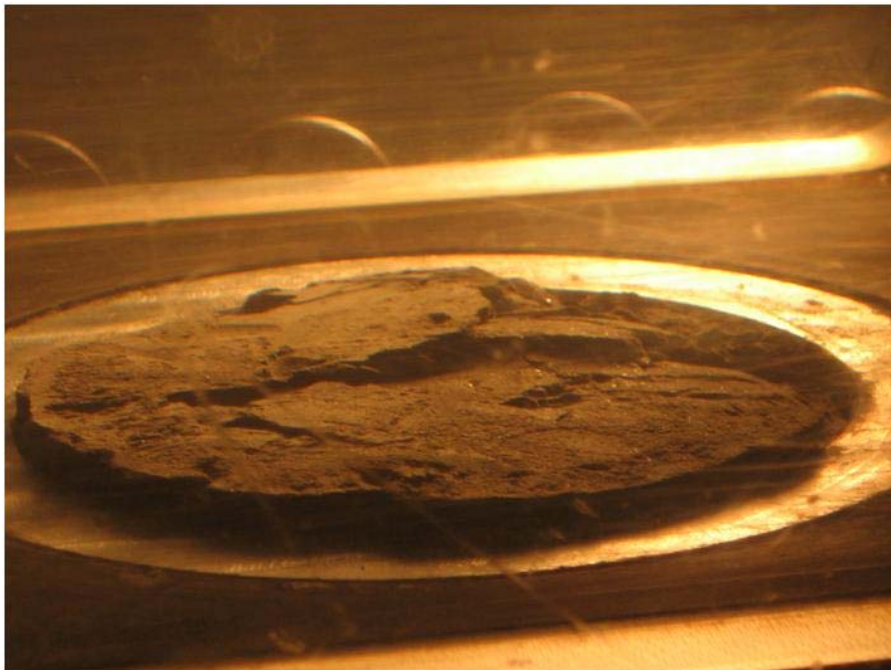
Figure C-10. Naheola Clay 16.0_1 Sample at the End of 1.5 m/s EFA Test.

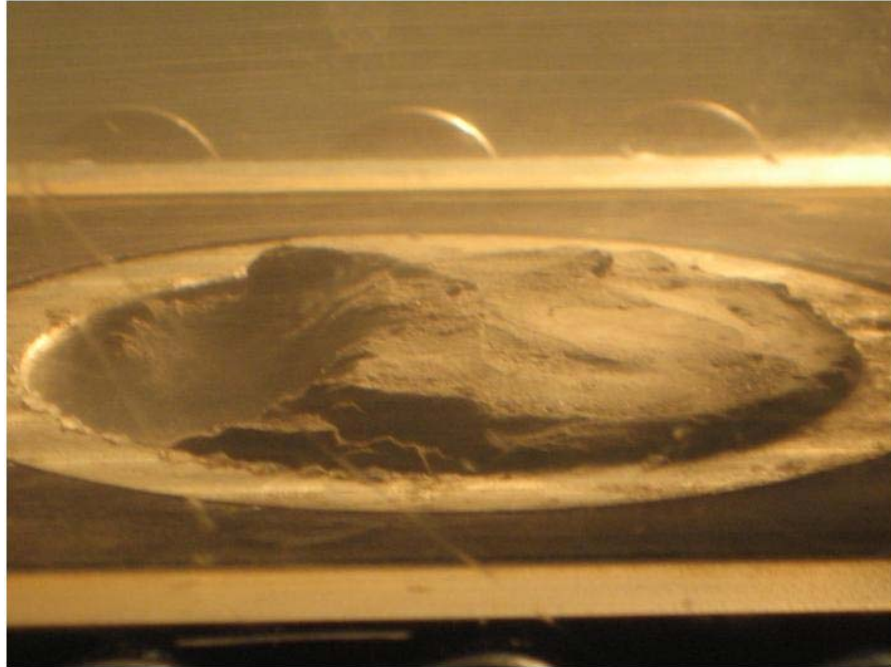
Figure C-13. Naheola Clay 19.5_4 Sample at the End of 2.0 m/s EFA Test.

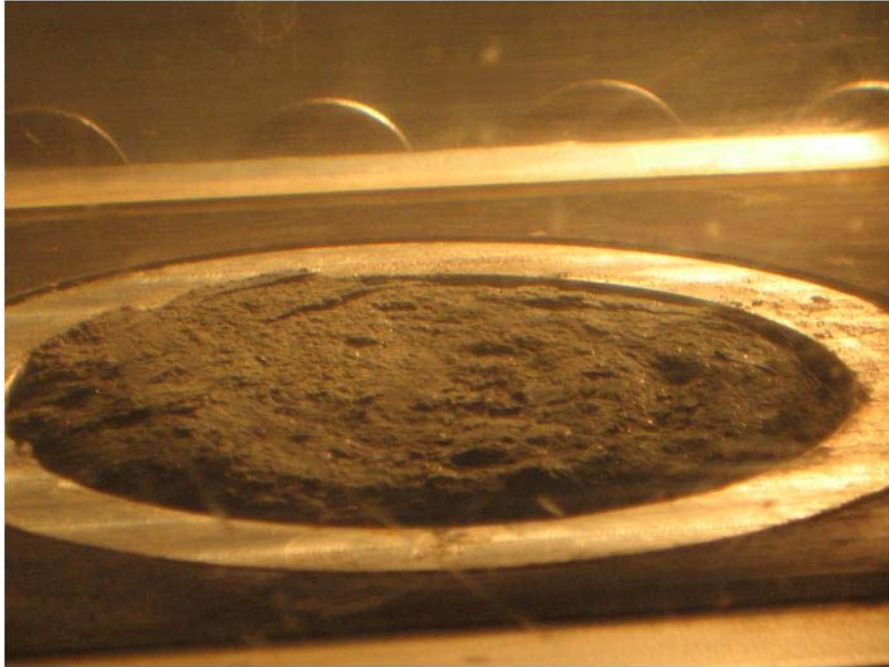
Figure C-17. Clayton 29.0_7 Approximately 8 Minutes into Test.

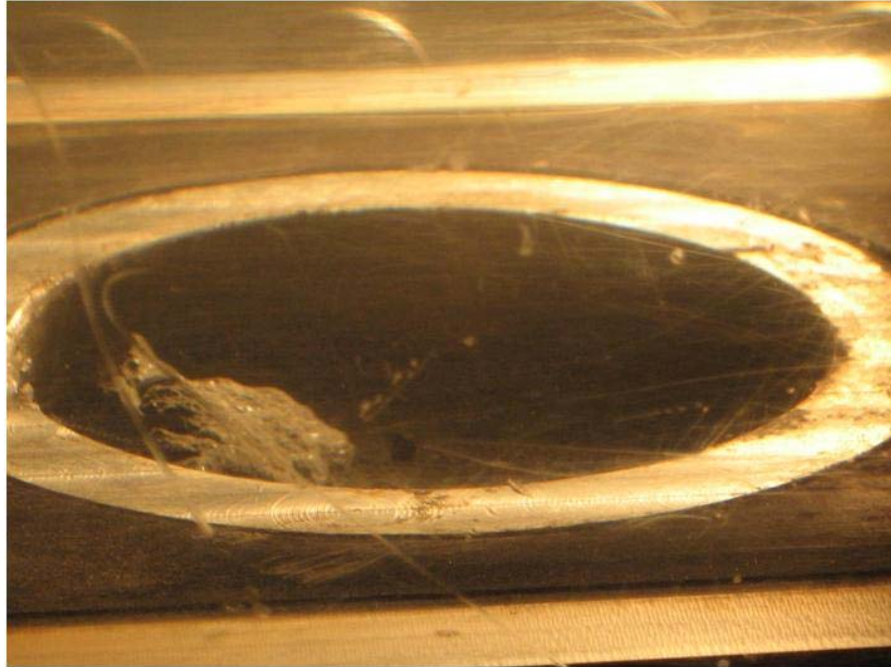
Figure C-19. Clayton 29.0_7 Approximately 27 Minutes into Test.

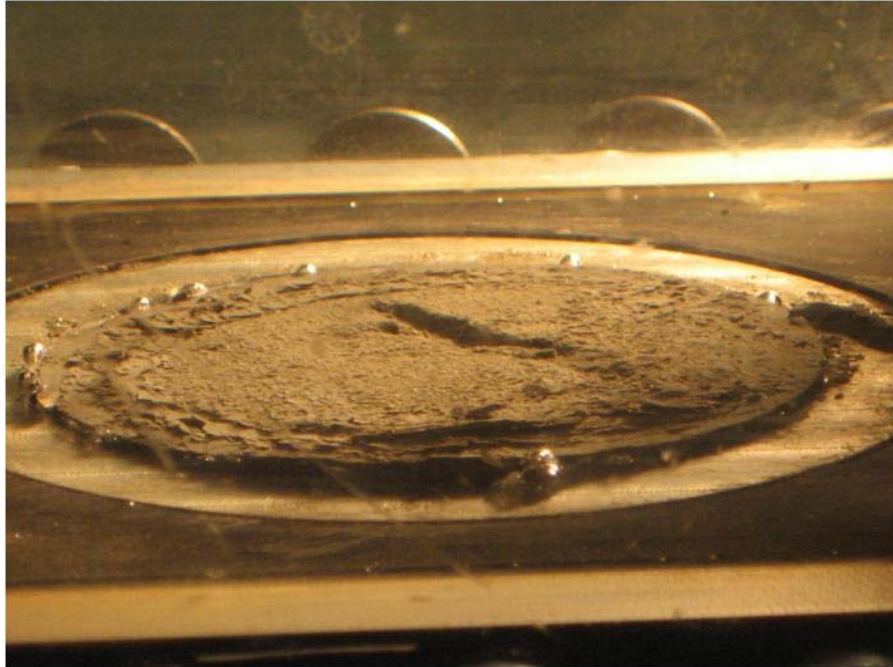
Figure C-21. Bucatunna 26.0_3 Sample Approximately 3 Minutes into 3.0 m/s EFA Test

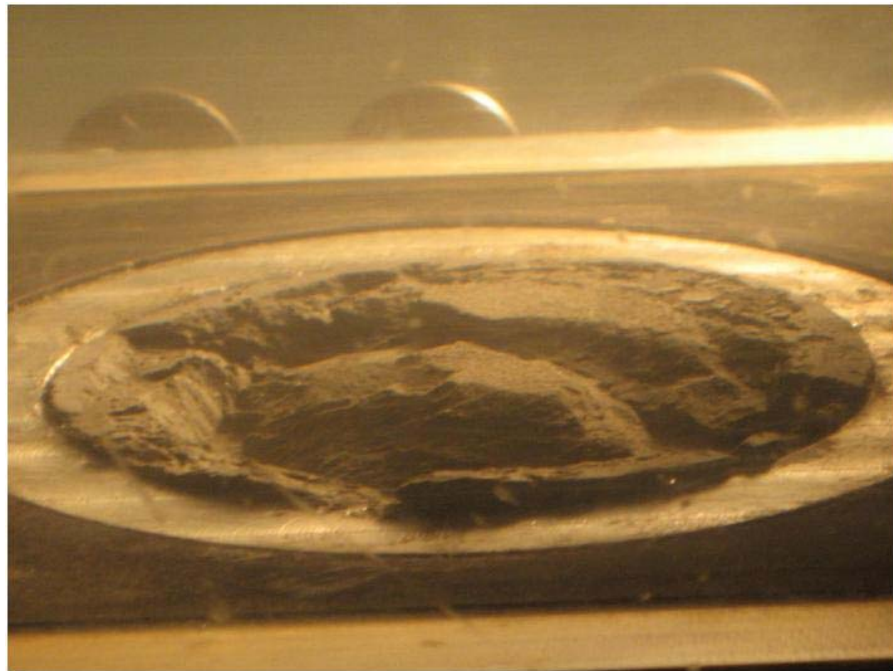
Figure C-22. Bucatunna 26.0_3 Sample Approximately 15 Minutes into 3.0 m/s EFA Test.

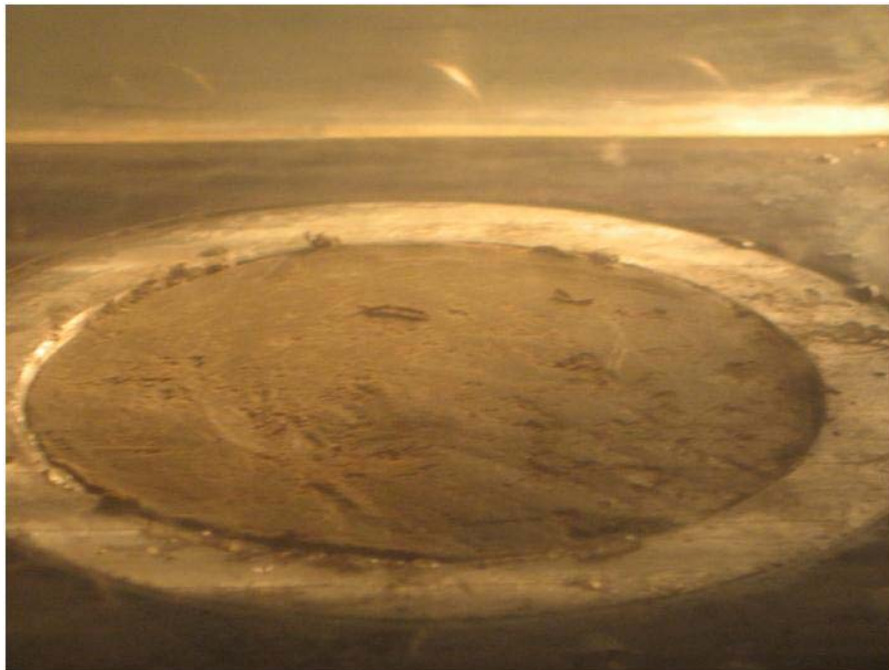
Figure C-23. Porter’s Creek 24.0_4 Sample at Start of 0.3 m/s EFA Test.

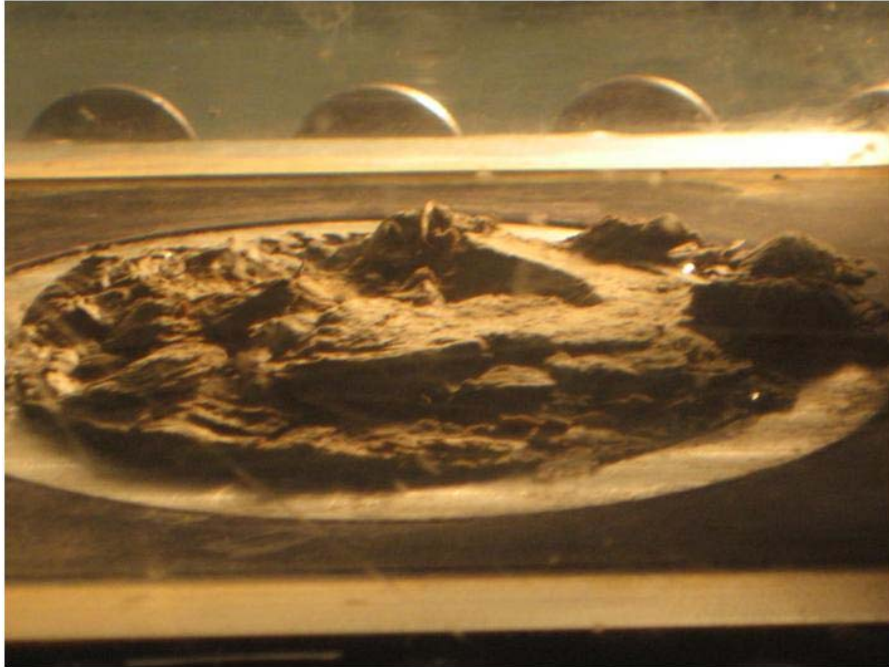
Figure C-24. Porter’s Creek 24.0_4 Sample 15 minutes After Push.

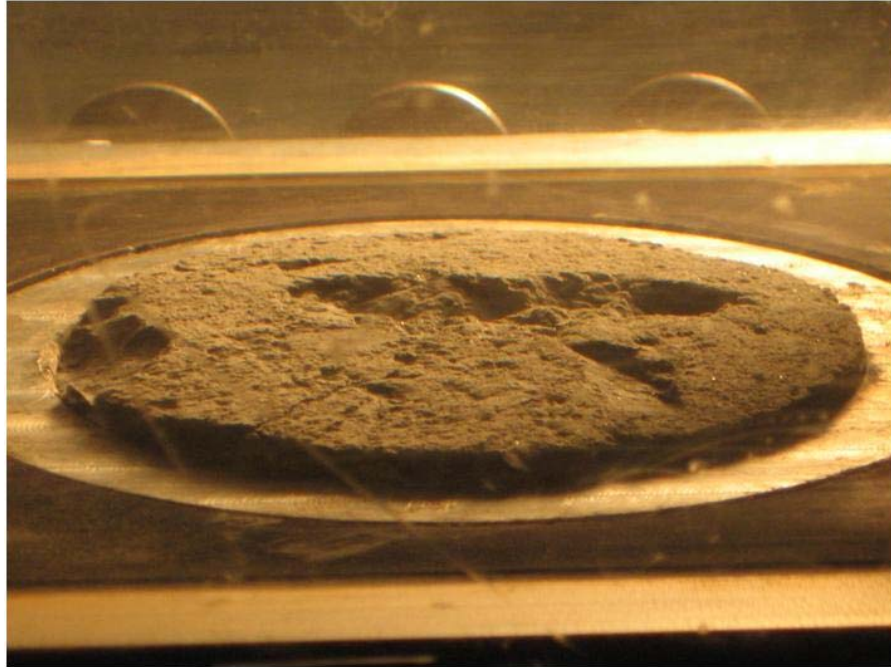
Figure C-27. Yazoo 21.0_4 Sample Approximately 57 Minutes after Push.
