**EVALUATION OF PRECUT TRANSVERSE CRACKS
FOR AN ASPHALT CONCRETE PAVEMENT IN
INTERIOR ALASKA (MOOSE CREEK – RICHARDSON
HIGHWAY)
FINAL PROJECT REPORT**

Jenny Liu, Ph.D, P.E., Professor
Department of Civil and Environmental Engineering
University of Alaska Fairbanks

1. Report No. 2013-S-UAF-0039	2. Government Accession No.	3. Recipient's Catalog No.	
4. Title and Subtitle Evaluation of Precut Transverse Cracks for an Asphalt Concrete Pavement in Interior Alaska (Moose Creek –Richardson Highway)		5. Report Date 8/31/2015

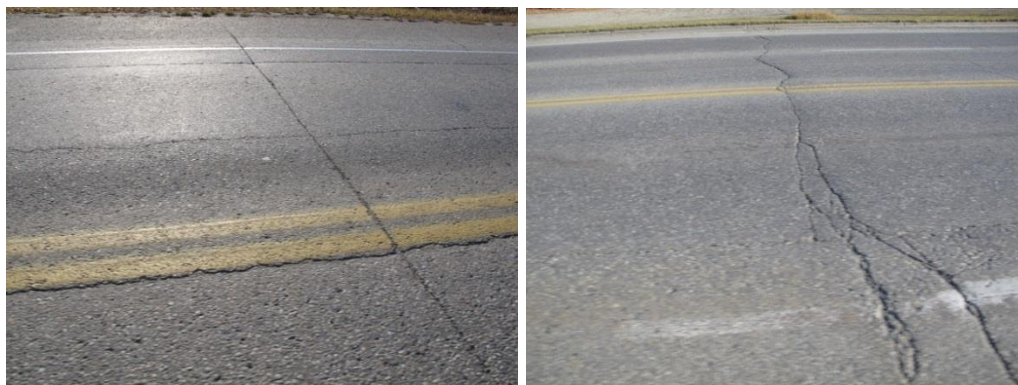
Figure 1. 25+ year old major transverse thermal cracks, precut (lt.) natural (rt.)

It is important to emphasize that the most critically important single distinguishing characteristic of major transverse thermal cracking is that it extends across the full width of the paved surface. Two examples of major transverse thermal cracks are shown in Figure 1. Figure 1 compares a 1984 precut Phillips Field Road crack with a natural major transverse thermal crack on another local Fairbanks, Alaska road. Both pavements were about 30 years old at the time of this report. Neither crack had ever been sealed. The precut crack provides a much better appearance. The natural crack looks much worse, exhibiting both spalling and bifurcation.

The authors strongly argue that the better appearance of precut transverse cracks, especially in urban areas, provides the impression that the pavement has been more “professionally finished.” On the other hand, although offering a somewhat broken appearance, general pavement performance in the vicinity of the natural crack (right hand photo in Figure 1) remains generally acceptable after 30 years. In fact, very recent Alaska research (McHattie, Mullin, and Liu, 2013) found considerable evidence that even the most ragged-appearing natural thermal cracking has most often posed little problem with respect to general pavement performance. But appearance and perception of quality construction is important. Regardless of other benefits, the driving public as well as most highway agency engineers would tend to perceive a successfully precut pavement as being less in need of maintenance than its naturally cracked counterpart.

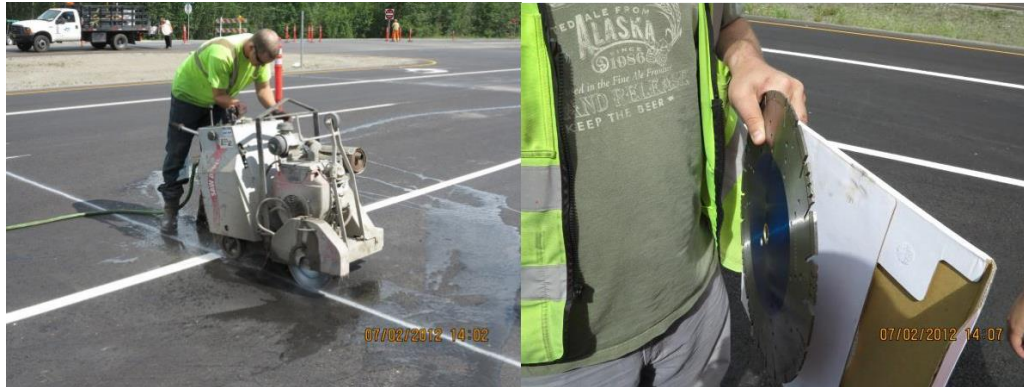
Figure 5. Saw Devil equipment and operator (lt) and thin diamond saw blade used (rt)

The equipment used was a Saw Devil walk-behind saw machine with a 12" diamond saw blade (one eighth inch thick) and a flatbed truck with a 300 gallon tank of water for cooling the saw blade. The time required to layout and cut the first two thirds of each line was approximately 12 minutes, or about 15 minutes total per line plus time required to move the cutting operation from one lane to the other. This time was averaged over several of the different depths of cuts. Figure 5 shows the saw equipment as well as the type of thin diamond saw used.

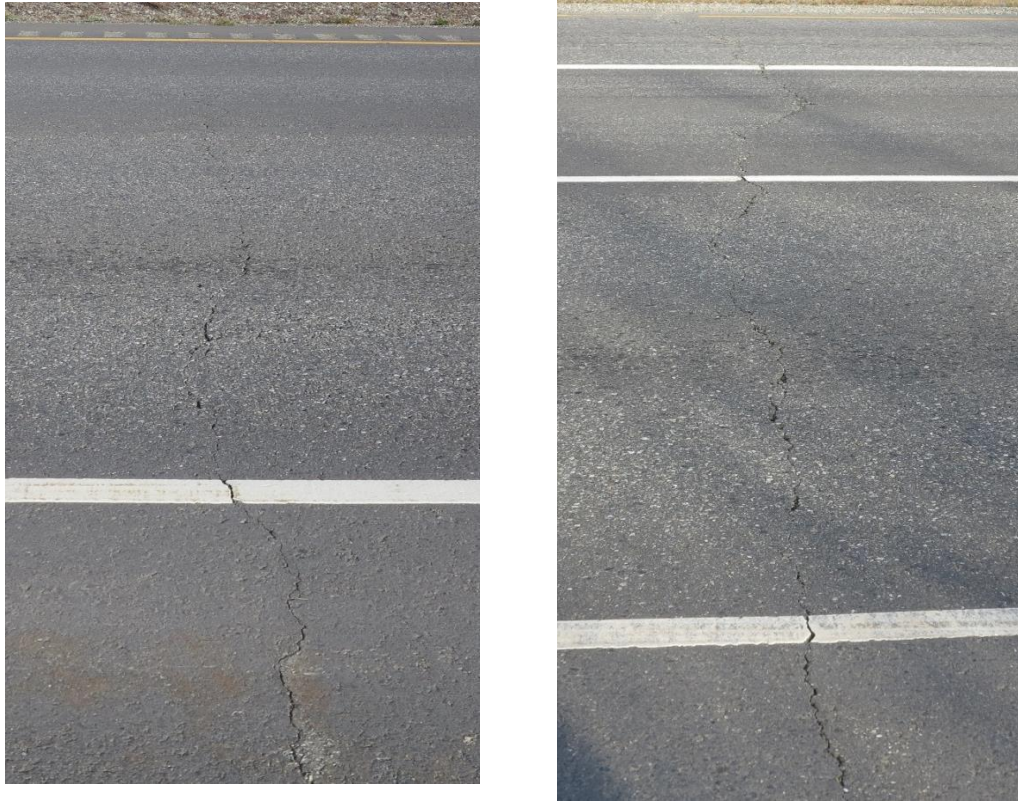
Figure 8. Natural transverse cracks at ~ Stations 999+27 (lt.) & 1029+13 (rt.)

Natural transverse thermal cracks (natural cracks) are the natural cracks that developed completely independent of any precutting, i.e., transverse thermal cracks as would be found on any other paved road in the general area. Photos of natural transverse thermal cracking at identified station locations are shown in Figure 8.

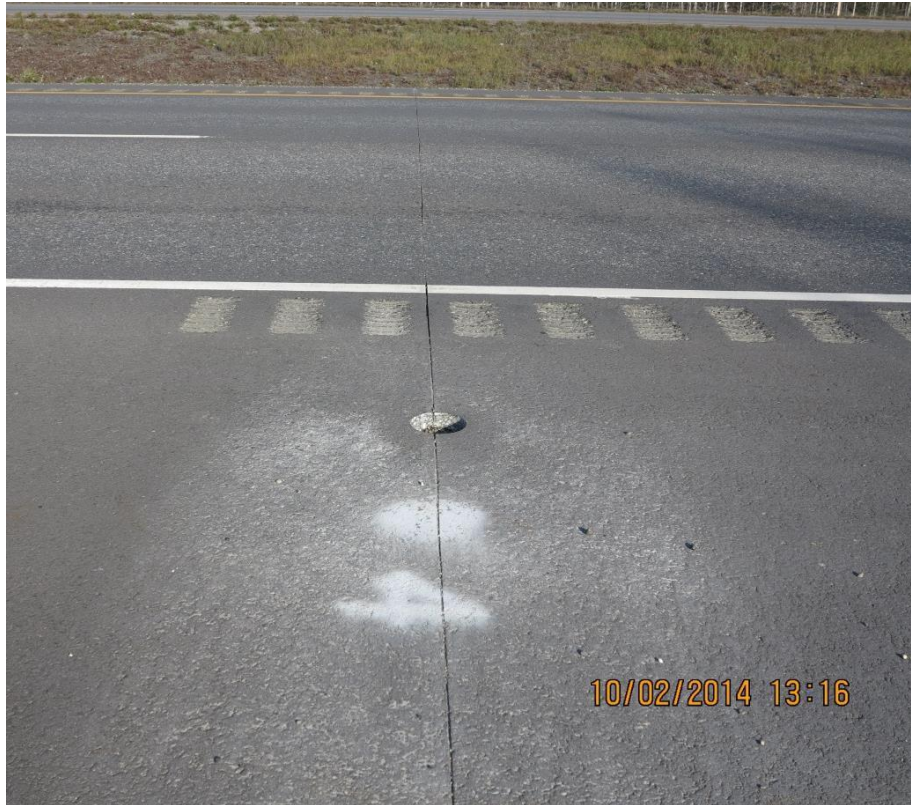
Figure 9. Precut non-active crack at ~ Station 1005+24

Precut transverse cracks—non-active (precut) are precut transverse cracks that have not been activated by intrusion of the natural thermal cracking process. In other words, a non-active precut crack is simply a slot that has been saw-cut across the pavement surface. In all precutting experiments done to date in Alaska, saw-cuts have not extended completely to the bottom of the pavement layer. Figure 9 shows a precut crack at about Station 1005+24 that is probably non-active and the hole left from core sample number 4. In the subsections where precutting was done (all subsections except control), pavement cores were obtained at precut locations.

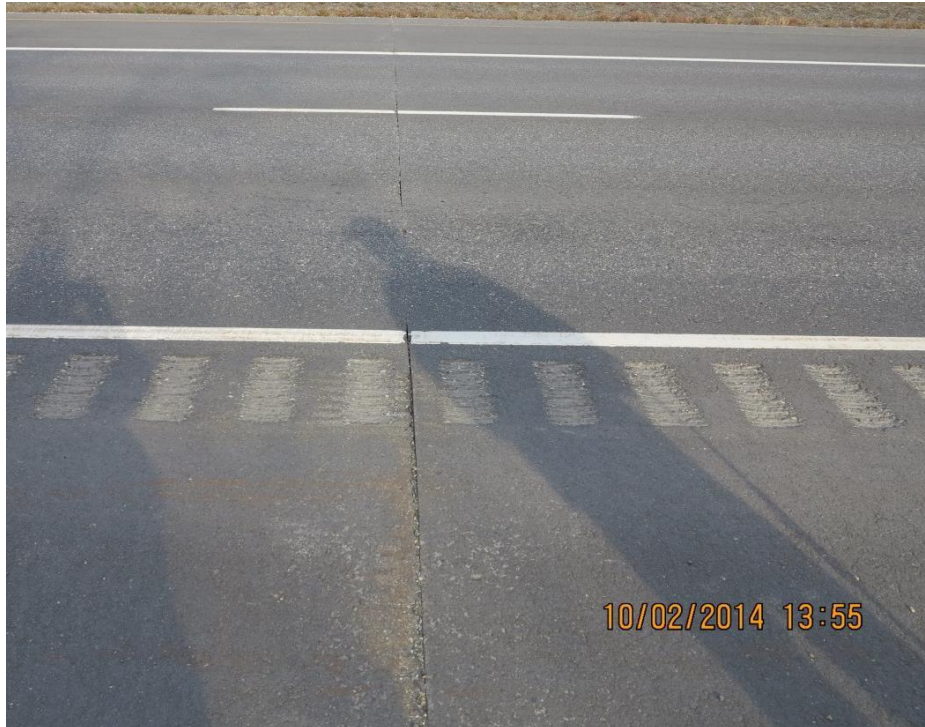
Figure 10. Precut active crack at ~ Station 1036+31

Precut transverse cracks—active (precut active) are precut transverse cracks that have been activated by the intrusion of natural thermal cracking process. Upon activation by the natural thermal cracking process these cracks become, in effect, simply man-influenced natural thermal cracks. Figure 10 shows a precut crack at about Station 1036+31 that is probably active at the present time.

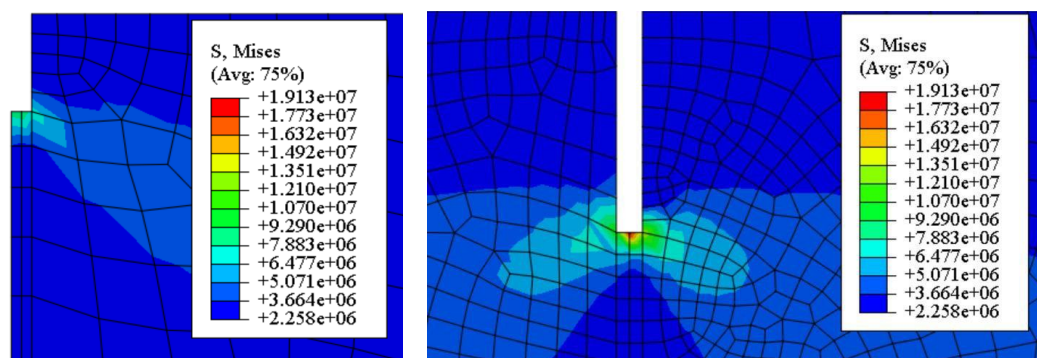
(a) 25' spacing without saw cut

(b) 25' spacing with 0.5'' saw cutting depth

(c) 25' spacing with 1.0'' saw cutting depth

(d) 25' spacing with 1.5'' saw cutting depth

Figure 15. Stress distributions for 25' spacing

To illustrate the distribution of Mises stress near the possible thermal crack and saw cutting areas, the result of AC layer was extracted from the database of calculated FEM simulation results. The stress distribution is illustrated by a color contour. The color scale is on the right of each figure with magnitudes. Here models with 25' spacing were used in Figure 15 as examples to demonstrate the simulation results indicated by Mises stress distribution.

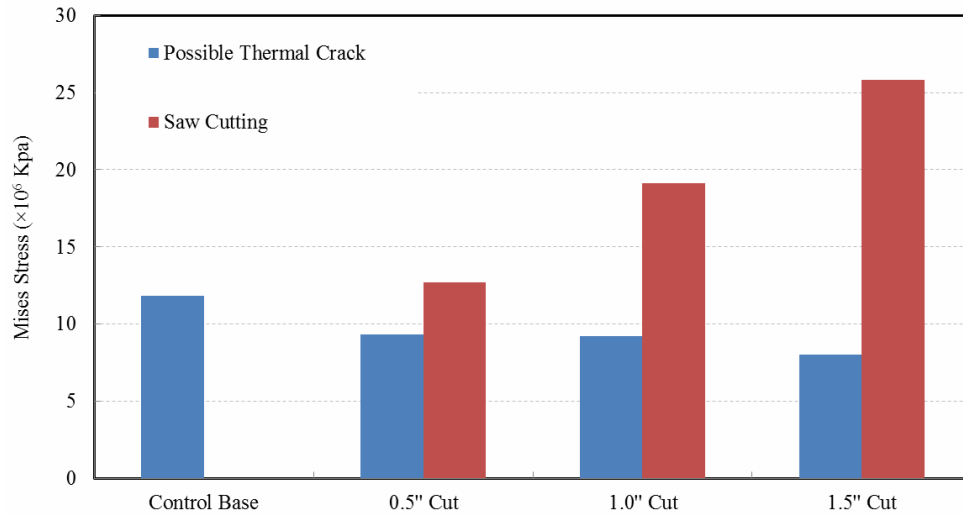
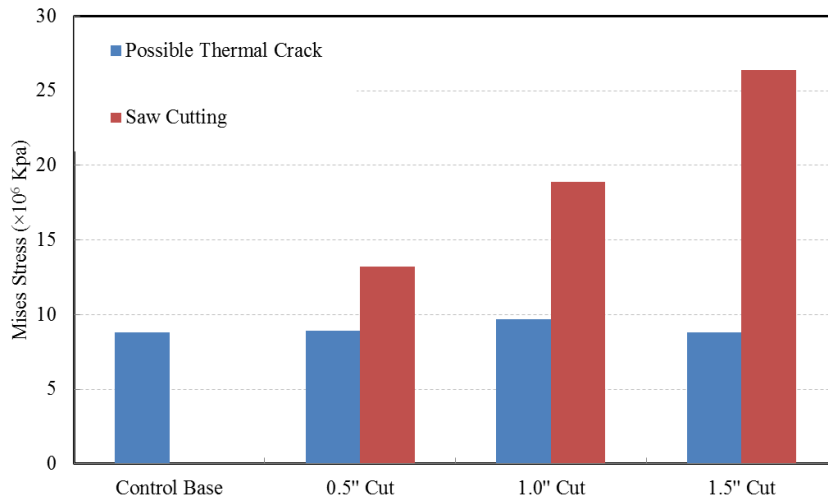
(a) 25' Spacing

(b) 40' Spacing

Figure 16. Summary of simulation results

Figure 16 summarizes simulation results of all cases. Figure 16(a) gives the maximum stresses at the locations of both possible thermal crack and saw cutting areas for 25' spacing sections. With the increase of cutting depth, the maximum stress at the bottom of the cutting tip increased dramatically while the stress at possible thermal crack location decreased. It is more likely to expect that crack occurs at the saw cutting location. This indicated that pre-cutting technique helped induce stress concentration (highest stress) and reduce stress anywhere else. In addition, increasing the cutting depth performed better in terms of controlling random occurrence of crack, which was consistent with the findings from the field observation in Chapter V.

Figure 16 (b) gives the maximum stresses at the locations of both possible thermal crack and saw cutting areas for 40' spacing sections. Similar to the case for 25' spacing, at 40' spacing, the maximum stress at the bottom of the cutting tip increased significantly with the increase of cutting depth. However, the reduction of stress at the bottom of the possible thermal crack location was not as significant as that for 25' spacing. This was also consistent with preliminary findings from the field observation which showed 25' spacing was more effective than 40' spacing with less amount of cracks occurred.

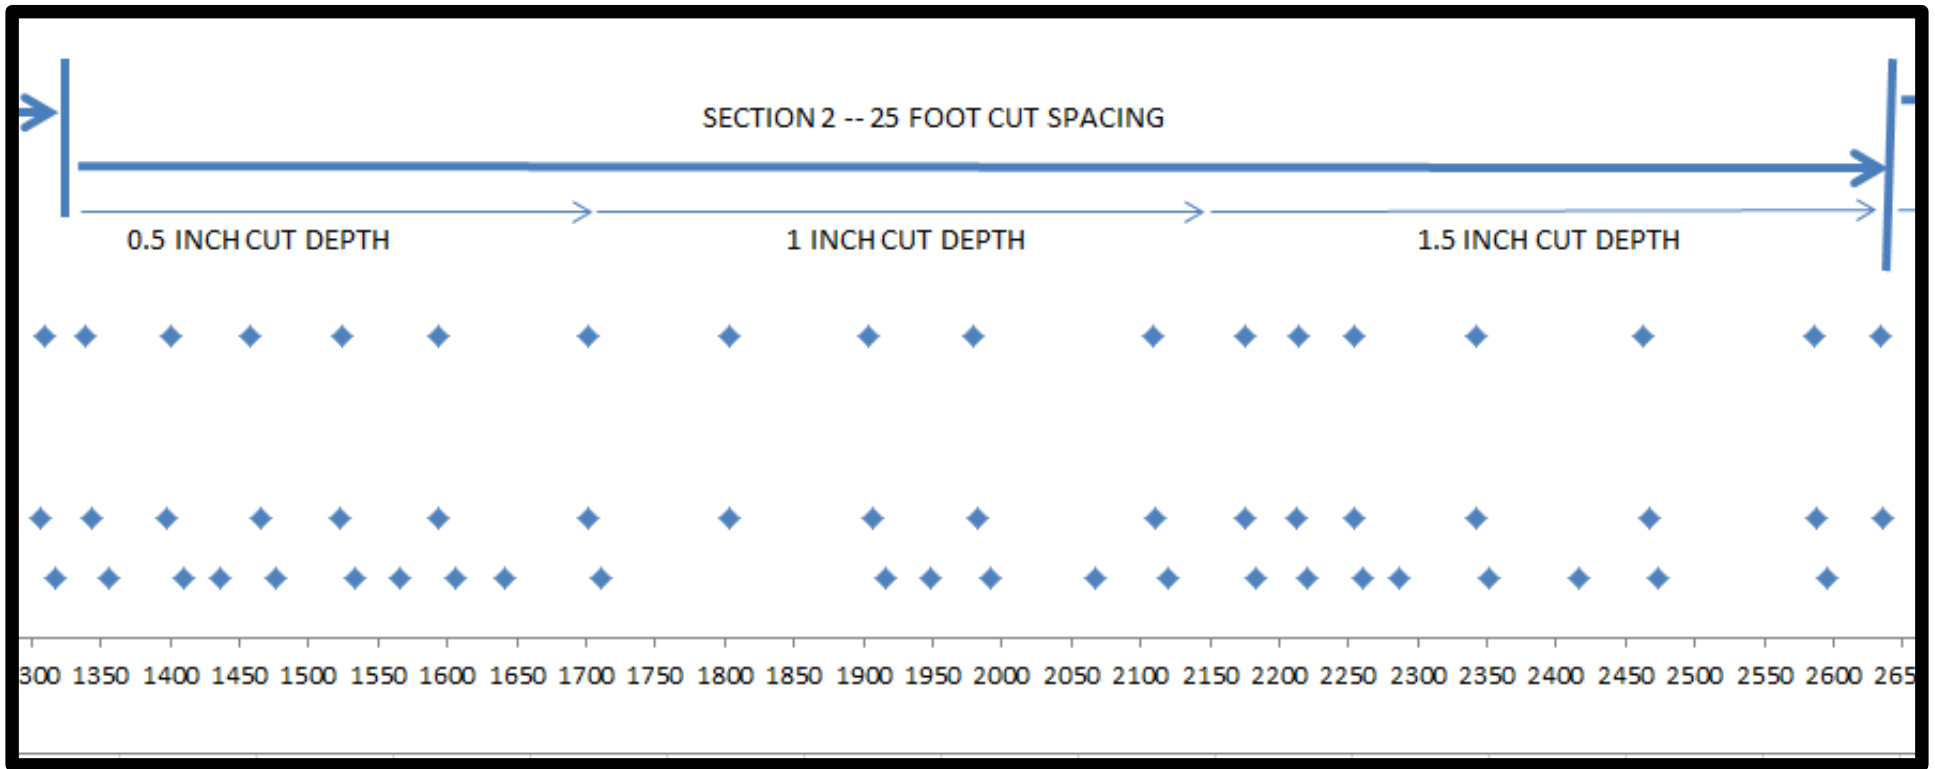
Appendix C2. Experimental Subsection 2 crack map

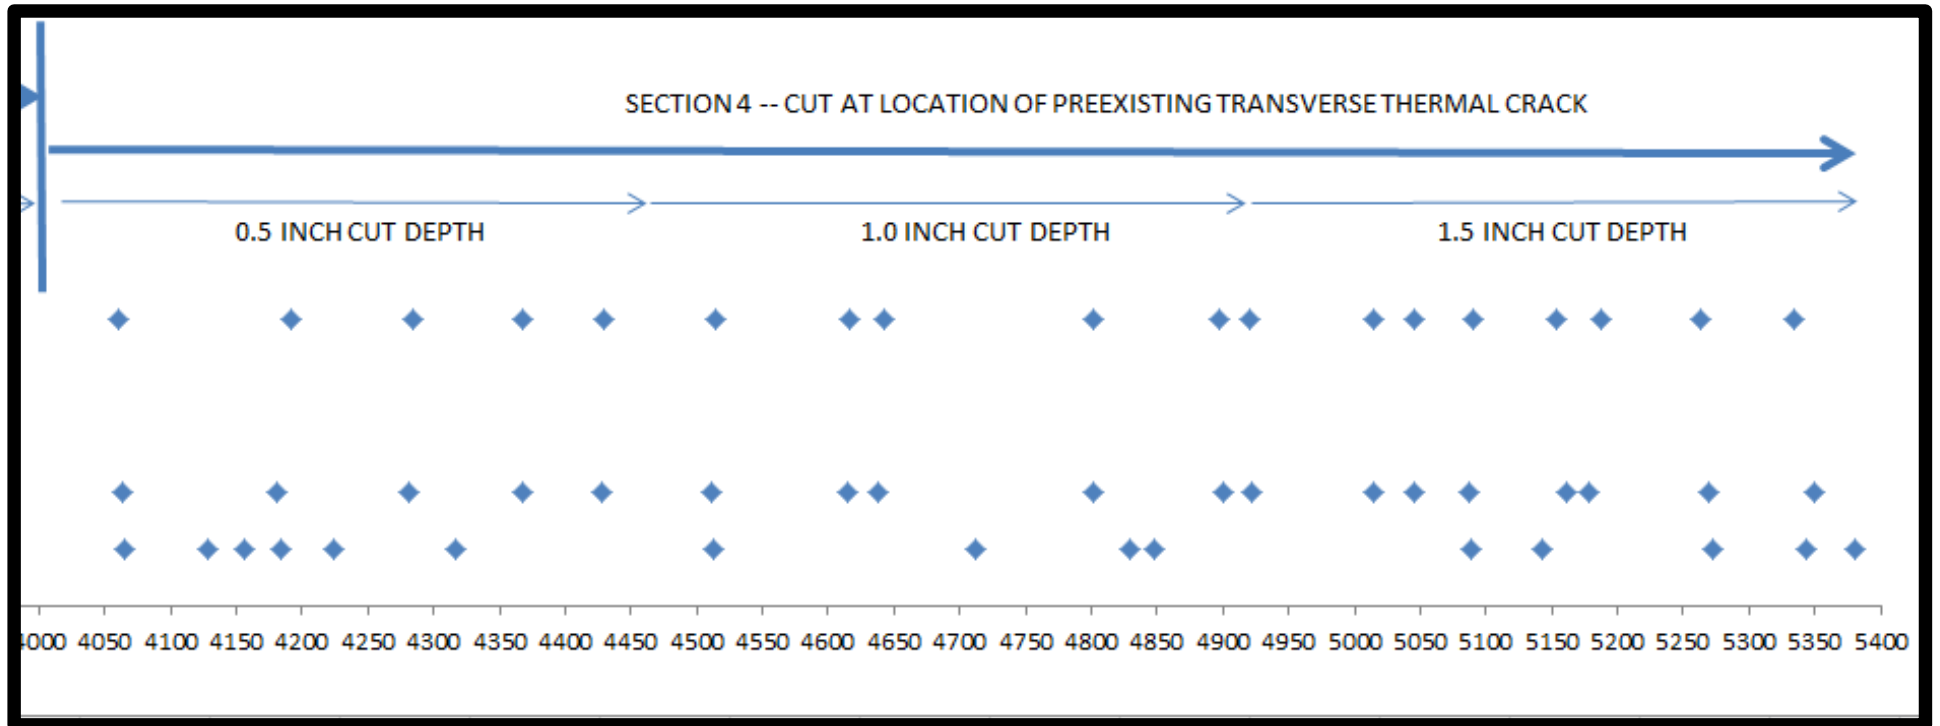
Appendix C4. Experimental Subsection 4 crack map
