# **DESIGN AND EVALUATION OF AN ENERGY- ABSORBING, REUSABLE ROADSIDE/MEDIAN BARRIER**

MwRSF Research Report No. TRP-03-317-15

July 29, 2015

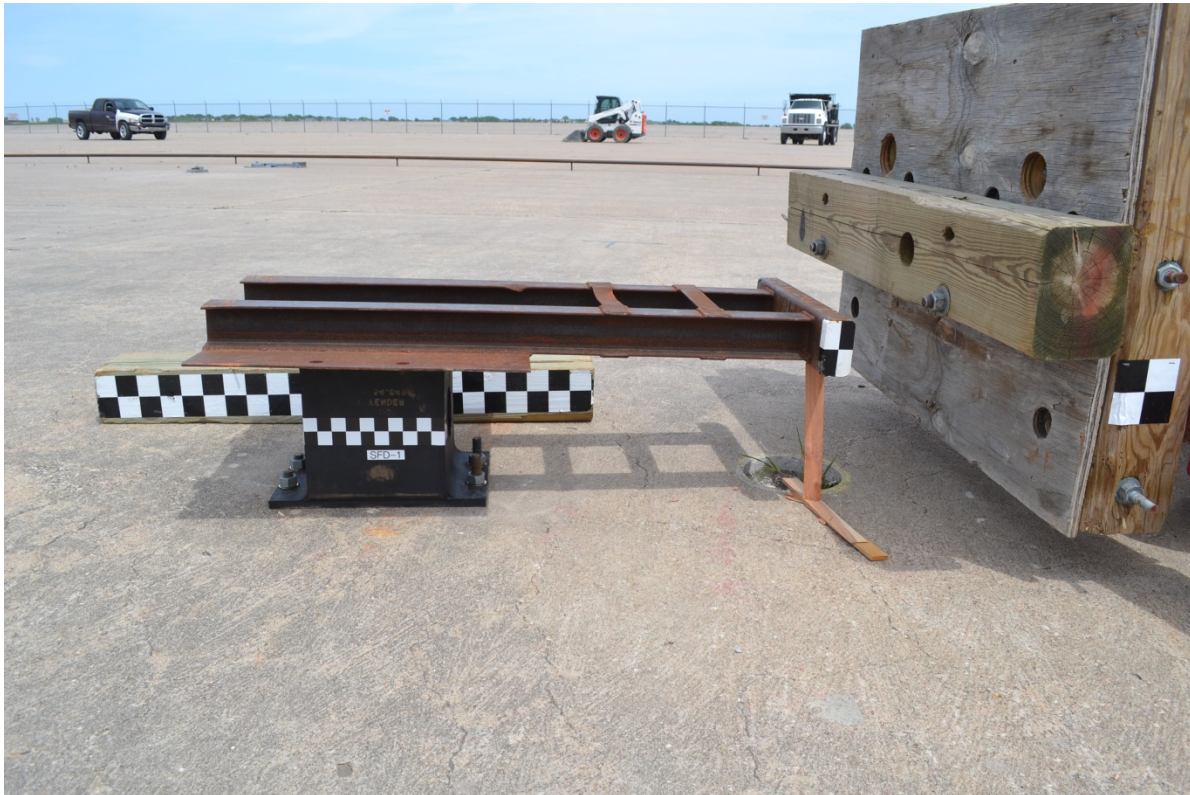
Figure 4. Bogie Test Setup, All Tests

A total of nine dynamic bogie tests were conducted on an E46496 shear fender with dimensions of 11 $\frac{5}{8}$  in. (295 mm) tall x 10 in. (254 mm) wide x 15 $\frac{3}{4}$  in. (400 mm) long with a 4-in. (102-mm) diameter hole lengthwise through the shear fender. The bogie tests were conducted with the post loaded longitudinally, which is parallel to the length of the hole. The target impact conditions for tests SF10-1, SF10-2, SF10P-1, and SF10P-2 were a speed of 5 mph (8 km/h) and

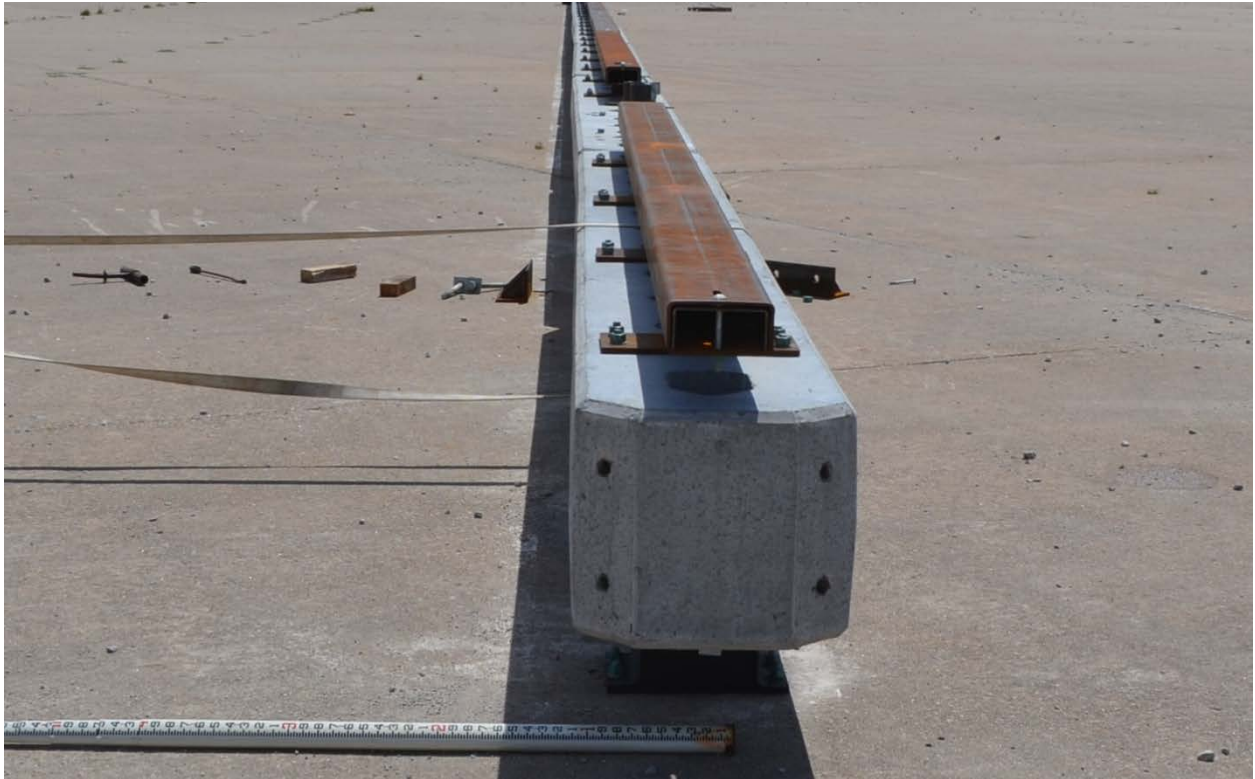
The steel plate shims were removed, and the barrier was stable and not leaning. The permanent set that had been noted previously was no longer present, and it was believed to be eliminated by overloading the posts from the opposite direction. The top skid plate was not supporting any weight of the beam as the heights to the bottom of the beam varied from 11 $\frac{1}{8}$  in. (283 mm) to 11 $\frac{1}{4}$  in. (286 mm). Thus, with only the posts supporting the beam, the system had a vertical deflection of  $\frac{3}{8}$  to  $\frac{1}{2}$  in. (9.5 to 12.7 mm) at approximately 70 degrees F (21 degrees C). The system also remained completely upright with only the rubber posts supporting the weight of the rail. However, the barrier did begin to lean after several hours. The steel shims were once again inserted in the gap between the bottom of the concrete beams and the top skid plate, and the system continued to remain completely upright and stable. In lieu of having varying thickness steel shims to stabilize the system on varying terrain, thick rubber sheet shims would allow adjustability more easily without multiple parts. Implementing the skids into the barrier system increased the stability and was further pursued.

Figure 70. Barrier Stability with Two Support Skids with Shims

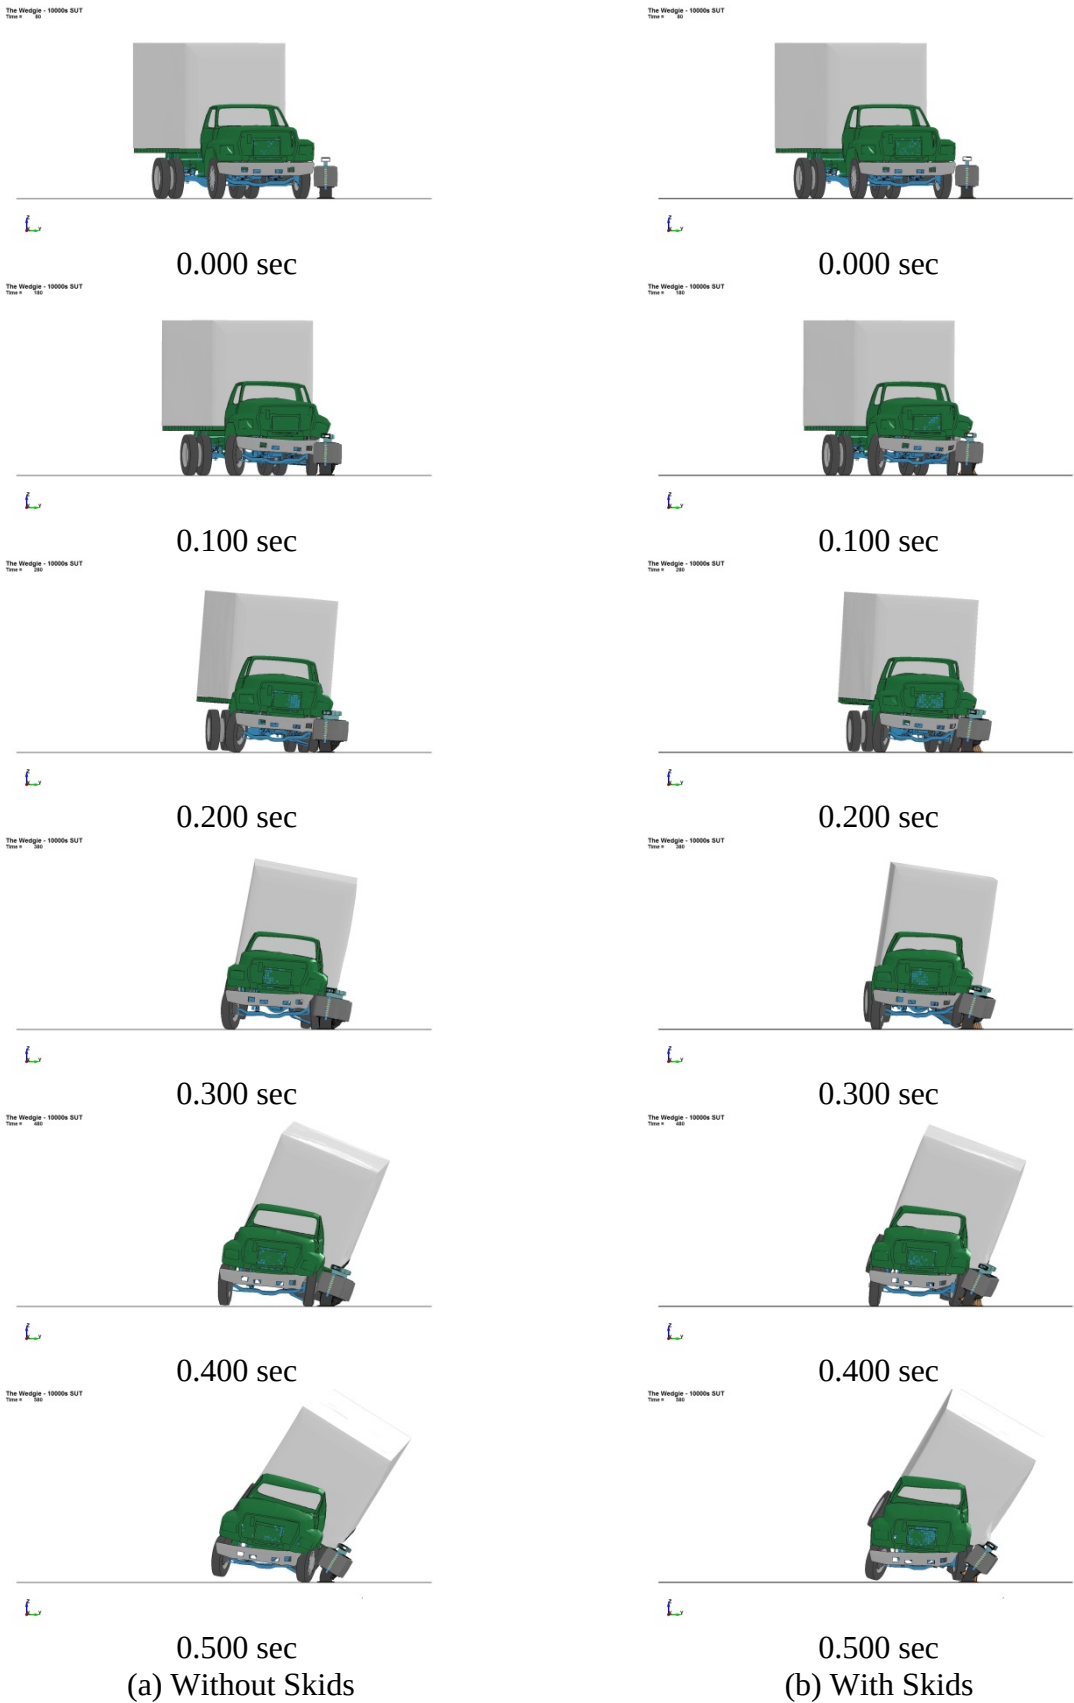
The barrier performance is slightly different between the two simulations, but the barrier still has a significant roll motion, which could lead to the barrier not restoring or to potential vehicle rollover. Since there are many parts of the model that have yet to be validated, it is hard to make predictive conclusions as to the performance of the vehicle and barrier. While it is still somewhat subjective if the 10000S impact into the RESTORE barrier will perform acceptably according to MASH TL-4 safety performance criteria, the skids do not appear to be detrimental to the barrier system. Throughout the duration of the project, several simulation issues occurred and are discussed in Appendix C.

Figure 76. RESTORE Barrier Simulation with Test Designation 4-12 Impacts
