# MoDOT Pavement Preservation Research Program

## Volume V. Site-Specific Pavement Condition Assessment

Final Report Prepared for Missouri Department of Transportation  
November 2015

Report cmr16-004

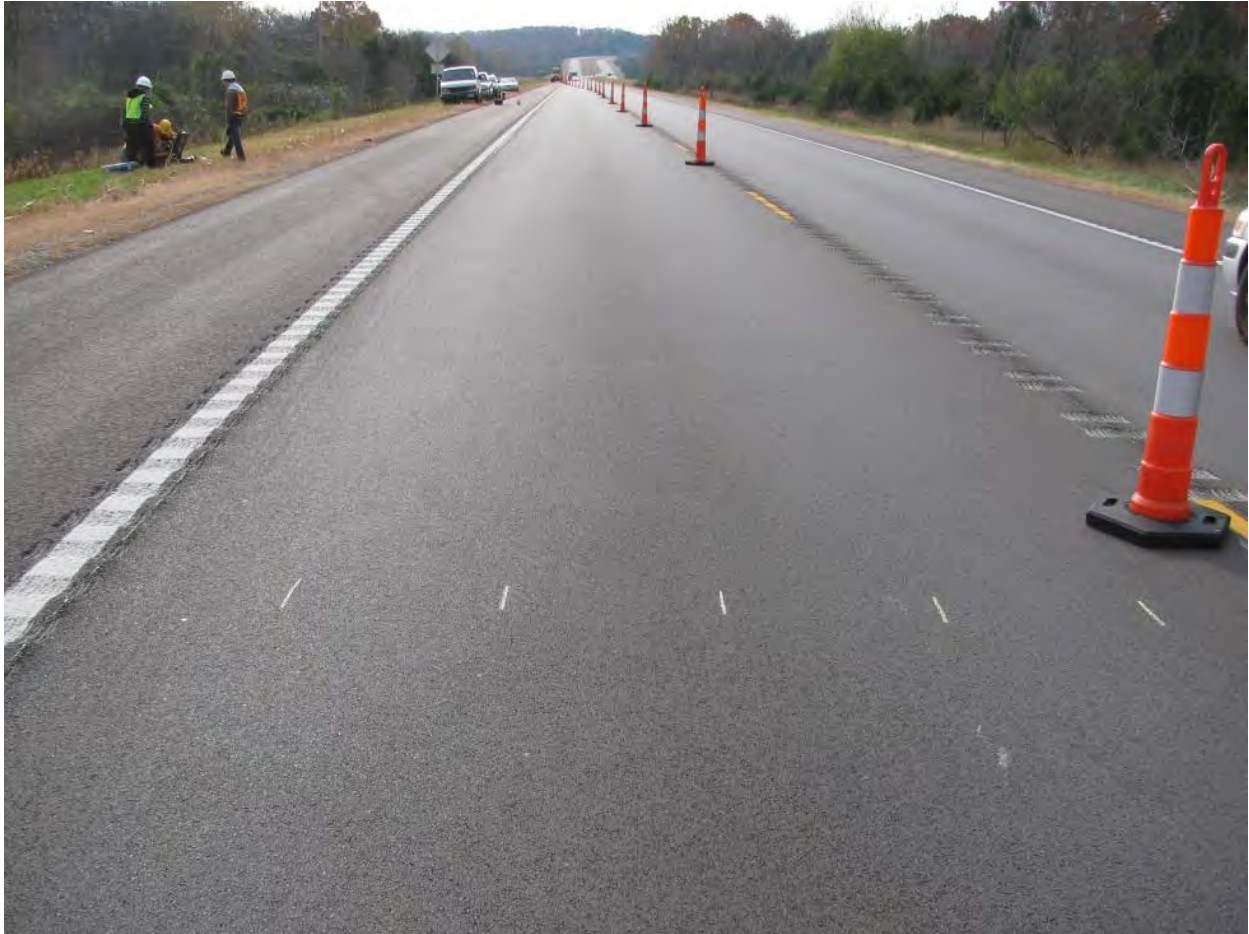
*Fig. 2.4—Photograph of US 63 (Site 1). The pavement was observed to be in excellent condition with no visible surface defects.*

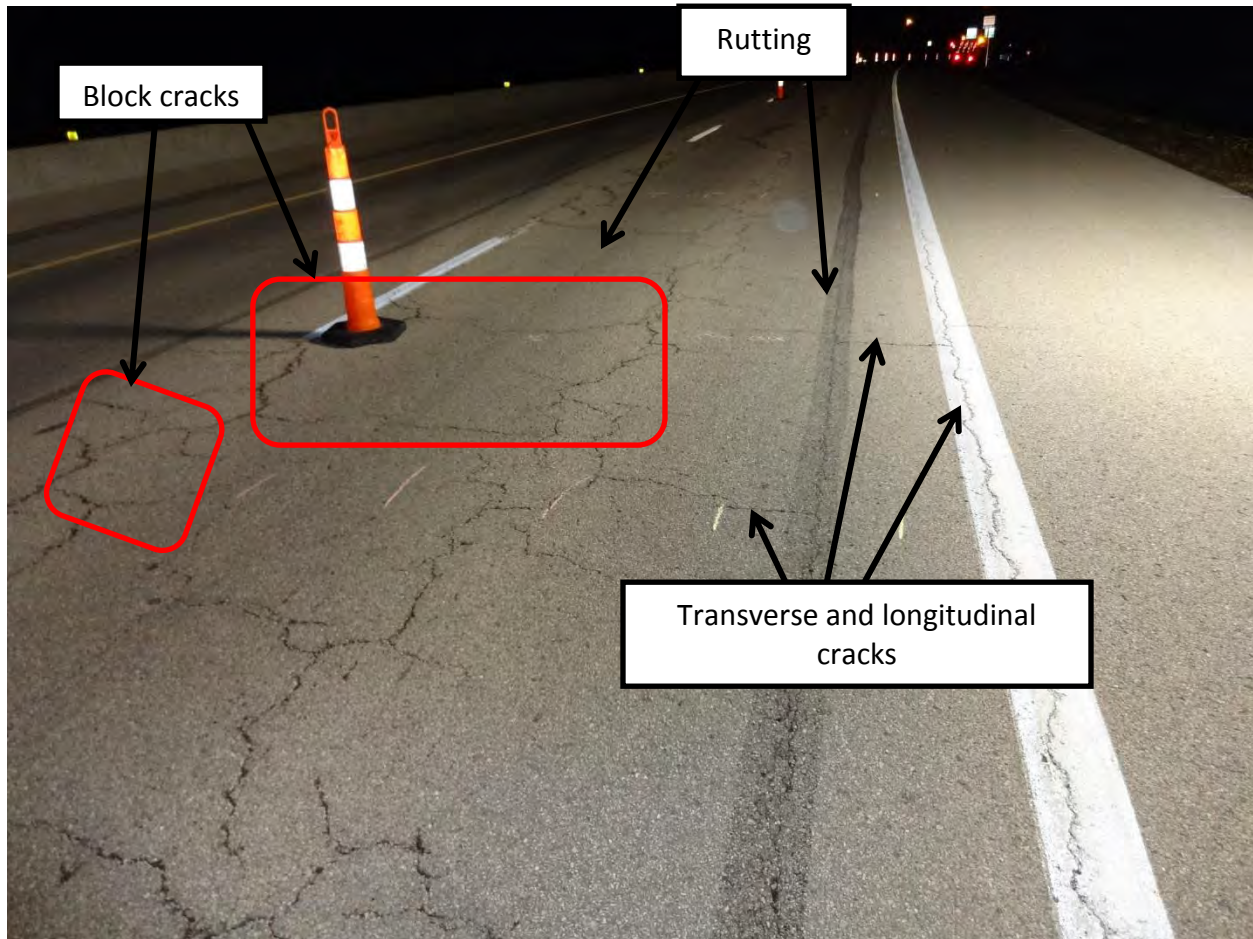
*Fig. 2.7–Photograph showing typical condition of the MO 179 (Site 3) pavement site at the time of field investigation.*

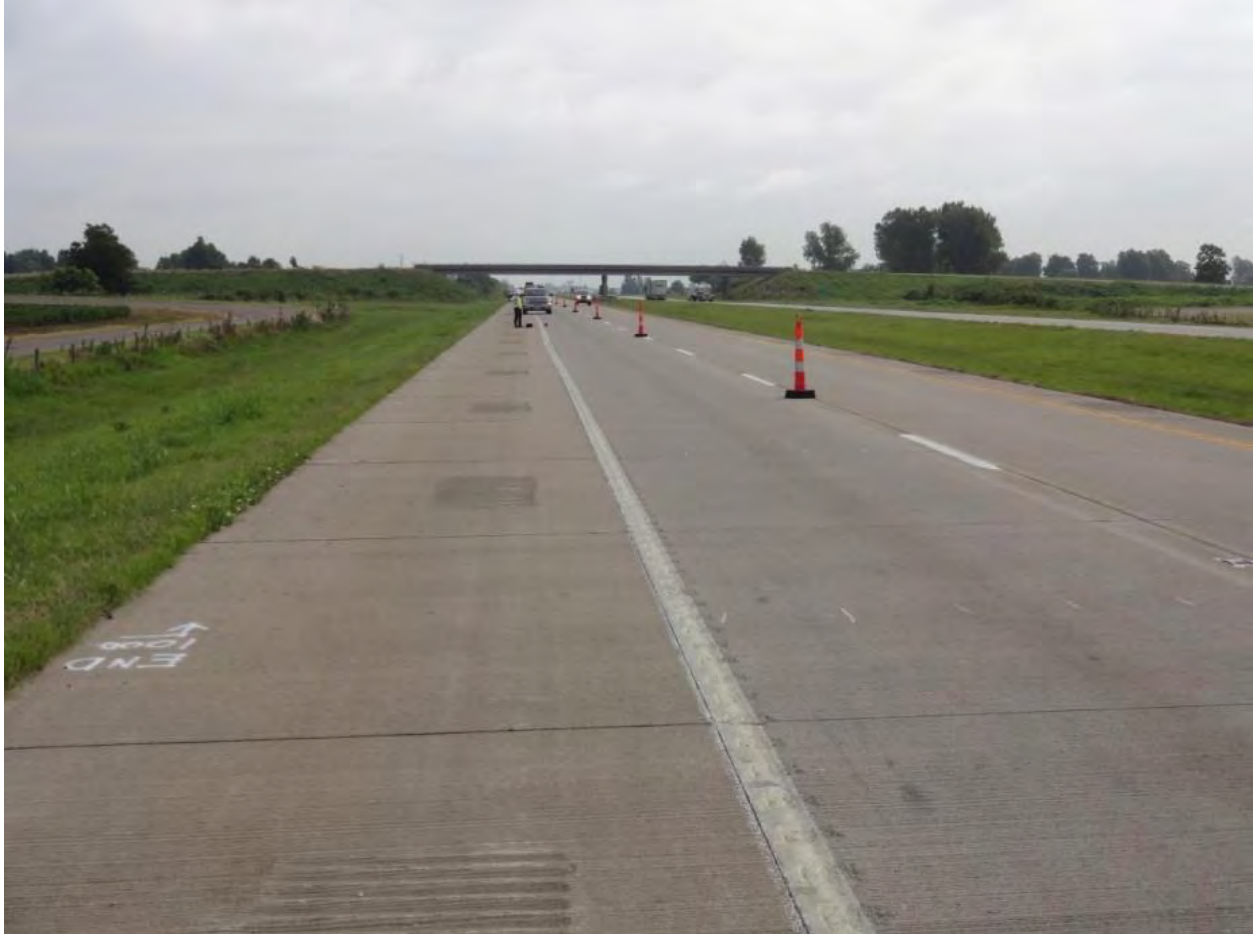
*Fig. 2.10—Photograph of I-55 Pemiscot County (Site 5) pavement.*

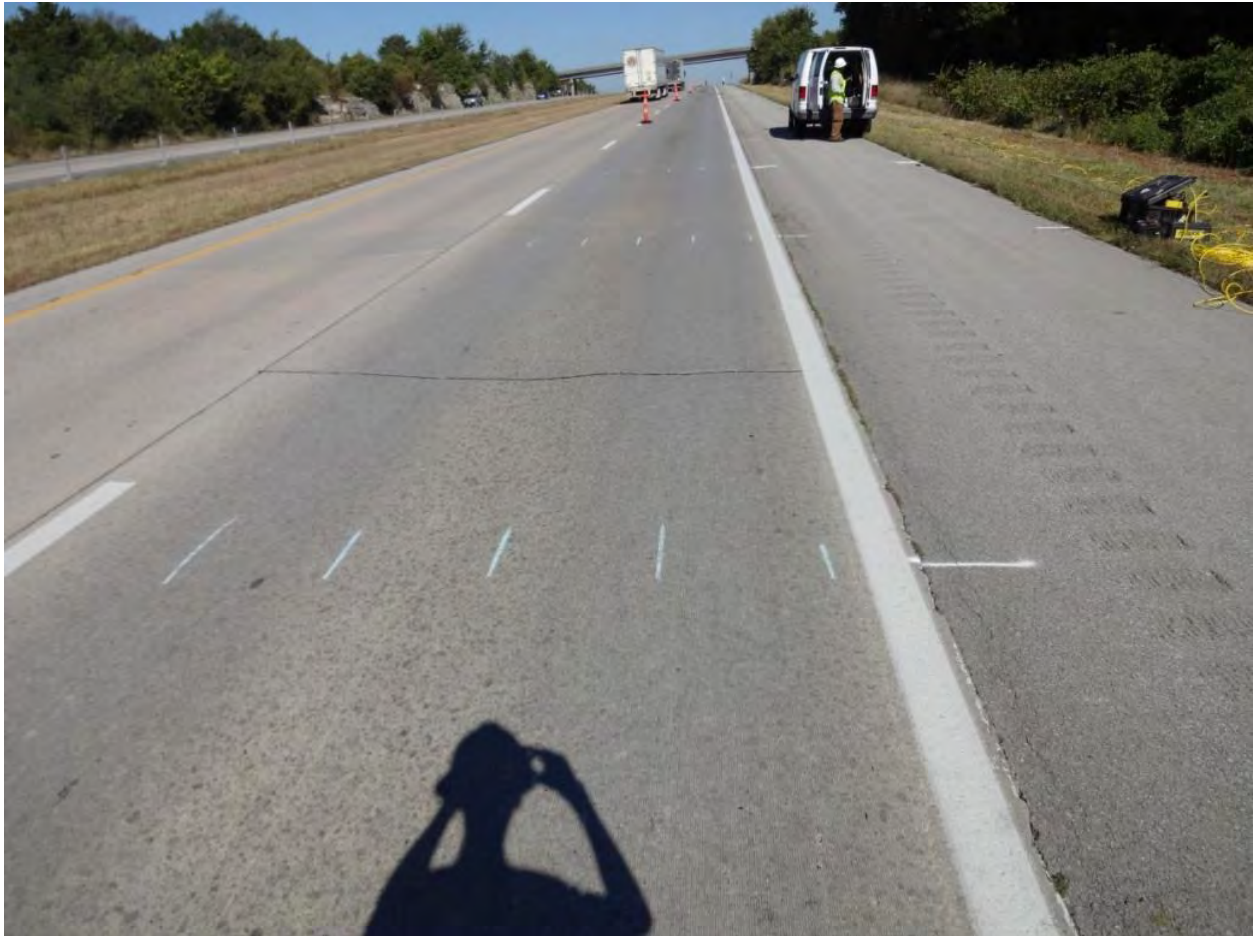
*Fig. 2.11—Photograph of I-55 Perry County (Site 6). The pavement appeared to be in very good condition with few cracks on the surface.*

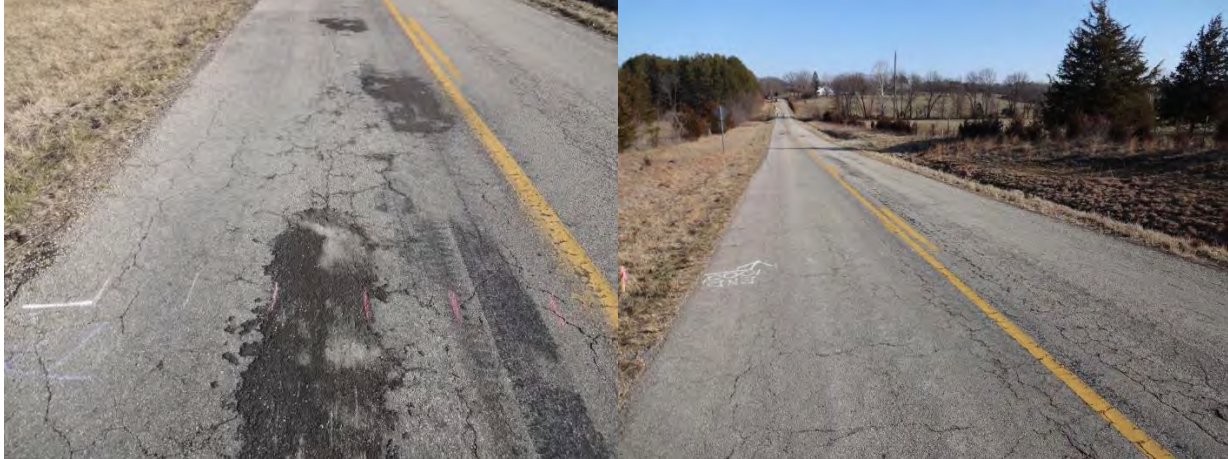
The asphalt pavement was observed to be in poor condition with a PASER rating of 3. The pavement showed evidence of multiple closely spaced longitudinal and transverse cracks, raveling, alligator cracks, and distortions. The condition of the pavement is shown in Fig. 2.12.

*Fig. 2.12—Cracks, rutting, and patches observed on the pavement surface at HWY U (Site 7).*

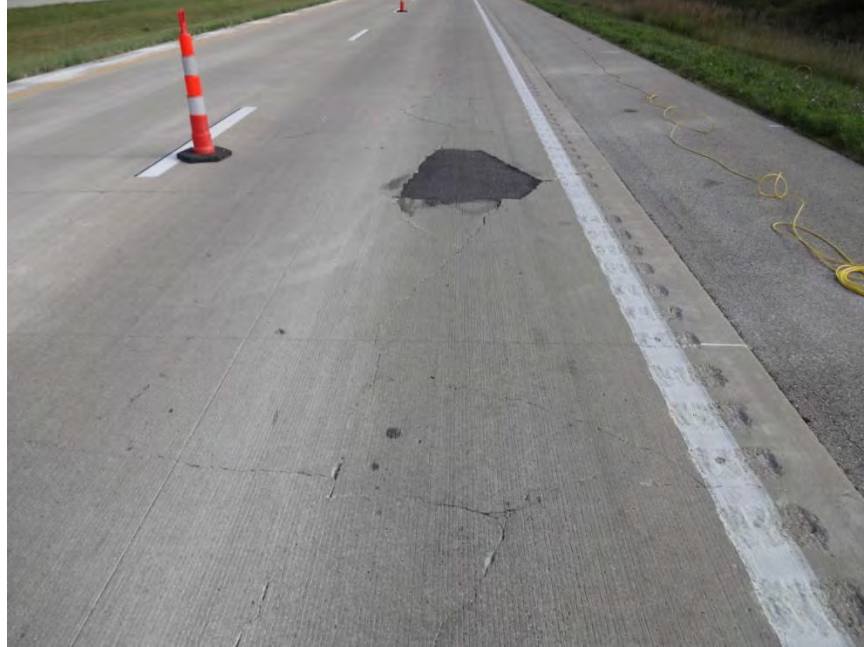
Visual assessment of Site 8 indicated that the pavement was in good condition with PASER rating of 7. A few patches and cracks (longitudinal and traverse) were observed at the site. The condition of the pavement is shown in Fig. 2.13 and Fig. 2.14.

*Fig. 2.13—I-35 (Site 8) showing evidence of cracks and patches on the pavement surface.*

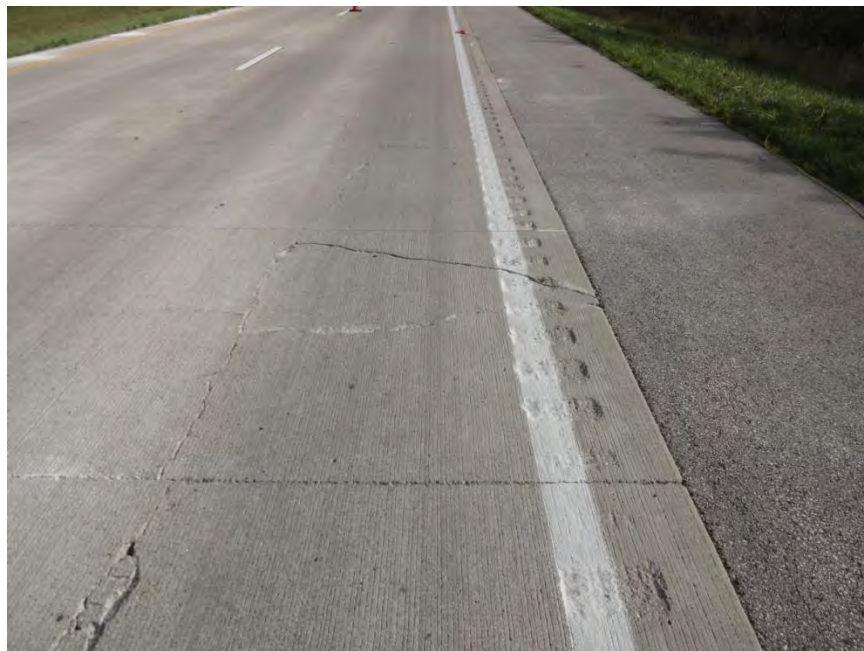
*Fig. 2.14—I-35 (Site 8) showing evidence of cracks on the pavement surface.*

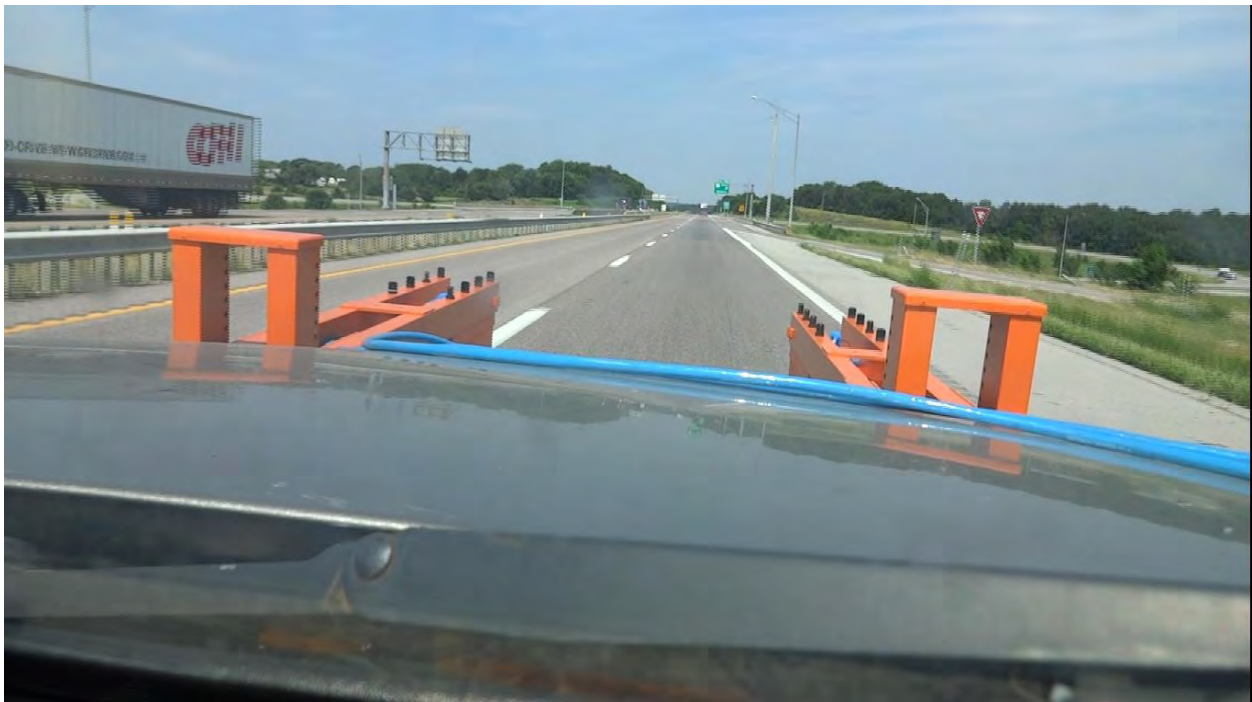
*Fig. 2.15—Typical section of the network-level Site 9 (I-70) pavement. This paved surface was judged to be in good condition.*

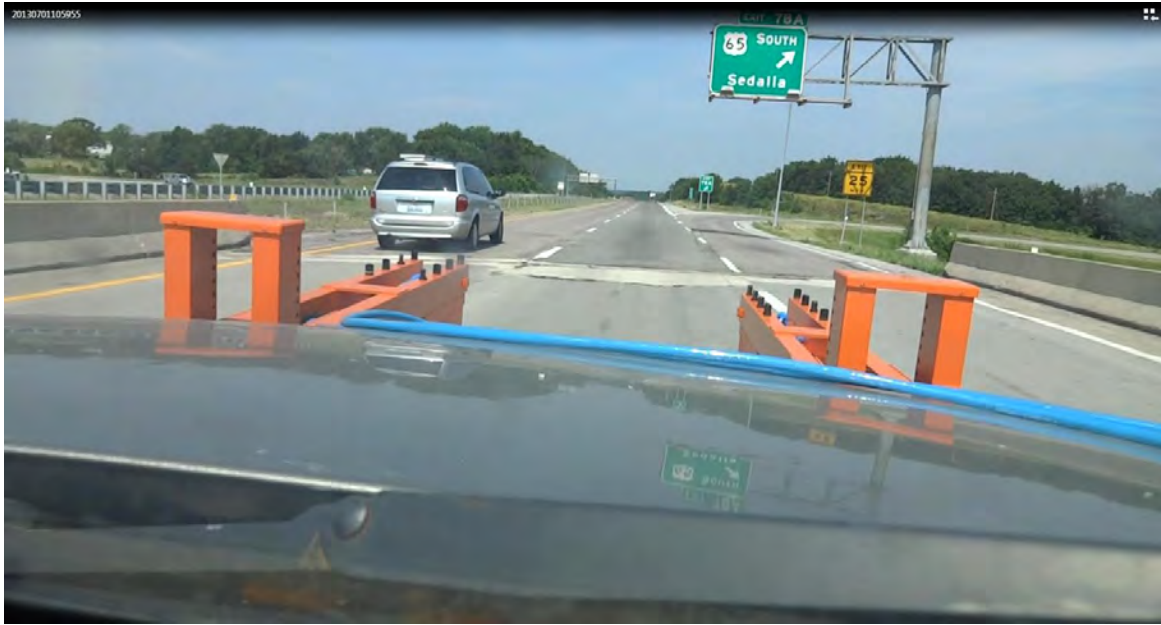
*Fig. 2.16—Photograph of section of network-level Site 9 (I-70) showing cracked and patched surface of a bridge deck.*

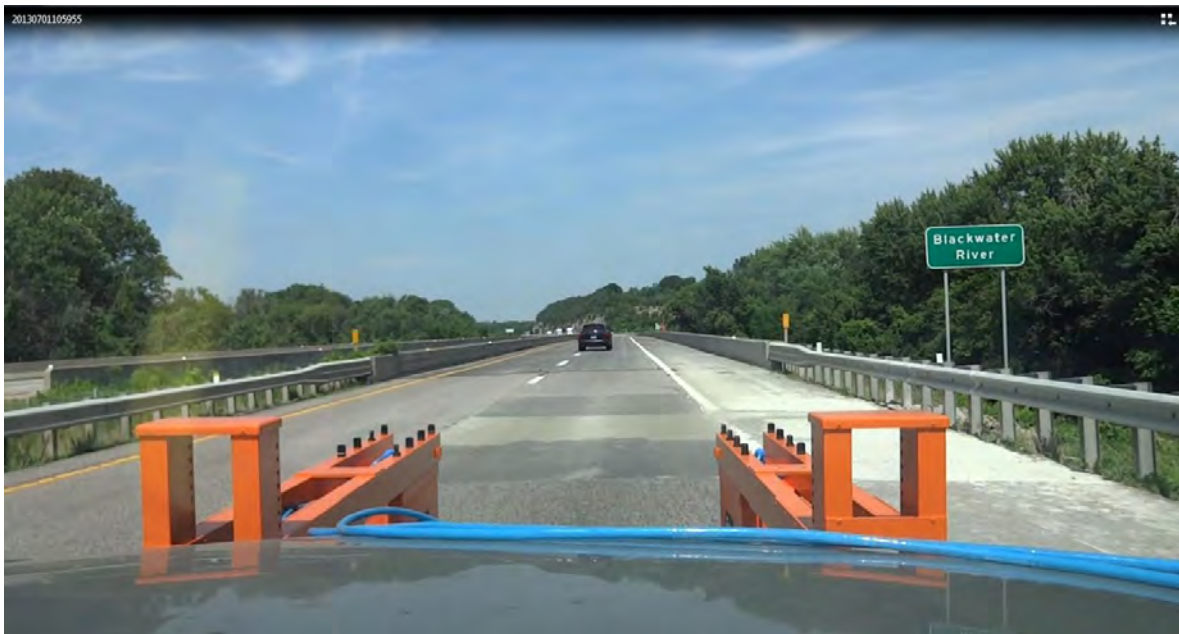
*Fig. 2.17—Photograph of section of network-level Site 9 (I-70) showing patched pavement near bridge.*

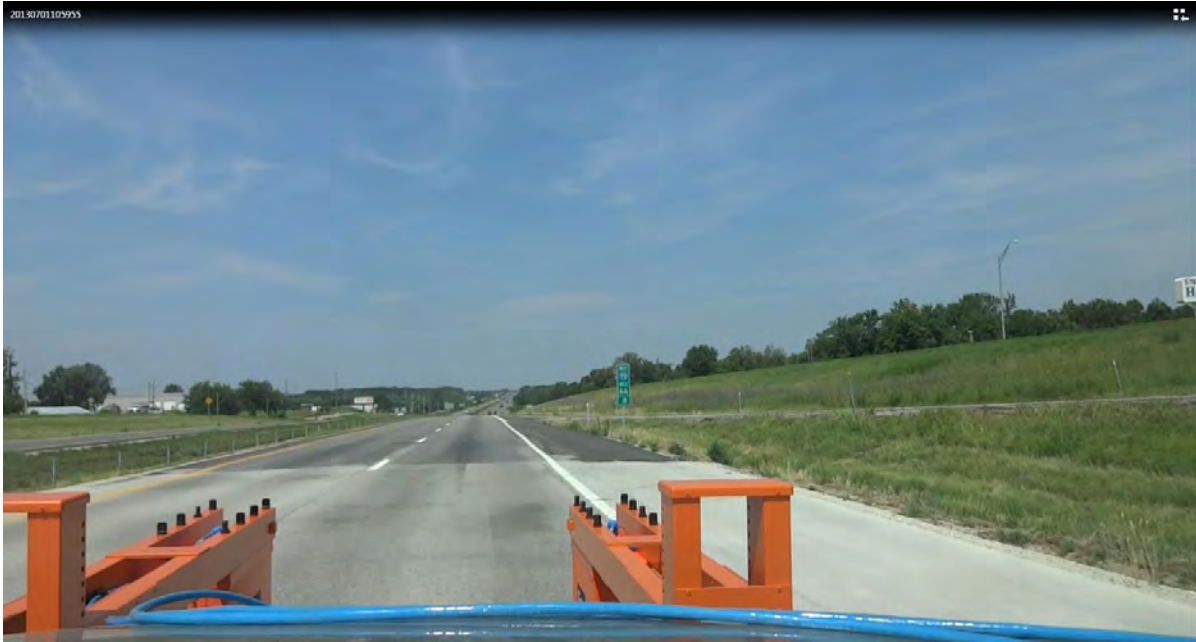
*Fig. 2.18—Photograph of section of network-level Site 9 (I-70) showing transition from PCC to bituminous mix.*

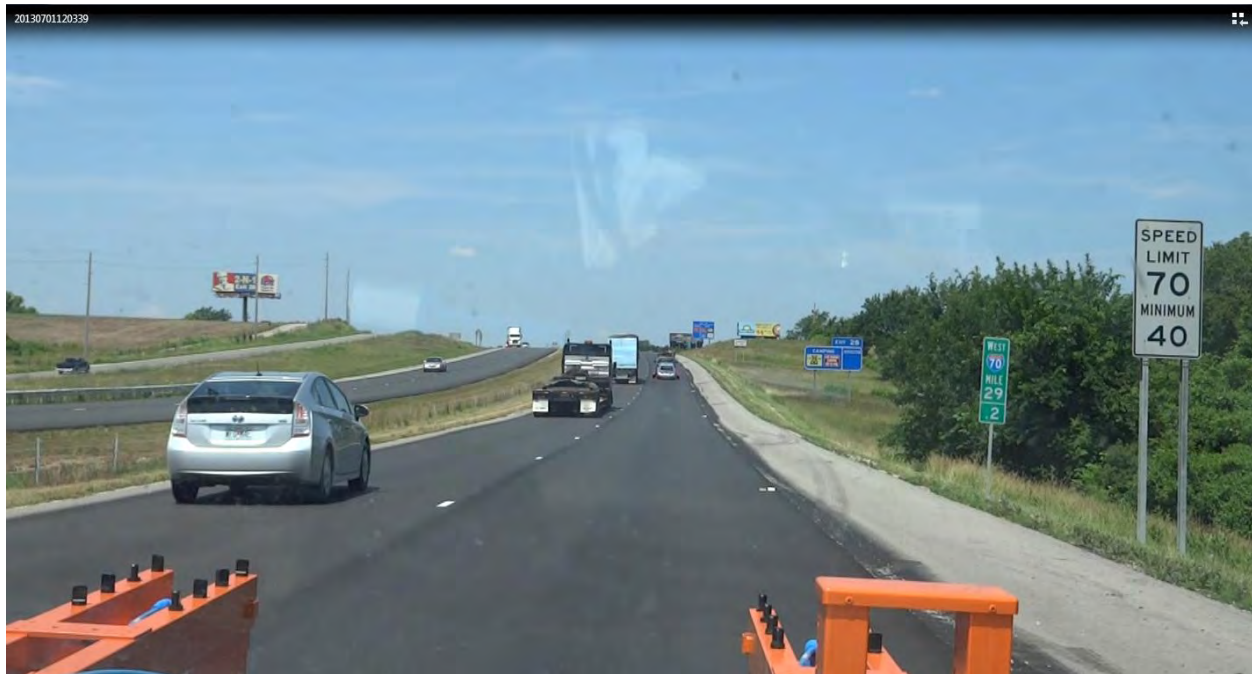
*Fig. 2.20—Photograph of section of network-level Site 9 (I-70) showing pavement that was recently treated.*

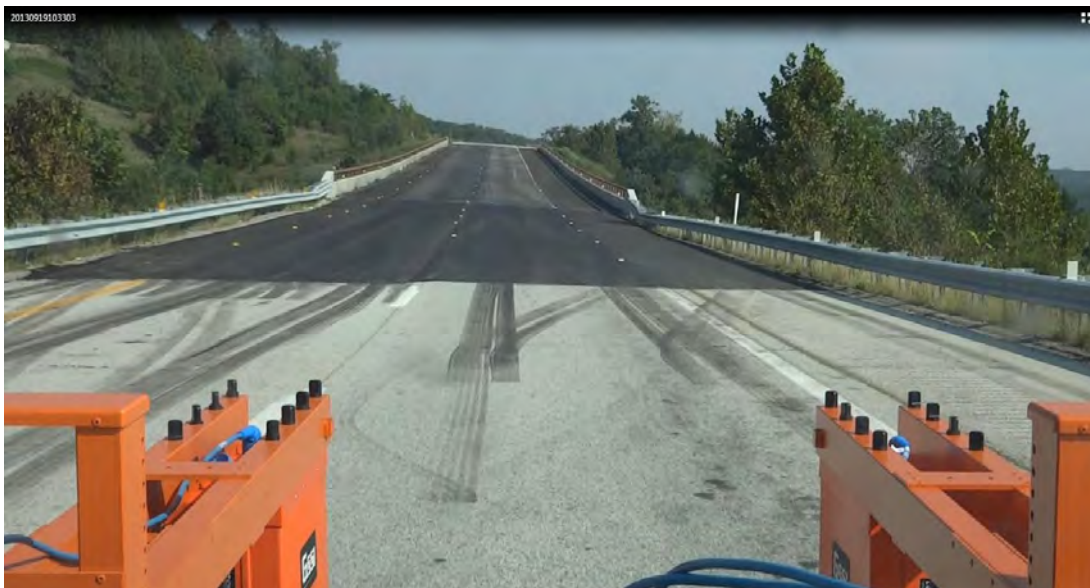
*Fig. 2.22—Photograph of segment of network-level Site 10 (MO 465) bridge with recently applied treatment.*

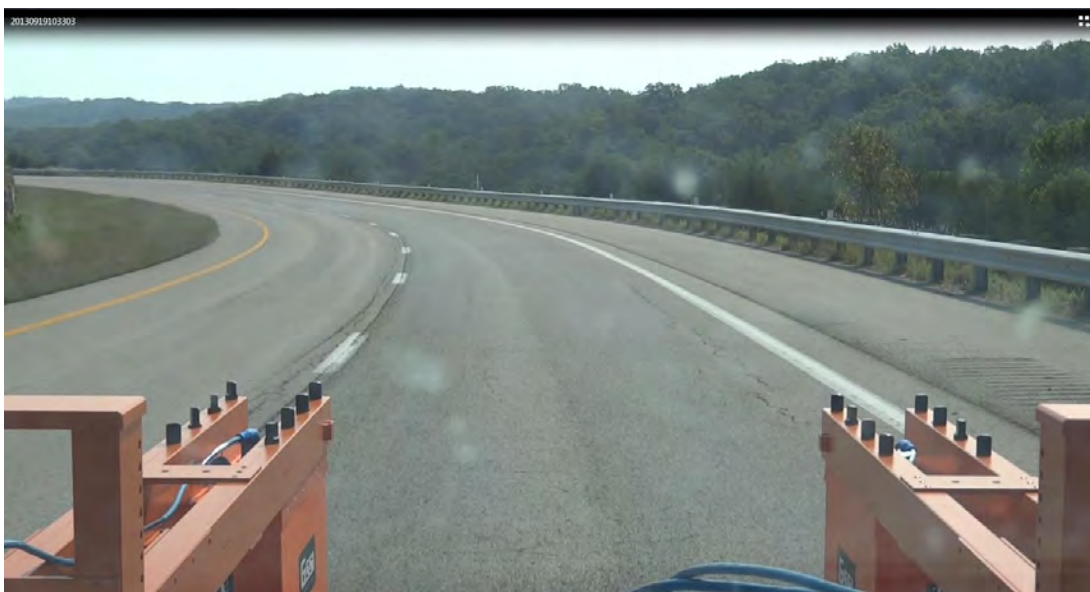
*Fig. 2.23— Section of network-level Site 10 (MO 465) pavement with evidence of cracks and rutting.*

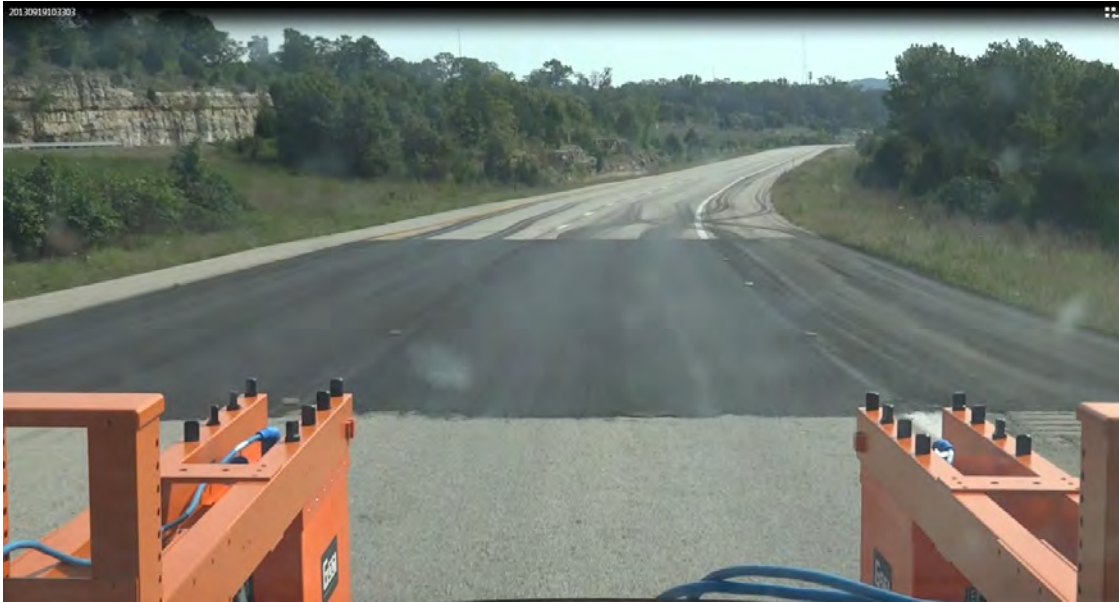
*Fig. 2.24—Recently treated segment of MO 465 (network-level Site 10).*

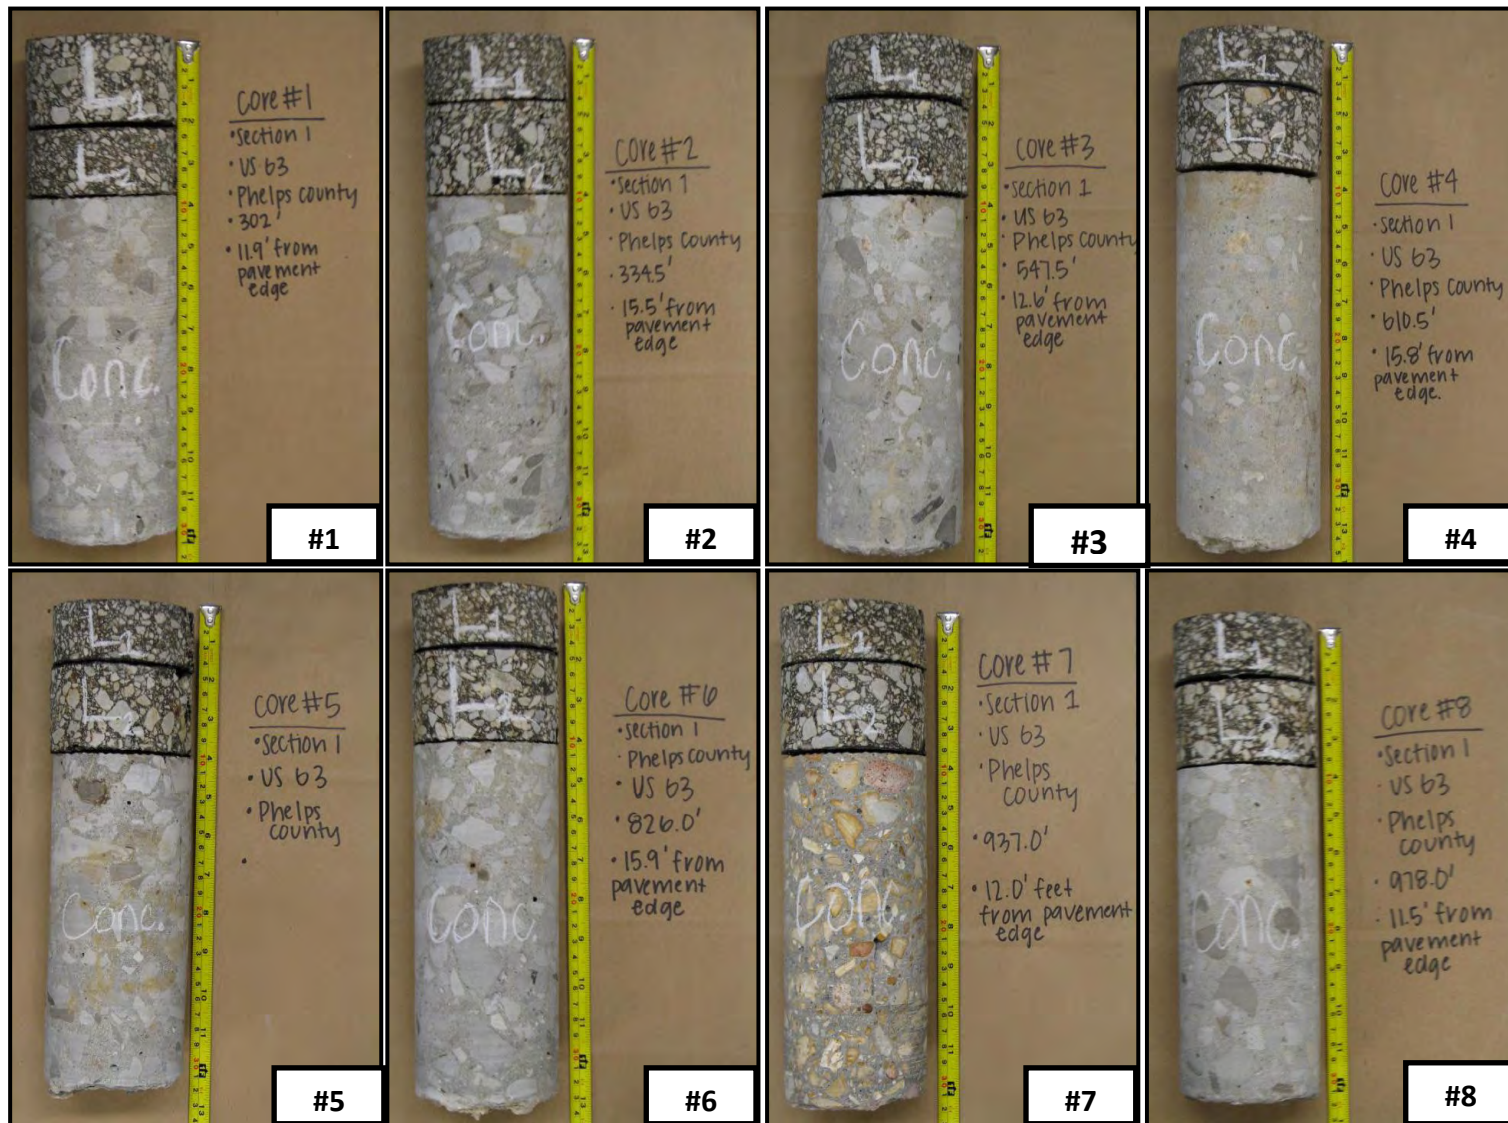
Fig. 2.25—Photographs of cores extracted at US 63 (project-level Site 1).

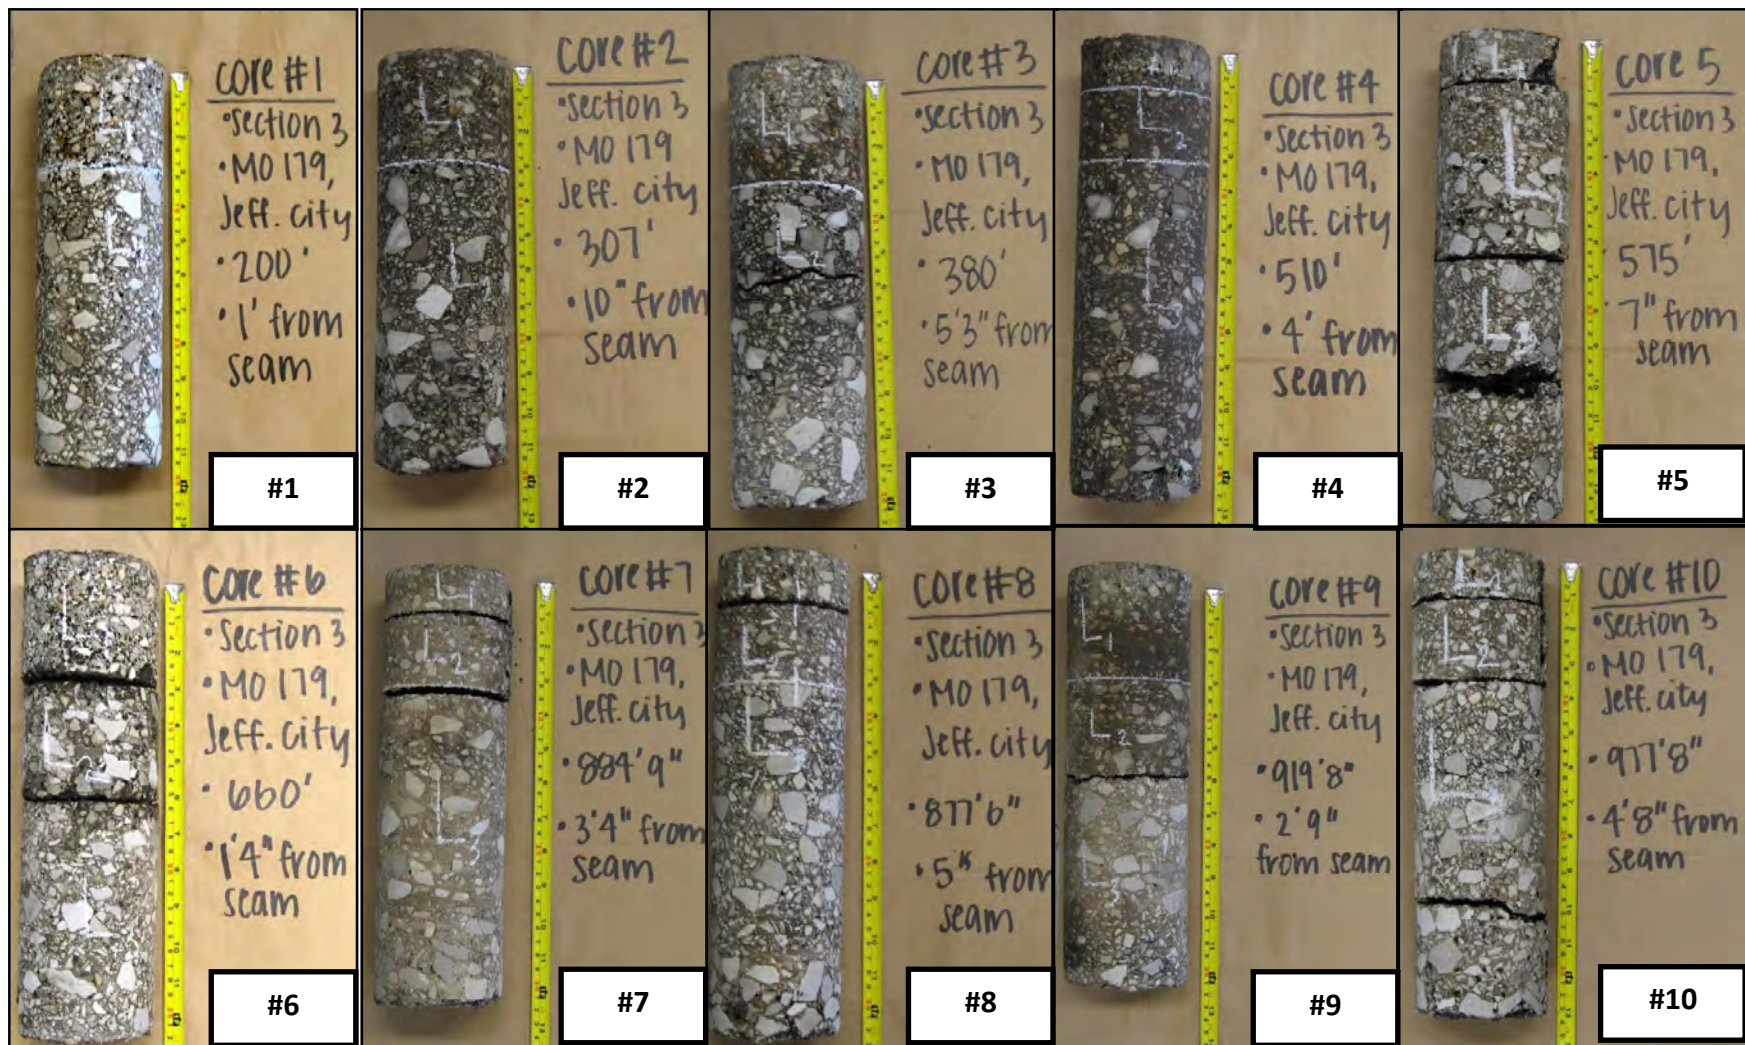
Fig. 2.29—Photographs of cores extracted at MO 179 (project-level Site 3).

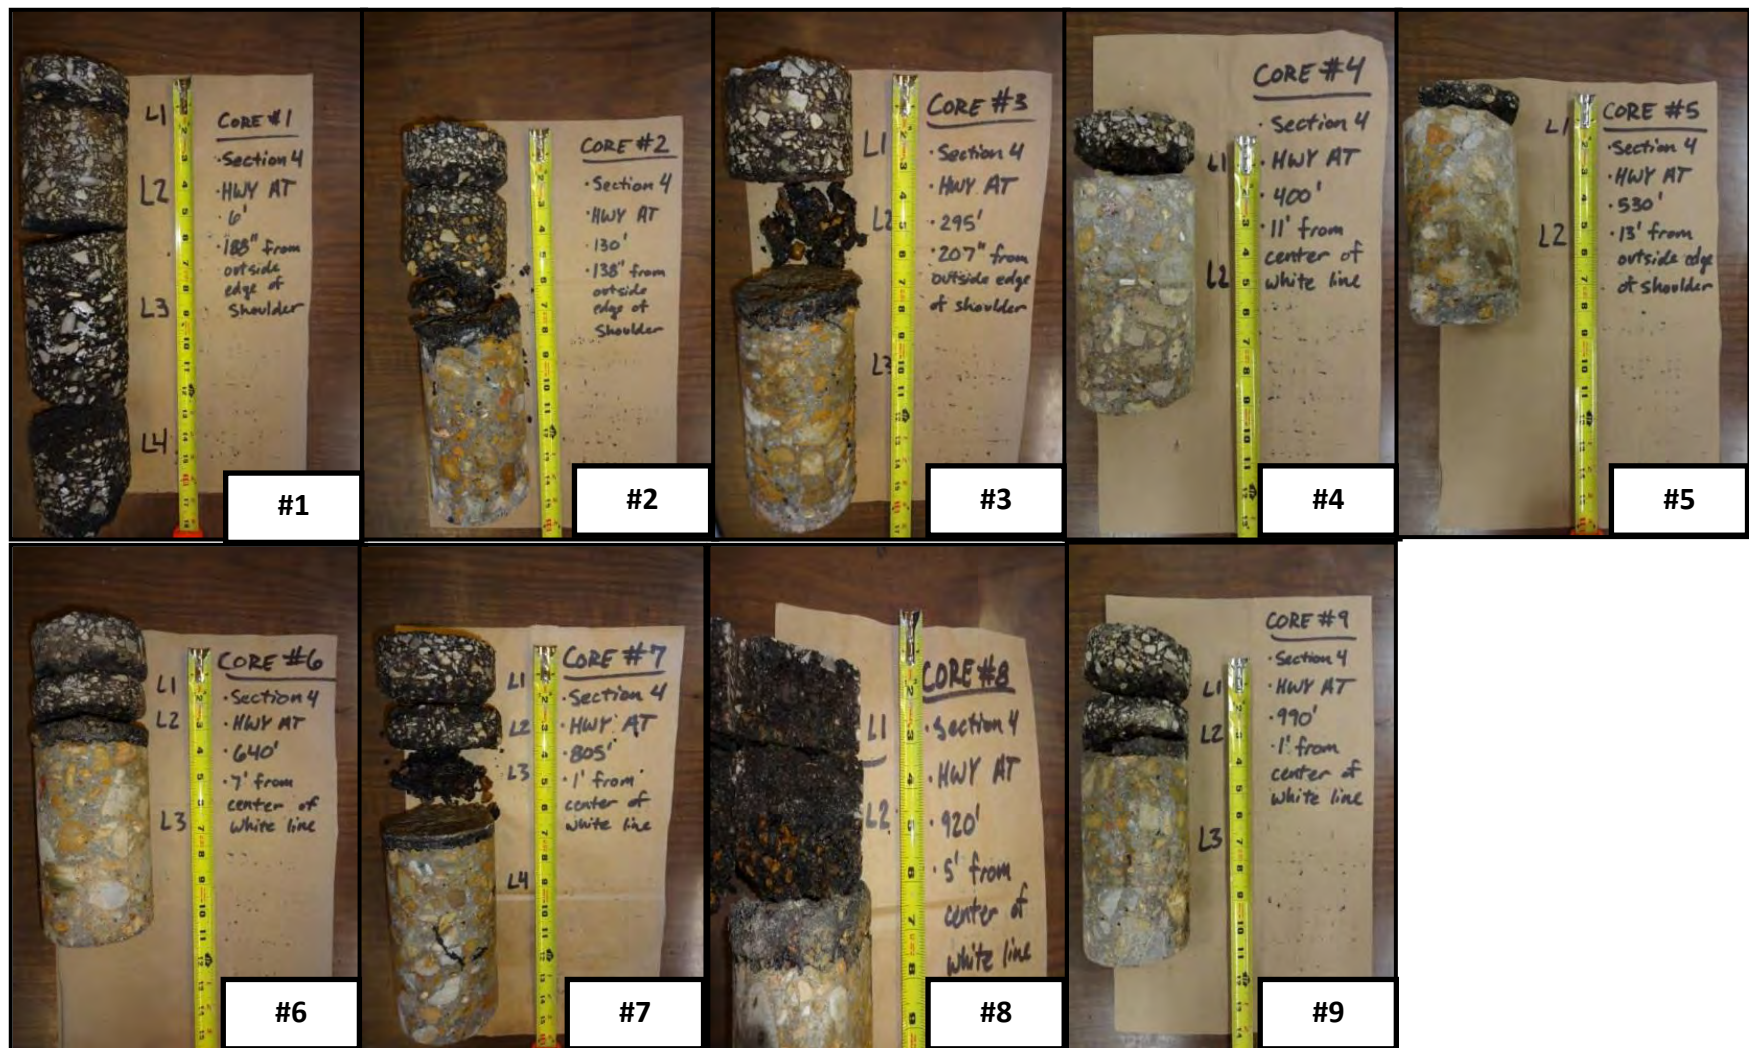
Fig. 2.31—Photographs of cores extracted at HWY AT (project-level Site 4).

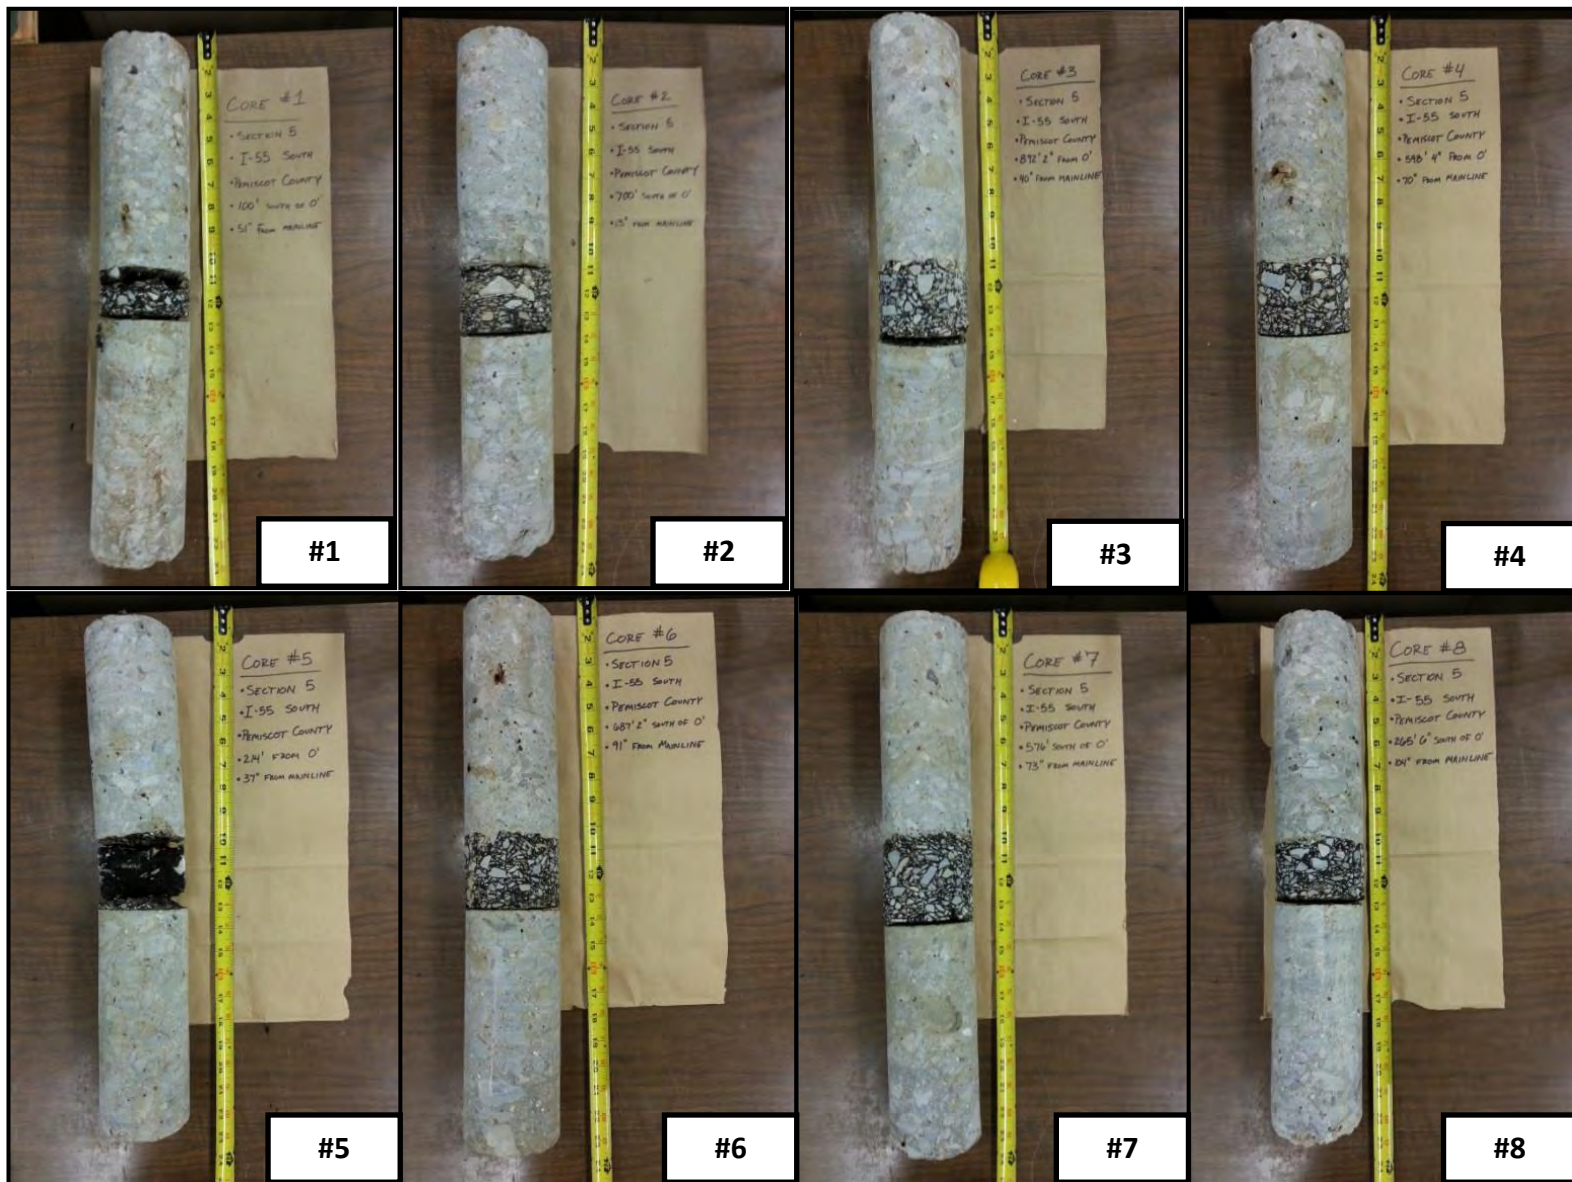
Fig. 2.33—Photographs of cores extracted at I-55 Pemiscot County (project-level Site 5).

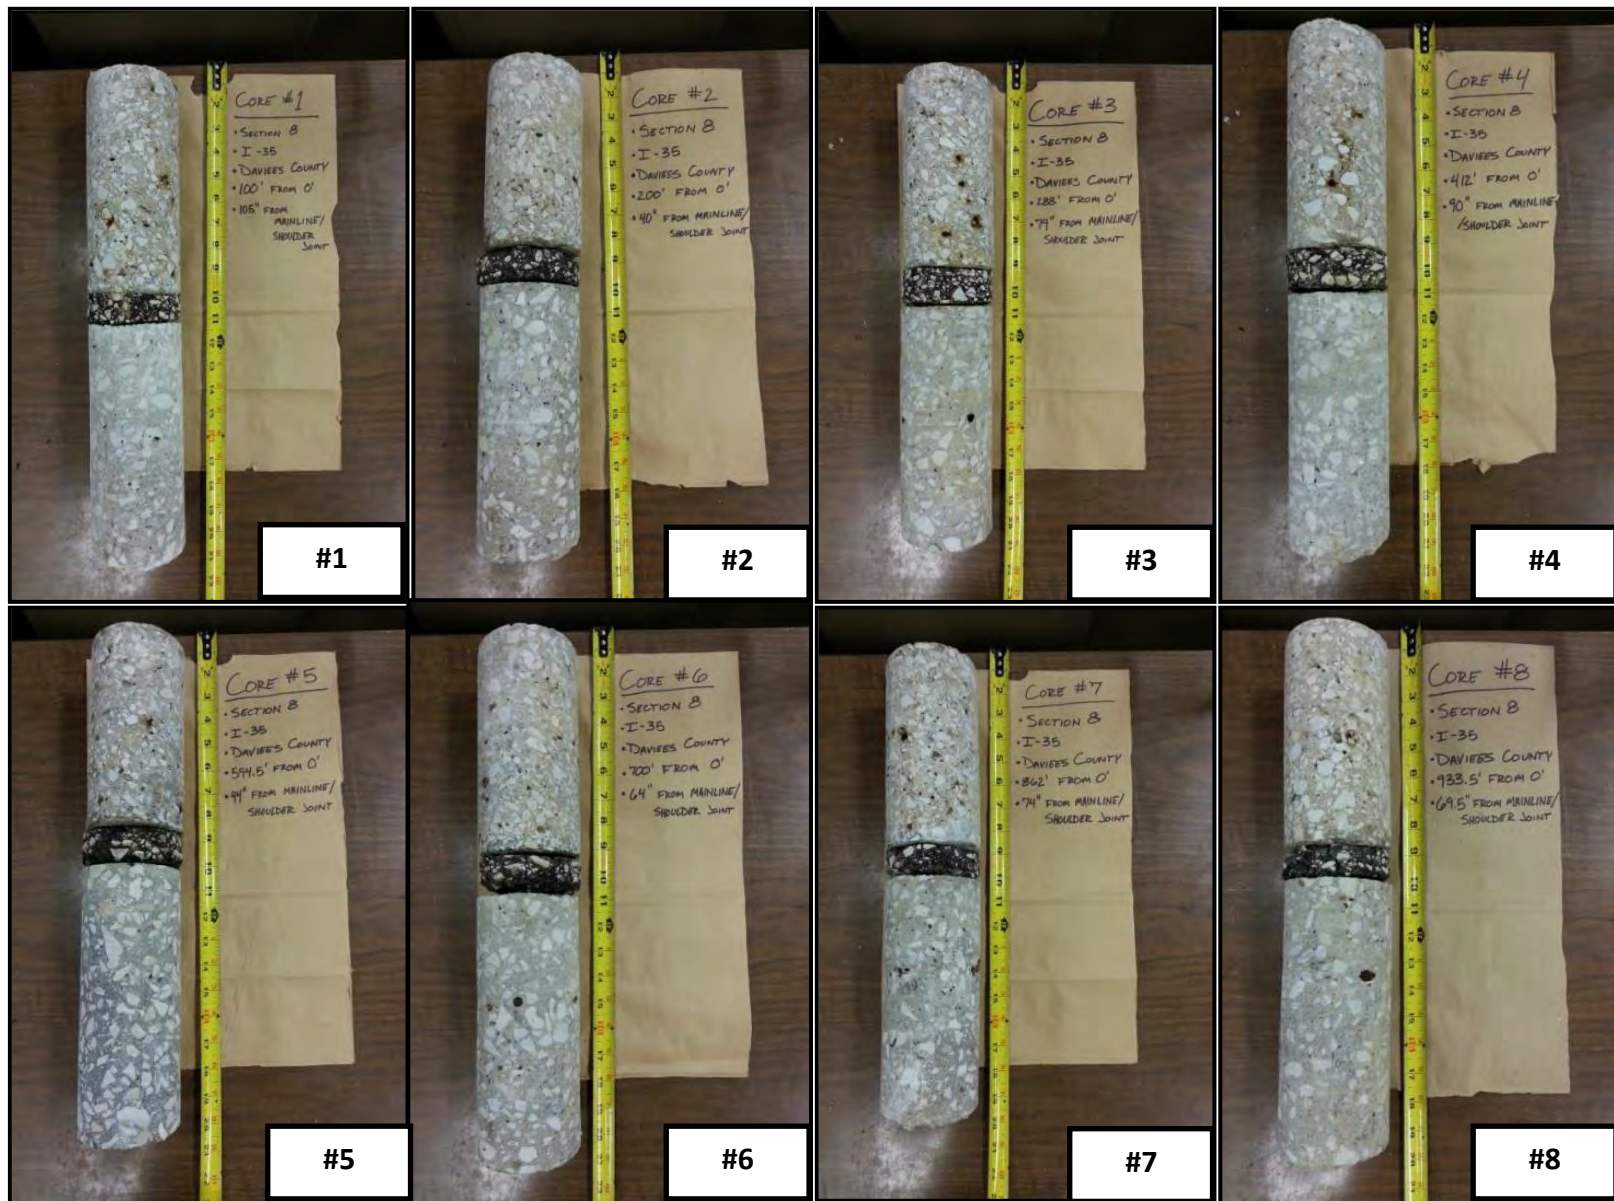
Fig. 2.37—Photographs of cores extracted at I-35 (project-level Site 8).
